# PRELIMINARY ARBORICULTURAL IMPACT ASSESSMENT AT CHALCROFT NURSERIES, CHALCRAFT LANE, BOGNOR REGIS

Prepared for Landform Estates

**By A.T. Coombes Associates Ltd.**

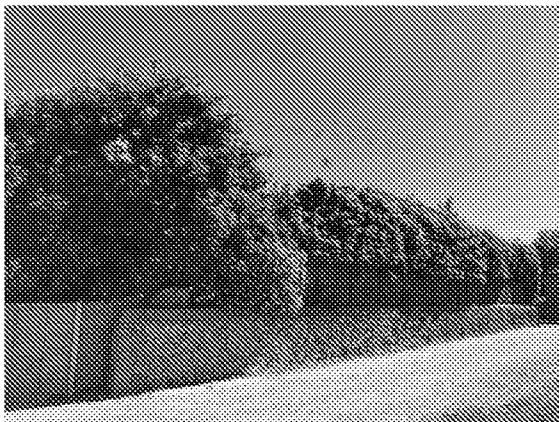
Fig 1: Trees in the neighbouring property to the north of the access road.

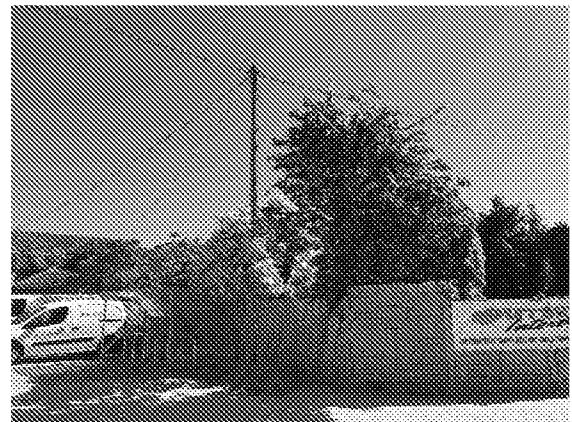
Fig 2: Trees in the neighbouring property to the north of the access road.

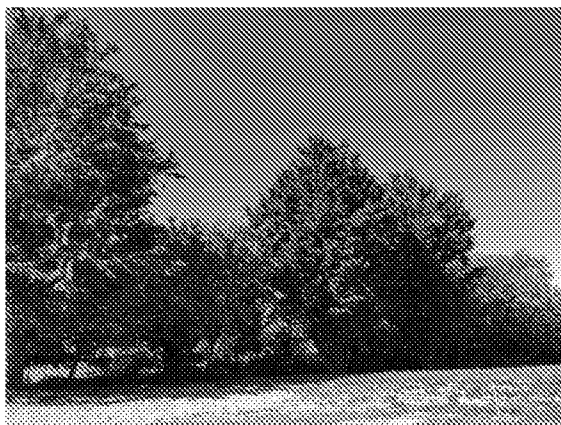
- 2.3 There is continuous tree cover on the southern boundary of the main site (Figs 3 and 4). At the eastern end of this tree belt on the southern boundary are two Leyland cypress and a Monterey cypress within the garden centre site (Fig 3).

Fig 3: Conifers at the eastern end of the southern boundary.

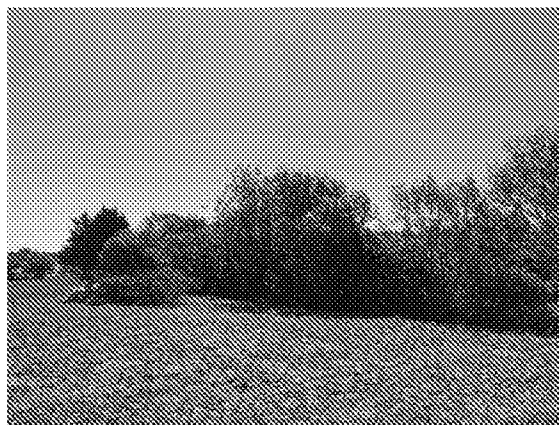
Fig 4: Western section of the southern boundary.

5.9.5 The southern boundary of the Chalcraft Nurseries site and the eastern boundary of the paddock both have continuous tree cover, the majority of which are tall trees that will cast shade into the site and therefore, shading will be a significant constraint. However, if a building is placed within the shade pattern this will need to be mitigated by adequate fenestration, light gathering features or placing habitable rooms away from the shaded areas. Whilst it is desirable to have some shelter from the sun within gardens, a total lack of sun is a common source of complaint from residents of houses adjacent to trees and can lead to pressure to remove trees.

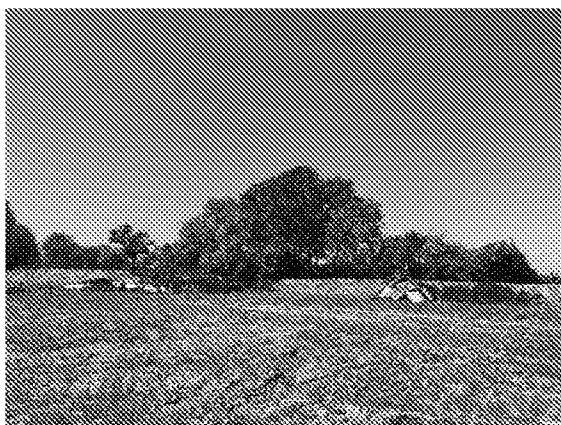
- 2.4 A numerous trees including oak, field maple, hawthorn and hazel is located on the western boundary (Fig 5) and in the north-west corner of the site (Fig 6).

Fig 5: Western boundary.

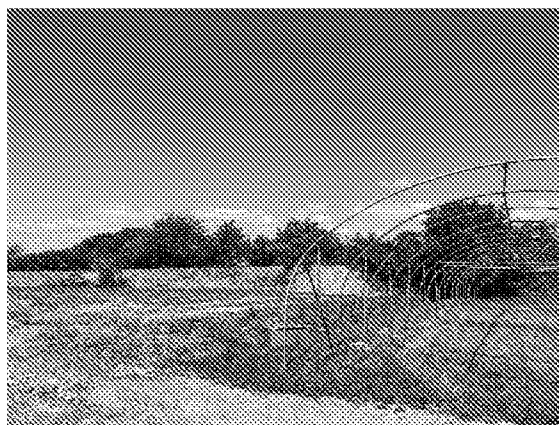
Fig 6: North-west corner of the site.

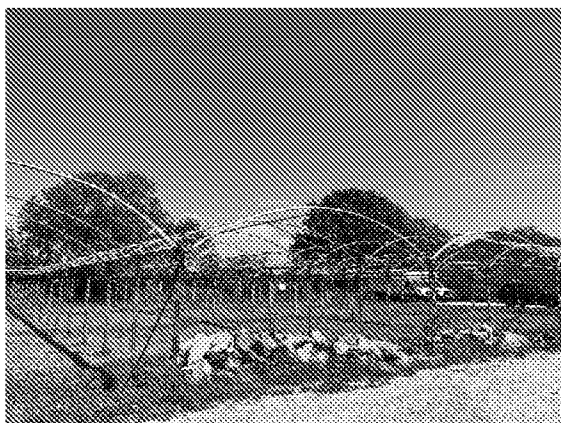
- 2.5 Several oak and ash trees are located on the northern boundary close to the existing buildings (Figs 7 and 8).

Fig 7: Northern boundary.

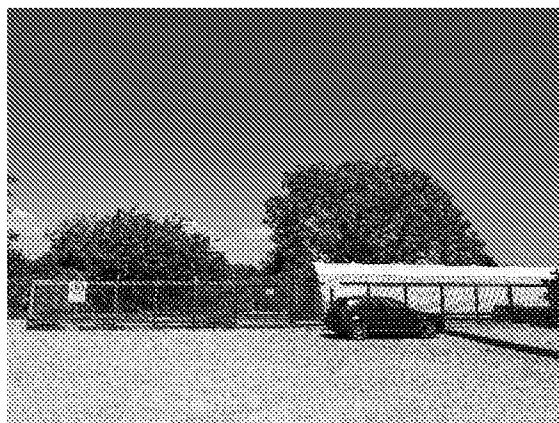
Fig 8: Northern boundary beyond the car park.

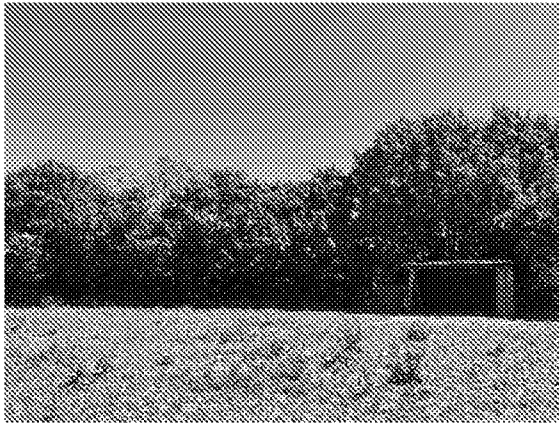
- 2.6 The grass paddock to the south of the main site has dense tree belts on both the eastern and western boundaries (Fig 9). A ditch with trees both sides forms part of the northern boundary of the paddock (Fig 10).

Fig 9: Eastern boundary of the grass paddock to the south of the main site.

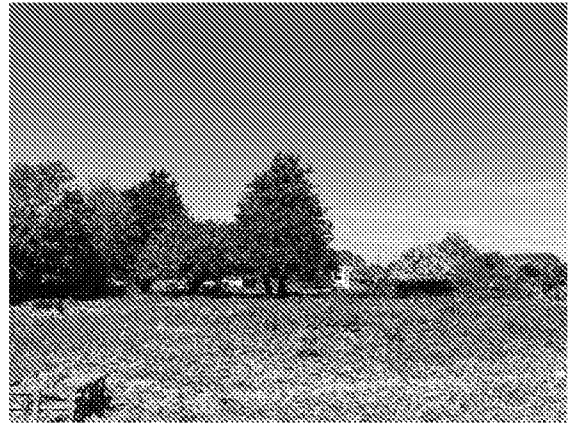
Fig 10: Trees either side of the ditch between the grass paddock and the main site.

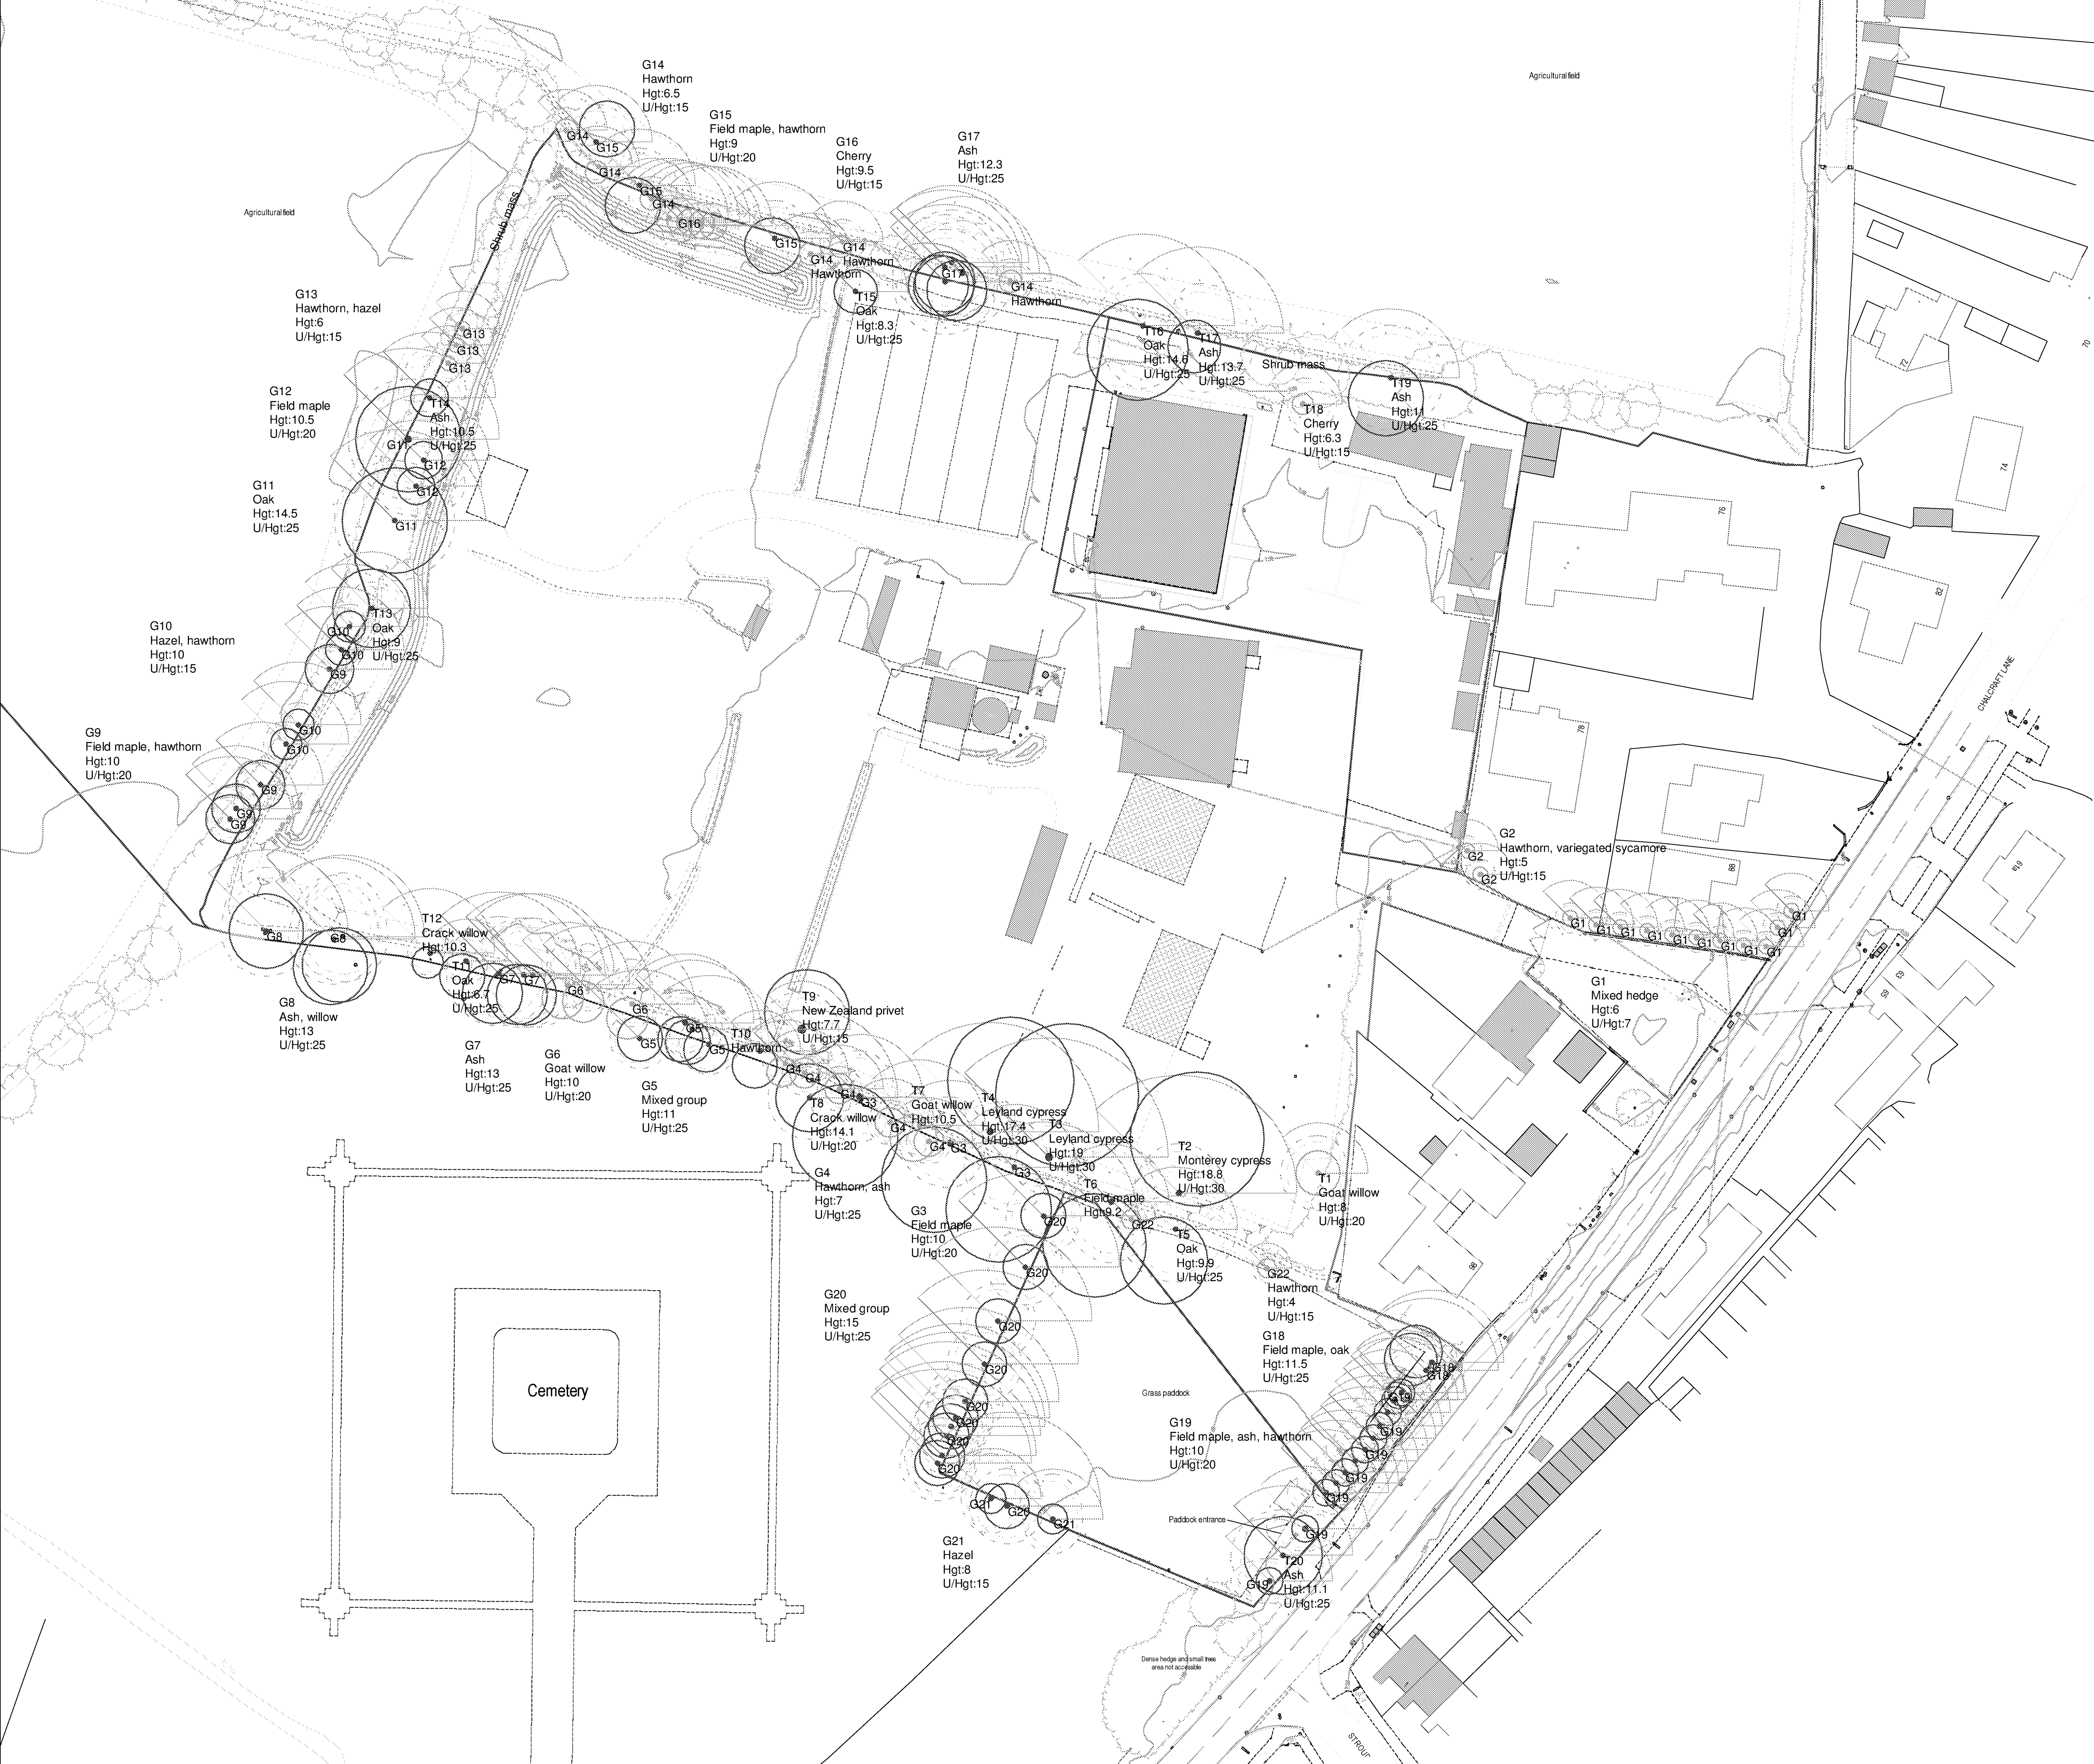
Drawing Title:  
**Appendix 3A - Tree  
Constraints Plan - Existing**

- 4.4 The Root Protection Areas (RPA) for the trees are shown as a coloured circle to match the retention category colour. The RPA will be used to help inform the closest positions of any future buildings. The RPA will be protected during any development work with temporary barriers as prescribed by the British Standard.
- 4.5 The British Standard states that likely root morphology should be considered when drawing the RPAs of trees. The root morphology is likely to be affected by features and structures currently in place on the site; in this instance, the ditches along many of the boundaries are likely to form root barriers and therefore, the RPA's of the adjacent trees have been adjusted accordingly.

- 4.6 The branch spreads were measured at the four cardinal compass points, with a shape drawn around these points to indicate approximate branch spread, represented by green broken lines on the plan. The ultimate crown spread has been shown with an orange dashed line. This is a predicted distance based on personal experience of how far it is likely the crown will grow.
- 4.7 A shade pattern has been shown for each tree forming an arc from north west to due east. This gives an indication of the patterns of shadows created by the trees around mid-day in the summer. This is as recommended in BS5837:2012 (Section 5.2.2) but actual shade patterns throughout the year will vary widely. If shading is likely to be a serious constraint a more detailed analysis of shade pattern using proprietary software may be deemed necessary.

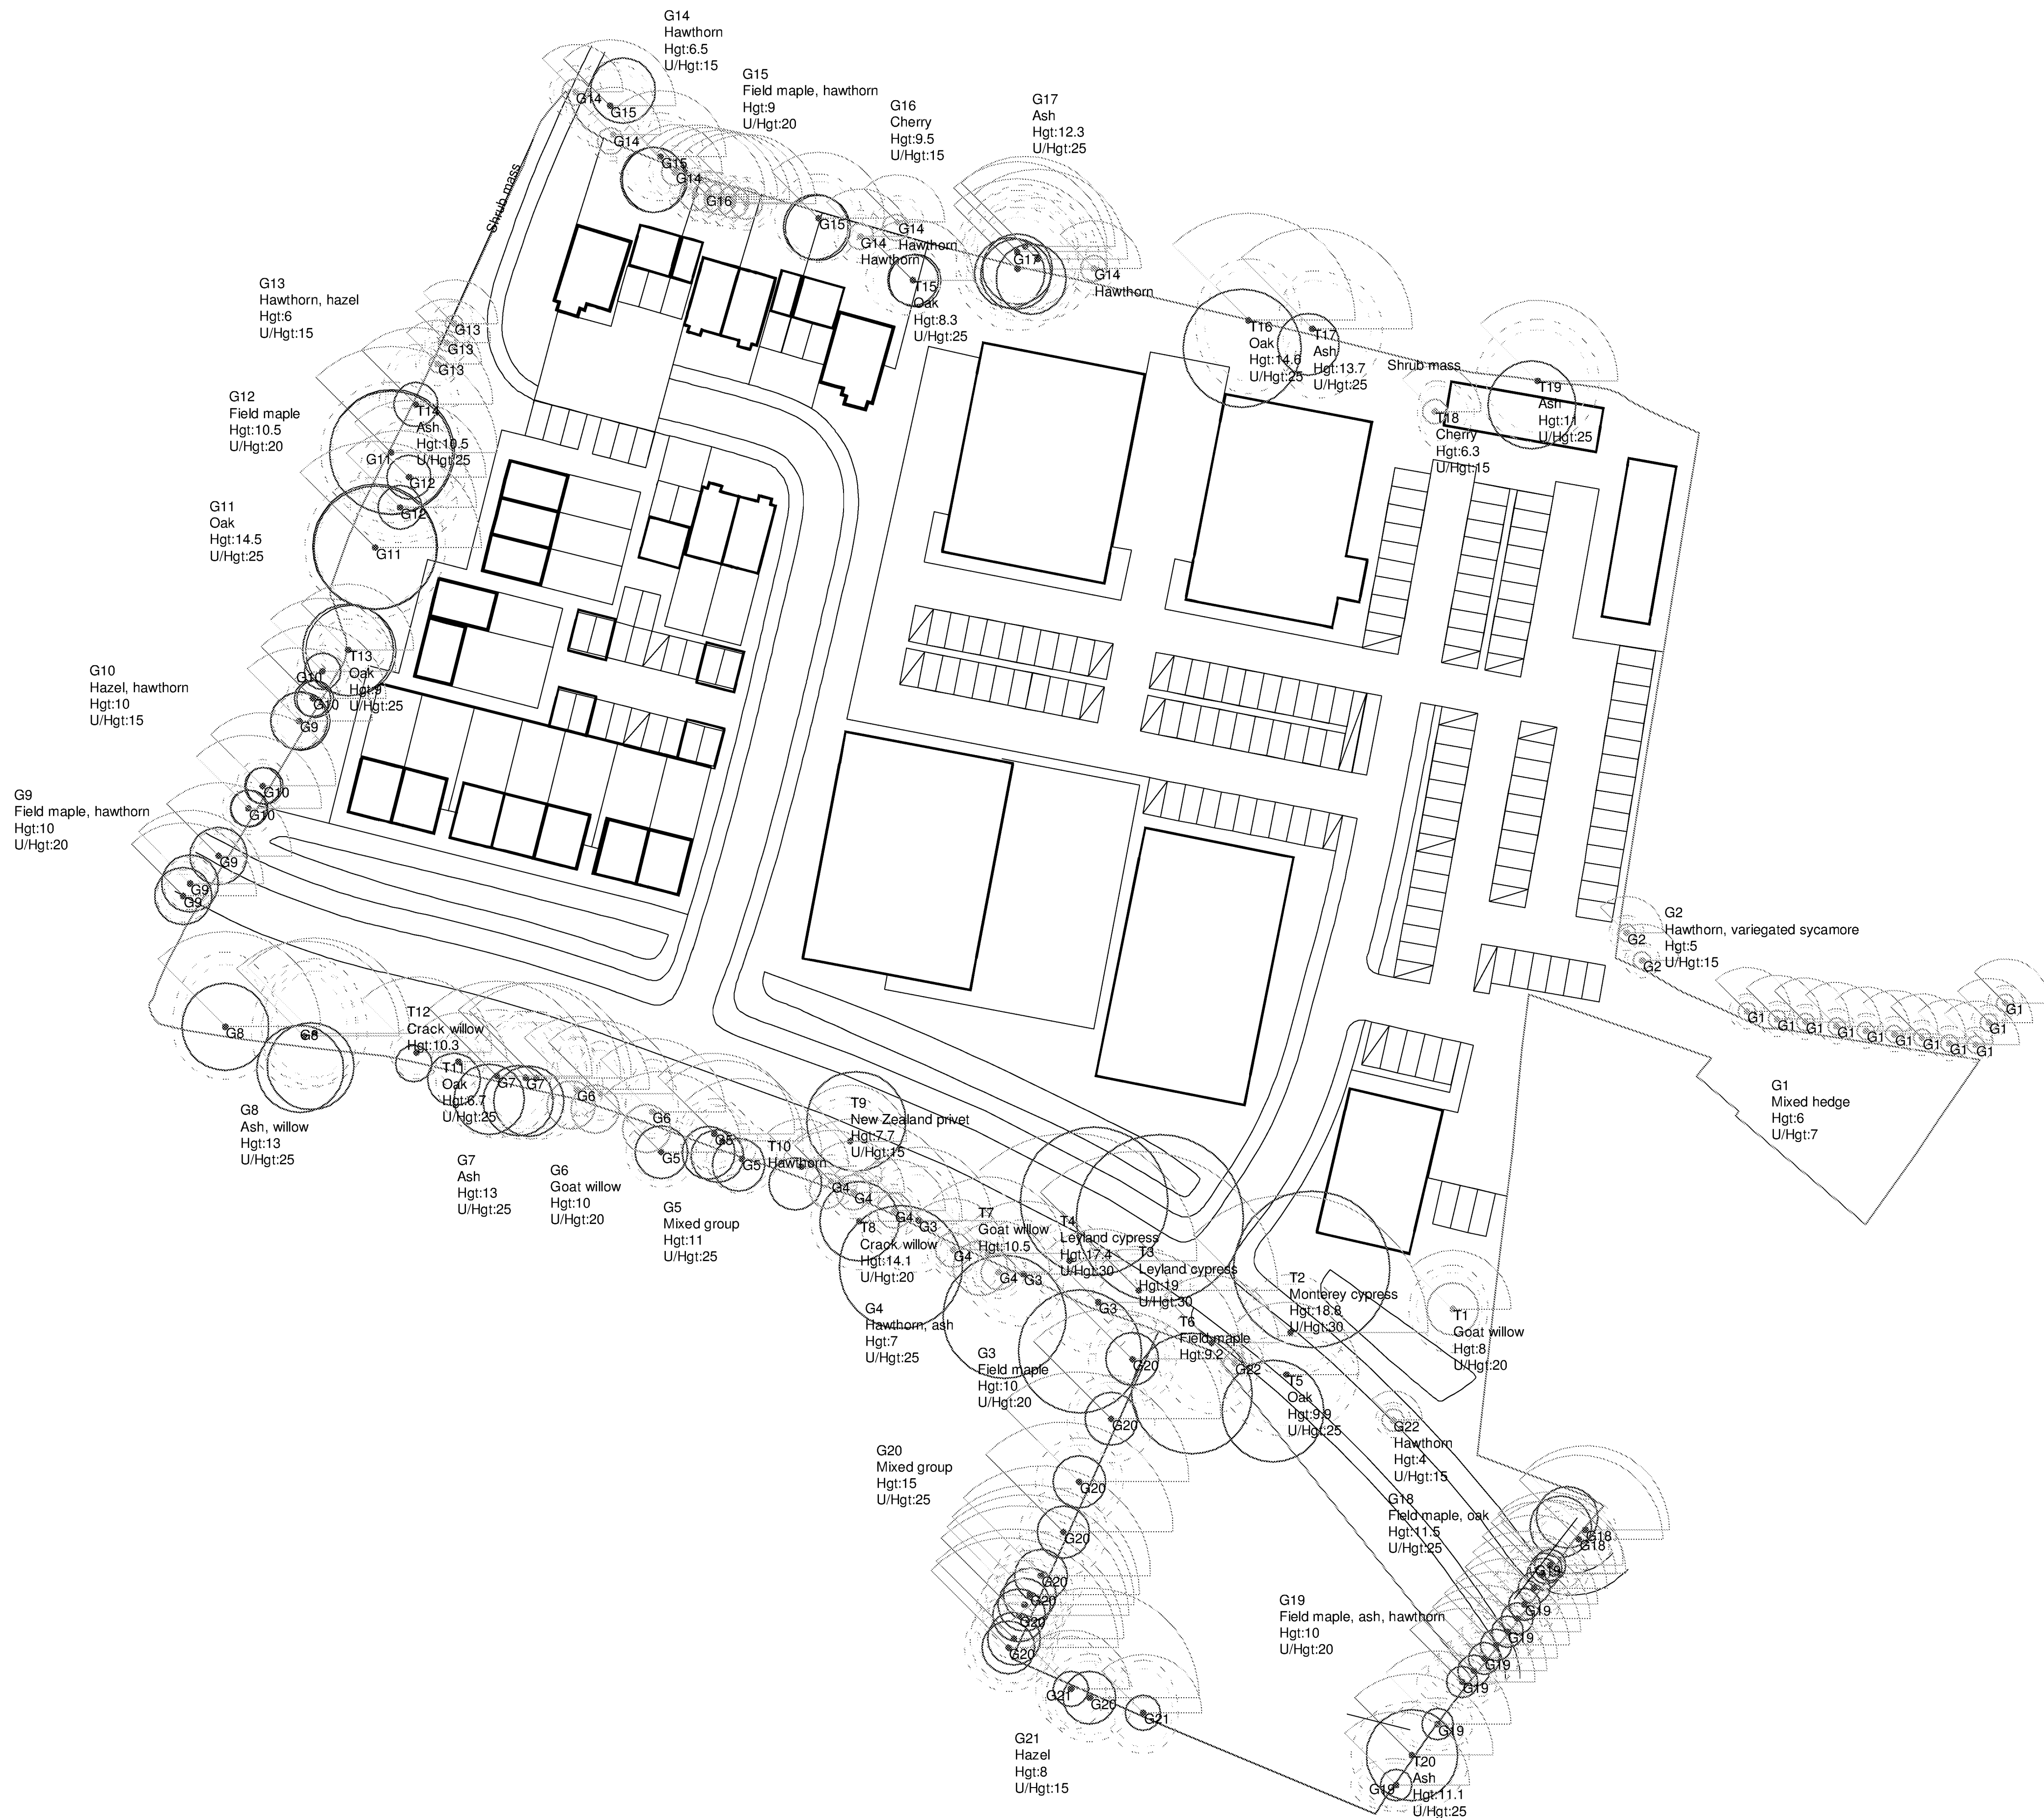
## Appendix 3B - Tree Constraints Plan - Illustrative Masterplan

5.9 Most of the trees included within this report are situated on the site periphery and therefore, and as can be seen in Appendix 3B – Illustrative Master Plan, the proposed development in the central area will be largely free from tree constraints.

5.9.2 The default position should be that any new buildings will remain outside the RPA of retained trees. The principal recommendation of this report is to provide ample space for the future growth of retained trees. The long-term liveability and usability of any buildings must be considered so that no post-development tree conflicts arise.

5.9.4 Any development should take place outside the current or predicted ultimate crown spreads as shown on the TCP to avoid damage to the trees or the new buildings during construction, and to avoid conflict between the future users of the building and the trees. A number of the trees included in the survey are mature examples and therefore, it is recommended that they are given sufficient room to prevent any pressure being placed on them to be removed.

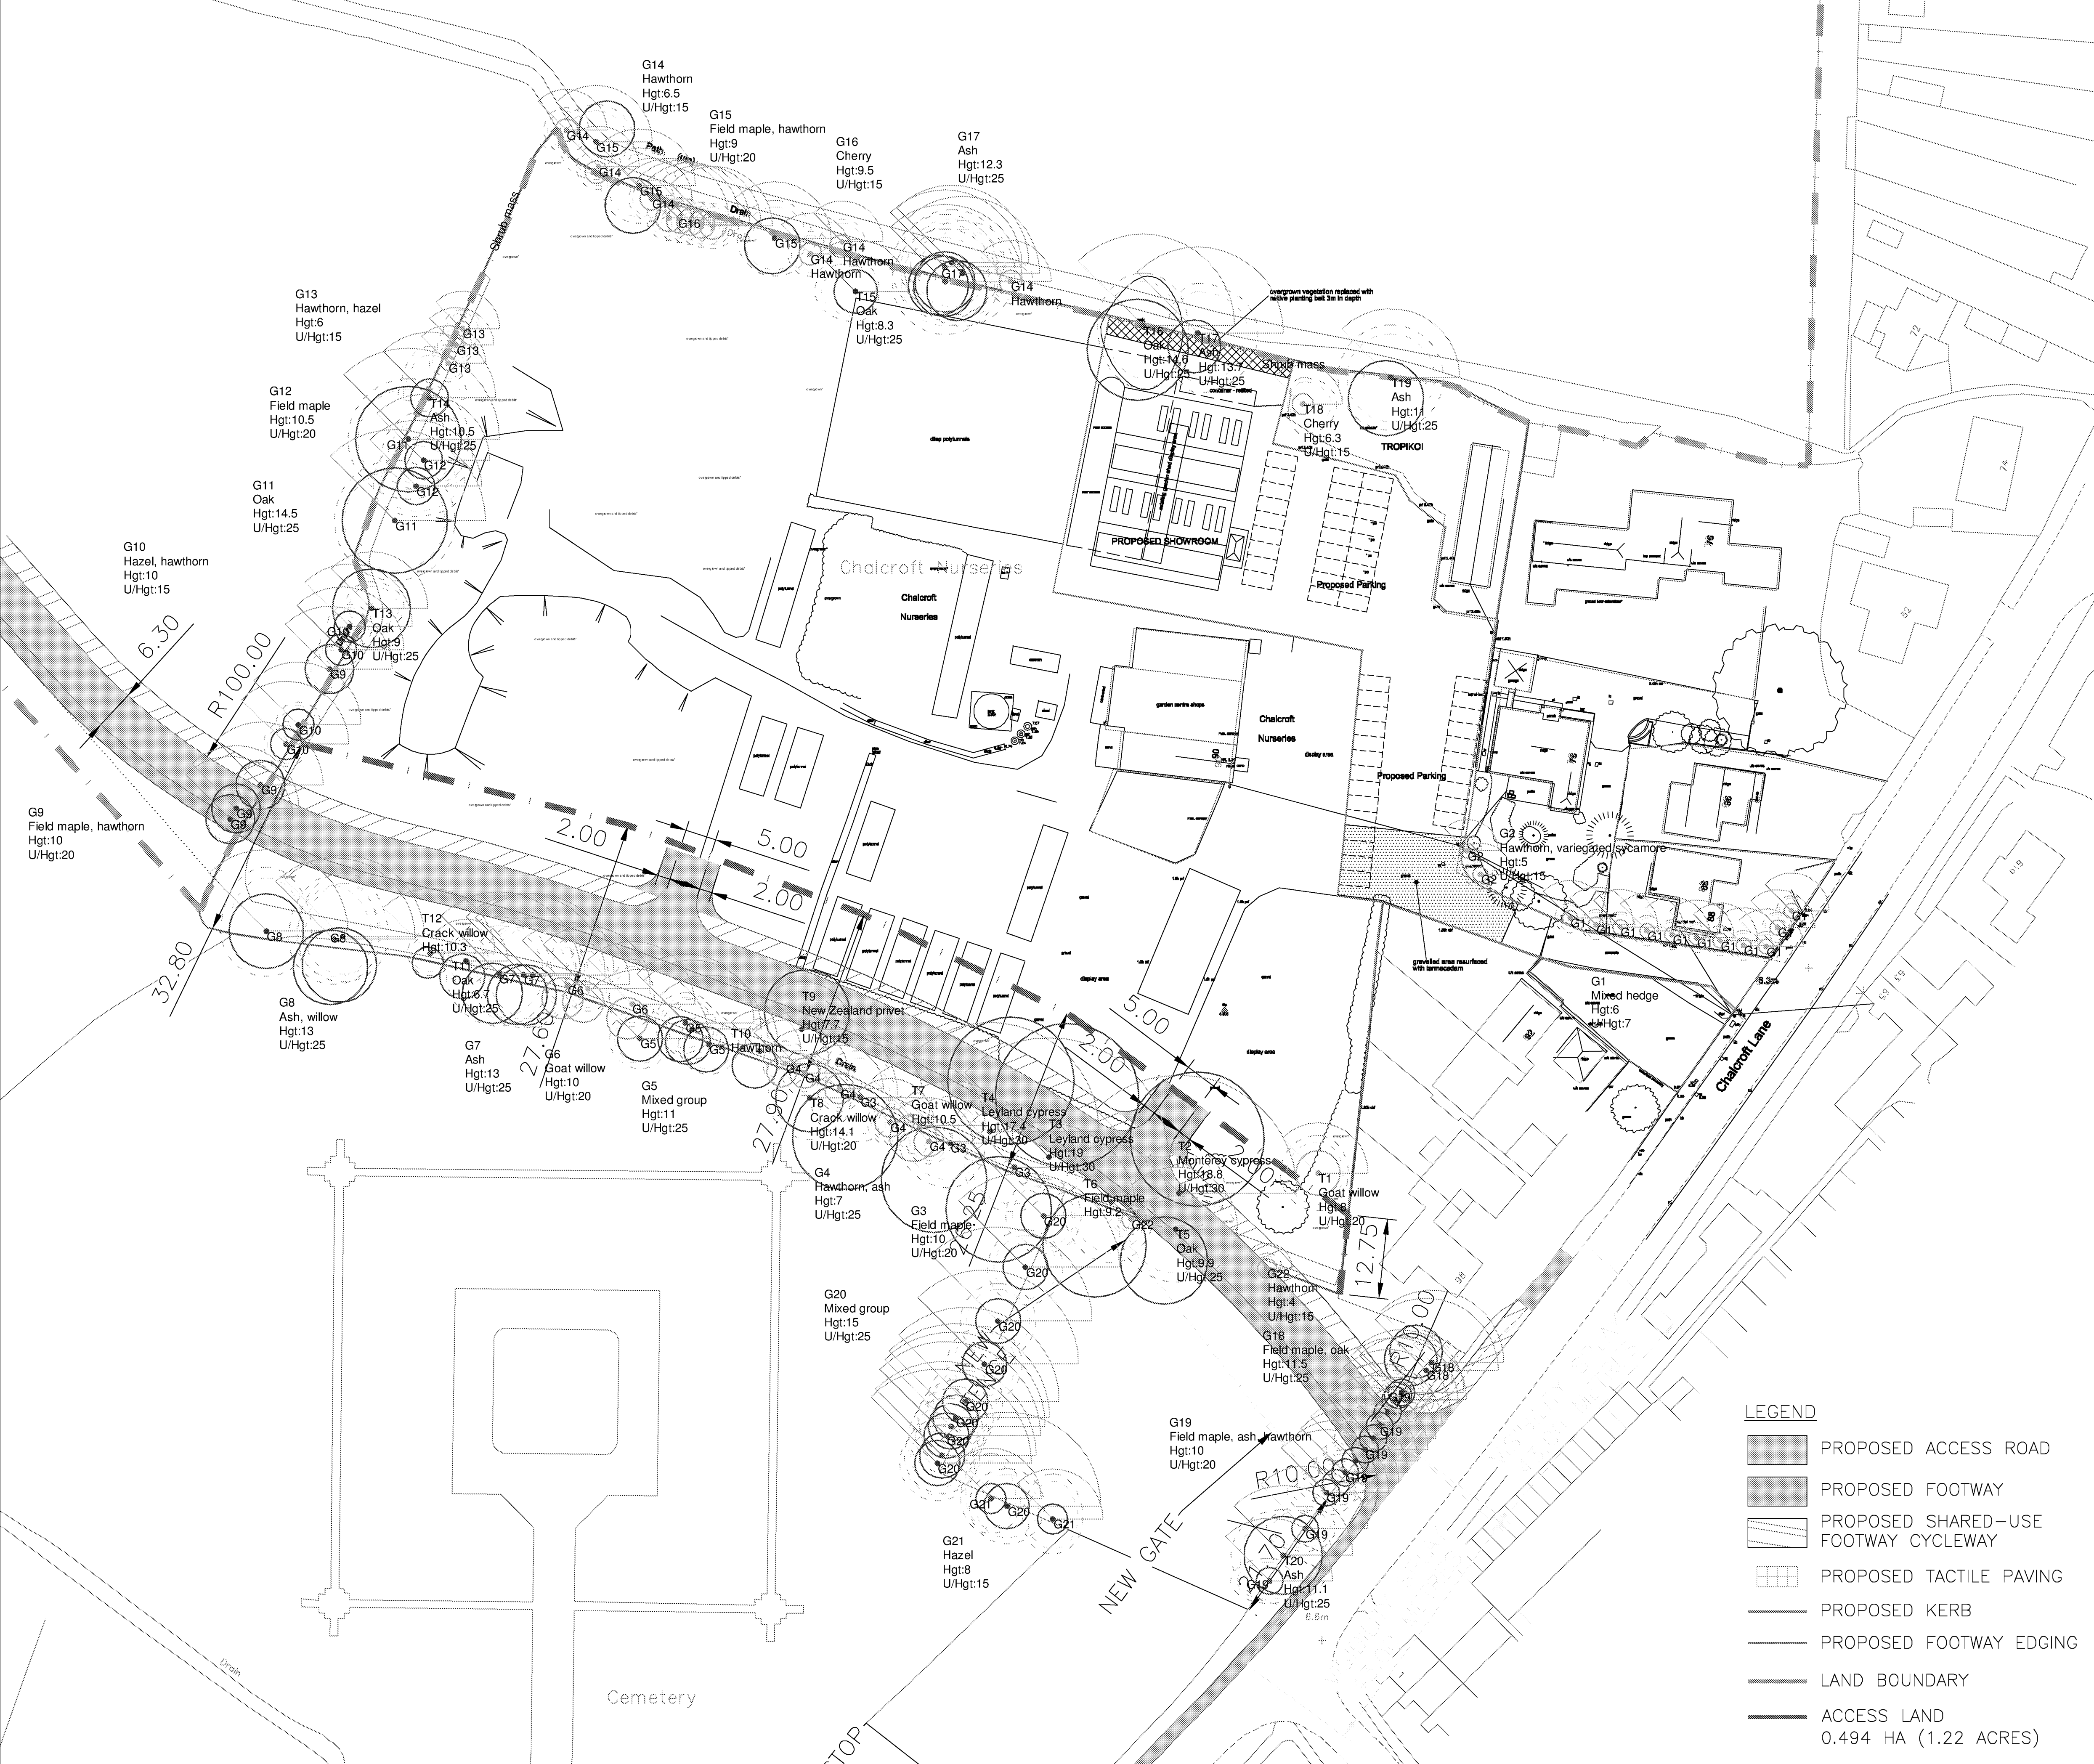
Drawing Title:  
**Appendix 3C - Tree  
Constraints Plan - Proposed  
Access Road**

- 5.10.1 The new access point from Chalcraft Lane, shown in Appendix 3C – Proposed Access Road, will require the removal of a 12 m stretch of the B category group (G19). These trees must be replaced elsewhere on the site as set out in Section 6.

- 5.10.2 The new access road, shown in Appendix 3C – Proposed Access Road, will be within the position or within the RPA of the following B category trees: T2-6, T9, G9 (Category B) and G22 (Category C). These trees will need to be removed and replaced elsewhere on the site as set out in Section 6.

- 5.10.3 If the new road is to be put in place within RPA of retained trees where there is no existing surface, it must be formed using a No-Dig method, with the road surface placed above ground level on a cellular confinement system such as Geocell, Cellweb or similar that will spread the weight to prevent compaction. Such a system must be designed by a suitably experienced engineer and in conjunction with the consulting arboriculturist to ensure that there is no damage to the tree roots. This No Dig surface must not be within 500 mm of the stem of a retained tree and must have a permeable top surface.
