Our Ref.: 18158/addendum report Rev. 2.

**Re: Land West of Fontwell Avenue, Eastergate, Chichester, West Sussex PO20 3RX**

*Figure 1. Trial Hole Location Plan*

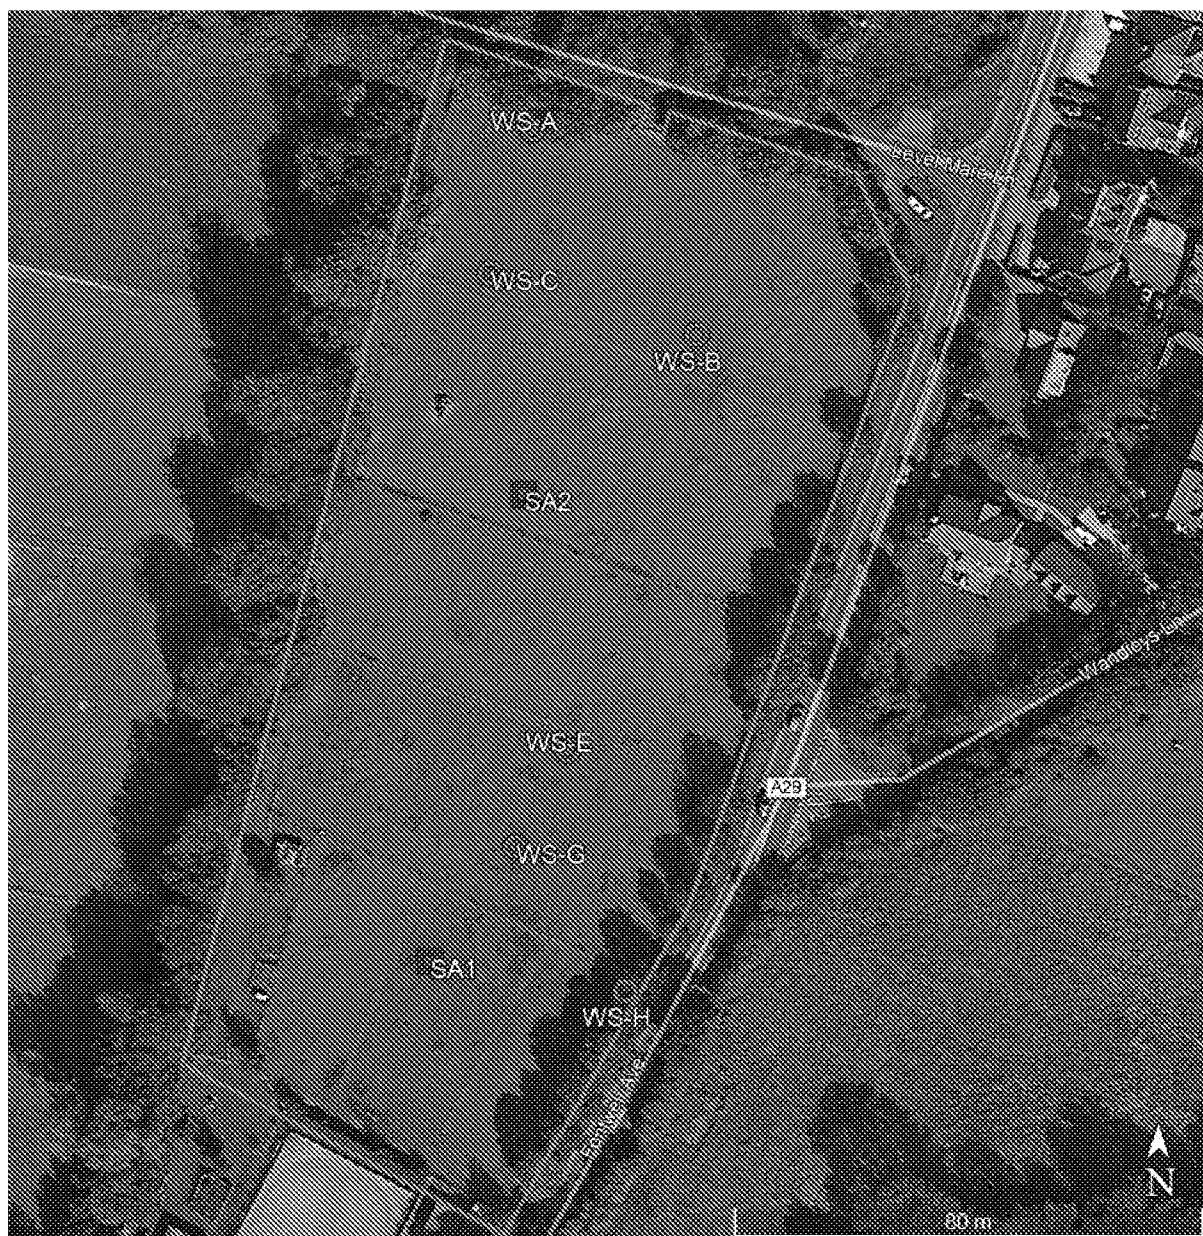
Figure number

The locations of all trial holes referenced in this report have been appended in Figure 1.

Trial Hole Location Plan

On 27<sup>th</sup> August 2020, six windowless sampler boreholes (WS-A, WS-B, WS-C, WS-E, WS-G & WS-H) were drilled to depths ranging between 2.00m and 5.60m below ground level (bgl) at locations approximate to their corresponding catchment (Catchment A – Catchment G) as indicated on drainage proposal drawing 020.5360 SK4 prepared by Paul Basham Associates Ltd. Catchments D and F are informed by SA2 and SA1, respectively, excavated as part of previous intrusive works reported in Soils Limited report reference 18158/FLR Rev 1.02, dated February 2020.

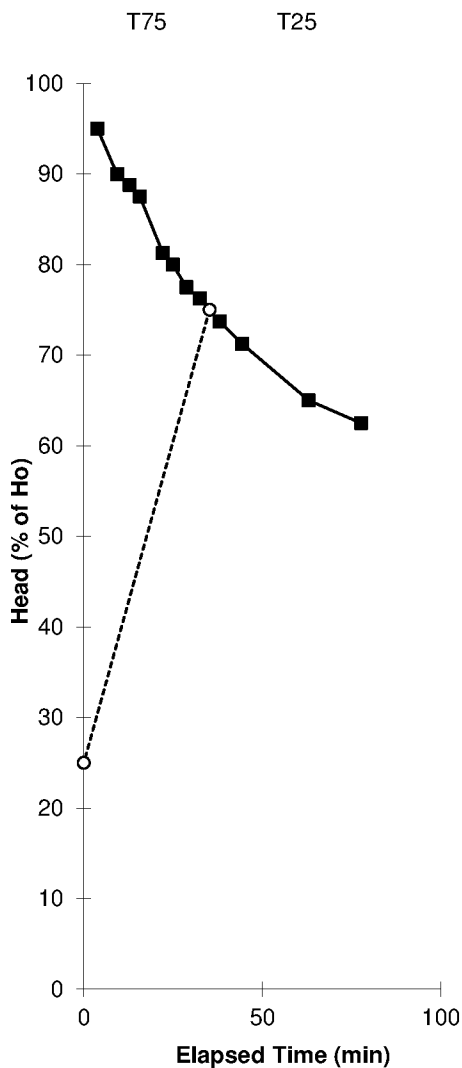
Pit walls collapsing. Test not complete within observation period.

| Trial Hole<br>(Test No.) | Test<br>Stratum | Trial Pit<br>Depth<br>(m bgl) | Water Level<br>Start of Test<br>(m bgl) | Infiltration<br>Rate<br>(m/sec) | Comments |
|---|---|---|---|---|---|
| SA1(2) | HEAD | 2.40 | 1.60 | n/a | Pit walls collapsing during test. Test did not complete within observation period. 300mm fall in head observed over 78 minutes. |
