BARHAM WINDMILL

### RESTORATION SPECIFICATION & SCHEDULE OF WORKS

## BARNHAM WINDMILL, YAPTON ROAD, BARNHAM

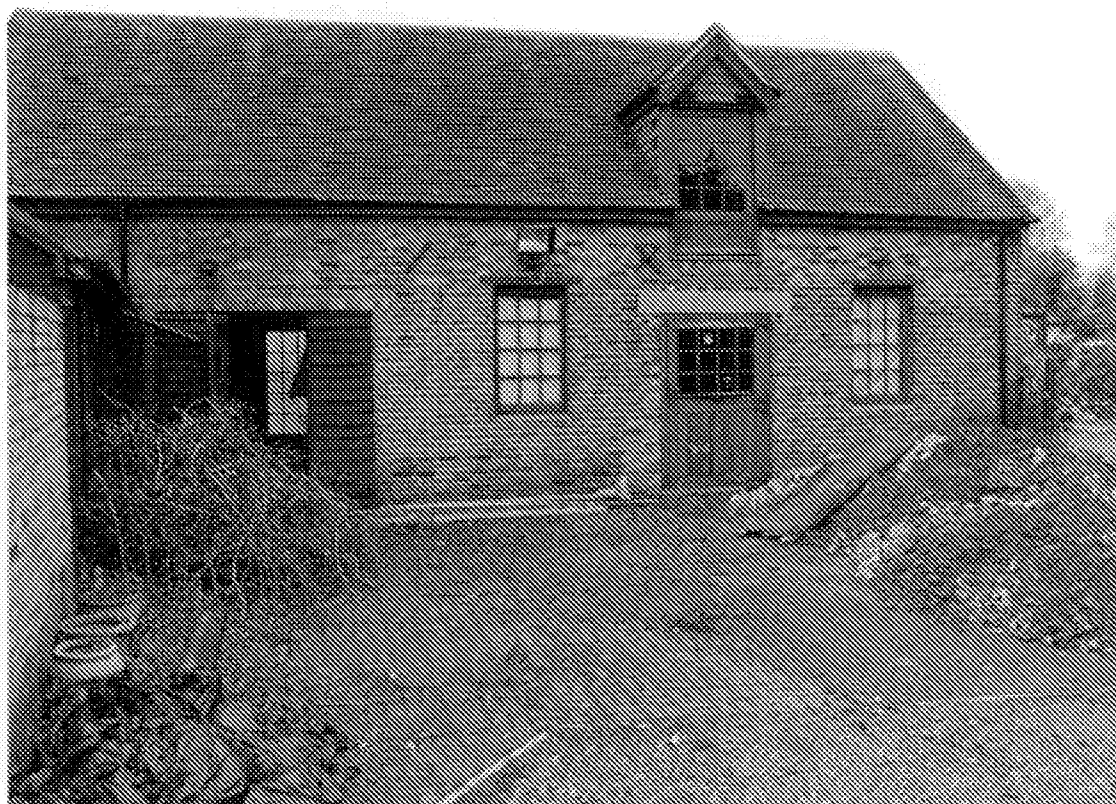
#### **3.1 Roof**

Carefully remove all existing roof coverings along with all timber rafters from previous 1989 refurbishment; all peg tiles to set aside for possible re use.

New 45 degree pitched timber trussed roof to be erected, new roof construction to incorporate thermal insulation values to the most current building regulation requirements.

The trussed roof to incorporate new dormer windows, dormer cheeks to be tile hung to match the appearance of the existing all as drawing 091/P/047/11

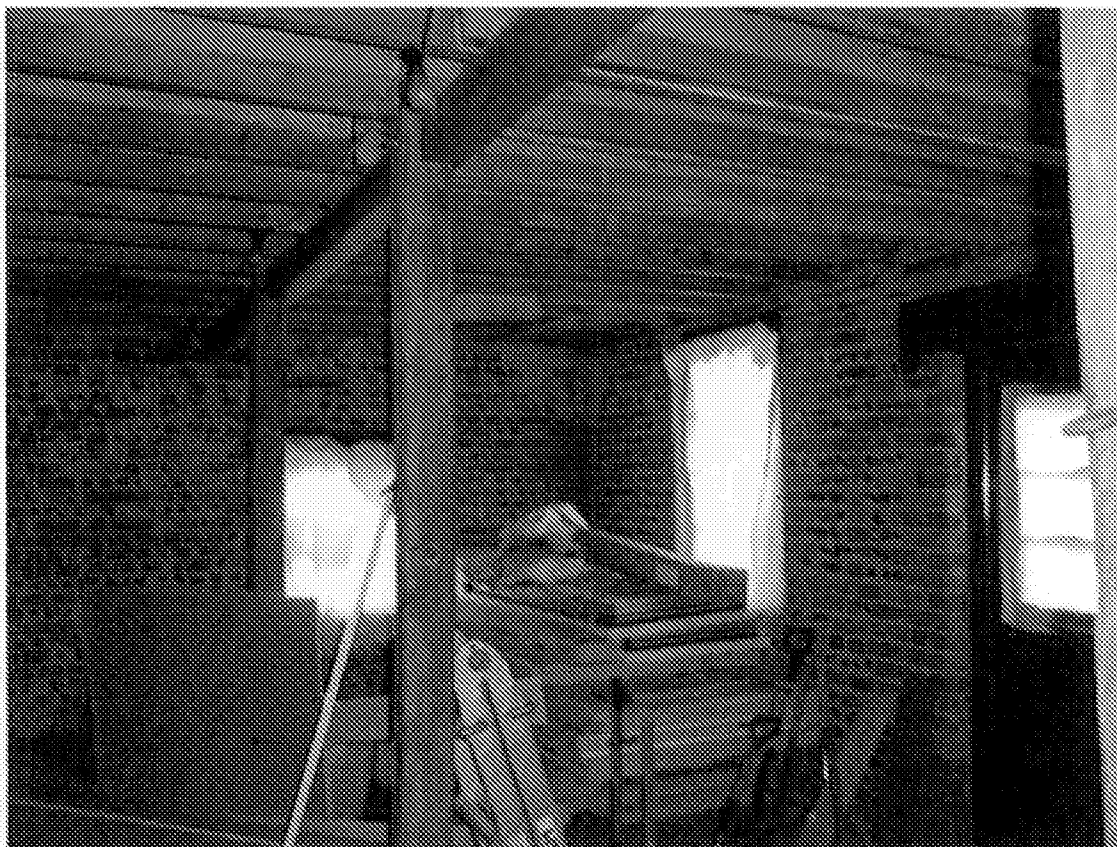
### 3.3 Internal Works to Tearoom Area

Remove first floor, flooring boards along with timber joists to enable the existing inbuilt timber wall plate to be removed along with the timber lintels over windows (replace window lintels as previously described). Renew timber joists with new 225 x 50 sawn built into flank walls. The original support timbers are to remain in the positions as a decorative feature, along with bridal pegs attached.

Floors to be reclaimed pine boarding, with sanded and polished finish, the floor construction to be installed to current building regulation for transference of sound. Walls to remain exposed face brickwork and flint work were new partitions and dividing rooms are to be formed, all walls will be constructed with studwork and plasterboards independent of the walls so as to preserve the original brick and flint work behind.

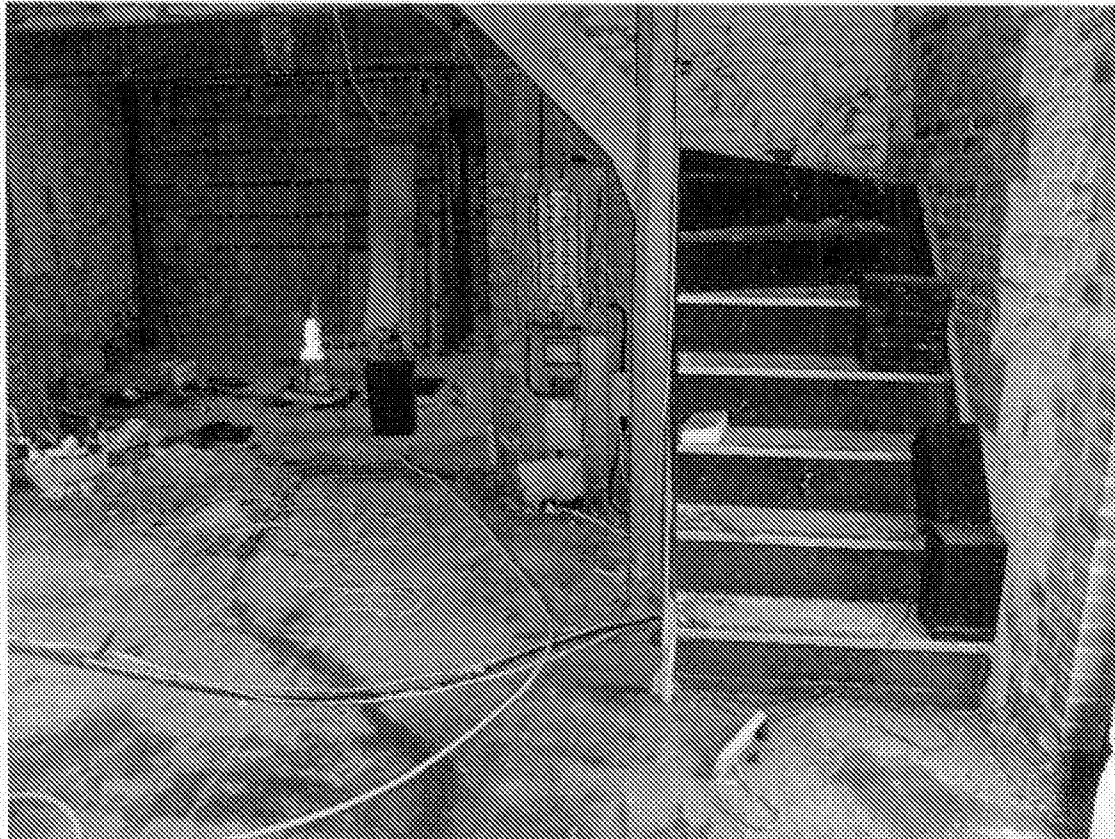
### 3.4 Servery Area

Existing stairs circa 1995 to be removed and disposed of, new stairs to be provided in new location as indicated on drawing 091/P/047/04.

Redundant electrical services are to be removed; new separate electrical services are to be provided to all dwellings independent of each other.

All ground bearing concrete floors will be over laid with fully insulated floating floors to comply with the current building regulation for thermal insulation.

Internal foul drainage chambers are to be removed as far as practical, the new foul waste water under ground drainage is to be designed to wherever possible elevate internal manhole chambers.

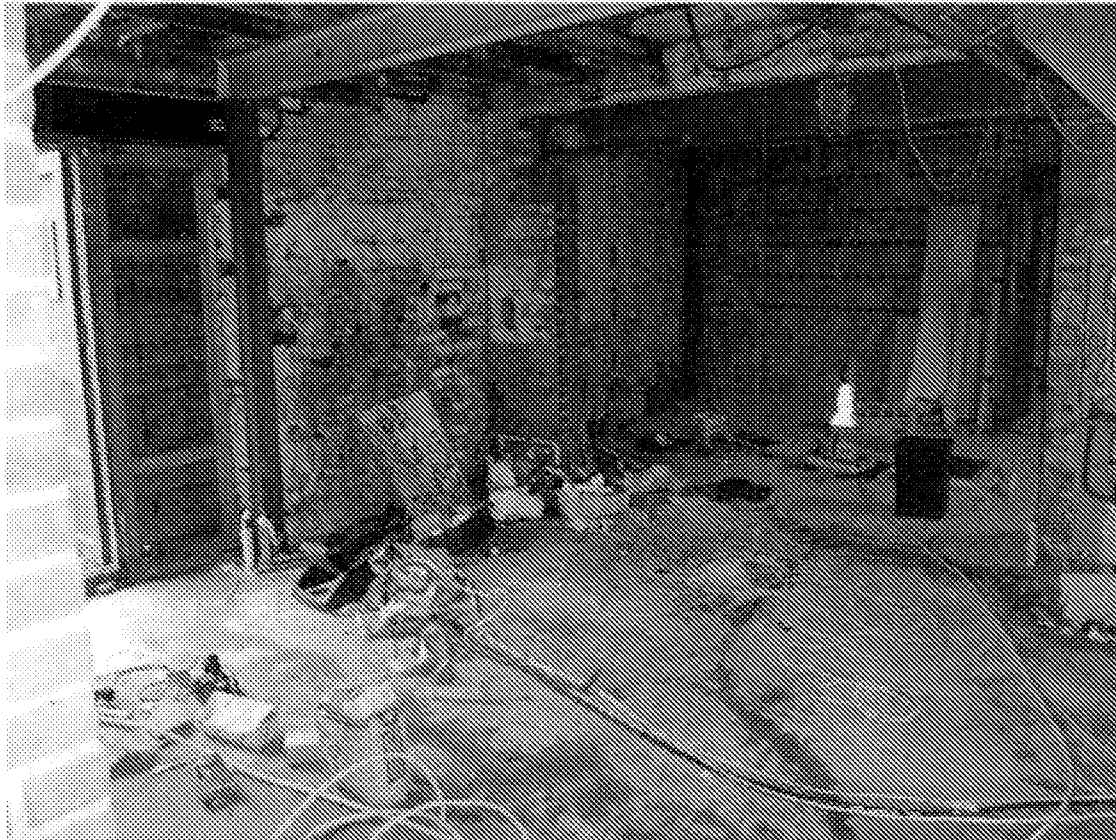
### Steel Beams

Existing steel beams circa 1989 are to be removed and replaced with new built in floor joists (as previously described) the Gable steel support is to be removed along with the Gable wall.

Separating wall between dwellings to be surface lined to provide appropriate fire and sound insulation to the current building regulations

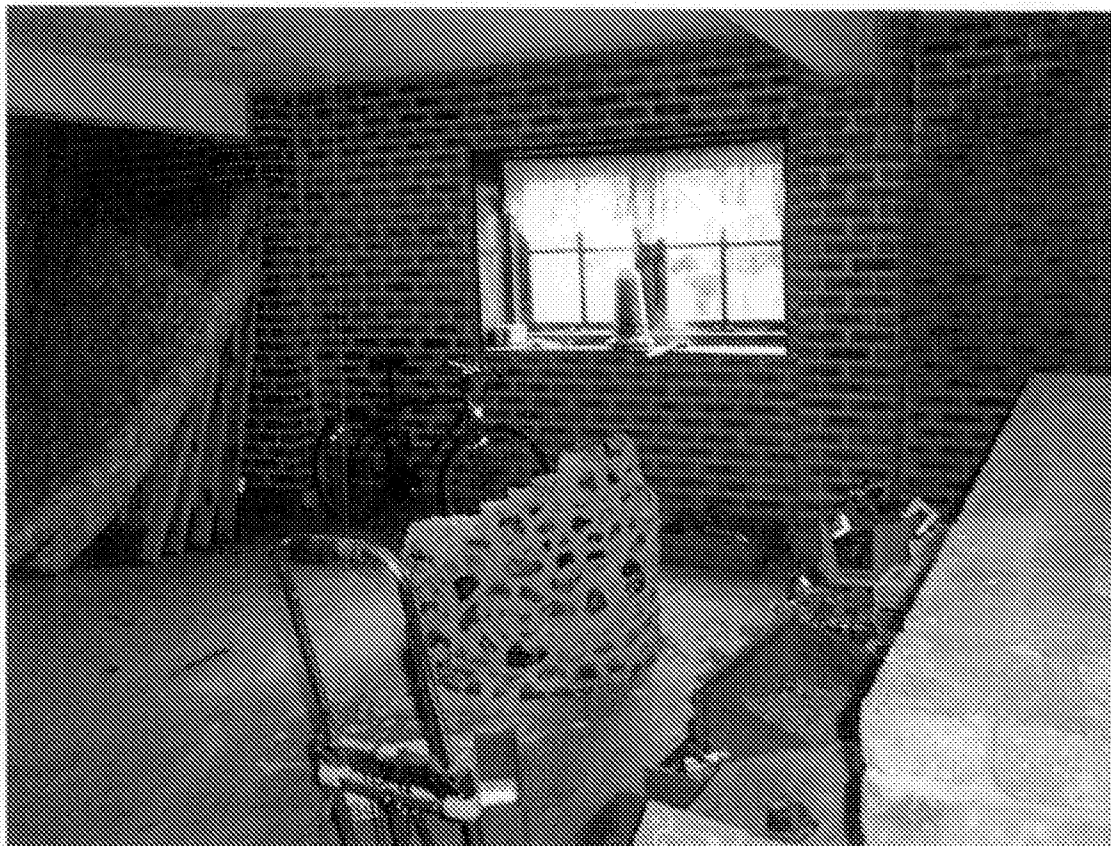
### 3.5 Well Room

- 3.5.1 Remove ceilings circa 1989, flat roof and steel supports, erect new timber framed pitched 45 degree trussed roof to match in with the tearoom pitched roof maintaining the ridge line parallel with the eastern boundary wall of the existing structure.

Roof shall incorporate thermal insulation to the current building regulations, tile coverings to be reclaimed clay peg tiles, to match the salvaged peg tiles from the tearoom roof.

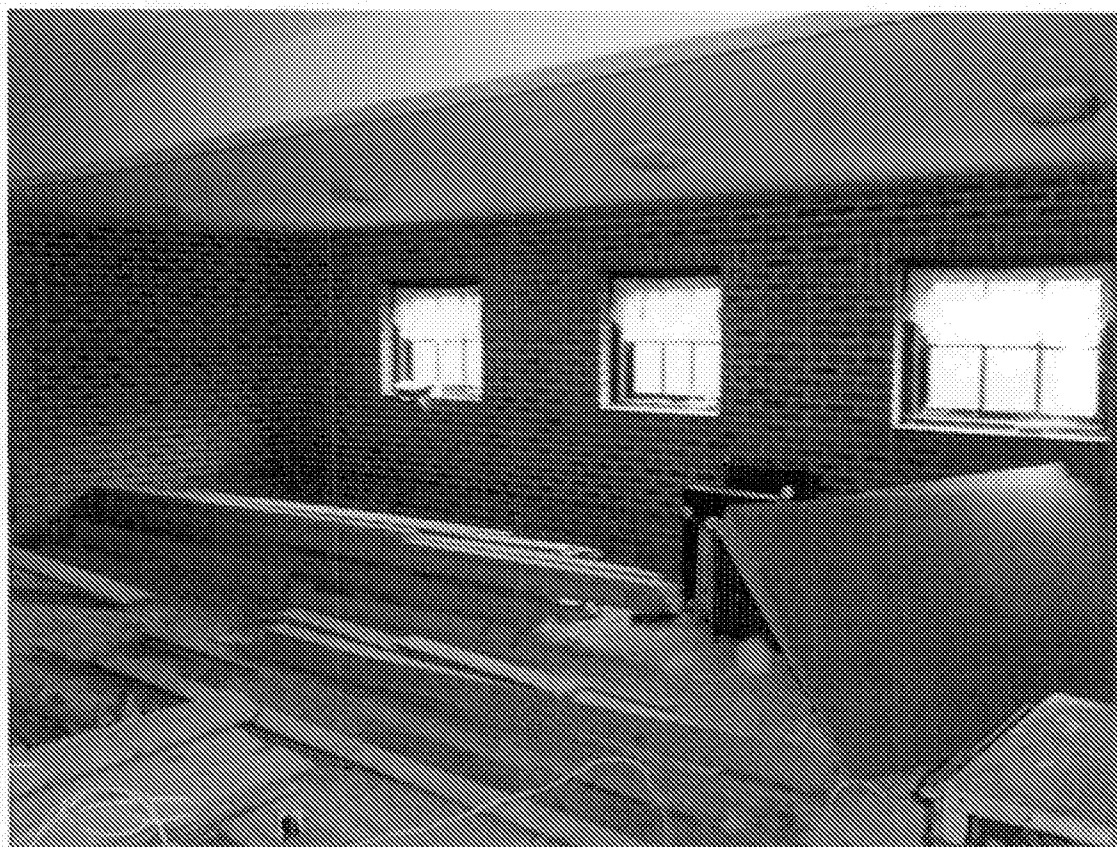
### 3.6 Function Room

- 3.6.1 Remove ceilings circa 1989, flat roof and steel supports, erect new timber framed pitched 45 degree trussed roof to match in with the tearoom pitched roof keeping the ridge line parallel with the eastern boundary wall of the existing structure.

- 3.6.2 Roof to incorporate thermal insulation to the current building regulations, surface coverings to be reclaimed peg tiles, to match the salvaged peg tiles from the tearoom roof.

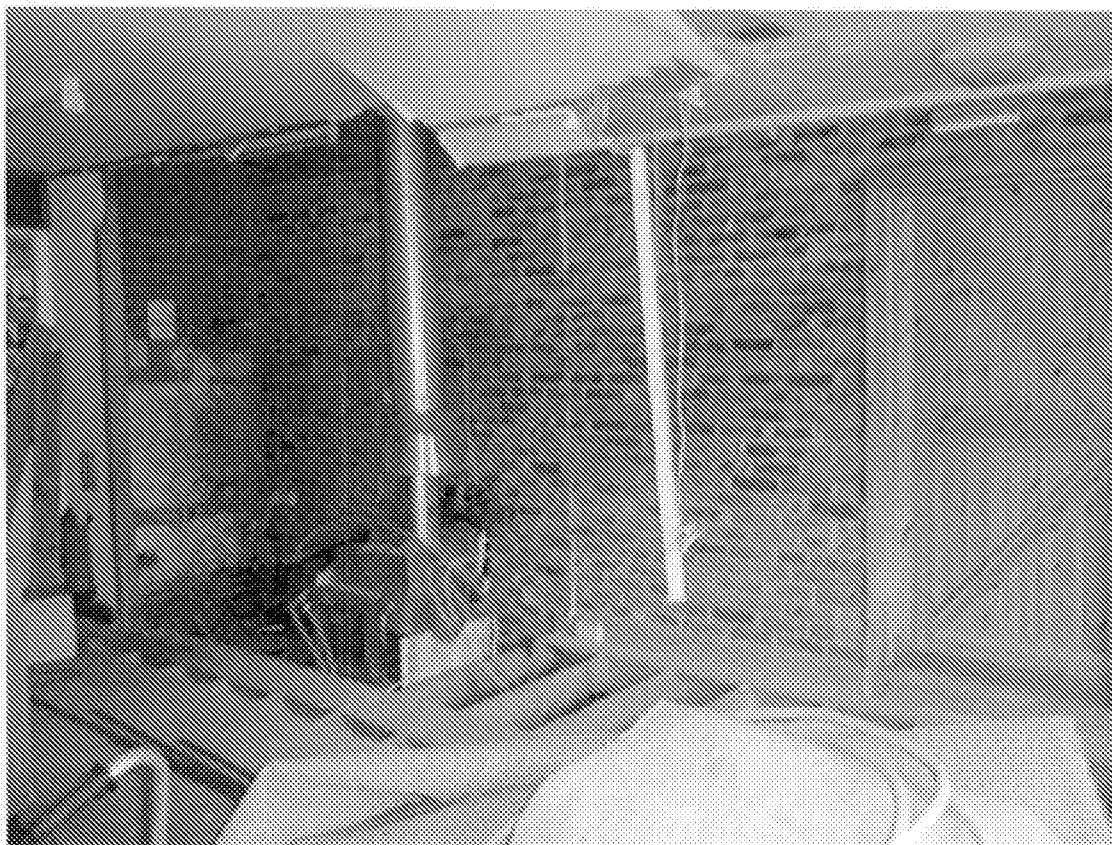
### 3.7 Museum Room

- 3.7.1 Remove ceilings, flat roof and steel supports, erect new pitched 45 degree trussed roof to match in with the tearoom pitched roof keeping the ridge line parallel with the eastern boundary wall of the existing structure.

- 3.7.2 Roof to incorporate thermal insulation to the current building regulations, surface coverings to be reclaimed peg tiles, to match the salvaged peg tiles from the tearoom roof.

- 3.7.3 Circa 1995 External walls to be carefully removed, all bricks cleaned and set aside for reuse, foundations to be inspected and increased were required, new walls to be constructed from the set aside bricks.

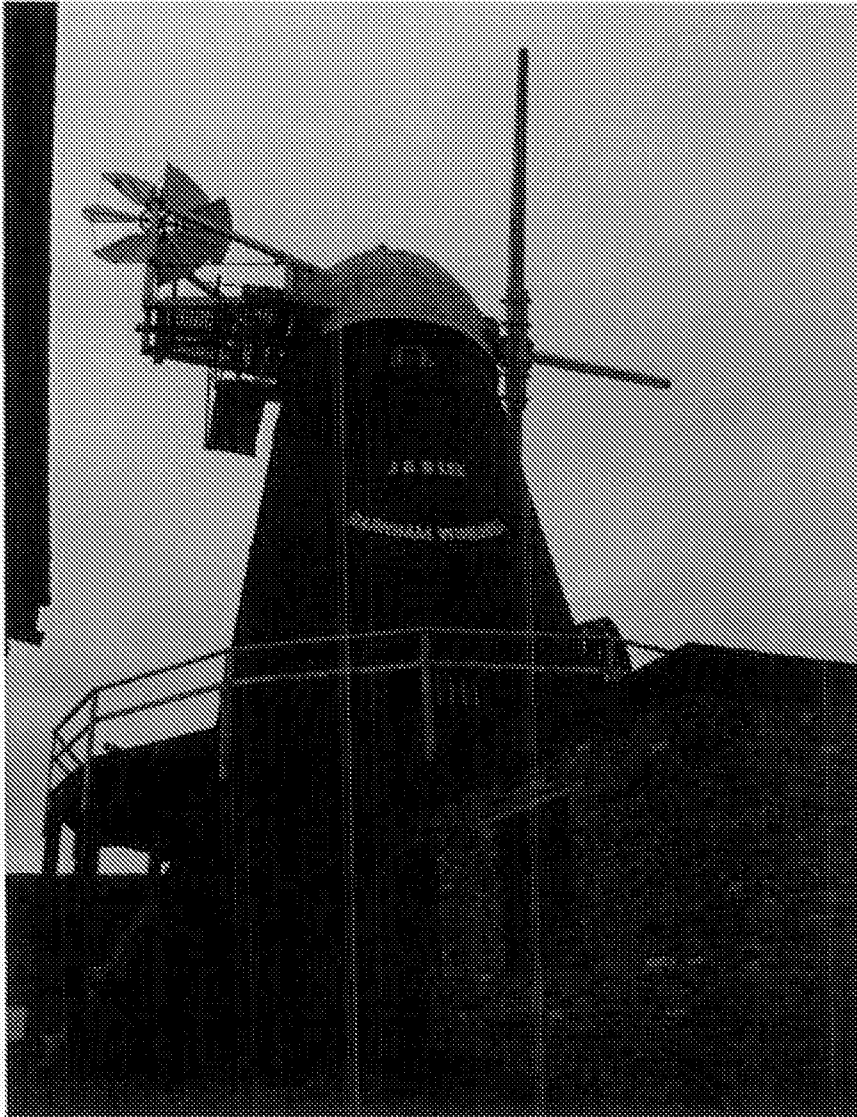
### Barnham Tower Mill

- 3.8.1 The tower mill consists of four floors held within a flint and brick tower, which is rendered on the outside and finished with a traditional tar based coating.

- 3.8.2 The tower has suffered from water penetration over the years, this is the result of the tar coating wearing off over the years and cracking occurring in the cement render which is being caused by the differential movement between the flint lime mortar structure and the hard sand and cement render that has been applied to the external of the tower.

To address the water penetration and minor cracking that has occurred over the years we propose to carefully cut out the cracks to 20mm in the sand and cement render, apply a flexible cementations product (ronafix or similar) and provide a new traditional tar based coating.

- 3.8.6 The fan stage is severely decayed and will be reconstructed in timber of similar profile and characteristic, the fan is to be taken down and refurbished and will be replaced in a skeleton form, to permit allow the wind to blow through and reduce the risks of future wind damage.

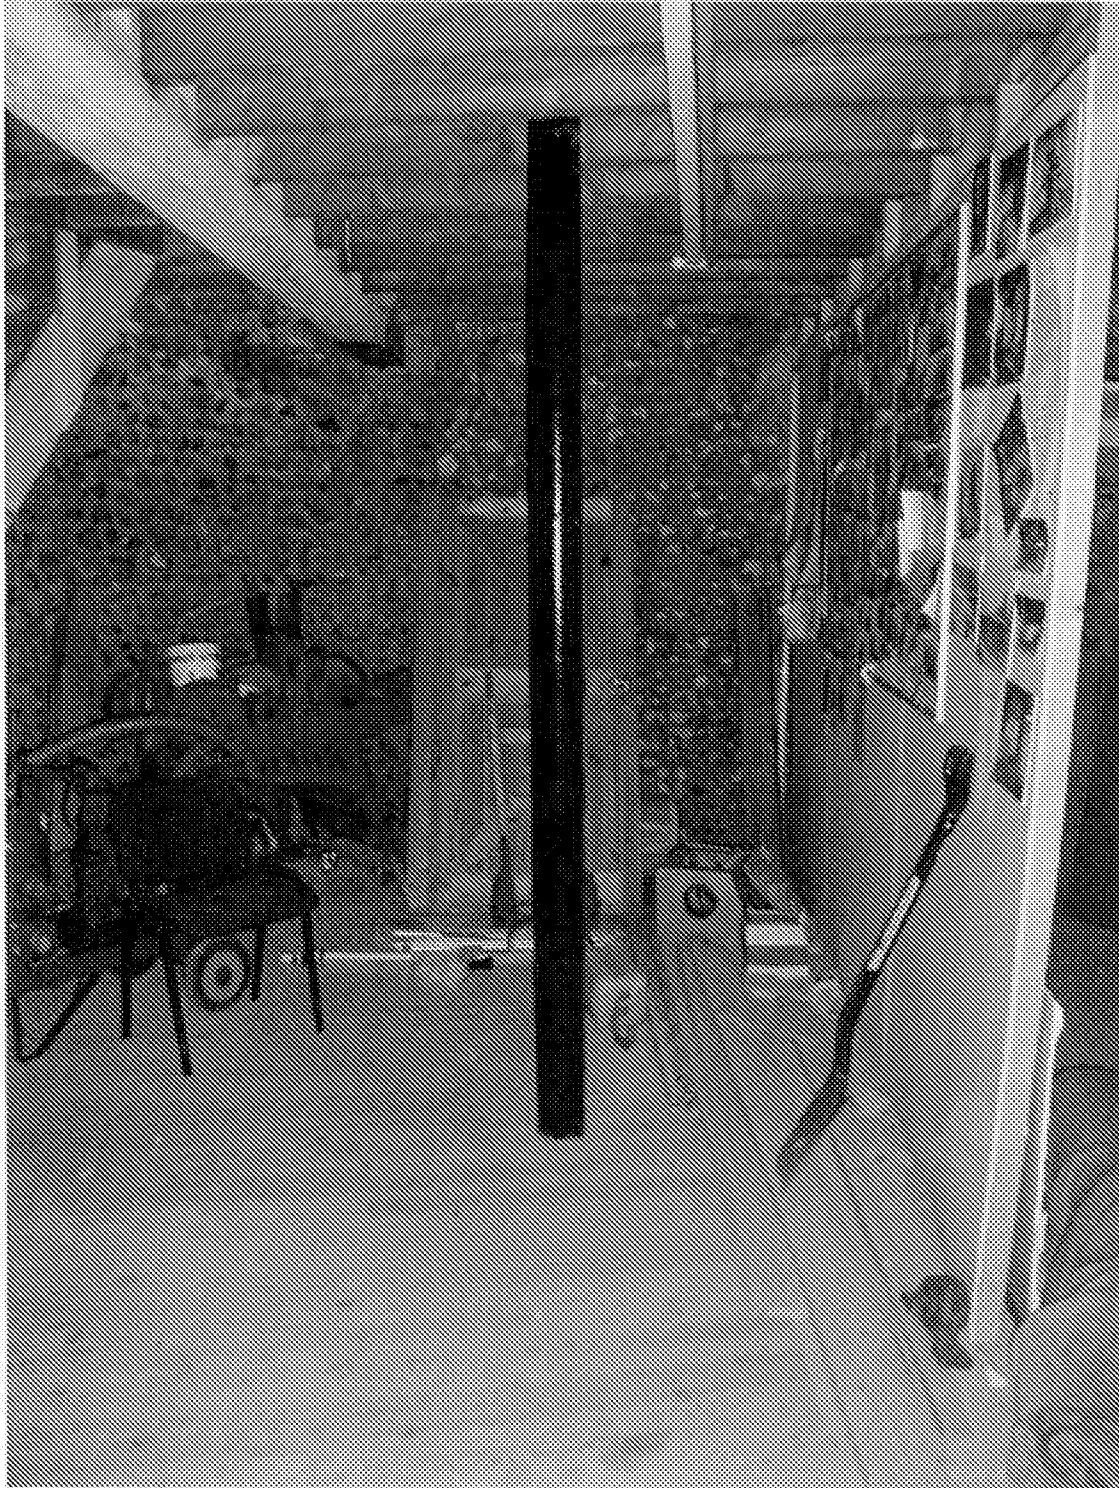
3.9 Interior of the Tower Mill

- 3.9.1 The walls internally have already been stripped of the lime putty plaster to allow the lime mortar to dry out and a visual inspection of the tower mill structure to be undertaken.

The inspection has identified some areas of minor deterioration to the lime mortar and flint / brick areas.

To address these minor areas of deterioration we propose to locally cut out the defective flint / brickwork, and replace with new flint / brickwork bedded in lime mortar.

- 3.9.2 On completion of these repair works we propose to protect the existing flint / brick finishes by carefully applying a high density (HDPE) John Newton & Co or similar membrane to the internal fabric of the structure to alleviate any further passage of water ingress into the proposed habitable tower.

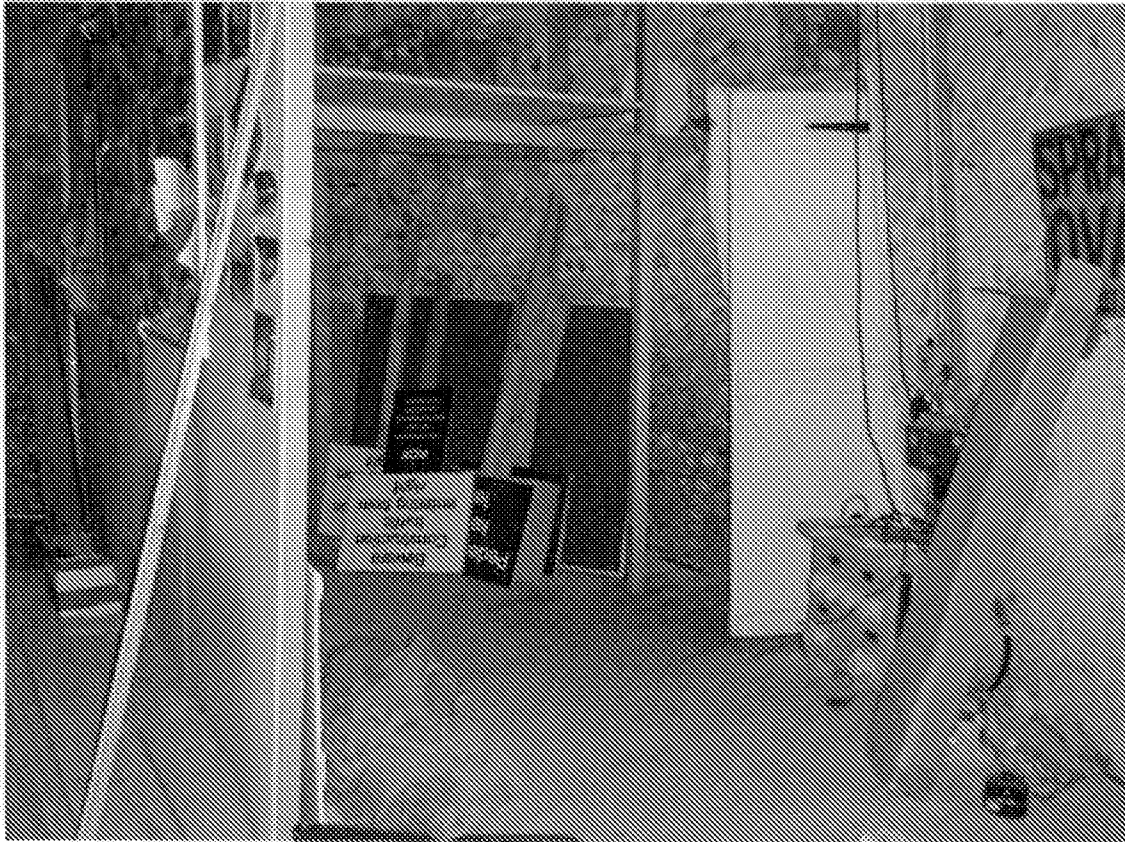
### 3.10 Ground Floor of Tower Mill

- 3.10.1 All temporary partitions are to be removed, all flooring to be taken up, a new floating floor to be installed with insulation.

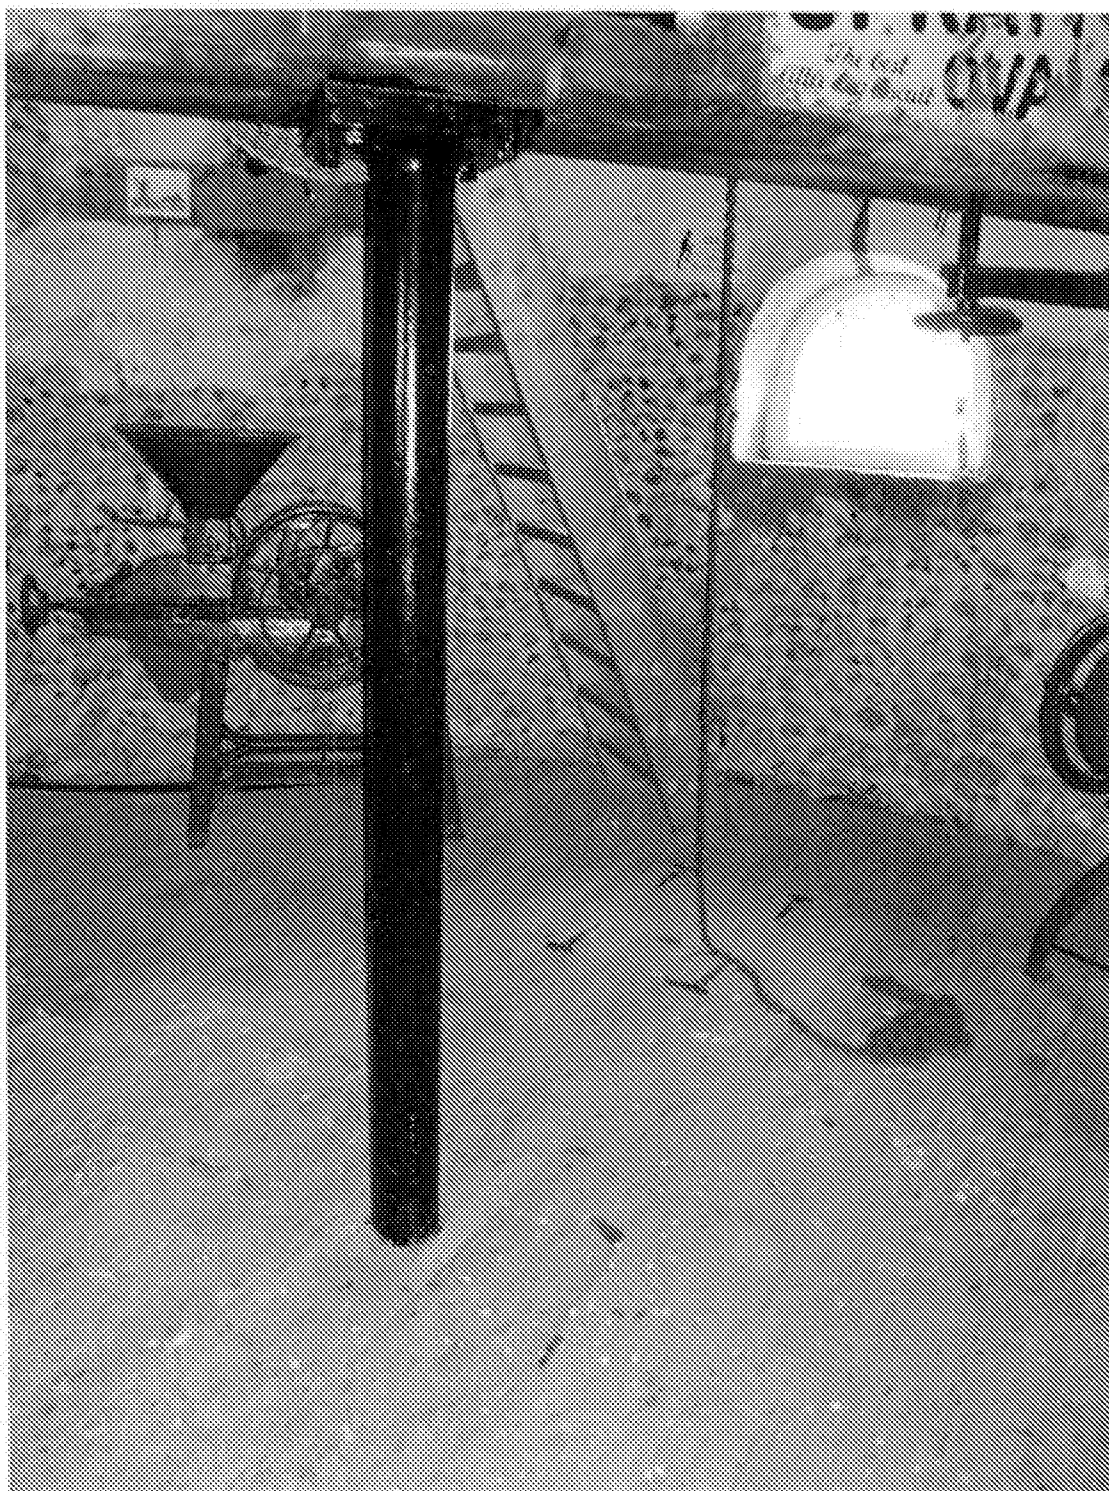
3.11 Spout Floor

- 3.11.1 The stairs circa 1989 leading from the ground floor to the spout floor are to be removed and replaced with traditional wrap around stair including half landing for ease of access; the stairs are to be fully enclosed to meet Building Control requirements for half hour fire resistance.

- 3.11.2 The two doors circa 1989 leading from the spout floor to the redundant (removed) gallery, one door to be removed and replaced with full height window, with opening lights, the second door to be replaced with new exterior purpose made timber door to allow access onto the enclosed roof area.

- 3.11.3 All windows in the tower are to be removed and replaced with purpose made timber double glazed units to match the existing profile and pattern of the windows already in the tower

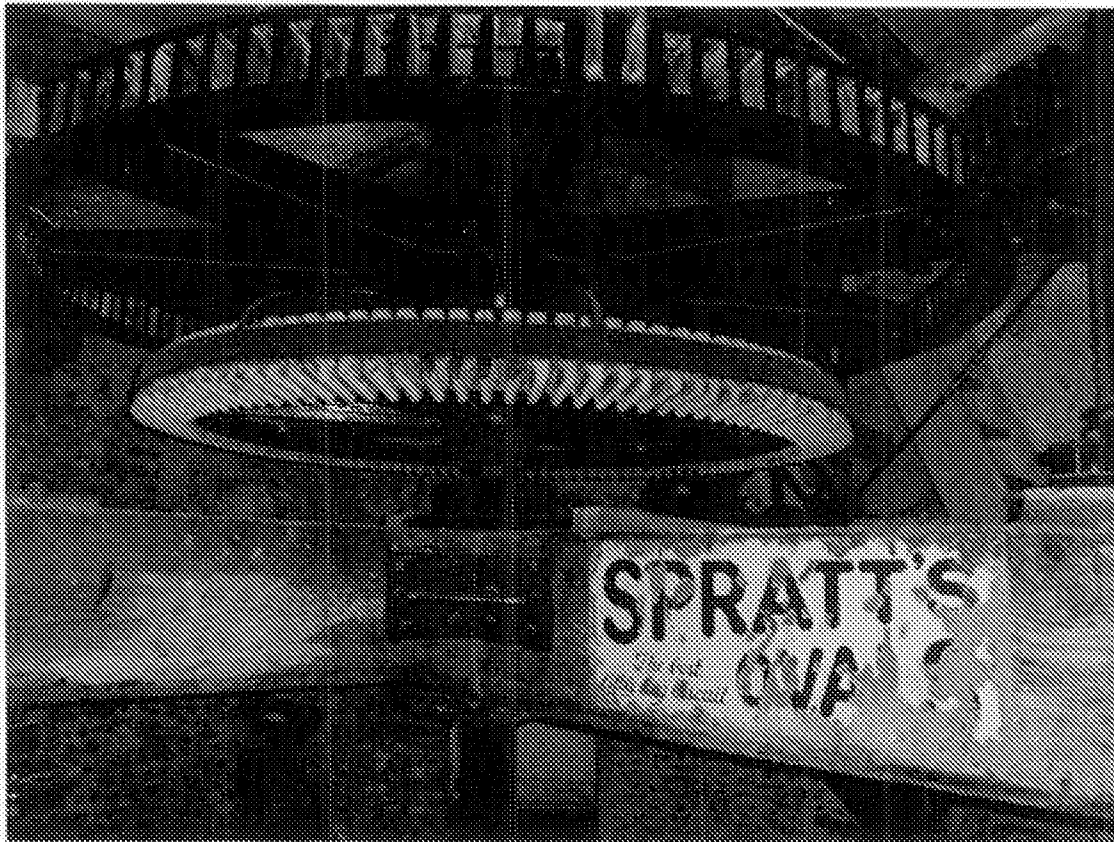
### 3.12 Retained Machinery

- 3.12.1 Machinery to remain in the tower will be carefully prepared and painted, all timbers will be brushed off, prepared, waxed and polished, the floors and timber joist shall be removed, prepared, waxed and polished.

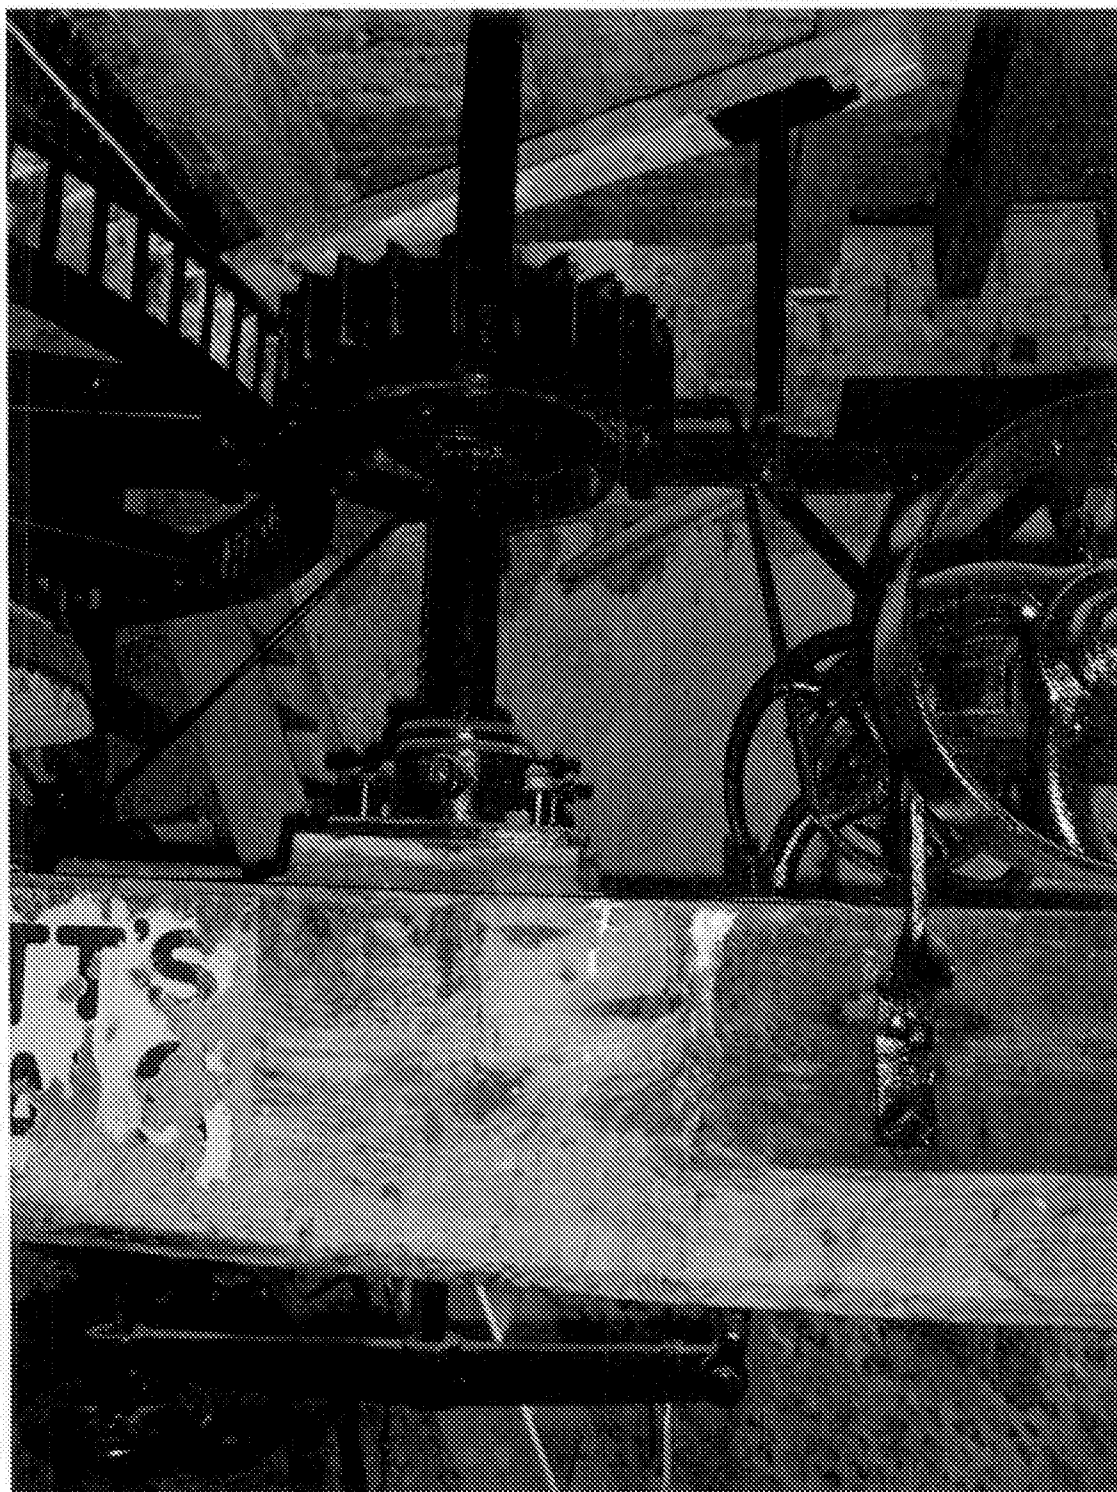
3.12.2 The tentering gear and auxiliary drive belt pulleys shall be prepared and painted and retained in the same positions.

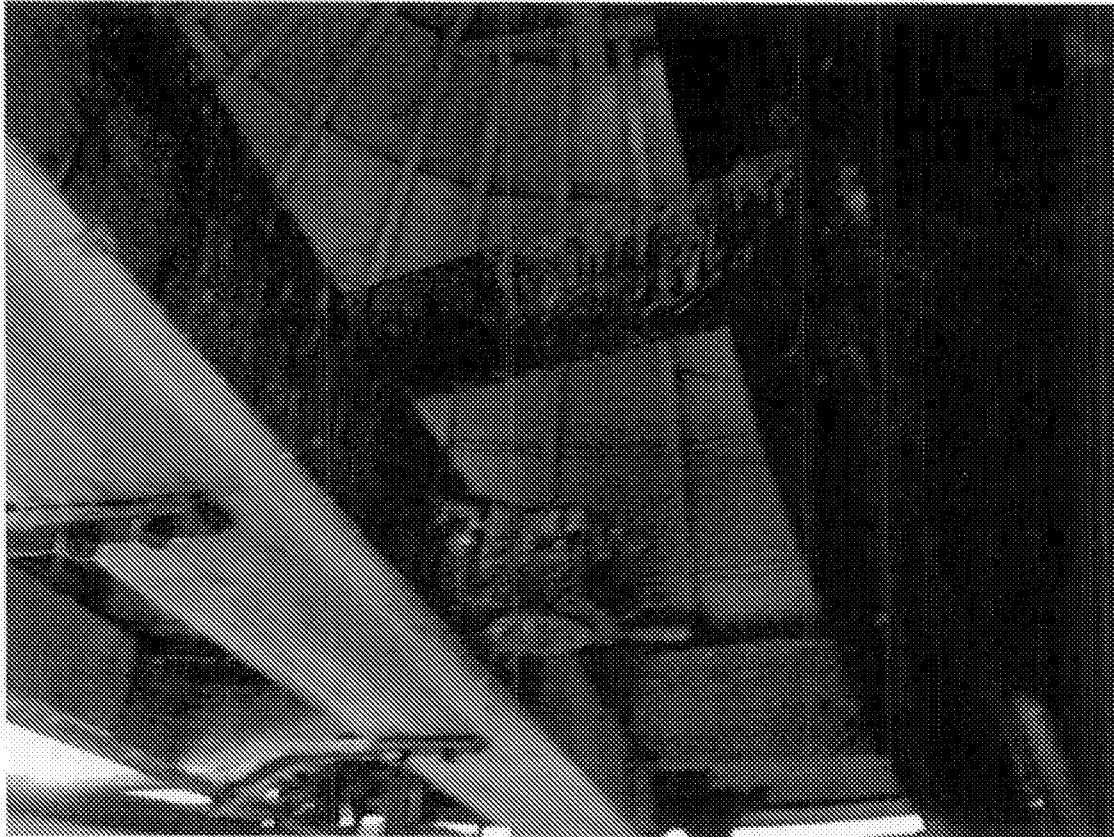
### 3.13 Windmill Cap

3.13.1 Prepare and decorate brake wheel and shaft, all truck wheels and fixing brackets.

3.13.3 Provide insulation to underside of domed cap, over board with plasterboard; fix false spare roofing timbers steamed to shape for authenticity.
