Project **Lake Lane, Barnham**

Title **Tree Protection Plan (Sheet 1 of 3)**

Drawing Number  
710

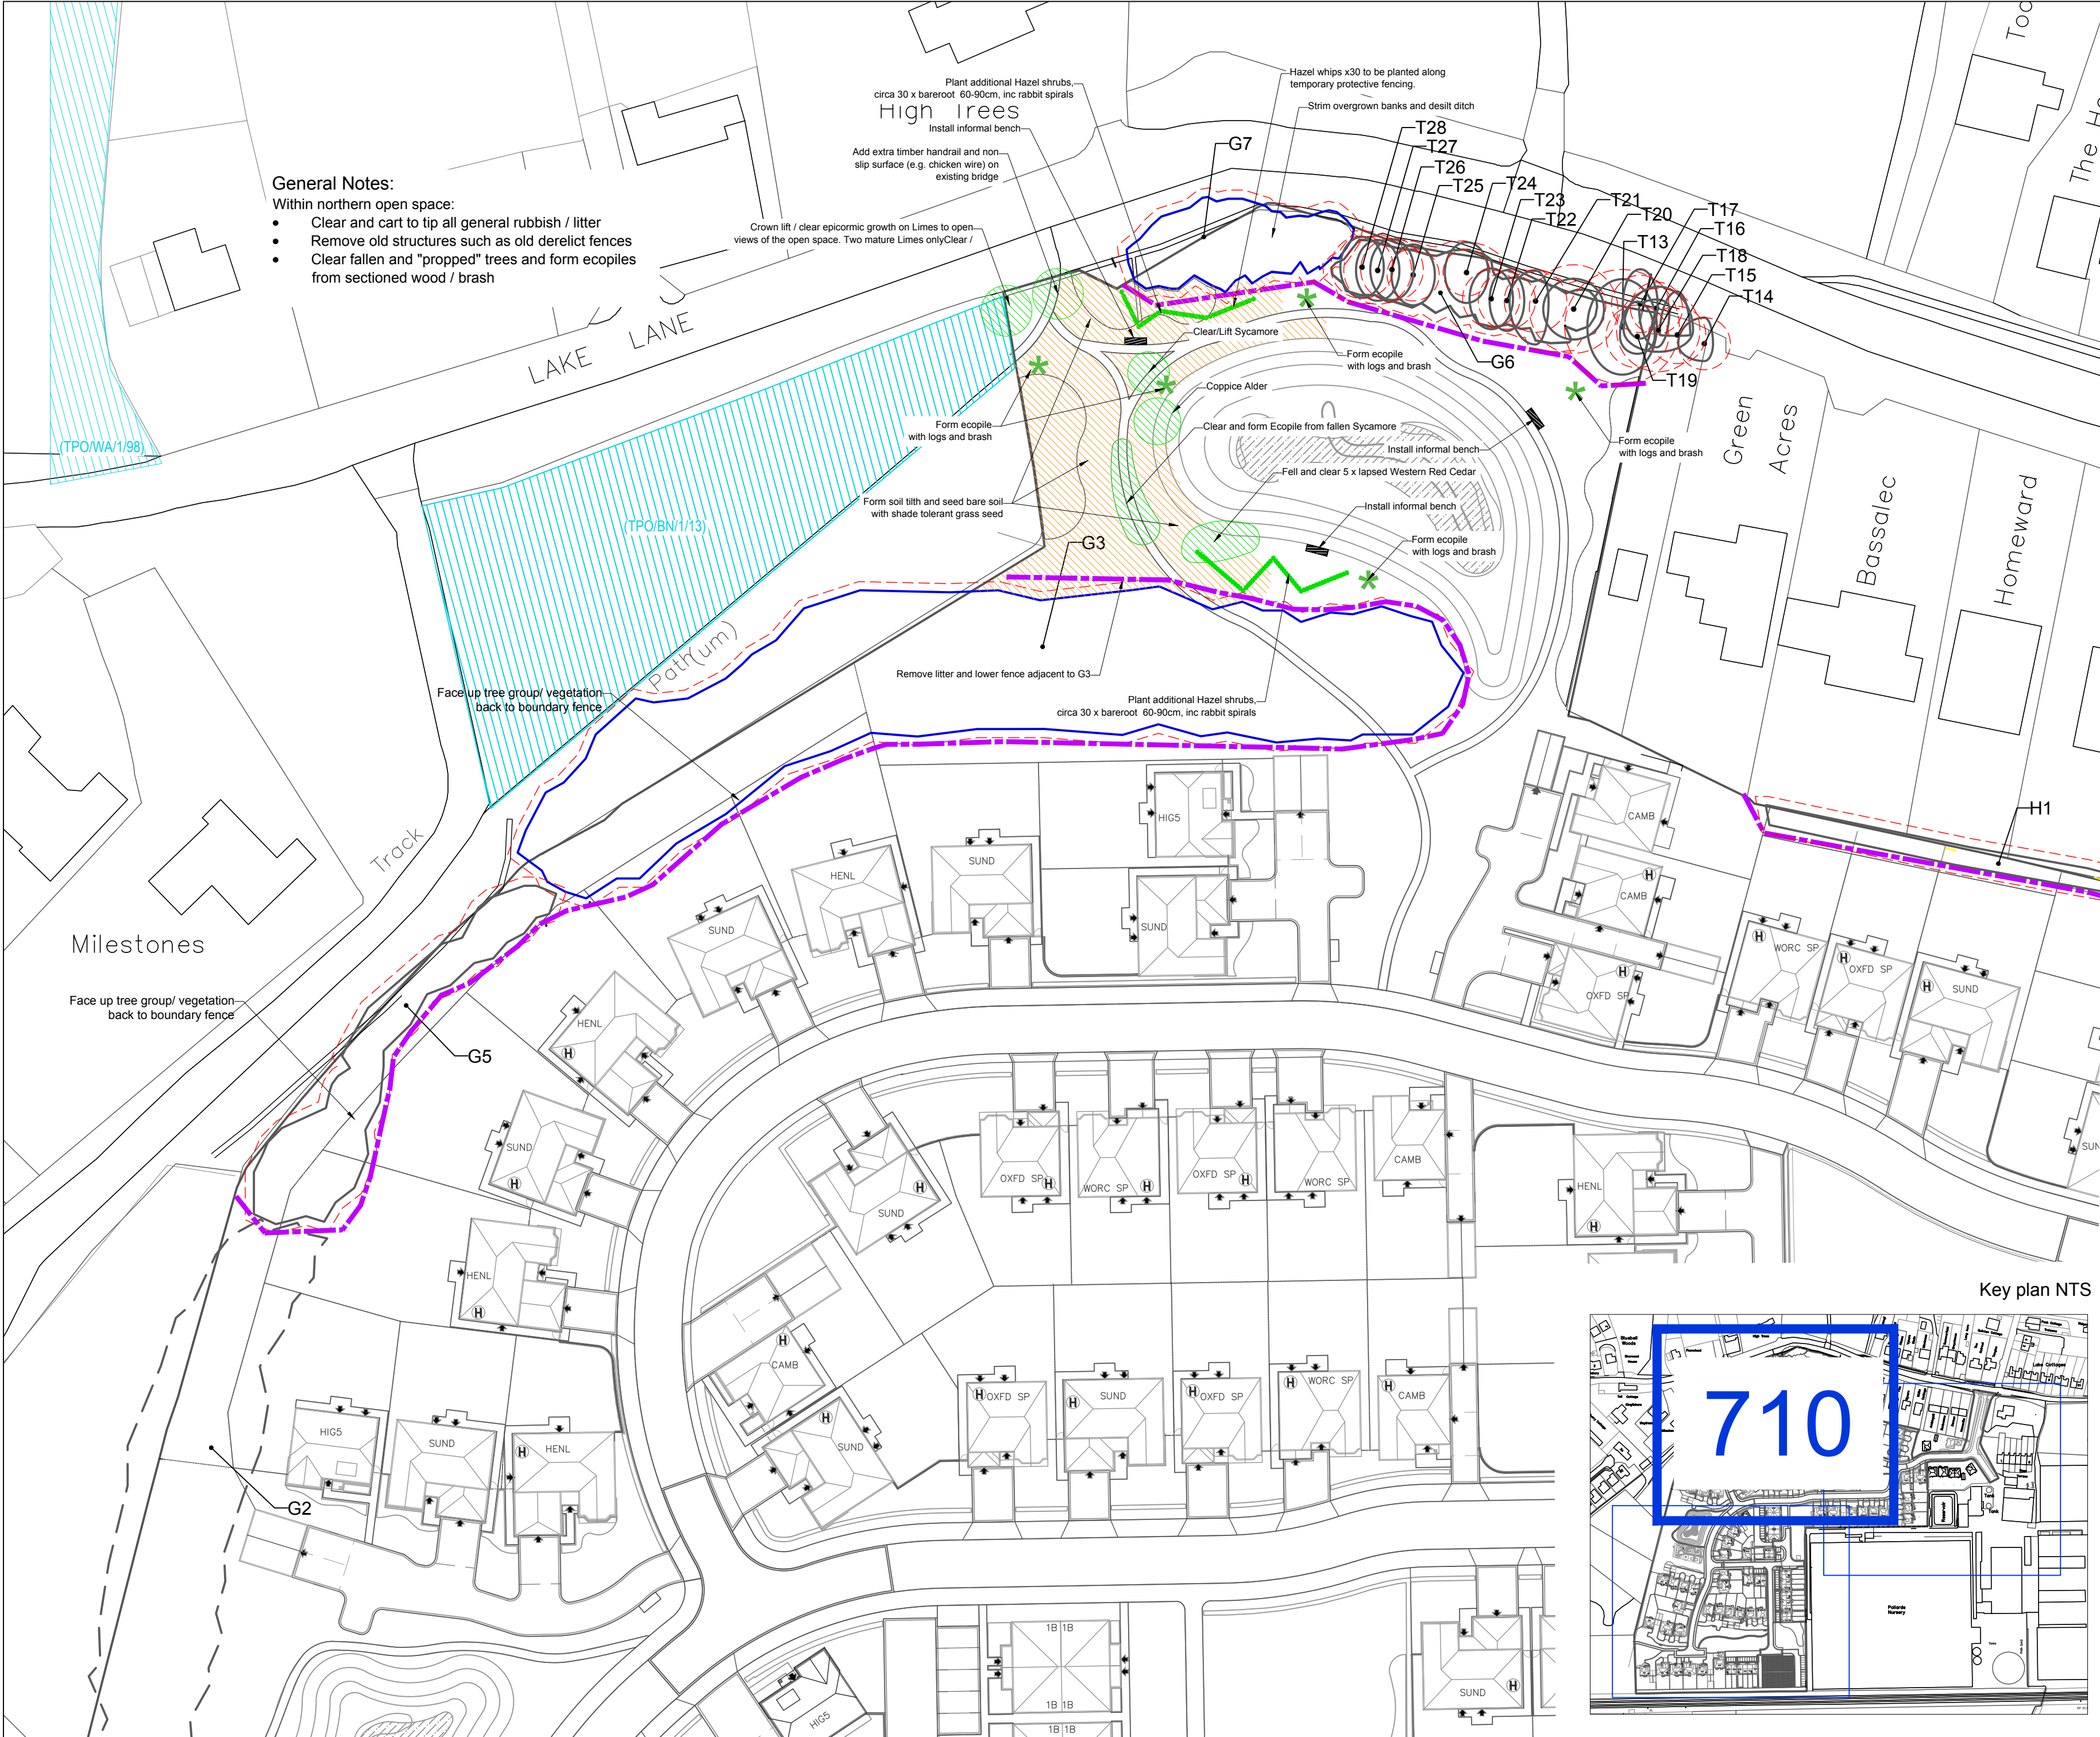
- General Notes:**
- Within northern open space:
- Clear and cart to tip all general rubbish / litter
  - Remove old structures such as old derelict fences
  - Clear fallen and "propped" trees and form ecopiles from sectioned wood / brash

- Proposed open space management/enhancements
