## Flood Risk Assessment and Drainage Strategy

**Tars Farm  
Barnham, West Sussex**

**Reference:** 1841

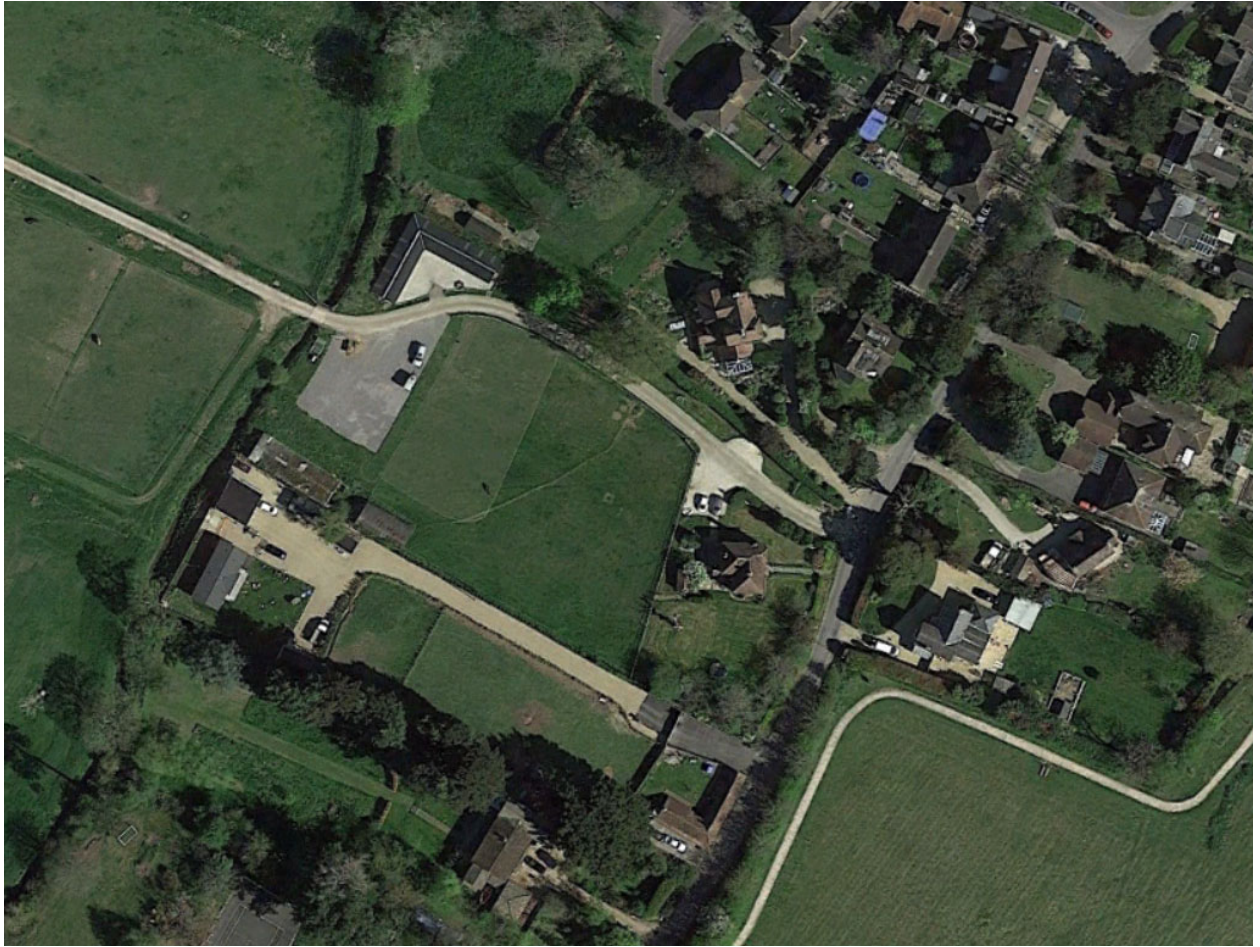
Site location

- 2.1 The site comprises approximately 0.43 Ha of land at Tars Farm, Church Lane, Barham (grid ref 495915 104135). The site extents are indicated on the annotated aerial photograph in Appendix A. The existing topography is shown on J Brotherton Surveys drawing 17118-A contained in Appendix A of this report.
- 2.2 The site comprises a gravel access track to grasslands connected to Tars Farm.
- 2.3 It is proposed to develop the site for 4 residential dwellings. The proposed layout is identified on Crossley Design Architecture drawing number 1816-2.20 rev - contained in Appendix A of this report.

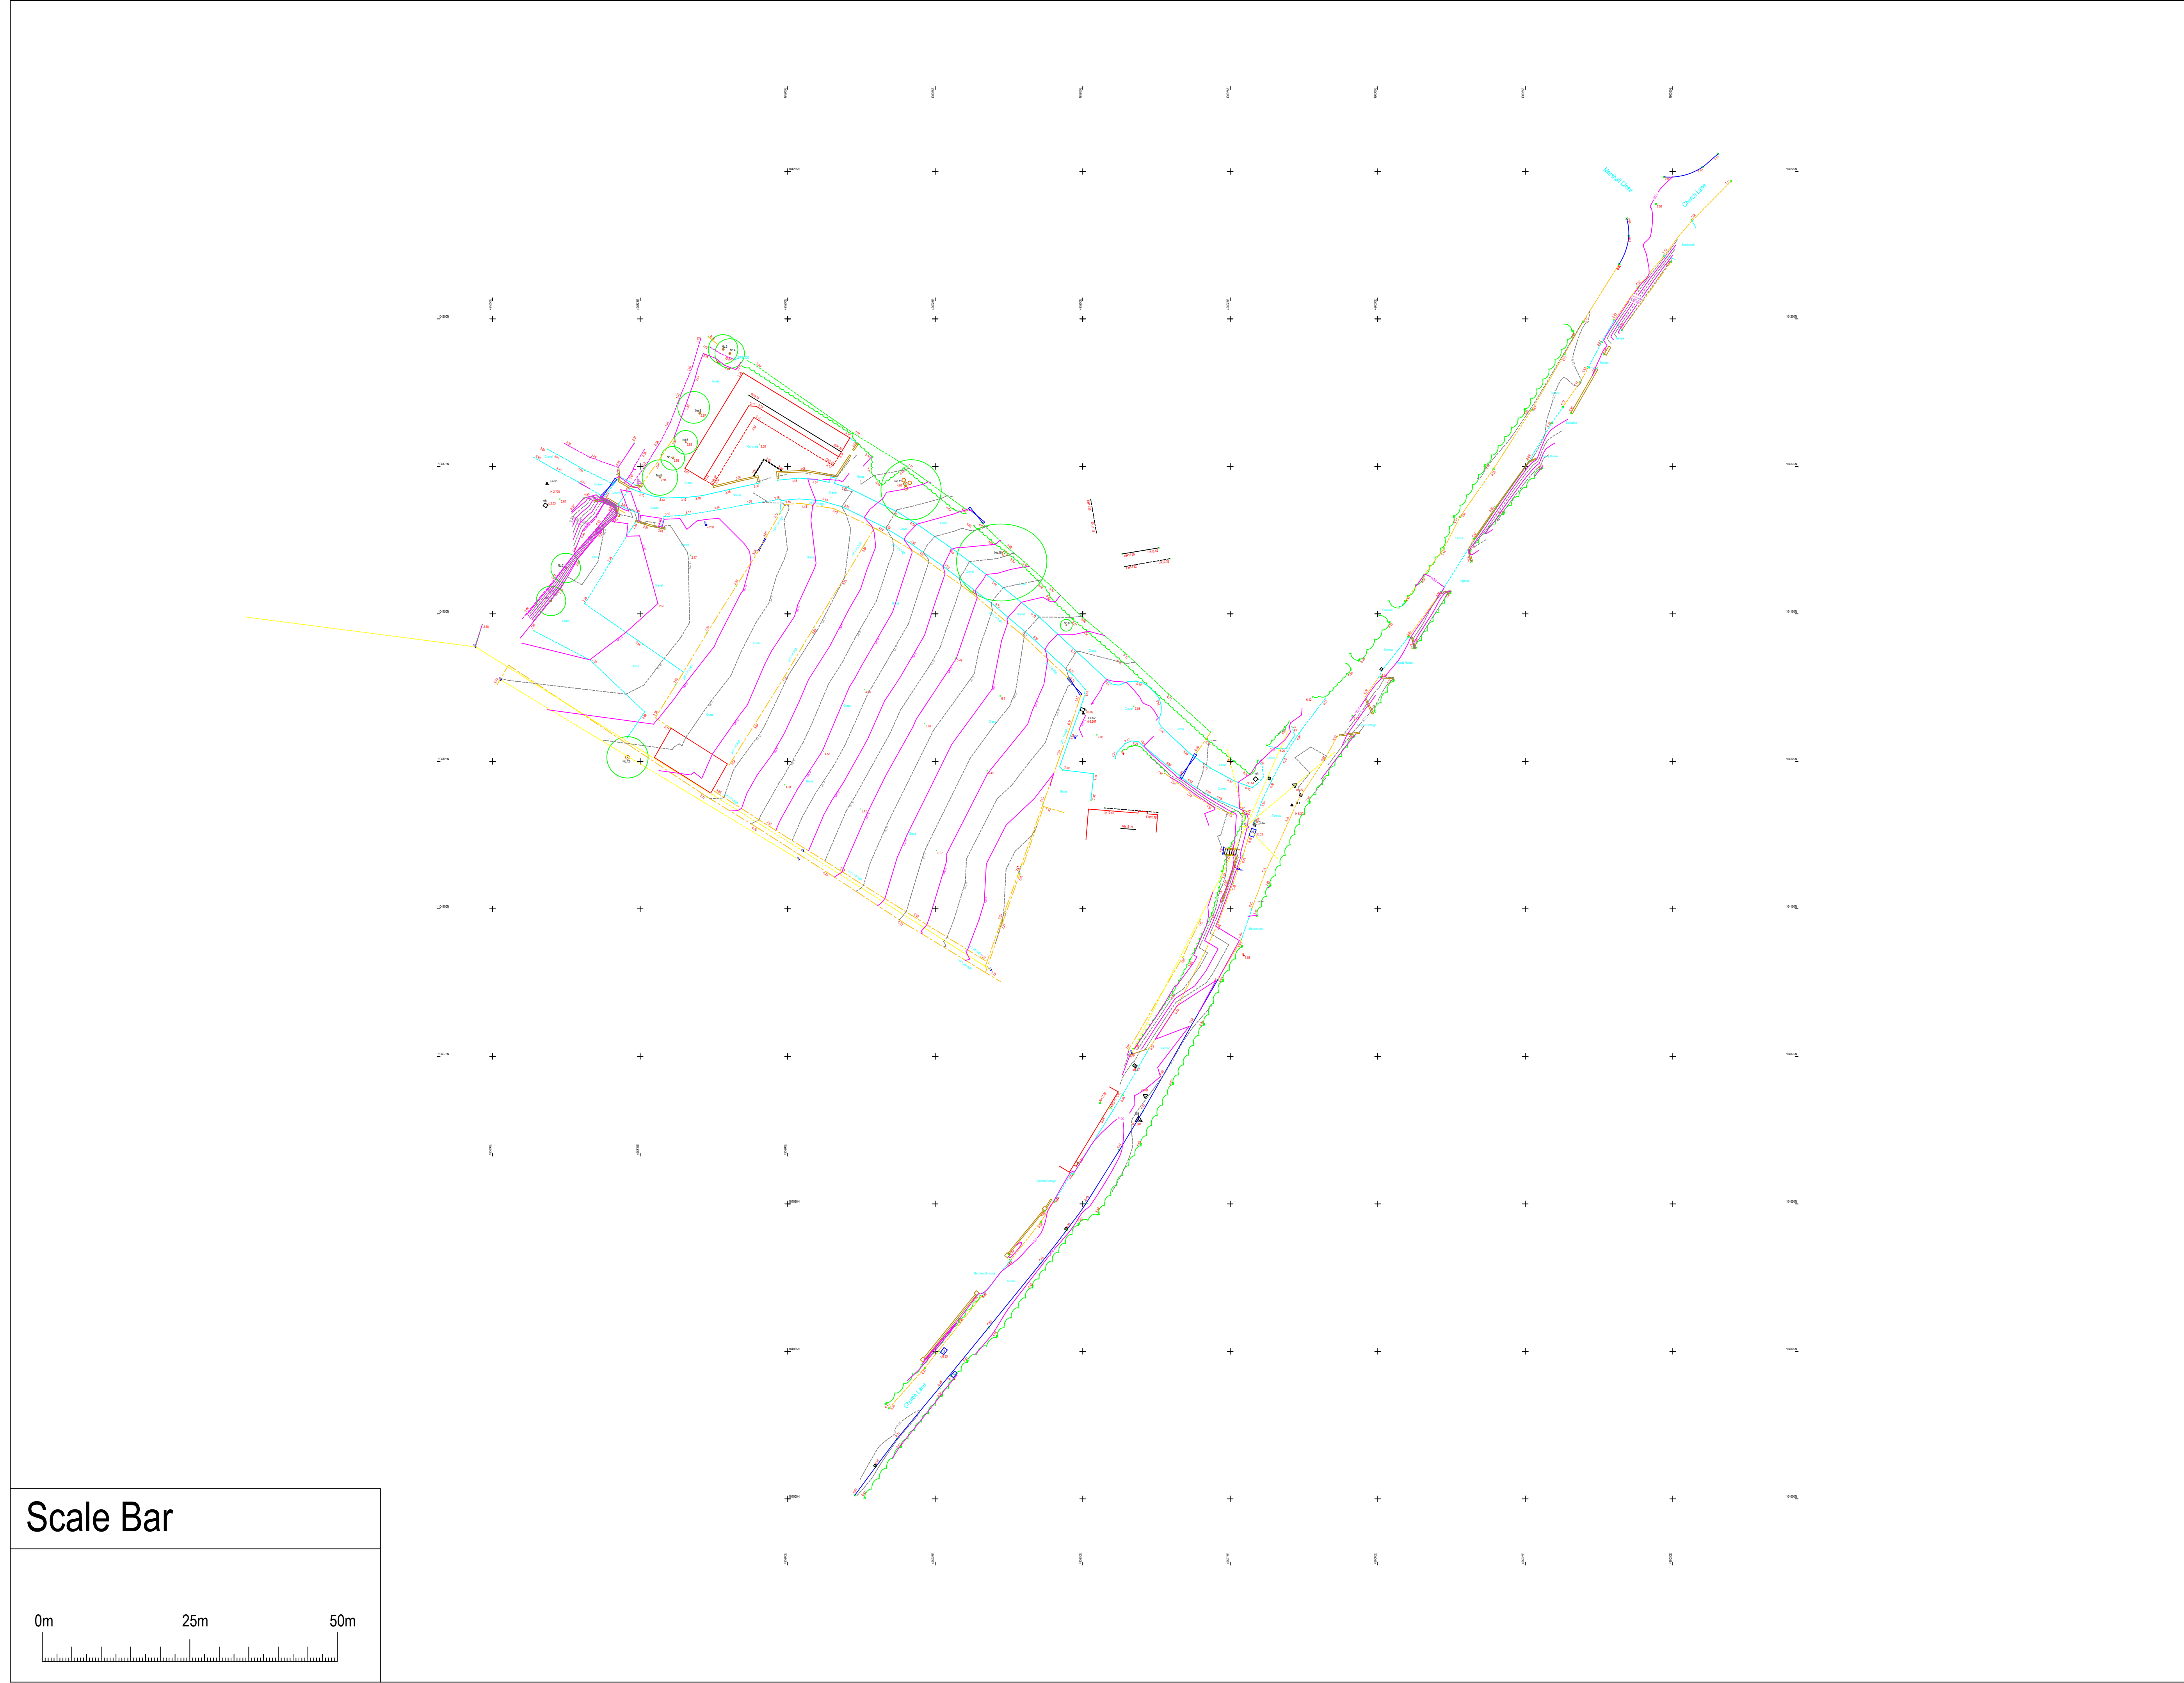
Tree List

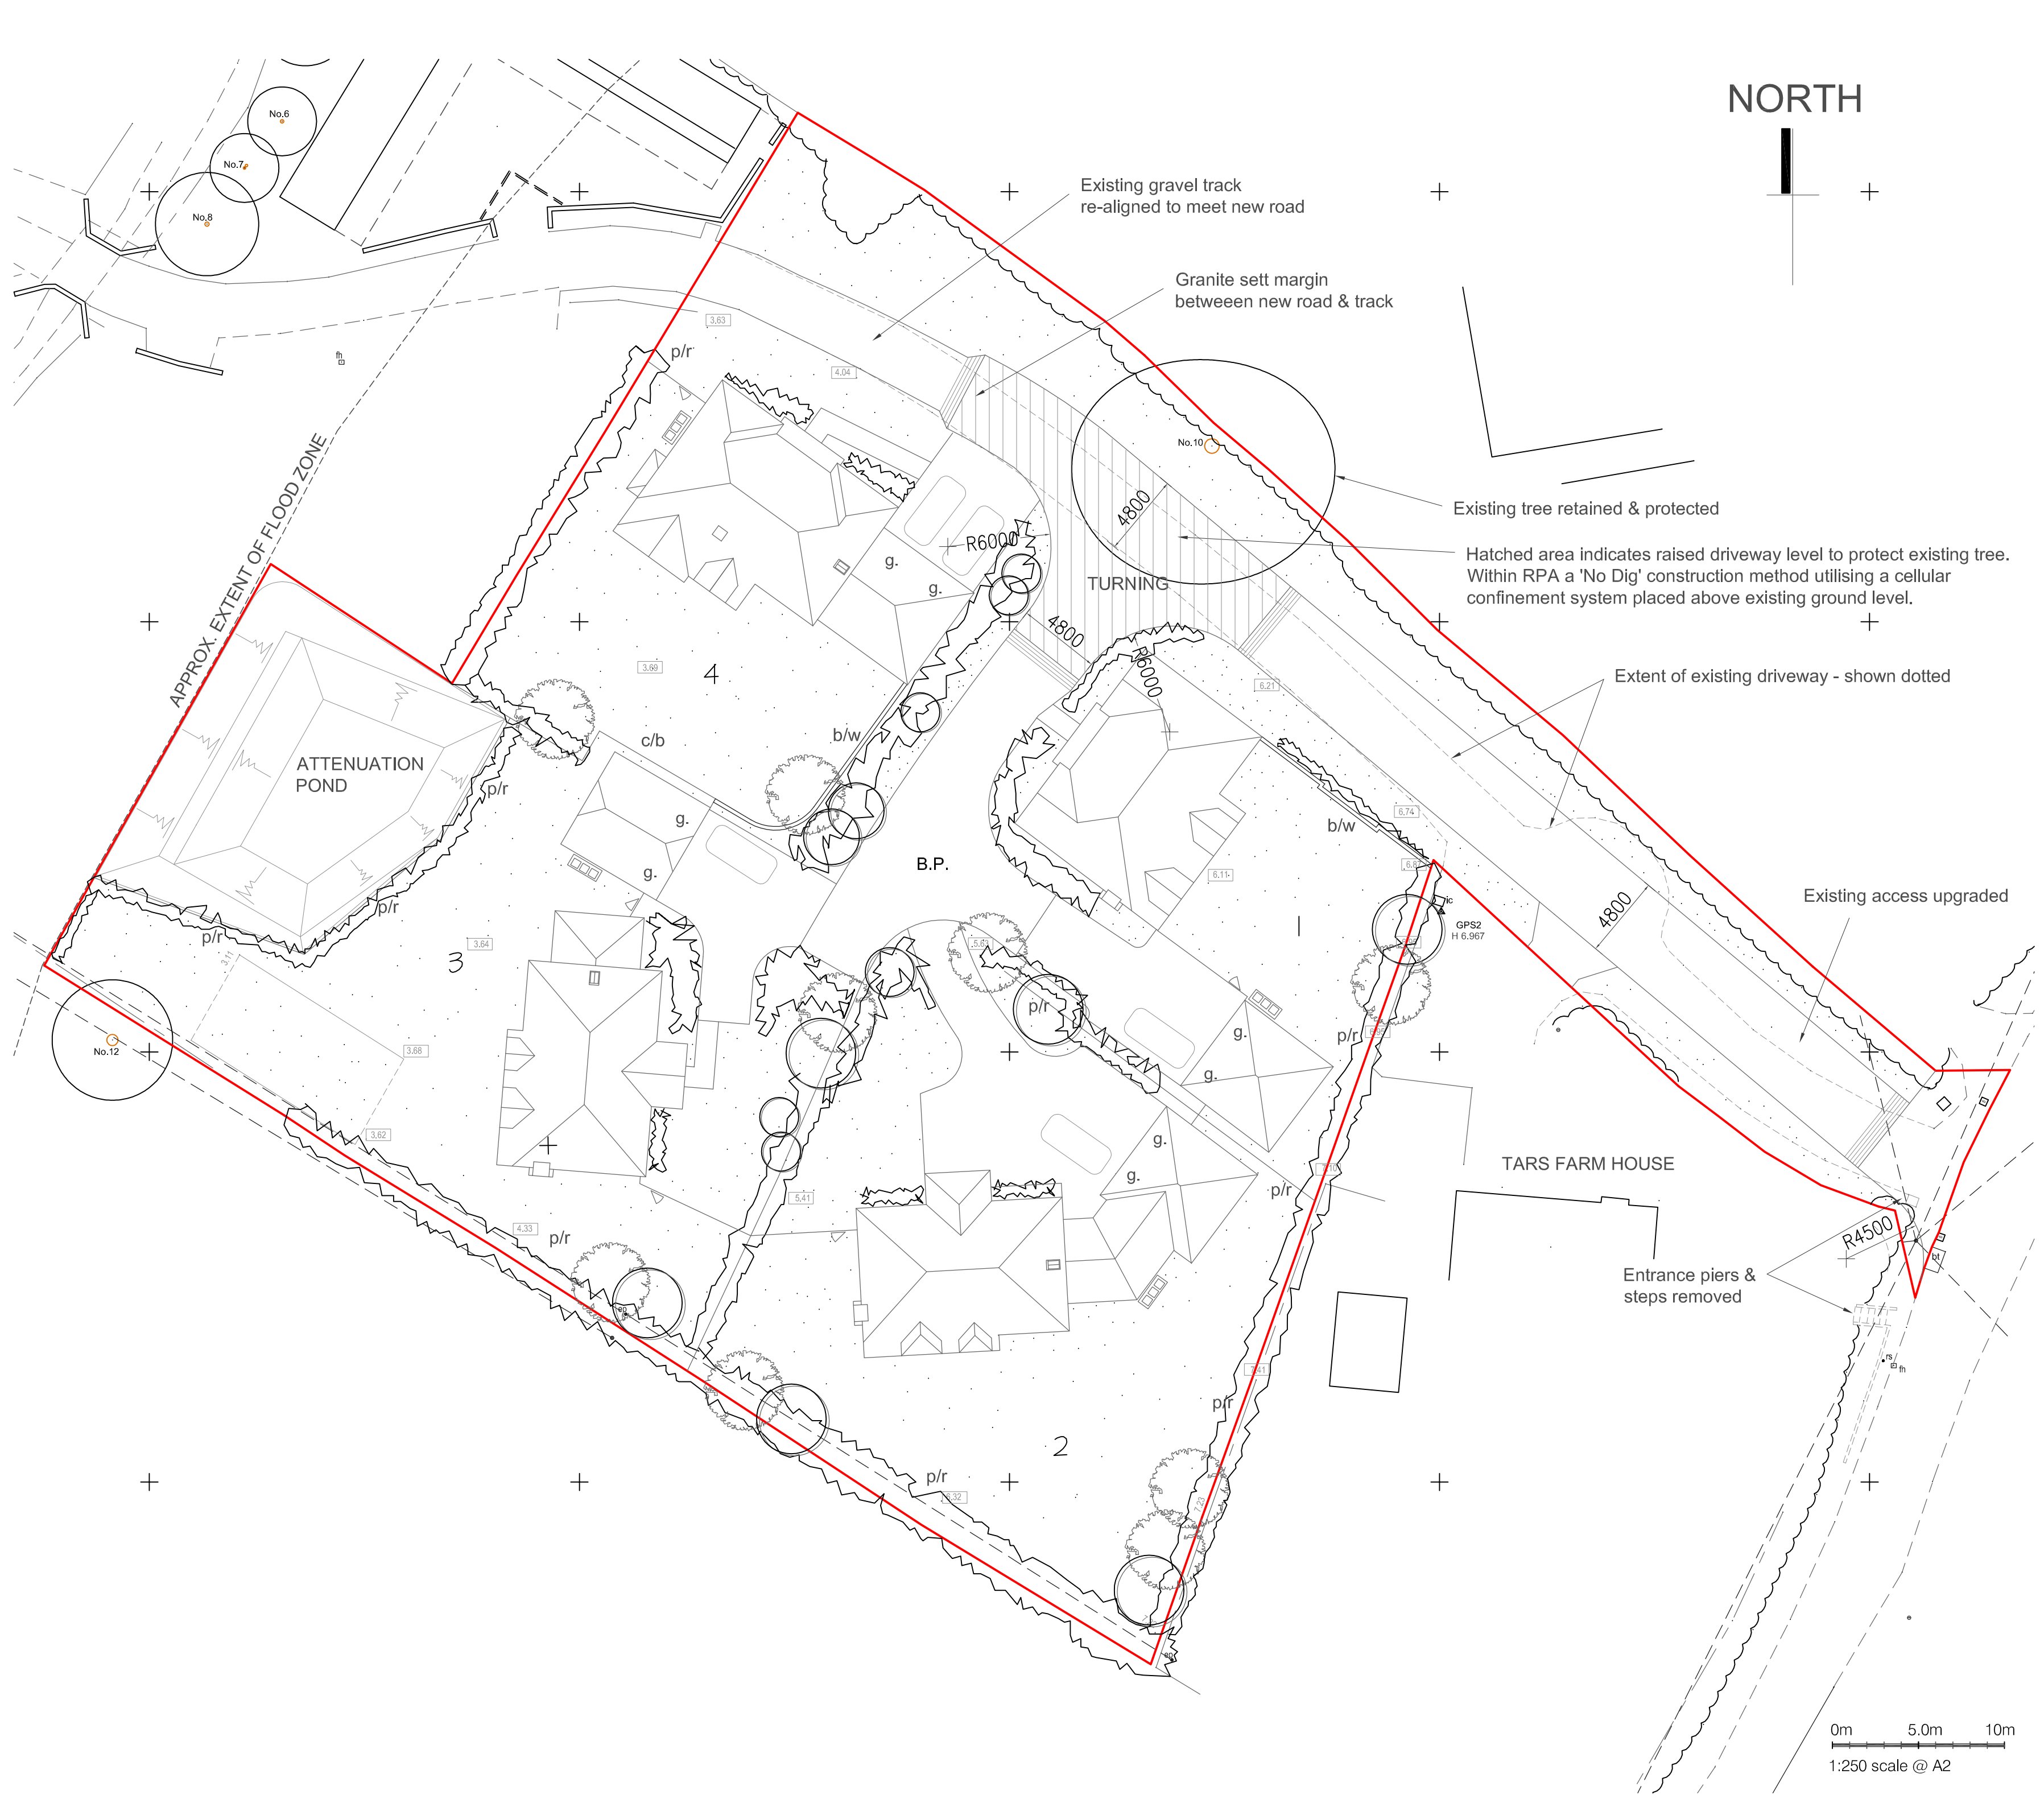
SCHEDULE OF UNITS - 4 Total

- DIGITAL / ORDNANCE SURVEY APPLICATION SITE BOUNDARY
- INDICATES INDIVIDUAL BIN STORE FOR 3 BINS IN EACH PRIVATE GARDEN.
- NOTE : ALL GARAGES TO MEASURE A MINIMUM OF 6x3m INTERNALLY. CYCLE STORAGE TO REAR OF EACH GARAGE.
- C/b INDICATES 1.8m HIGH CLOSEBOARDED FENCE
- p/r INDICATES 900mm HIGH POST & TWIN RAIL FENCE
- b/w INDICATES 1.8m HIGH FACING BRICK GARDEN WALL
- g. INDICATES GARAGE
- INDICATES GATE ACCESS TO REAR GARDEN
- B.P. INDICATES BLOCK PAVED ROAD FINISH
- GRANITE SETTS RUMBLE STRIP
- EXISTING GROUND SPOT LEVELS

11.3 The existing and proposed site characteristics comprise:

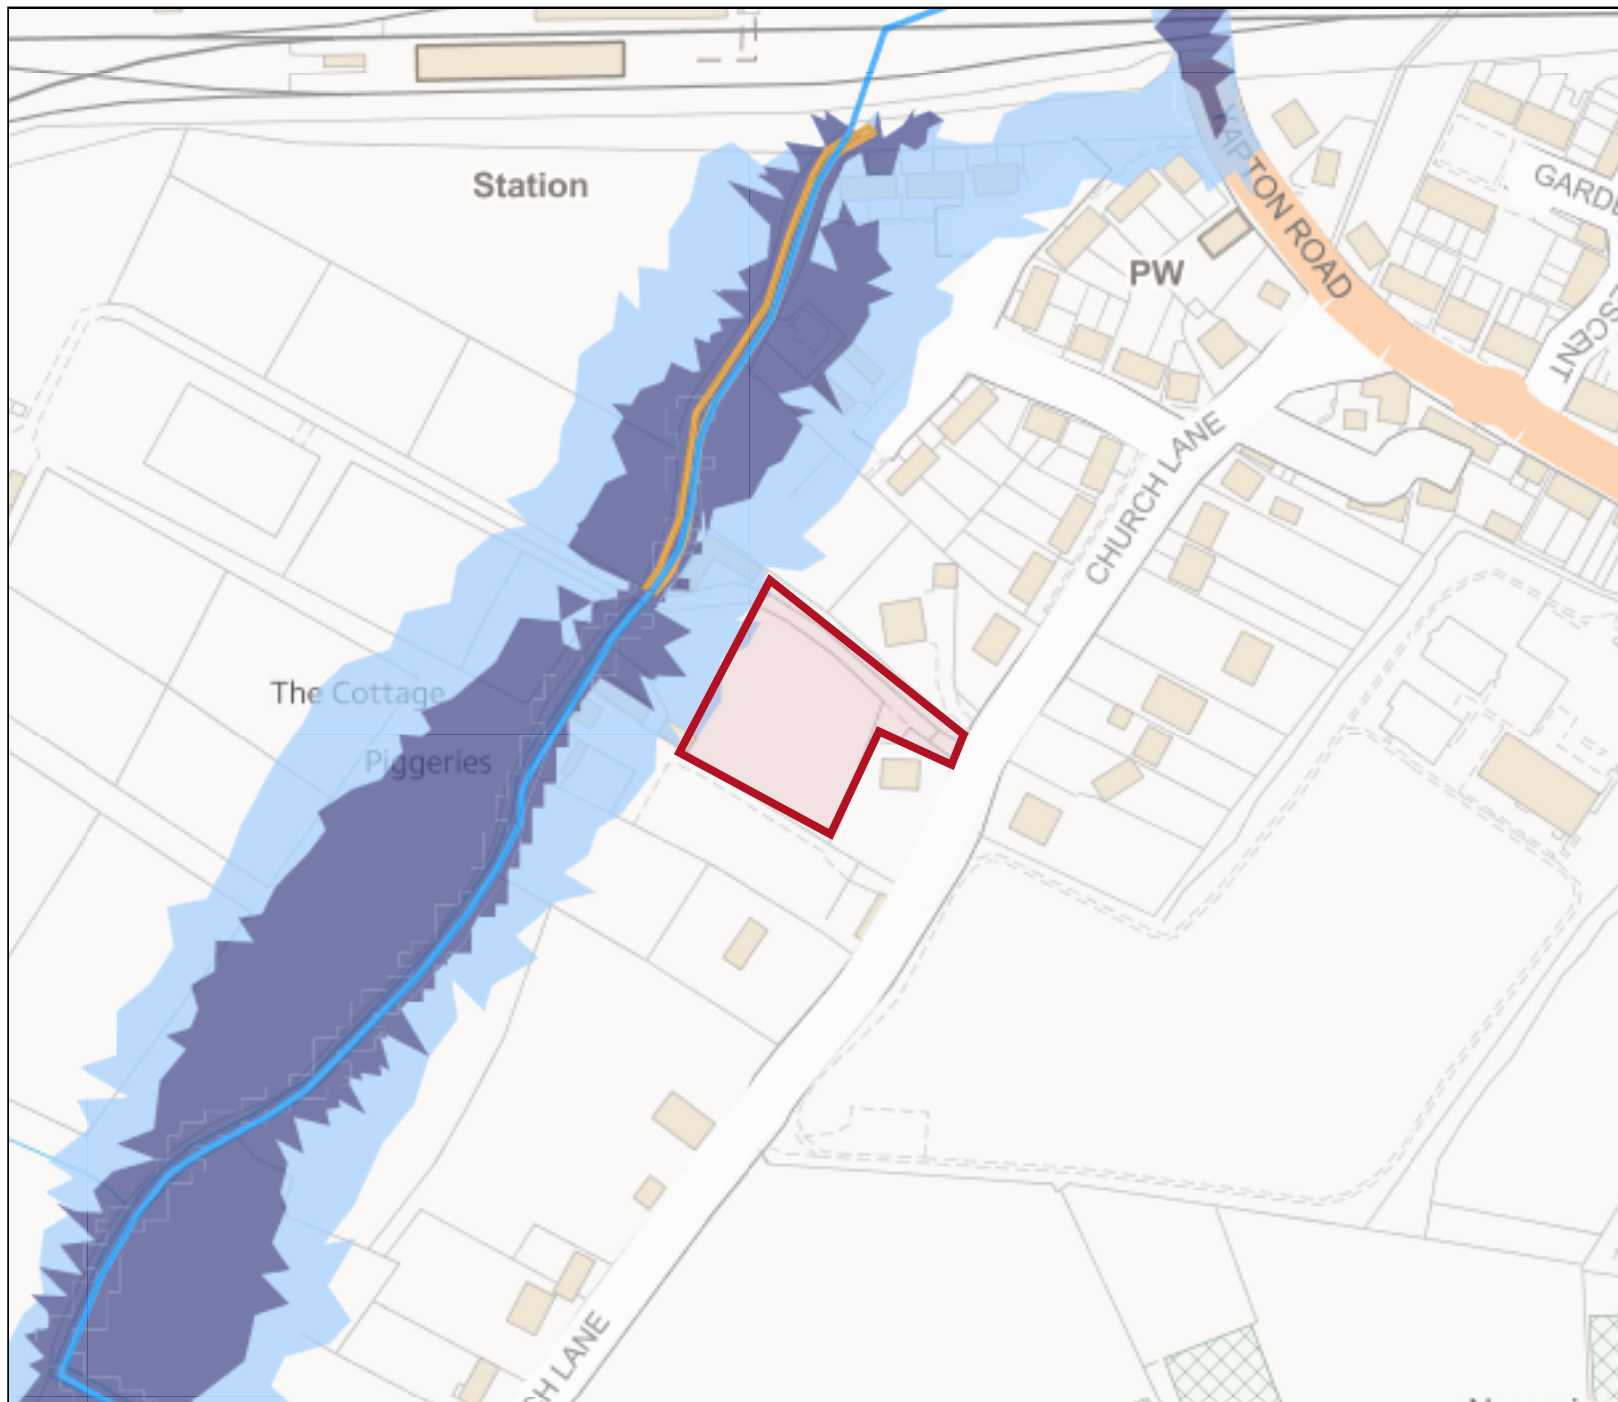
### Flood map for planning

- 3.8 Flood mapping data has been reviewed from the Environment Agency (EA) website. (refer to Appendix B ). This indicates the following:
- 3.9 The EA mapping indicates the existing site is located in Flood Zone 1.
- 3.10 The EA mapping indicates the site is at very low (<0.1% AEP) surface water flood risk
- 3.11 The EA mapping indicates the site is not in an area of reservoir flood risk.

- 8.1 The site is in FZ1 and has a low fluvial and tidal flood risk of <0.1%AEP.
- 8.2 The EA mapping indicates the site is at very low risk <0.1%AEP of surface water flooding.

9.2 The site is located in Flood Zone 1 (low risk).

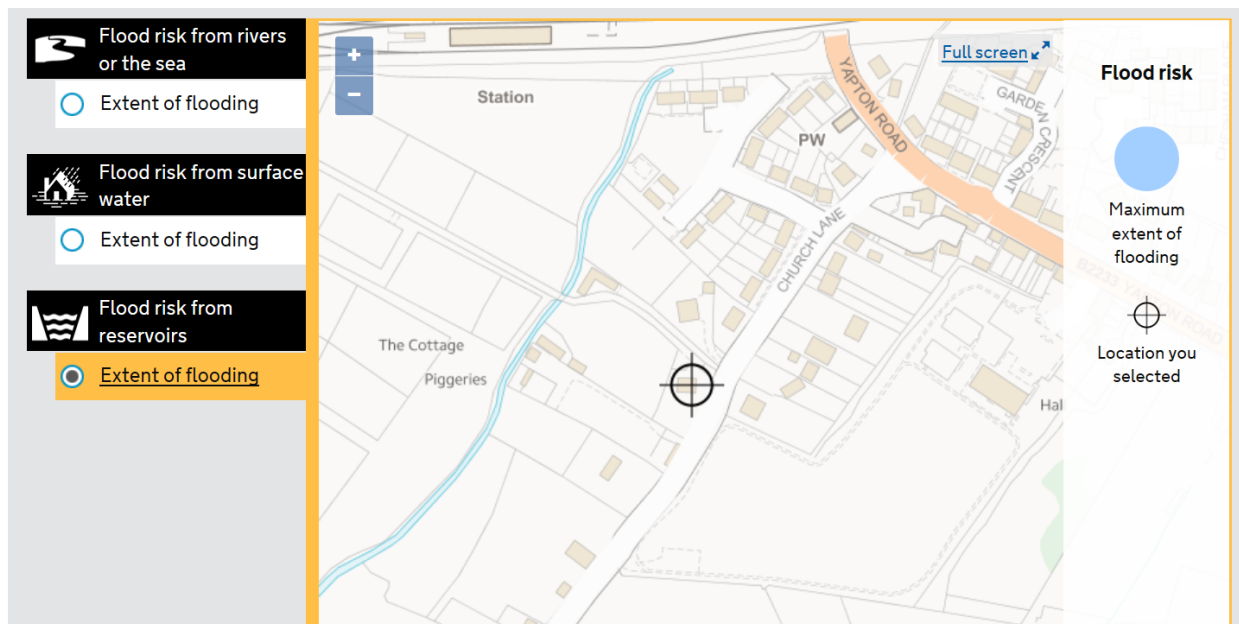
Reservoir flood risk

- 8.3 The EA mapping indicates the site is not in an area of reservoir flood risk.
- 8.4 The SFRA indicates the site is not in a groundwater emergence zone. The site soils investigation encountered high groundwater levels, however the site is on a moderate gradient and the land to the north of the site falls contiguously to Barnham Rife. The site morphology does not facilitate the accrual of groundwater at the surface.

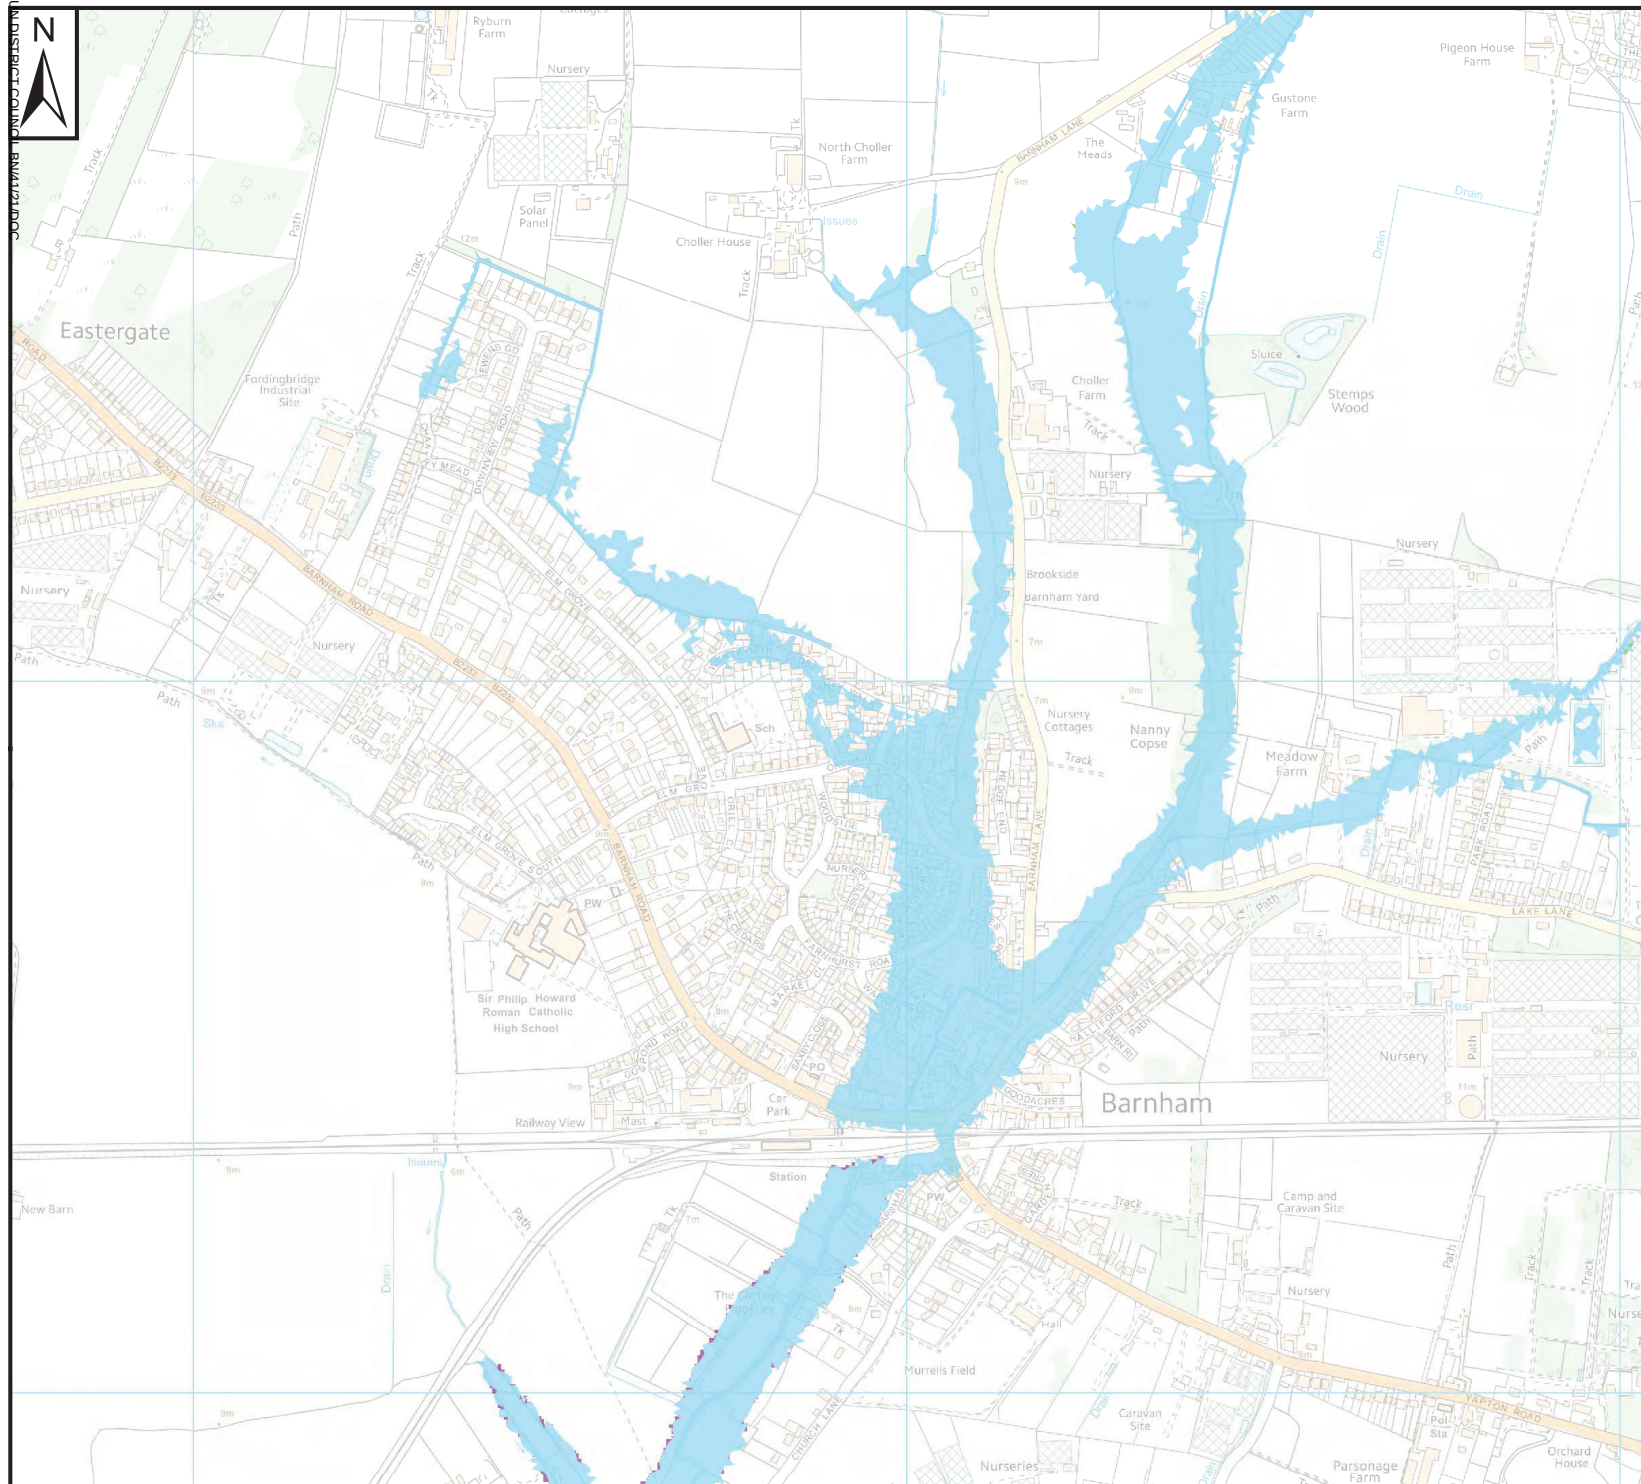
Hydraulic modelling has been undertaken as part of this SFRA to provide updated climate change flood mapping in the Arun District for Flood Zone 3a. This modelling followed the latest guidance for climate change in FRAs/SFRAs released by the Environment Agency in February 2016 (and updated in April 2016). Climate change for fluvial events has been based on the Higher Central estimates for the years 2031, 2061 and 2111. Present day flood risk information is available for comparison. Arun District is within the South East River Basin District and therefore allowance are:

For tidal/coastal models, undefended case still water level and defended case still water level with wave overtopping simulations have been completed to inform future flood risk within the Arun District. Again, climate change allowance predictions are for the years 2031, 2061 and 2111, with present day outputs for comparison.

- 3.3 SFRA map tile C-32 indicates the site is located in FZ1.
- 3.4 SFRA map tile D-32 indicates the site lies outside FZ3a 2111<sup>AD</sup> for climate change.

10.2 SFRA map tile D-32 indicates the site lies outside FZ3a 2111<sub>AD</sub> for climate change.

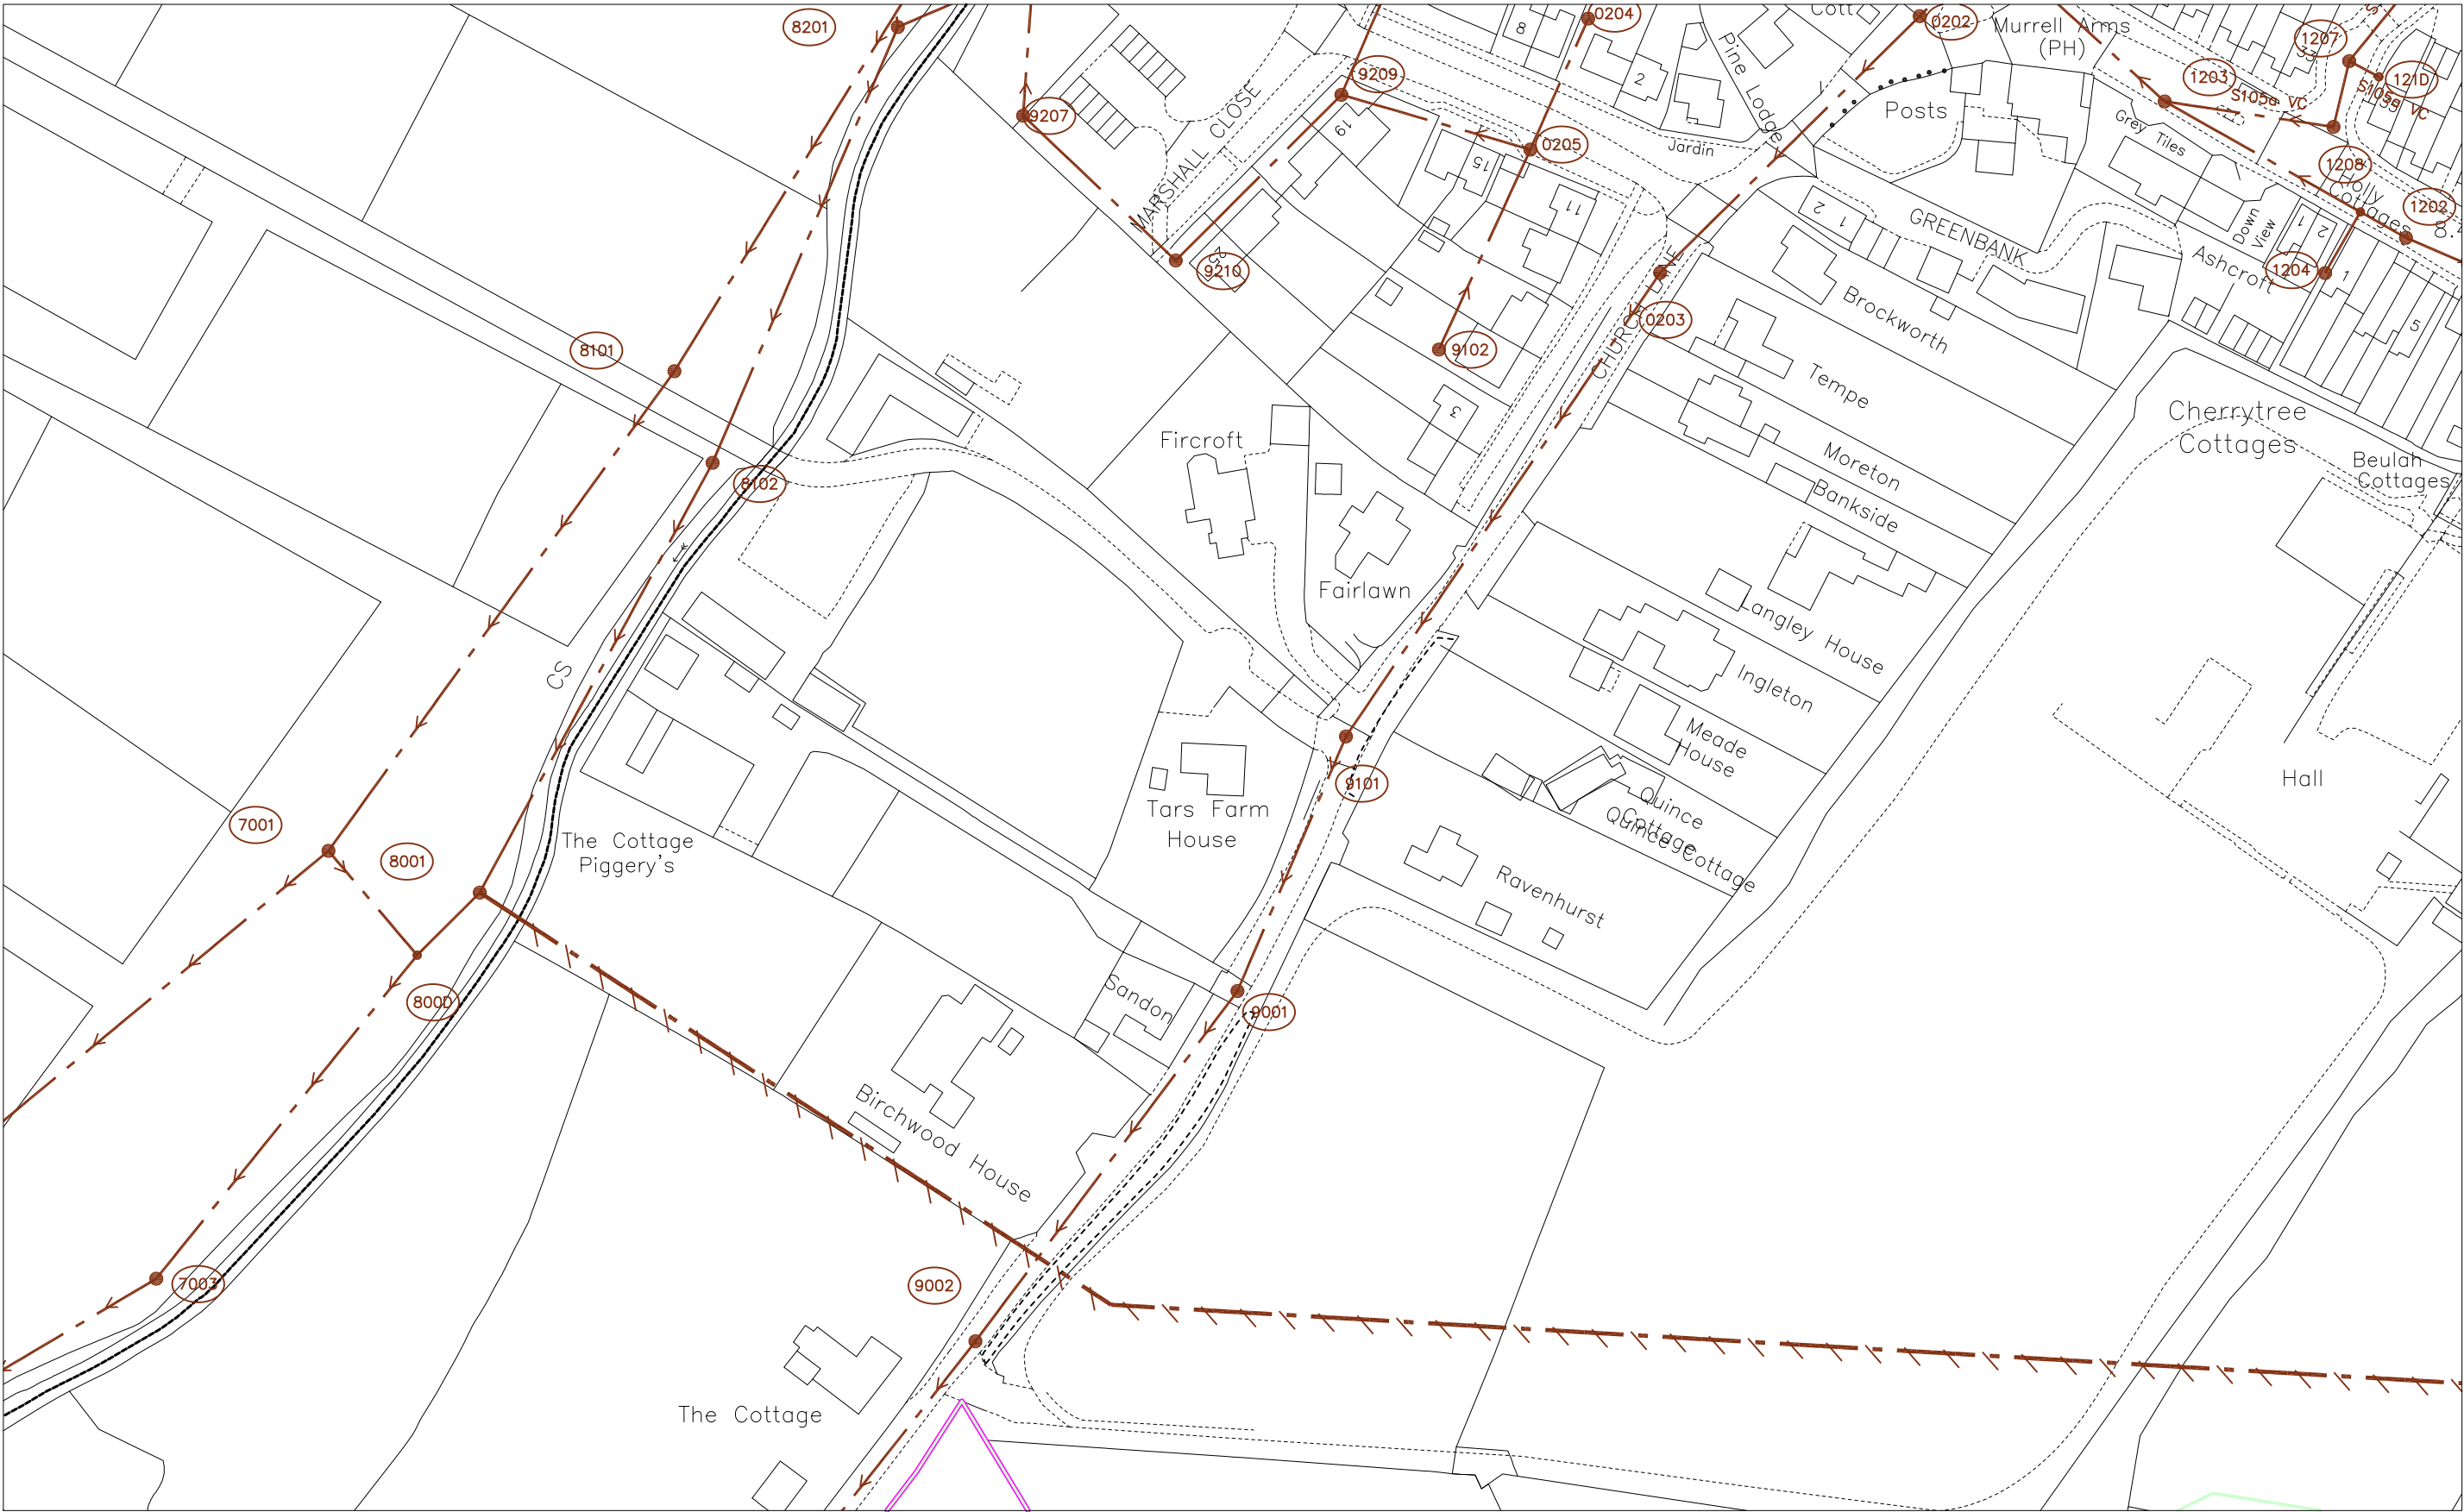
SEWER RECORDS PAGE 1 OF 2

- 6.1 The existing farmhouse is served by a high level existing 175mm DN gravity foul sewer to the front. There is also a 350mm DN and 375mm DN lower level gravity foul water sewers to the rear of the site. A copy of the local sewer plan is contained in Appendix B.
- 6.2 The proposed redevelopment will discharge foul water (FW) to one of the rear public FW sewers. The additional load for 4 dwellings will be *de minimis*, but notwithstanding this the standing wastewater Infrastructure Charge (IC), which came into force from 1<sup>st</sup> April 2018,
