**Arboricultural Impact Appraisal and Method Statement**  
The Lillies Caravan Park, Yapton Road, Barnham

**23<sup>rd</sup> February 2018**  
**17160-AA2-DC**

This report contains the supporting tree information relating to the proposal to construct a mixed residential development at The Lillies Caravan Park, Yapton Road, Barnham.

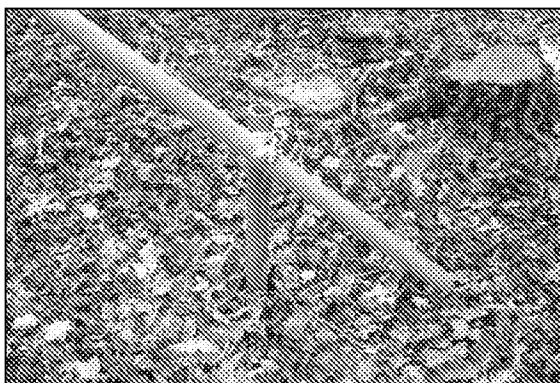
**Photo 3:** Close up of bracing detail, essential for increasing the stability of the vertical framework.

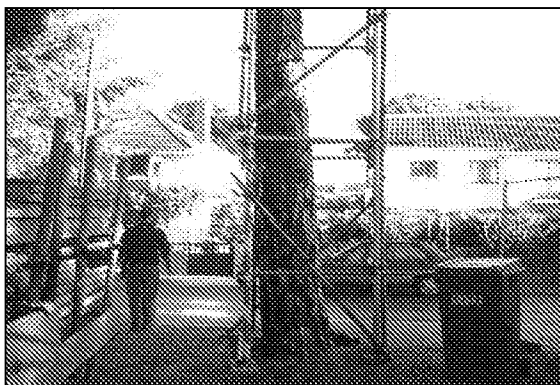
**Photo 5:** A scaffold braced framework surrounding the trunk reduces the risk of accidental impact.

Where individual trunks or branches are vulnerable to impact damage, a framework of scaffold or wood can be constructed to provide protection (photos 5 and 6).

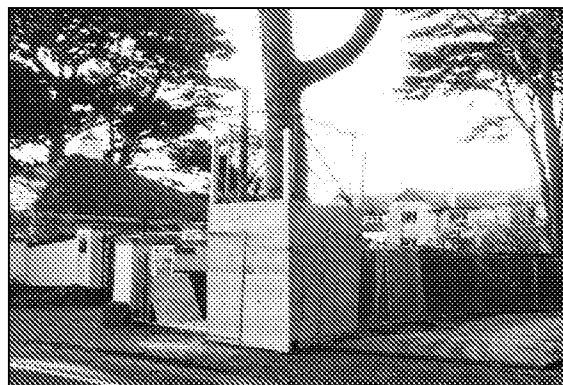
**Photo 6:** Board secured to scaffold framework adds another layer of protection for vulnerable trunks and branches.

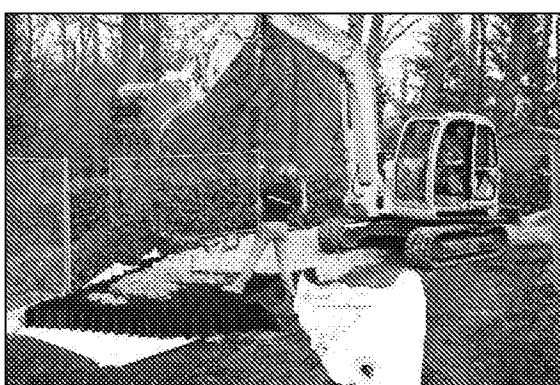
**Photo 11:** Cellular products are a very effective means of providing ground protection where heavy vehicle use is expected. Here, it is being used to temporarily widen an existing road, to be removed once the construction is finished.

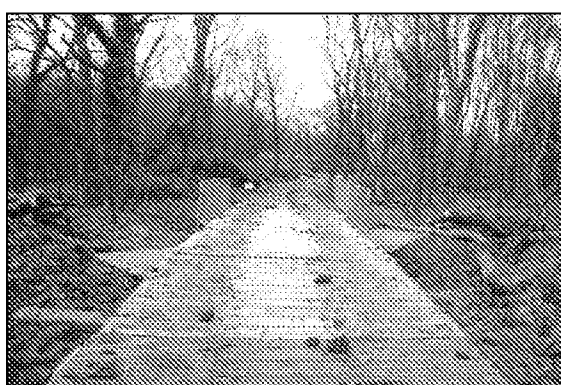
**Photo 12:** Custom designed sectional tracks can be joined to support very heavy traffic use through sensitive areas.

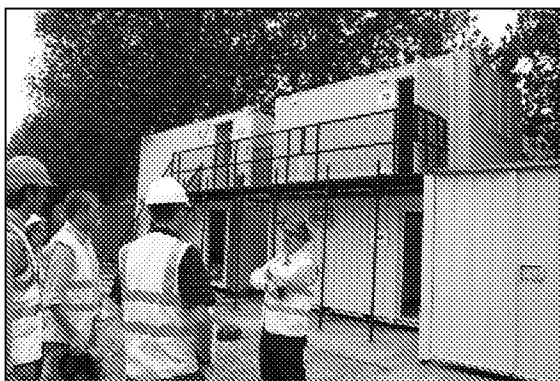
**Photo 13:** A combination of retaining existing surfacing and using temporary construction cabin accommodation can be a very effective means of preventing damage to sensitive areas.

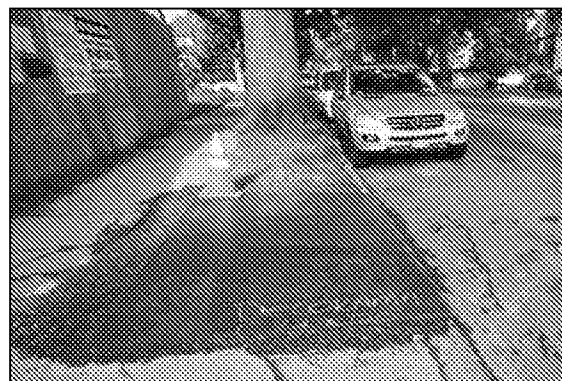
**Photo 14:** Steel plates can be an effective way of temporarily reinforcing weak surfacing over a construction access during the development activity.

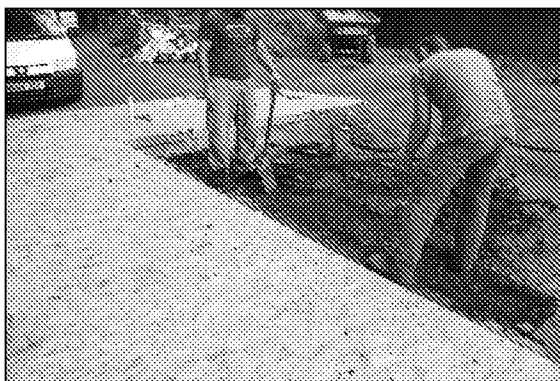
**Photo 15:** Careful hand-digging using conventional tools is acceptable for exposing roots in RPAs.

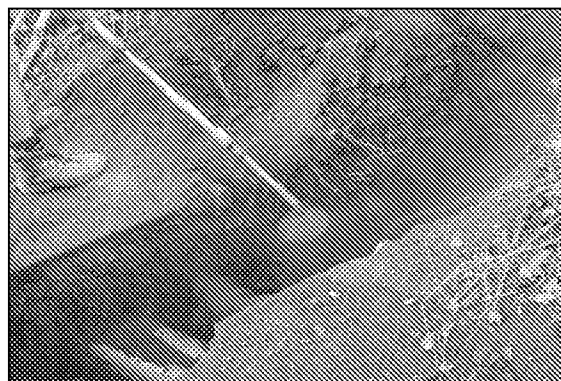
**Photo 16:** Air spades are very effective at exposing roots and services with minimal damage.

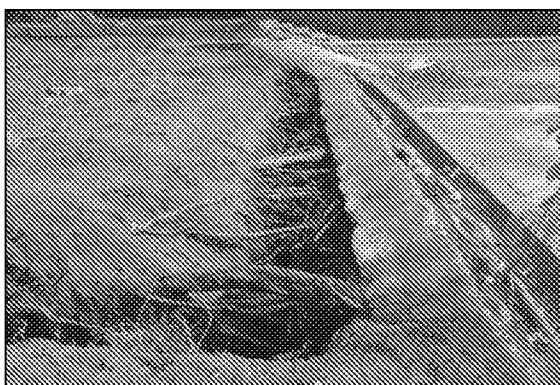
**Photo 17:** Air spades are particularly useful where roots are very dense.

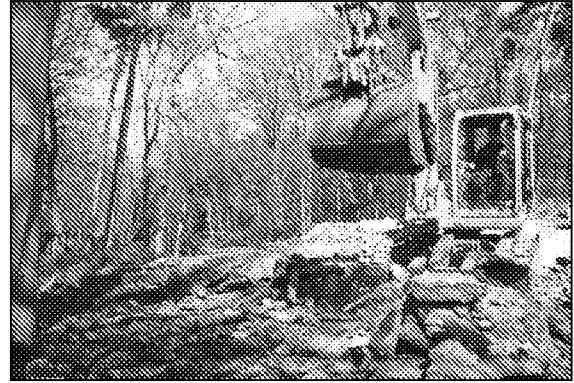
**Photo 20:** Machines with a long reach can be used to lift out heavy surfacing and structures as long as the machine sits outside the RPA and the exposed surface is protected before there is any further access.

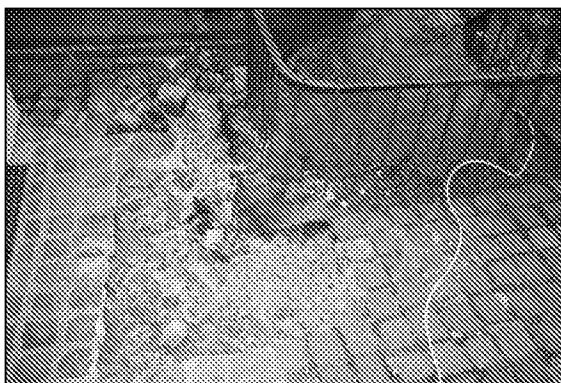
**Photo 21:** Careful lifting of cemented-in sets round this tree allowed them to be re-laid on a permeable sand base, improving the water input into the soil around the trunk.

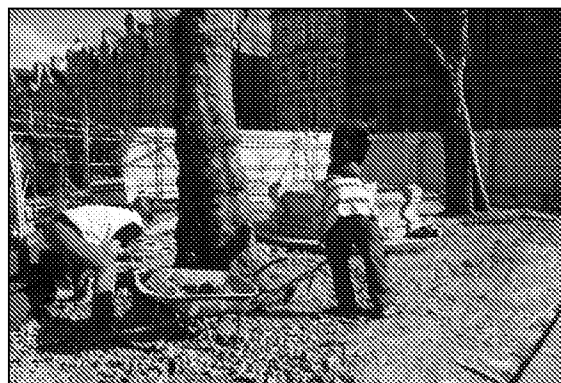
**Photo 22:** These trees had impermeable surfacing right up to their trunks, which had to be removed by hand before installing new structures.

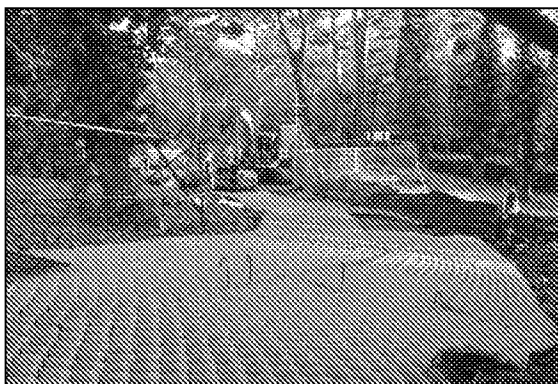
**Photo 24:** The three-dimensional cells are opened up, spread across the area to be surfaced and pinned in place ready for the stone filling.

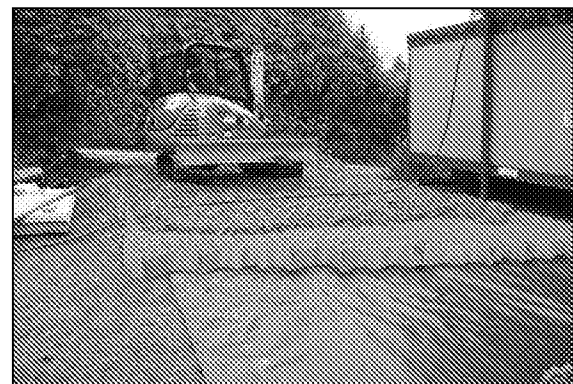
**Photo 25:** The stone-filled cells spread the load of traffic and the geotextile membrane on the ground prevents migration of the stone into the soil profile.

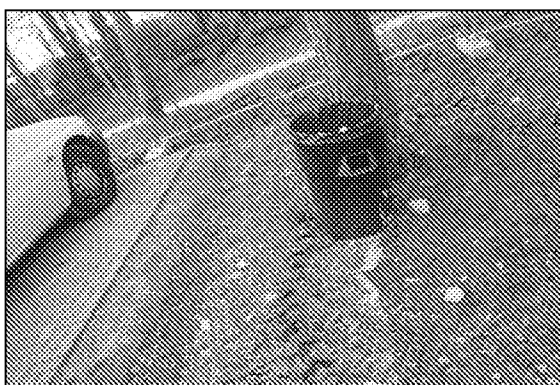
**Photo 26:** A conventional concrete haunching can be used to retain new surfacing as long as it is not dug into a trench - here it is placed on top of the CellWeb layer.

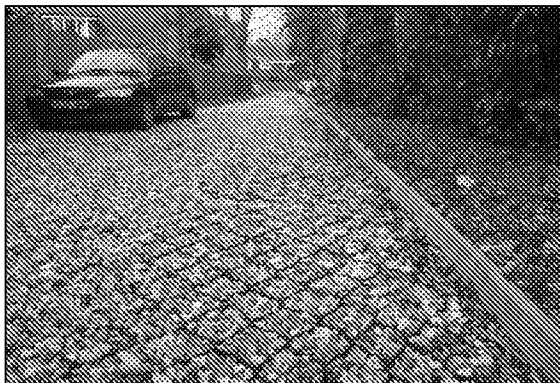
**Photo 28:** Wooden board pinned in place or held in position with backfilled topsoil can provide more informal and rustic surface edging.

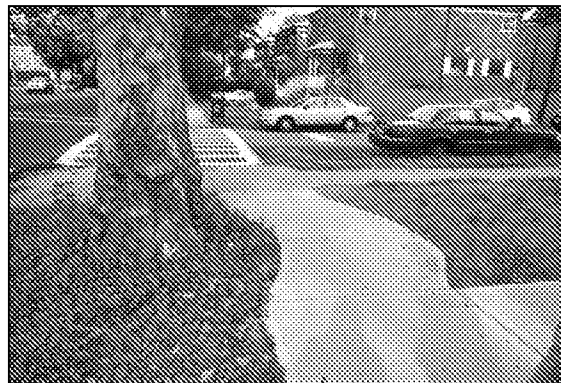
**Photo 29:** In some situations, it may be appropriate to cast a free floating concrete surface directly onto the soil surface provided provision is made to prevent soil contamination while the concrete is being poured, i.e. an impermeable membrane separating the concrete from the soil.

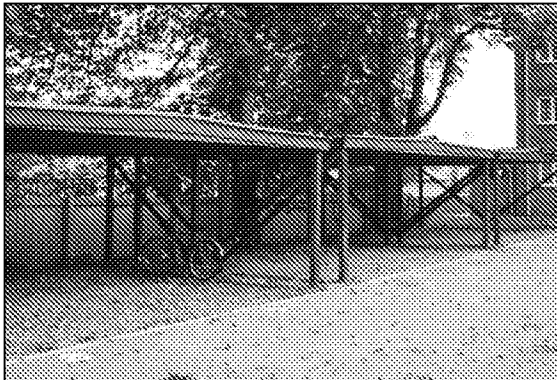
**Photo 34:** These carports are formed by wooden posts above a three dimensional cellular no-dig and load-spreading surface of permeable crushed stone.

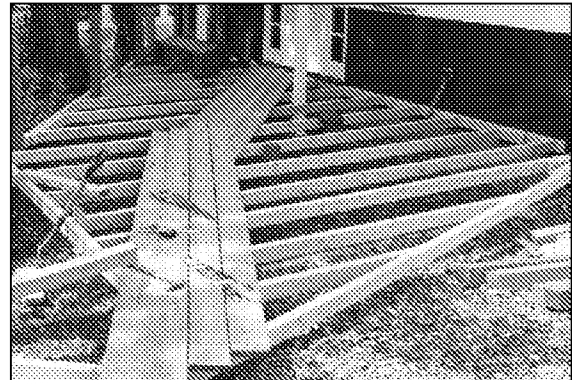
**Photo 35:** This deck supported above the ground on small posts provides a low-impact alternative to conventional stone patio surfacing in RPAs.

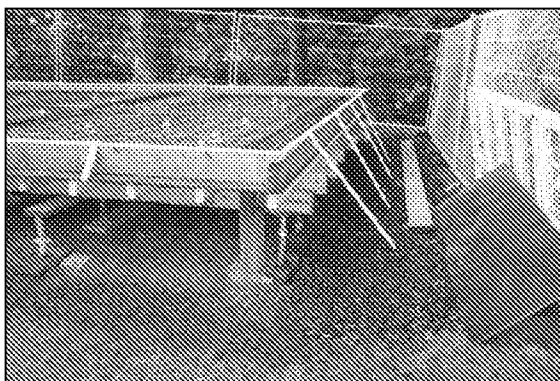
**Photo 36:** Small diameter piles (less than 150mm) are an effective means of supporting structures in RPAs with minimal disturbance.

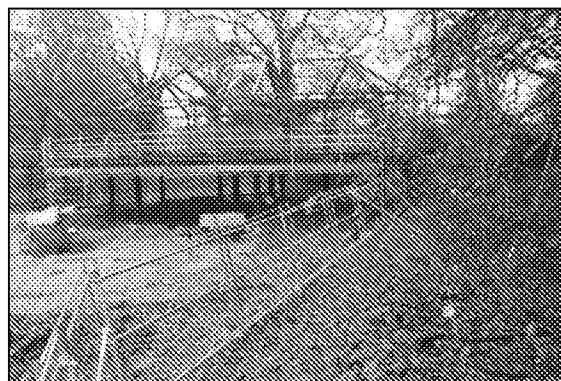
**Photo 37:** It is possible to support very large structures on piles within sensitive RPAs without any significant adverse impact on tree roots.

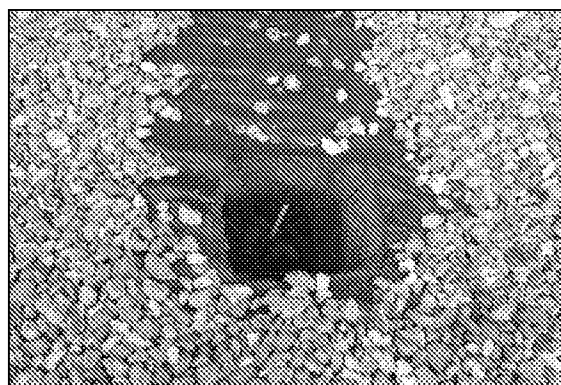
**Photo 39:** Ground protection must be used to spread the load of the piling rig once excavation has confirmed that no substantial roots are in the preferred pile location.

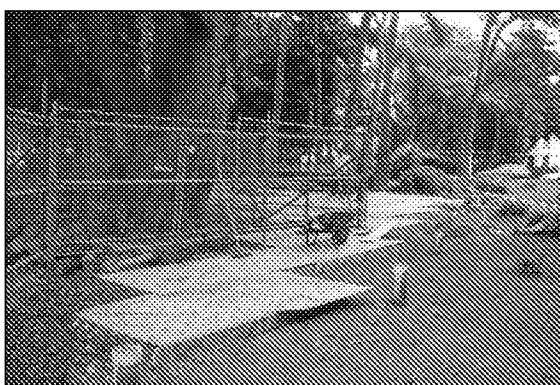
**Photo 40:** Once the piles have been installed (yellow tops), the ground protection to support the piling rig is removed ready to fix the void-former onto the bare soil, in advance of pouring the building slab.

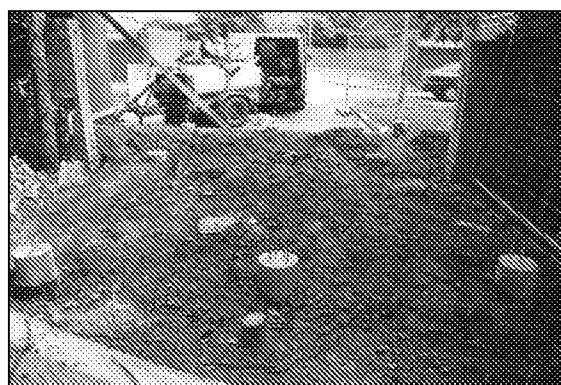
**Photo 41:** Piles can also be used to support bridges across sensitive RPAs, but the temporary ground protection has to be removed before the main structure is either imported in or cast on site.

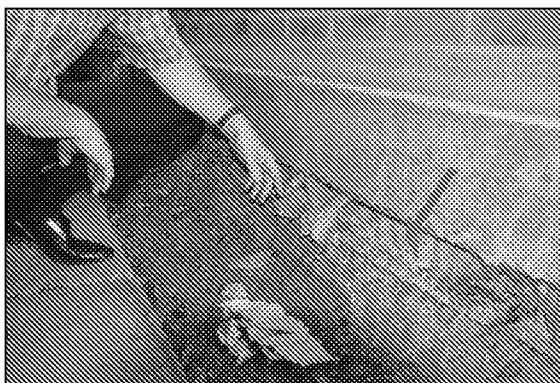
**Photo 42:** Where a slab is cast on site, a biodegradable void-former (red arrow) temporarily supports the weight of the liquid concrete until it sets. The void-former can then be wetted and washed away to leave a void or left to degrade naturally, both of which allow movement of air beneath the slab.

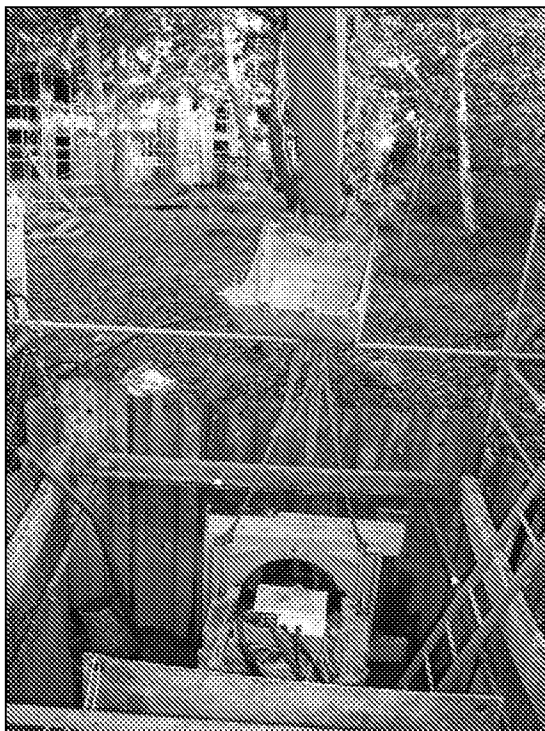
**Photo 44:** If possible, thrust boring is the preferred option for installing service routes through the RPAs of important trees, but there has to be space at the start and finish to dig substantial working pits.

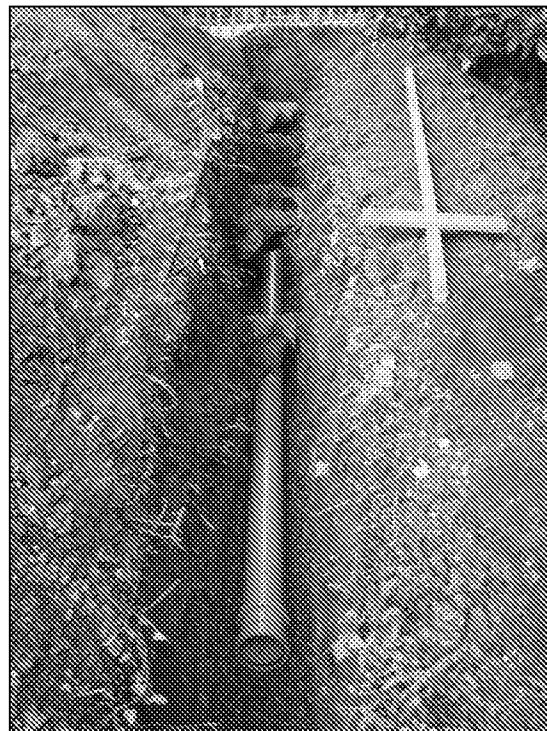
**Photo 45:** Continuous trenches dug by hand so that important roots can be retained (with the service ducting threaded beneath) is an effective means of minimising damage (note the ground protection boards with soil piled on top on the left).

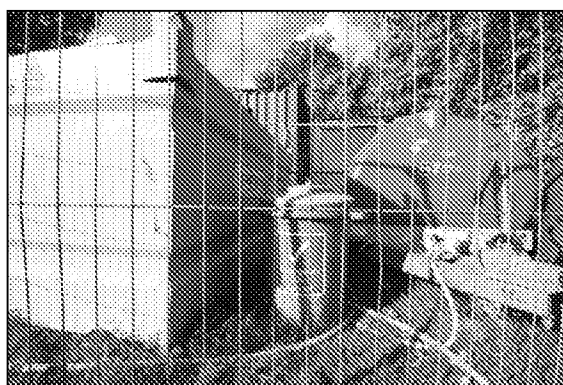
**Photo 46:** Where fuel or other chemical are stored on site, it is now standard practice to have emergency spillage kits available to restrict the environmental impact of accidents.

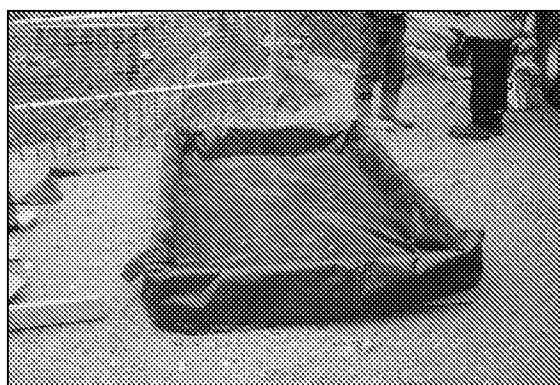
**Photo 47:** Soil bunding or a supporting framework covered in heavy-duty plastic sheeting is essential where there is a risk of

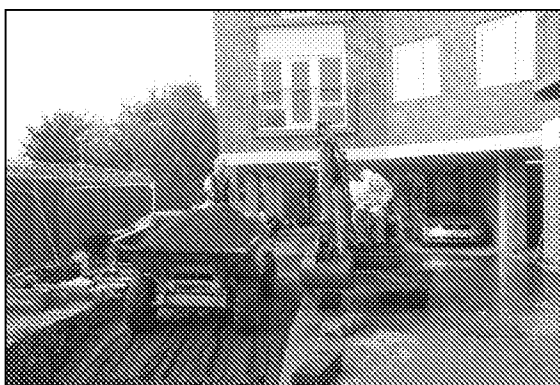
**Photo 53:** Structural tree soil retains sufficient structure for tree roots to grow, even when compacted.

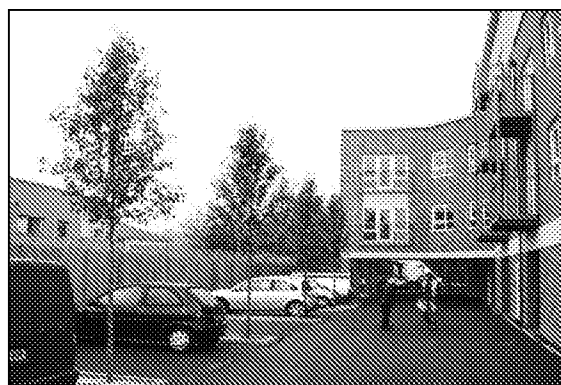
**Photo 54:** It allows trees to be successfully established in areas of extensive hard surfacing, with very little, if any, loss of parking space

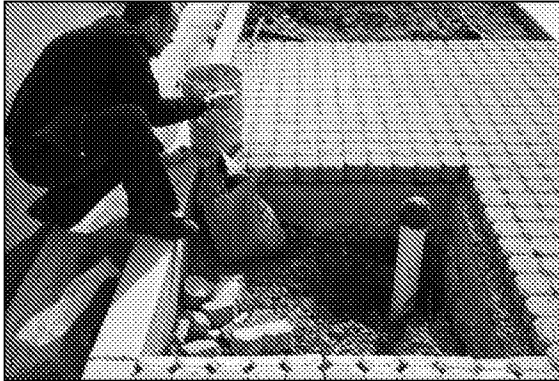
**Photo 57:** The finished surfacing is profiled to leave the tree pit open, ready to be filled with good quality topsoil and the new tree.
