Project: Standard Details

Title: ANPR Lighting Column General Arrangement

Drg. No: C-0000-001 Rev: A

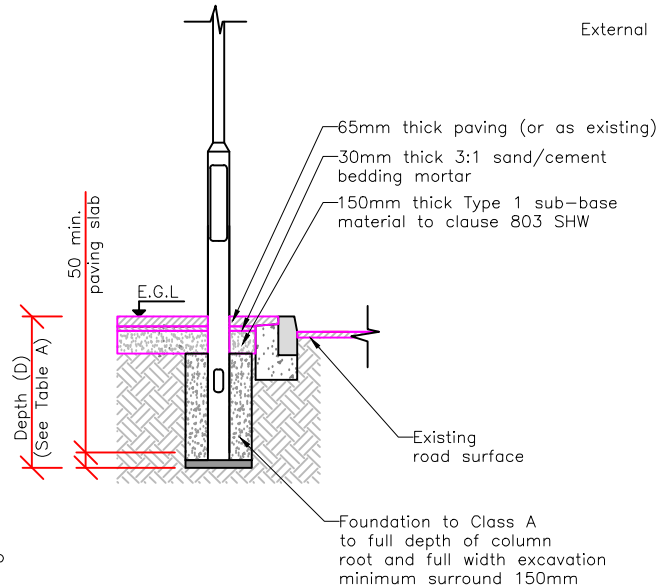
Column Foundation and  
Reinstatement Details

| TABLE A: | DEPTH (D) (mm) | | |
| COLUMN HEIGHT (H) (mm) | G630 GOOD SOIL | G390 AVERAGE SOIL | G230 POOR SOIL |
| 5000 | 800 | 1000 | 1200 |

Soil Type: (Factor G) (BS 5649 Part 2)

G630 Good: Compact, well graded sand and gravel, hard clay, well graded fine and coarse sand, decomposed granite rock and soil. Good material should be well drained and in locations where water will not stand.

G390 Average: Compact fine sand, medium clay, compact, well drained sandy loam, loose coarse sand and gravel. Average soils should be drained sufficiently well that water does not stand on surface.

G230 Poor: Soft clay, clay loam, poorly compacted sand, clays containing a large amount of silt and vegetable matter, and made ground. Poor soils will normally be wet and have poor drainage.
