CLIENT **Metamorph Management LLP**  
PROJECT **The Royal Hotel Apartments**  
DRAWING TITLE **Railing Details**

DATE **March 2019**  
DWG NO. **169 / 3.902**  
SCALE **N/A**  
REVISION **01**  
DATE **18.03.19**

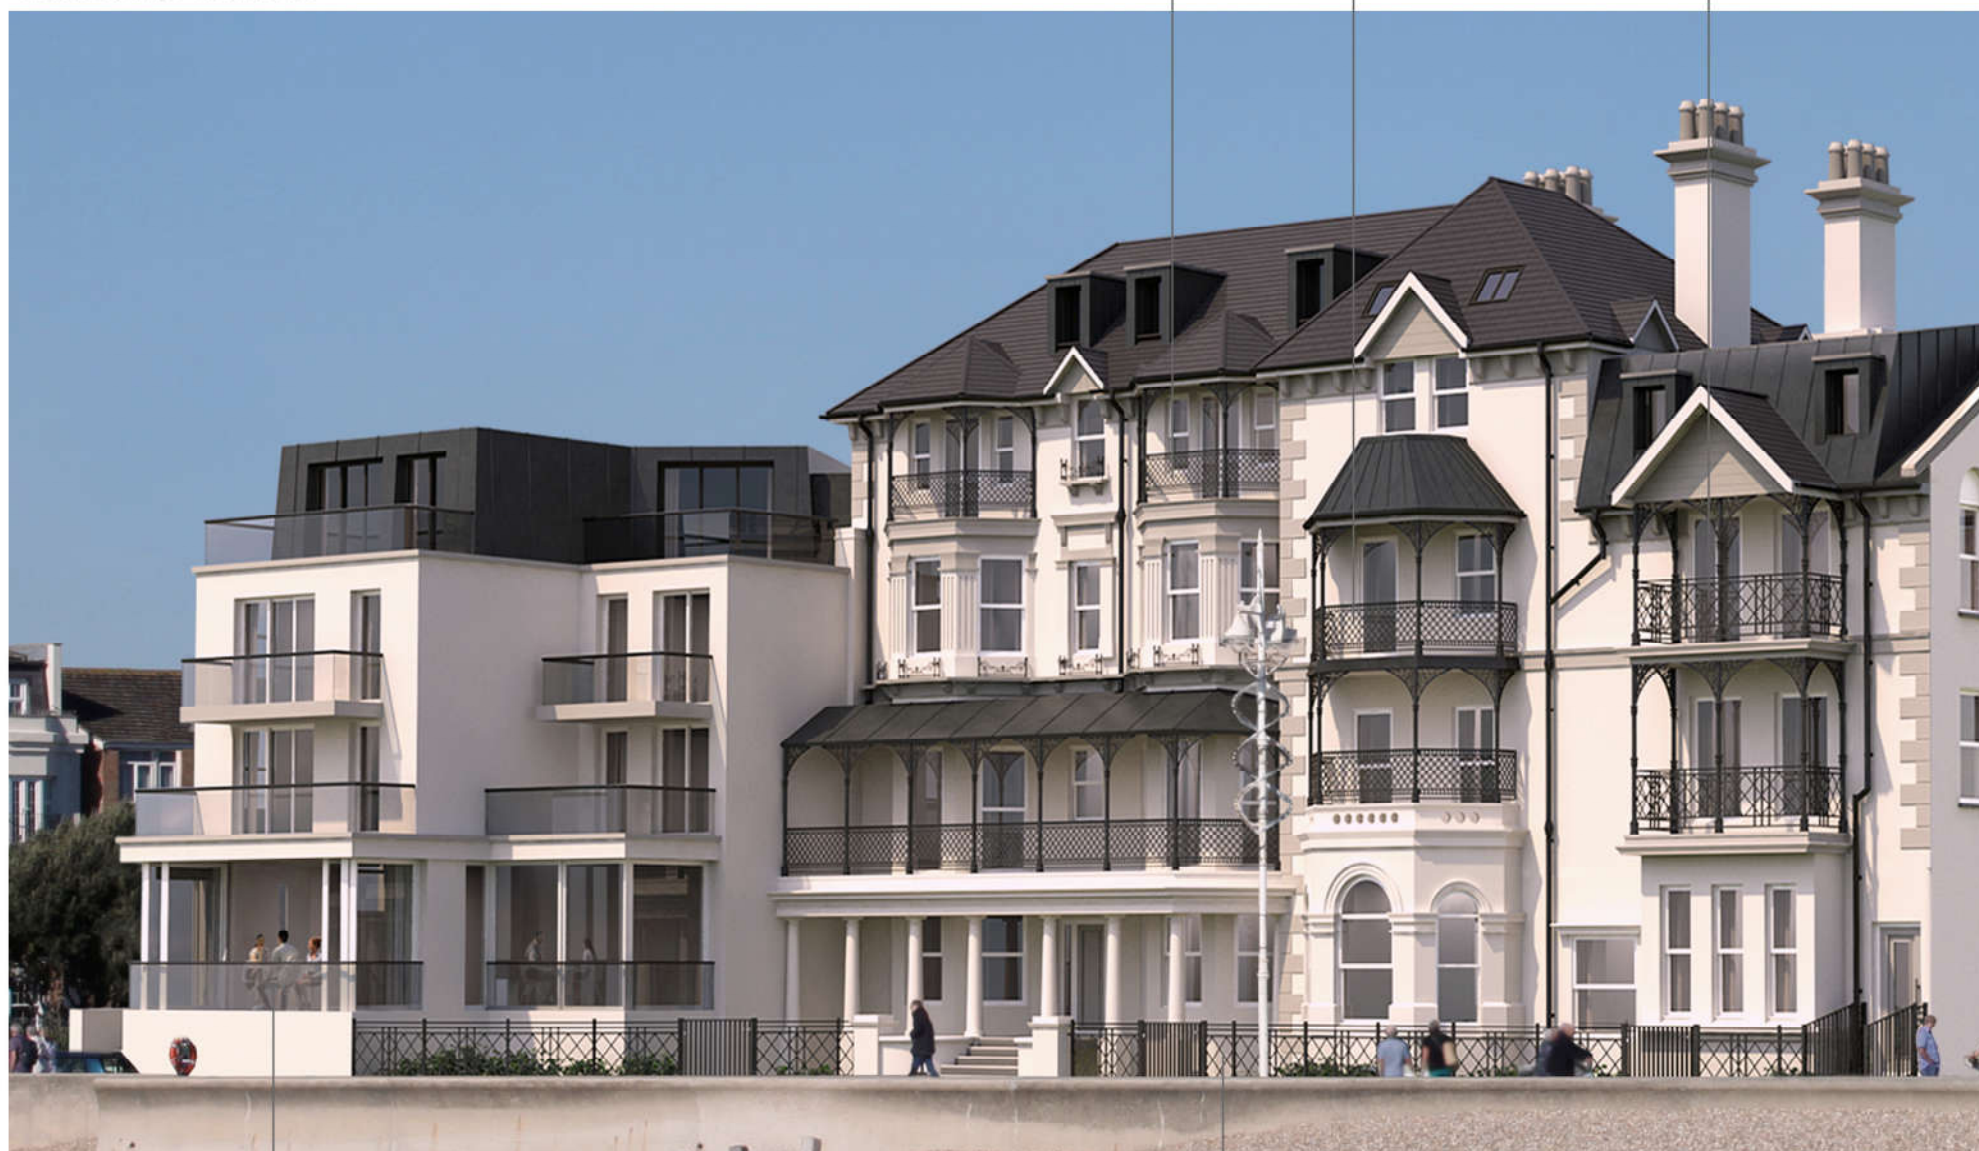
PROPOSED SCHEME

EXISTING IRON RAILINGS TO BE  
SANDBLASTED & REFINISHED IN  
BLACK ANTI-CORROSIVE PAINT (a)

NEW GLAZED BALUSTRADE (c)

NEW BLACK PAINTED IRON RAILING AT STREET  
LEVEL TO REPLICATE EXISTING RAILING (b)

Due to a lack of maintenance the existing ironwork is in a poor state of repair. Degradation of the ironwork where balconies connect to the main facade is evident, furthermore there are sections where large areas of rust are evident. It is proposed the existing localised connections to the facade be removed and new sections installed. Where rust is beyond repair localised sections are to be cut out and replaced. The entire ironwork is to be sand blasted back and refinished with black anti-corrosive paint to suit the marine environment.

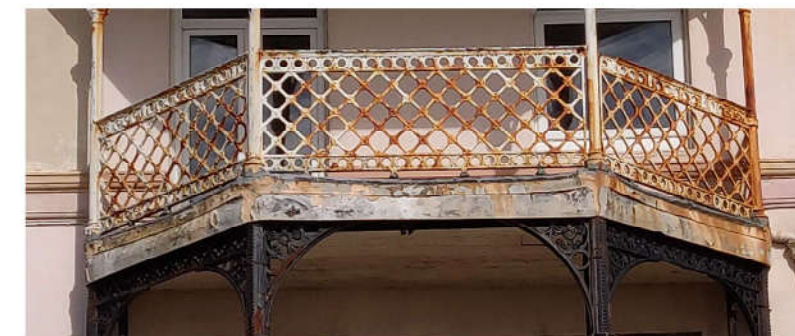
a) EXAMPLE OF EXISTING RAILINGS TO BE REMEDIATED AND  
PAINTED BLACK

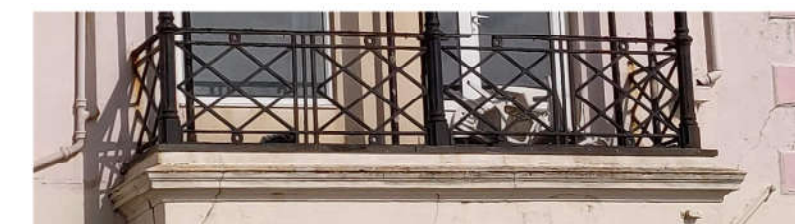
b) EXAMPLE OF EXISTING RAILING TO BE REPLICATED FOR  
GROUND FLOOR NEW RAILING

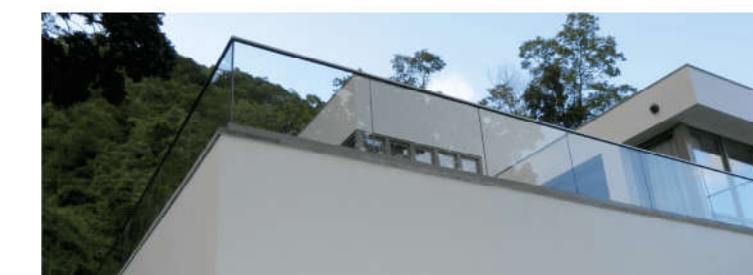
c) FRAMELESS CHANNEL GLAZING TO FORMER JACK RABBIT  
SLIMS ADDITION
