For  
Bognor Rugby Club

Project  
Hampshire Avenue  
Bognor Regis  
PO21 5JH

Title  
New Container Store to  
replace existing garage

| Date | Drawn | Scale | Checked |
|---|---|---|---|
| 1764 | P | 29 | B |

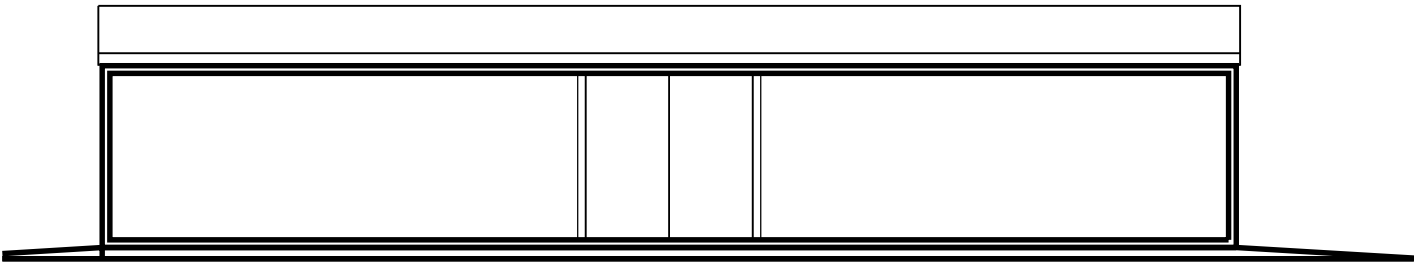
South West Elevation    reduce slab width and plant with mixed spiky hedgerow species

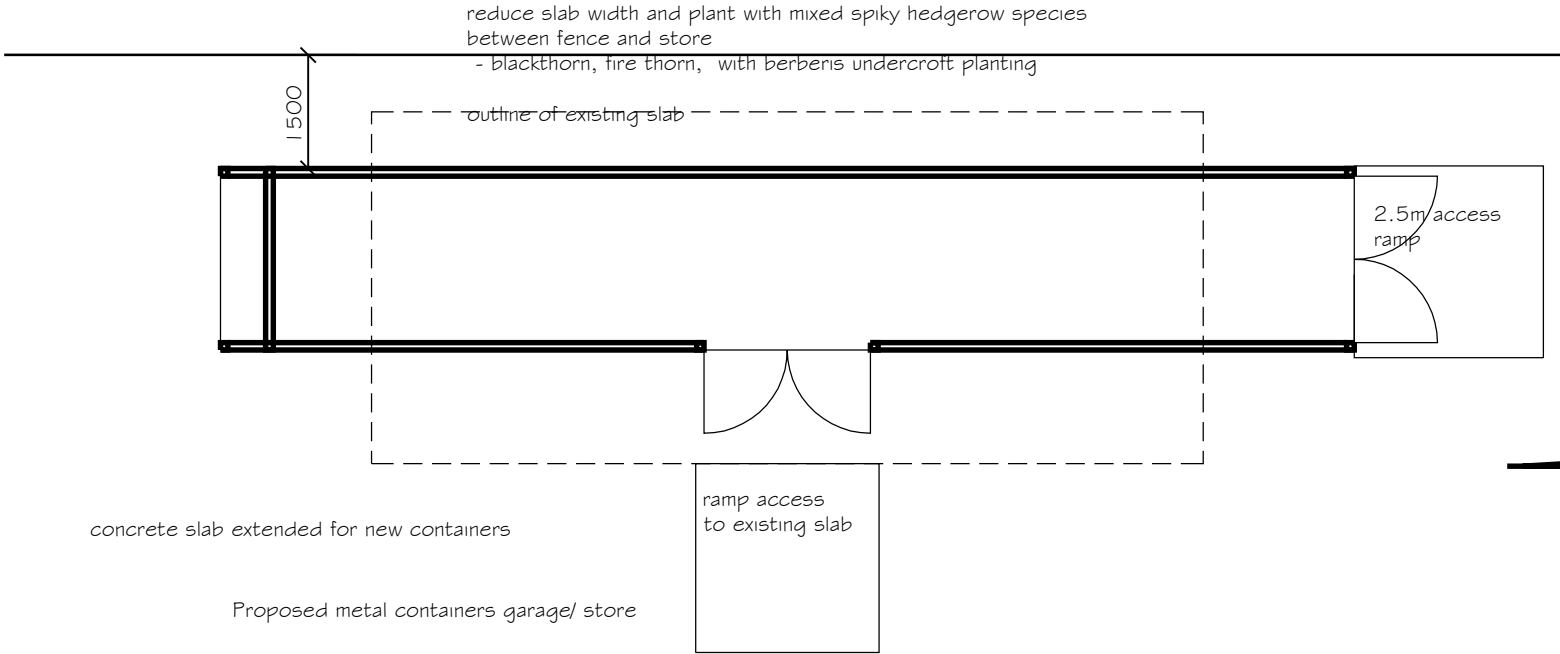
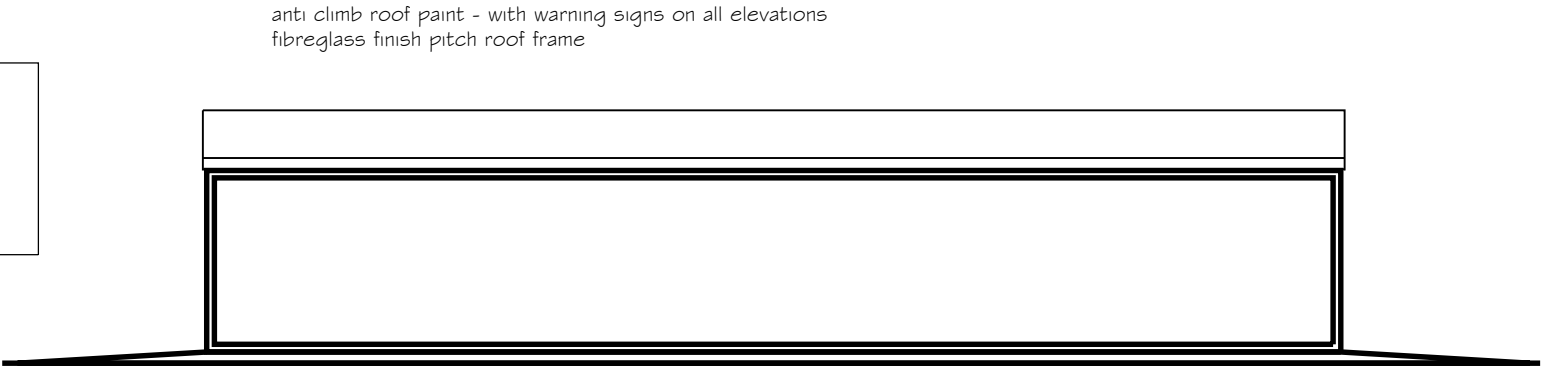
North East Elevation

anti climb roof paint - with warning signs on all elevations  
fibreglass finish pitch roof frame

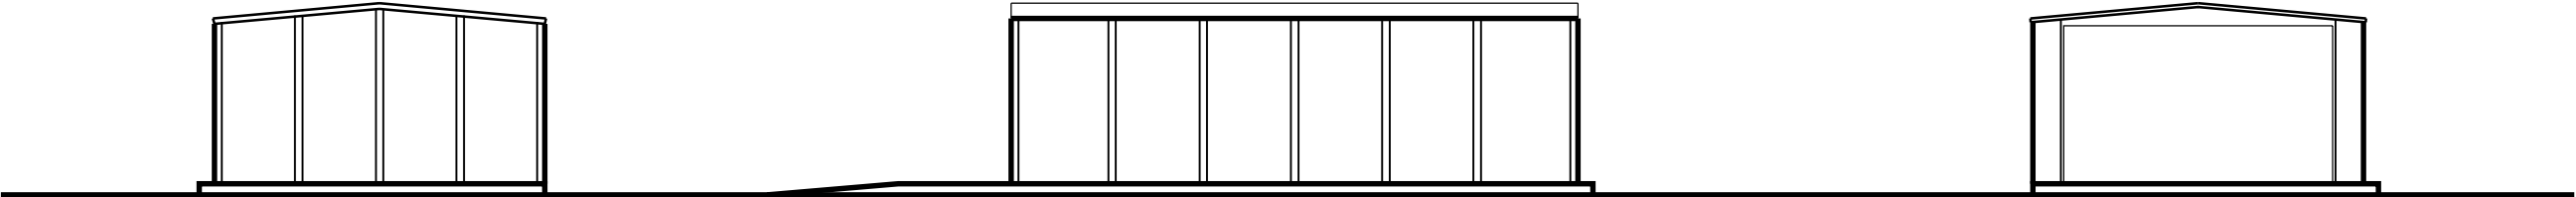
Existing prefabricated concrete  
garage/ store
