# Flood Risk Assessment

Climping Mill, Climping Street, Climping BN17 5RN

**Ref:** 6923

**Date:** December 2017

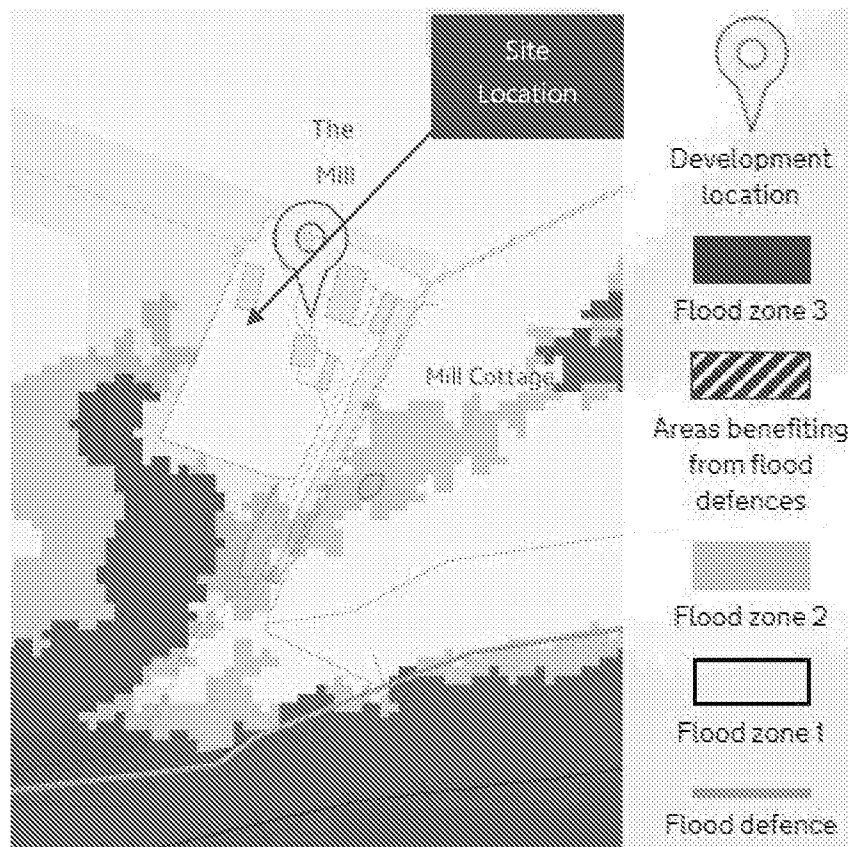
### EA's Online Flood Map for Planning (Rivers and Seas)

The coach house is in coastal Flood Zone 3A (FZ3A)

- 2.4 Tidal flooding: the Environment Agency's (EA) Flood Map for Planning (Rivers and Seas) in Appendix B shows the site is liable to flood from the coast in the 0.5% (1 in 200 years) event. This places the site in Flood Zone 3A, High Probability (FZ3A).

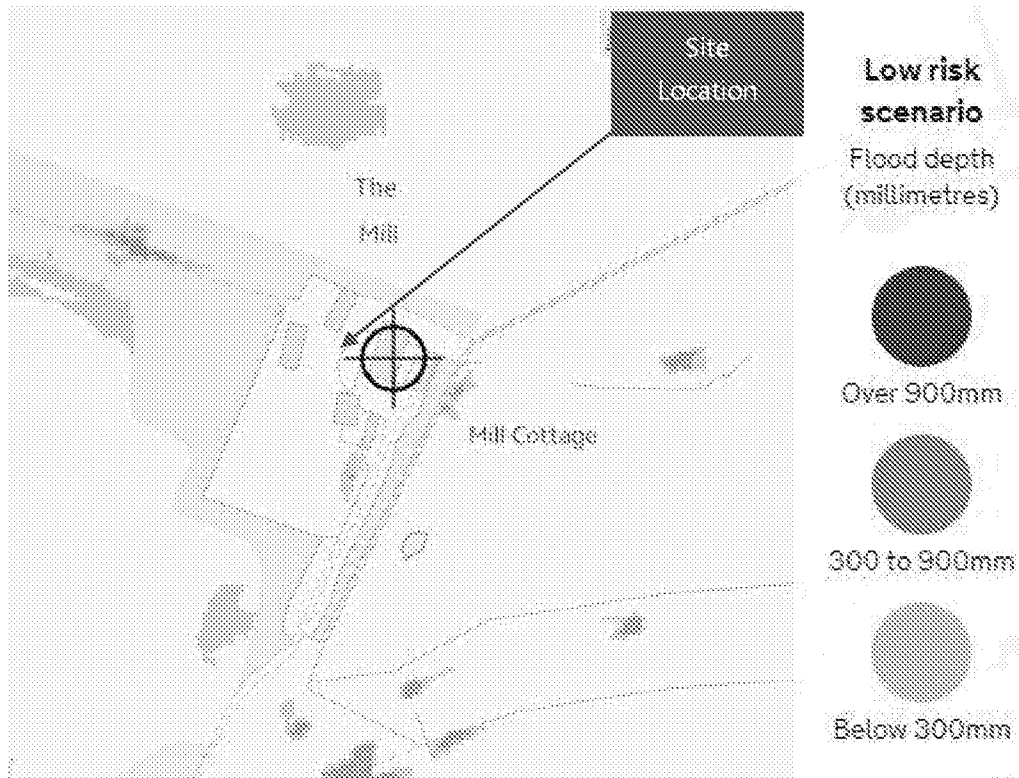
**EA's Online Surface Water Flood Depth Map in the 'Low Risk Scenario'**  
**(1 in 1000 years storm event)**

Although there is a small area of ponding within the site, this is contained and will have no effect on this or neighbouring sites.

- 2.7 Surface water flooding: occurs when rainwater does not infiltrate into the ground, or is not intercepted by urban drainage systems, and instead flows across the surface. The EA's surface water flood map in the 'low risk' scenario ('1 in 1000 years' storm event) shows the site is all but removed from this source of flooding – refer to Appendix B. Although there is a small area of ponding in the southern part of the site, this is small and shallow. It does not affect neighbouring sites either.

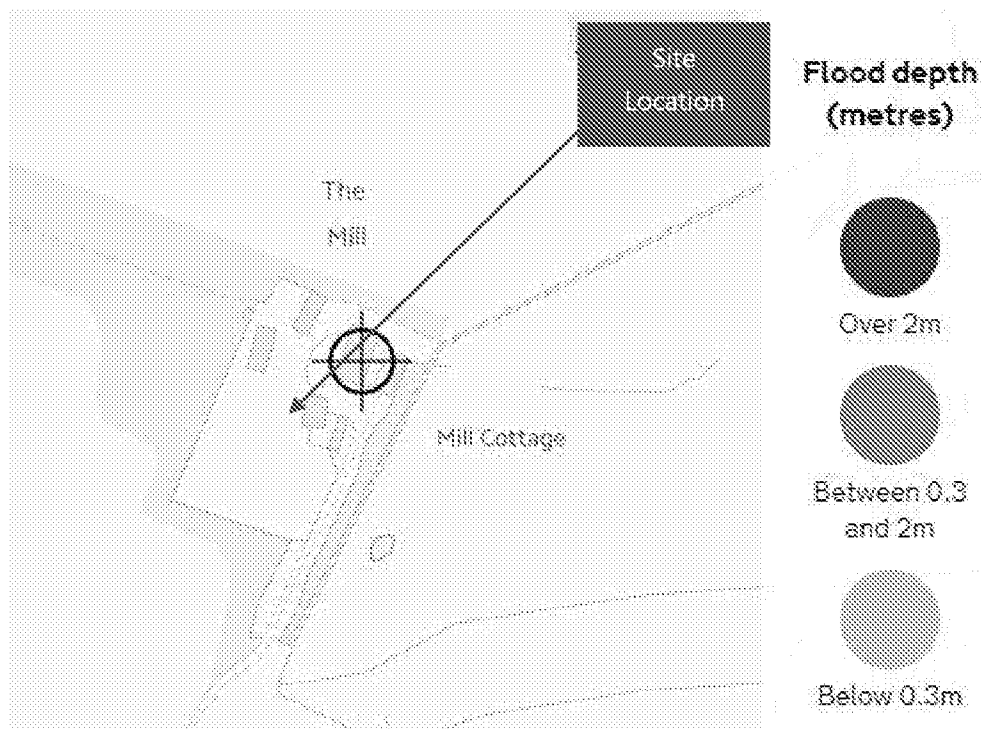
**EA's Online Risk of Flooding from Reservoirs' Map**

The site is removed from this source of flooding.

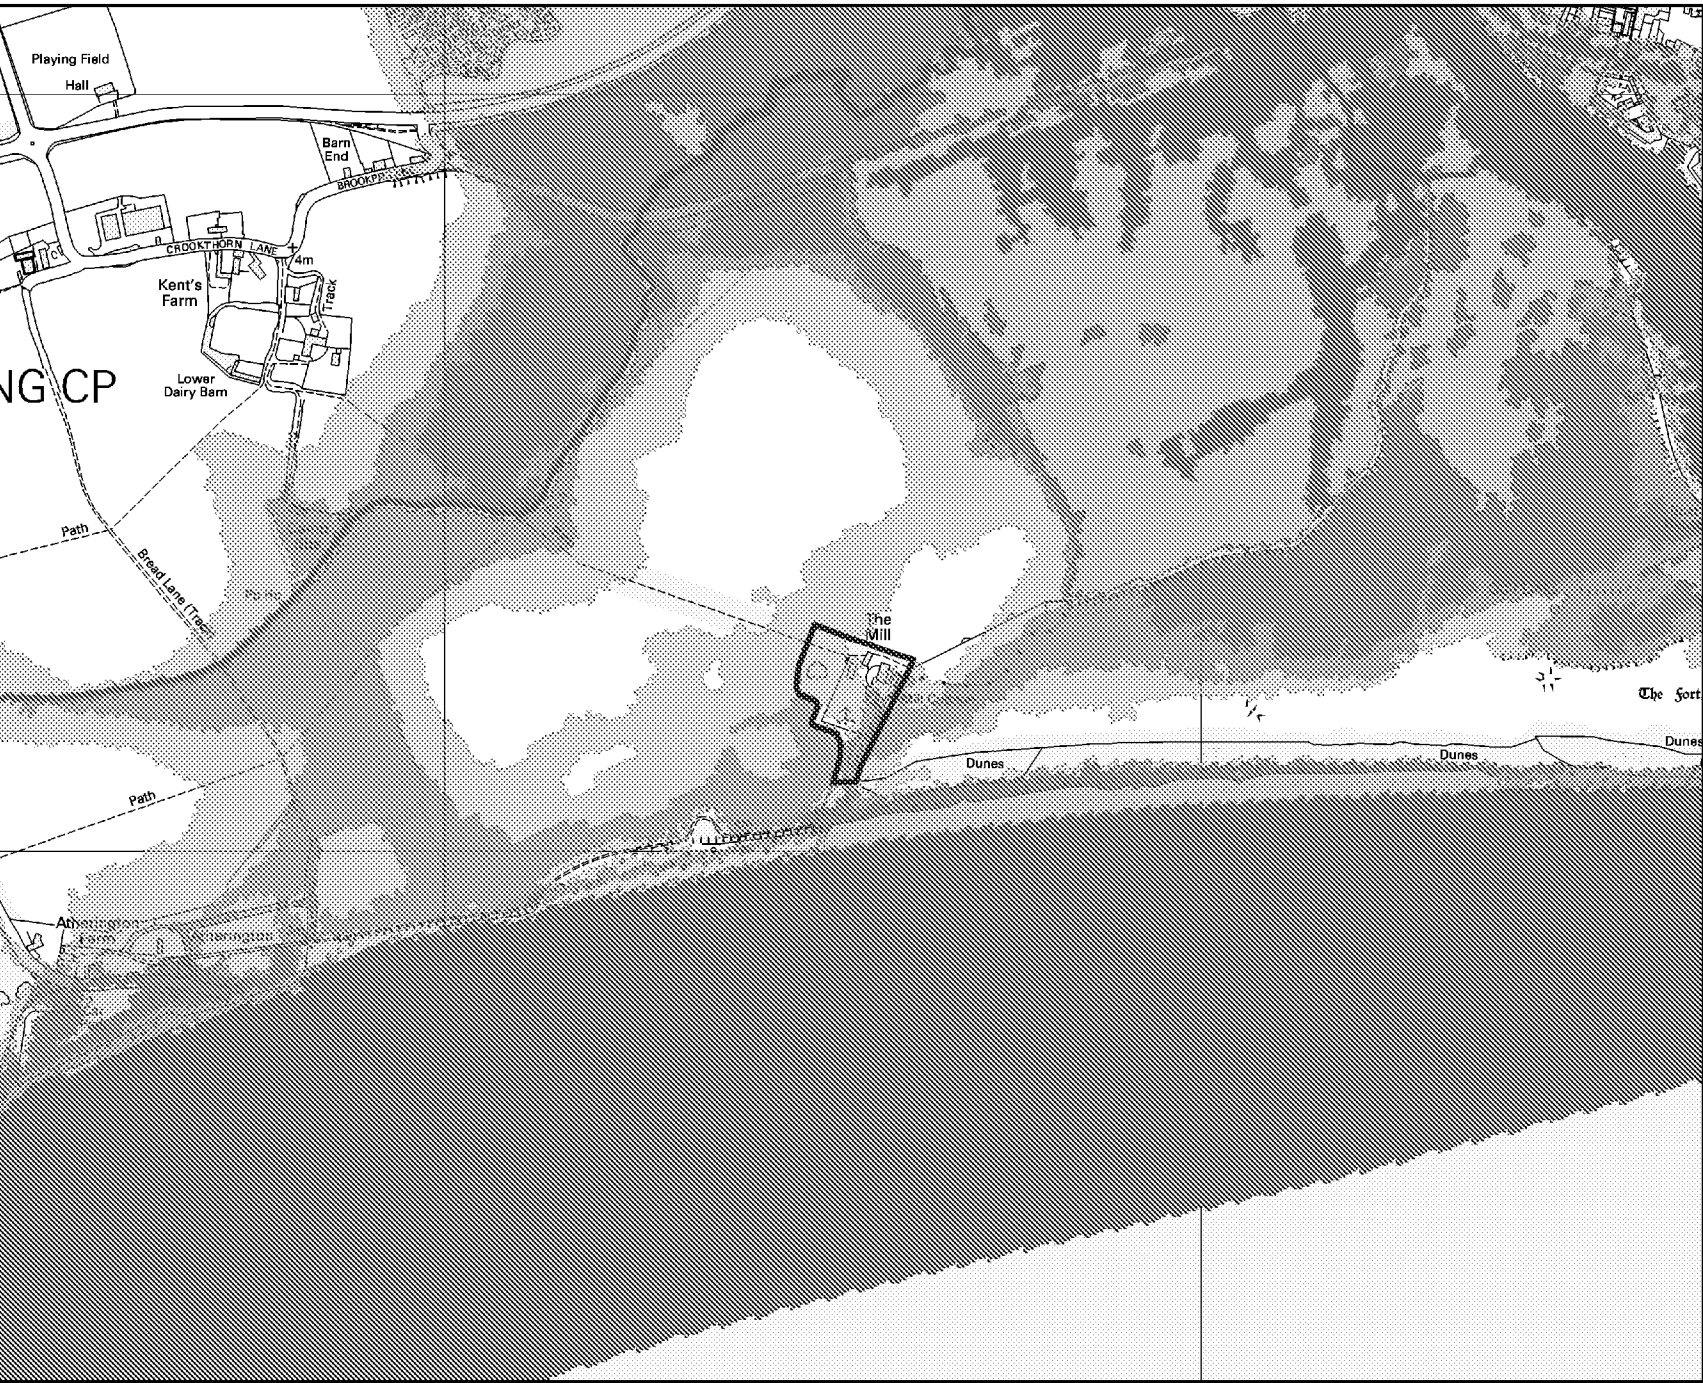
- Legend**
- Site Boundary
  - Main River
  - 5% AEP (Defended Tidal)
  - 0.5% AEP (Defended Tidal)
  - 0.5% AEP (2070) NPPF (Defended Tidal)
  - 0.5% AEP (2115) NPPF (Defended Tidal)
  - 0.1% AEP (Defended Tidal)

Annual Exceedance Probability (AEP) The probability of a flood of a particular magnitude, or greater occurring in any given year.

- 2.5 Although the site benefits from flood defences, these are limited in effectiveness - and in standard of protection.
- 2.6 The EA's flood data in Appendix B shows the flood level in various scenarios, with the undefended 2115 range being pertinent to this study. The nearest node to the location of the proposed dwelling unit is #7. The 2115 flood level is **3.76m AOD**, but is less where the site levels are lower.

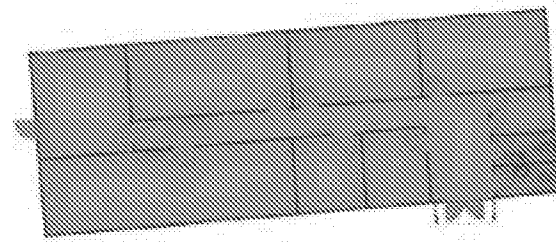
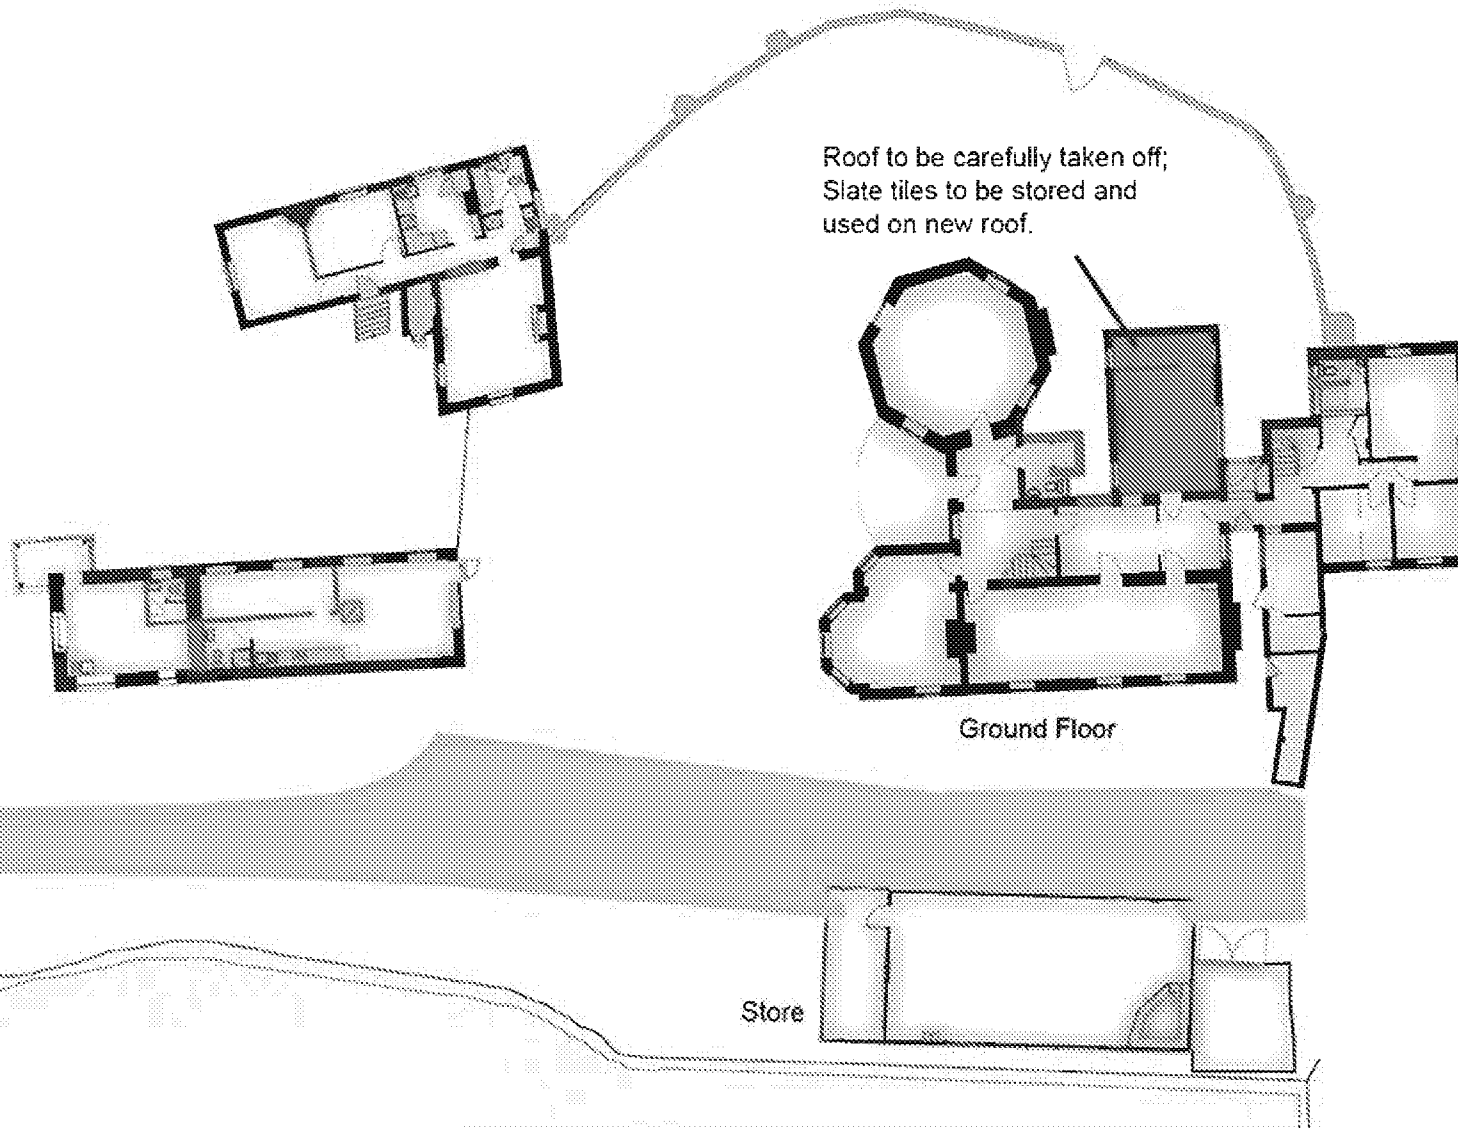
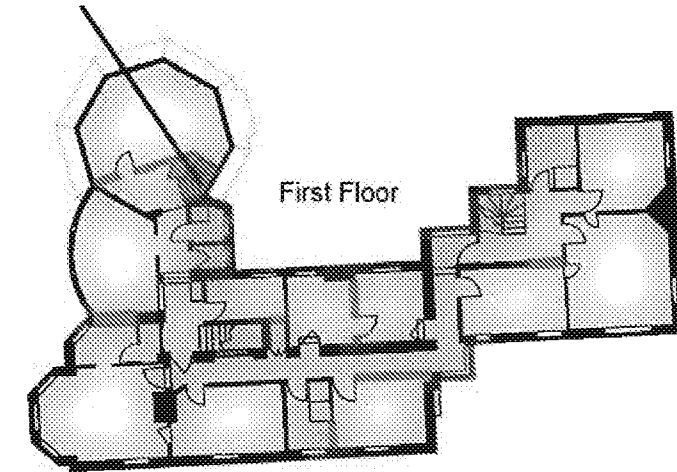
Drawing No. 8 Drawing Title:  
Demolition Plan

To be demolished entirely

Roof to be carefully taken off;  
Slate tiles to be stored and  
used on new roof.

Old studwork and stairs in Mill structure added during the 50's,  
poorly eaten by death watch beetle (see H&R report)

Take down nominal areas of 50's/70's  
poorly thought through stud-work  
revealing badly executed (causes of  
damp) 50/70's architecture

- 3.1 The planning application is for demolishing the 'school dormitory' and 'lodge', which are the 2 buildings at the north end of the cluster of 6 units; refurbishing the original unit, Climping Mill, and erecting a new 'Pond House' on the northwest part of the site. The Mill Building will also be slightly reduced in footprint area – as shown on the 'demolished buildings layout'. The proposed scheme drawings are shown in Appendix C. The cottage and thatch buildings are to remain with some internal alterations and the Store will remain as is.

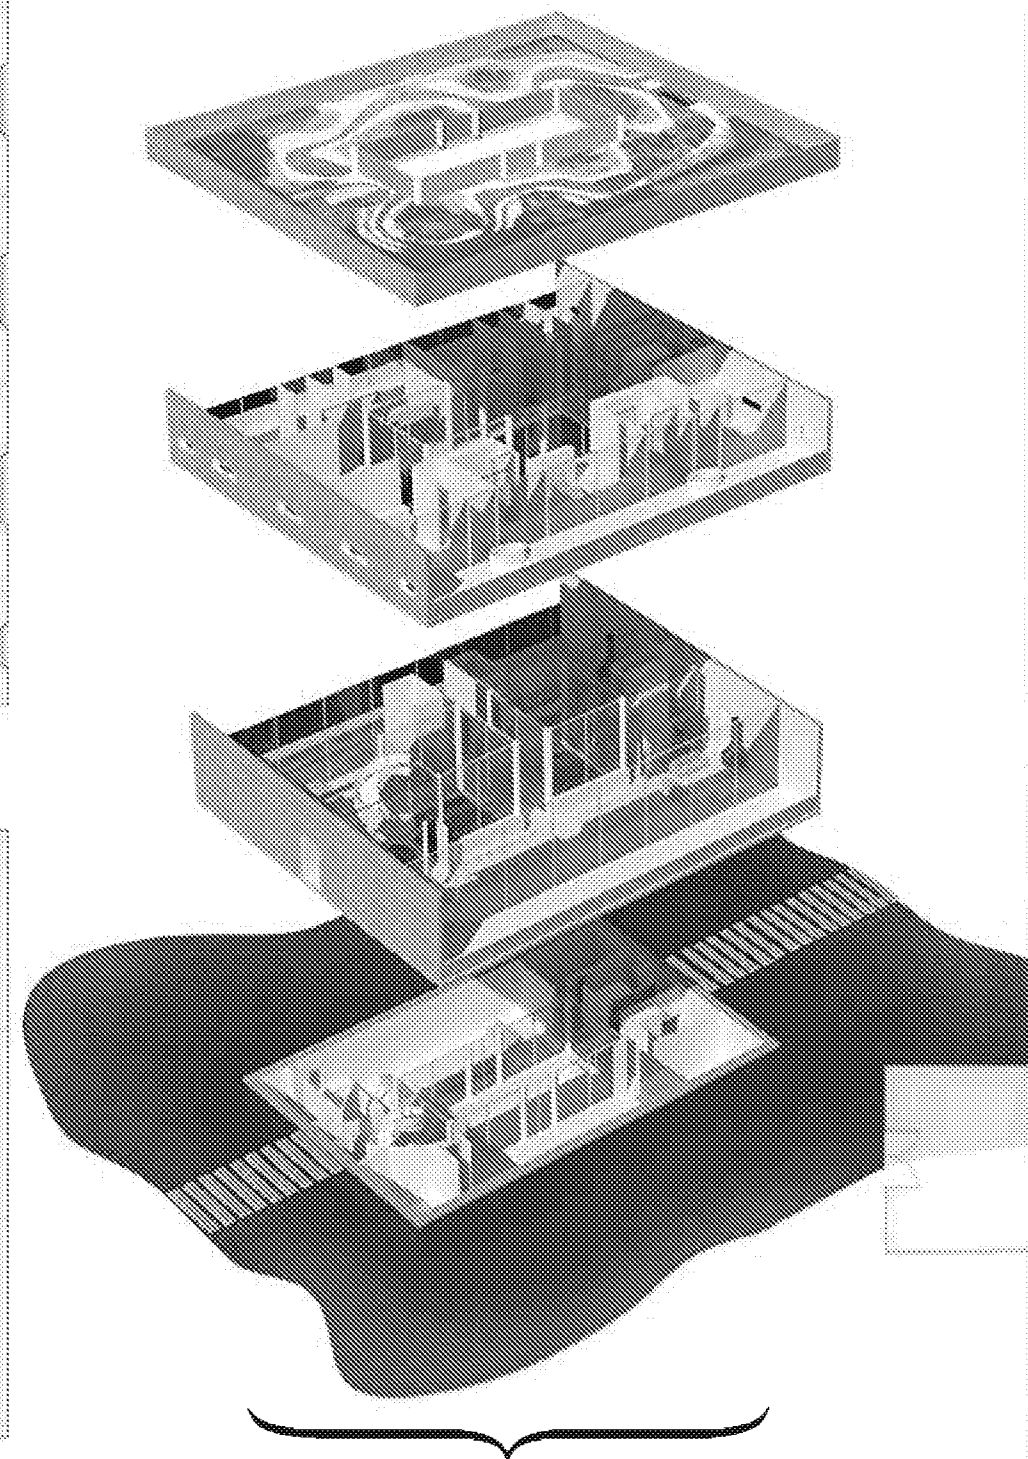
Basement plan

Illustration only, not to scale

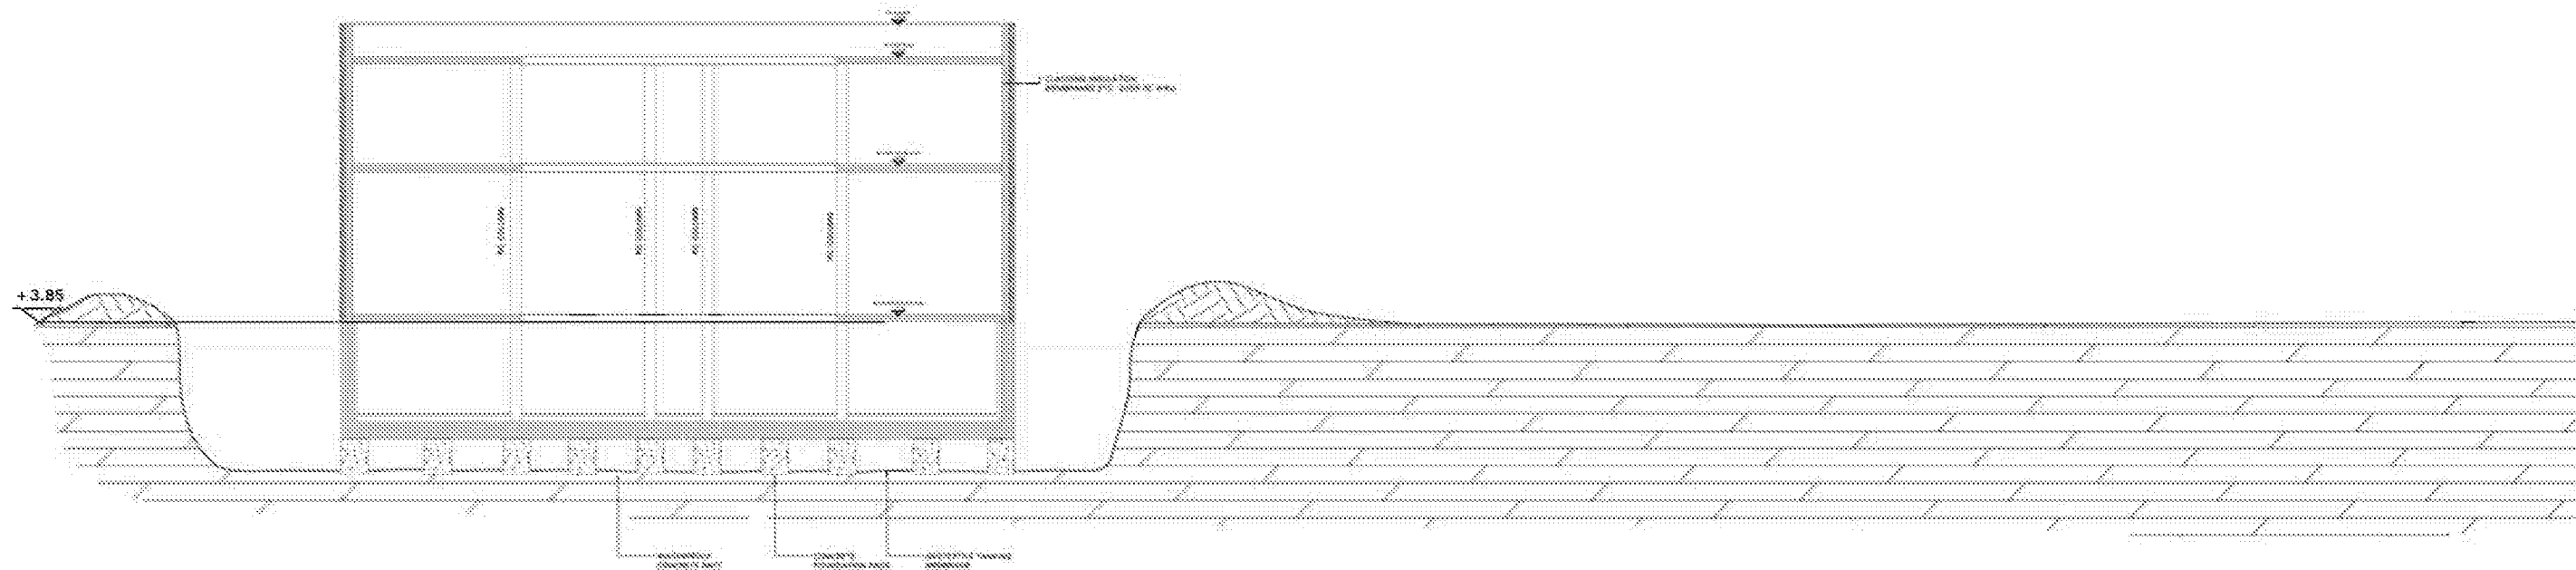
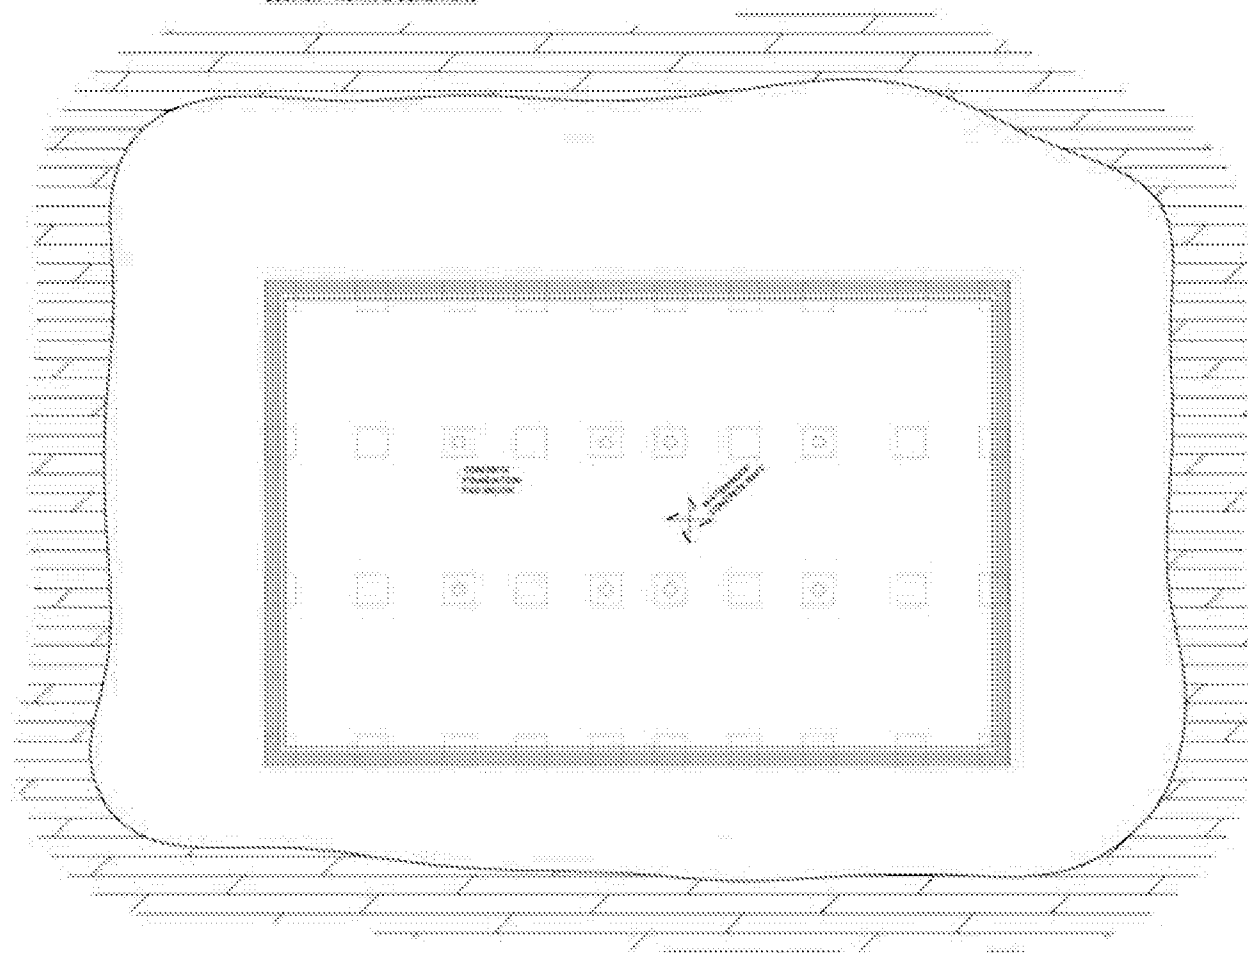
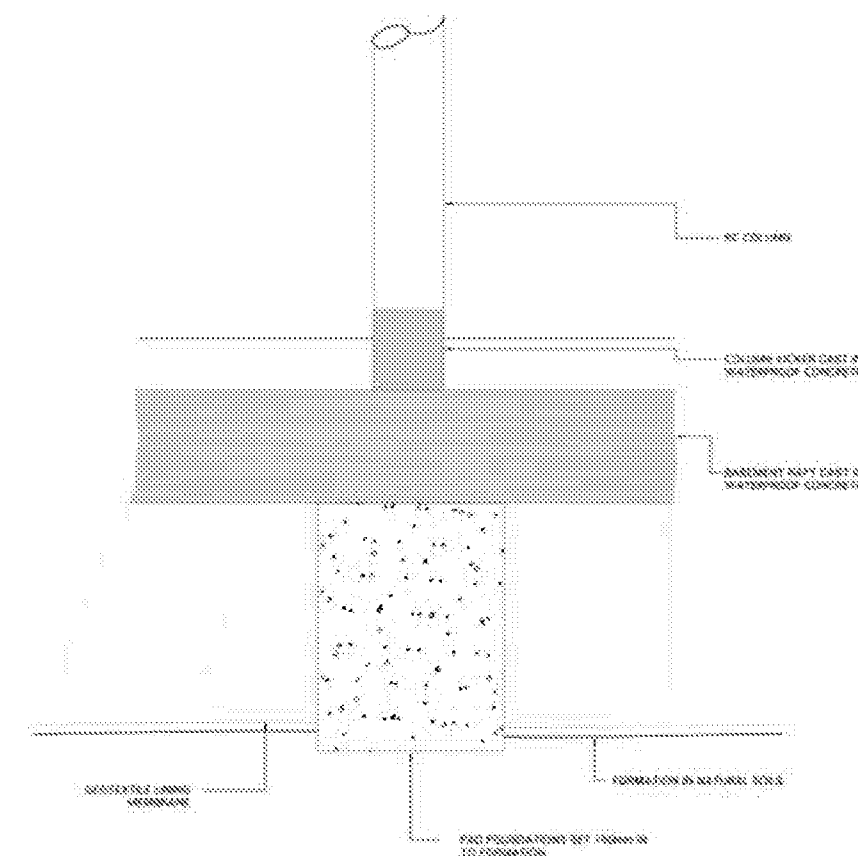
Drawing Title:  
Structural Section & Basement Plan

SECTION - NORMAL CONDITIONS

- 3.3 The Pond House will be sitting on concrete blocks in a pond – to give the impression of floating.. The walls and base will be of waterproof concrete, eg Caltite.

- 3.4 For full compliance the floor level shall be set at 0.3m above the nearest node's 2115 flood level of 3.76m ie **4.06m AOD**.
- 3.5 Sequential Test: the scale of development will have been reduced by removing 2 sizeable buildings and erecting only one single dwelling unit. The siting of this has been done with a Sequential Approach, meaning that it is placed as close as is practical to the highest elevation within the site.
