# Baseline Noise Survey Report

Proposed Development at Bognor Regis Golf Club

For Hallam Land Management

| Date of Issue | 08/12/2021 | Report Number | JAJ02792–REPT–02–R2 |

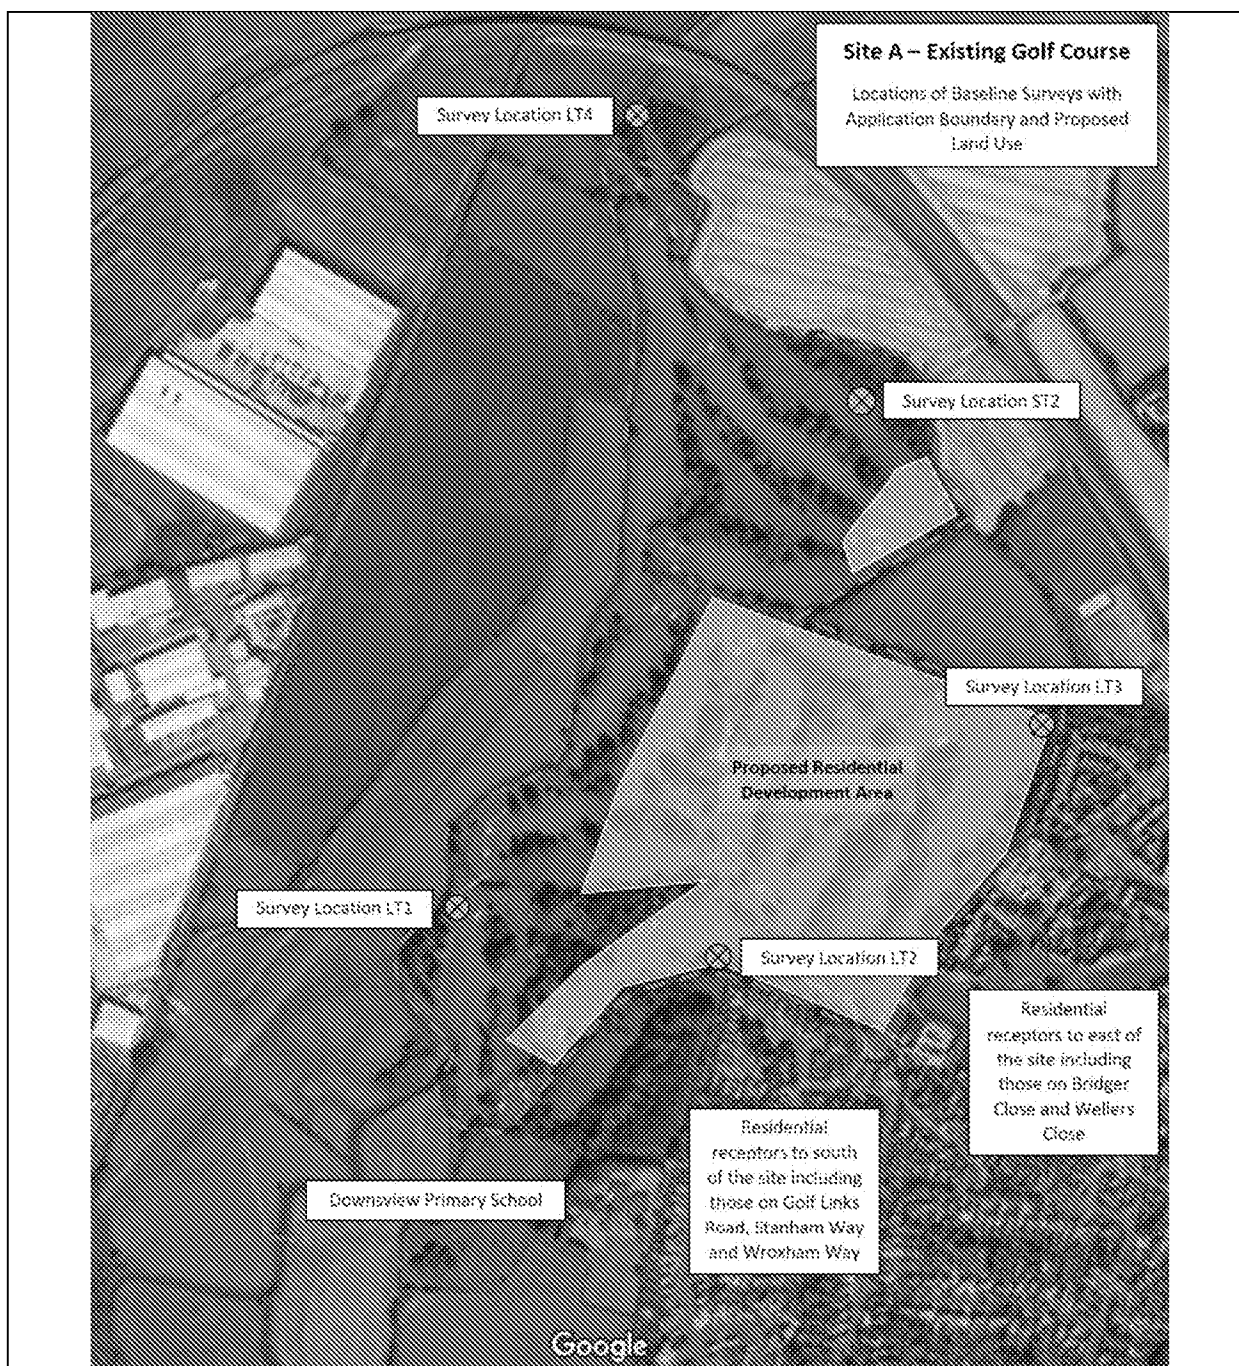
**Figure 1: Noise Monitoring Locations at Site A**

- 3.2 At Site A, four long-term (LT) sound level meters (SLMs) were deployed for a period of six days, with a further 15-minute short-term (ST) measurement taken on collection of the long-term surveys. At Site B, two long-term surveys were deployed over the same timeframe as Site A. For each survey listed below, the microphone was set up 1.5 m above ground level (AGL) with an environmental protection kit including windshield. The survey locations can be seen in Figure 1 and Figure 2 for Site A and B respectively.

- 3.3 Survey location LT1 was located on the western side of Site A approximately 5 m in from the redline boundary, next to a tree. Directly to the west is Lec Airfield, used for light aircraft and gliders with the runway approximately 100 m away, as well as the railway line, which is approximately 270 m away at its closest point.

- 3.4 Survey location LT2 was located on the southern side of Site A, approximately 35 m northwest of 28 Golf Links Road, approximately 10 m inside the redline boundary. This location is representative of noise sensitive receptors (NSRs) on Golf Links Road and Wroxham Way, which are located to the south and southeast of the SLM location.

- 3.5 Survey location LT3 was located on the eastern side of Site A at the edge of the golf course, approximately 10 m west of the boundary fence with 16 Bridger Close. This location is representative of NSRs on Bridger Close.

- 3.6 Survey location LT4 was located at the northern tip of Site A in an area of trees by the redline boundary. The A259 is located approximately 90 m to the north with the trainline approximately 150 m at its closest point, to the west.

- 3.7 Survey location ST2 was located at the northeast Site A near the redline boundary approximately 420 m southeast of LT4 and 420 m northwest of LT3. This was located approximately 50 m in from the redline boundary due to a patch of trees and bushes.

2.7 Figure 1 shows the site boundary and the areas of site proposed for development.

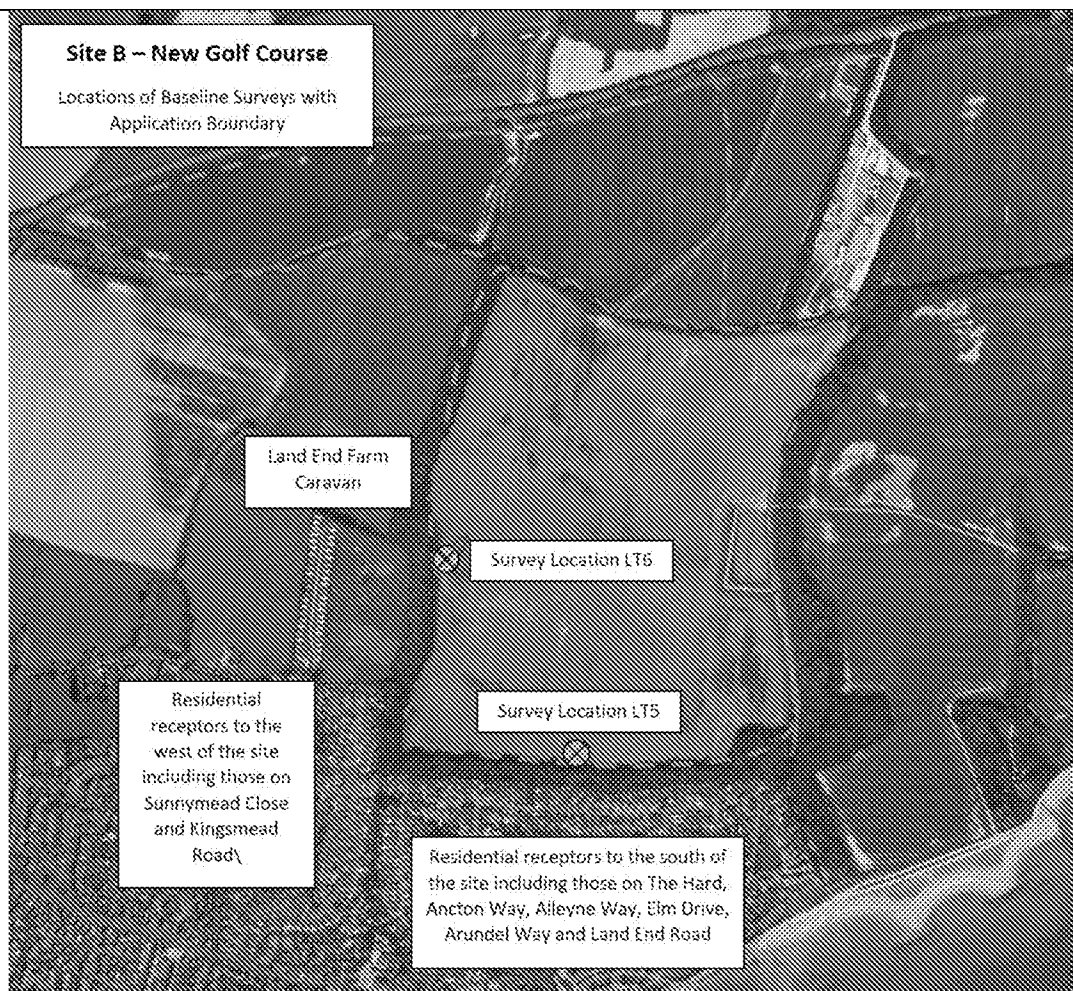
**Figure 2: Noise Monitoring Locations at Site B**

- 3.8 At Site B, survey location LT5 was located approximately halfway along the southern boundary of the new site next to a treeline and a lightly used public footpath. This location is representative of NSRs on Ancton Way.

3.9 Survey location LT6 was located at the western boundary of Site B, approximately 350 m north of the southern boundary, next to a treeline. This location is representative of NSRs at Lane End Farm Caravan Site.

- 2.9 The sources of noise affecting the site mainly included a distant broadband traffic 'hum' to the north and west (from the A259 and surrounding roads) and wind noise in the trees.
- 2.10 Figure 2 shows the site boundary and locations of noise monitoring equipment.

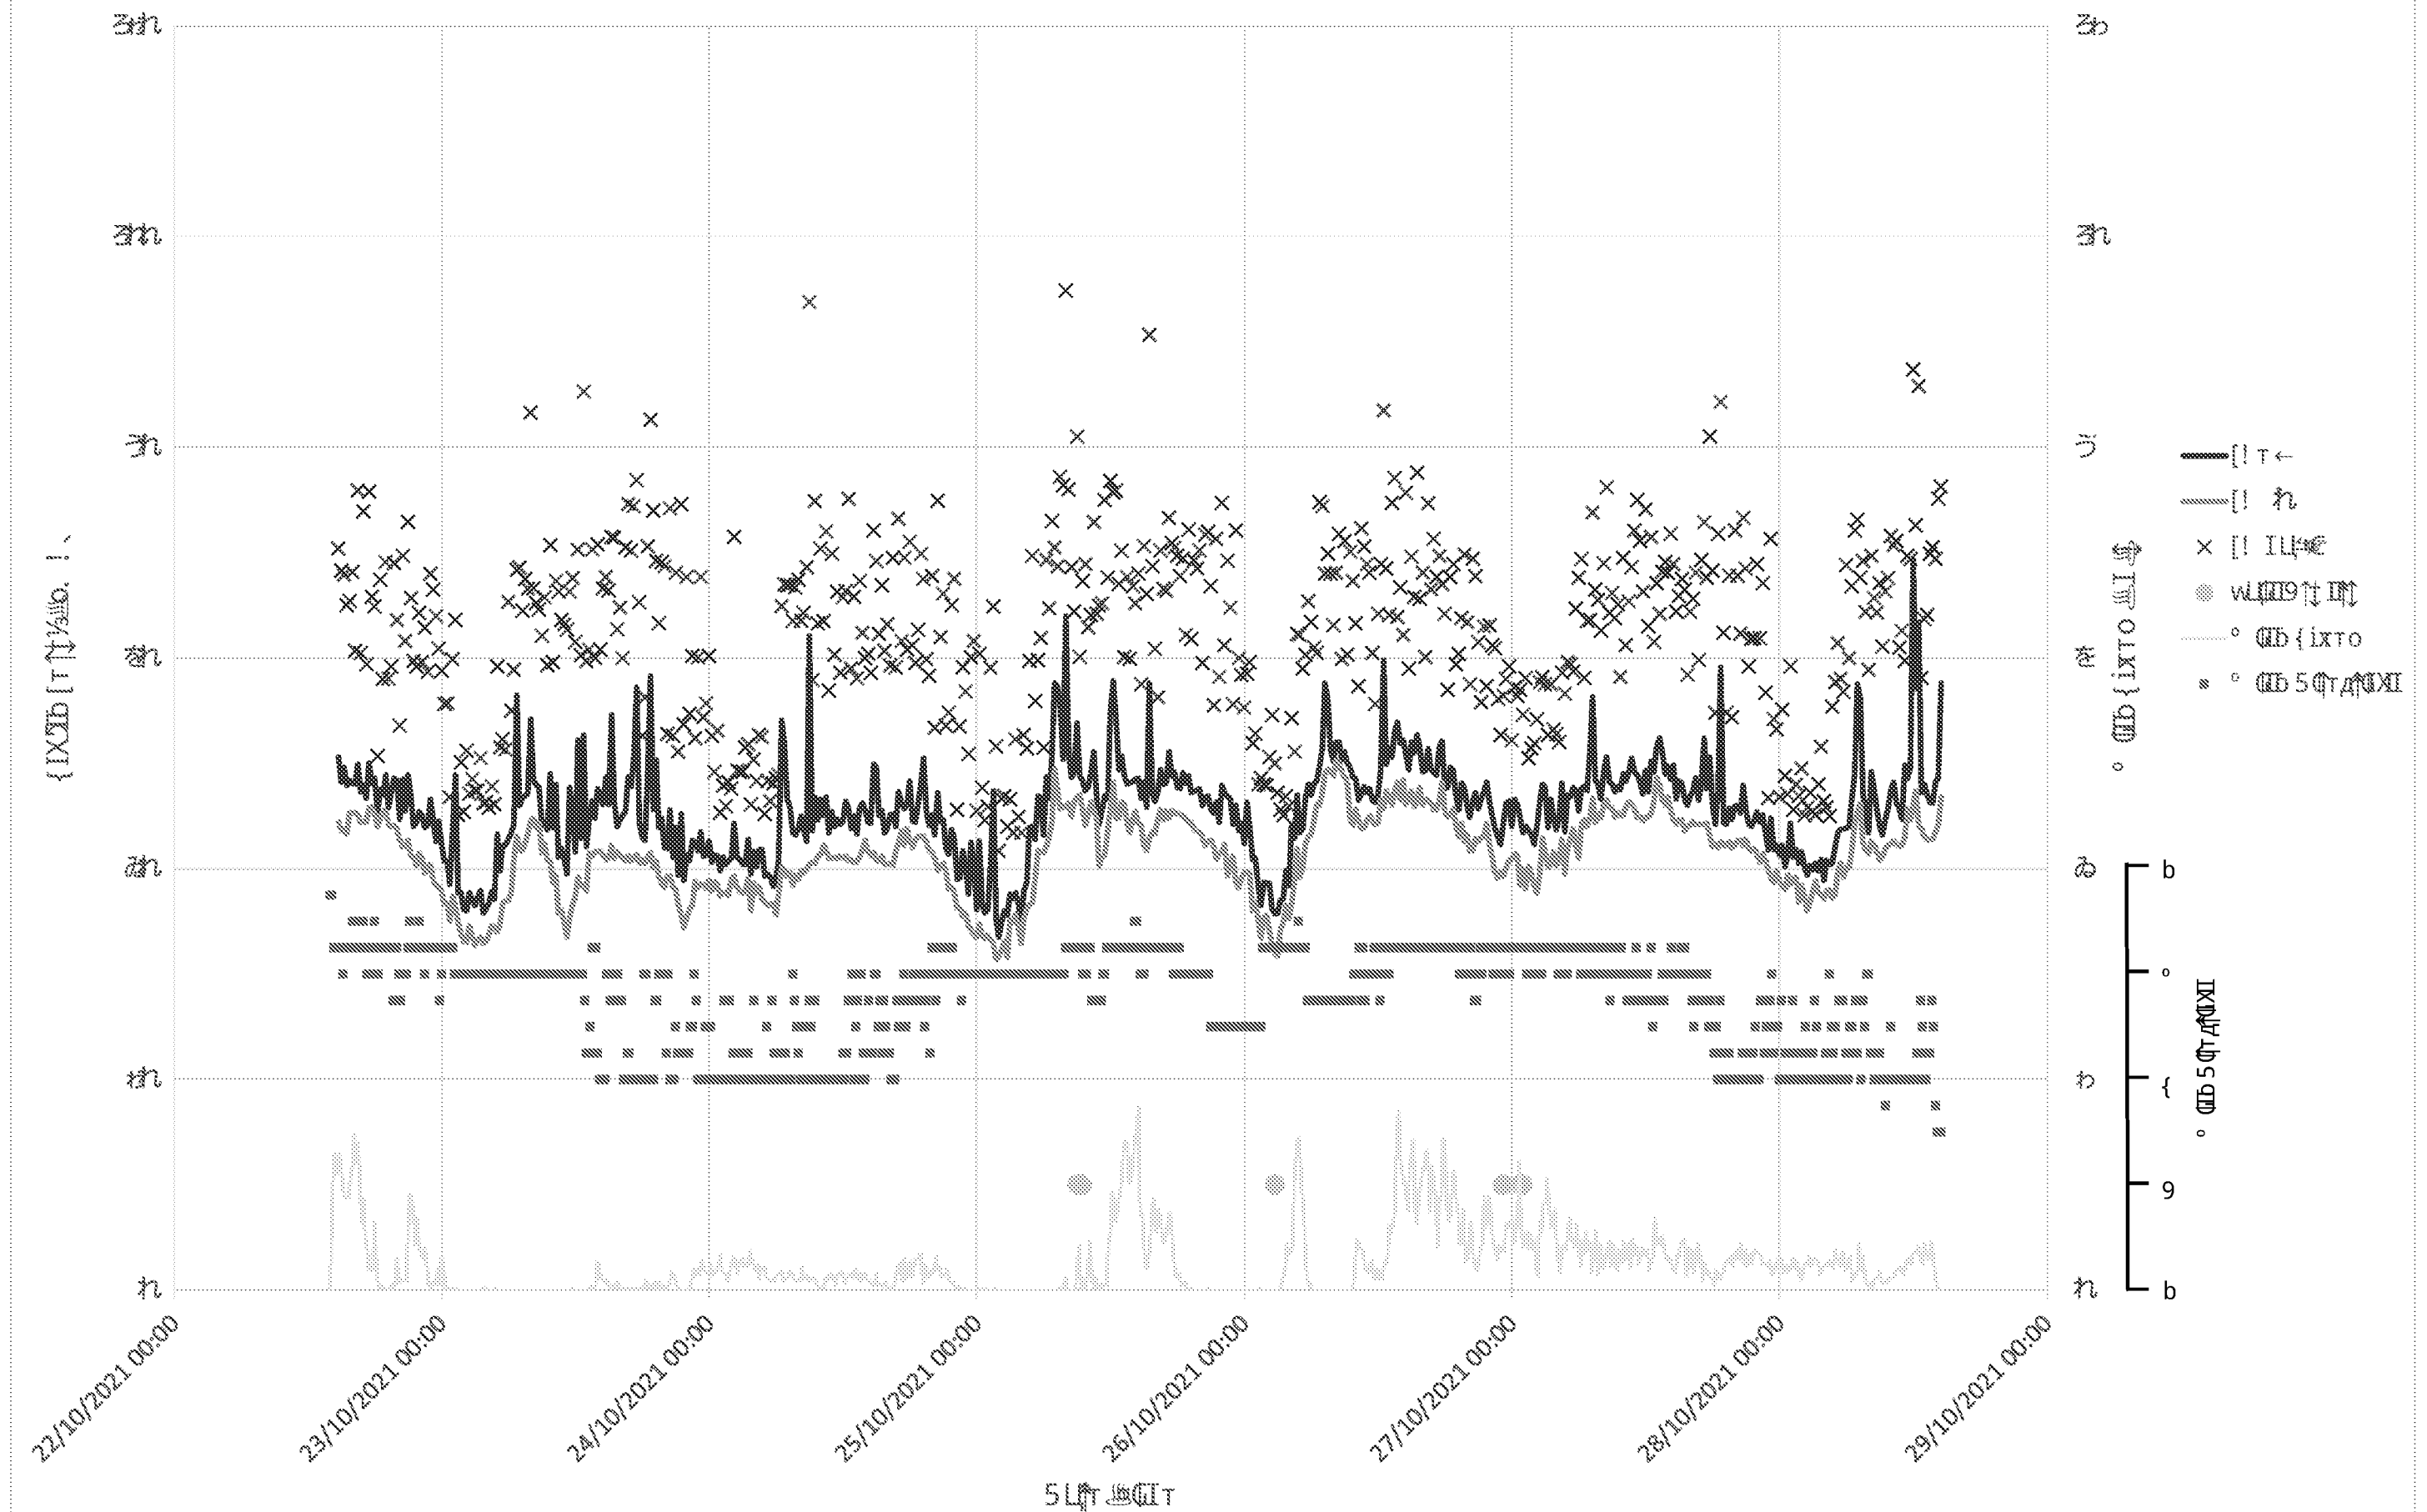
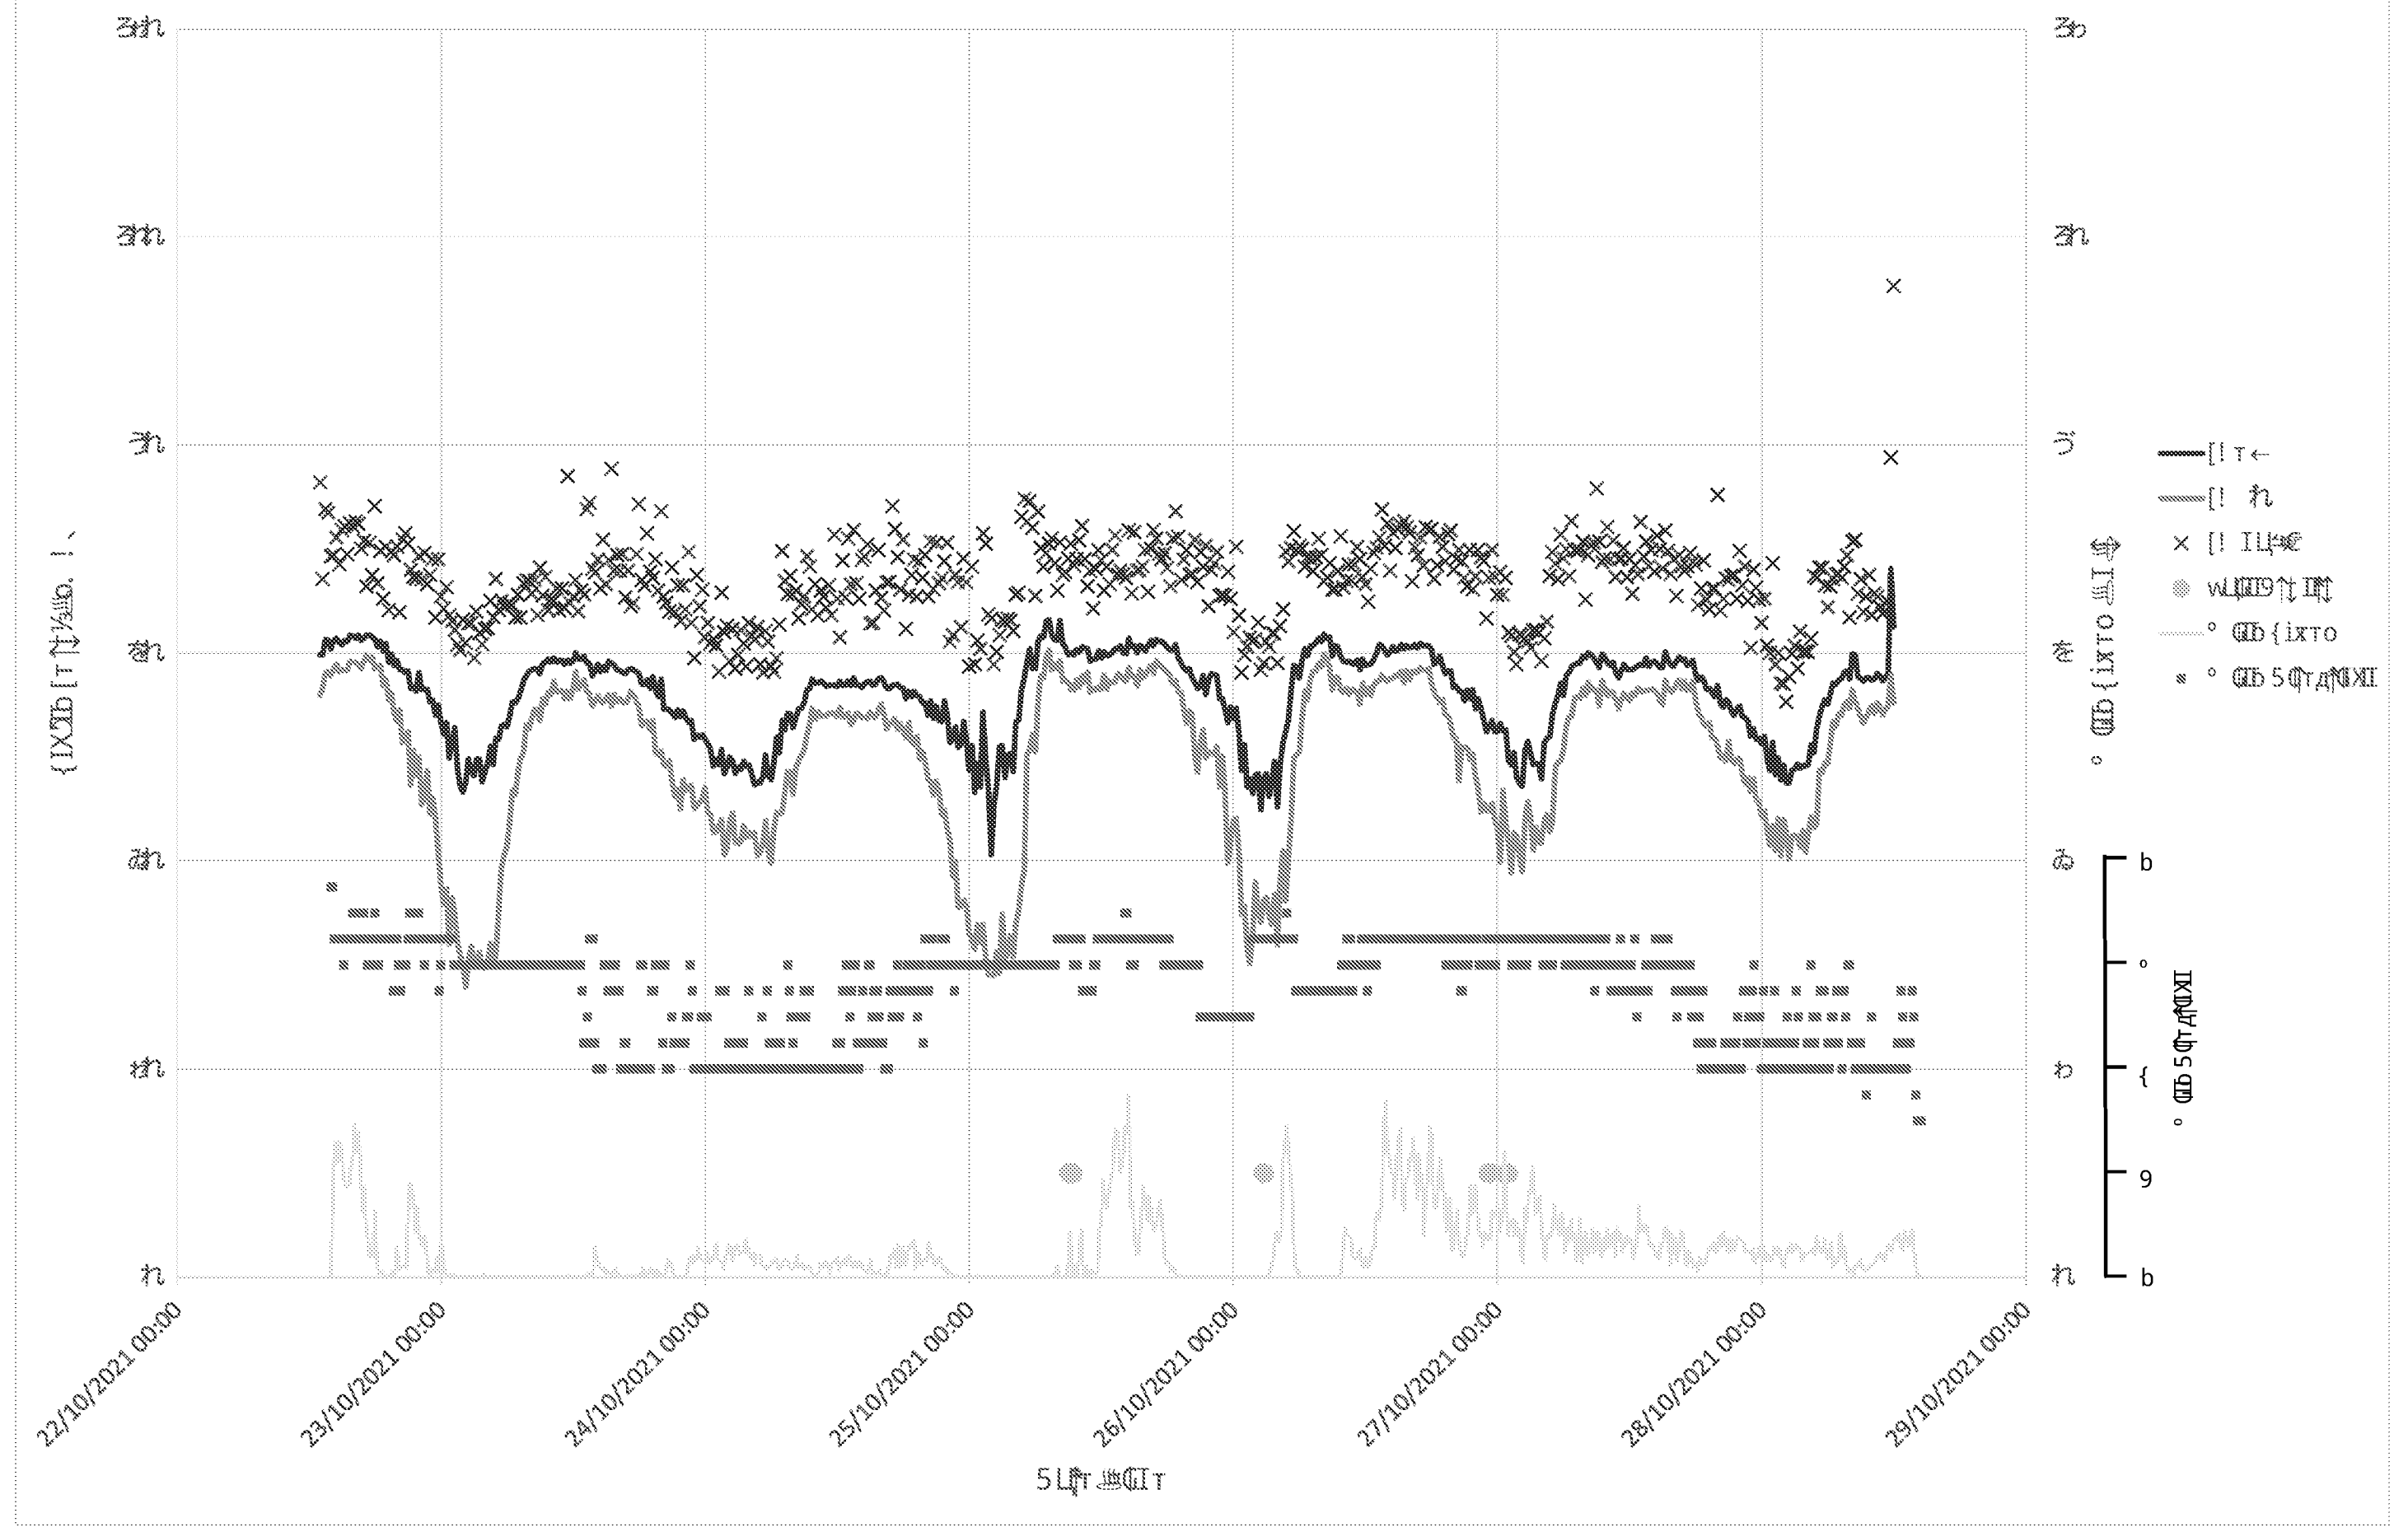
## Appendix A: Baseline Survey Time Histories

3.21 The results of the noise surveys are summarised in Table 3.4. Full time history data for each location can be seen in Appendix A.

3.22 Five 15-minute periods were excluded from the calculations due to rainfall. The locations of these data points are included as 'rain events' on the graphs in Appendix A. No data has been excluded due to wind, as wind speeds remained low (maximum 2 m/s) throughout the survey duration. This data was gathered by the unattended wind logger and rain gauge deployed with survey LT2.

3.12 In addition, an unattended wind logger and rain gauge was deployed at survey location LT2 for the duration of the survey. The data from this station can be seen overlaid on the graphs in Appendix A.

3.23 The values in Table 3.4 have been visually checked against the graphs of the time histories (available in Appendix A) and the individual day-by-day values to ensure the values are representative.
