**PLAY AREA**

**BLAKES MEAD,  
BOGNOR REGIS**

# Post Installation Report

Blakes Mead

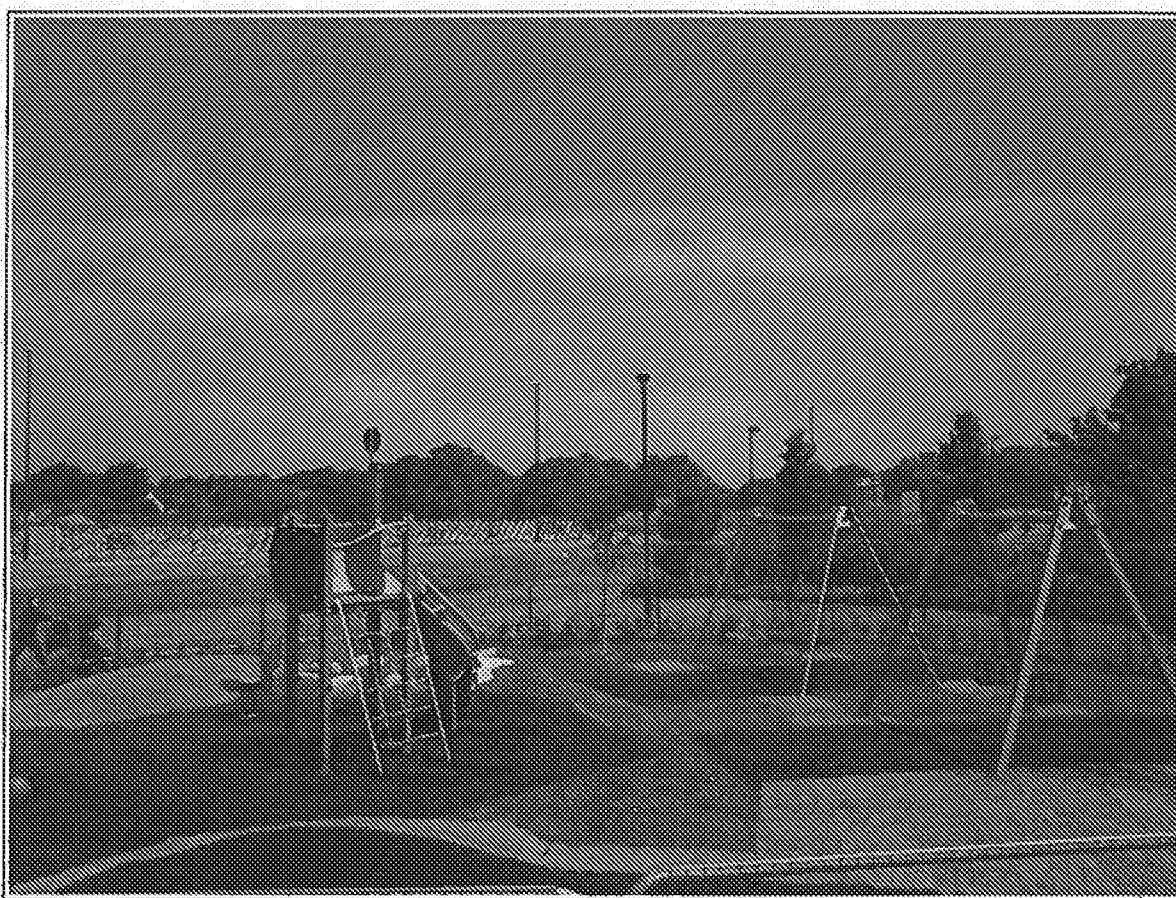
**Location:** The site is located in an area of public open space and is overlooked by a number of properties in the local community.

**Disabled Access:** Some accessible features – an area that presents difficulties to the majority of people with disabilities but in favourable circumstances and certainly in partnership can be accessed.

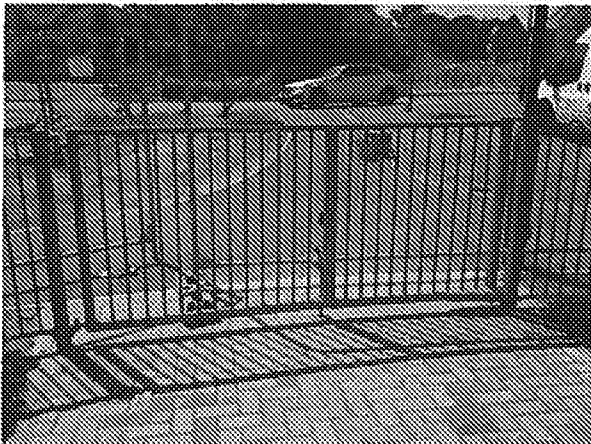
| 2 - Very Low Risk | |
|---|---|
| <b>Item:</b> | Ancillary Items - Combination Gate |

| Finding 1 | |
|---|--|
| This item is satisfactory - no work required | |

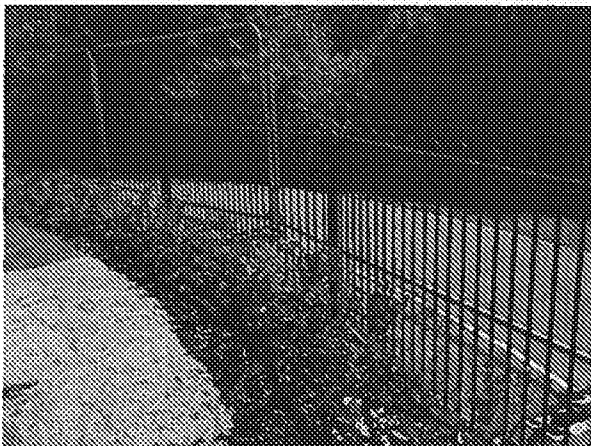
| 3 - Very Low Risk | |
|---|---|
| <b>Item:</b> | Ancillary Items - Bow Top Fence (Steel) |

| Finding 1 | |
|---|--|
| This item is satisfactory - no work required | |

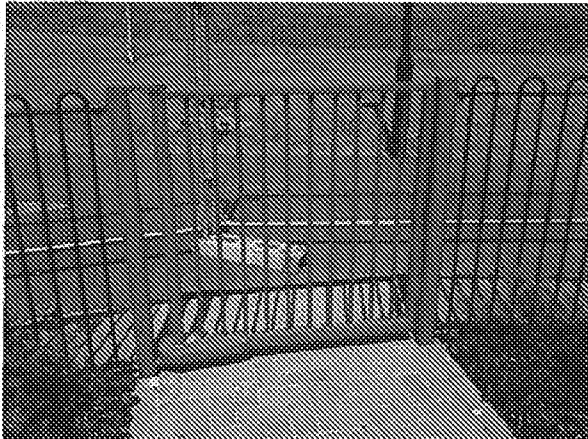
| 2 - Very Low Risk | |
|---|---|
| <b>Item:</b> | Ancillary Items - Self Closing Gate |

| Finding 1 | |
|---|--|
| This item is satisfactory - no work required | |

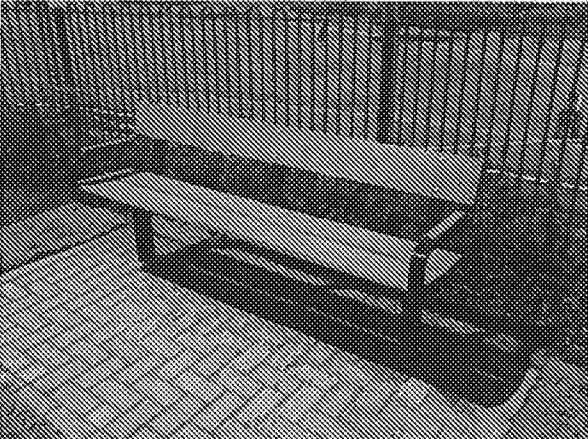
| 3 - Very Low Risk | |
|---|---|
| <b>Item:</b> | Ancillary Items - Bench |

| Finding 1 | |
|---|--|
| This item is satisfactory - no work required | |

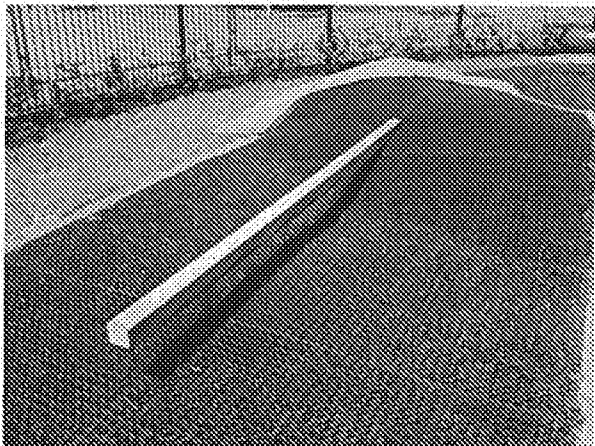
| 3 - Very Low Risk | |
|---|---|
| <b>Item:</b> | Agility - Balance Beam |

| This item is satisfactory - no work required |

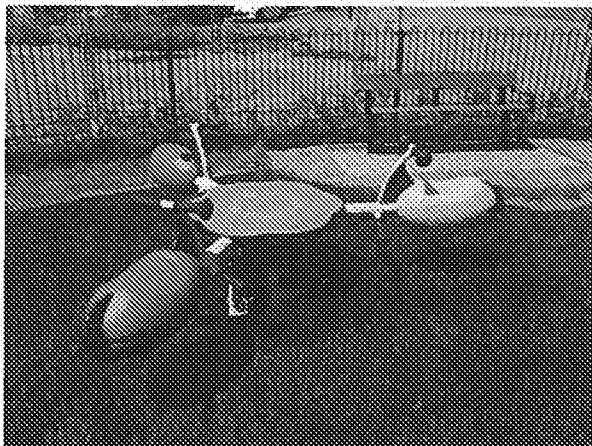
| 4 - Very Low Risk | |
|---|---|
| <b>Item:</b> | Spring - Spring See-Saw |

| This item is satisfactory - no work required |

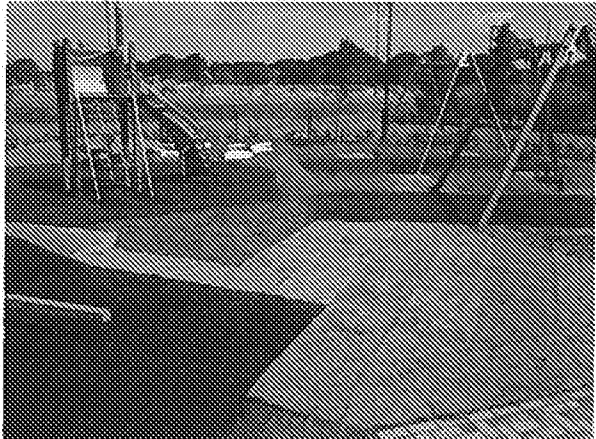
| i 4 - Very Low Risk | |
|---|---|
| <b>Item:</b> | Ancillary Items - Site General |

| Finding 1 | |
|---|--|
| Some of the turfed areas have dried out and the grass has died off - Rectify as required | |

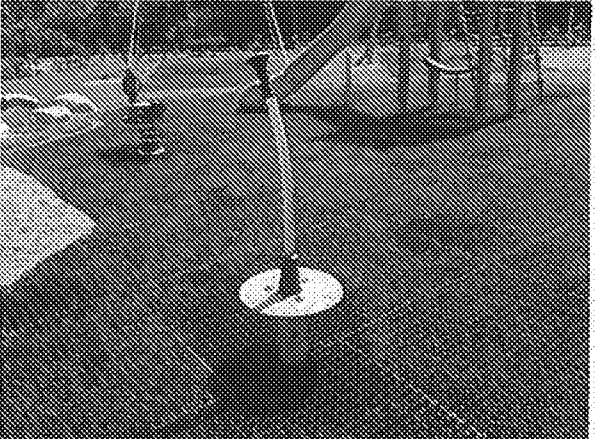
| i 4 - Very Low Risk | |
|---|---|
| <b>Item:</b> | Rotor Play - Spinning Pole |

| Finding 1 | |
|---|--|
| This item is satisfactory - no work required | |

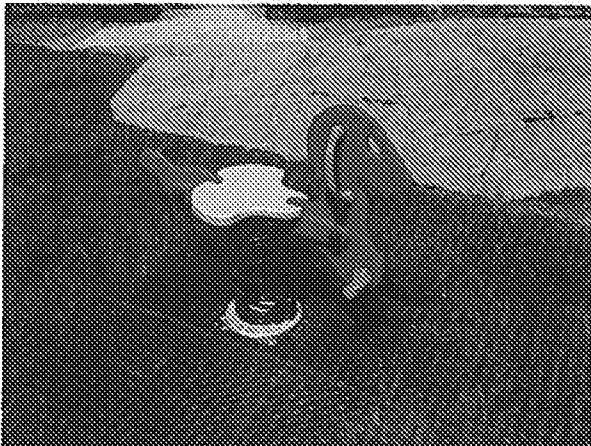
| 3 - Very Low Risk | |
|---|---|
| <b>Item:</b> | Spring - Spring Dog |

| Finding 1 |
|---|
| This item is satisfactory - no work required |

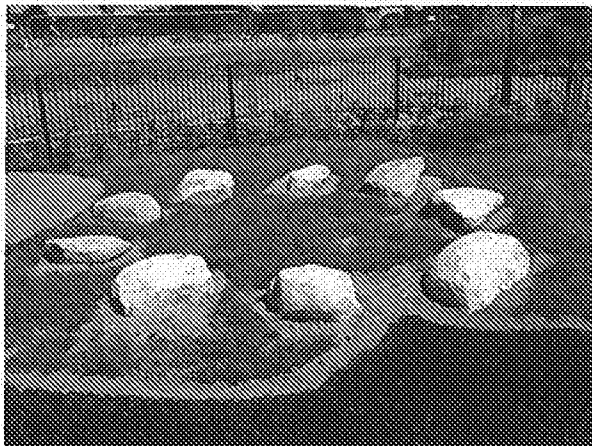
| 5 - Very Low Risk | |
|---|---|
| <b>Item:</b> | Other - Boulders |

| Finding 1 |
|---|
| The use of boulders in the play area presents a risk to users of falling onto hard objects - Monitor use |

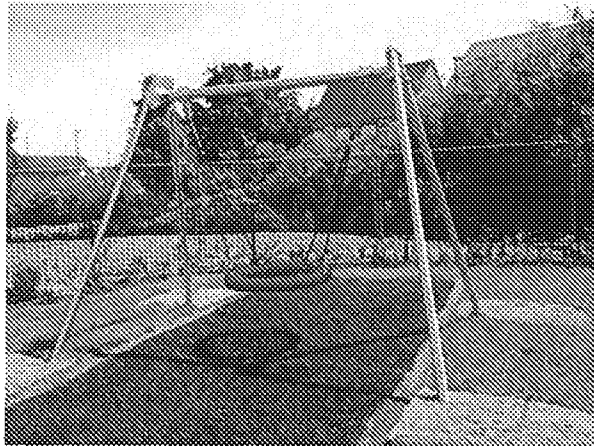
| i 4 - Very Low Risk | |
|---|---|
| <b>Item:</b> | Swings - Basket Swing |

| Finding 1 |
|---|
| This item is satisfactory - no work required |

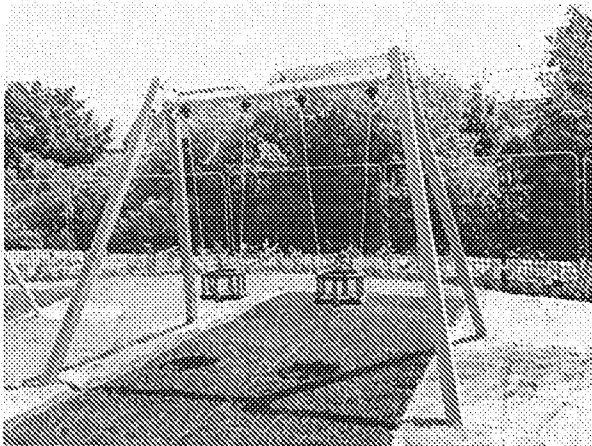
| i 4 - Very Low Risk | |
|---|---|
| <b>Item:</b> | Swings - 1 Bay 2 Seat (cradle) |

| Finding 1 |
|---|
| This item is satisfactory - no work required |

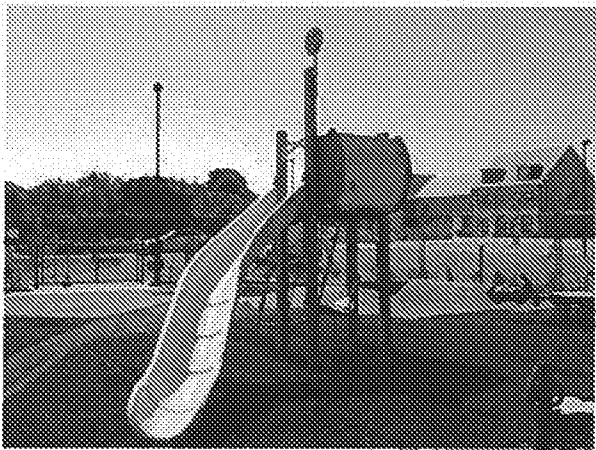
| 4 - Very Low Risk | |
|---|---|
| <b>Item:</b> | Agility - Tower & Slide |

| <b>This item is satisfactory - no work required</b> |

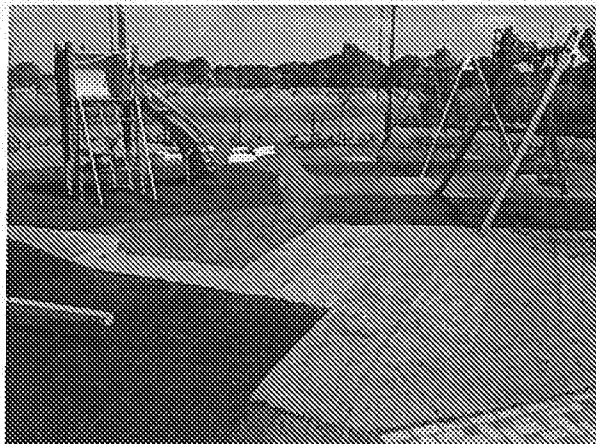
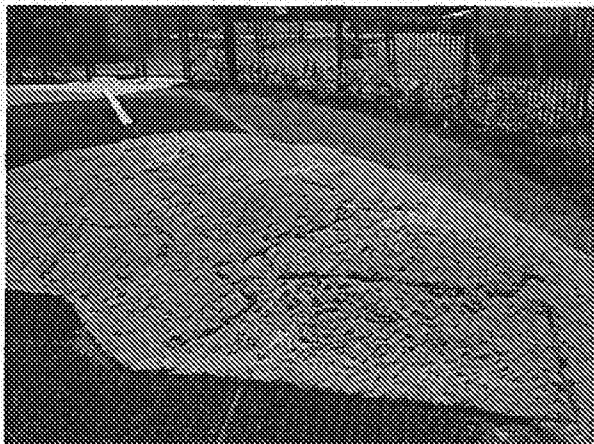
| i 4 - Very Low Risk | | | |
|---|---|---|---|
| <b>Item:</b> | Ancillary Items - Site General | <b>Risk Level:</b> | V - Very Low Risk |

| i 4 - Very Low Risk | | | |
|---|---|---|---|
| <b>Finding:</b> Some of the turfed areas have dried out and the grass has died off | | <b>Action:</b> Rectify as required | |

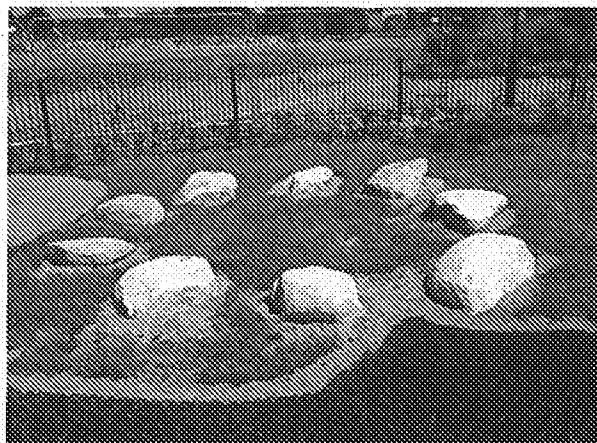
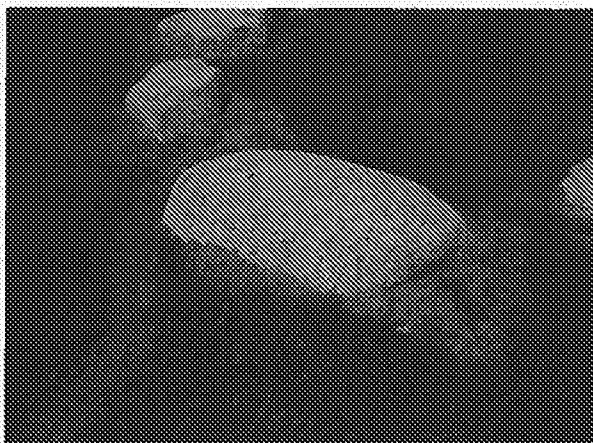
| i 5 - Very Low Risk | | | |
|---|---|---|---|
| <b>Item:</b> | Other - Boulders | <b>Risk Level:</b> | V - Very Low Risk |

| i 5 - Very Low Risk | | | |
|---|---|---|---|
| <b>Finding:</b> The use of boulders in the play area presents a risk to users of falling onto hard objects | | <b>Action:</b> Monitor use | |
