## Arboricultural Impact Appraisal and Method Statement

Burndell Road, Yapton

Date: 16 April 2014  
Ref: **14029-AIA-MW**

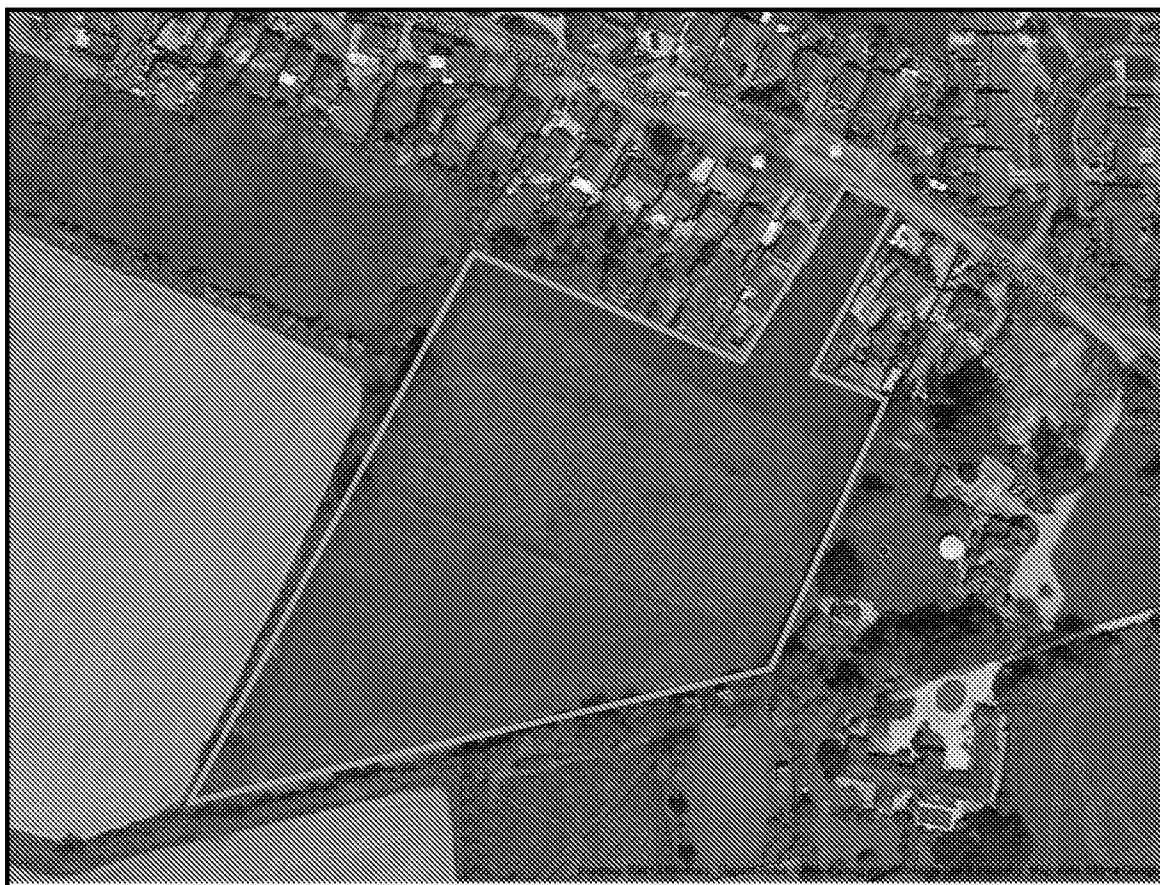
**Image 1:** The site boundaries are approximately illustrated by the red outline

The proposed site is located on the southern side of Burndell Road, accessed by a track between two properties (Kyrie and Northwood Cottages). It is set back from the roadside with fields to the south and west, and a variety of mixed species of young, maturing and mature trees and hedgerows around the boundaries (Image 1).

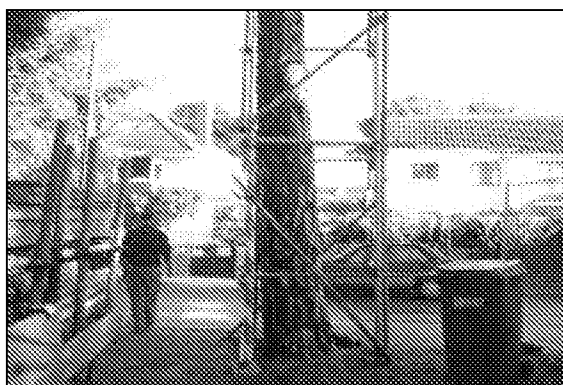
**Photo 5:** A scaffold braced framework surrounding the trunk reduces the risk of accidental impact.

Where individual trunks or branches are vulnerable to impact damage, a framework of scaffold or wood can be constructed to provide protection (photos 5 and 6).

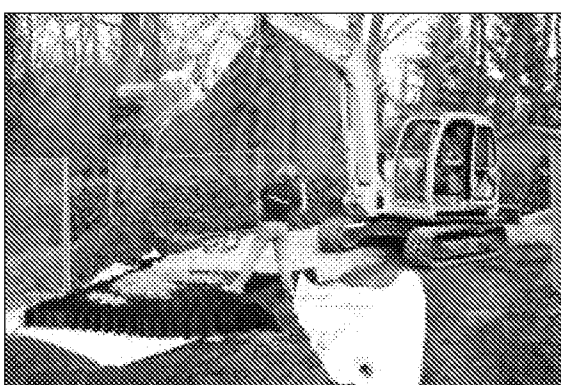
**Photo 11:** Cellular products are a very effective means of providing ground protection where heavy vehicle use is expected. Here, it is being used to temporarily widen an existing road, to be removed once the construction is finished.

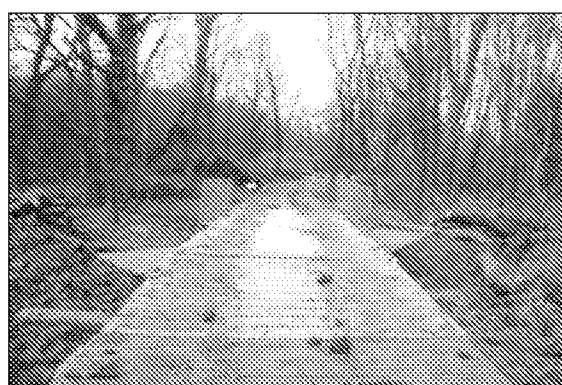
**Photo 12:** Custom designed sectional tracks can be joined to support very heavy traffic use through sensitive areas.

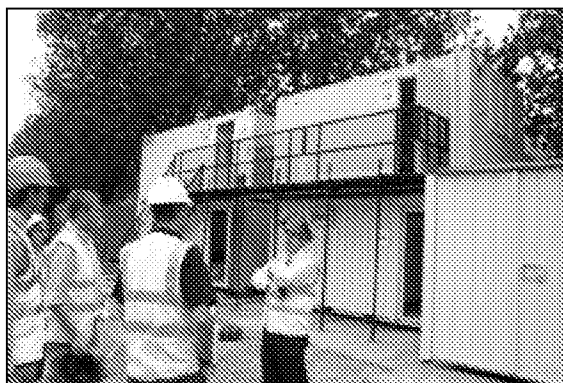
**Photo 13:** A combination of retaining existing surfacing and using temporary construction cabin accommodation can be a very effective means of preventing damage to sensitive areas.

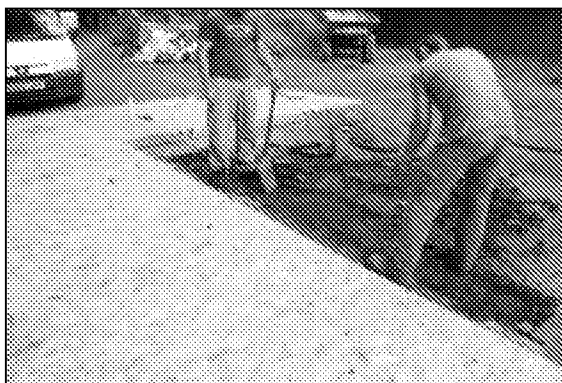
**Photo 15:** Careful hand-digging using conventional tools is acceptable for exposing roots in RPAs.

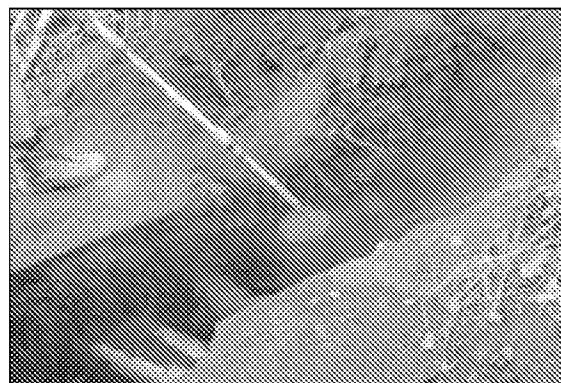
**Photo 16:** Air spades are very effective at exposing roots and services with minimal damage.

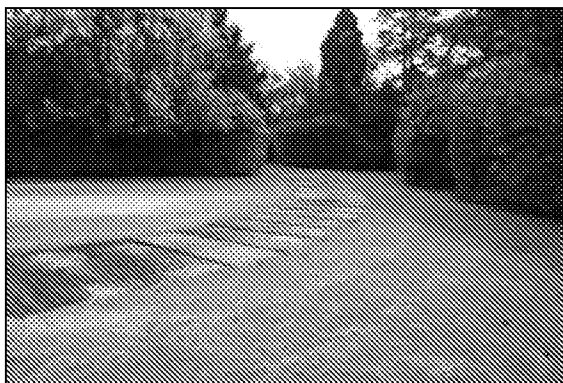
**Photo 19:** Ground protection must be used where repeated foot or vehicle traffic could cause compaction in sensitive RPAs. It can be as simple as plywood for pedestrians, but must be more robust for vehicles.

In summary, there should be no vehicular or repeated pedestrian access unless existing ground protection is retained or new protective measures are installed (photo 19). All exposed RPAs must be protected until there is no risk of damage from the development activity.

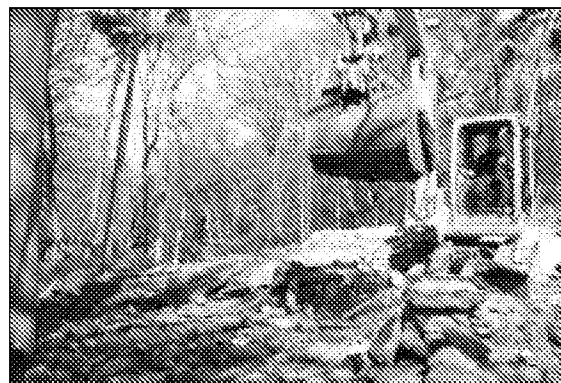
**Photo 20:** Machines with a long reach can be used to lift out heavy surfacing and structures as long as the machine sits outside the RPA and the exposed surface is protected before there is any further access.

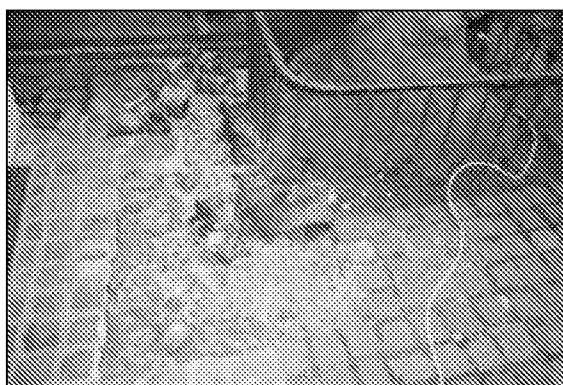
**Photo 21:** Careful lifting of cemented-in sets round this tree allowed them to be re-laid on a permeable sand base, improving the water input into the soil around the trunk.

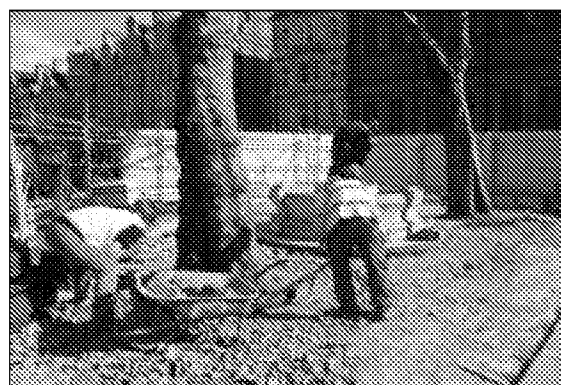
**Photo 22:** These trees had impermeable surfacing right up to their trunks, which had to be removed by hand before installing new structures.

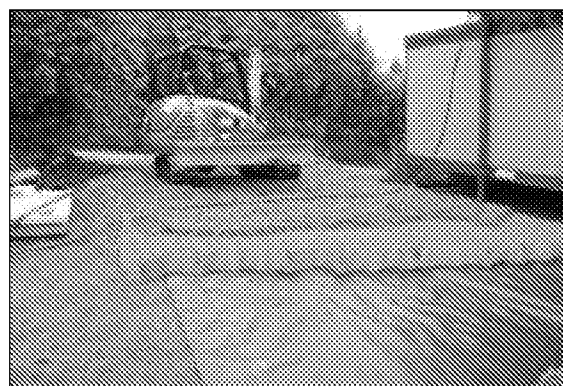
**Photo 25:** The stone-filled cells spread the load of traffic and the geotextile membrane on the ground prevents migration of the stone into the soil profile.

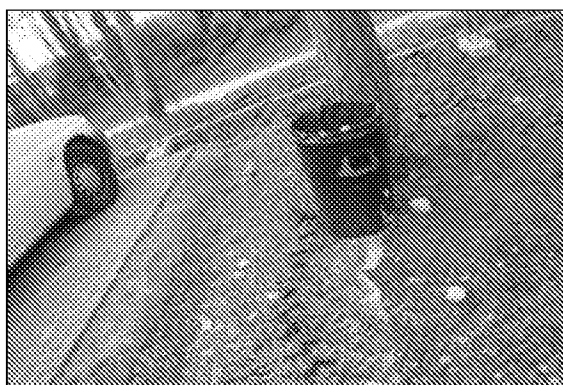
**Photo 26:** A conventional concrete haunching can be used to retain new surfacing as long as it is not dug into a trench - here is it placed on top of the CellWeb layer.

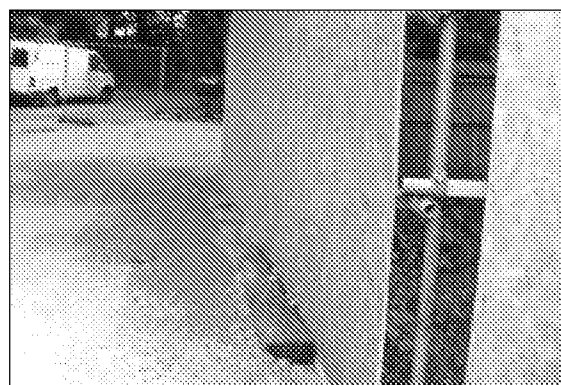
**Photo 27:** Although this is only a temporary surface, railway sleepers pinned into the ground can be used to retain the edges of new surfacing.

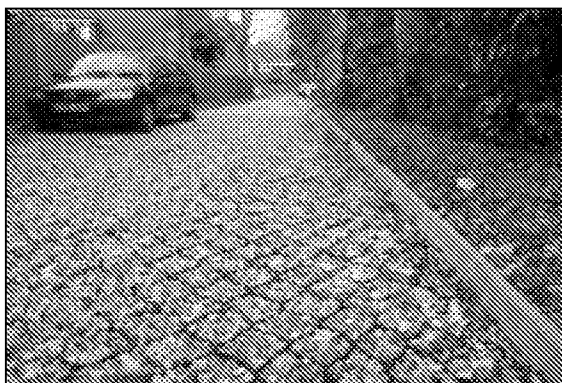
**Photo 28:** Wooden board pinned in place or held in position with backfilled topsoil can provide more informal and rustic surface edging.

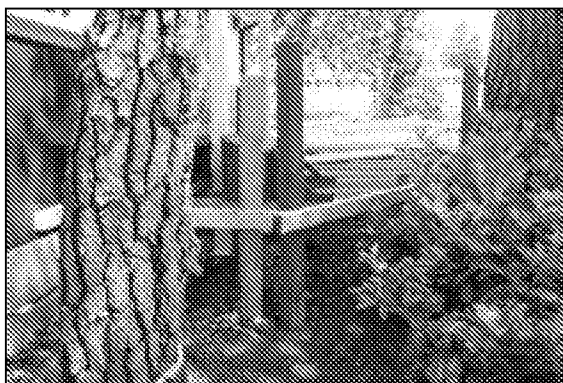
**Photo 32:** New surfacing can be supported above the ground on posts leaving the soil surface beneath undisturbed.

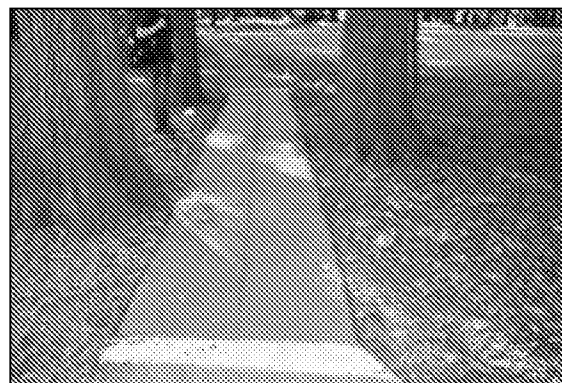
**Photo 33:** Where surfacing is needed close to rapidly growing buttress roots, a light metal frame with rubberised surfacing will allow the path to distort without cracking as the roots grow.

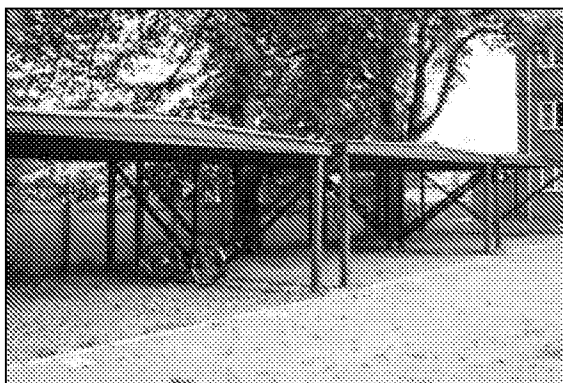
**Photo 34:** These carports are formed by wooden posts above a three dimensional cellular no-dig and load-spreading surface of permeable crushed stone.

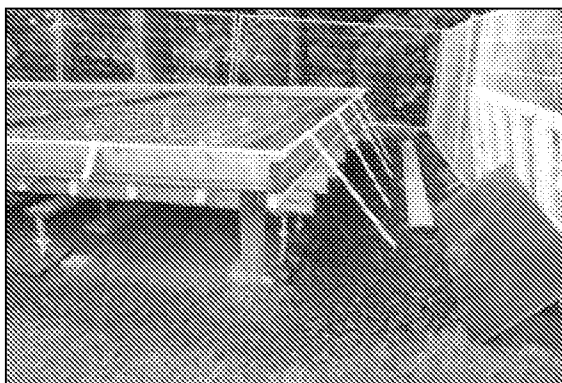
**Photo 36:** Small diameter piles (less than 150mm) are an effective means of supporting structures in RPAs with minimal disturbance.

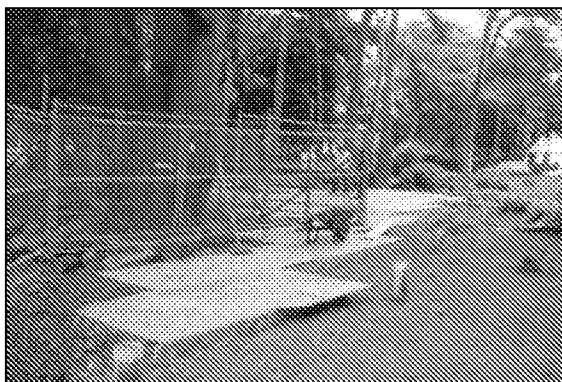
**Photo 40:** Once the piles have been installed (yellow tops), the ground protection to support the piling rig is removed ready to fix the void-former onto the bare soil, in advance of pouring the building slab.

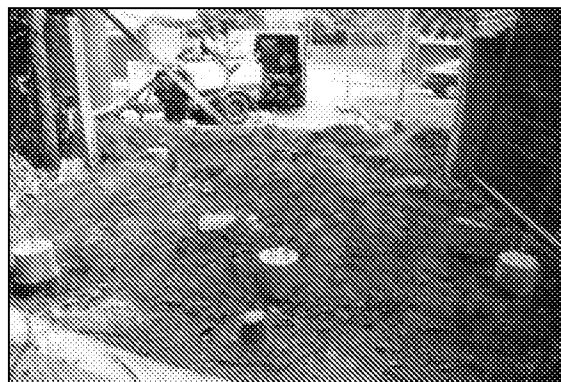
**Photo 41:** Piles can also be used to support bridges across sensitive RPAs, but the temporary ground protection has to be removed before the main structure is either imported in or cast on site.

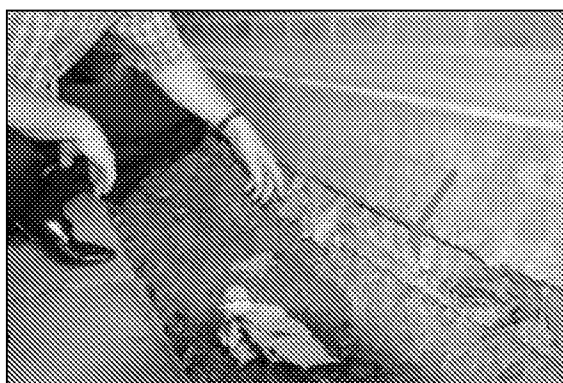
**Photo 42:** Where a slab is cast on site, a biodegradable void-former (red arrow) temporarily supports the weight of the liquid concrete until it sets. The void-former can then be wetted and washed away to leave a void or left to degrade naturally, both of which allow movement of air beneath the slab.

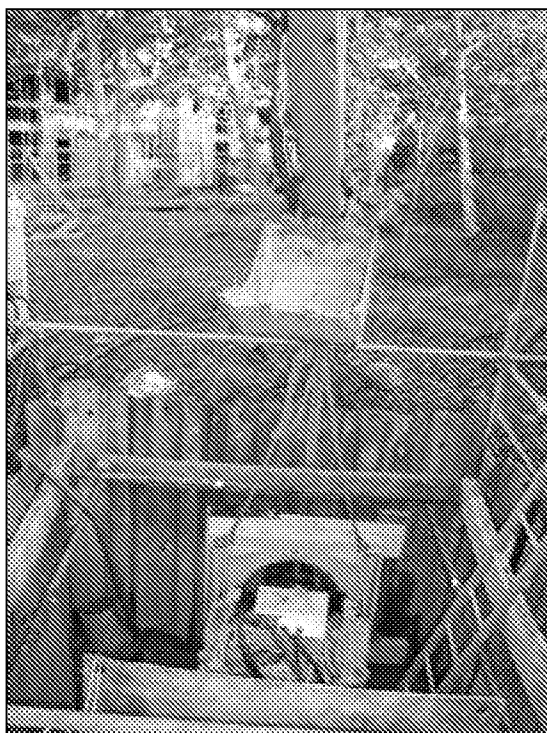
**Photo 44:** If possible, thrust boring is the preferred option for installing service routes through the RPAs of important trees, but there has to be space at the start and finish to dig substantial working pits.

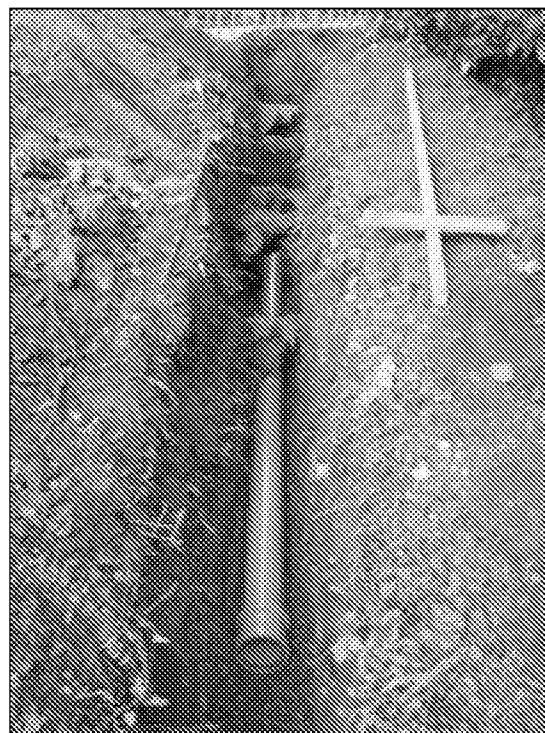
**Photo 45:** Continuous trenches dug by hand so that important roots can be retained (with the service ducting threaded beneath) is an effective means of minimising damage (note the ground protection boards with soil piled on top on the left).

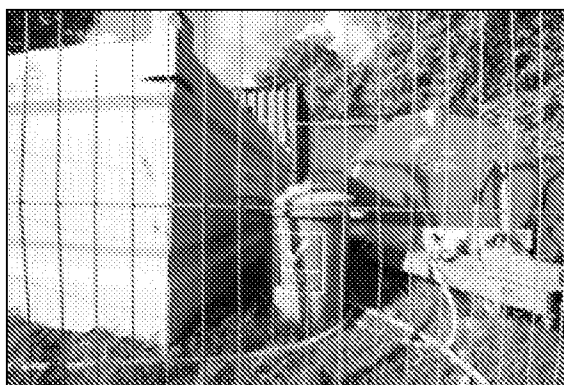
**Photo 46:** Where fuel or other chemical are stored on site, it is now standard practice to have emergency spillage kits available to restrict the environmental impact of accidents.

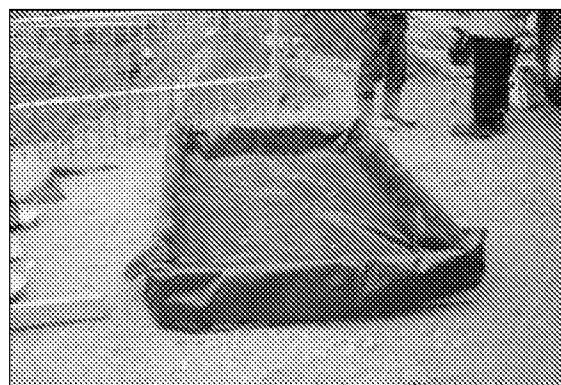
**Photo 47:** Soil bunding or a supporting framework covered in heavy-duty plastic sheeting is essential where there is a risk of spillages contaminating RPAs. This specifically applies to cement mixing areas and vehicle washing facilities.

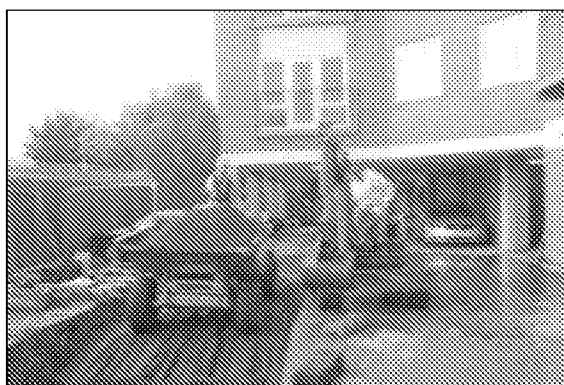
**Photo 53:** Structural tree soil retains sufficient structure for tree roots to grow, even when compacted.

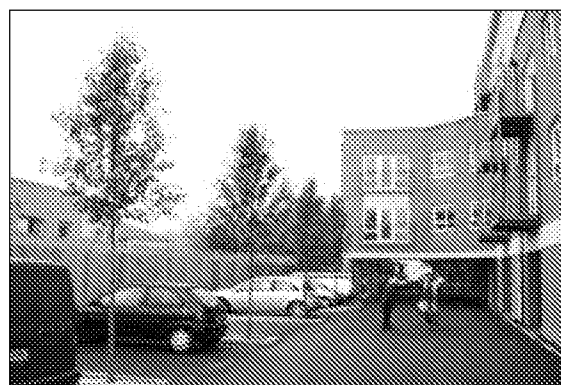
**Photo 54:** It allows trees to be successfully established in areas of extensive hard surfacing, with very little, if any, loss of parking space

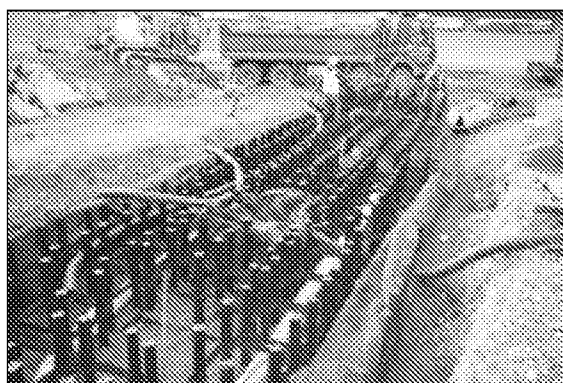
**Photo 55:** The individual Silva Cells can be assembled in layers and service ducting threaded through before filling with soil and fitting the reinforced tops.

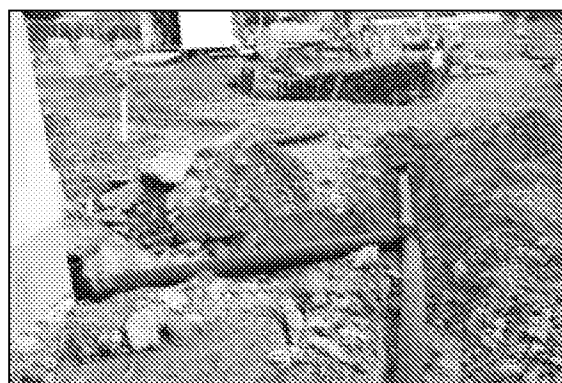
**Photo 56:** Drainage from adjacent buildings can be directed into Silva Cells, significantly buffering rainwater runoff from urbanised areas.

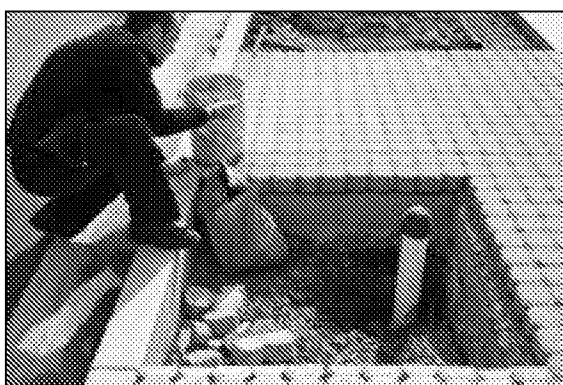
**Photo 57:** The finished surfacing is profiled to leave the tree pit open, ready to be filled with good quality topsoil and the new tree.
