Address  
Courtwick Park, Courtwick Lane,  
Littlehampton, BN17 7PD

Status Existing and Proposed

Drawing East

Drawing No. 2601CO\_200

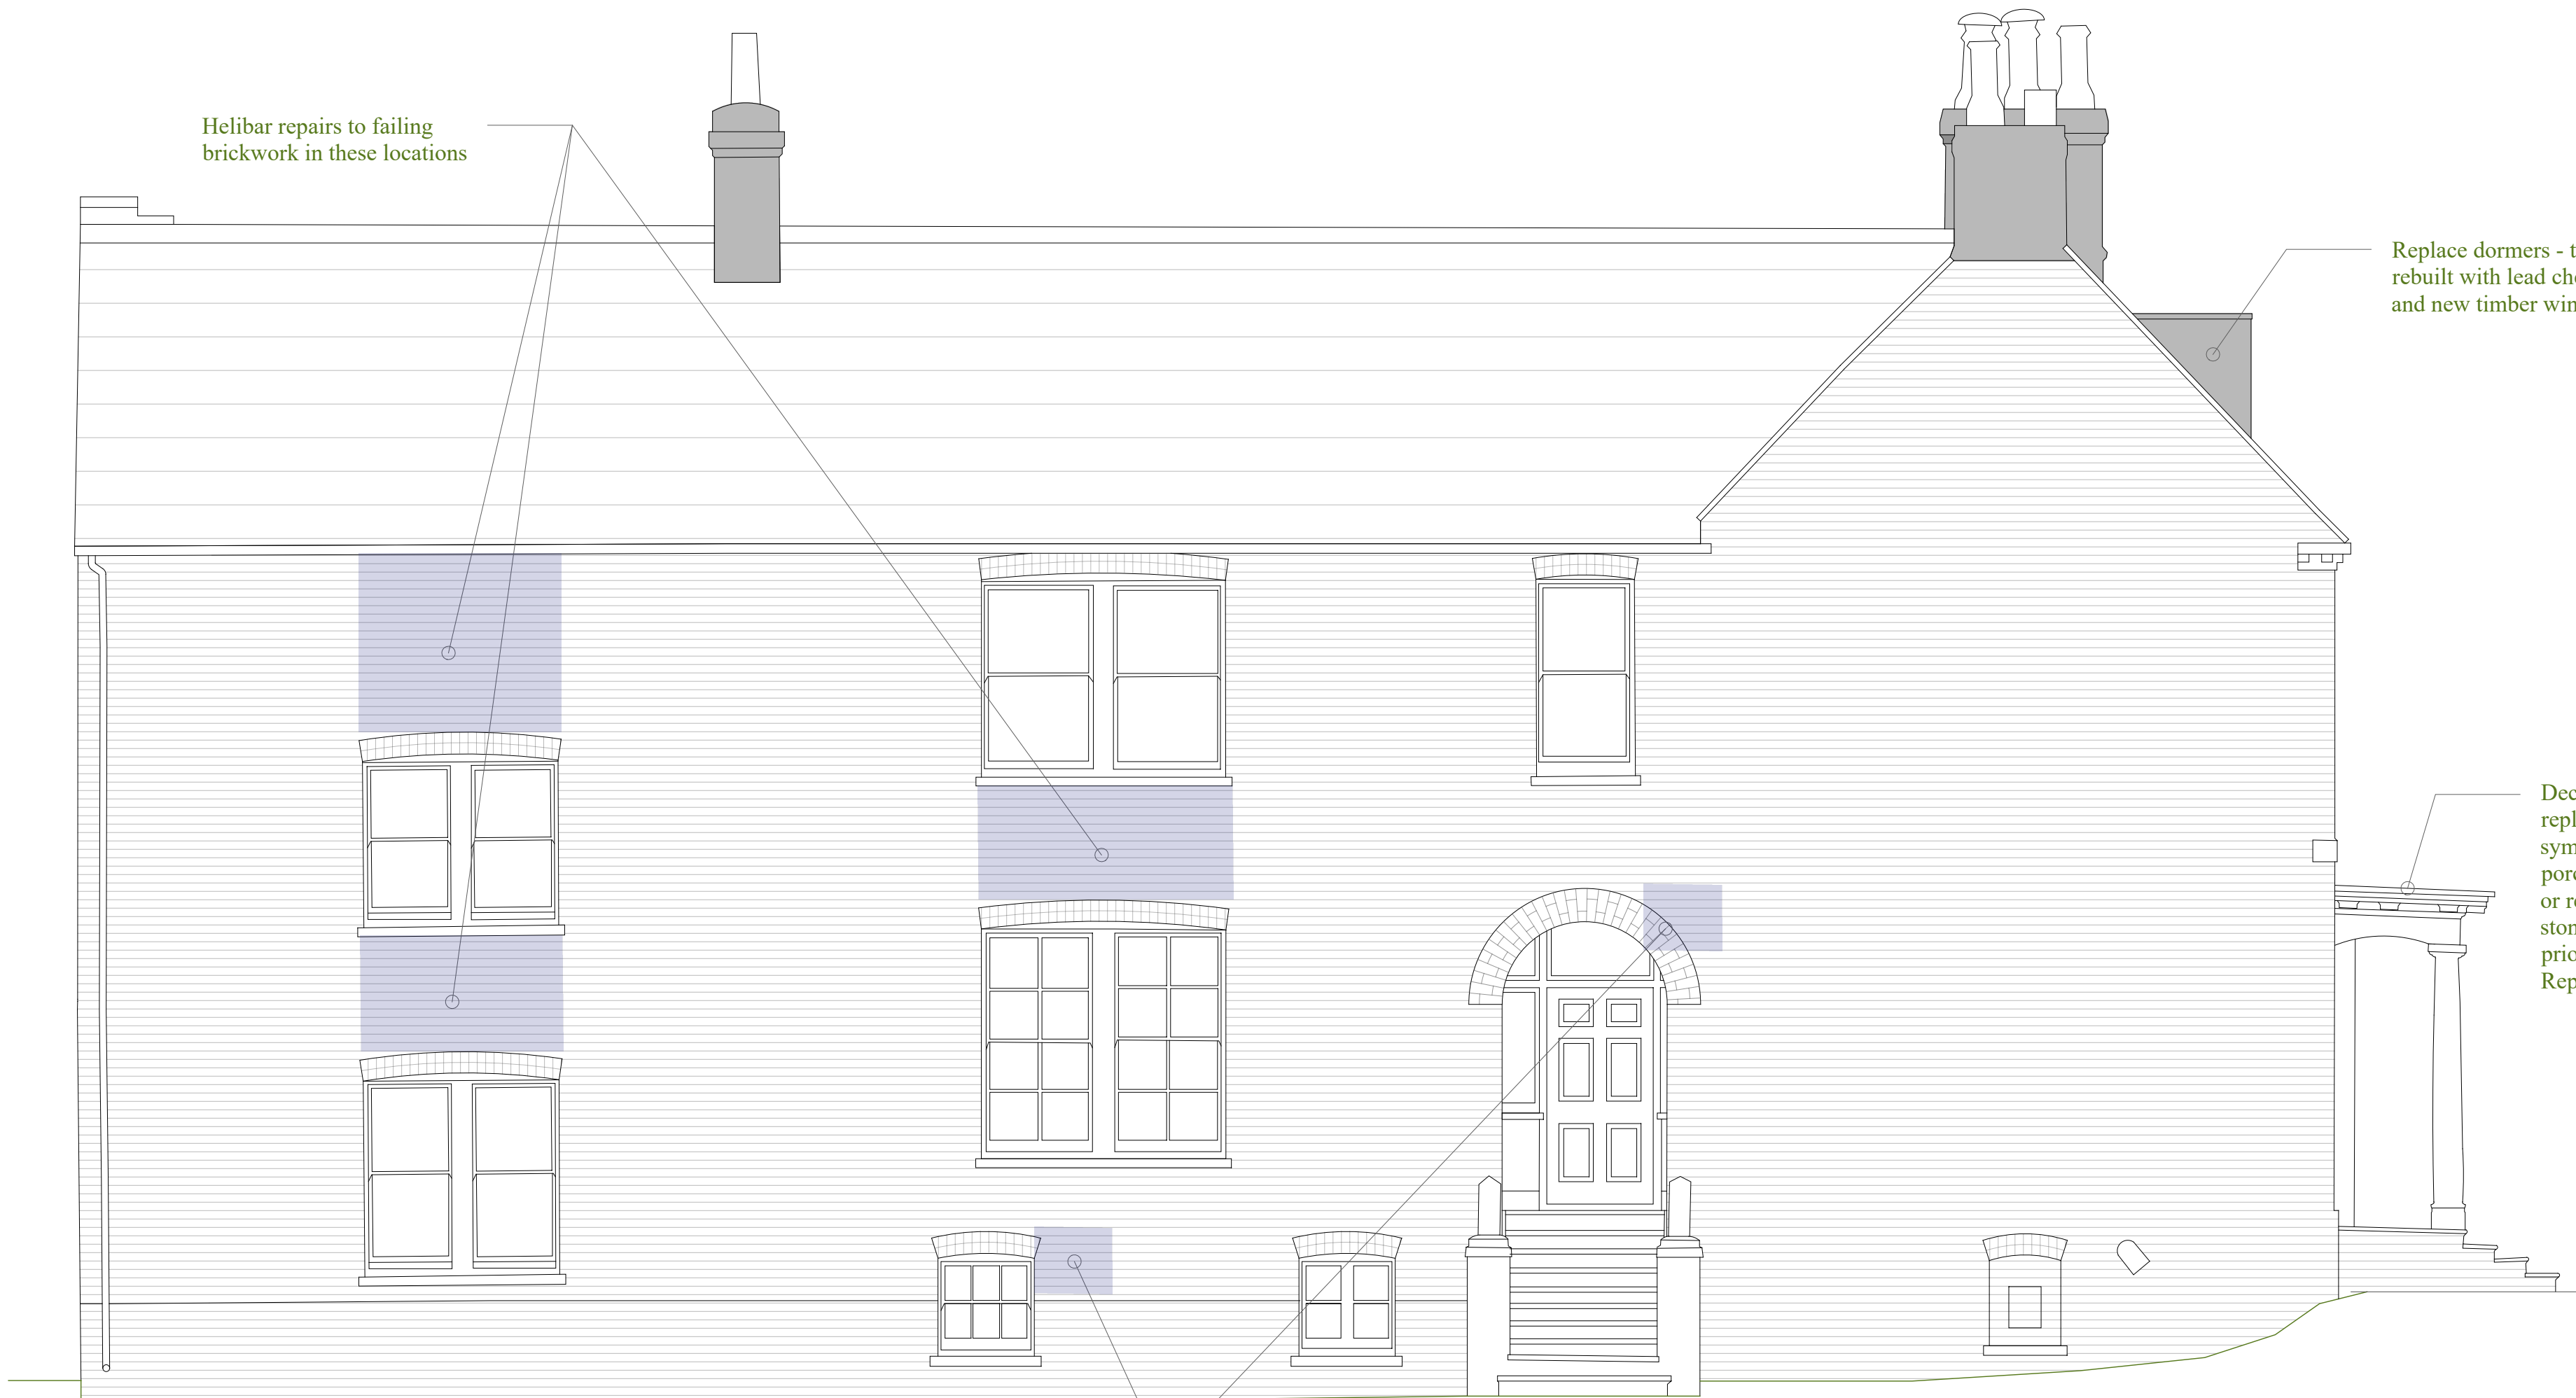
East  
1:50 PROPOSED

Helibar repairs to failing  
brickwork in these locations

Replace dormers - to be  
rebuilt with lead cheeks, roof  
and new timber windows

Decayed porch  
replaced with new  
sympathetic design  
porch, built in timber  
or reconstituted  
stone - Details TBA  
prior to installation.  
Repair steps
