# Road Safety Audit Report

Incorporating  
Stage 1 Completion of Preliminary design

## The Old Dairy Littlehampton

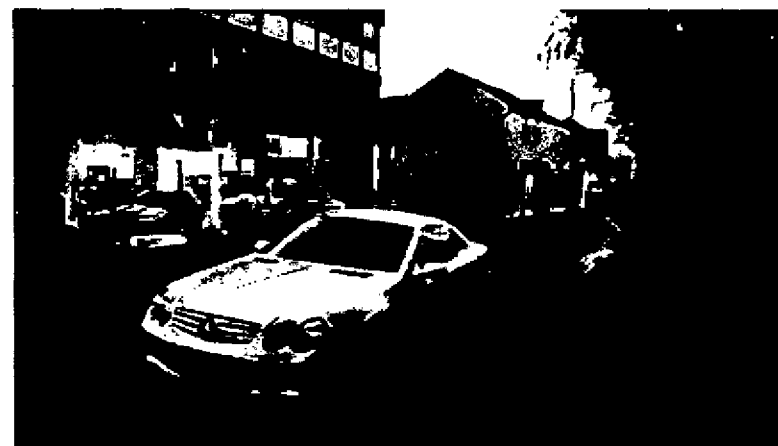
| dlt<br>n No. | Audit Team Observation | Audit Team Recommendation | Designer / Scheme Response |
|---|---|---|---|
| .1 | <p><b>Problem</b>      <i>Restricted visibility</i></p> <p><b>Accident Type</b>      <i>Vehicle Collisions</i></p> <p><b>Location</b>      <i>Church Street west of the existing access</i></p> <p>Although vehicles were observed to be travelling at low speeds in proximity of the access, visibility to the west is restricted by the adjacent boundary. Restricted visibility could lead to a vehicle egressing the site when it is not safe to do so.</p> | <p>A speed survey should be undertaken and visibility increased if necessary.</p> | <p><b>The alignment of Church Street to the west and the presence of the on-street parking bays adjacent to the site result in vehicles not travelling along the channel line and therefore visibility is sufficient, ref: paragraphs 10.6.1 and 10.6.2 of Manual for Streets II.</b></p> |

Visibility to the west

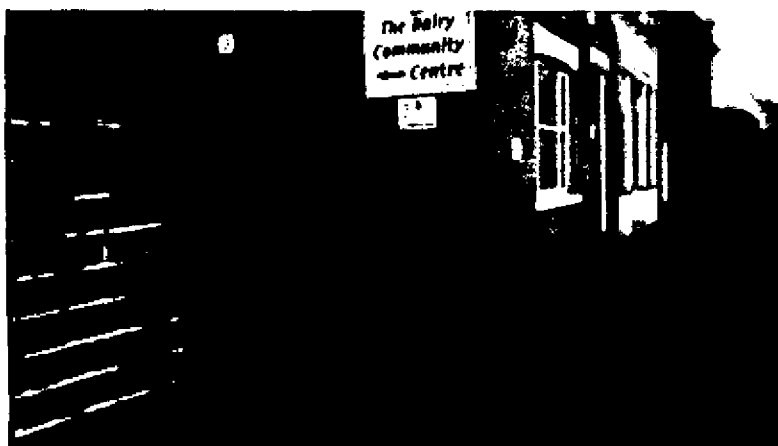
| dit<br>n No. | Audit Team Observation | Audit Team Recommendation | Designer / Scheme Response |
|---|---|---|---|
| .1 | <p><b>PROBLEM</b>      <i>Pedestrian visibility is restricted</i></p> <p><b>Accident Type</b>      <i>Pedestrian/vehicle collisions</i></p> <p><b>Location</b>      <i>Access</i></p> <p>Pedestrian visibility associated with the access is restricted by No. 3 Church Street to the east and a boundary wall/hedge to the west. This could result in collisions where pedestrians and vehicles do not have sufficient warning of each other's presence.</p> | <p>Pedestrian visibility in either direction should be increased.</p> | <p>The access is historic and observations show that vehicles approach the junction slowly as recognised at paragraphs 10.6.1 and 10.6.2 of Manual for Streets II. Furthermore, the traffic generation of the redevelopment is significantly less than the lawful use and it is not possible to increase pedestrian visibility. However, the hedge to the west could be trimmed to increase pedestrian visibility.</p> |

Pedestrian visibility from the west

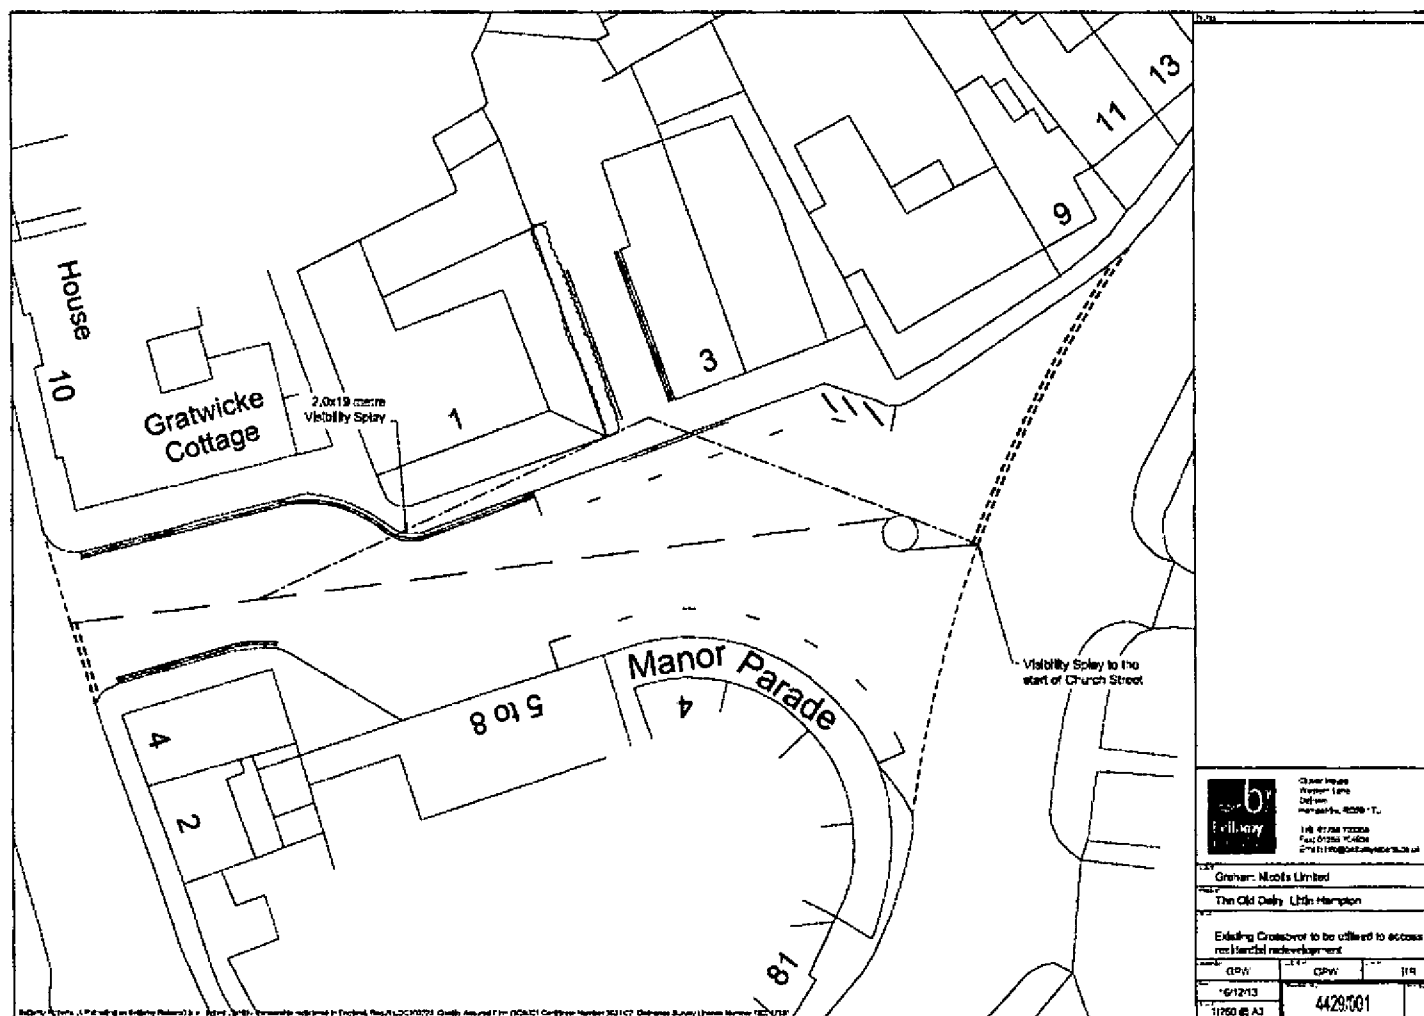
- 0 The existing crossover access provides a visibility splay from the channel line of 2.0x19 metres to the west but this increases to reach the start of Church Street when taken at an offset of 2 metres from the edge of the parking bay adjacent to the site. To the east, visibility extends to the start of this section of Church Street to the east.

| <u>Audit Stage</u> | <u>Drawing Number</u> | <u>Rev</u> | <u>Title</u> |
|---|---|---|---|
| Stage 1 | 4429//001 | | Existing crossover access |
