Acoustic Associates Sussex Ltd

# Discharge of Planning Condition 4 of LU/321/17/PL BS 8233:2014 Assessment

Site: 22 Beach Road, Littlehampton, West Sussex. BN17 5HT  
Client: Darren Godfrey

Project: J2707

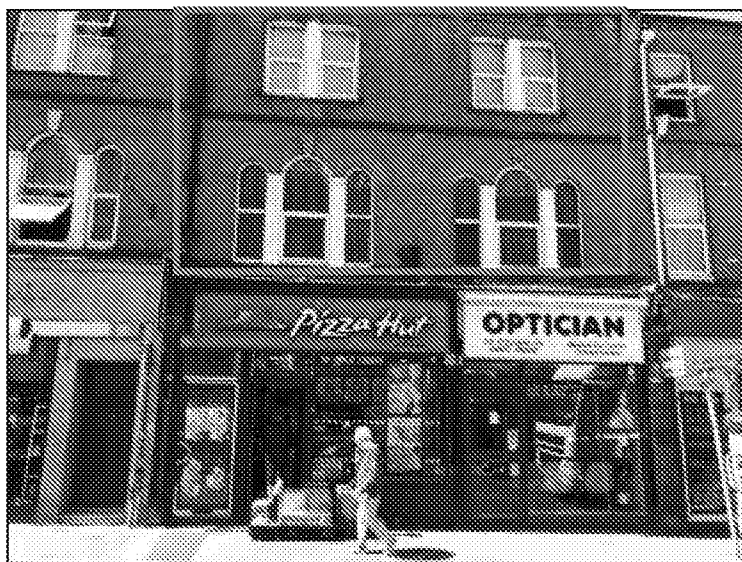
**Figure 1. Location of 22 Beach Road, Littlehampton.**

A pedestrianised rear area known as Evans Gardens exists to the West and contains three shops accessed via foot including a shop for infant clothes, a gym studio and an arts studio. The site can be seen in Figure 1 below with the residential windows marked in red.

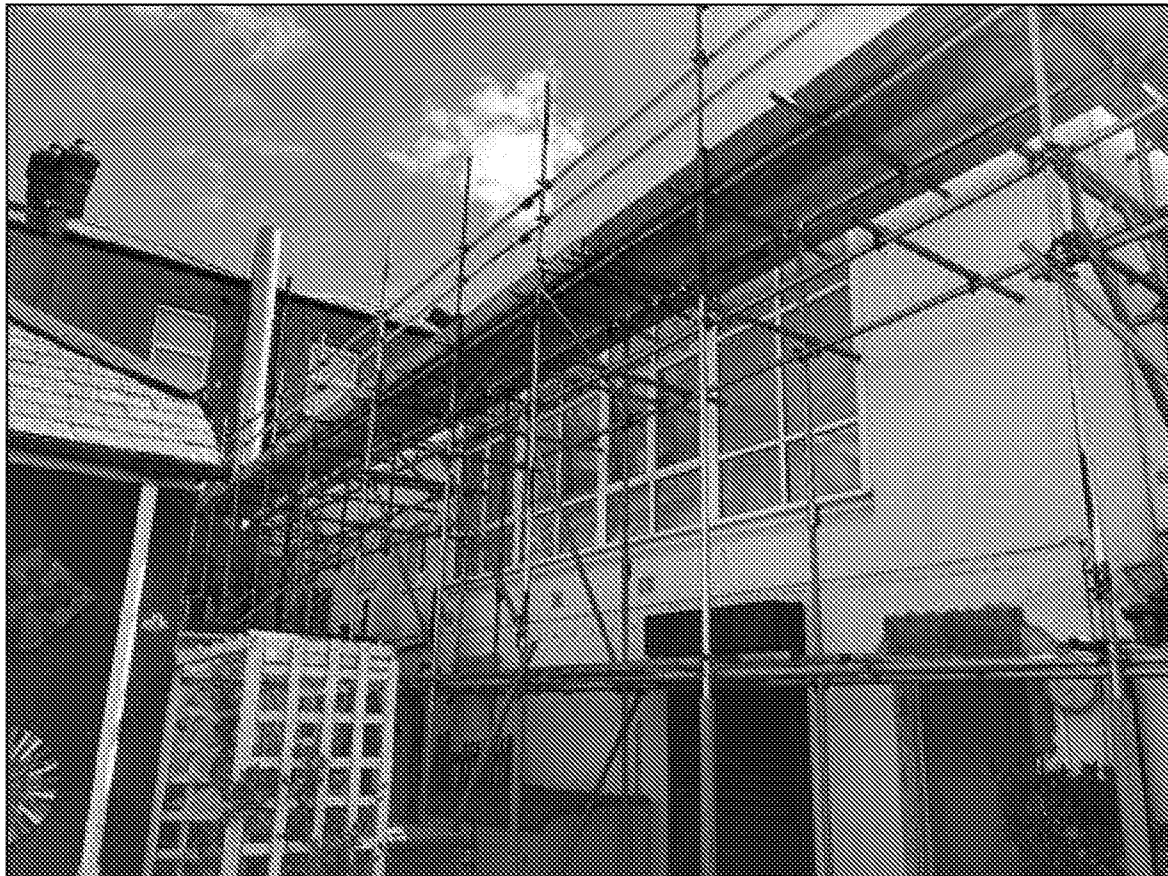
Figure 5. Pizza Hut Vertical Discharge Flue

A site photograph below shows the existing ductwork and importantly that the termination point is well away from the bedroom window and above eaves. Whilst present on site, Flat 3 was visited and subjectively listened to, before determining where to set up the various survey instruments. The rationale behind the selection of survey positions was already detailed within the report.

Flat 3 is located on the second floor with the extract ductwork passing at exactly the same position as the first floor, where the flat 2, rear bedroom was examined.

The top flat is closer to the termination point which discharges, upwards, well above the 2<sup>nd</sup> floor windows.

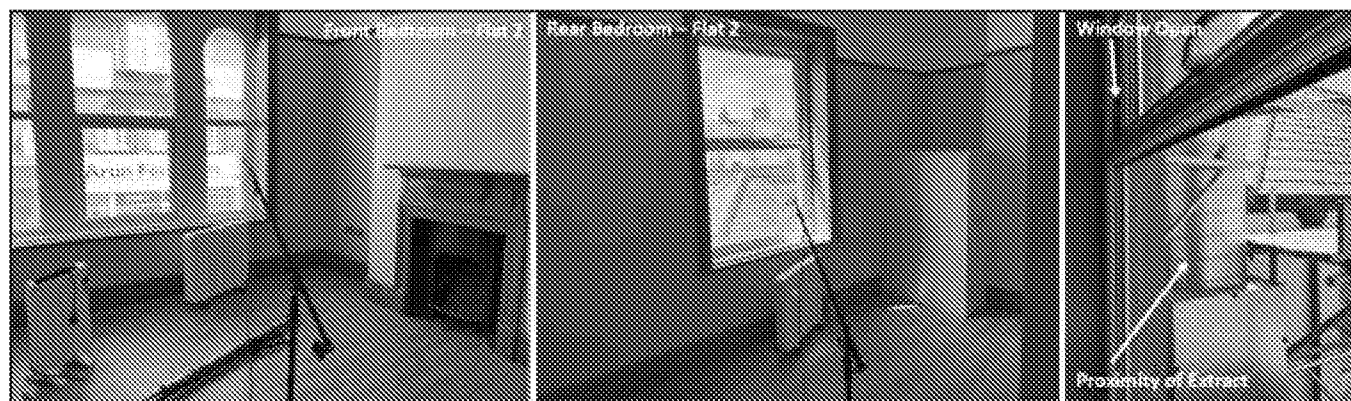
**Figure 6. Internal Measurement Positions**

1. Flat 1, Bedroom above pizza hut kitchen area and overlooking rear of 22 Beach Road.
2. Flat 2, Front bedroom overlooking Beach Road. Window Closed.
3. Flat 2, Bedroom overlooking the rear of 22 Beach Road, closest to Pizza Hut extract vent. Window Open.

| Location of Microphones | Symphony Microphone A – Flat 2 Front Bedroom<br>Symphony Microphone B – Flat 2 Rear Bedroom<br>01dB SIP95 – Flat 1 Bedroom |

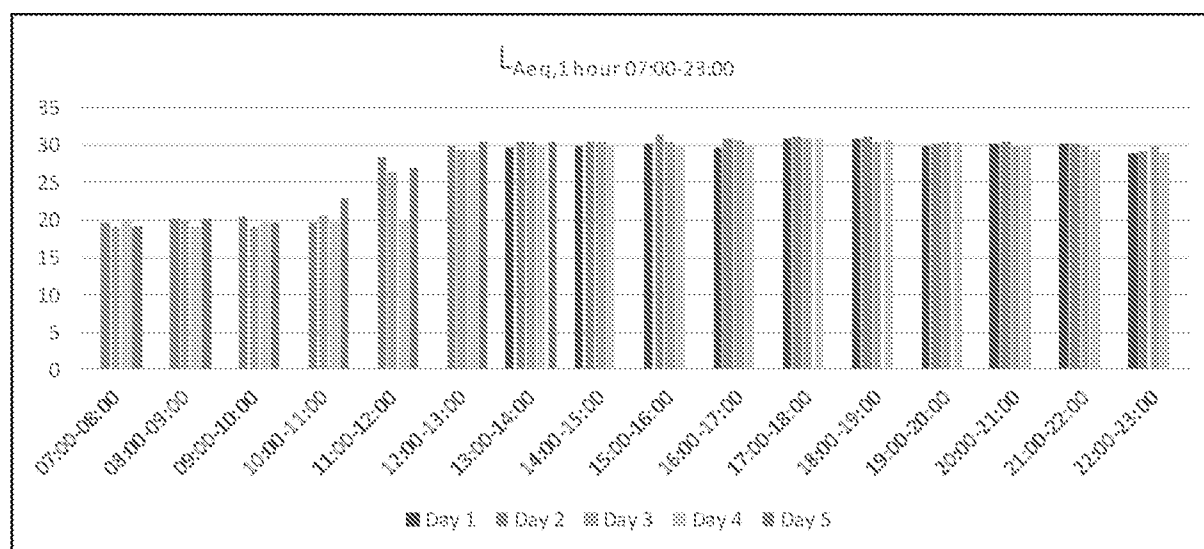
Figure 9. Review of 1-hour periods inside Flat 1 bedroom

Reviewing the one-hour data for inside the bedroom of Flat 1, it is apparent that the sound level increases between 11:00-12:00 hours when the fan is switched on around 11:30 before a test pizza commences at 12:00 hours for normal service. This is commensurate with day to day operations.

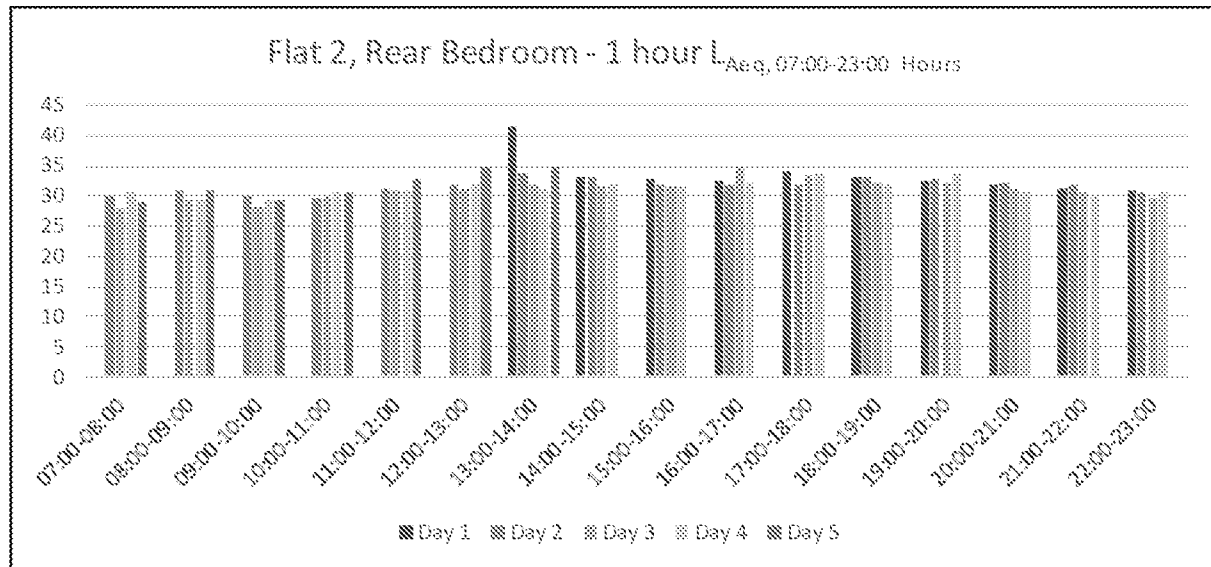
Figure 11. Review of 1-hour periods inside Flat 2, rear bedroom during the daytime period.

The results for the rear bedroom were noted as follows in Figures 8 and 9 below. The rear bedroom easily meets BS8233:2014 for both the daytime and night time periods and is noted to meet the British Standard with the window open. The daytime hours in Figure 9 below show the daytime levels at just below 30 prior to 12:00 hours when the fan would be switched on.

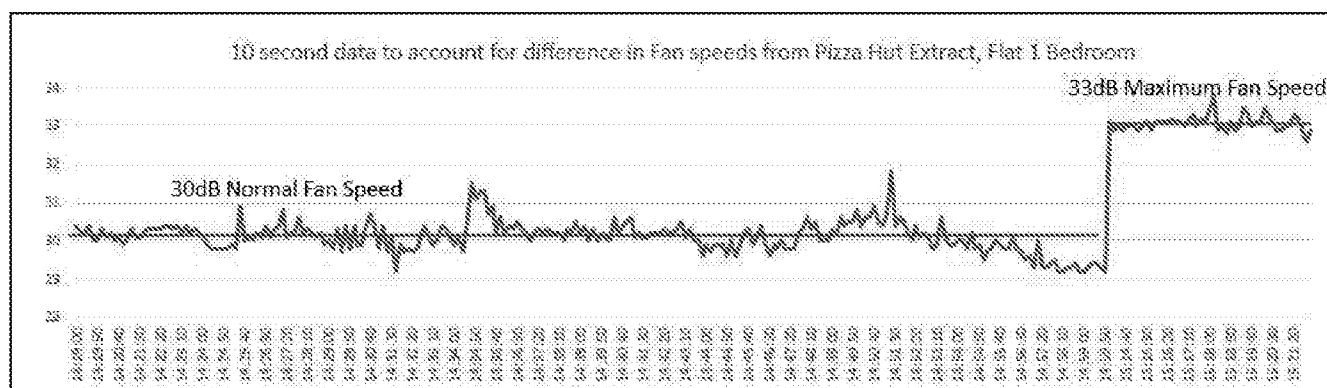
Figure 14. Flat 1 bedroom, fan speed change in sound levels

The SIP95 in Flat 1 bedroom was used to assess the difference between the fan speed operating at normal levels and the maximum speed as detailed in Figure 12 below.

It is noted that the increased fan speed caused a 3dB increase internally, however, it is important to reflect that the fan is never used at 100%. With a 3dB increase inside the bedroom in Flat 1, the daytime sound criterion in BS8233:2014 is still achieved. It is noted that the fan stops at 23:00 hours.

Reference was made to ensuring that the Pizza Hut fan speeds for the extract ductwork were included within the supporting data. Accordingly, the fan speeds were increased at the time of collecting the survey equipment with the results captured inside the bedroom of Flat 1. It is important to note that the fan is never run at full speed and remains a constant and continuous sound. The fan and motor for the ductwork are located close to the extract canopy inside the restaurant premises on the ground floor.

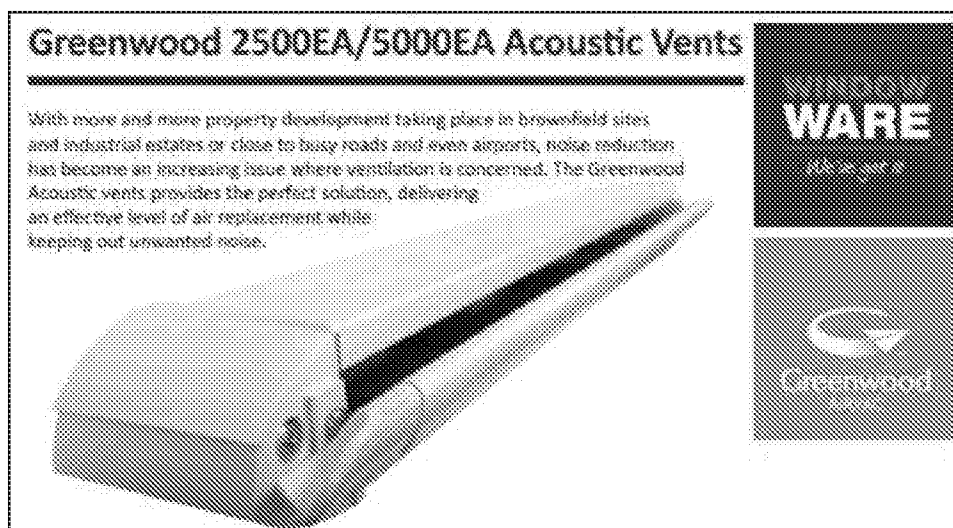
Figure 15. Greenwood Acoustically Attenuated Trickle Vent

The model selected is a Greenwood 5000EA model providing high levels of air flow and good acoustic performance of between 39 dB  $D_{n,e,w}$  and 42 dB  $D_{n,e,w}$ . An illustrative image is seen in Figure 15 below. Ultimately, it will be the decision for the end tenant/resident as to whether the trickle vents are used. Introducing the high-performance acoustic trickle vents will have minimal performance on the current internal soundscape.

The client has agreed to fit a system 1 ventilation type which are acoustically attenuated trickle vents to the windows for the habitable rooms in flat 1 and in flats 2 and 3 facing Beach Road for the purposes of providing background ventilation. The trickle vents compliment the already existing fireplaces for flats 2 and 3.
