# Fence and Associated Gates Installation and Secondary Entrance Alterations

## Heritage Impact Statement

### Flintstone Centre

21 September 2021

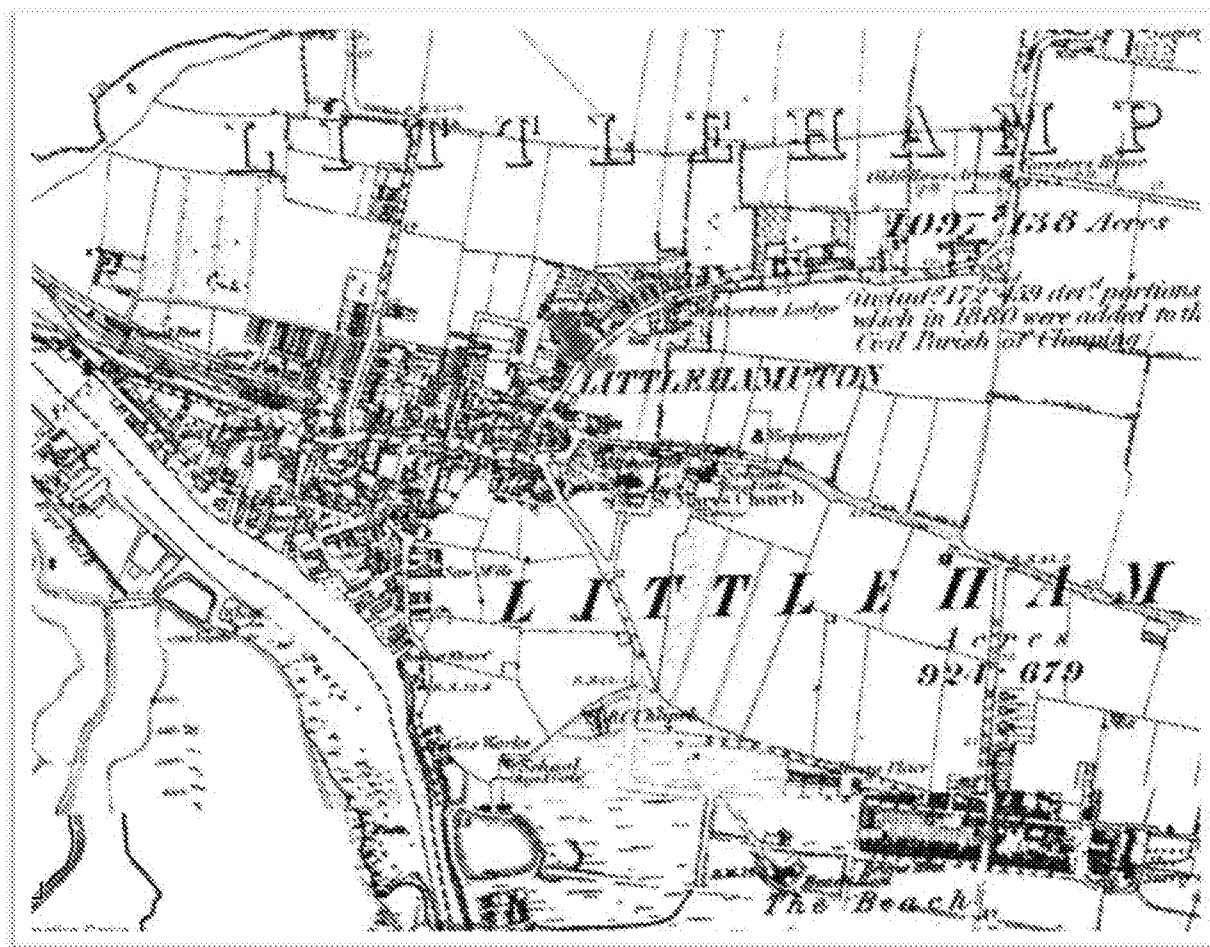
Figure 3: Littlehampton 1843-1893 – Map derived from the Arun & Worthing Councils website<sup>17</sup>.

As seen in Figure 3, East Street School had not yet been constructed and the surrounding area is still relatively rural and undeveloped. East Street was the main vehicular access route via the North East of town. Five residential terrace houses lined the north flank of the road. This confirms a previous statement which believed the north terrace buildings and south neighbours were originally Victorian in construction and refurbished to have a rendered/tiled elevation.

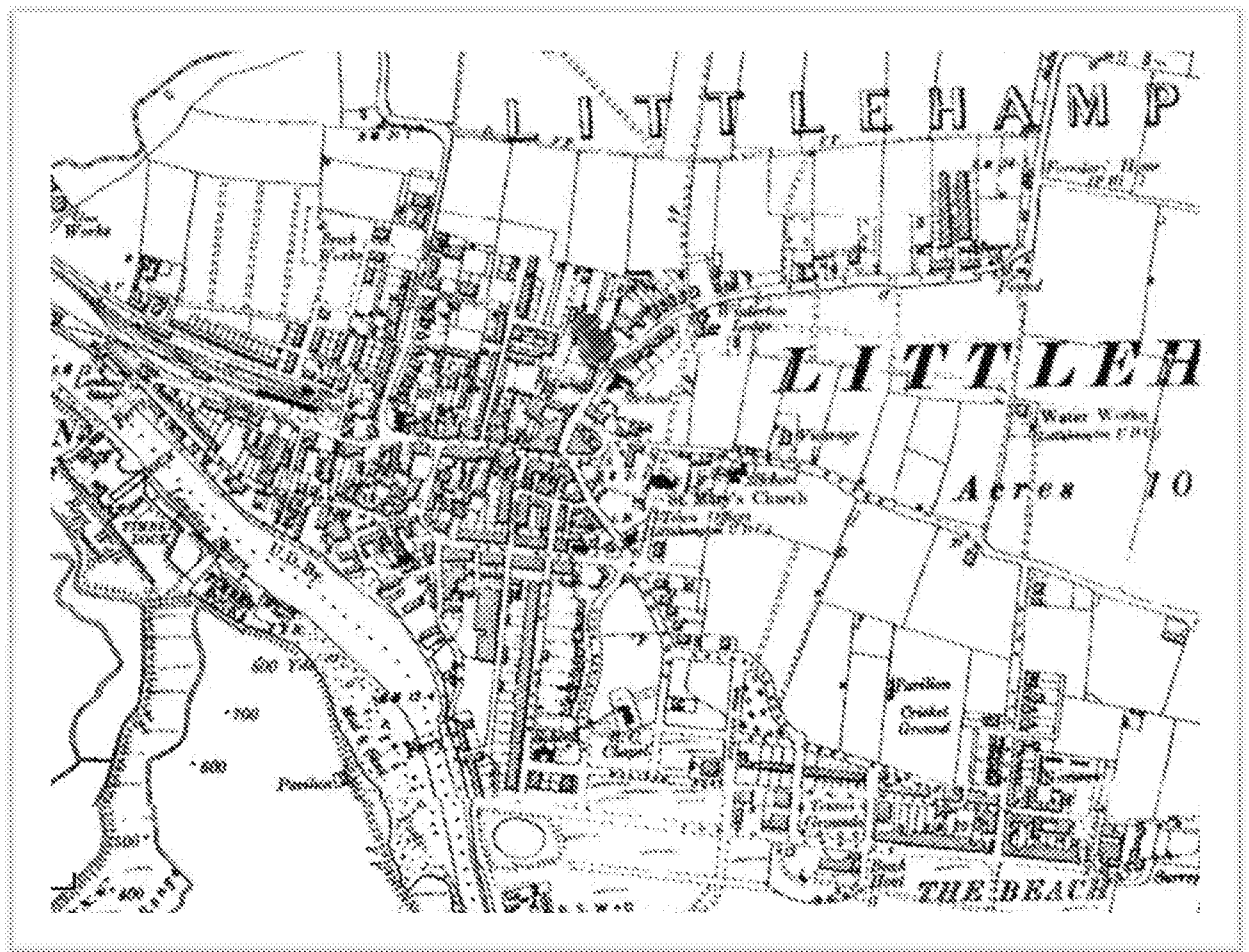
Figure 4: Littlehampton 1891-1912 – Map derived from the Arun & Worthing Councils website<sup>18</sup>.

Figure 4 shows that the town has started to change, extending South and North with no distinctive developments along East Street apart from the construction of the East Street School (The Flintstone Centre). From this we can establish a date on the school's construction and recognise the Victorian architecturally prevalent style of the era. The urbanisation of the town is testament to the Victorian's leisurely retreat to the south coast and evident by the urban planning. At this time the rail connections were established and as a result several more permanent structures established throughout the town indicating a necessity to provide amenities for permanent residences and reflects the beginning of socio-economic prosperity in the region and engendered the need for a hotel industry to the area.

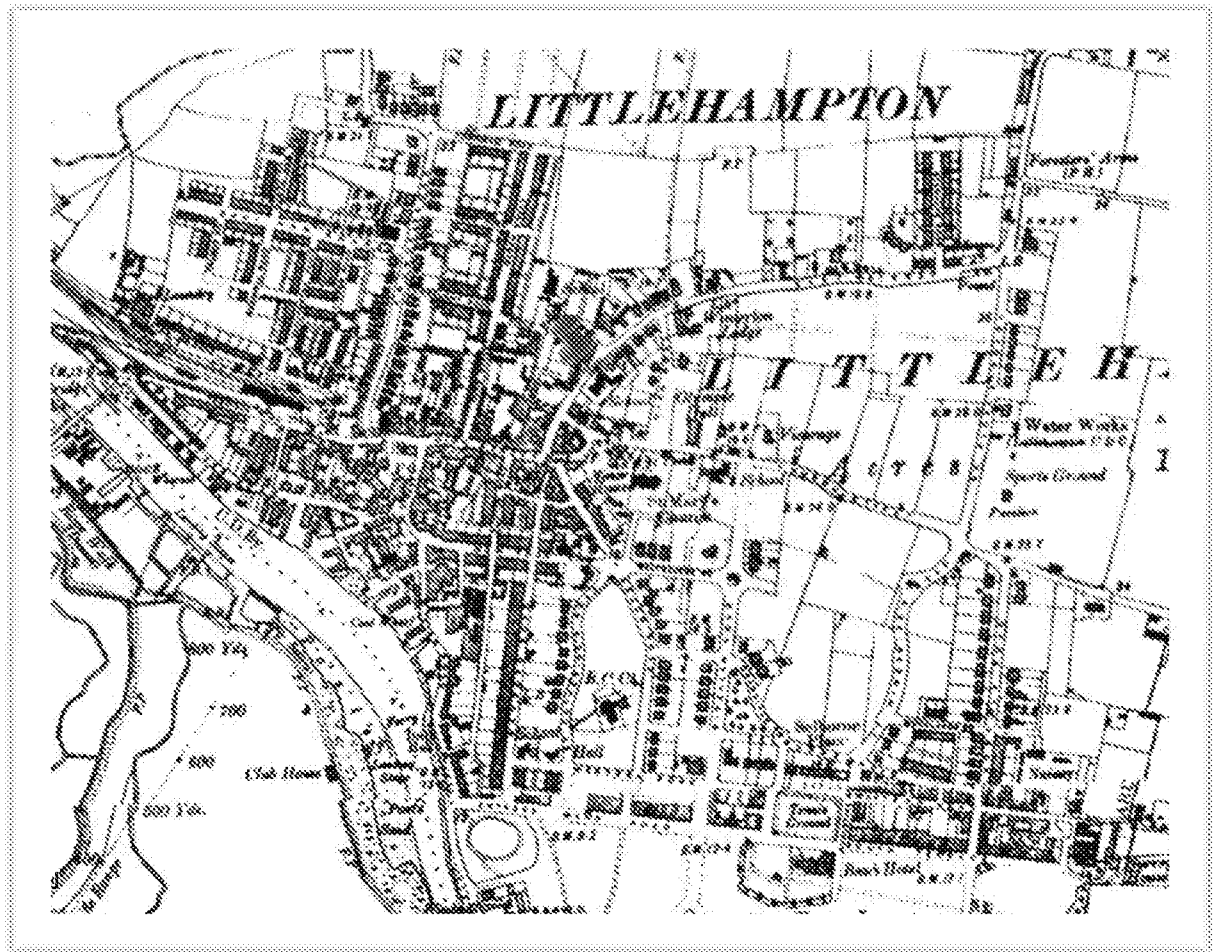
Figure 5: Littlehampton 1904-1934 – Map derived from the Arun & Worthing Councils website<sup>19</sup>.

The development of the town continues (highlighted in Figure 5), with the hotel industry visually growing to accommodate increased visitors around the coastal area. Pockets of rural land started to infill at East and North margin of the town and the dynamic of town planning became more regular with denser residential zones. Other amenities such as halls, ferries club houses etc. started to become more common and with this an expanded low-density commercial area in the town centre to cater for the leisure industry. East Street school has extended to the north to have a significantly larger capacity. In today the extension is imperceptible as it matches the existing building aside from the visually evidence of the existing finials at the gables between the main core and the extension.

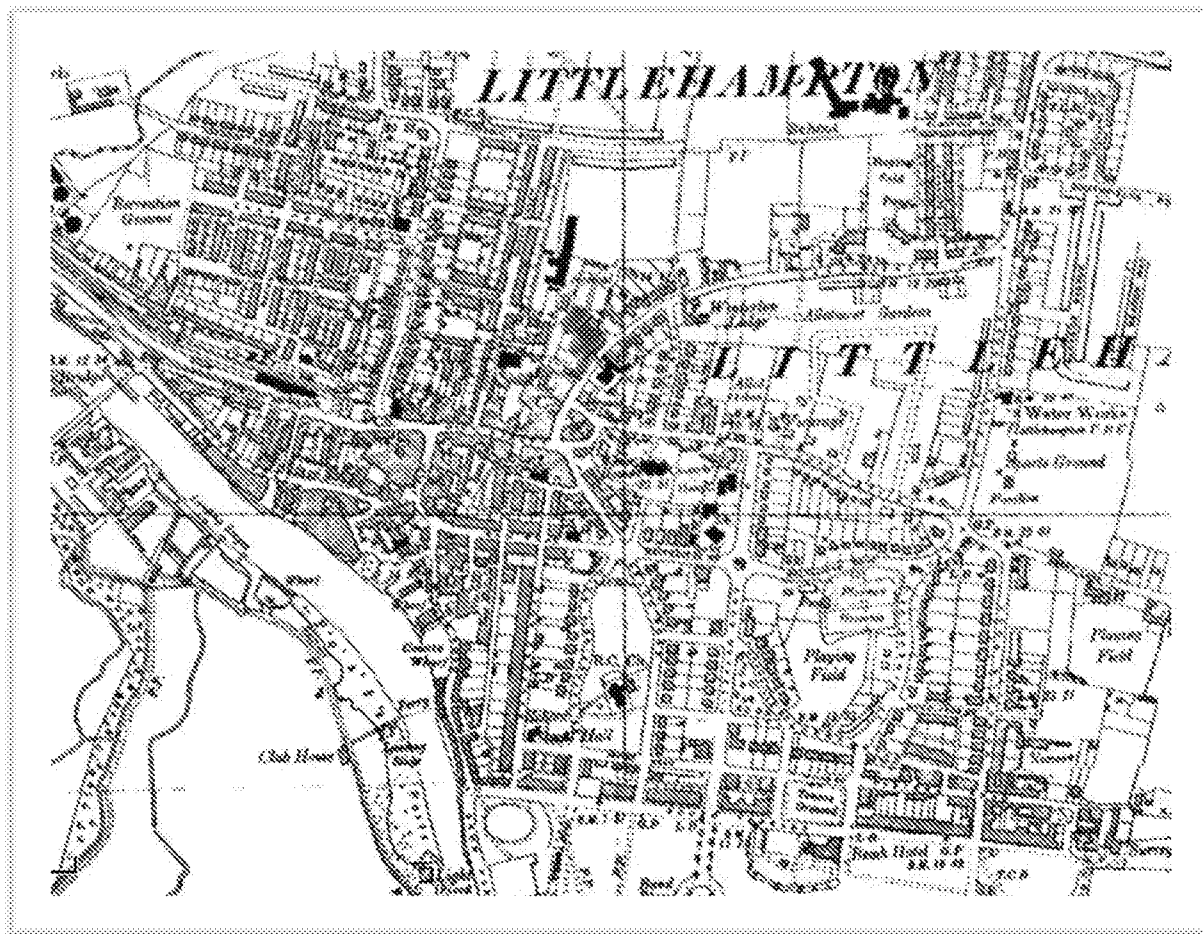
Figure 6: Littlehampton 1919 - 1939 – Map derived from the Arun & Worthing Councils website<sup>20</sup>.

Figure 6 shows large rural areas to the East were developed into sparse low-density residential housing and the infrastructure had been refined for a permanent settlement of residents throughout the town. Whilst the urban landscape had evolved East Street remained relatively similar as the growth of the town continued along the South coast. The Old Dairy to the rear of The East Street School (The Flintstone centre) had not been developed and this area was seemingly a green space with a temporary structure erected. Smarts Fair opens circa 1932 which shows that the town is still widely recognised as a retreat and caters to the children.

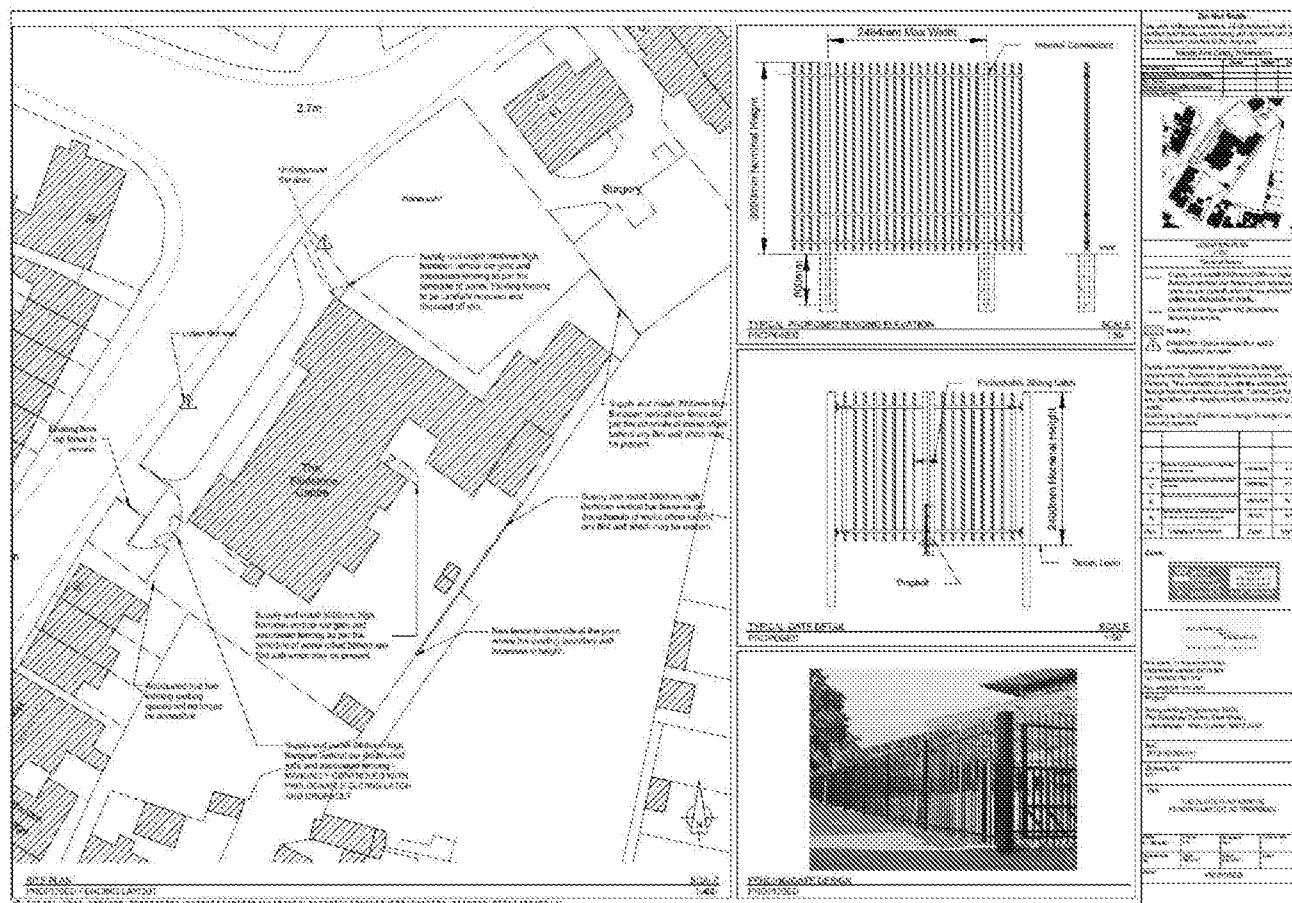
Figure 10: Previous planning application - 2020

The proposed works mainly consist of the erection of a new fence to isolated locations around the perimeter of the premises. A planning application had previously been submitted in 2020 for a now superseded fencing proposal. However, this was withdrawn following commentary being provided by the planning authority. For reference, the superseded fencing proposal and commentary provided by the planning authority can be seen below:

In line with the commentary provided by the planning authority following the previous planning application being submitted (REF: LU/218/20/PL), the proposed design of the fence to areas that can be seen from the front elevation seeks to have a low impact, complement the historical style of the building, conform with current legislation and is specified to a maximum of 2m in height. The separation between the carpark and the front hardstanding is proposed be set back from the boundary to avoid encroaching or shrouding the front elevation.

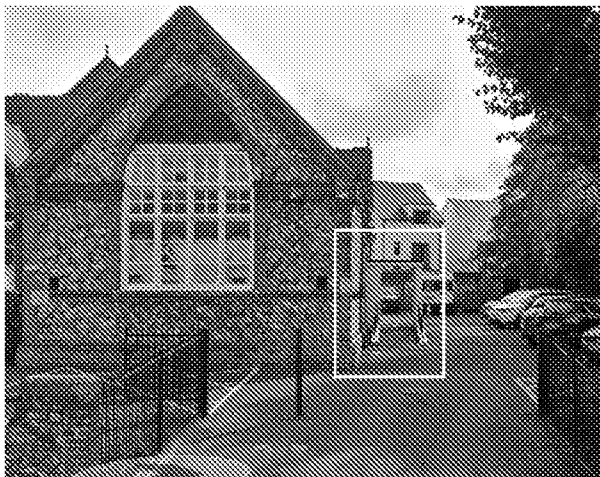
Due to the proposed fencing installation including the setting back of the fencing to provide the separation between the carpark and the front hardstanding, there is also a requirement to alter the secondary access to the south elevation of the building (shown in figure 11 below). This entrance is located within a flat roofed extension, that is understood to have been constructed within the past 15 years. This extension operates as a porch access area, and due to its age, construction, and current condition it is deemed to be of limited significance. This proposal includes for the careful removal of the flat roof extension including the ramped access and all associated fixings, with the ground to be prepared with a suitable sub-base to receive a new, level, tarmacadam finish to match the surrounding. The existing level platform externally, which includes stepped access, will remain in situ to ensure compliance with Part M of the Building Regulations. Please see the below images identifying the flat roof extension that is proposed to be carefully removed from site.

*Figure 11: Flat roof extension (shown in yellow), proposed for removal*

Following the careful removal of the extension, it is anticipated that there will be a requirement for minor brickwork repairs and flint wall repairs to the main building. These are to be surveyed in detail following the careful removal of the flat roof extension, with specialist repairs to be specified to ensure the appropriate conservation and repair of the south elevation wall and to prevent the appearance of blemishes/scars within the masonry. All repairs are to be conducted using materials to match the existing and a specialist contractor will be employed to complete this portion of the work. Due to the unknown nature of this work, until the extension area is removed, it is requested that the repair be dealt with as a Planning / LBC condition.

| 6 | Flat roof extension to south elevation of the building | Carefully remove flat roof extension to south elevation and dispose off site | LOW IMPACT – Extension believed to be constructed circa 15 years ago. Material to be removed deemed to be of no historical significance, but will need to carefully remove to ensure no damage to main building wall materials and finishes | LOW IMPACT – Building works to take place to extension area only. Limited original fabric of the building will be disturbed because of the proposed works. The extension area will be carefully dismantled and removed from site. Specialist stonemasons to be employed to repair any damage to cobble setts and brickwork | None | Site control of contractor works, and specific instruction denoted in Schedule of Works. Agent control over the design process. Original building material abutting fabric that is to be removed will be inspected following careful dismantling and removal from site and specialist repairs will be |

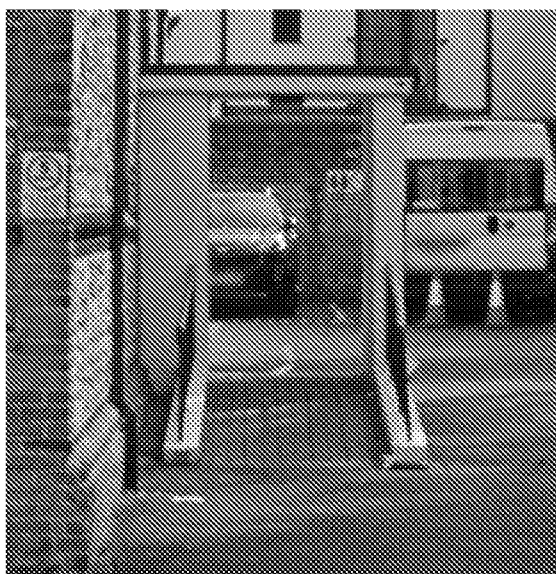
Figure 12: Flat roof extension, proposed for removal
