Lyminster Cottage  
Lyminster  
Littlehampton  
West Sussex  
BN17 7QF

### Pre Planning Submission 2019.

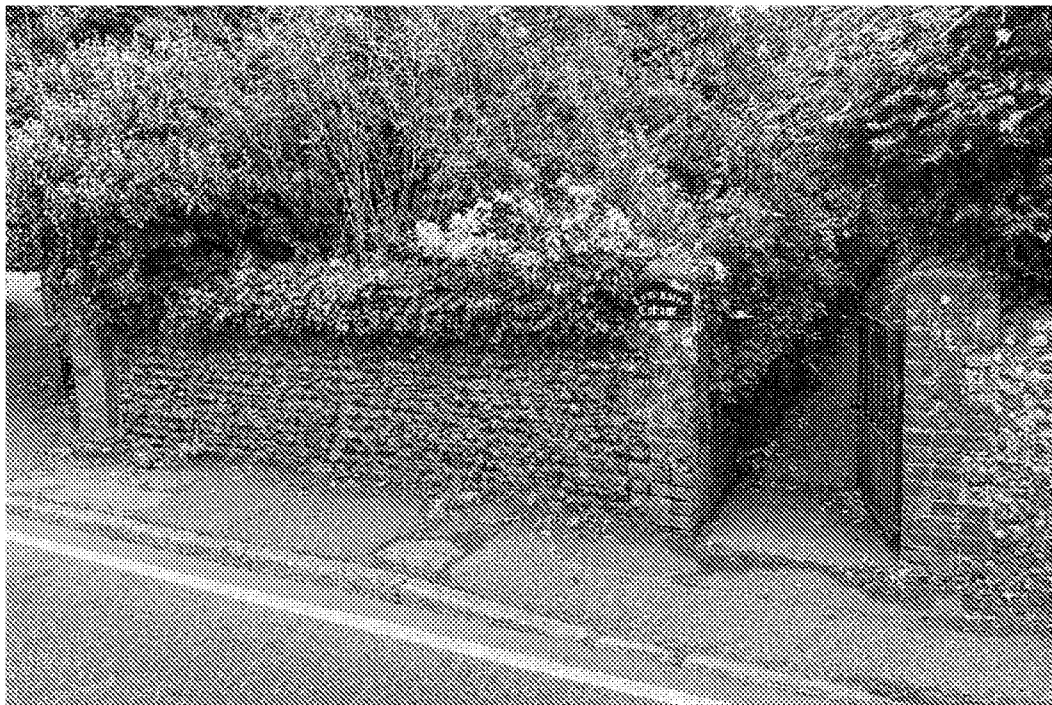
EFFECTIVELY MOVING THE WALL TO THE LEFT OF THE GATE 1.5M FROM BOUNDARY.

Please refer to figure A. for reference (within the scanned plans/drawings), The removed pillar and wall will be utilised to build the return wall for the drive also drawn in figure A. Any mortar required will be matched from existing by the lime centre and required napped flint sourced for the wider project.

Our proposal means that we only need to remove 2.8>3m of existing wall to create a 4m opening.

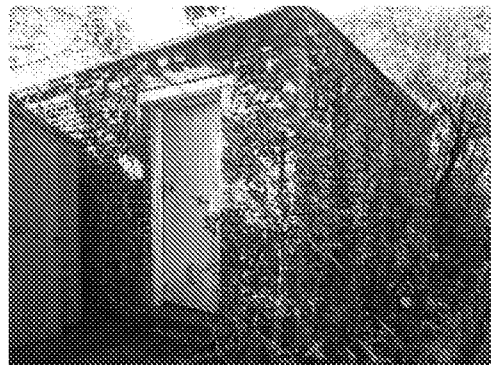
This is the external building situated next to the road & front gate to the property.

The small out building to the front of the property is in a state of disrepair. The wall closest to the road is subsiding and leaning towards the road, it has dropped an estimated 8 inches and is clearly visible to the naked eye. At some point in the past work to prevent this has occurred by utilising building tie's bolted to the adjacent/attached wall and the opposite wall to right of the door as you walk in. This is now resulting in the rest of the building being dragged with the wall and clear cracks have formed caused by the stress. This pressure to the building has caused the roof to twist and is no longer water tight, the resulting moisture now within the building is simply adding to the subsidence issues.

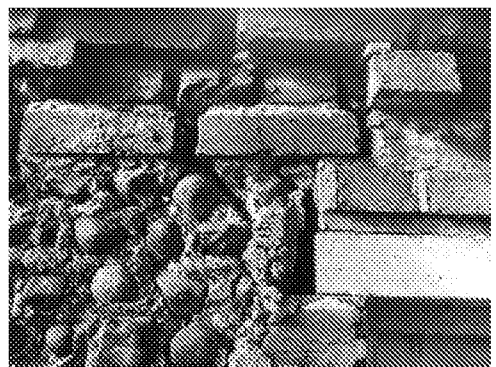
Separation of supporting wall to the top left of the door due to the building tie pulling the top half and roof towards the road side.

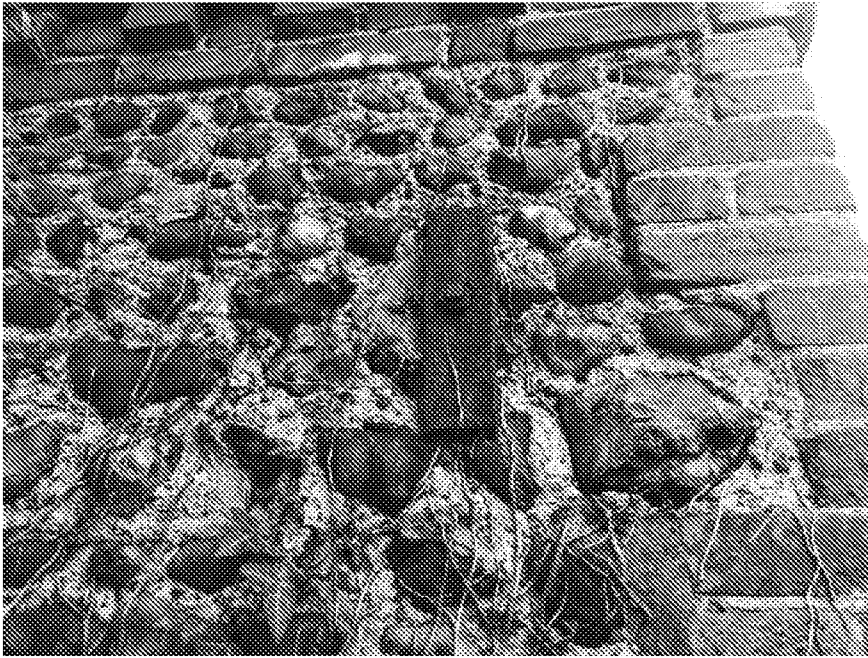
One of the two building ties.

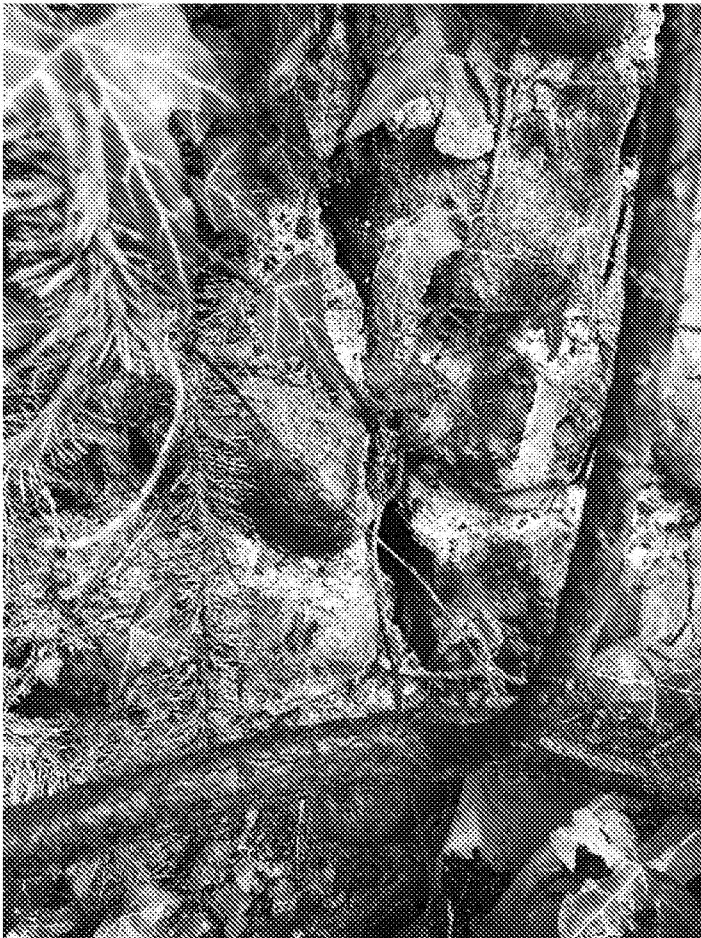
Low level crack/separation below the above pictured tie.

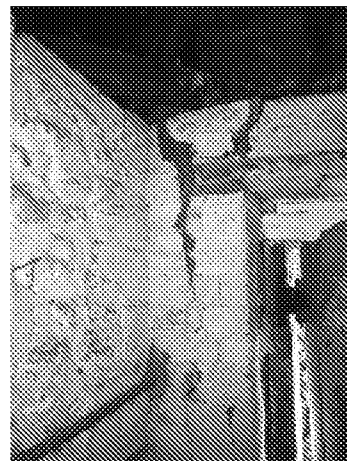
Internal picture of poorly repaired separation to the top right of the door, also pictured the second building tie at mid level.

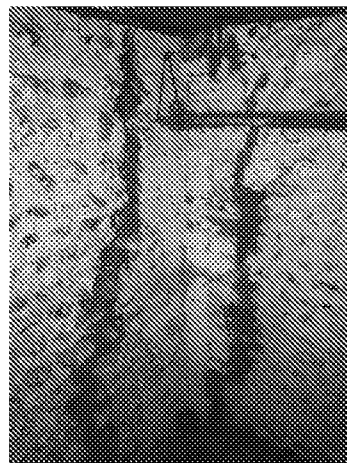
Internal repair work by previous occupants to the road side wall that is subsiding, also pictured the first building tie. This damage is mirrored on the opposite wall.

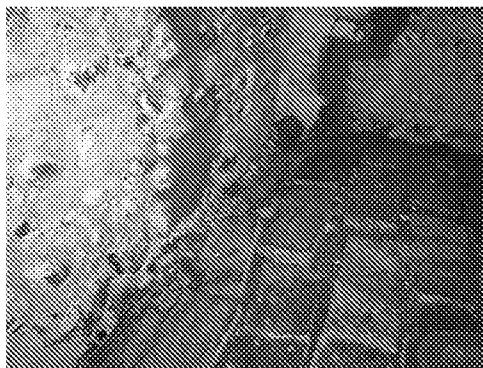
Evidence of the subsiding wall and damage to the existing floor. Again repair work to the wall as mentioned in the picture above.

Our proposal is to take up the internal brick floor, clean and store on site for full reinstatement after underpinning the road & garden sides, this will be achieved by careful removal of small sections of flint for needles, then propped by way of ackros. Foundations added in 1m lengths before reinstating and restoring wall back to their original form with matched mortar. The roof timbers can then be fully assessed and repairs made where needed to the joists, we are not sure to what extent this will be as until the walls are level it is difficult to ascertain the exact amount of damaged caused by the sinking building. This followed by restoration of the slate roof which we believe to be complete and just require adjustment.

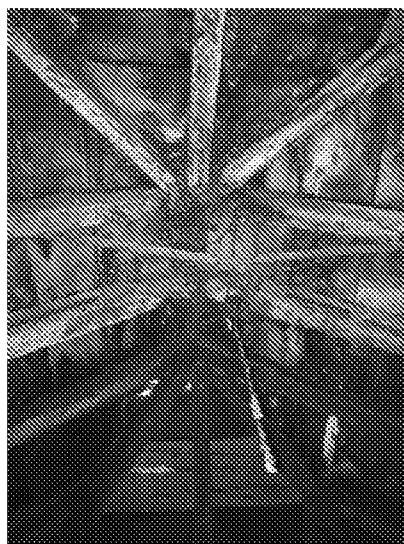
Roof to be restored after remedial work undertaken to underpin and restore the brick/flint structure.

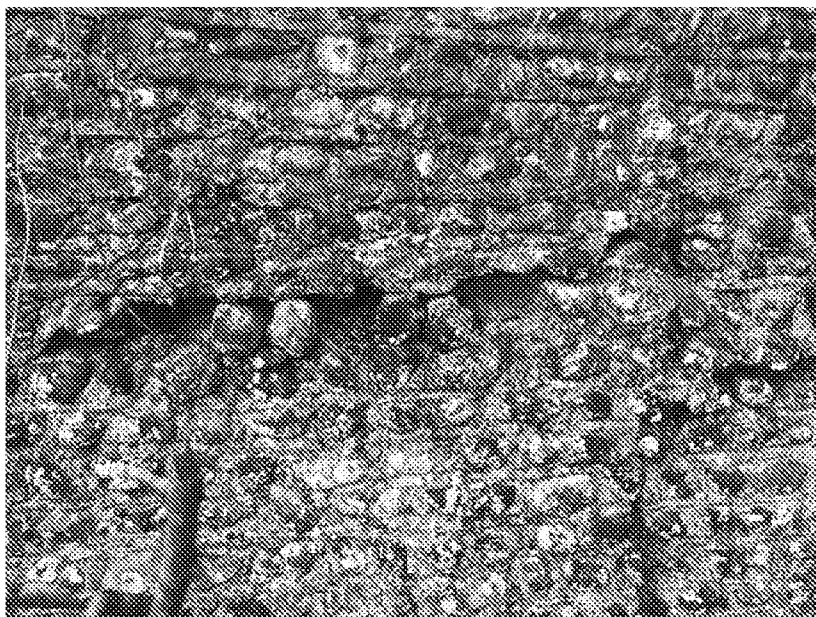
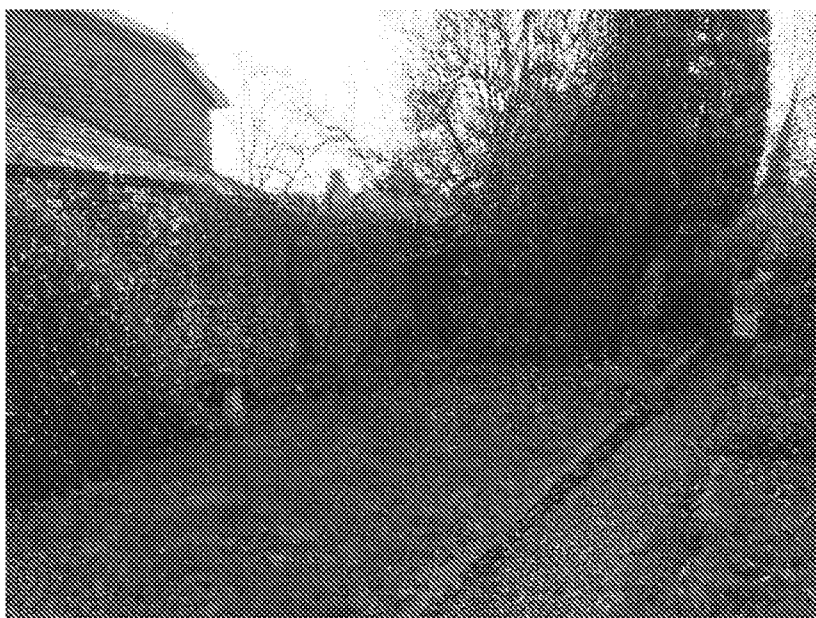
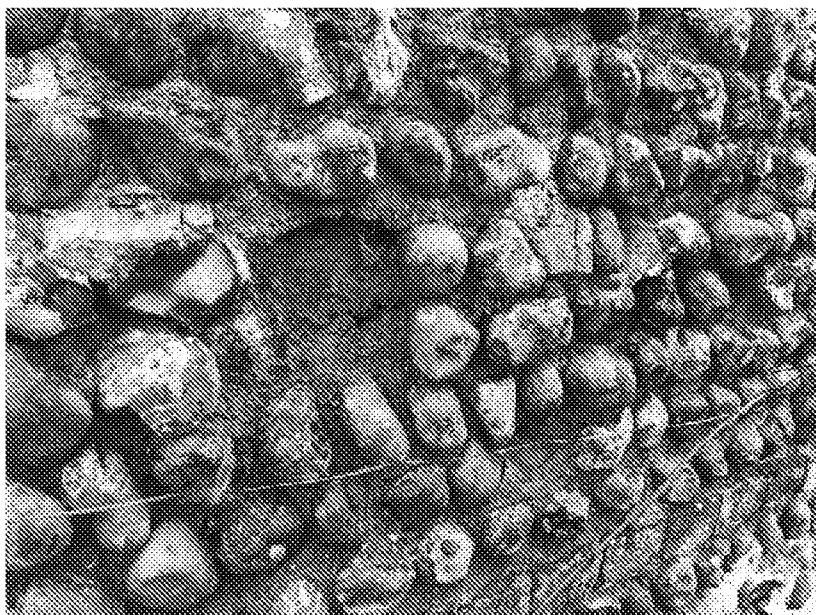
Example of the typical restoration requirements to the walled garden, front and back.

The wall to the right of the property (as looked at from the road) requires repair, its not in a terrible state but needs patching and some new flint in various places, we would like to suggest/propose that if we are able to add a new entrance that flint removed from that wall could be utilised as the materials to repair thus in keeping with the existing.

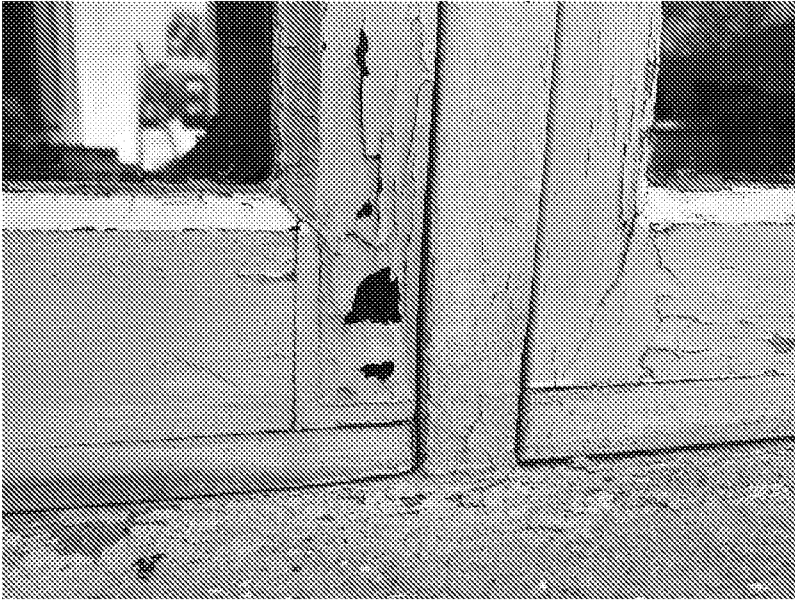
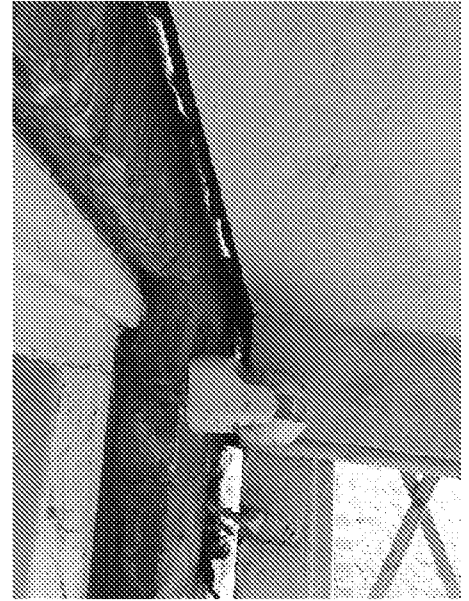
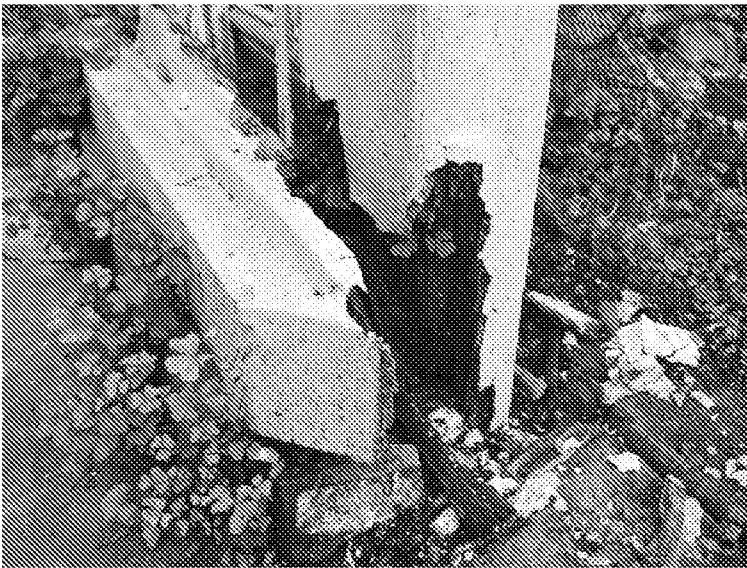
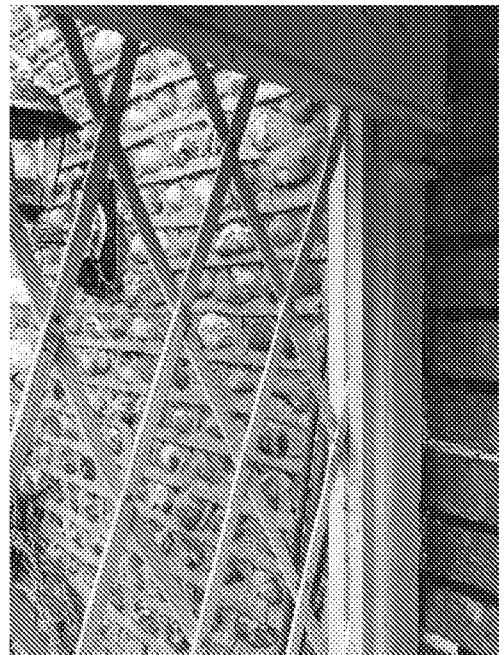
Separation of the front porch from the main building, rotten wood at the base, example of plastic lattice work added to replace damaged wooden features by previous owners and an example of typical damage to windows to be restored.

Two of the front windows are in need of mild restoration, simple lower sections cut out and rotten wood removed. Appropriate wood added and windows restored, the other windows at the property simply require stripping, treating and fresh paint before reinstatement. The Small porch needs restoration/replacement, it has dropped forward and is no longer properly attached to the building. The lower levels are rotten and previous

owners have replaced what we suspect was wooden lattice work with PVC. We would like to re-build the porch to its original state.

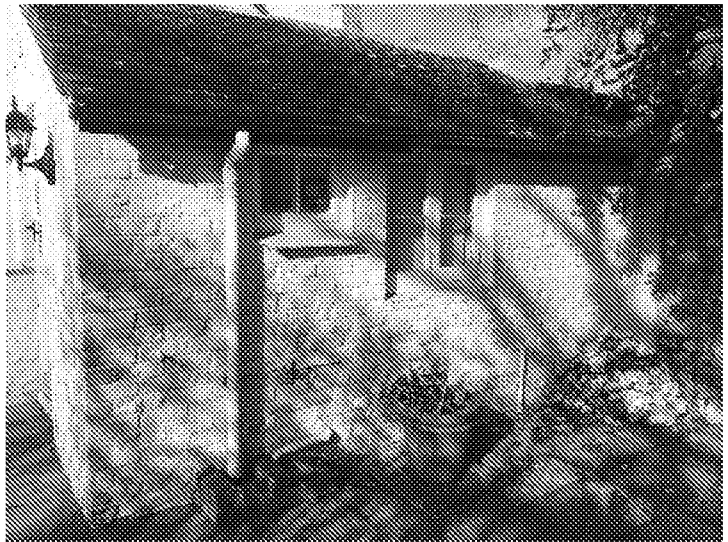
Existing extension housing a family bathroom and utility space, to the right of the picture you can see they have poorly attached the build to the wall although further investigation shows that this is infill, the separation gap can be seen from above and a better understanding of the build seen via the next picture.

Both of these extensions are brick and block by construction obstructing any access to the rear of the property for both works and maintenance.

The larger extension pitched roof is causing damp in one of the existing bedrooms. Without incredibly intrusive investigation it is hard to tell why this is as the pitched roof has no access.

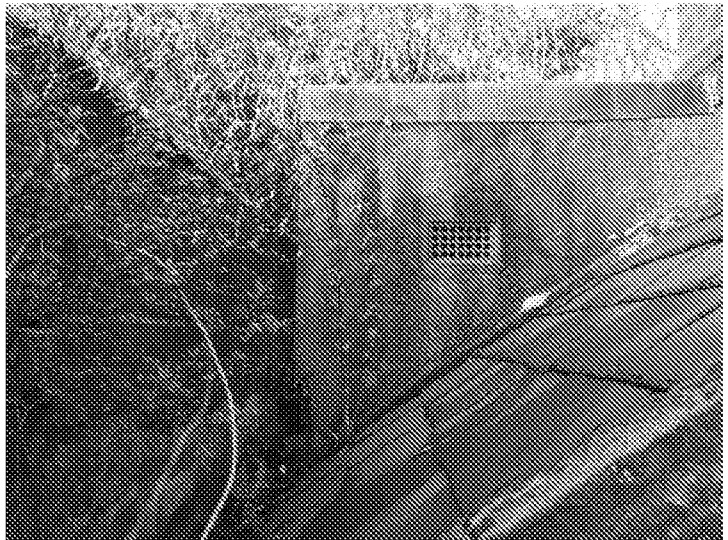
The rear of the pictured extension.

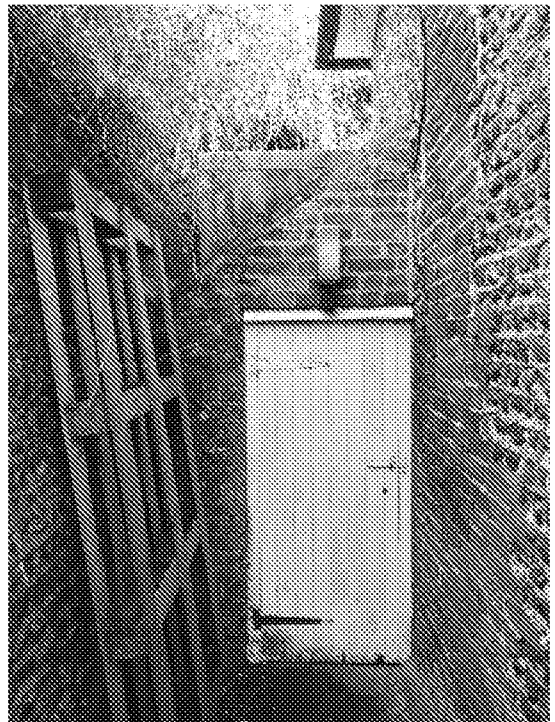
Small services cupboard to the side of the property attached to the above extension and brick tied to the wall.

At differing points previous owners have added two extensions to the building. A small add on to the side of the build (this is tied to both the building and one of the garden walls) which houses a gas meter and the electrical distribution board.

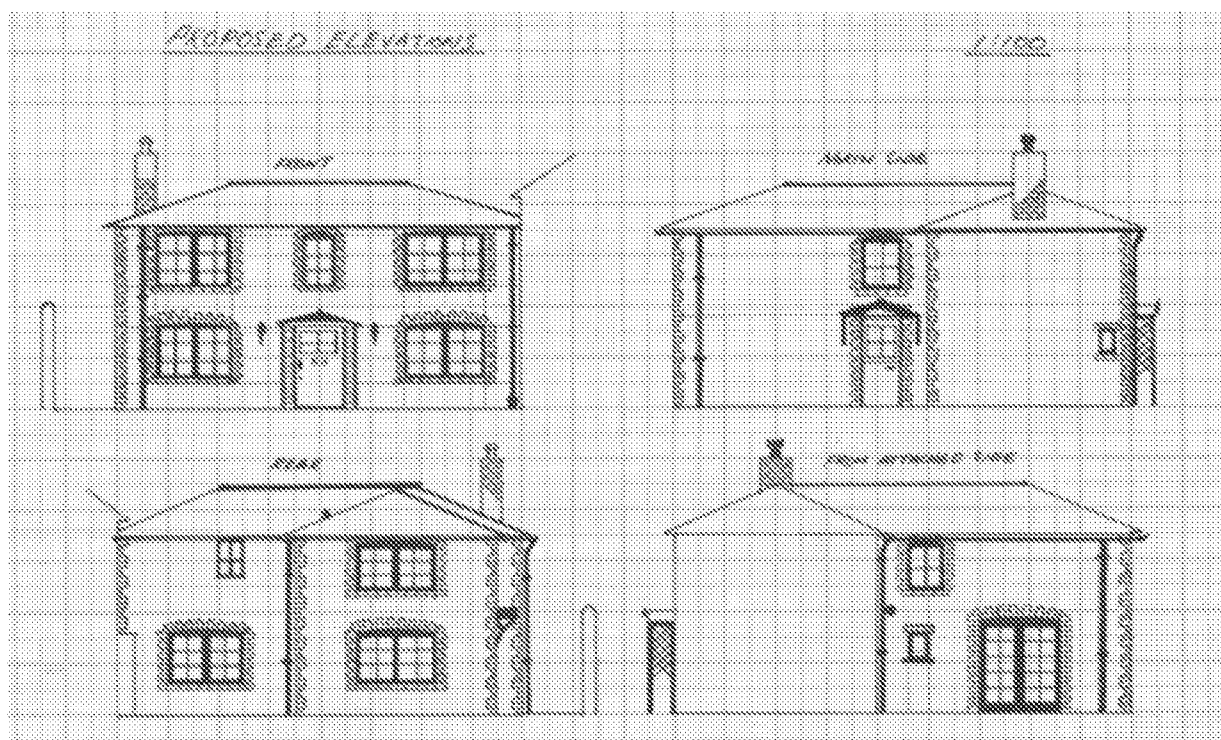
## Lyminster Cottage proposed elevations.

Top Left: The front elevation would remain unchanged with sensitive restoration where needed.

Top Right: The North elevation is obscured by an approximate 9ft wall, demolition of the extension and stepping in the proposed extension would allow air to flow around the building and permit much needed access to the rear of the property.

Bottom Left: The rear elevation shows the biggest change, the original permitted extension had 4 windows, we would like to match the size of the front elevation windows to compliment the building. On the left of the diagram you will also notice an additional window, this was part of the planning also but at some point previous owners have added a UPVC door in its place.

Bottom Right: Elevation as seen from the attached side of the property. A simple hard wood set off doors to match the style of existing windows at the property would lead out from the kitchen area.
