~~Robinswood, The Street, Patching, West Sussex~~

~~Design, Access and Heritage Statement~~

Survey Report, January 2007.

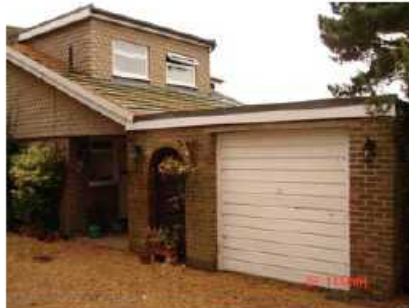
Fig 1

- a. The site under consideration is Robinswood, The Street, Patching, West Sussex. The property is located on the southern edge of Patching village with views over the fields to the south. It is a very secluded site of almost exactly 1 acre, which is barely visible from anywhere other than the farm fields to the south. There are neighbouring dwellings but the plots are large and densely covered with trees and shrubs.
- b. The proposal is to demolish the existing garage, an unsympathetic extension to the west side of the existing house, which has a very poor visual connection with the house and is also in poor structural order, considered to be a result of inadequate foundations. Fig 1, below, shows the garage to be demolished.

- 3.4 The westernmost part of the property is the garage, which is a later addition. This flat roofed building abuts the house at the eaves of the main roof slope. It would appear that this building was not built on adequate foundations, as there are three very significant cracks. One is in the west wall and the other two are in the head of arches that form the entrance to the passageway. This suggests that the garage has settled unevenly.

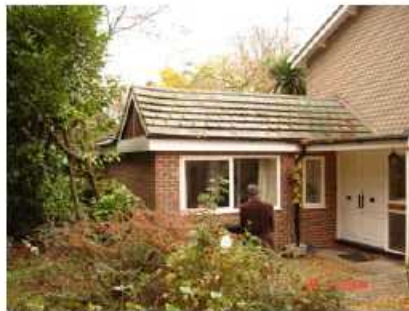
- c. The original garage was converted into living accommodation as part of the main house many years ago and is also poorly constructed and with little, if any thermal insulation. It is proposed to demolish this also, together with the porch, the Summer House and a large shed at the rear of this building. Fig 2 below shows the extension to be demolished.

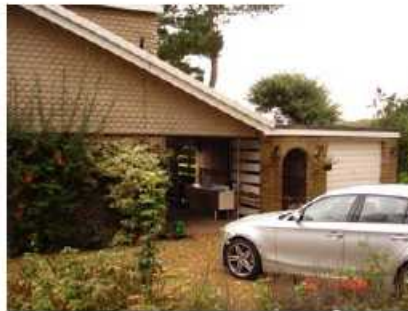
Fig 3

- d. The proposed extension will occupy the area of this former garage, summer house and shed and will provide a new front door to the dwelling, a small office/sitting area, an ensuite guest bedroom, cloakroom, storage and double garage. It is intended that this extension will be part of the main dwelling and not used as an annexe.
- e. In addition, the existing car port on the west side of the house would be in-filled to create a breakfast/garden room, opening onto a patio area. Fig 3, below, shows the car port between the house and the garage.

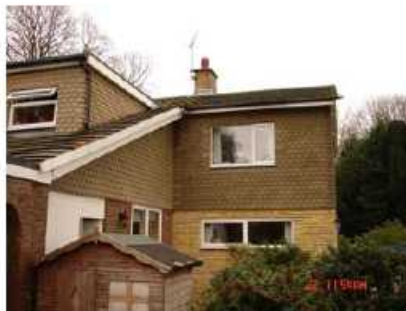
- f. The existing house is a mixture of brickwork, stone and tile hanging, see Fig 4 below. It is proposed to remove the tile hanging, which is entirely at first floor level and to replace it with additional thermal insulation and horizontal timber cladding.

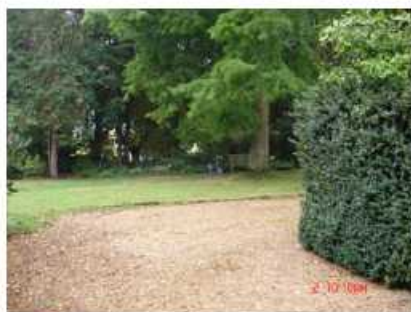
Fig 5

- a. The site is approached from The Street, via a pull-off from the road which also provides an entrance to the neighbouring properties, who have right of access over the Applicants' land. The main gate to the drive is the only frontage that the site has on The Street and even this is set back from the road.
- b. The only access to this site is a combined vehicular/pedestrian access. Fig 5, below.

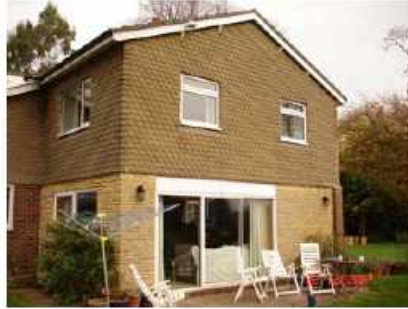
Fig 7

- a. The existing building is in two storeys under an unequal pitched roof, with north and south-facing gables. The first floor was extended over the ground floor lounge on the south side some years ago. Fig 7.

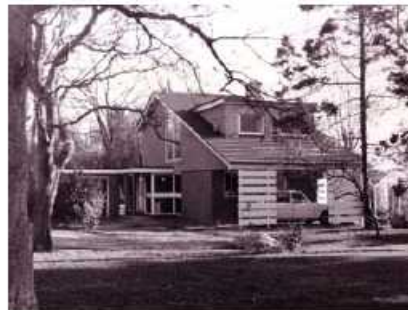
Fig 8

- a. Prior to preparing this planning application some informal advice was sought from the duty planner (Claire Forest) at Arun District Council on 4 April 2008.
- b. We believe that the proposal will add to the quality of the existing building. The main house is an attractive example of the architecture of its period, but has been spoilt by unsympathetic extension and alteration. The new extension, linked to main house with a flat roof, will remain subservient to the main house, as did the original northern extension – see Fig 8, below. The simplicity of the proposed extension will enhance the existing house and by replacing the rather drab concrete tile hanging with unpainted timber; it will create a more cohesive building, by tying the new extension into the existing using a material suited to this wooded site.
