## Design and Access Statement

Christmas Cottage, Poling Street, Poling, BN18 9PU

Grade II listed building consent

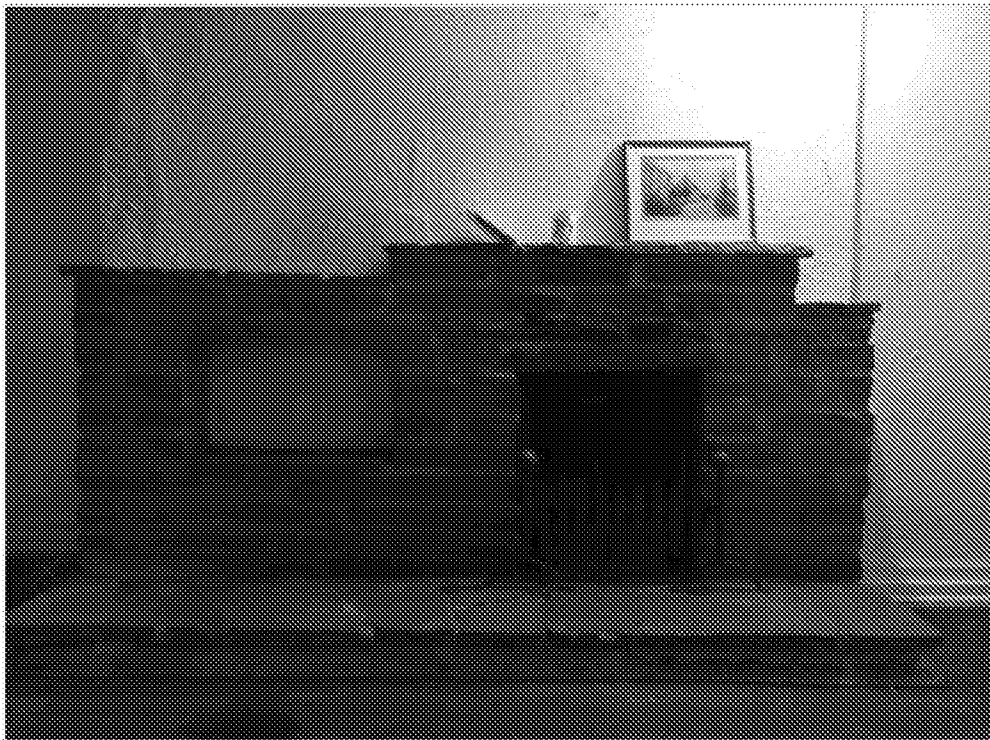
*2 fireplace in living room*

The fireplace is not in keeping with the character of the cottage. We propose to reduce the size and have a simple brick fireplace with small log burner. Similar the photo below:

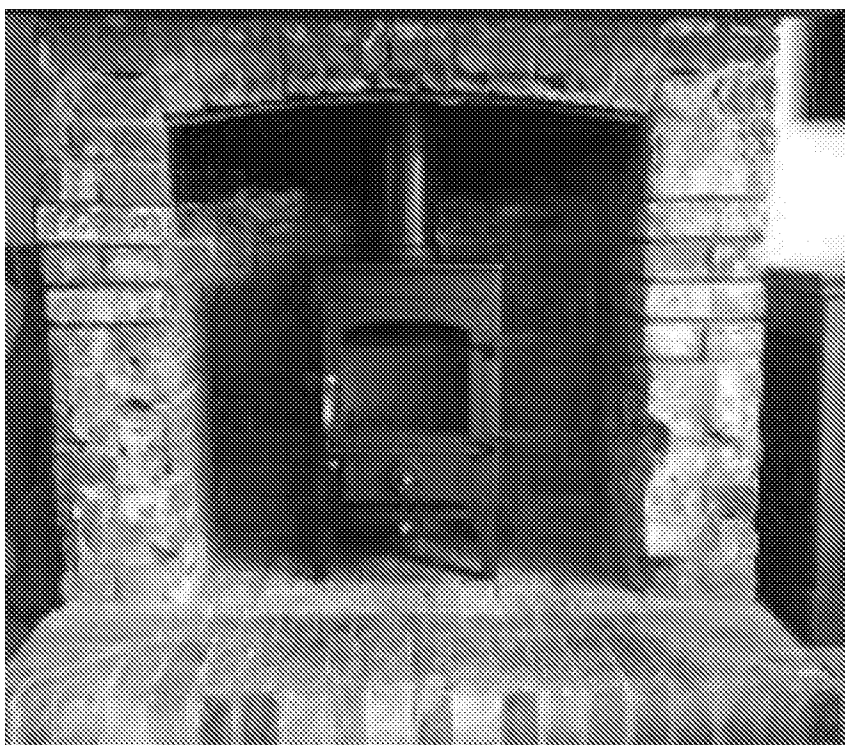
*3proposal for new fireplace*

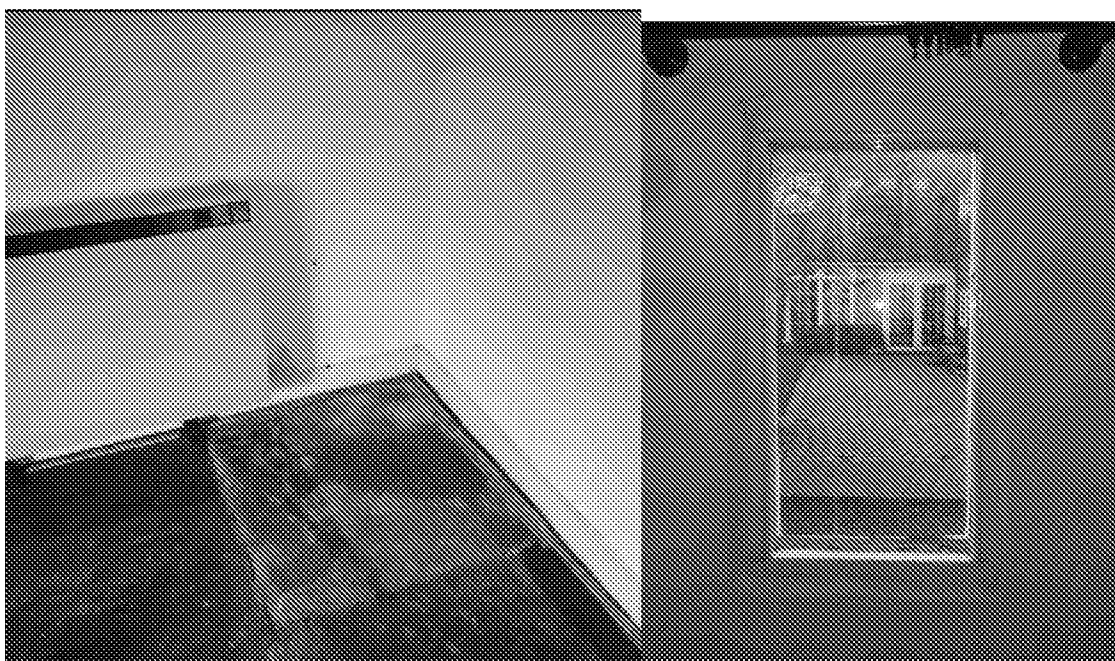
Artex has been used throughout the property and is cracking, flaking and damp in many places. Due to the time the artex was put in the property it is likely to contain asbestos. Therefore, we would like to remove due the damage.

*4Artex on walls and ceiling. Flaking and cracking shown near radiator*

*5Artex around window, damp and damaged*

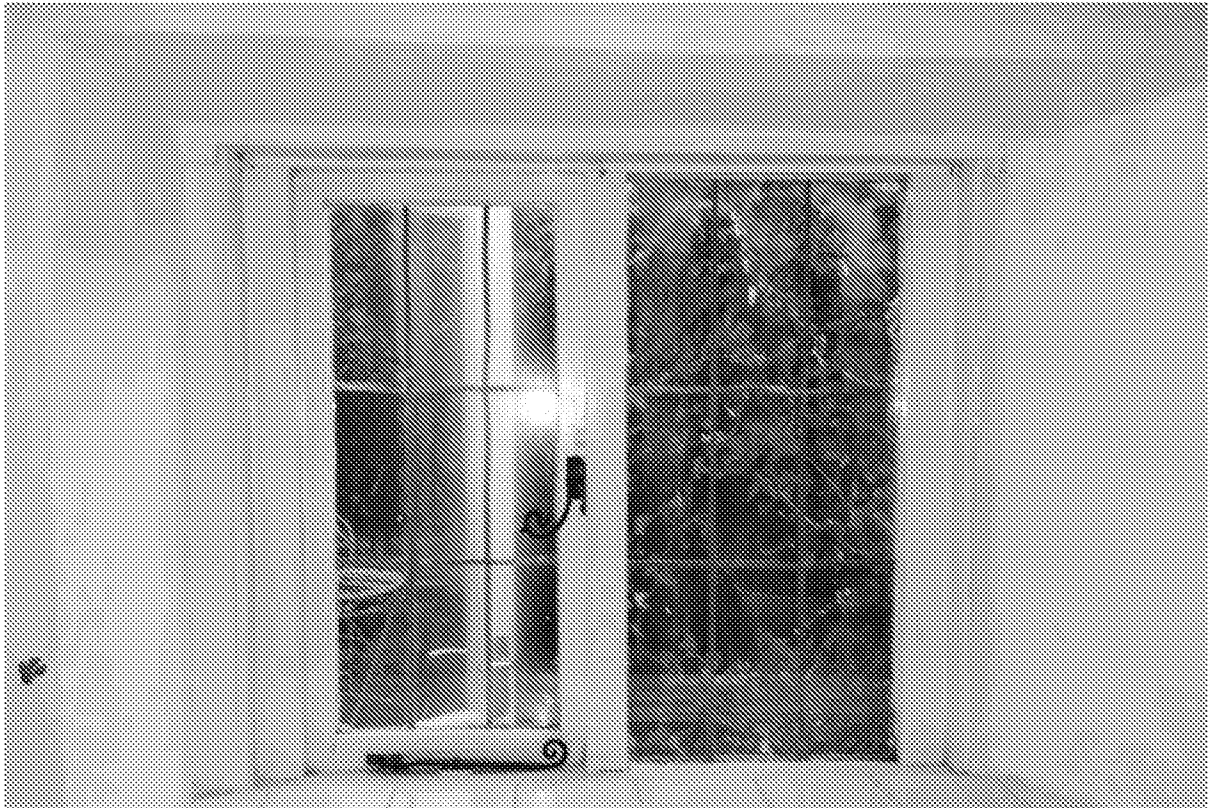
Several windows are in need of replacement as they are damaged and sealed shut. The upstairs windows are a like for like window but double glazed in some rooms, therefore we propose to replace with the same windows.

*6kitchen window - sealed shut, frame beyond repair*

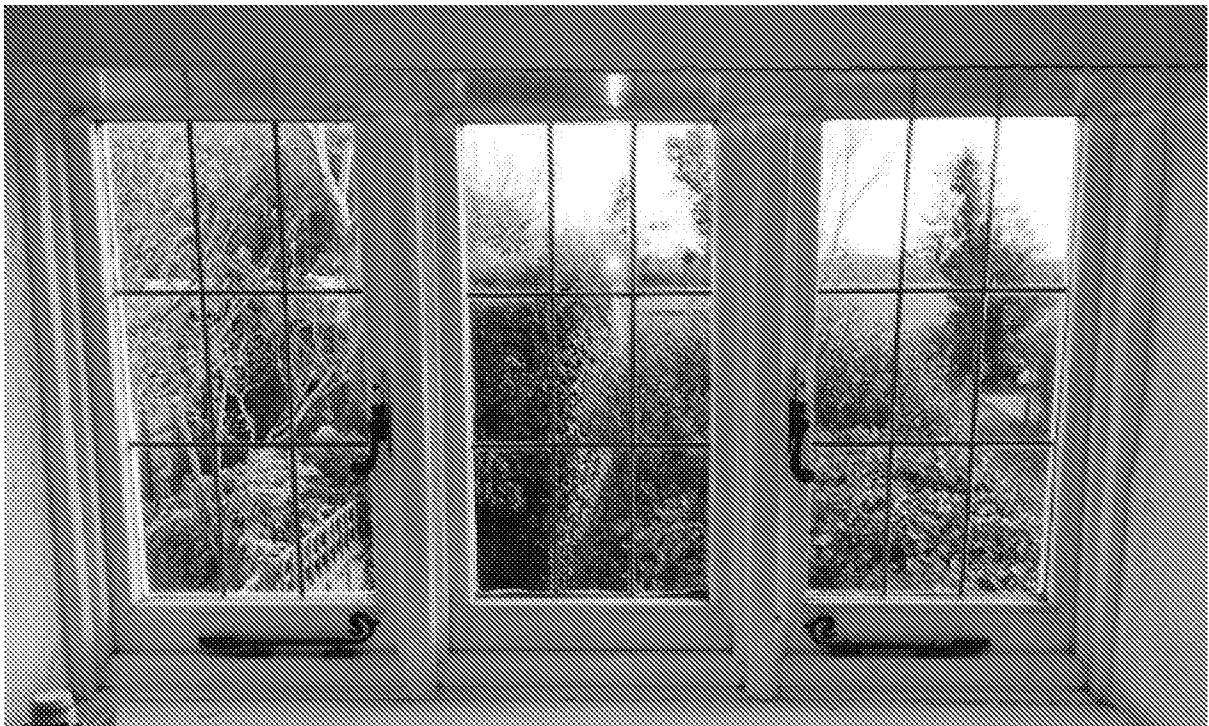
*7master bedroom window - double glazed*

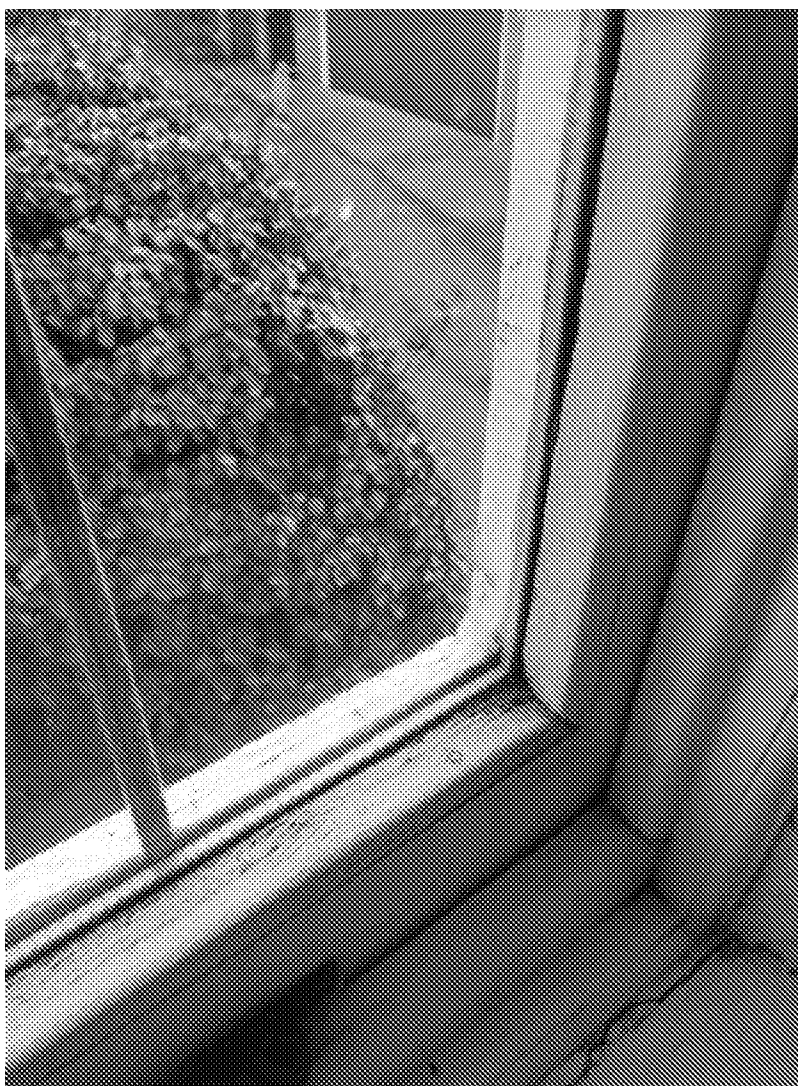
*8Upstairs window - similar window but double glazed*

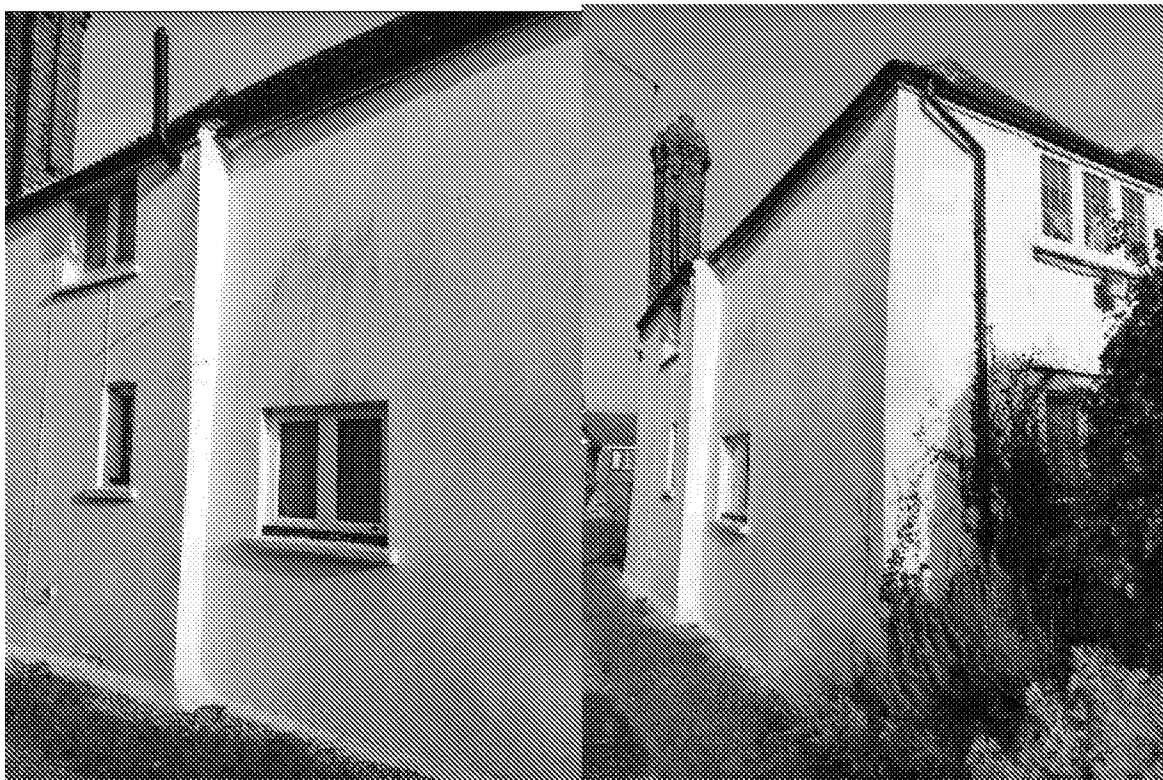
*Elevations showing damp*

The external walls require removal of the paintwork and replacement with a micro porous white paint, to restore the walls to a white finish but allowing the property to breath and prevent damp entering due to the cracks.
