**PROPOSED RESIDENTIAL DEVELOPMENT  
LAND NORTH OF SEFTER ROAD. BOGNOR REGIS**

**DRAINAGE STRATEGY  
& SUDS STATEMENT-**

**FEBRUARY 2020**

**Report Title** Drainage Strategy &  
SuDS Statement

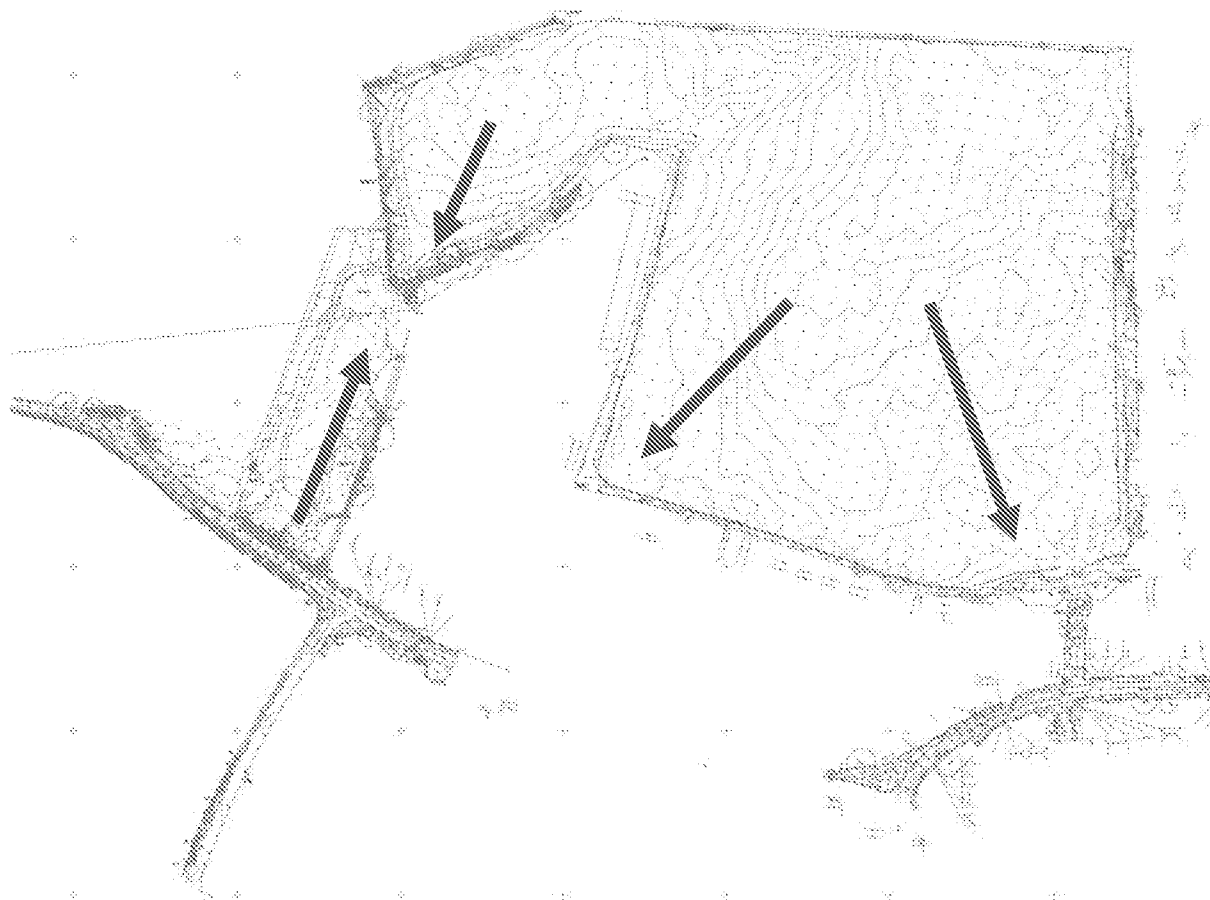
*Figure 2: Site Topography*

The application site comprises of three catchment areas. The first catchment area in the south west falls in a northerly direction towards the existing “anti-tank” ditch, the second catchment located in the north west falls in a southerly direction and the third catchment in the east falls in a south easterly direction. An overview of the change in topography in this part of the wider site is presented as **Figure 2** overleaf. A copy of the topographical survey can be found in **Appendix A**.

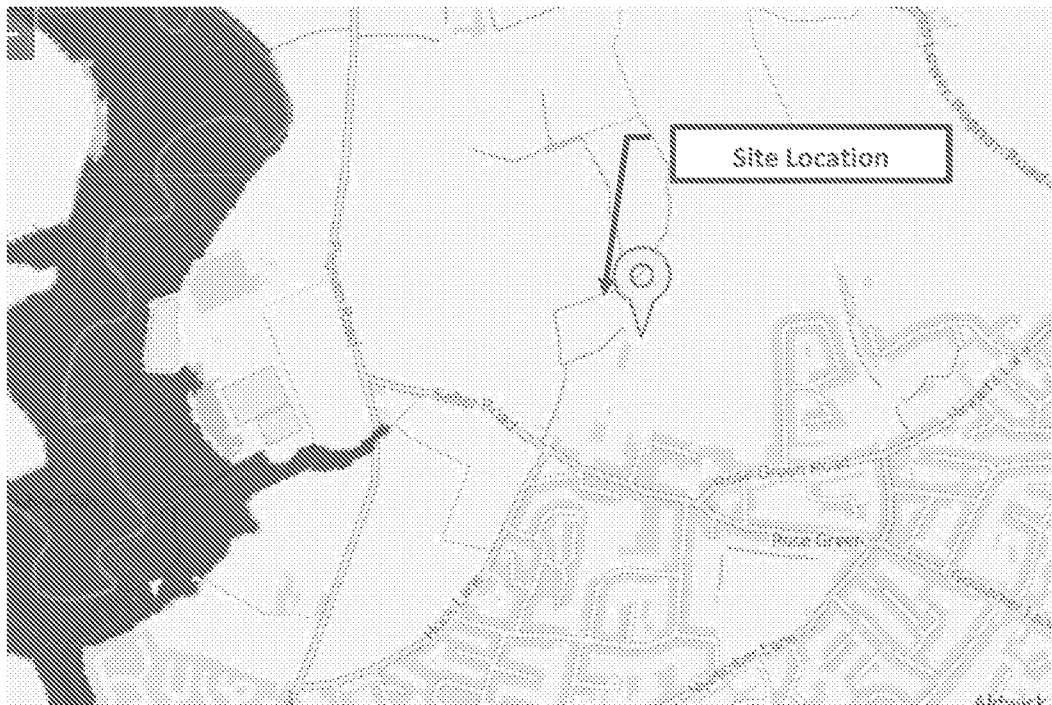
*Figure 3: Extract of Flood Map from the EA's website*

Based on a review of the EA's Flood Zone maps (see **Figure 3**), the development site appears to lie wholly within Flood Zone 1, considered to be at low risk from fluvial and tidal flooding.

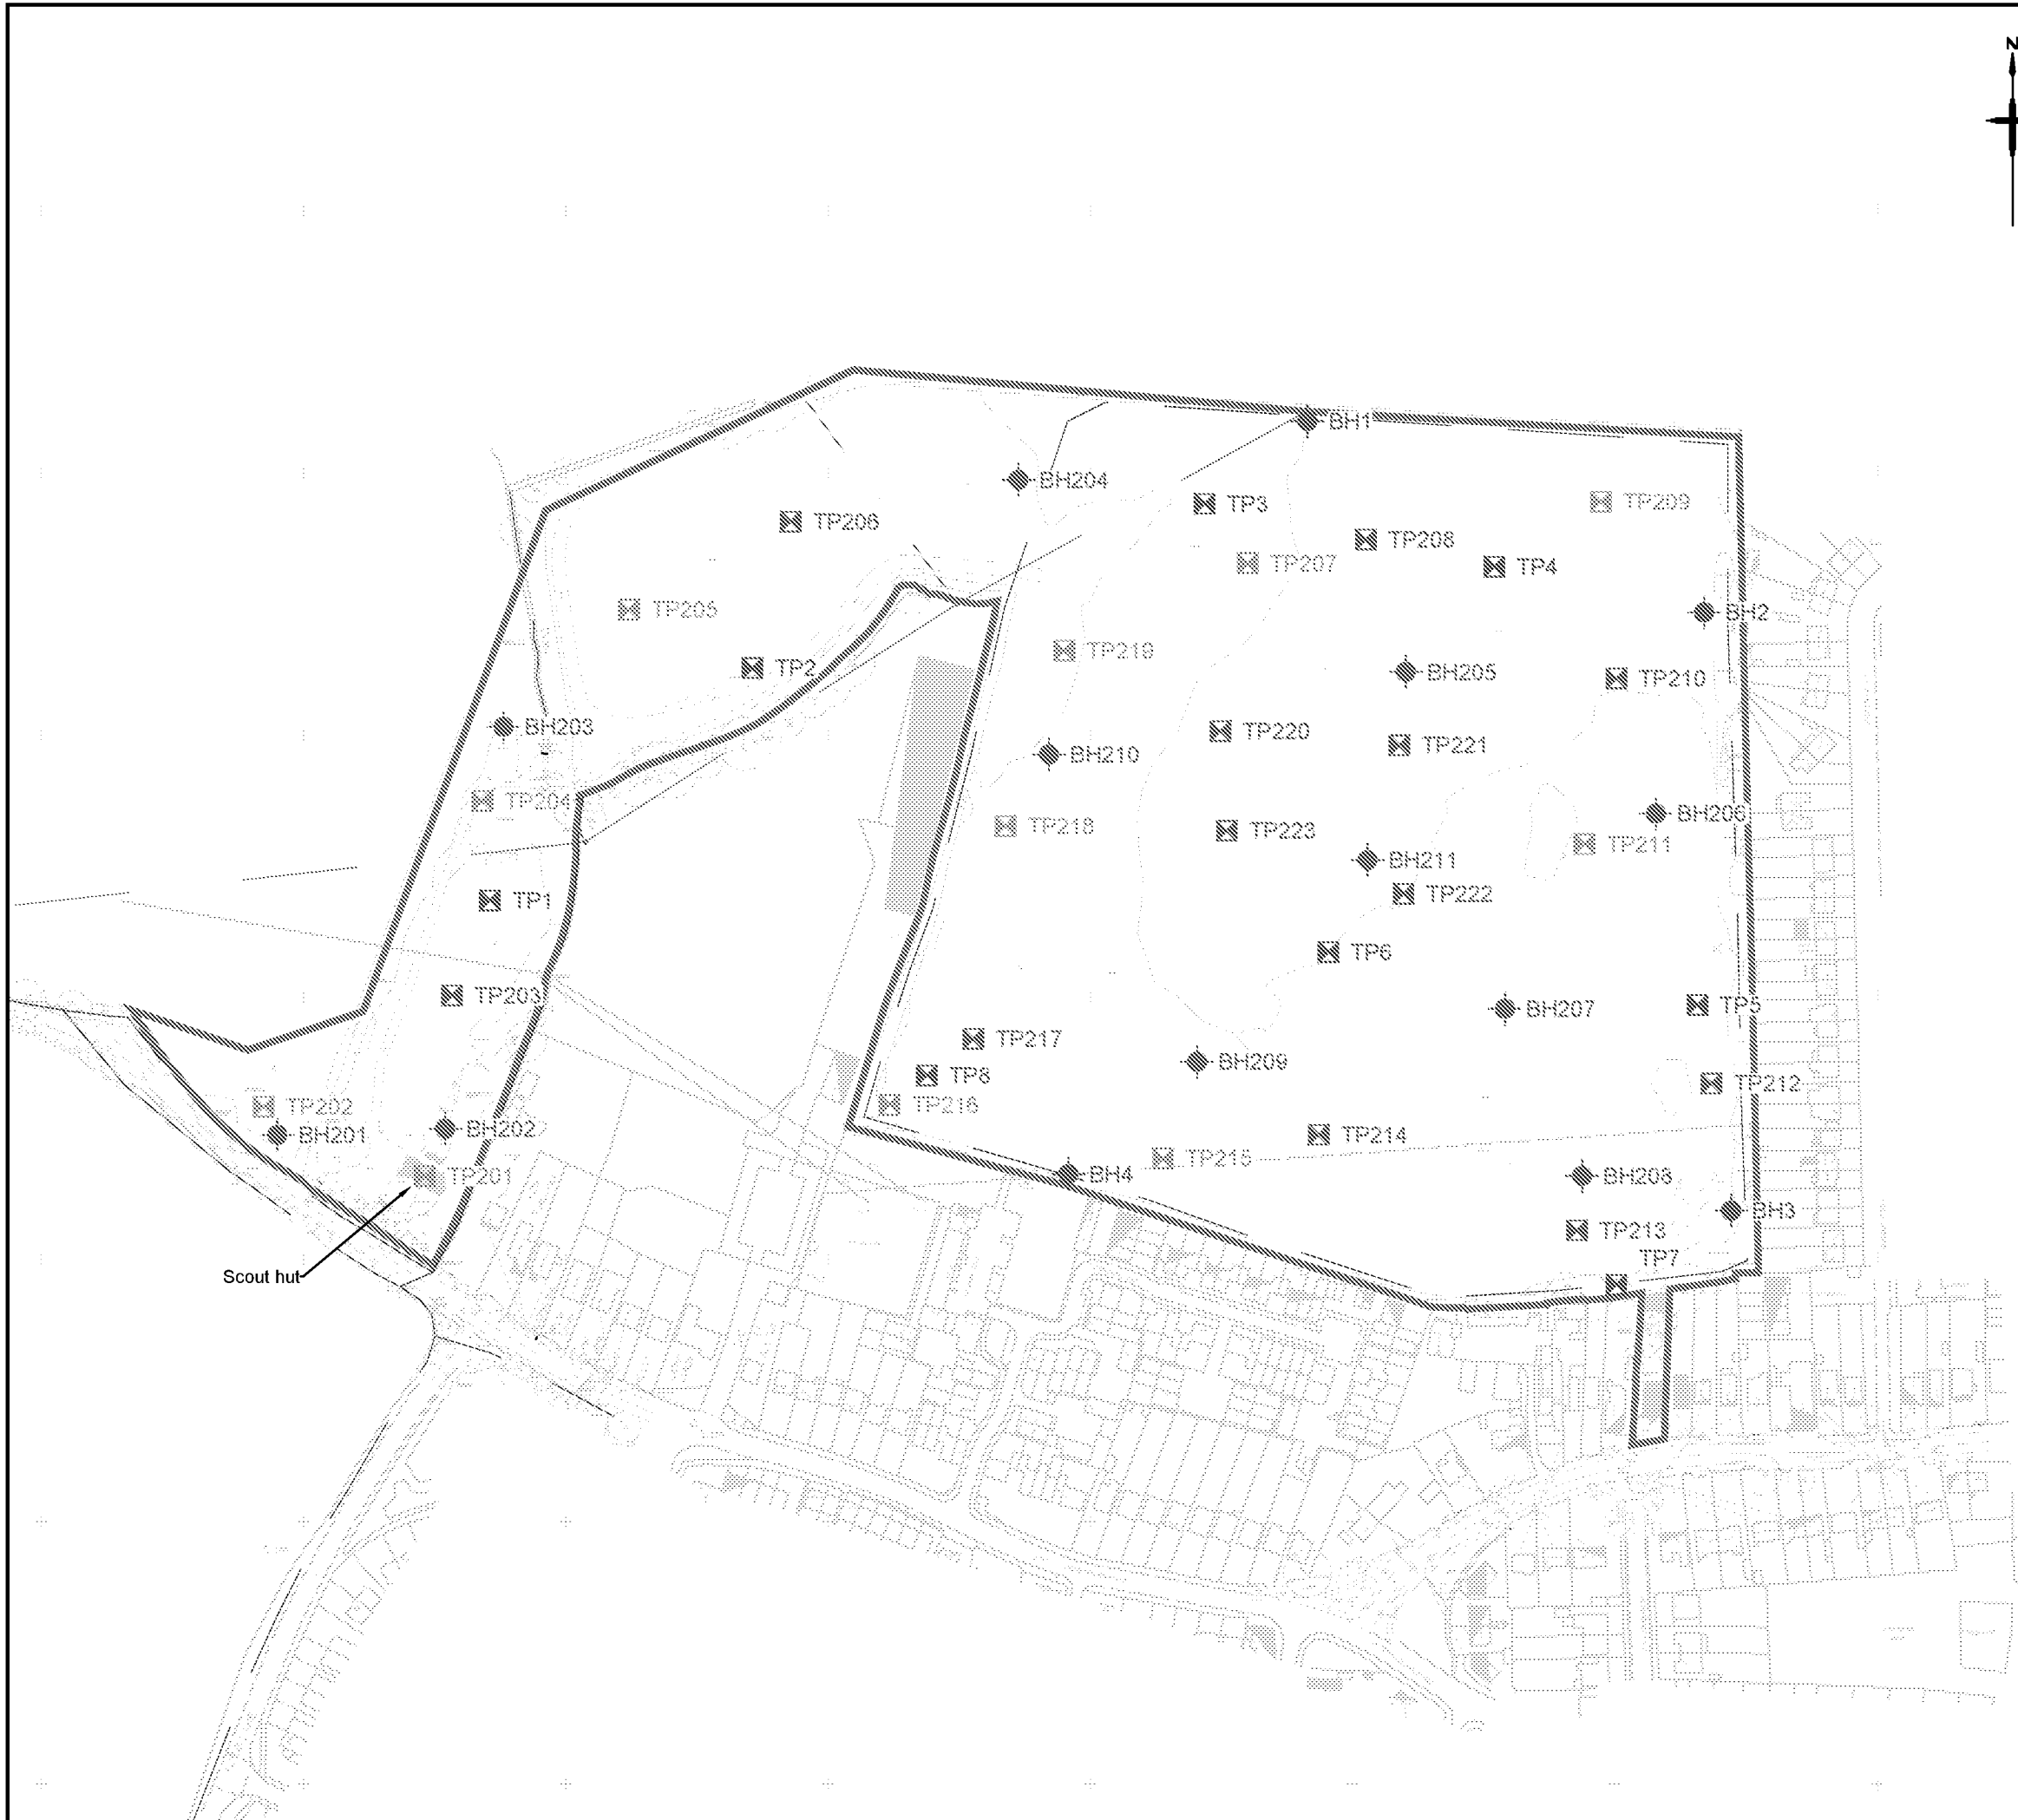
| FIGURE 2 | P1 |

- LEGEND
- Borehole Installation and Falling Head Test Location (RSK, 2016)
  - Trial Pit Soakage Test Location (RSK, 2016)
  - Borehole Location with Groundwater Monitoring Well Installation (RSK, 2019)
  - Trial Pit Soakage Test Location to ~1.50mbgl (RSK, 2019)
  - Trial Pit Soakage Test Location to ~0.50mbgl (RSK, 2019)
