**PROPOSED RESIDENTIAL DEVELOPMENT  
LAND NORTH OF SEFTER ROAD. BOGNOR REGIS**

**DRAINAGE STRATEGY  
& SUDS STATEMENT- REV B**

**MARCH 2021**

**Report Title** Drainage Strategy &  
SuDS Statement

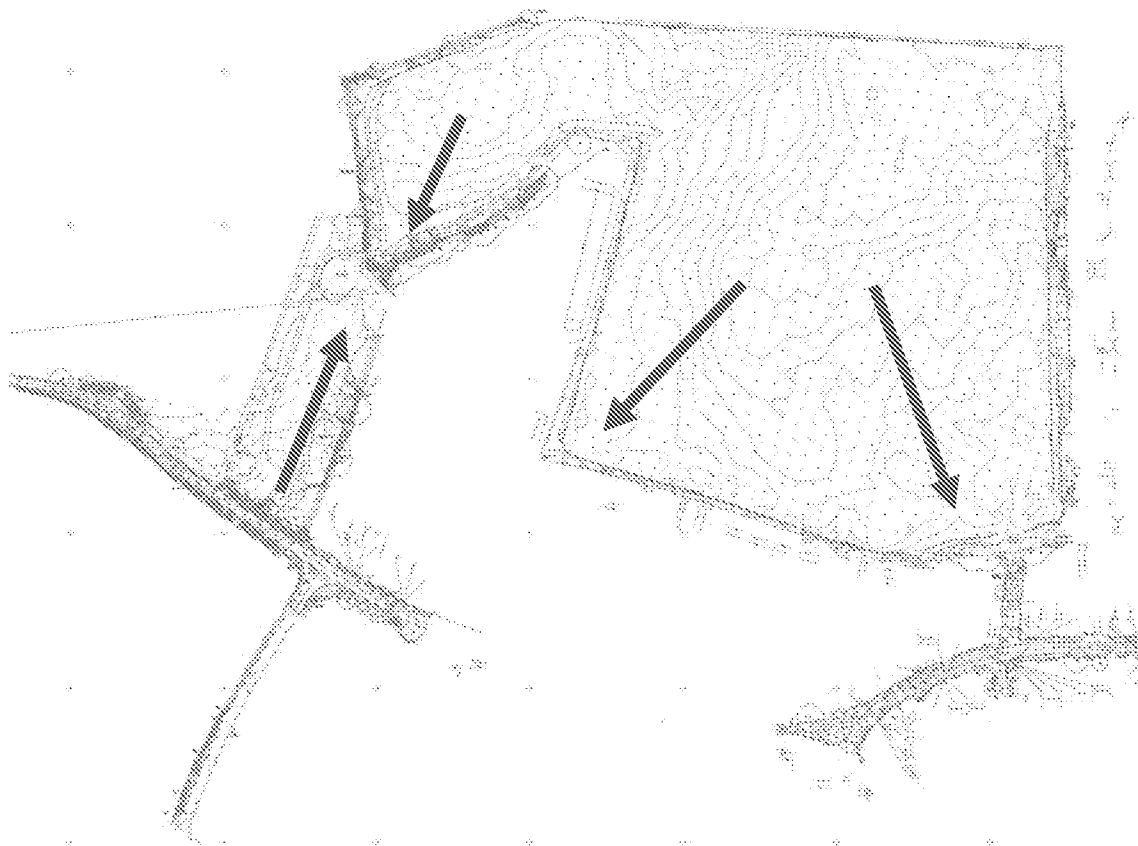
*Figure 2: Site Topography*

The application site comprises of three catchment areas. The first catchment area in the south west falls in a northerly direction towards the existing “anti-tank” ditch, the second catchment located in the north west falls in a southerly direction and the third catchment in the east falls in a south easterly direction. An overview of the change in topography in this part of the wider site is presented as **Figure 2** overleaf. A copy of the topographical survey can be found in **Appendix A**.

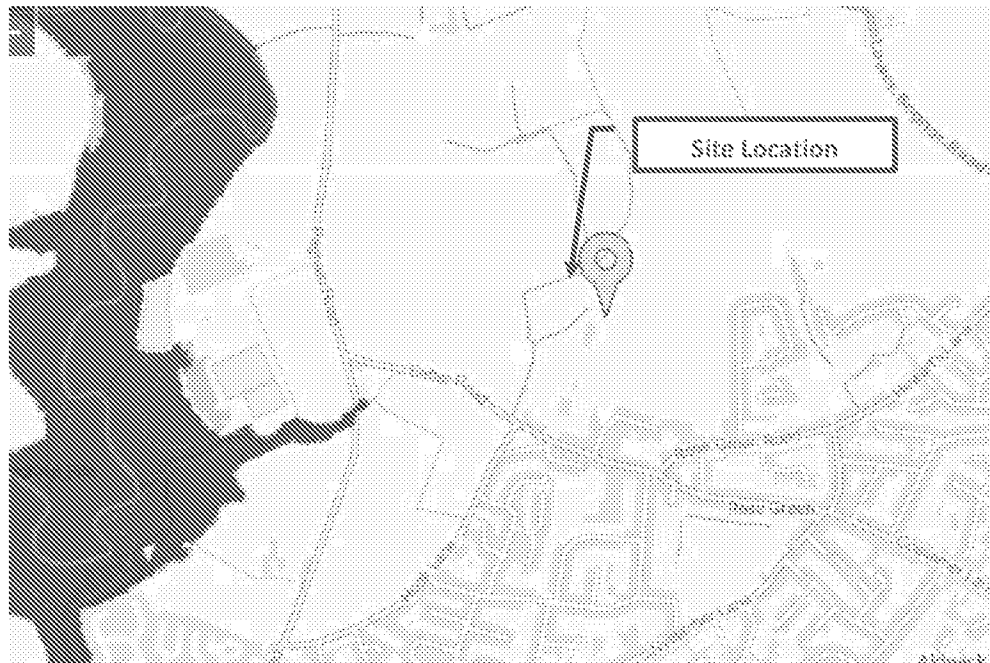
Figure 3: Extract of Flood Map from the EA's website

Based on a review of the EA's Flood Zone maps (see **Figure 3**), the development site appears to lie wholly within Flood Zone 1, considered to be at low risk from fluvial and tidal flooding.

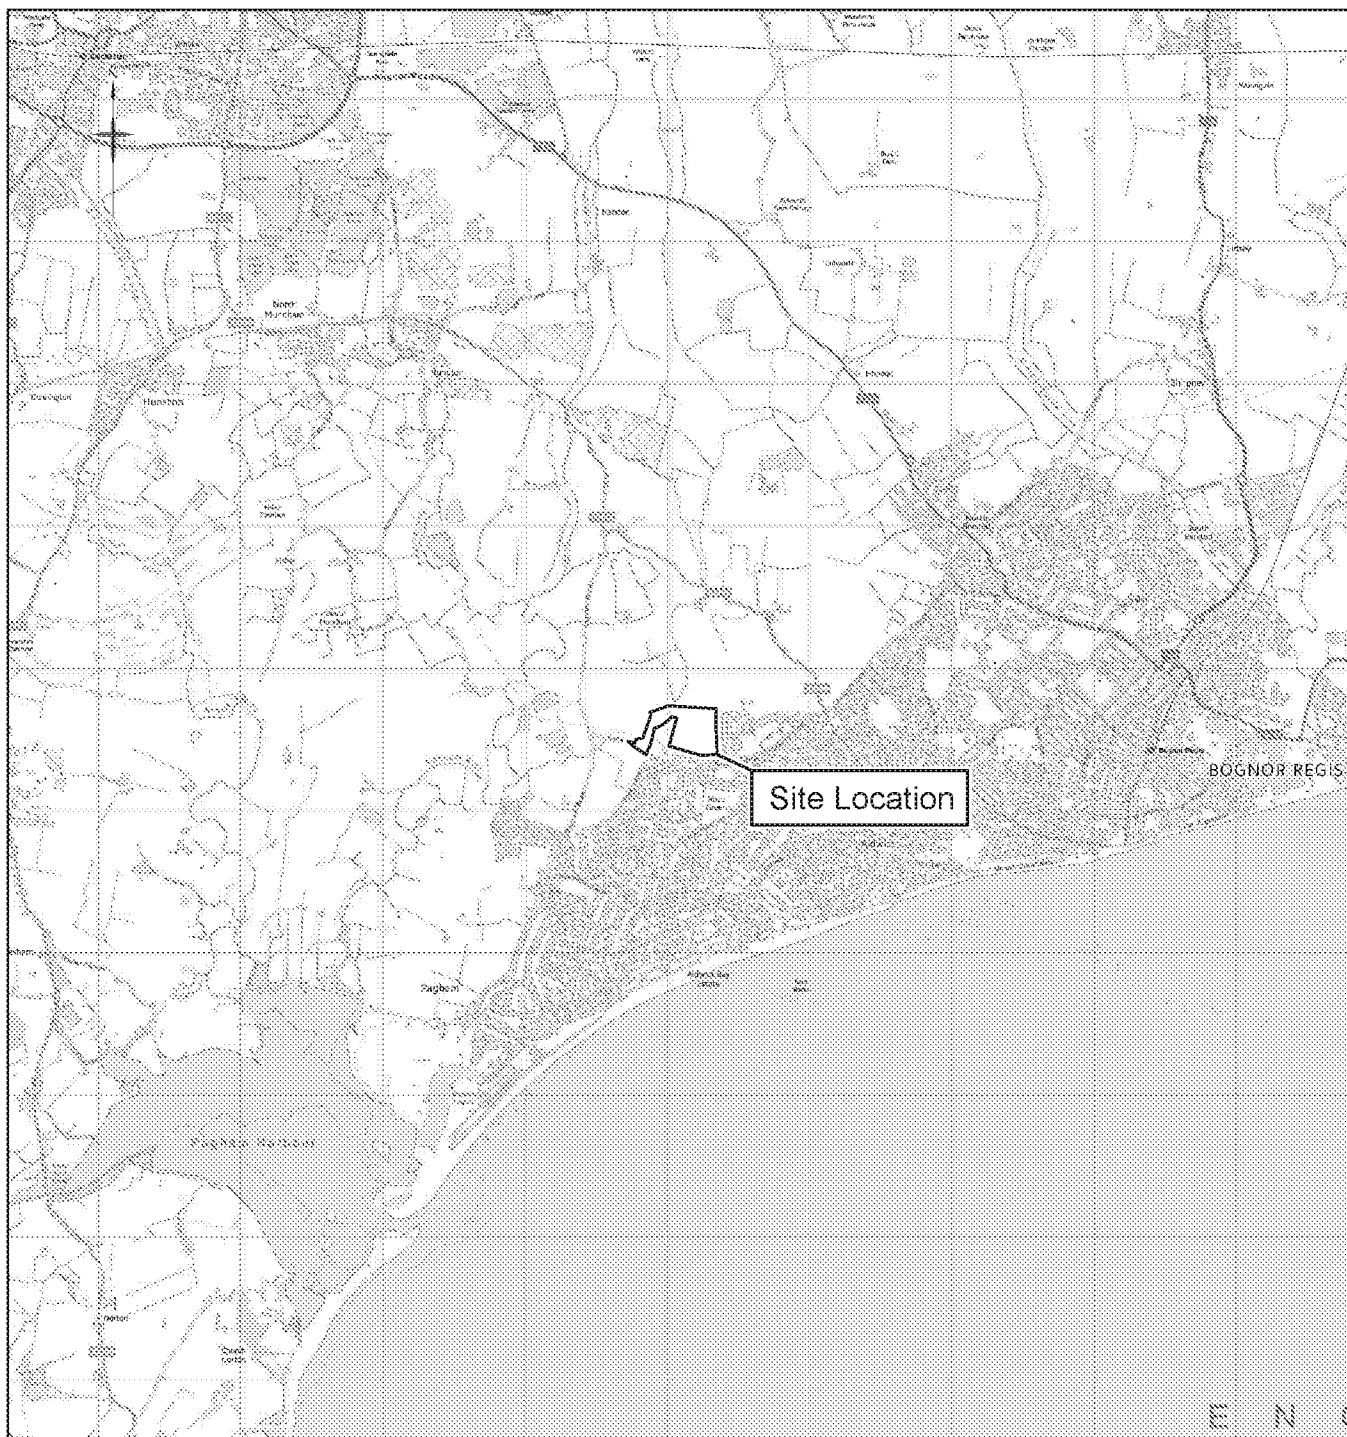
| NTS | A4 | m | FIGURE 1 | | A | | |

RSK Environment Limited (RSK) was commissioned by Taylor Wimpey (Southern Counties) Ltd (the client) on 10<sup>th</sup> January 2019 to carry out a supplementary hydrogeological site assessment of land at Sefter Road, Bognor Regis, PO21 3EE (the site). The majority of the site currently comprises undeveloped fields, with a scout hut, associated car park and area of soft landscaped communal open space in the west of the site. A site location plan is given in **Figure 1**.

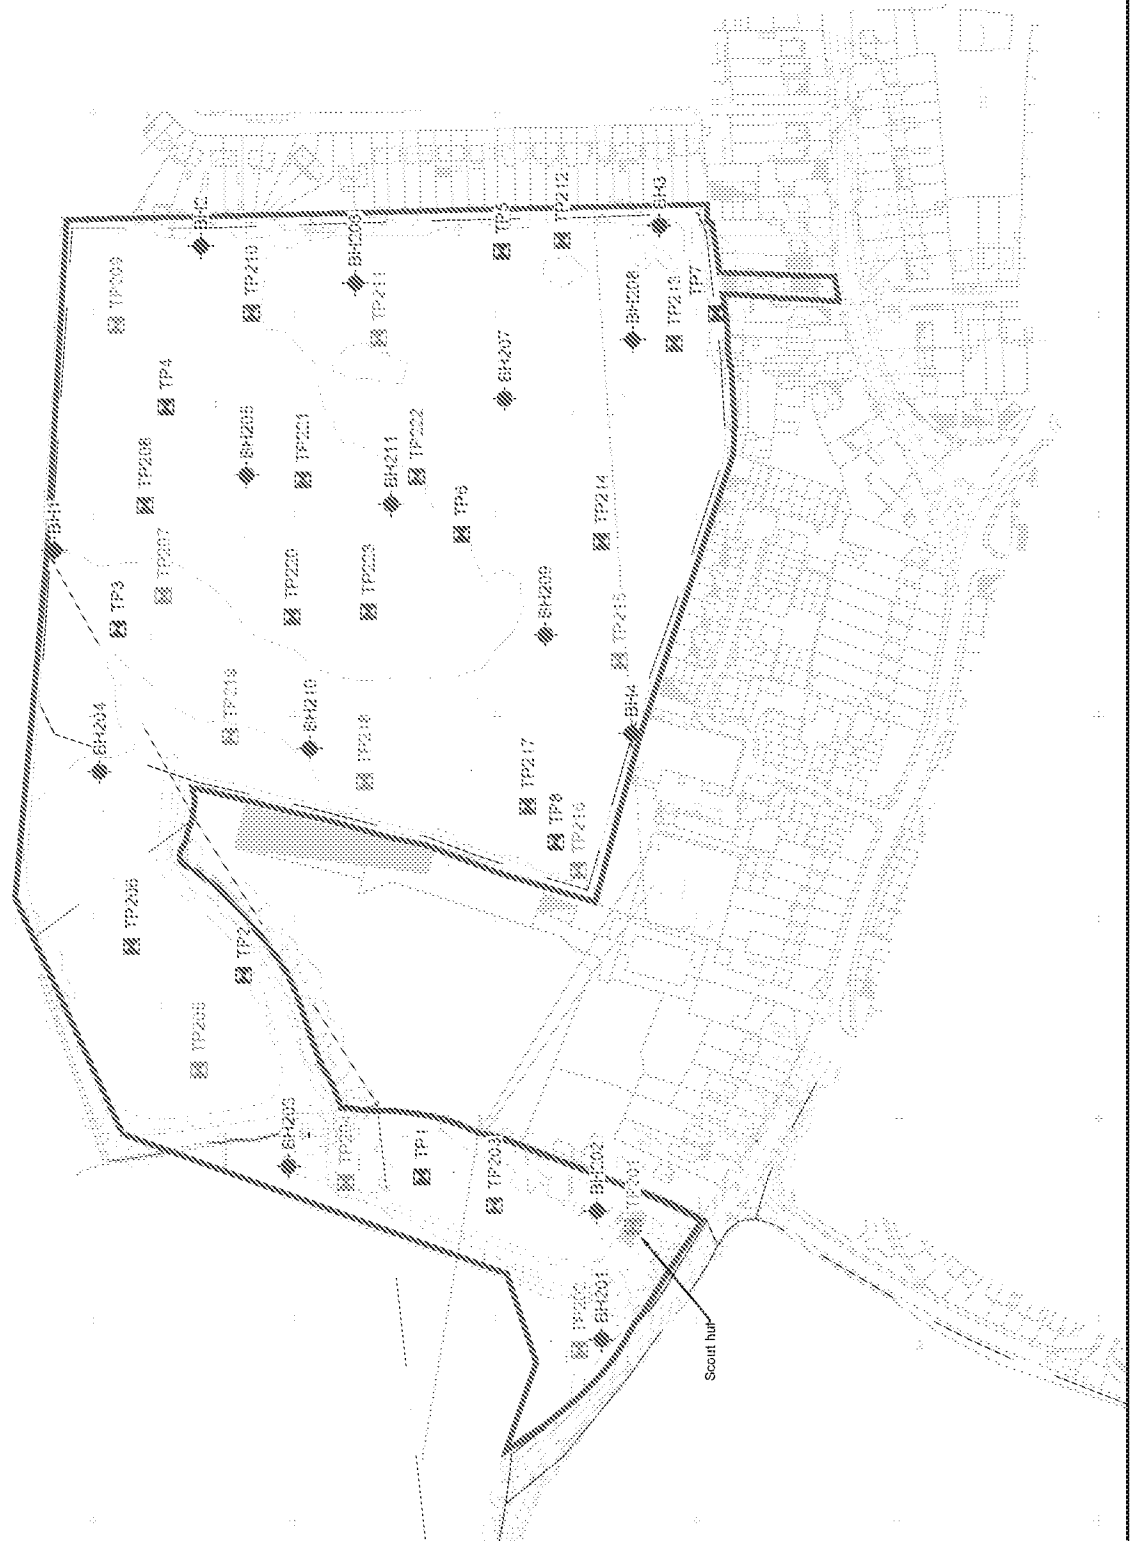
| Drawing No. | FIGURE 2 | Rev. | P1 |

It is understood that Arun District Council (ADC) requested further information relating to the potential for infiltration drainage to be utilised as far as possible in the proposed development strategy. Rogers Cory Partnership Ltd (RCP) – on behalf of Taylor Wimpey – scoped an additional intrusive ground investigation comprising a further 23 trial pit soakaway tests and 11 groundwater monitoring well installations, followed by twice-monthly groundwater monitoring visits from completion of the site works until the end of April. Of the 23 trial pit soakaway tests, it was initially proposed that 15 locations were to be to c. 1.5 mbgl (or groundwater level if shallower) and 8 locations were to be to c. 0.5 mbgl, however due to shallow groundwater conditions, only 11 locations could be completed to c. 1.5 mbgl, with 12 locations completed to c. 0.5 mbgl, as detailed in **Section 2**. The positions of all new locations in addition to those from previous investigations are given in **Figure 2**. All new locations were surveyed to Ordnance Datum by GPS, with this data shown in **Appendix B**.

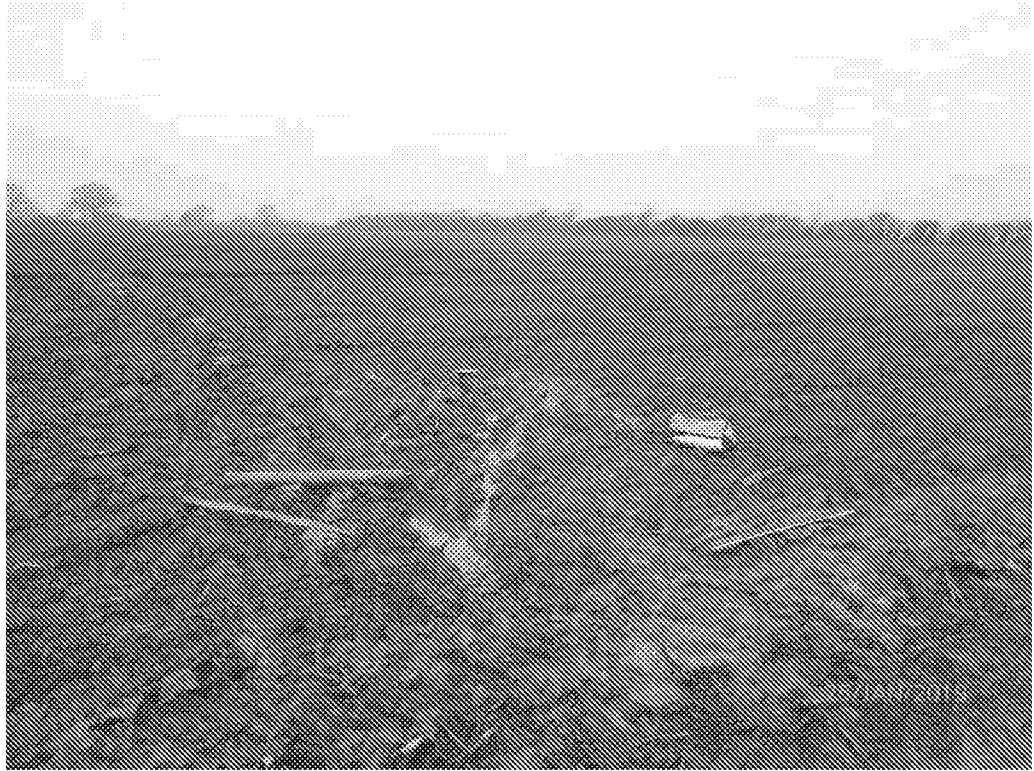
| PHOTOGRAPHIC LOG | | 305035 L01 (00) |
|---|---|---|
| <b>Photo No.</b><br>1 | | |

| PHOTOGRAPHIC LOG | | 305035 L01 (00) |
|---|---|---|
| Facing northwest, overview of BH206 | | |

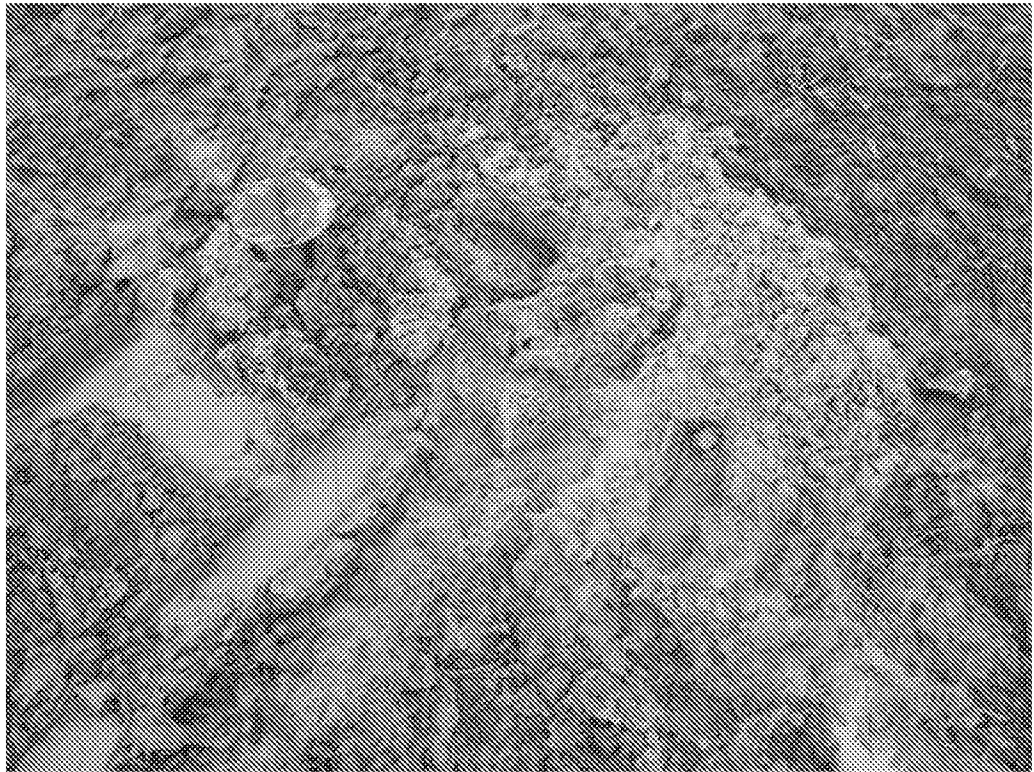
| PHOTOGRAPHIC LOG | | 305035 L01 (00) |
|---|---|---|
| <b>Photo No.</b><br>2 | | |

| PHOTOGRAPHIC LOG | | 305035 L01 (00) |
|---|---|---|
| BH206 hand pit arisings | | |

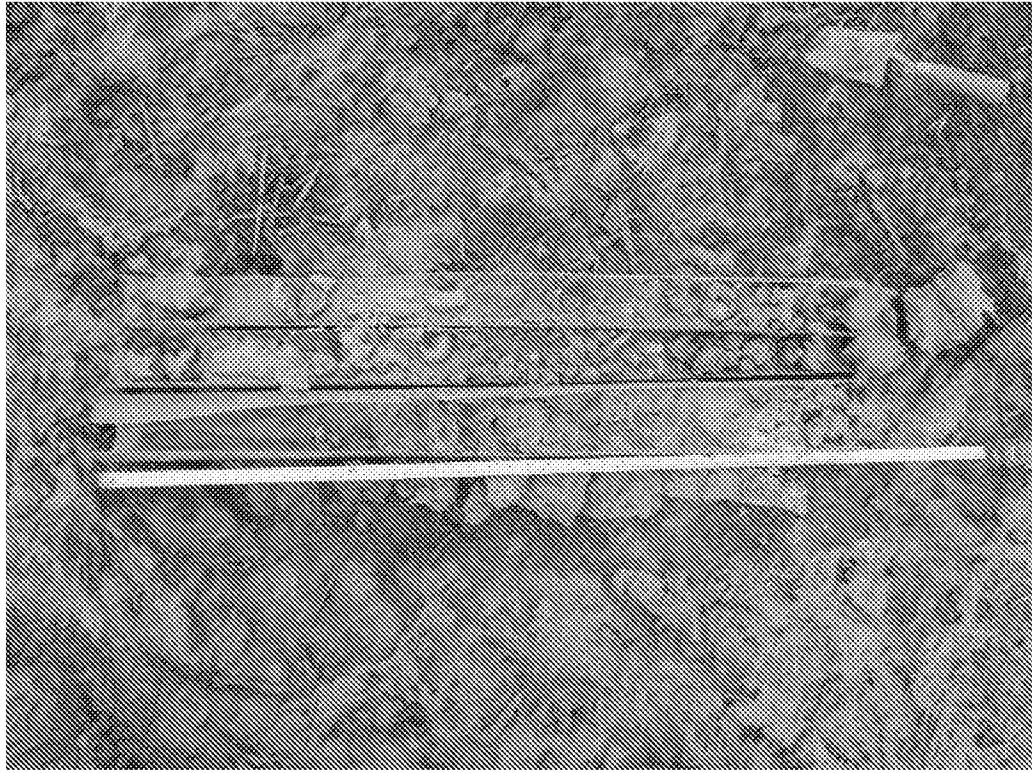
| PHOTOGRAPHIC LOG | | 305035 L01 (00) |
|---|---|---|
| <b>Photo No.</b><br>3 | | |

| PHOTOGRAPHIC LOG | | 305035 L01 (00) |
|---|---|---|
| BH206 core<br>soils recovery:<br>1. 2-3 m (L-R)<br>2. 1-2 m (L-R) | | |

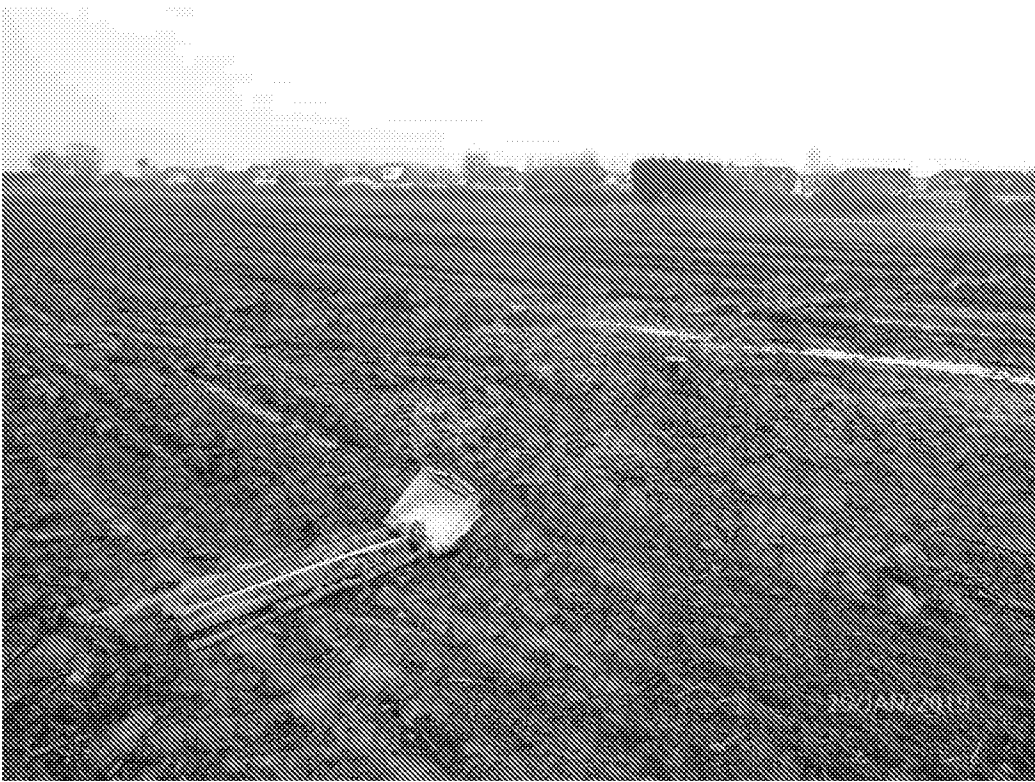
| PHOTOGRAPHIC LOG | | 305035 L01 (00) |
|---|---|---|
| <b>Photo No.</b><br>4 | | |

| PHOTOGRAPHIC LOG | | 305035 L01 (00) |
|---|---|---|
| Facing<br>northeast,<br>overview of<br>BH207 | | |

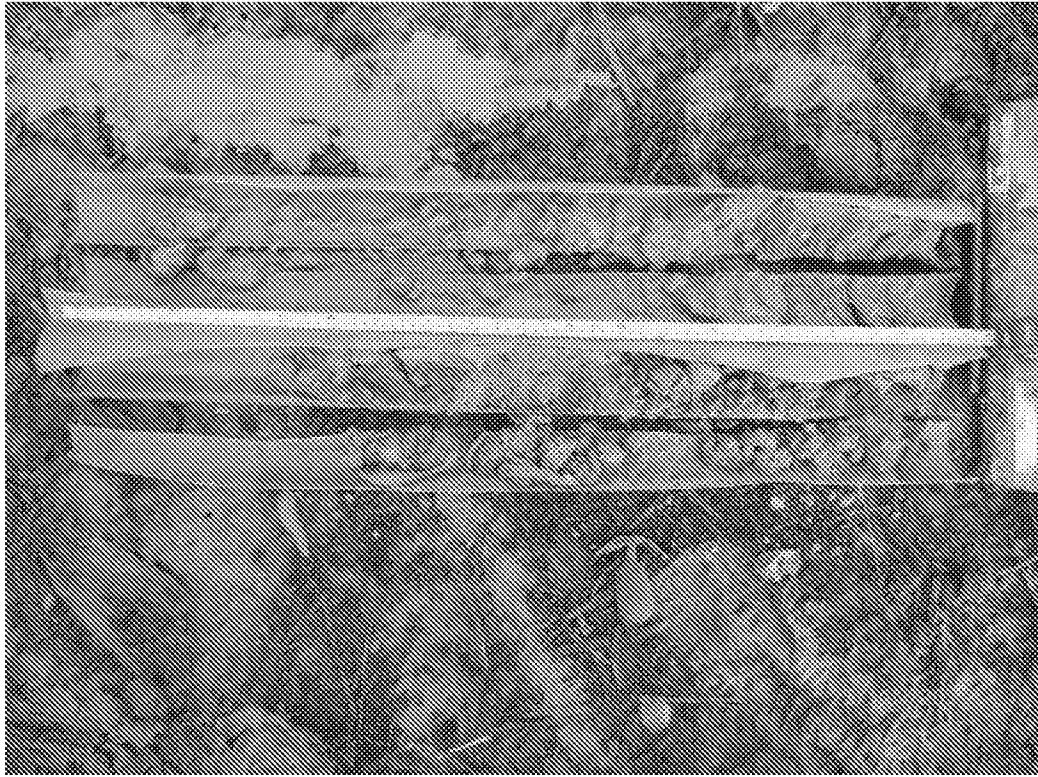
| PHOTOGRAPHIC LOG | | 305035 L01 (00) |
|---|---|---|
| <b>Photo No.</b><br>5 | | |

| PHOTOGRAPHIC LOG | | 305035 L01 (00) |
|---|---|---|
| BH207 core<br>soils recovery:<br>1. 2-3 m (L-R)<br>2. 1-2 m (L-R) | | |

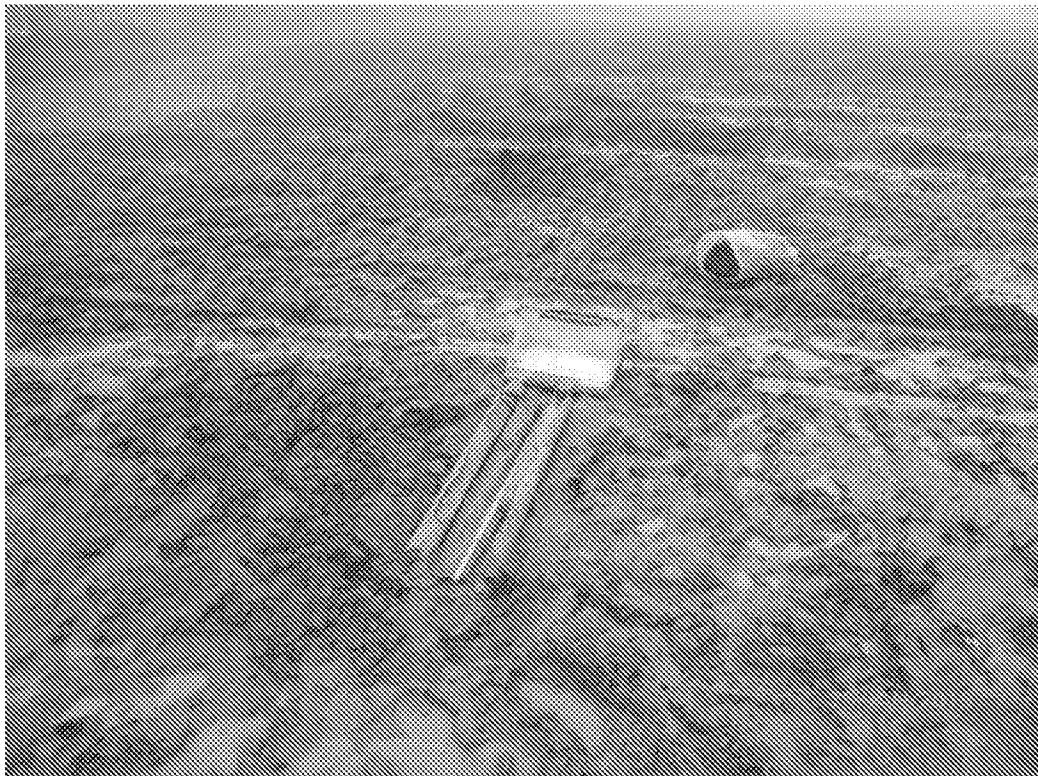
| PHOTOGRAPHIC LOG | | 305035 L01 (00) |
|---|---|---|
| <b>Photo No.</b><br>6 | | |

| PHOTOGRAPHIC LOG | | 305035 L01 (00) |
|---|---|---|
| Facing<br>northwest,<br>overview of<br>BH208 | | |

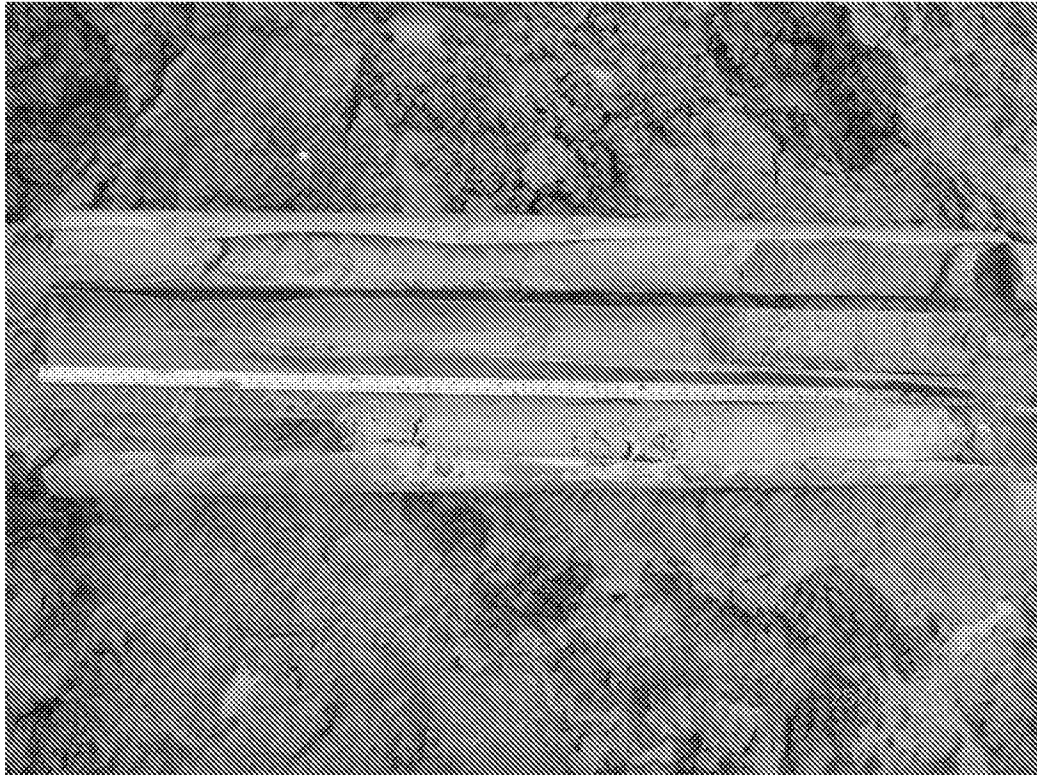
| PHOTOGRAPHIC LOG | | 305035 L01 (00) |
|---|---|---|
| <b>Photo No.</b><br>7 | | |

| PHOTOGRAPHIC LOG | | 305035 L01 (00) |
|---|---|---|
| BH208 core<br>soils recovery:<br>1. 2-3 m (L-R)<br>2. 1-2 m (L-R) | | |
