# Ashdown Site Investigation Limited

Site: Land South of Summer Lane, Pagham, West Sussex

Report No. R18-13402

## Groundwater Monitoring Results - WS101

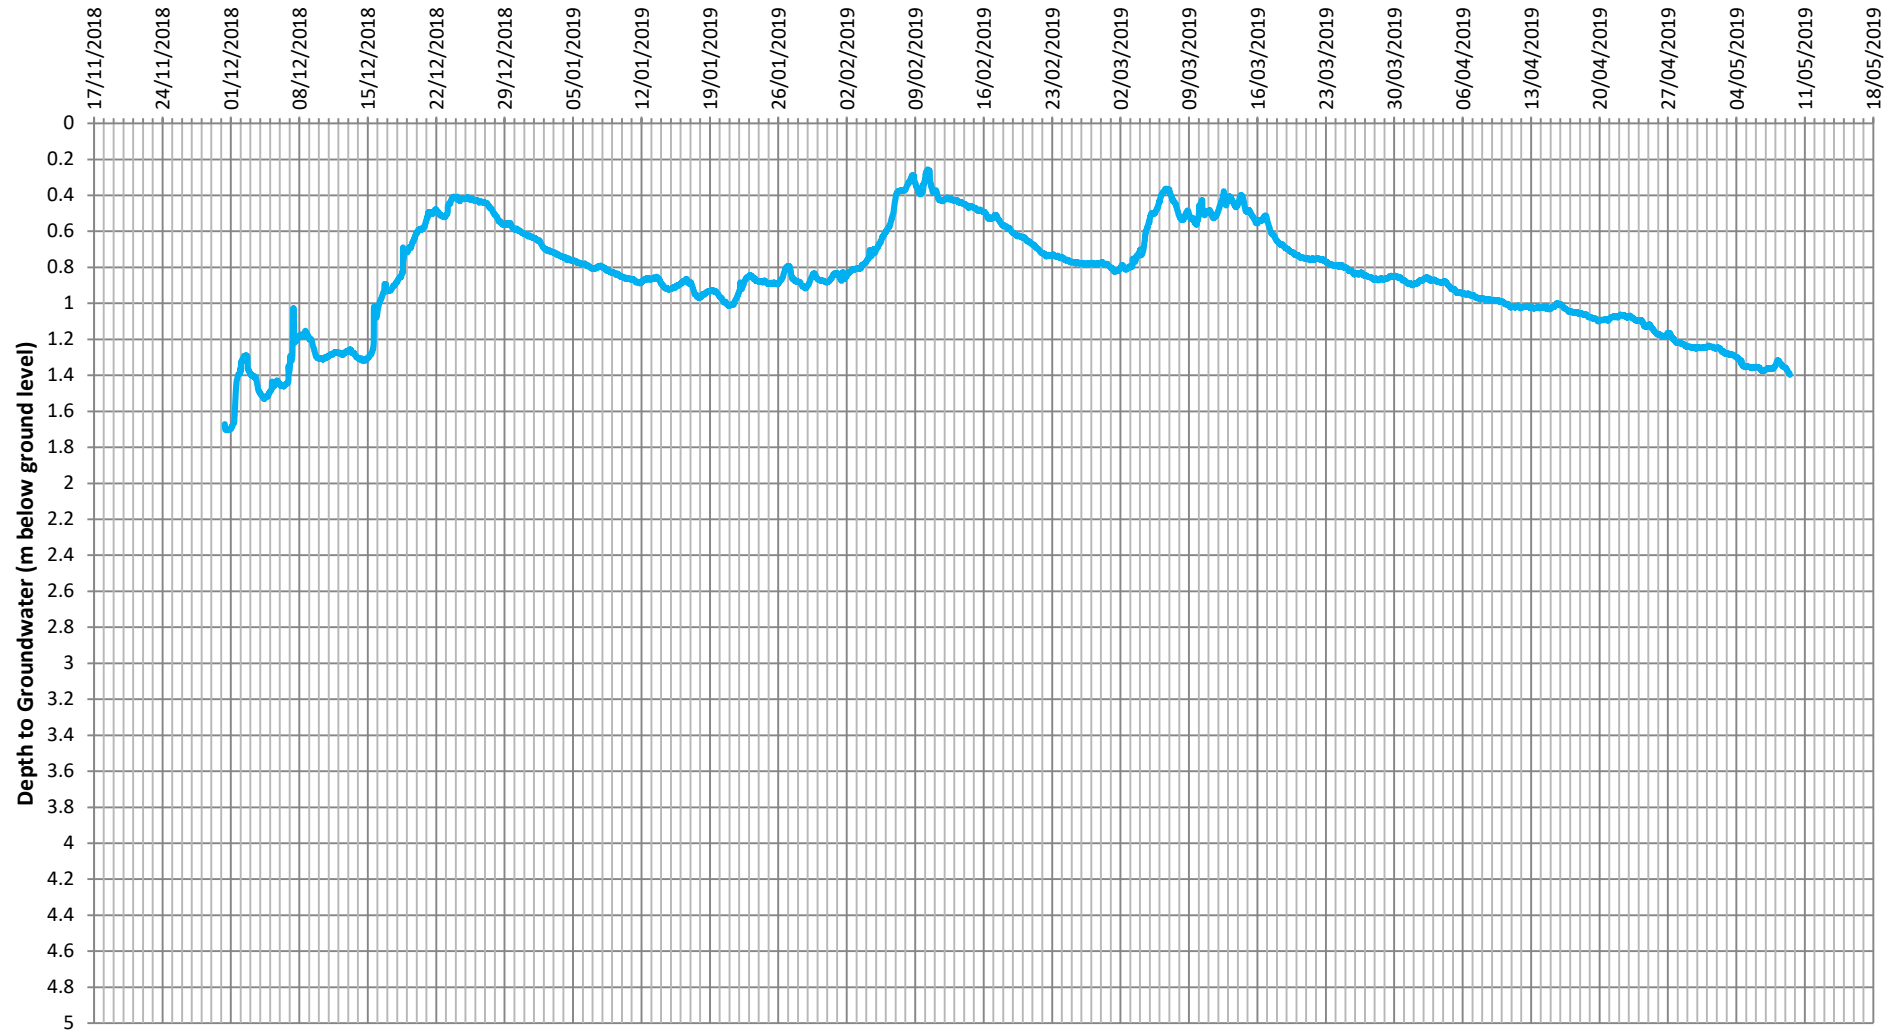
## Groundwater Monitoring Results - WS114

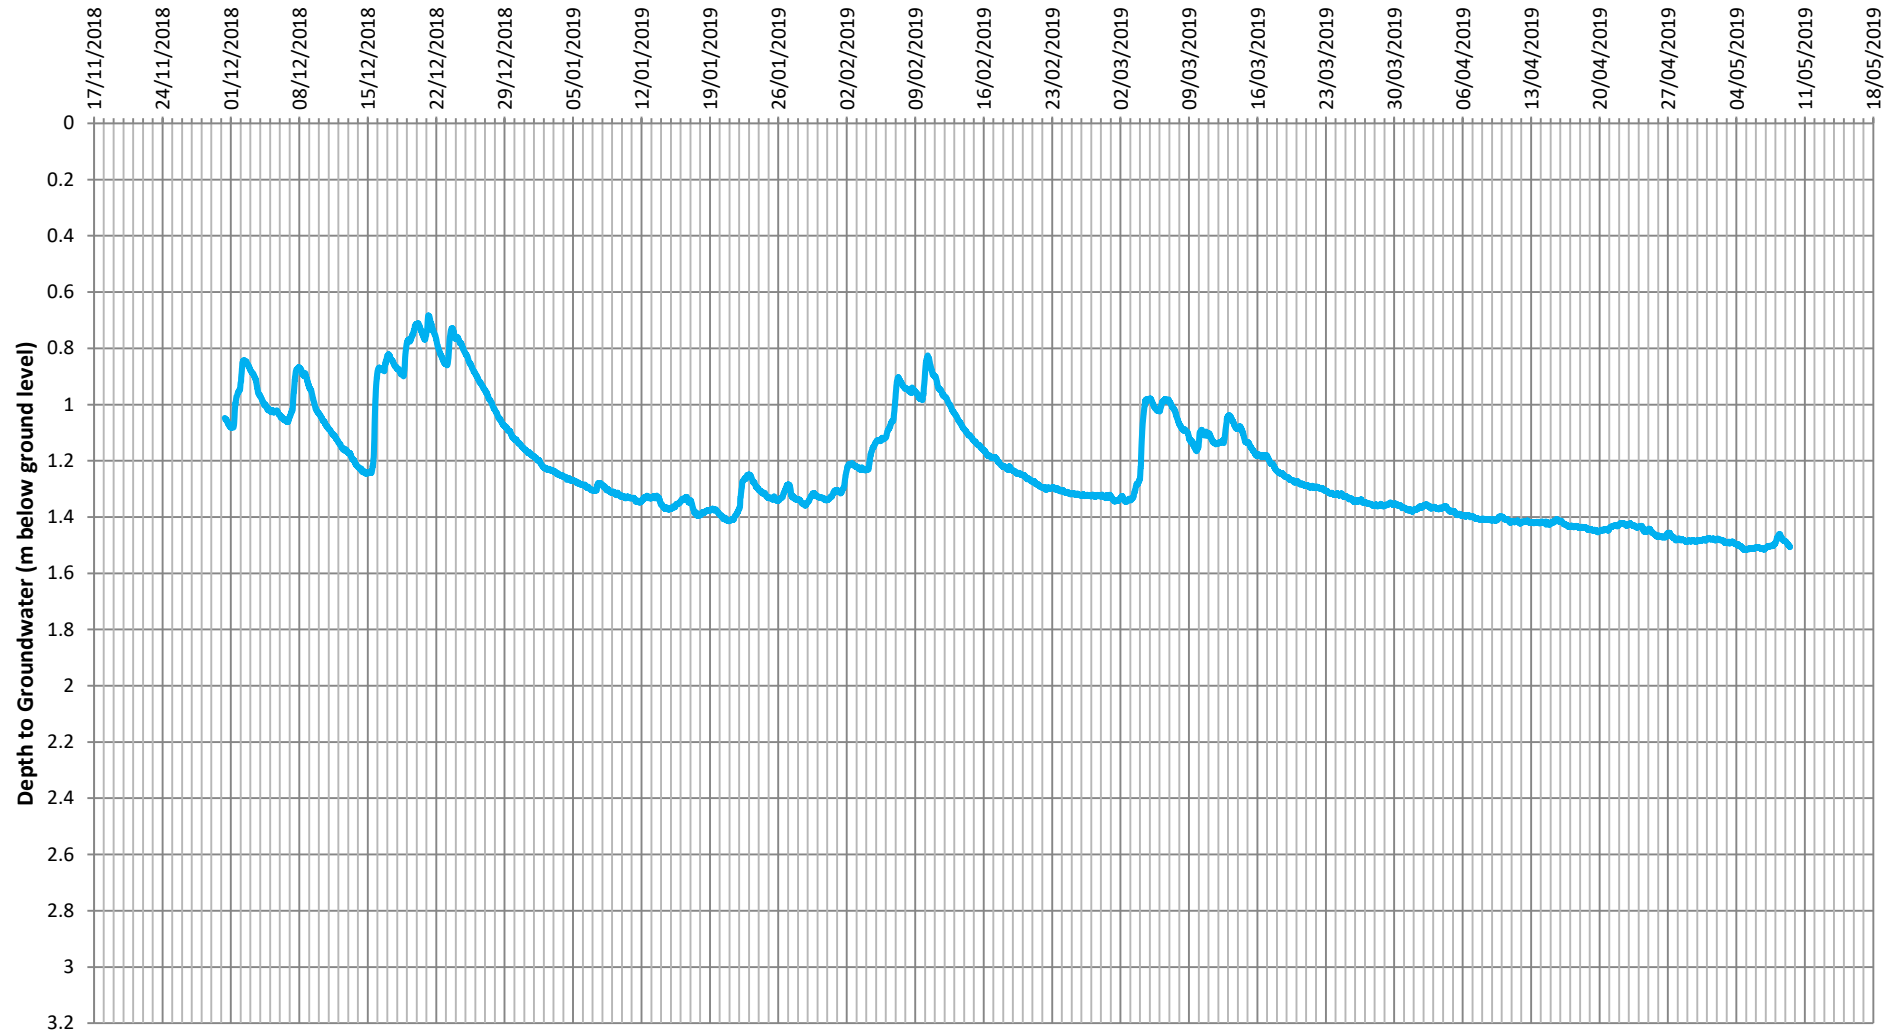
## Groundwater Monitoring Results - WS123

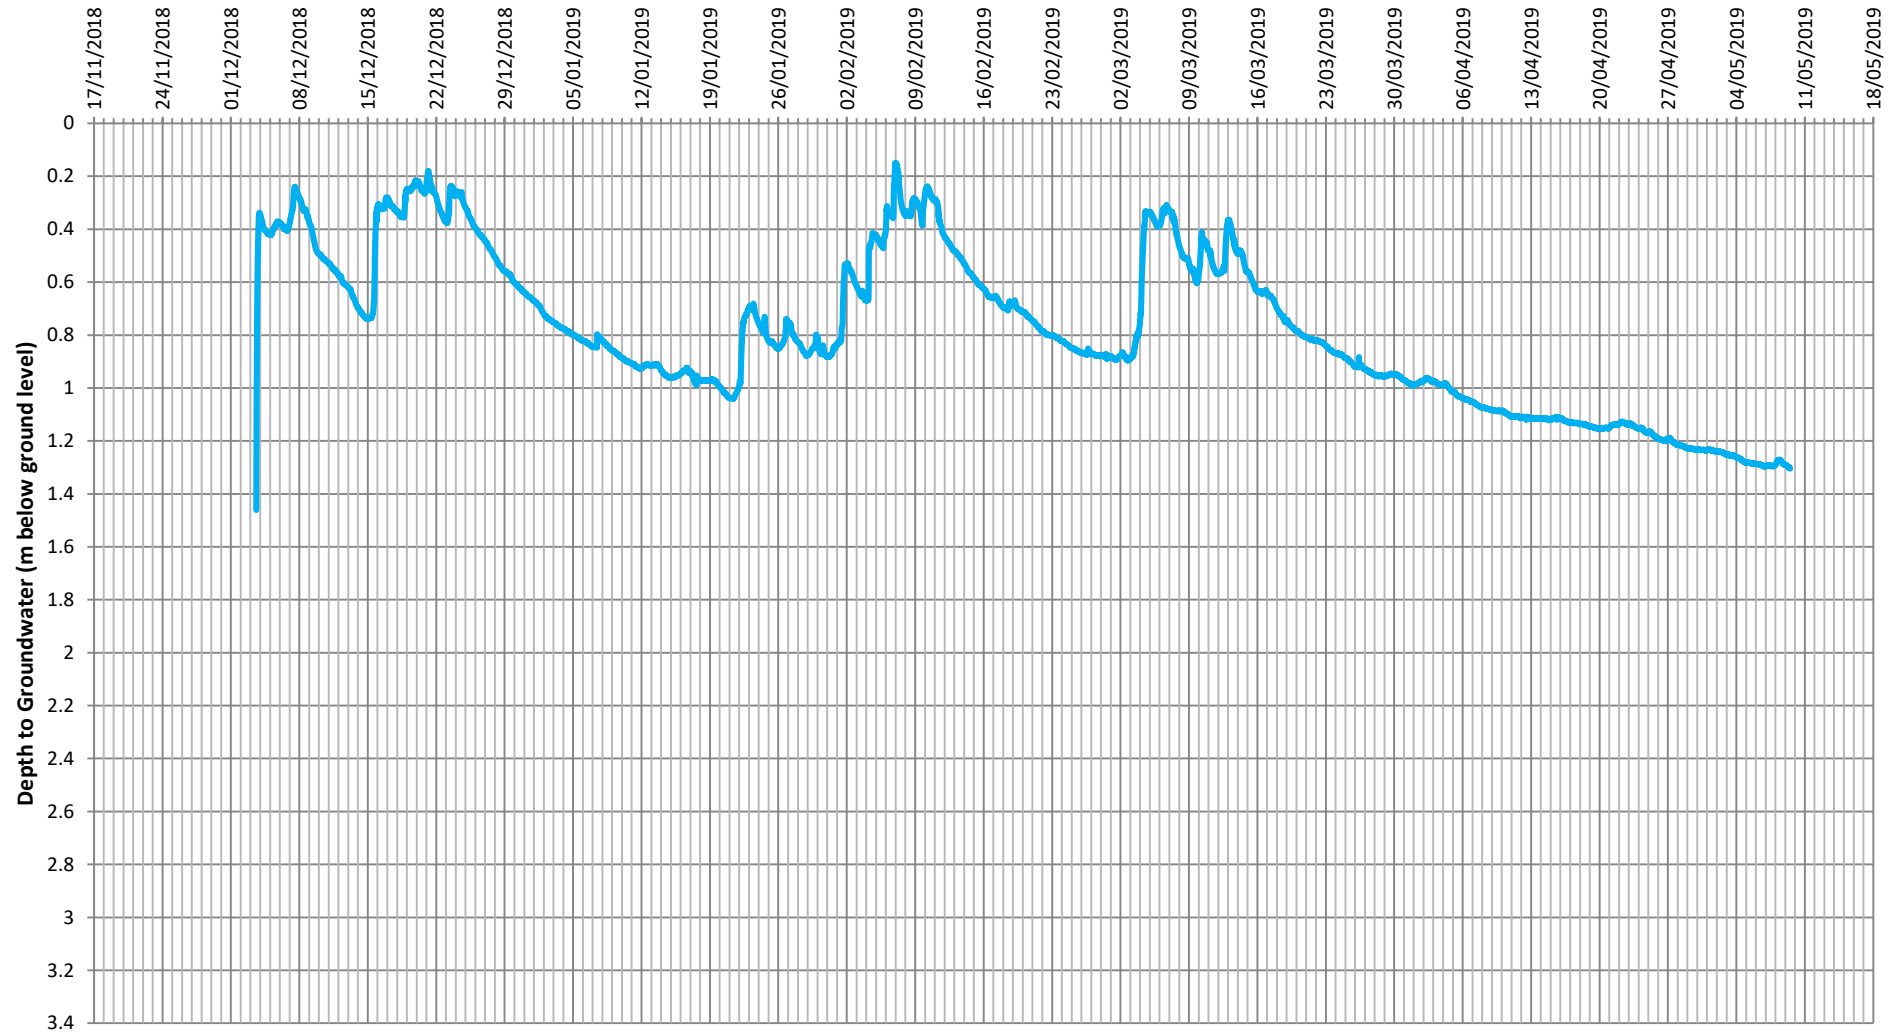
## Groundwater Monitoring Results - WS134

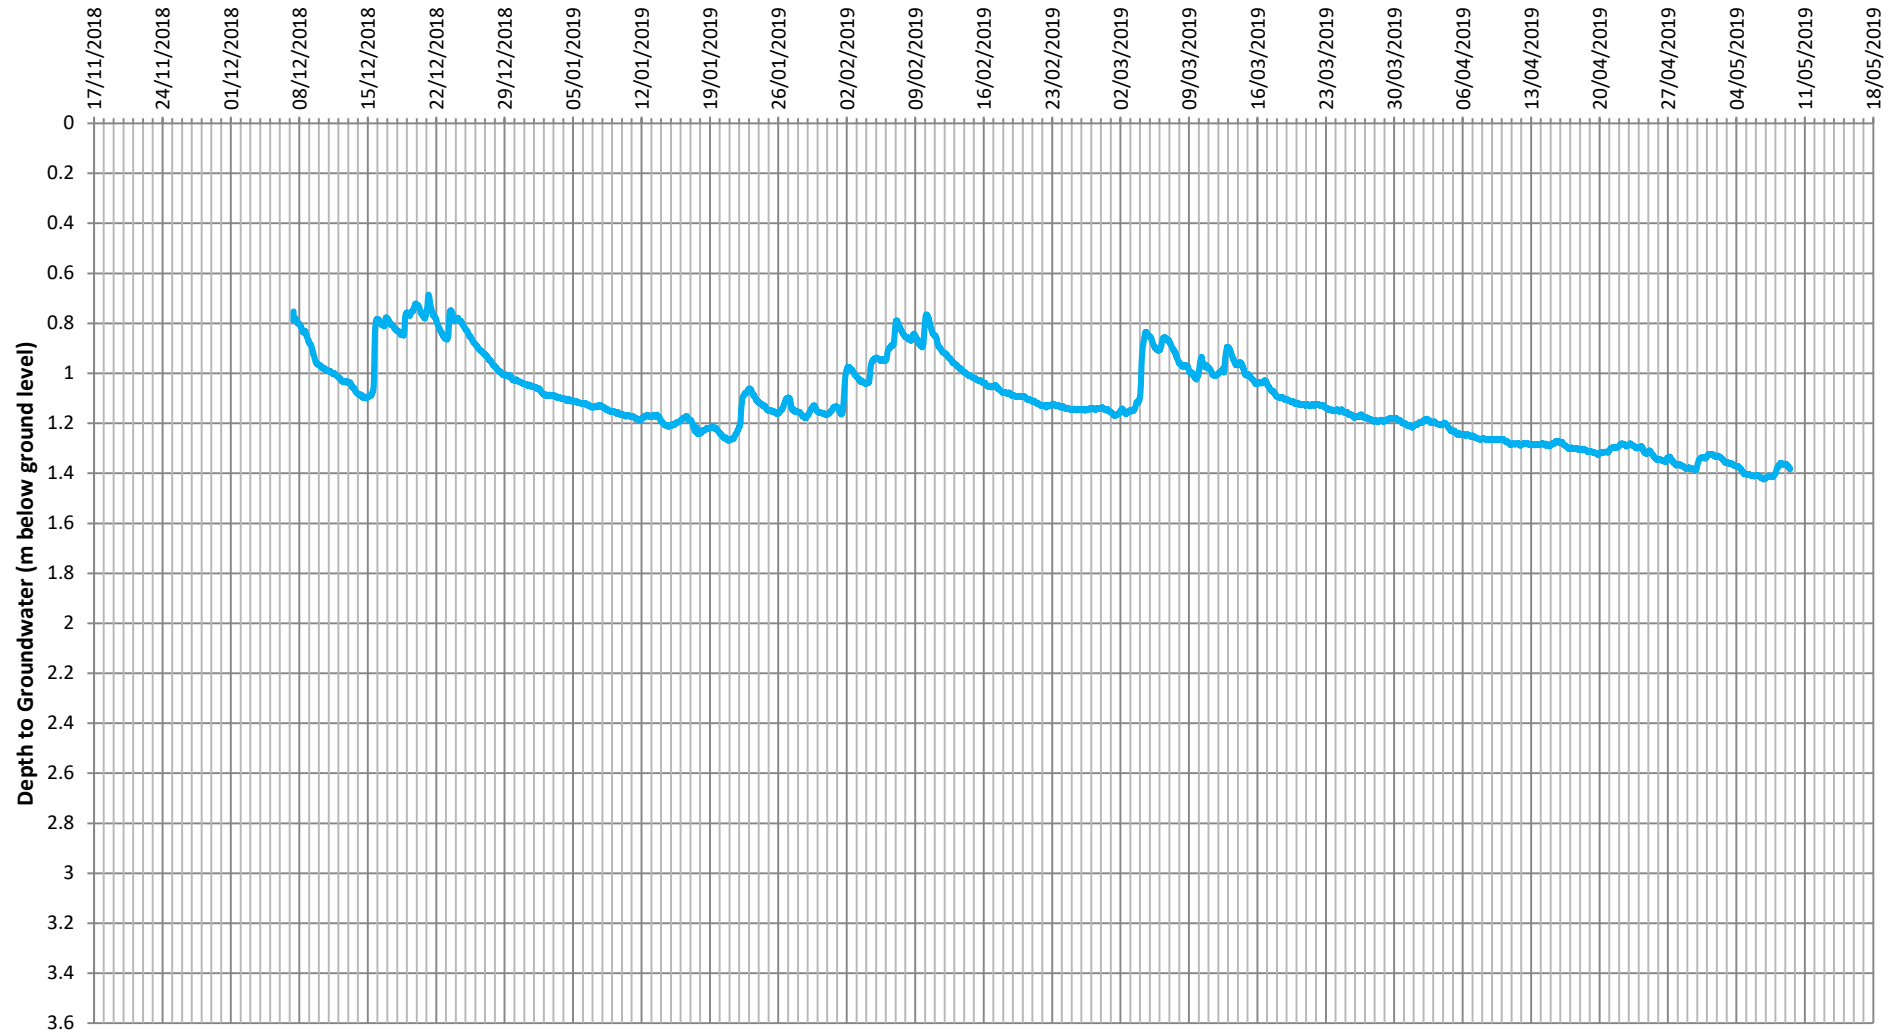
## Groundwater Monitoring Results - WS135

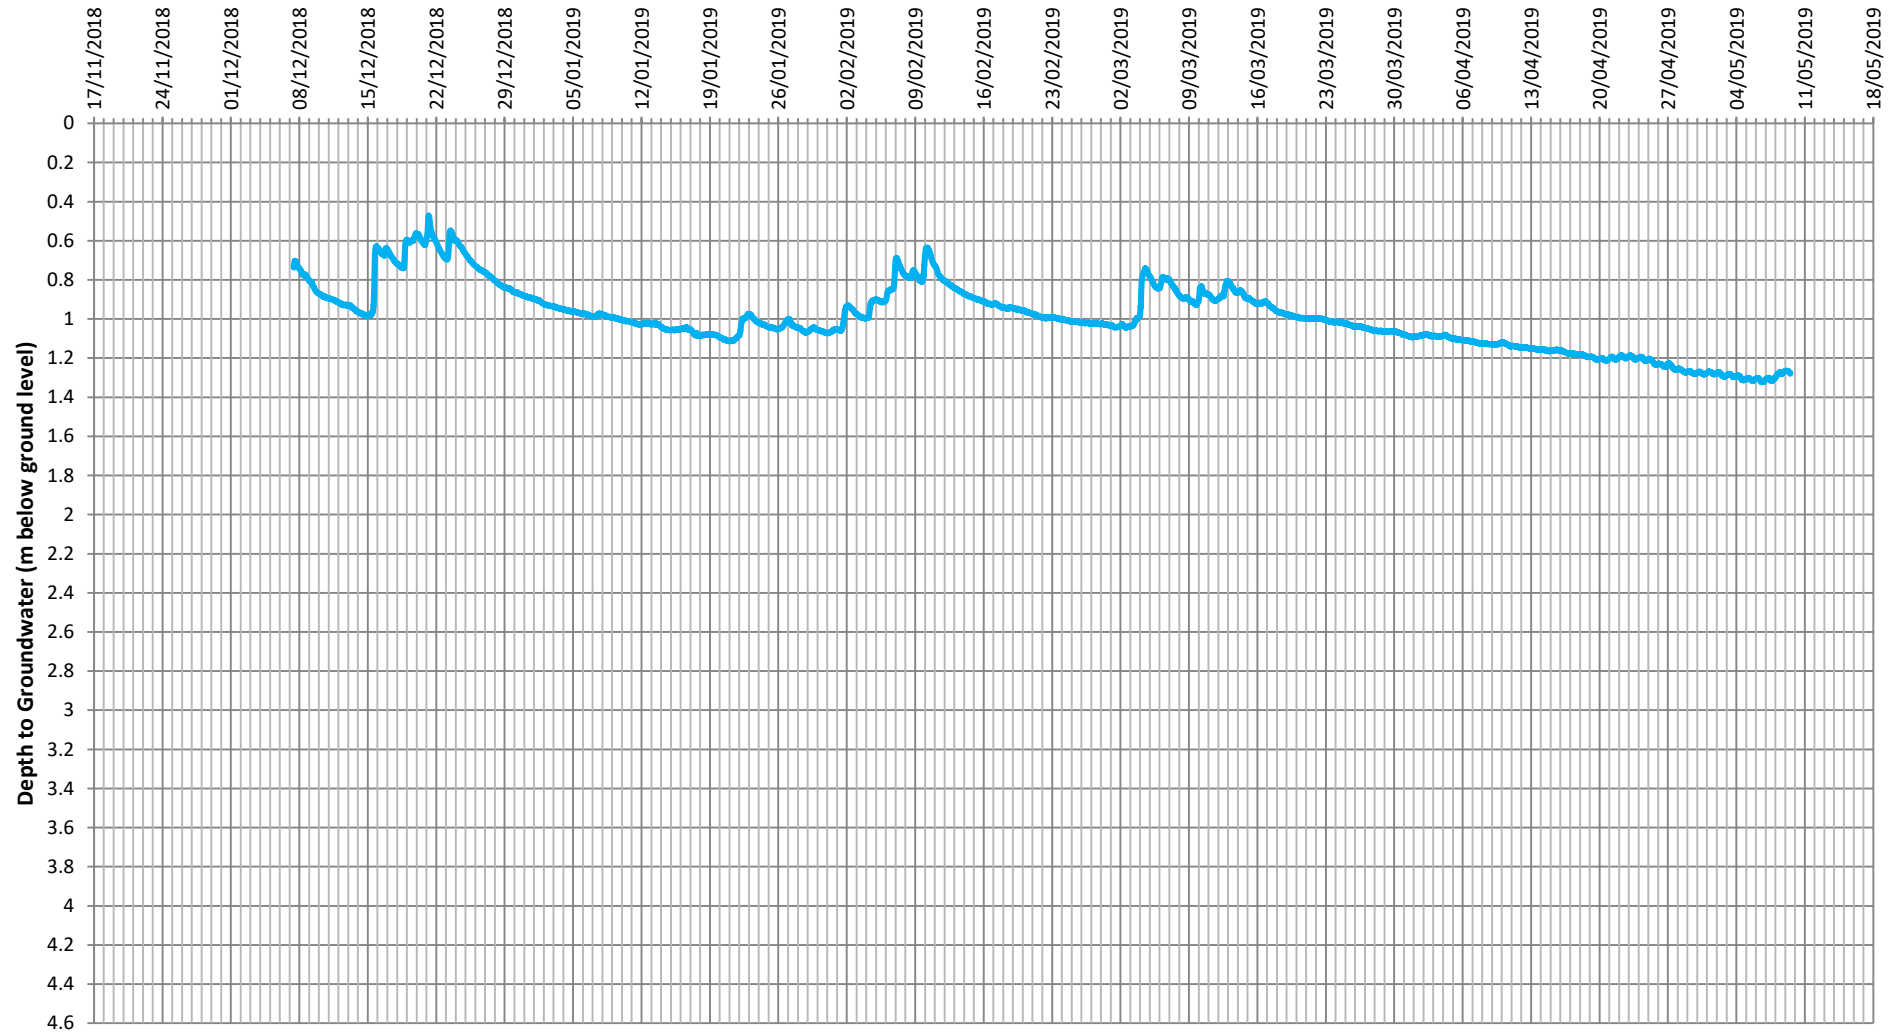
## Groundwater Monitoring Results - WS150
