| Project Name: Fontwell Additional Shallow Soaks | | | | Project No.<br>LP01878 | | Co-ords: -<br>Level: | | Date<br>04/03/2019 | |
| Location: Land near Fontwell, BN18 0SW | | | | | | Dimensions (m):<br><div style="display: flex; align-items: center; justify-content: space-between;"> <div>Depth<br/>2.00</div> <div style="border: 1px solid black; width: 100px; height: 30px; display: flex; align-items: center; justify-content: center;"> <div style="writing-mode: vertical-rl; transform: rotate(180deg); font-size: 10px;">47</div> <div style="margin-left: 10px;">182</div> </div> </div> | | Scale<br>1:25<br>Logged<br>SN | |
| Client: Dandara Ltd | | | | | | | | | |

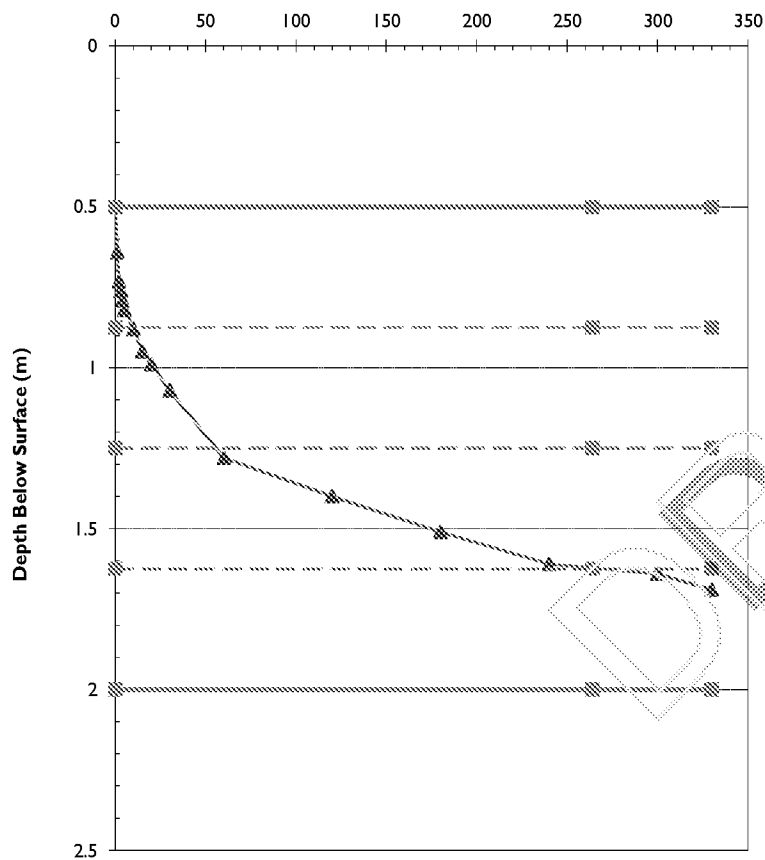
Test Hole No: TP302  
Test No: Test No 1

Filling to Max Water Depth (min)

| BRE Soil Infiltration Rate (m/sec) | 2.28E-06 |

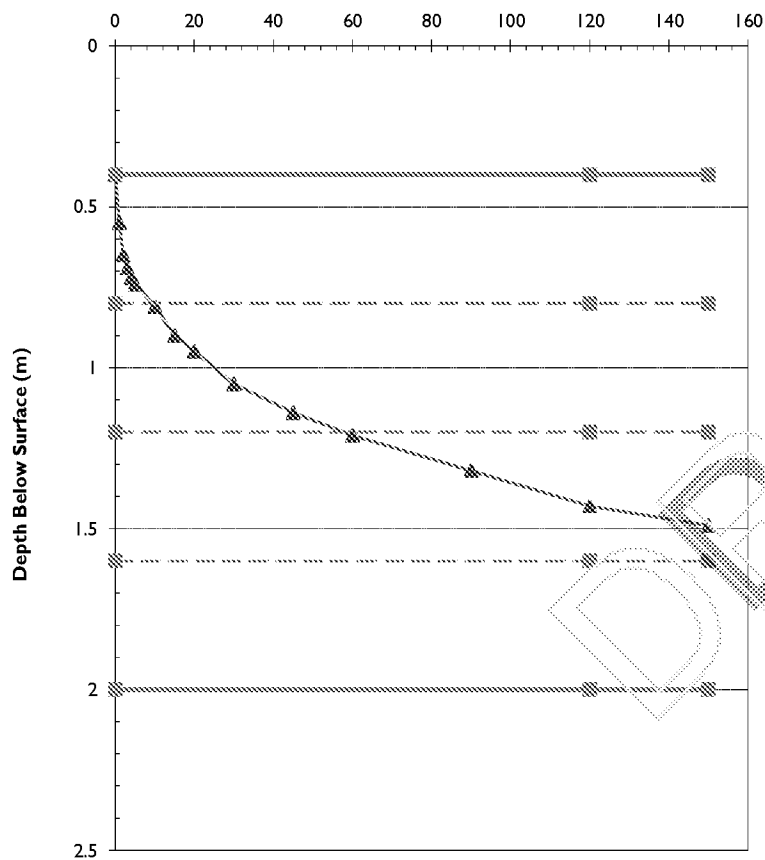
Test Hole No: TP302  
Test No: Test No 2

Filling to Max Water Depth (min)

| BRE Soil Infiltration Rate (m/sec) | 3.01E-06 |

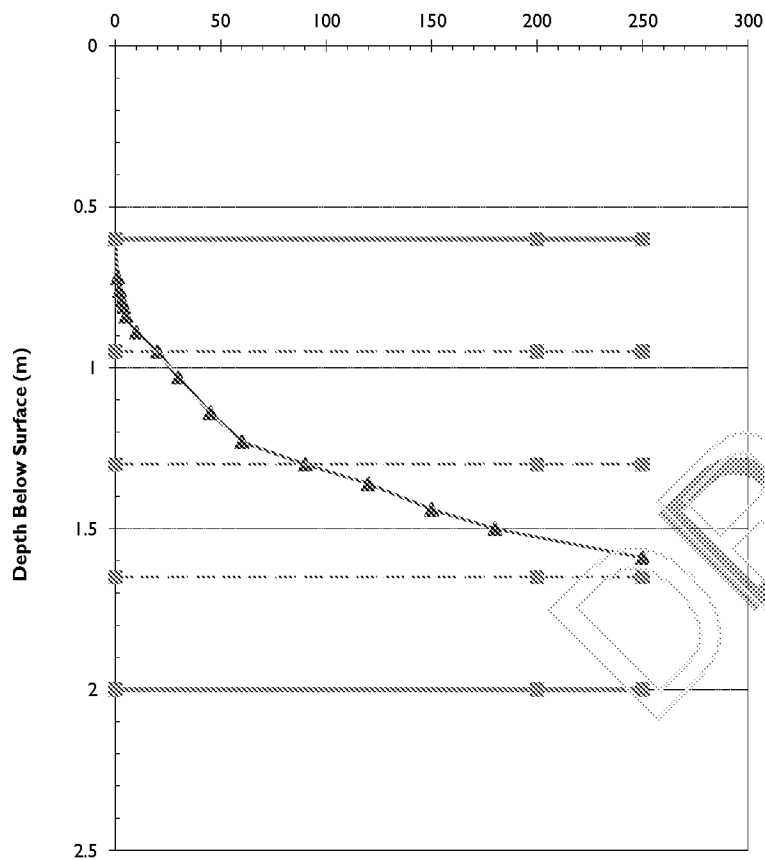
Test Hole No: TP302  
Test No: Test No 3

Filling to Max Water Depth (min)

| BRE Soil Infiltration Rate (m/sec) | 1.97E-06 |

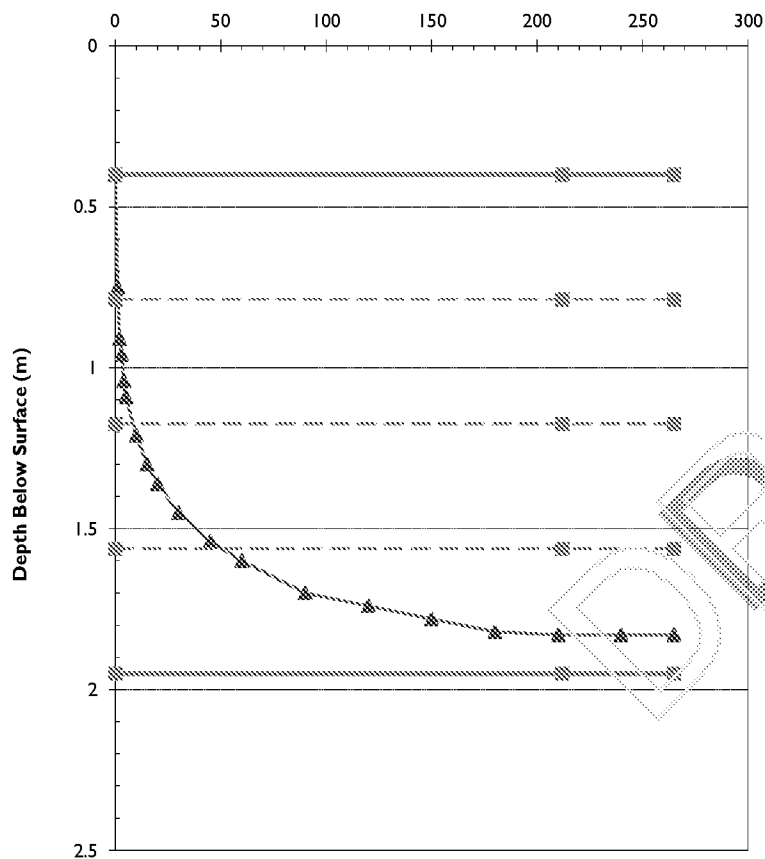
Test Hole No: TP303  
Test No: Test No 1

Filling to Max Water Depth (min)

| BRE Soil Infiltration Rate (m/sec) | 1.01E-05 |

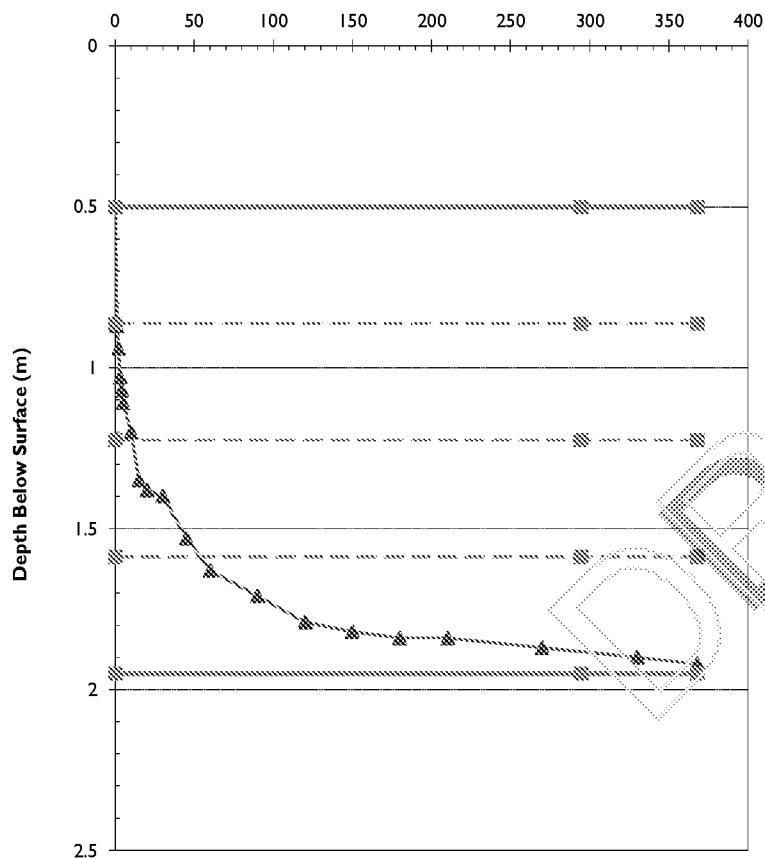
Test Hole No: TP303  
Test No: Test No 3

Filling to Max Water Depth (min)

| BRE Soil Infiltration Rate (m/sec) | 9.33E-06 |

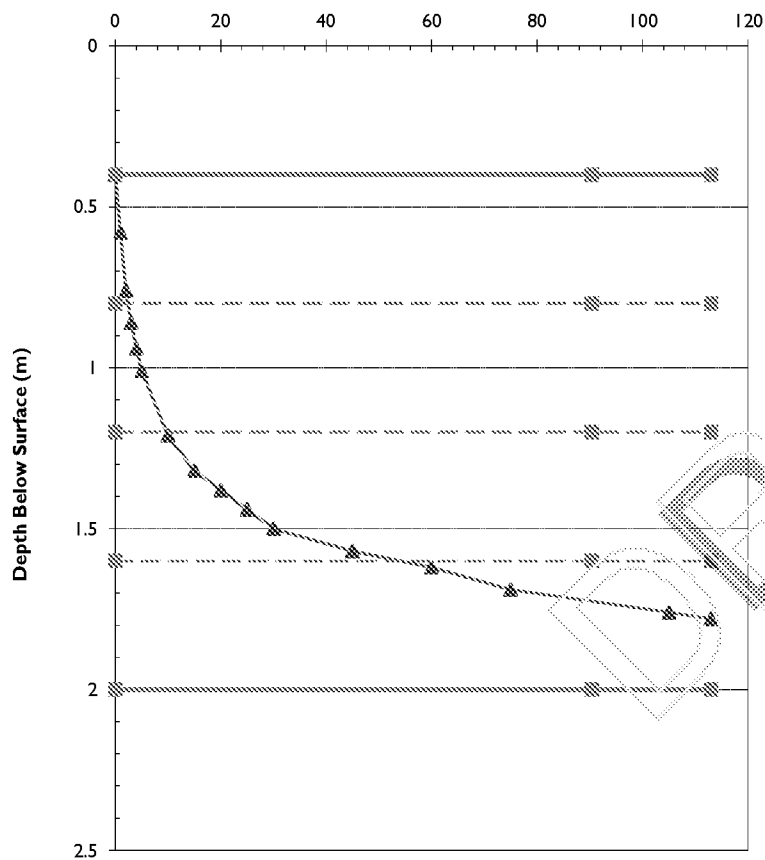
Test Hole No: TP304  
Test No: Test No 1

Filling to Max Water Depth (min)

| BRE Soil Infiltration Rate (m/sec) | 9.78E-06 |

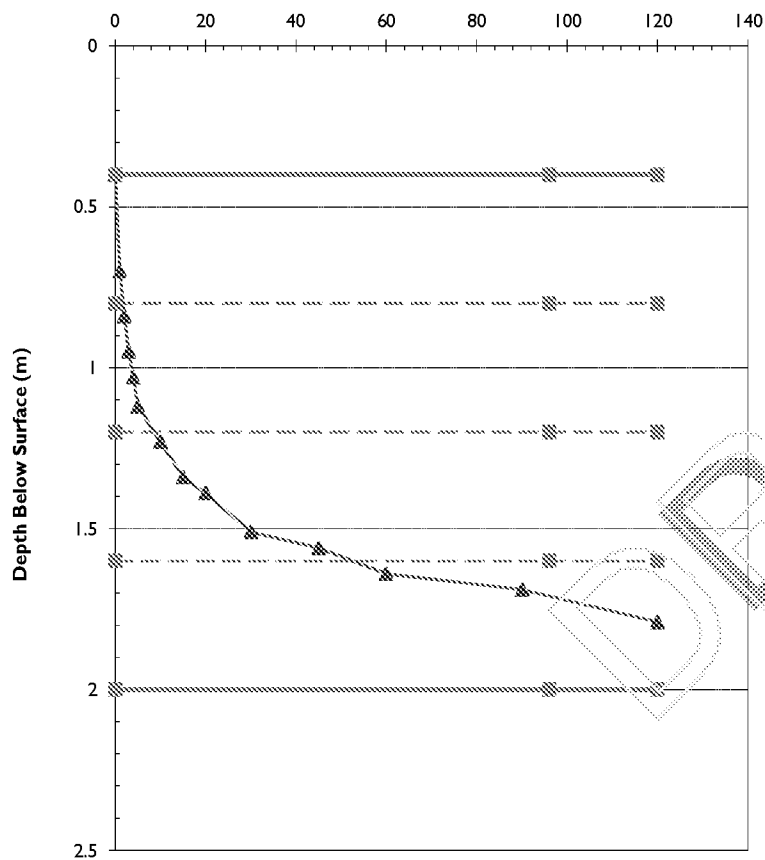
Test Hole No: TP304  
Test No: Test No 2

Filling to Max Water Depth (min)

| BRE Soil Infiltration Rate (m/sec) | 9.94E-06 |

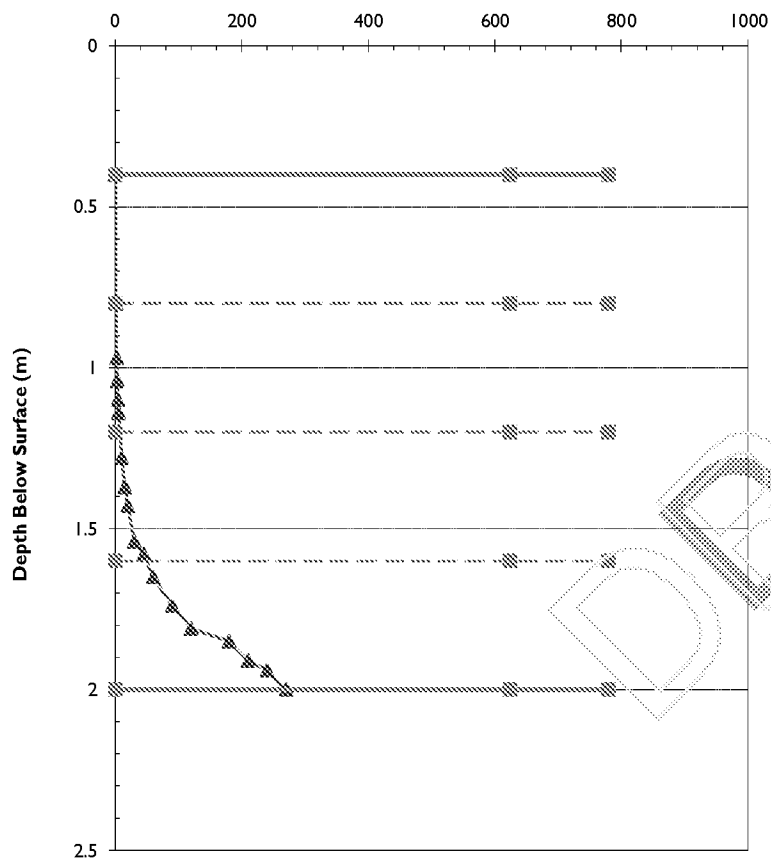
Test Hole No: TP304  
Test No: Test No 3

Filling to Max Water Depth (min)

| BRE Soil Infiltration Rate (m/sec) | 1.05E-05 |

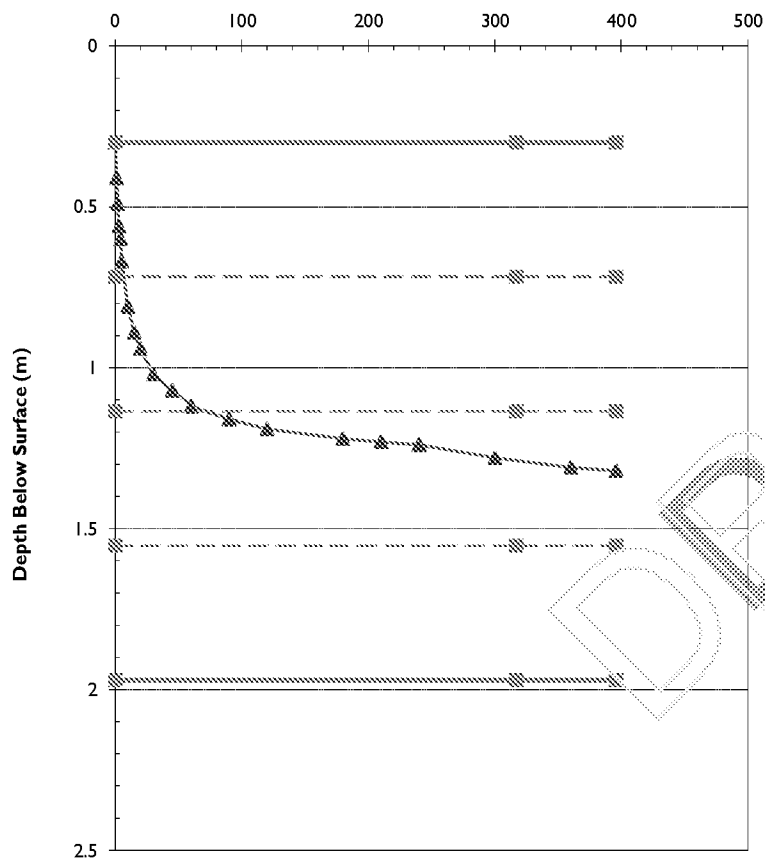
Test Hole No: TP305  
Test No: Test No 1

Filling to Max Water Depth (min)

| BRE Soil Infiltration Rate (m/sec) | 1.27E-06 |

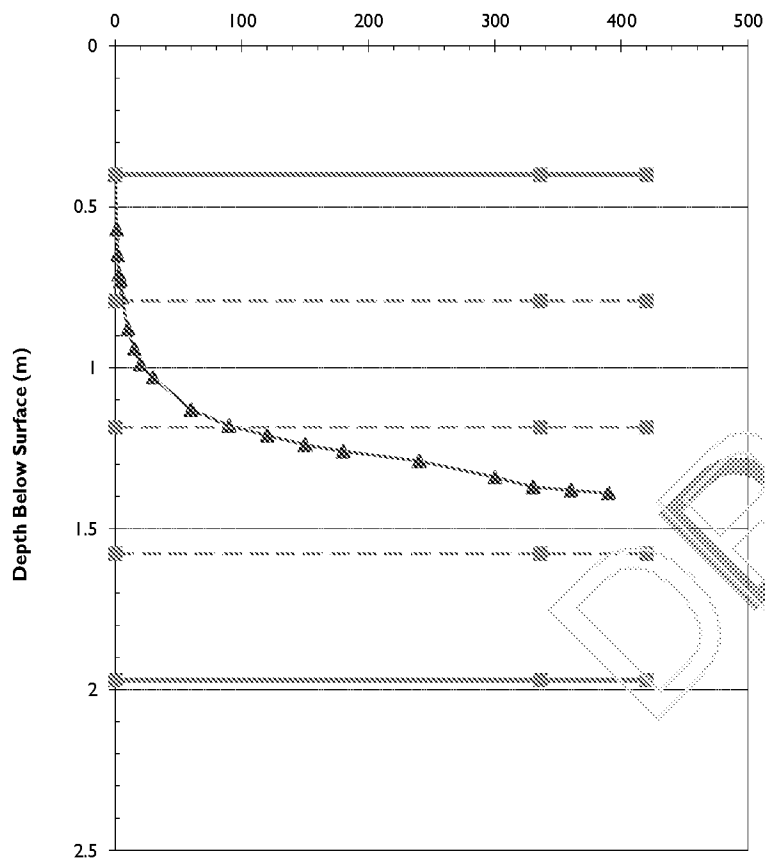
Test Hole No: TP305  
Test No: Test No 2

Filling to Max Water Depth (min)

| BRE Soil Infiltration Rate (m/sec) | 1.31E-06 |

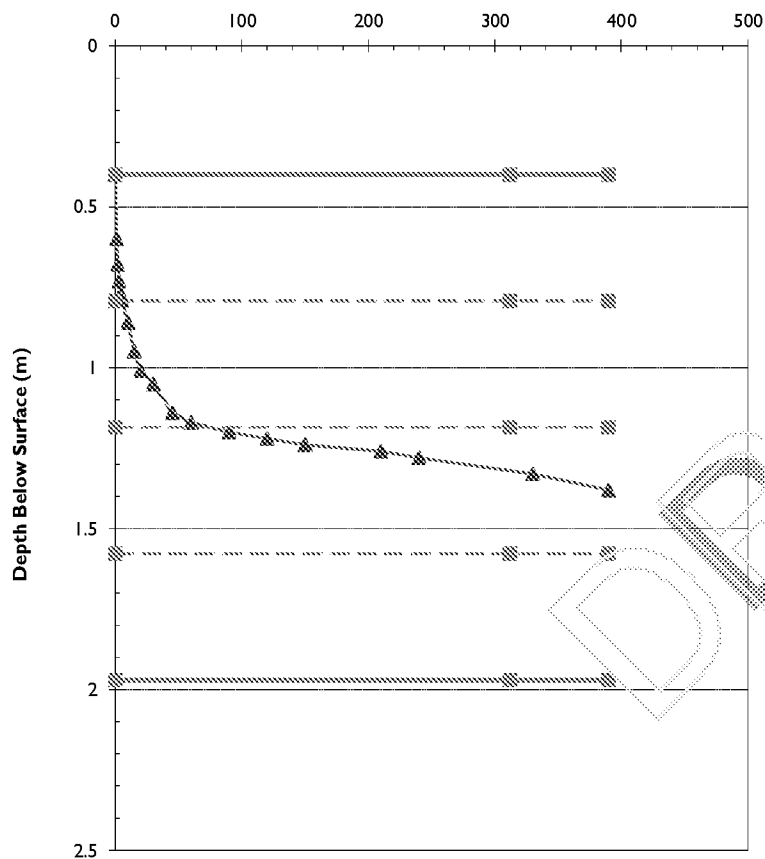
Test Hole No: TP305  
Test No: Test No 3

Filling to Max Water Depth (min)

| BRE Soil Infiltration Rate (m/sec) | 1.34E-06 |

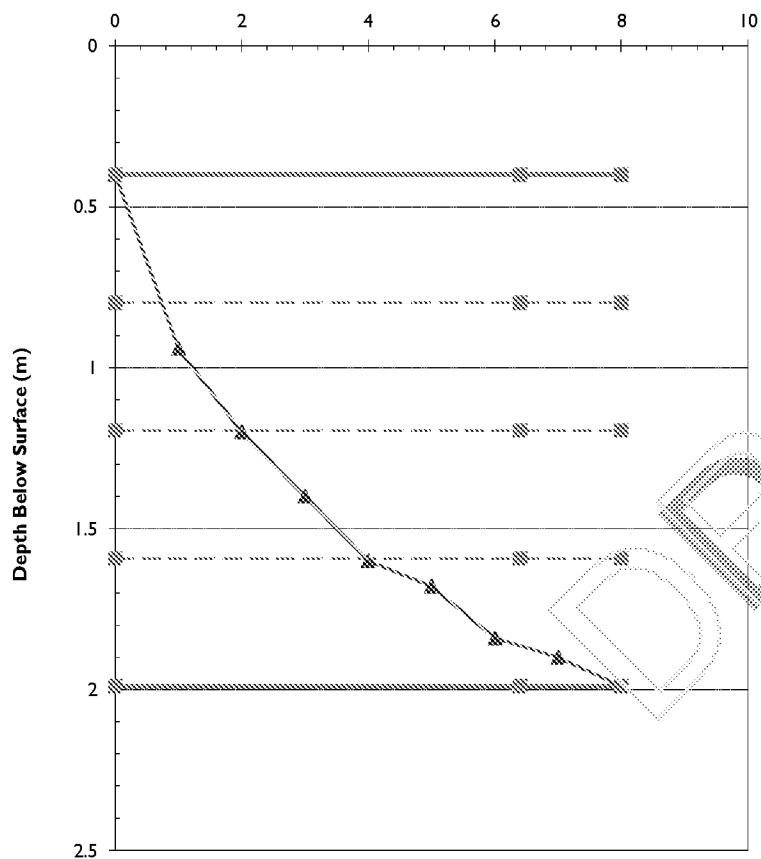
Test Hole No: TP307  
Test No: Test No 1

Filling to Max Water Depth (min)

| BRE Soil Infiltration Rate (m/sec) | 0.000159 |

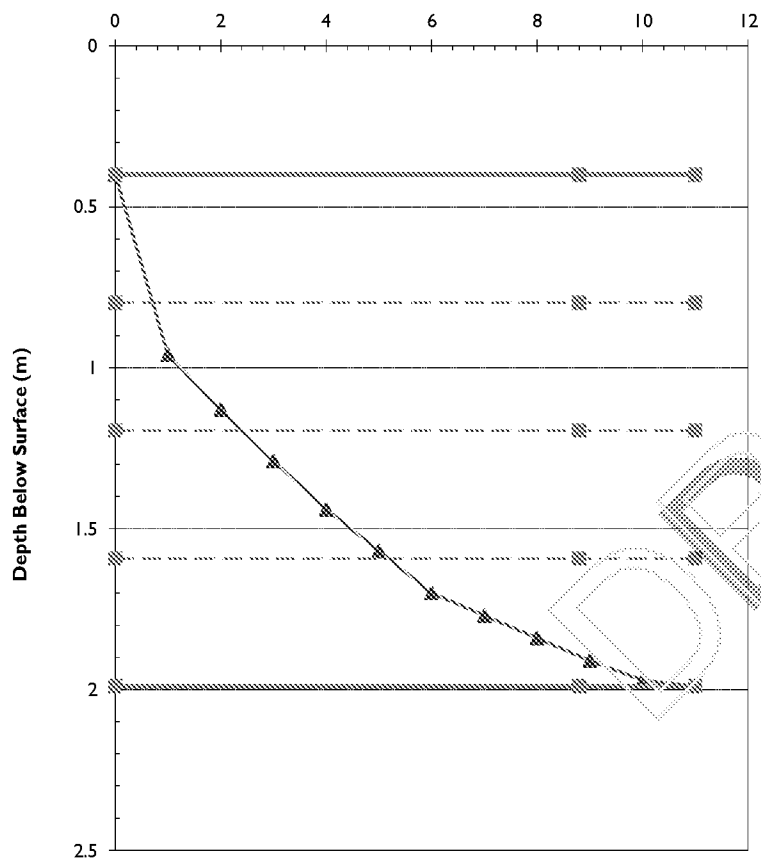
Test Hole No: TP307  
Test No: Test No 3

Filling to Max Water Depth (min)

| BRE Soil Infiltration Rate (m/sec) | 0.000115 |

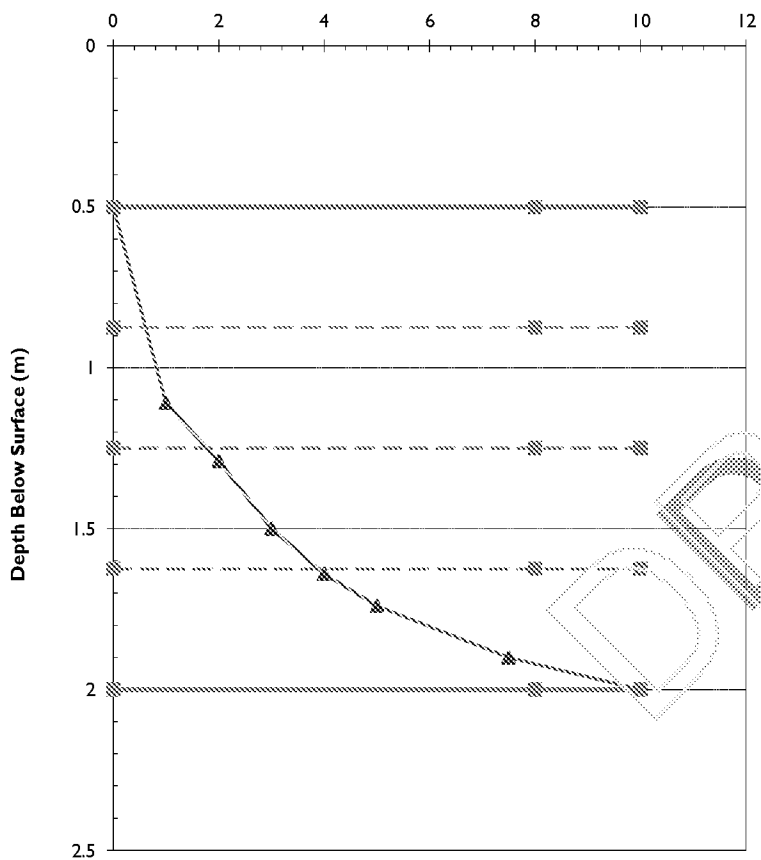
Test Hole No: TP309  
Test No: Test No 1

Filling to Max Water Depth (min)

| BRE Soil Infiltration Rate (m/sec) | 0.000155 |

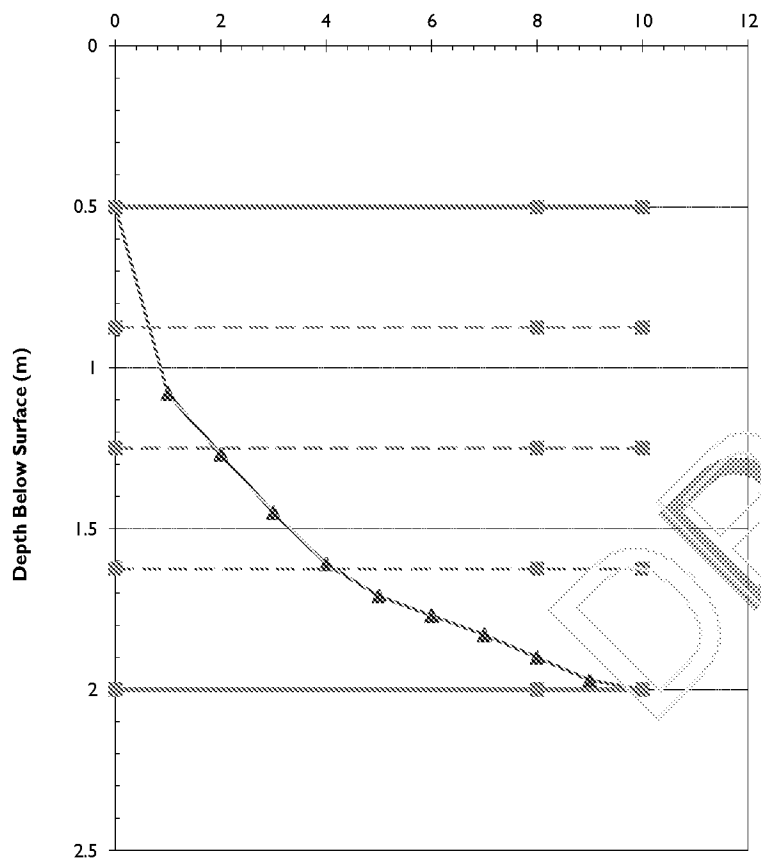
Test Hole No: TP309  
Test No: Test No 2

Filling to Max Water Depth (min)

| BRE Soil Infiltration Rate (m/sec) | 0.000145 |

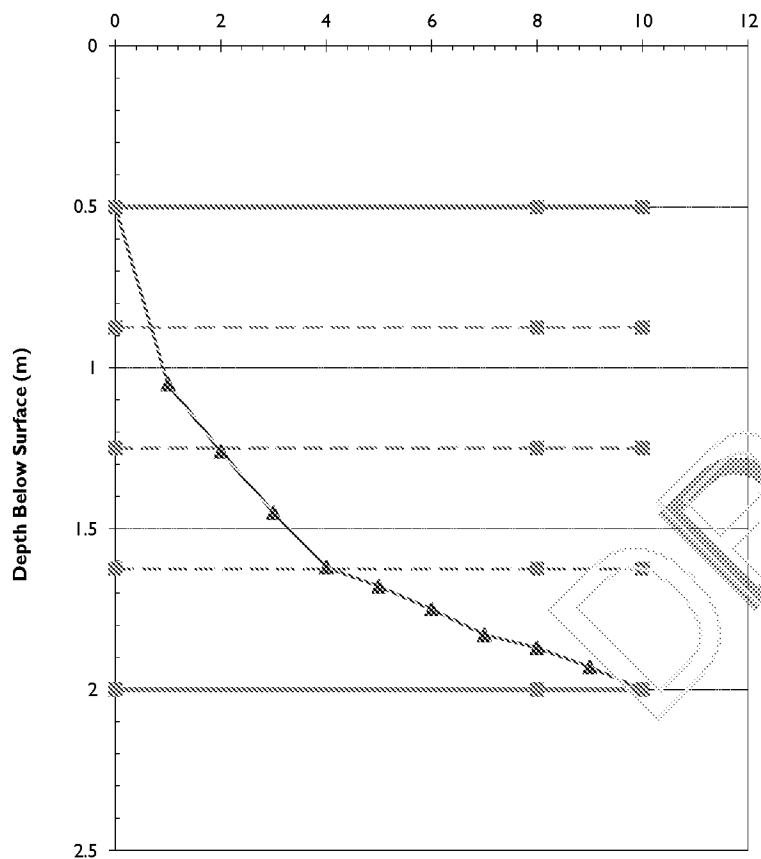
Test Hole No: TP309  
Test No: Test No 3

Filling to Max Water Depth (min)

| BRE Soil Infiltration Rate (m/sec) | 0.00015 |

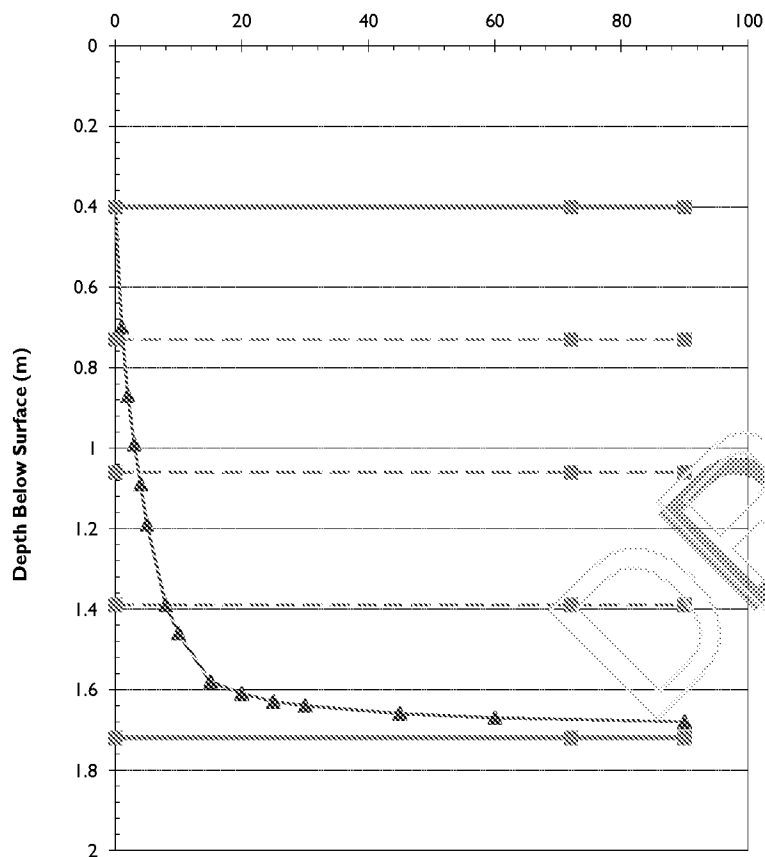
Test Hole No: TP310  
Test No: Test No 2

Filling to Max Water Depth (min)

| BRE Soil Infiltration Rate (m/sec) | 5.44E-05 |

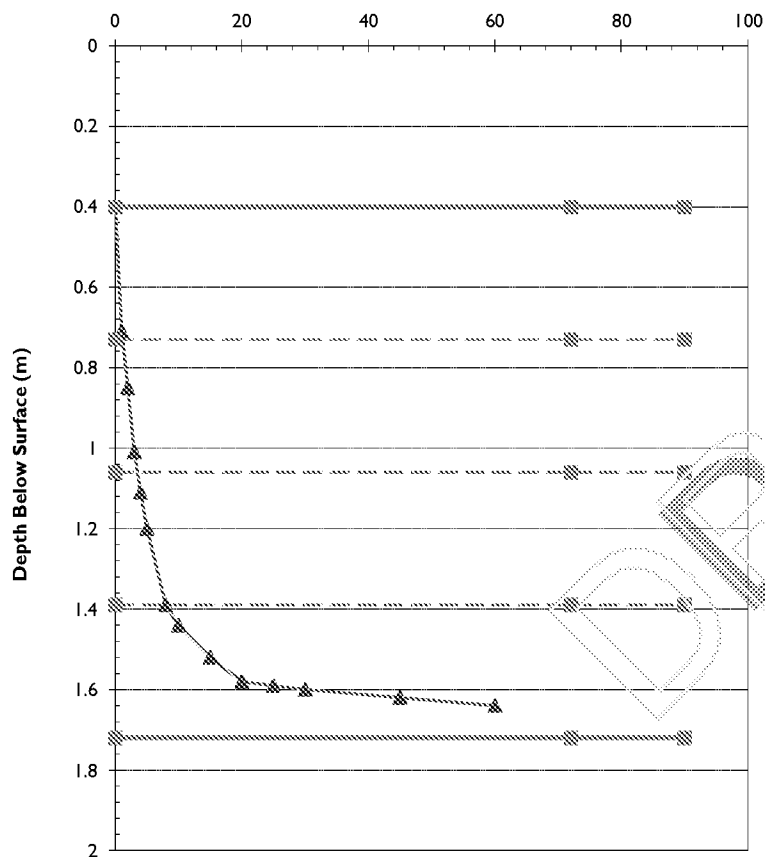
Test Hole No: TP310  
Test No: Test No 3

Filling to Max Water Depth (min)

| BRE Soil Infiltration Rate (m/sec) | 4.26E-05 |

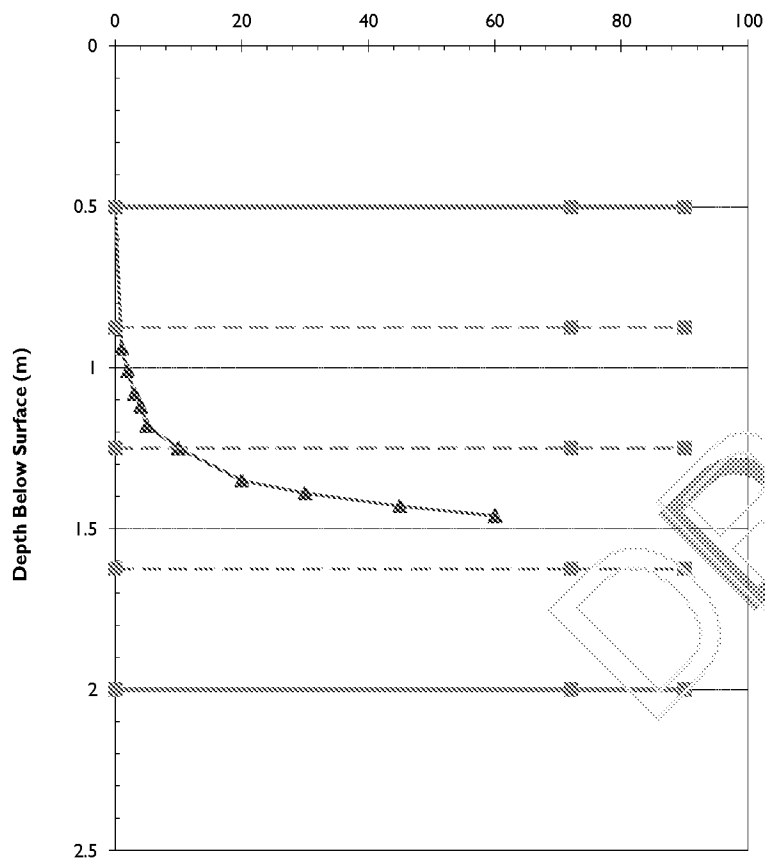
Test Hole No: TP311  
Test No: Test No 3

Filling to Max Water Depth (min)

| BRE Soil Infiltration Rate (m/sec) | 4.04E-06 |

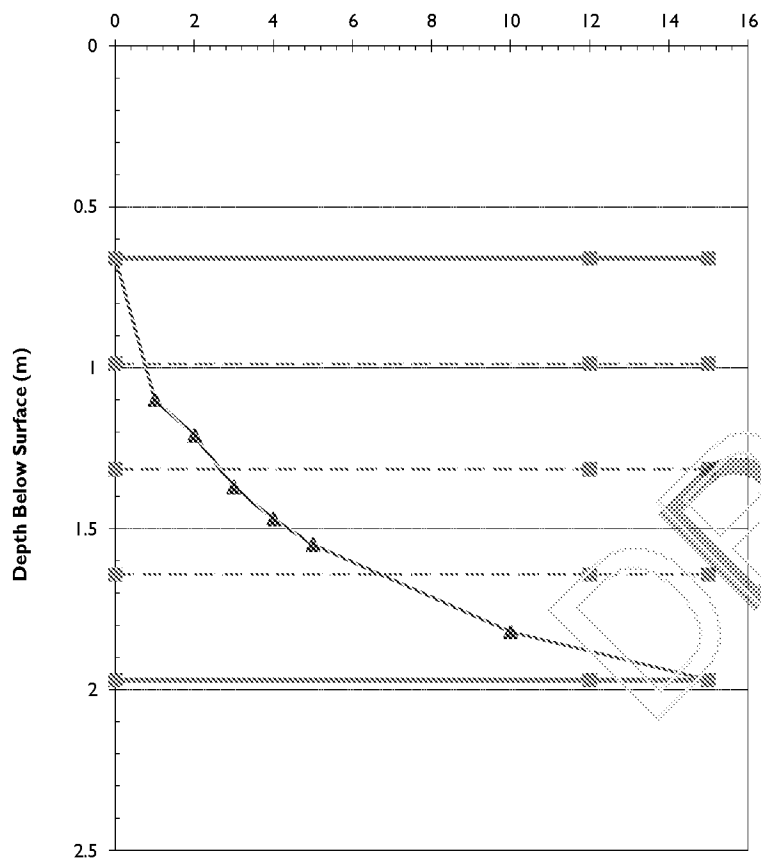
Test Hole No: TP315  
Test No: Test No 1

Filling to Max Water Depth (min)

| BRE Soil Infiltration Rate (m/sec) | 8.15E-05 |

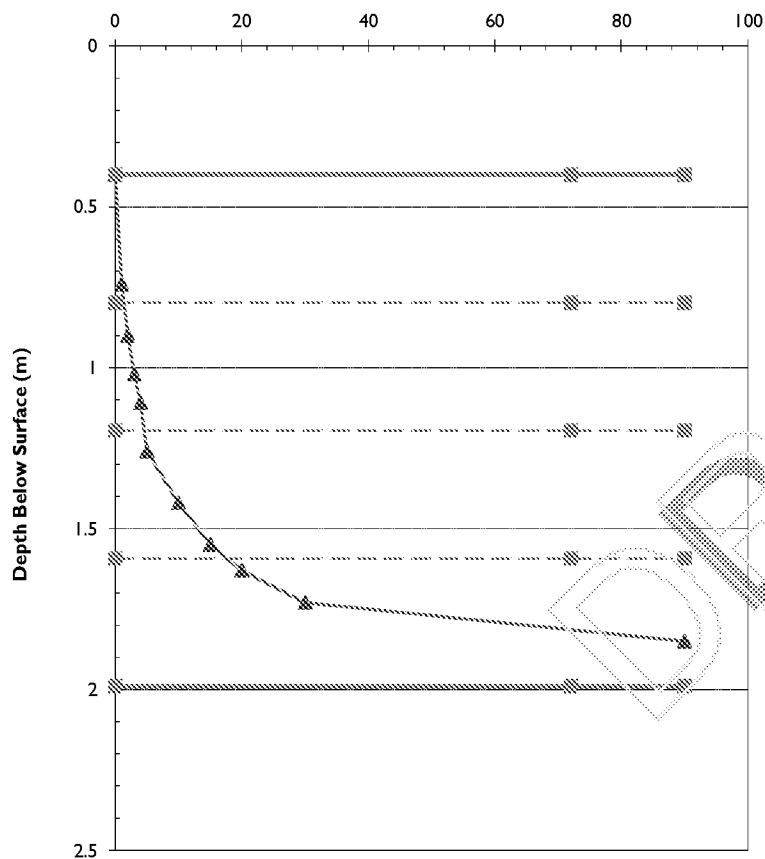
Test Hole No: TP316  
Test No: Test No 1

Filling to Max Water Depth (min)

| BRE Soil Infiltration Rate (m/sec) | 4.01E-05 |

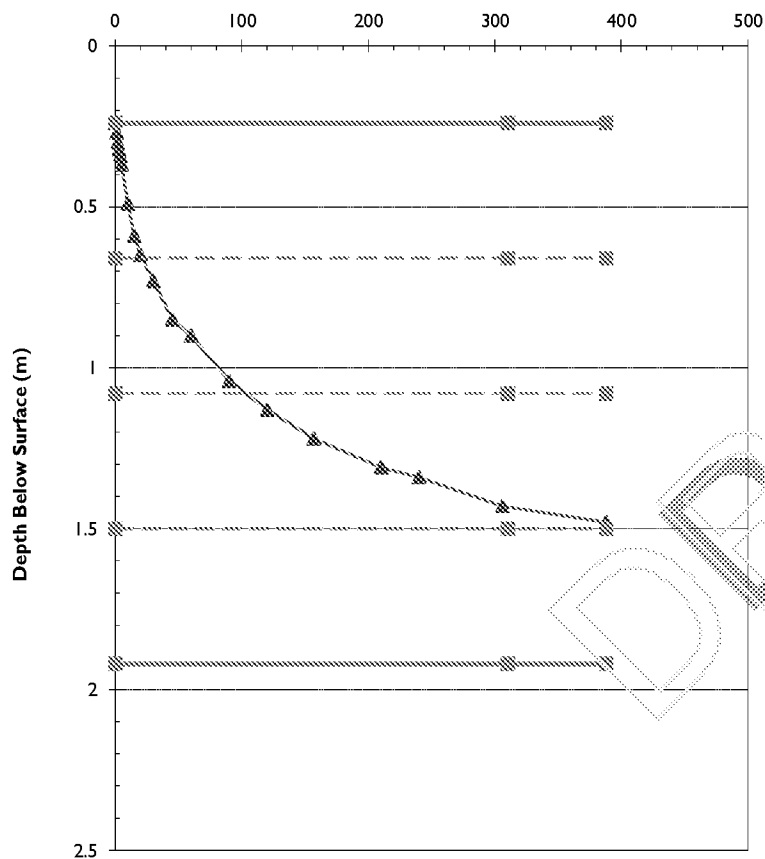
Test Hole No: TP319  
Test No: Test No 1

Filling to Max Water Depth (min)

| BRE Soil Infiltration Rate (m/sec) | 1.34E-06 |

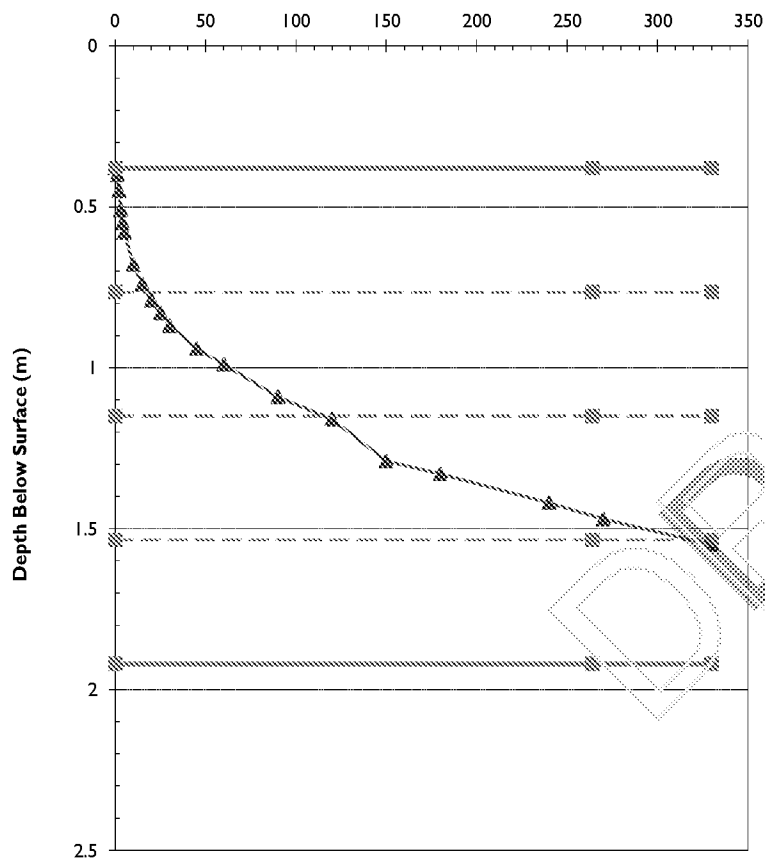
Test Hole No: TP319  
Test No: Test No 2

Filling to Max Water Depth (min)

| BRE Soil Infiltration Rate (m/sec) | 1.66E-06 |

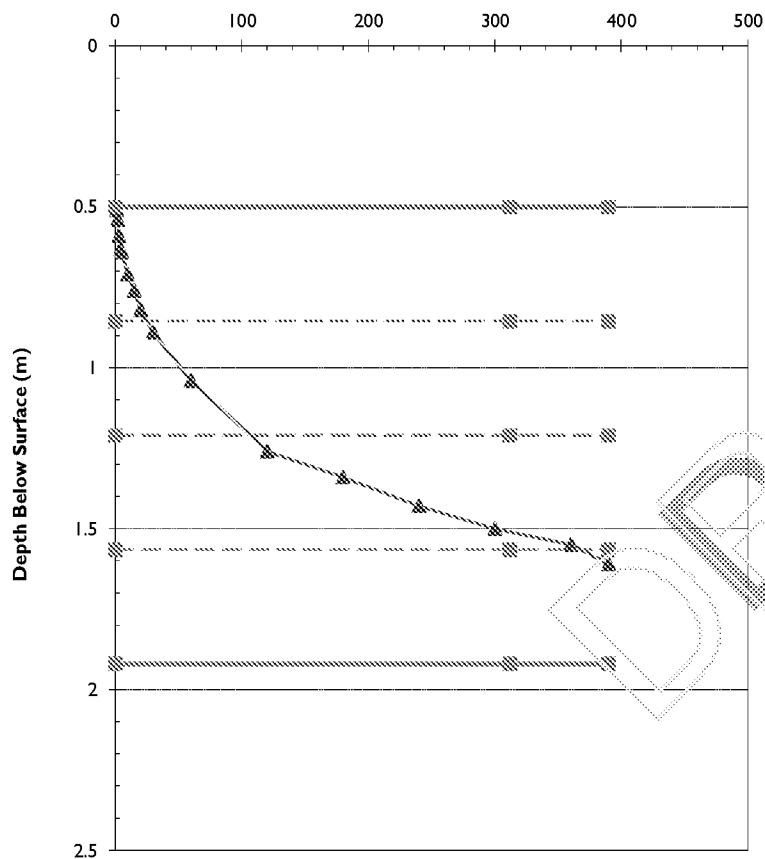
Test Hole No: TP319  
Test No: Test No 3

Filling to Max Water Depth (min)

| BRE Soil Infiltration Rate (m/sec) | 1.43E-06 |

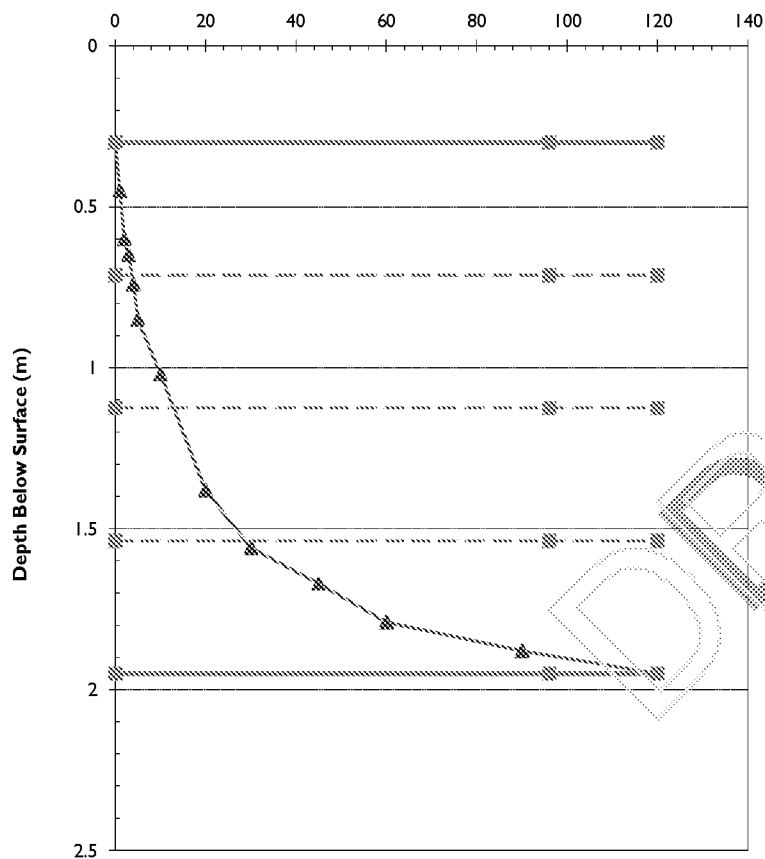
Test Hole No: TP321  
Test No: Test No 3

Filling to Max Water Depth (min)

| BRE Soil Infiltration Rate (m/sec) | 1.97E-05 |

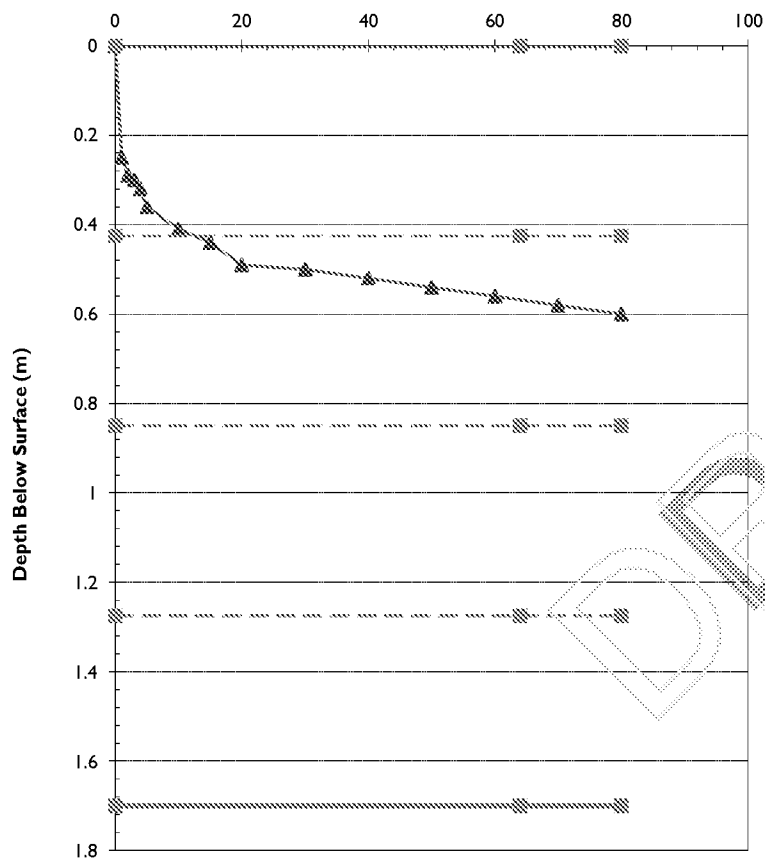
Test Hole No: TP323  
Test No: Test No 2

Filling to Max Water Depth (min)

| BRE Soil Infiltration Rate (m/sec) | 8.39E-06 |

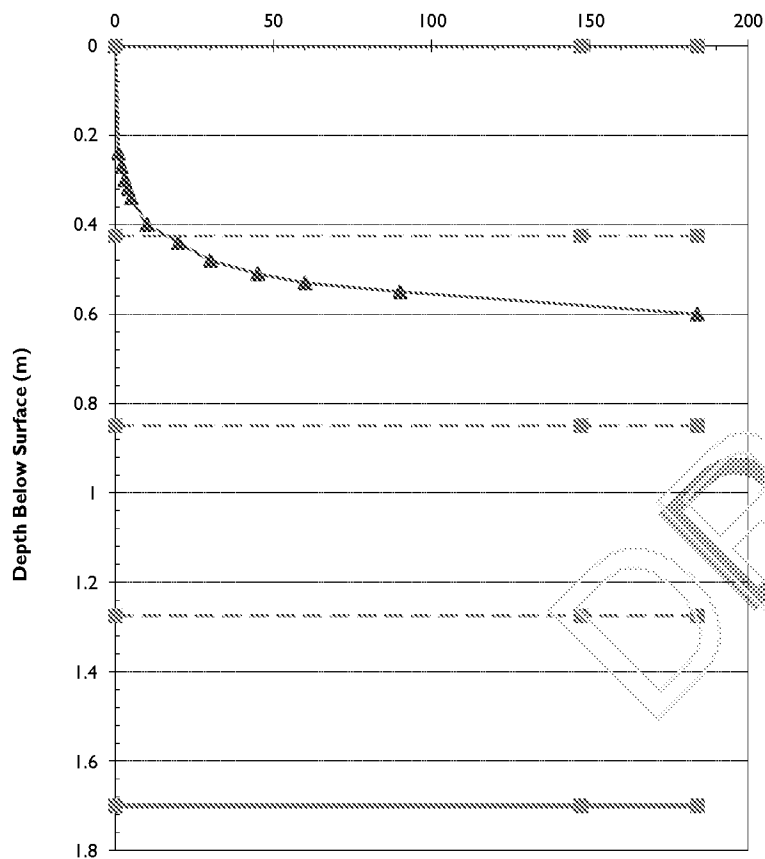
Test Hole No: TP323  
Test No: Test No 3

Filling to Max Water Depth (min)

| BRE Soil Infiltration Rate (m/sec) | 3.63E-06 |

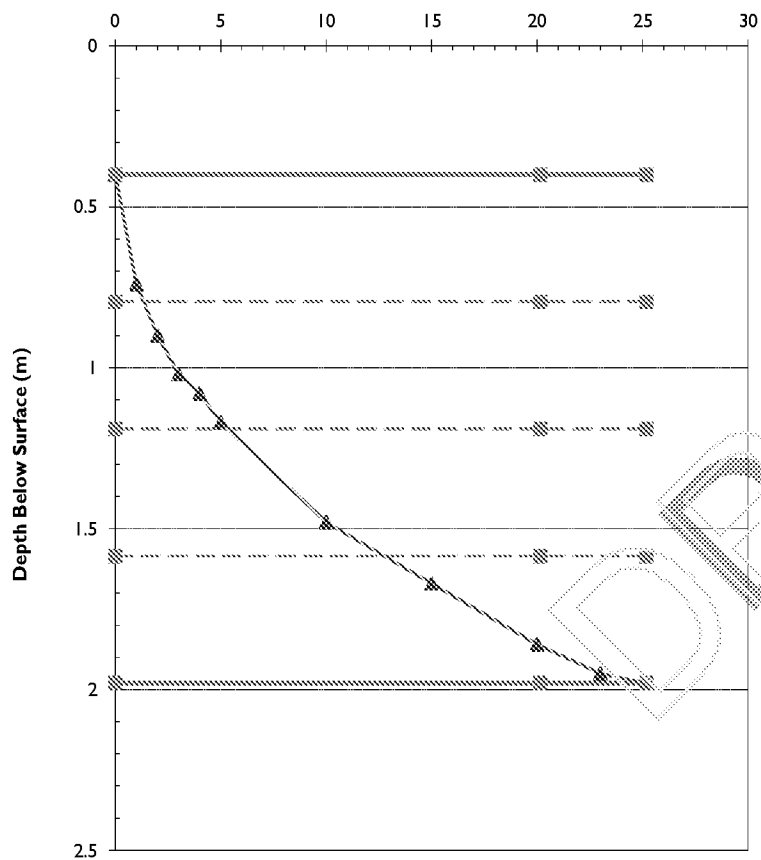
Test Hole No: TP324  
Test No: Test No 2

Filling to Max Water Depth (min)

| BRE Soil Infiltration Rate (m/sec) | 4.34E-05 |

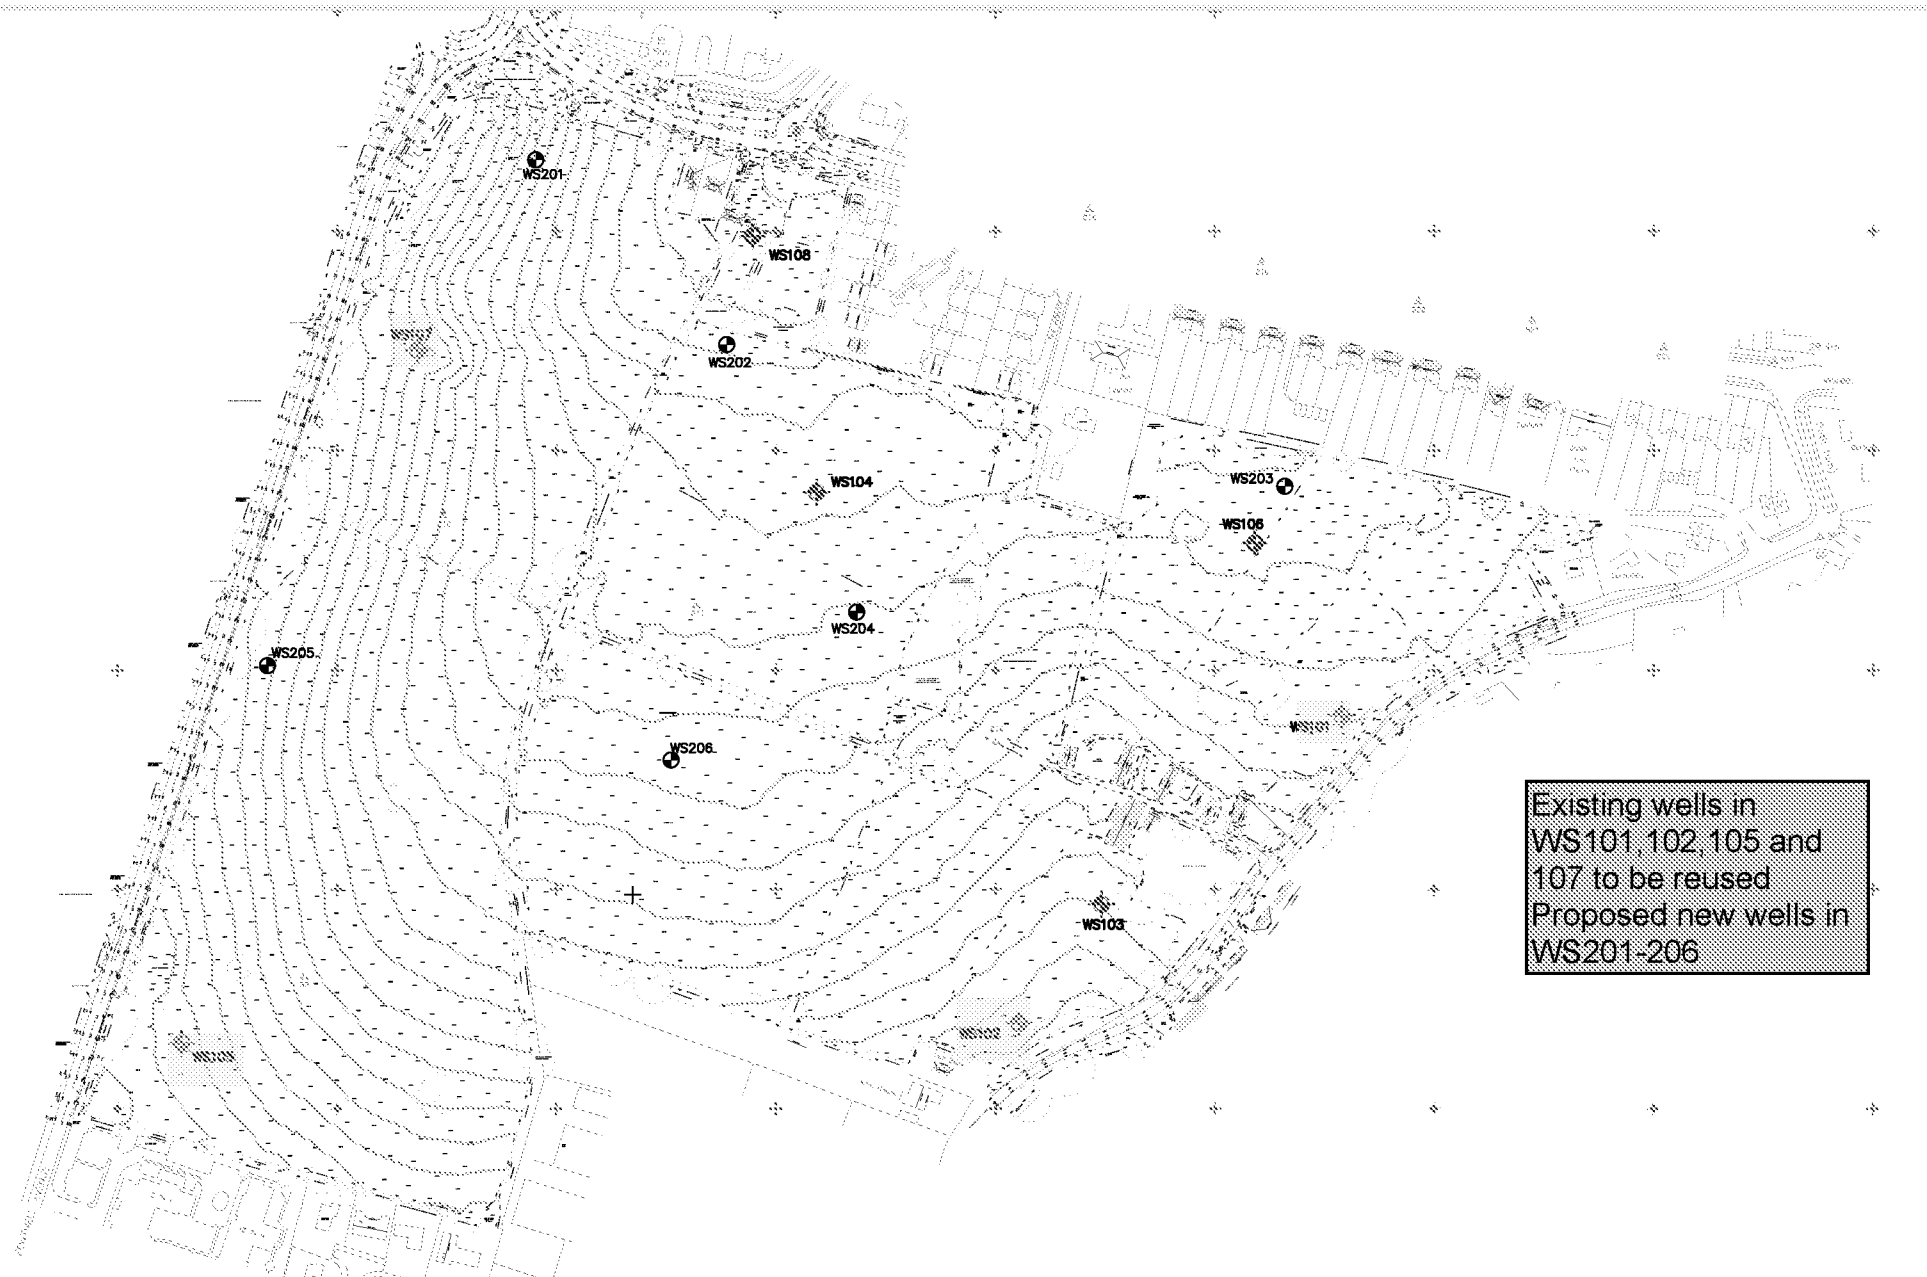
| Project | Northfield Cottages, Fontwell | Scale at A4 | NTS | Fig No. | 2 |

| Title | Proposed Shallow Groundwater Monitoring Well Locations | | | | |

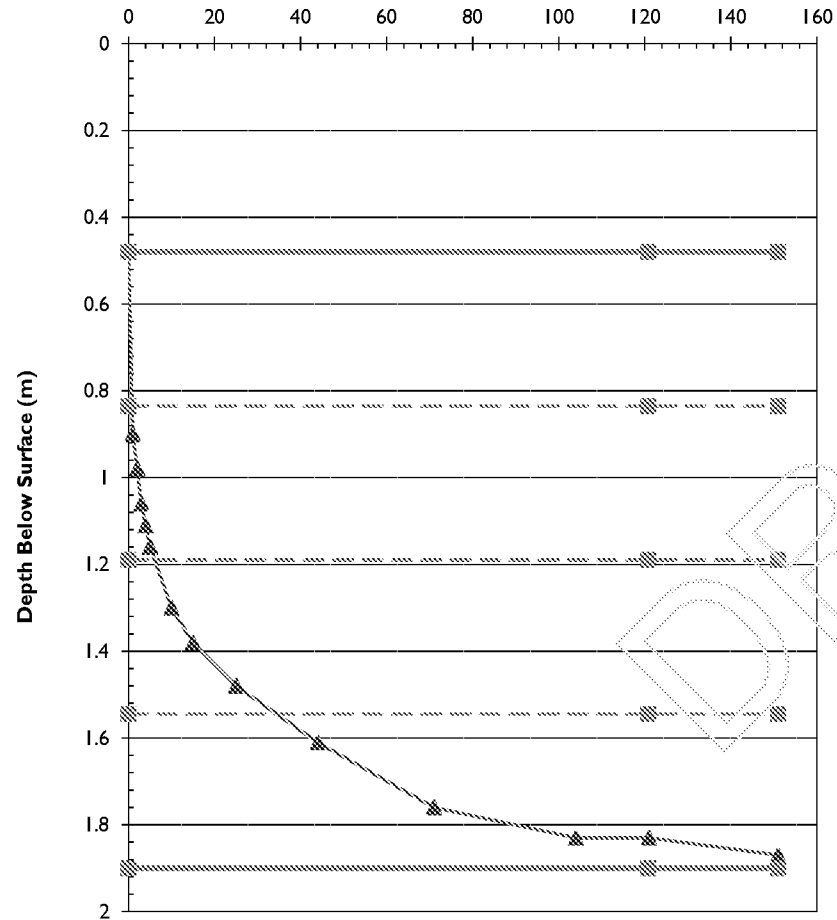
Test Hole No: TP303  
Test No: Test No 1

Filling to Max Water Depth (min)

| BRE Soil Infiltration Rate (m/sec) | 2.544E-05 |
