| Project Name: Fontwell Additional Shallow Soaks | | | | Project No.<br>LP01878 | | Co-ords: -<br>Level: | | Date<br>04/03/2019 | |
| Location: Land near Fontwell, BN18 0SW | | | | | | Dimensions (m):<br><div style="display: flex; align-items: center; justify-content: space-between;"> <div>Depth<br/>2.00</div> <div style="border: 1px solid black; width: 100px; height: 30px; display: flex; align-items: center; justify-content: center;"> <div style="writing-mode: vertical-rl; transform: rotate(180deg); font-size: 10px;">47</div> <div style="margin-left: 10px;">182</div> </div> </div> | | Scale<br>1:25<br>Logged<br>SN | |
| Client: Dandara Ltd | | | | | | | | | |

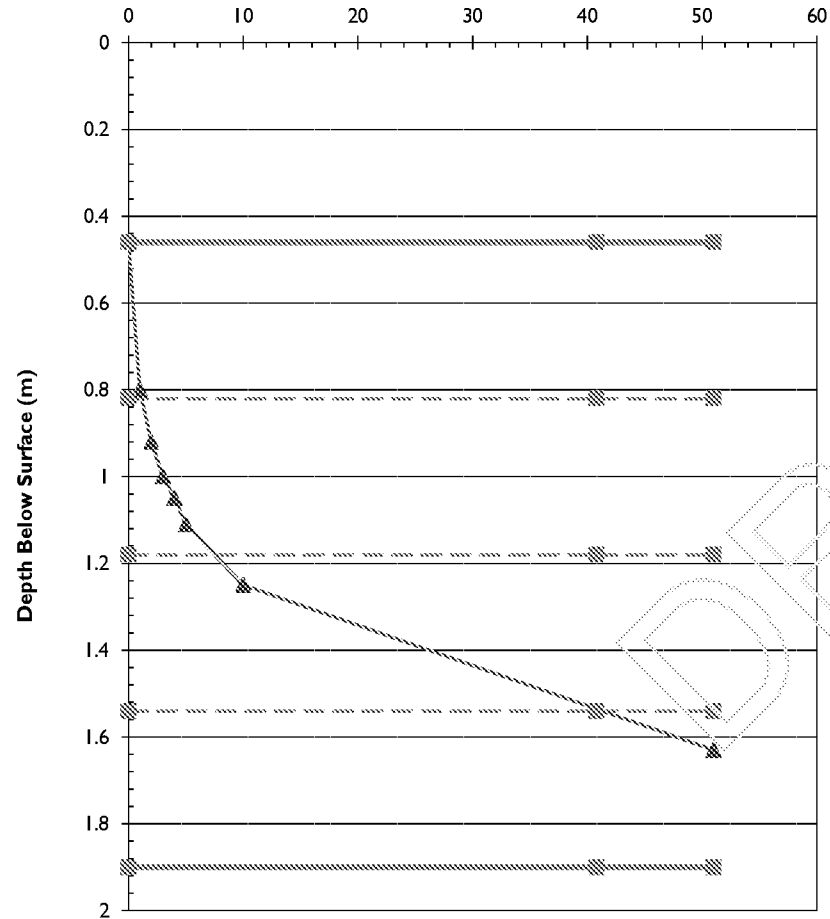
Test Hole No: TP303  
Test No: Test No 2

Filling to Max Water Depth (min)

| BRE Soil Infiltration Rate (m/sec) | 2.14E-05 |

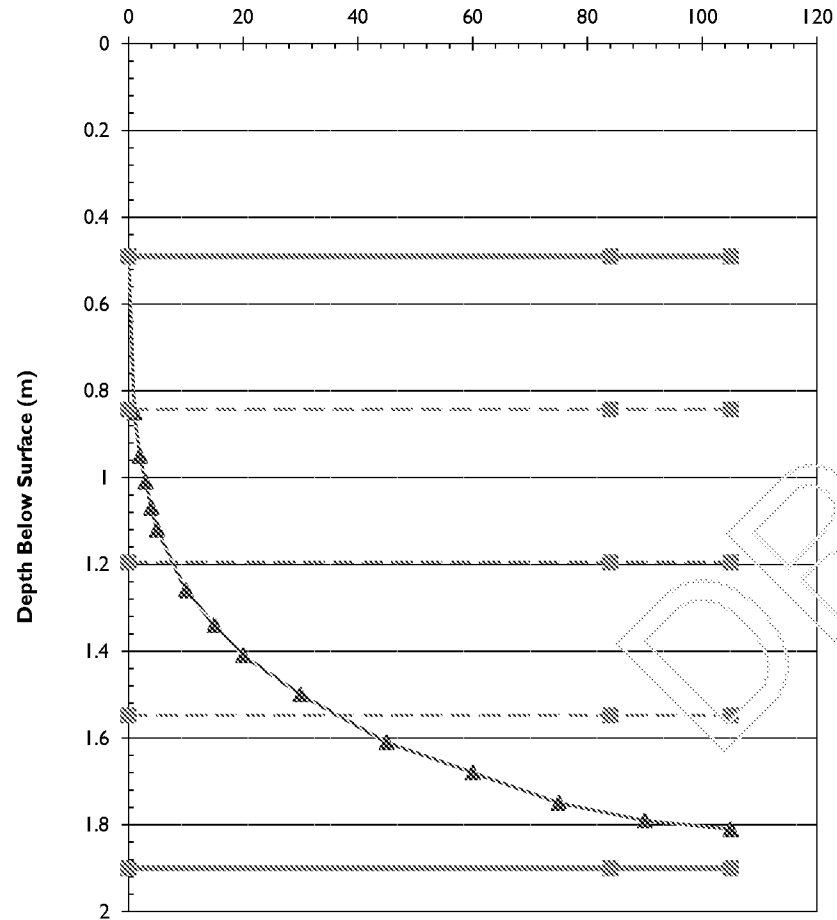
Test Hole No: TP303  
Test No: Test No 3

Filling to Max Water Depth (min)

| BRE Soil Infiltration Rate (m/sec) | 2.408E-05 |

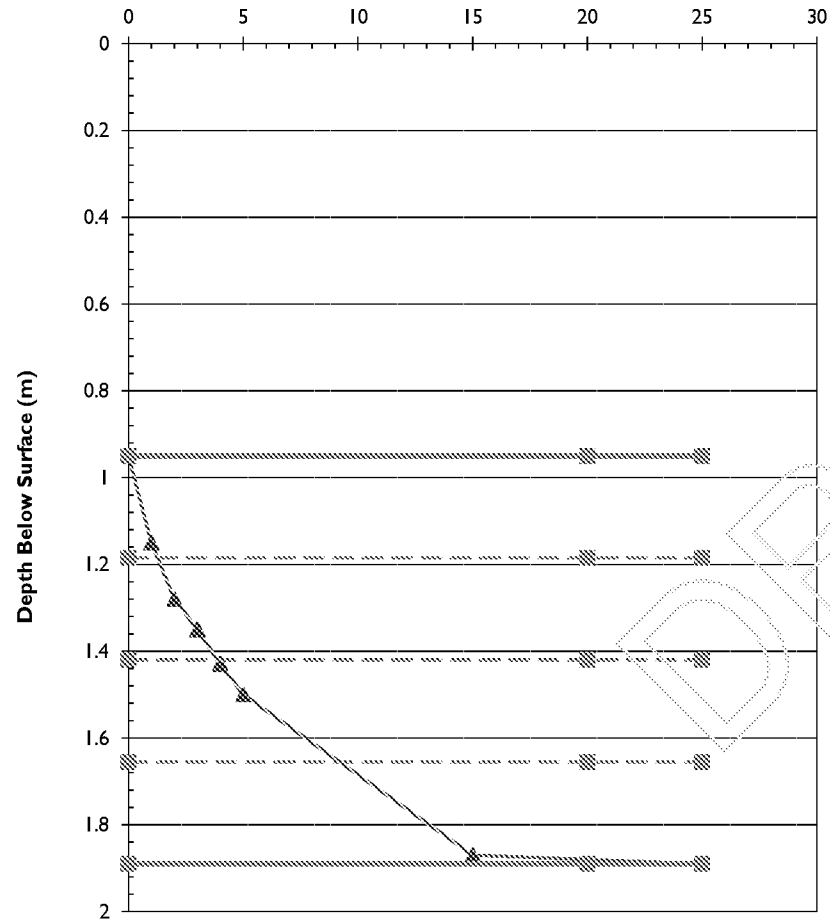
Test Hole No: TP304  
Test No: Test No 1

Filling to Max Water Depth (min)

| BRE Soil Infiltration Rate (m/sec) | 9.844E-05 |

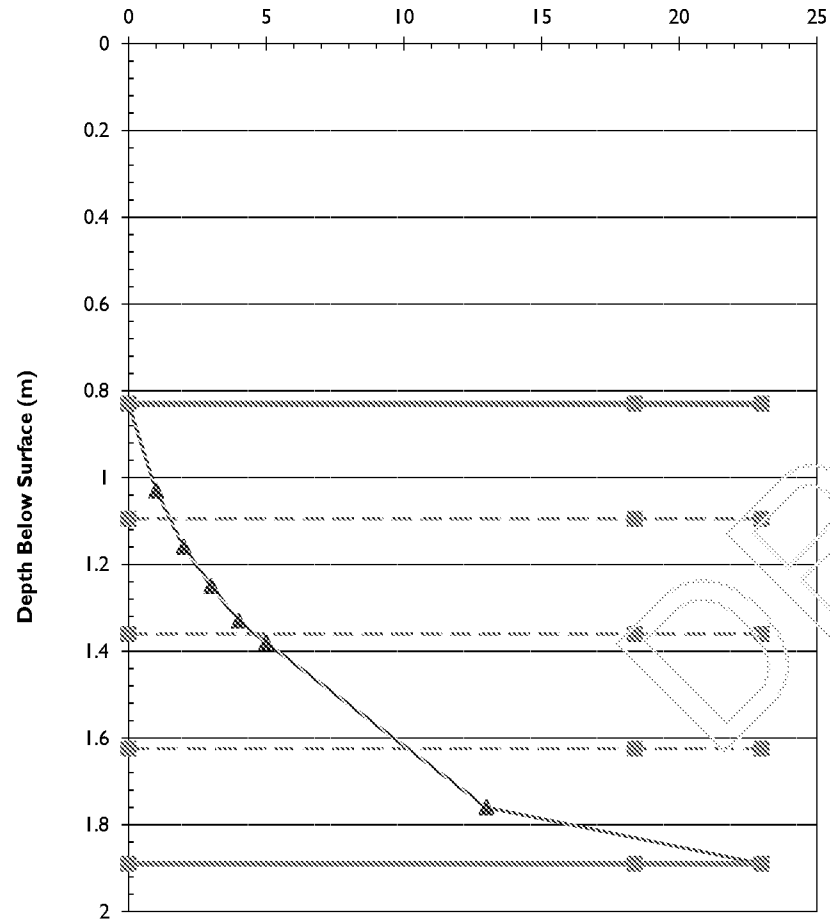
Test Hole No: TP304  
Test No: Test No 2

Filling to Max Water Depth (min)

| BRE Soil Infiltration Rate (m/sec) | 9.305E-05 |

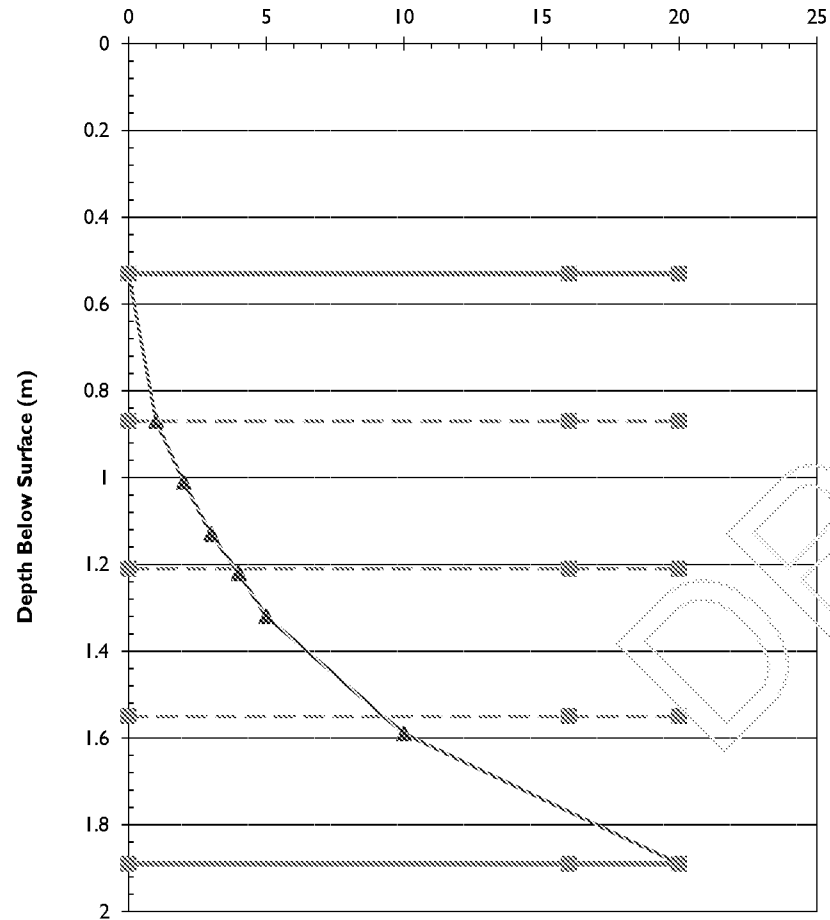
Test Hole No: TP304  
Test No: Test No 3

Filling to Max Water Depth (min)

| BRE Soil Infiltration Rate (m/sec) | 0.0001035 |

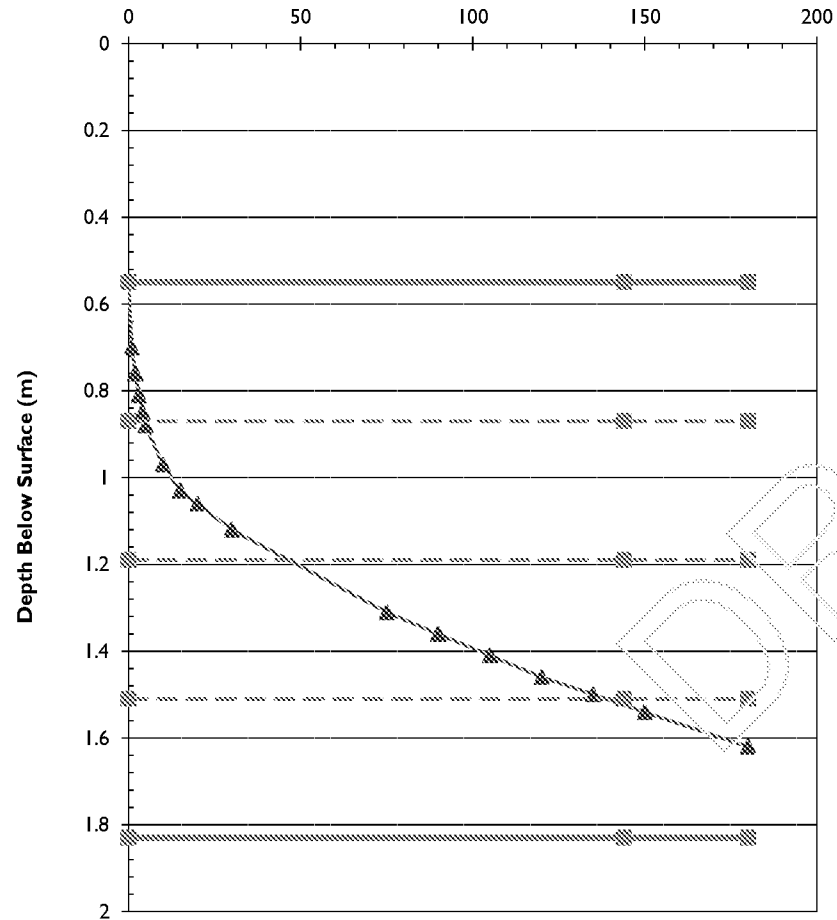
Test Hole No: TP305  
Test No: Test No 1

Filling to Max Water Depth (min)

| BRE Soil Infiltration Rate (m/sec) | 6.114E-06 |

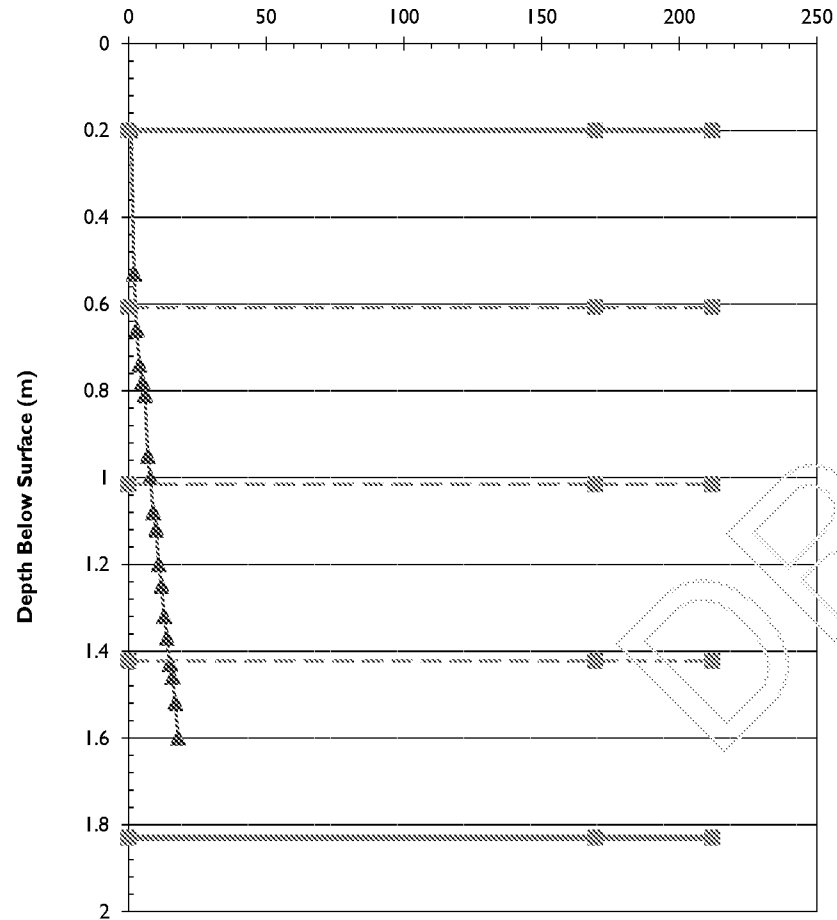
Test Hole No: TP305  
Test No: Test No 2

Filling to Max Water Depth (min)

| BRE Soil Infiltration Rate (m/sec) | 8.475E-06 |

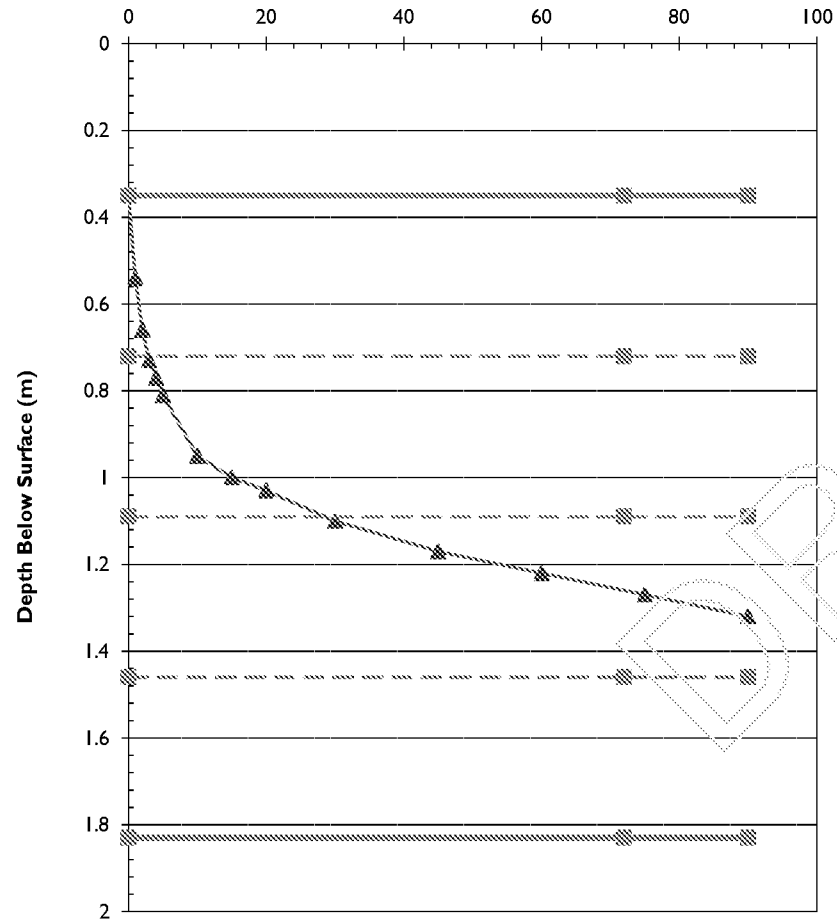
Test Hole No: TP305  
Test No: Test No 3

Filling to Max Water Depth (min)

| BRE Soil Infiltration Rate (m/sec) | 7.306E-06 |

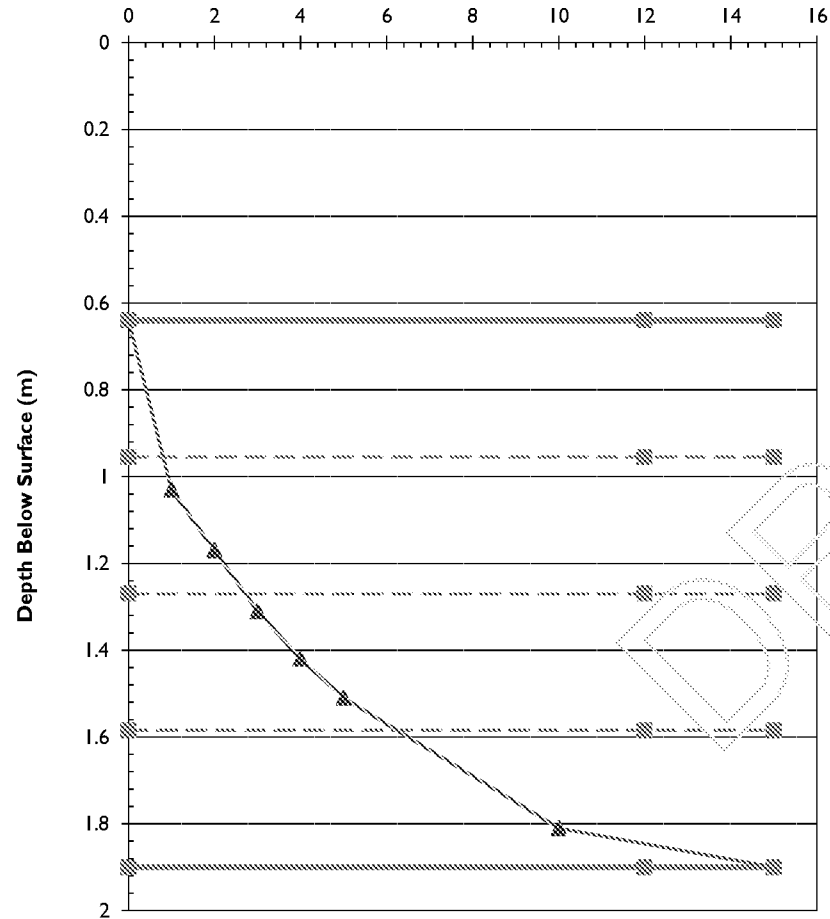
Test Hole No: TP311  
Test No: Test No 1

Filling to Max Water Depth (min)

| BRE Soil Infiltration Rate (m/sec) | 0.0004449 |

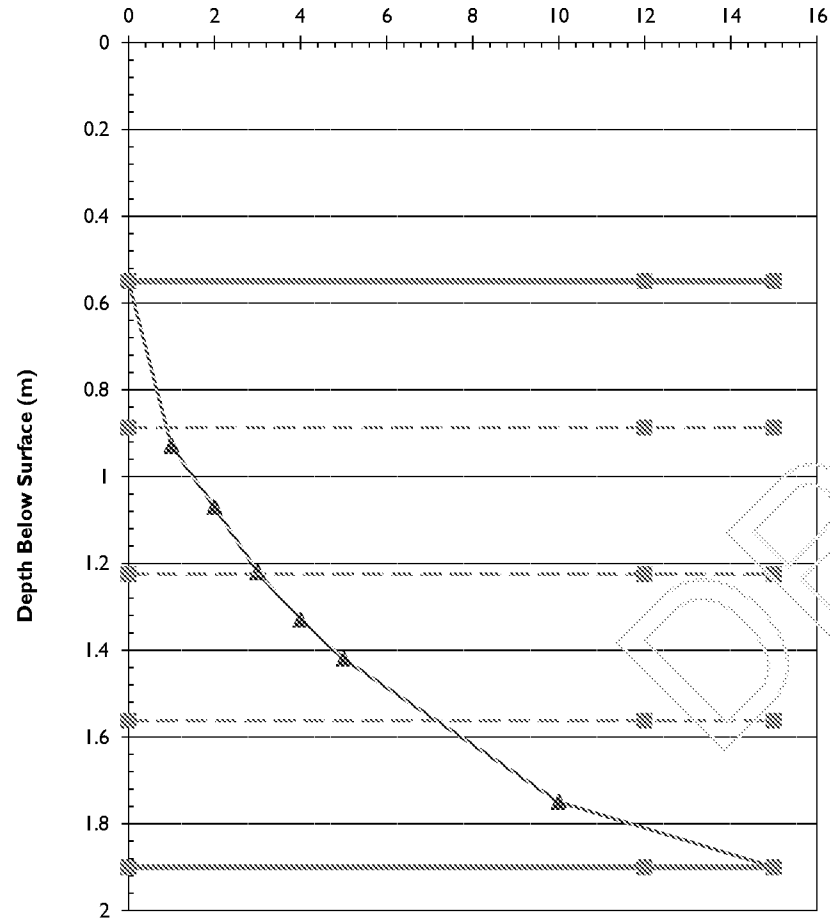
Test Hole No: TP311  
Test No: Test No 2

Filling to Max Water Depth (min)

| BRE Soil Infiltration Rate (m/sec) | 0.0003921 |

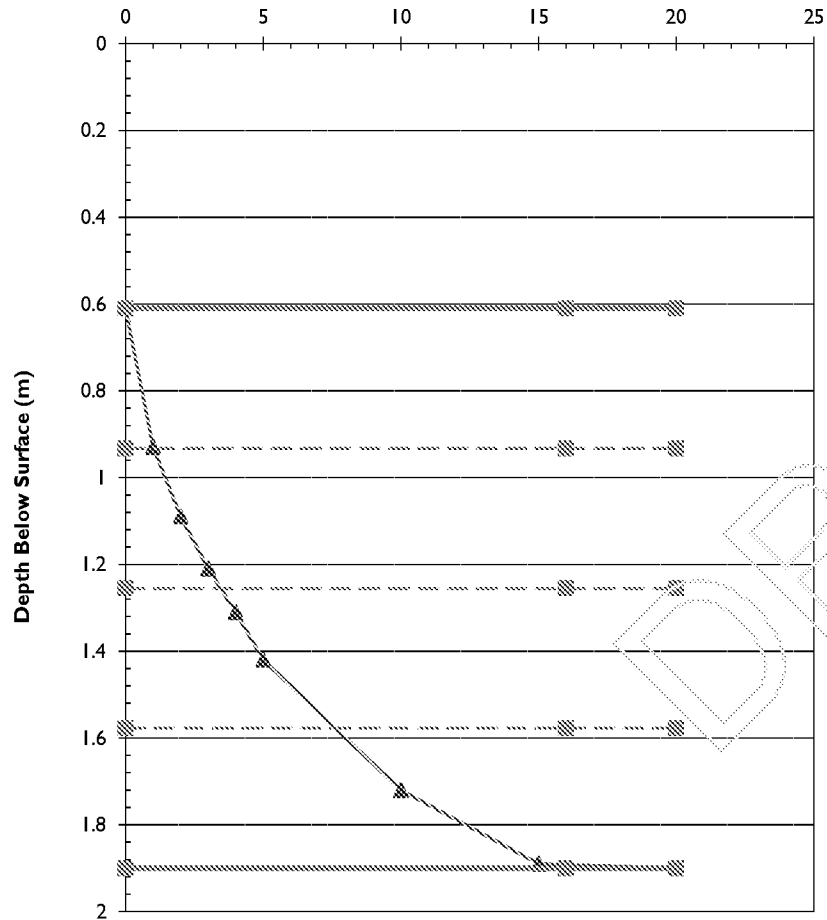
Test Hole No: TP311  
Test No: Test No 3

Filling to Max Water Depth (min)

| BRE Soil Infiltration Rate (m/sec) | 0.0003683 |

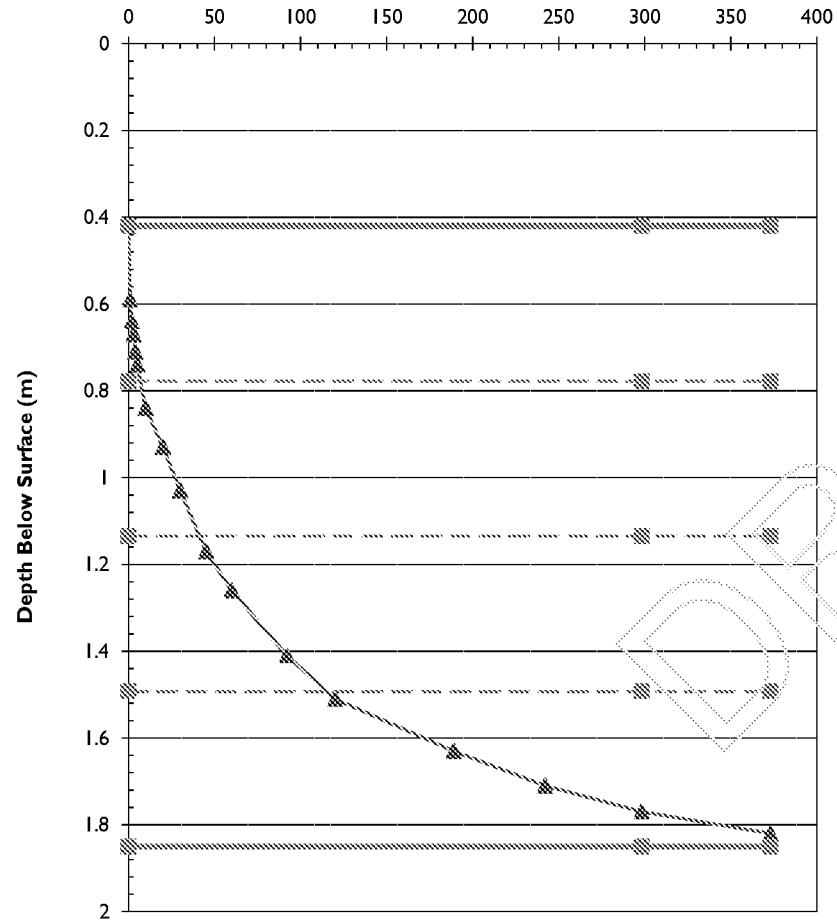
Test Hole No: TP319  
Test No: Test No 1

Filling to Max Water Depth (min)

| BRE Soil Infiltration Rate (m/sec) | 2.272E-05 |

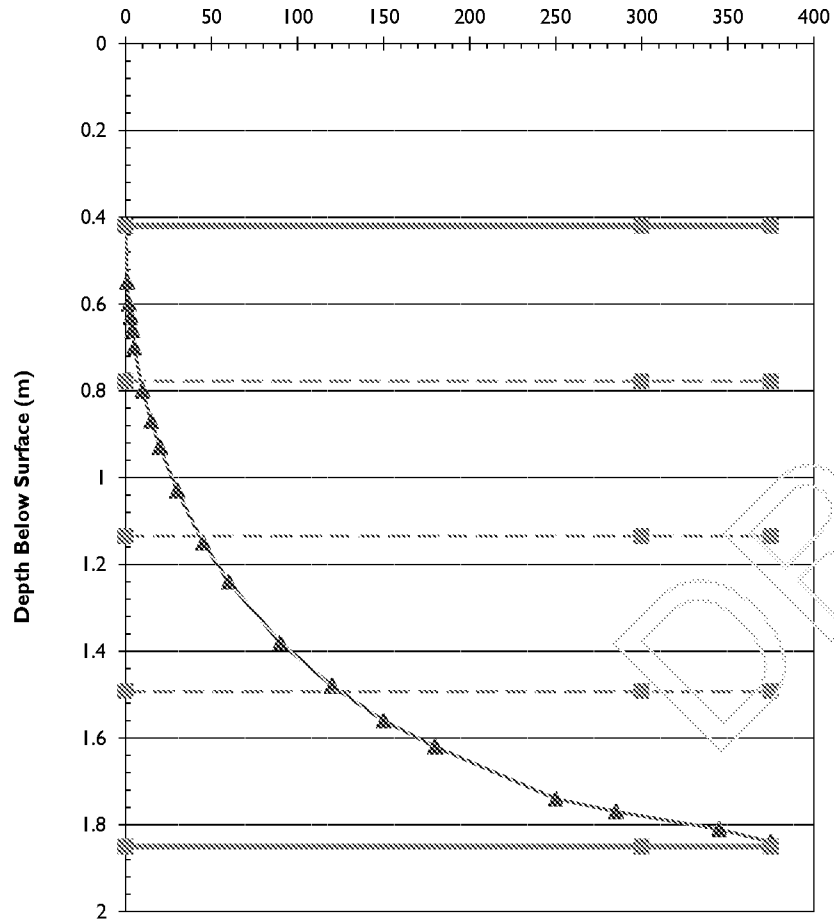
Test Hole No: TP319  
Test No: Test No 2

Filling to Max Water Depth (min)

| BRE Soil Infiltration Rate (m/sec) | 2.123E-05 |

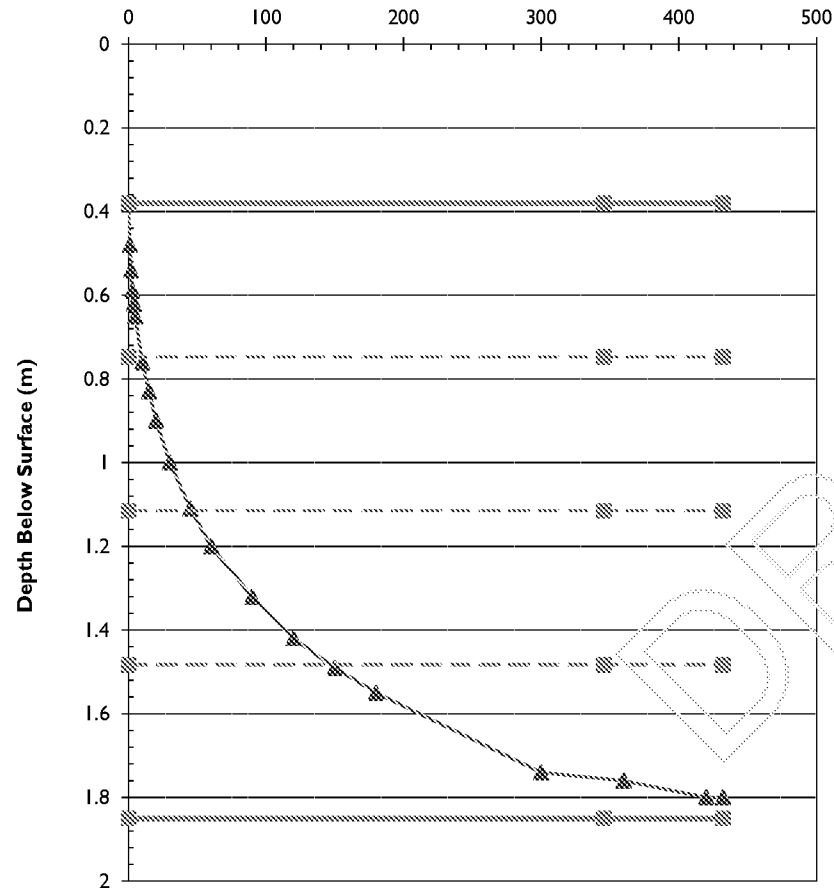
Test Hole No: TP319  
Test No: Test No 3

Filling to Max Water Depth (min)

| BRE Soil Infiltration Rate (m/sec) | 1.8E-05 |

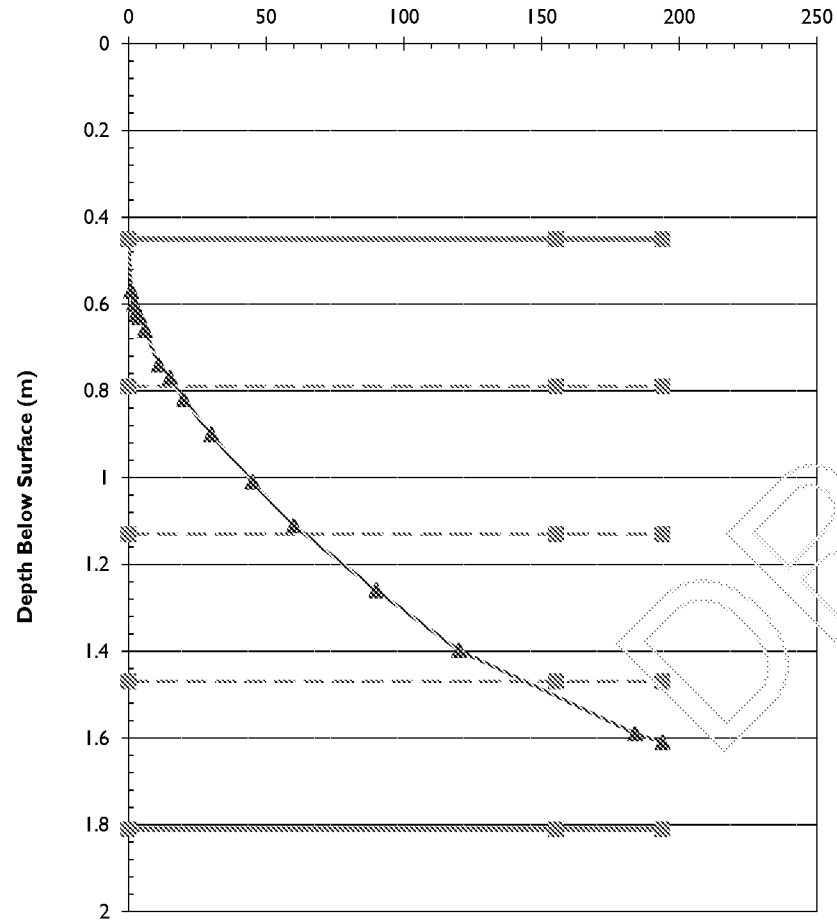
Test Hole No: TP323  
Test No: Test No 1

Filling to Max Water Depth (min)

| BRE Soil Infiltration Rate (m/sec) | 1.909E-05 |

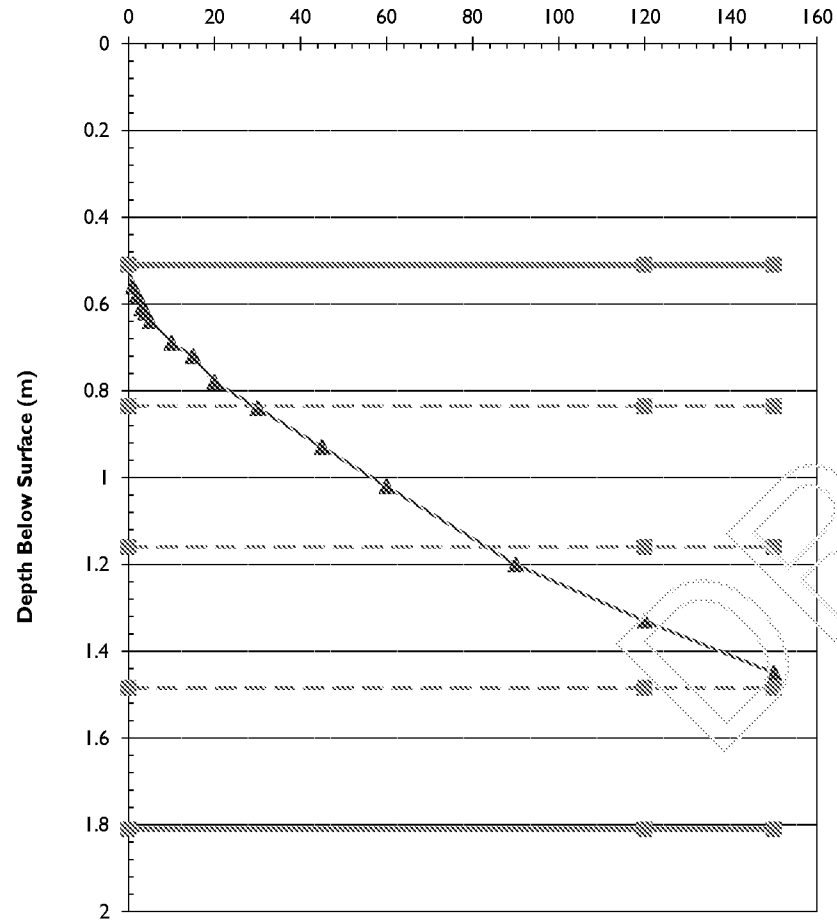
Test Hole No: TP323  
Test No: Test No 2

Filling to Max Water Depth (min)

| BRE Soil Infiltration Rate (m/sec) | 1.841E-05 |

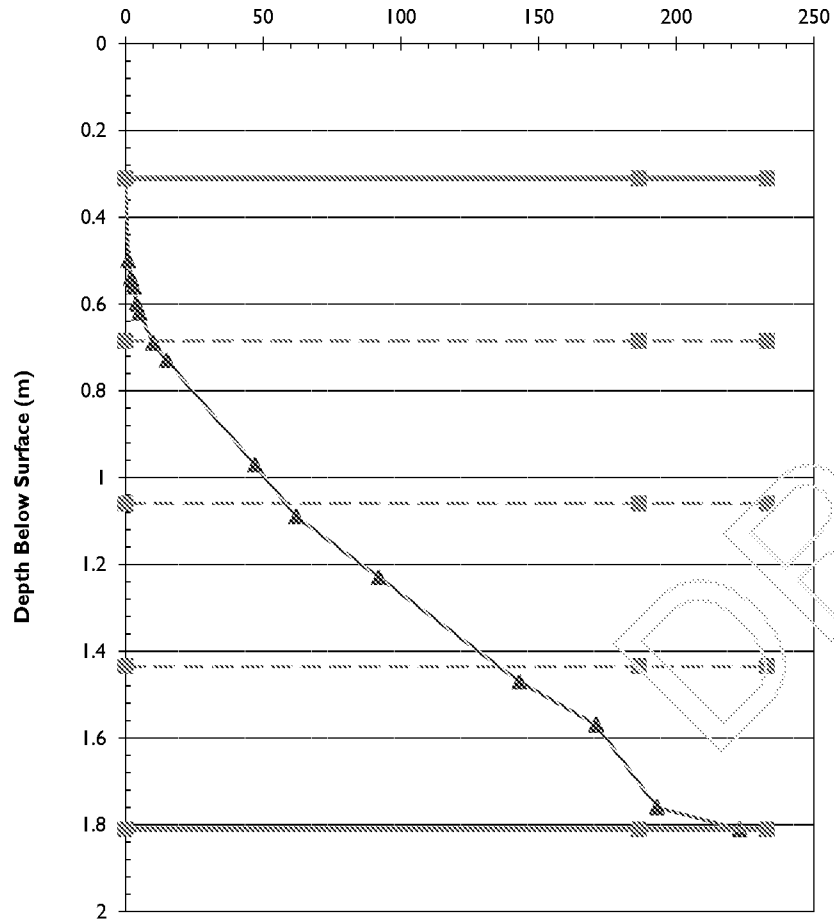
Test Hole No: TP323  
Test No: Test No 3

Filling to Max Water Depth (min)

| BRE Soil Infiltration Rate (m/sec) | 1.964E-05 |

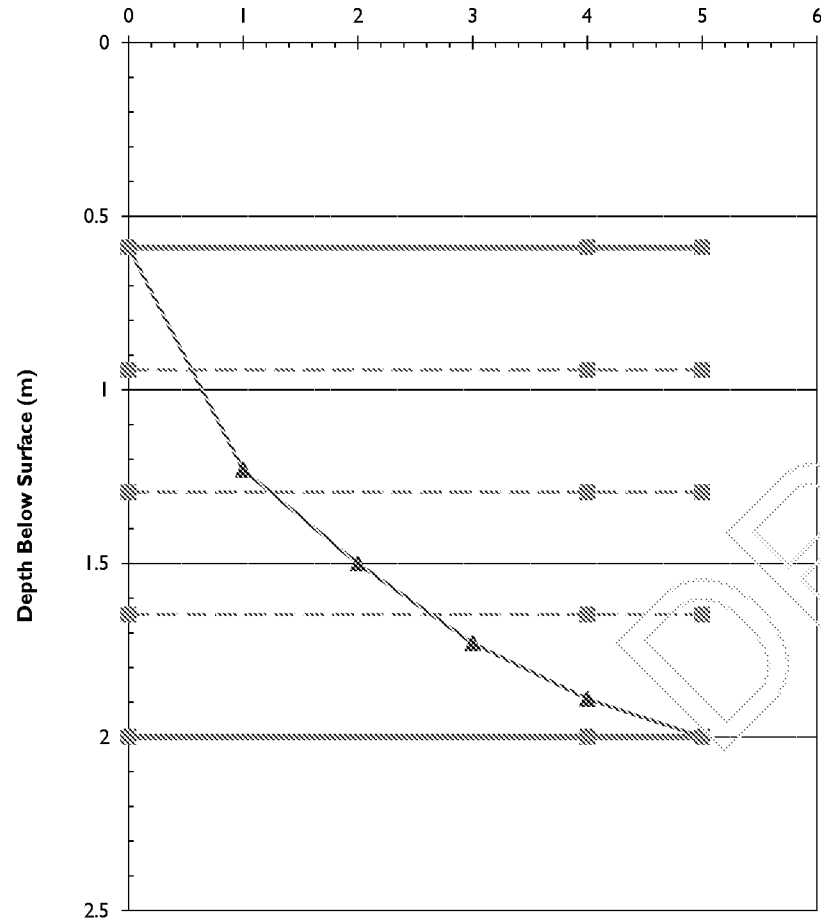
Test Hole No: TP401  
Test No: Test No 1

Filling to Max Water Depth (min)

| BRE Soil Infiltration Rate (m/sec) | 0.0004558 |

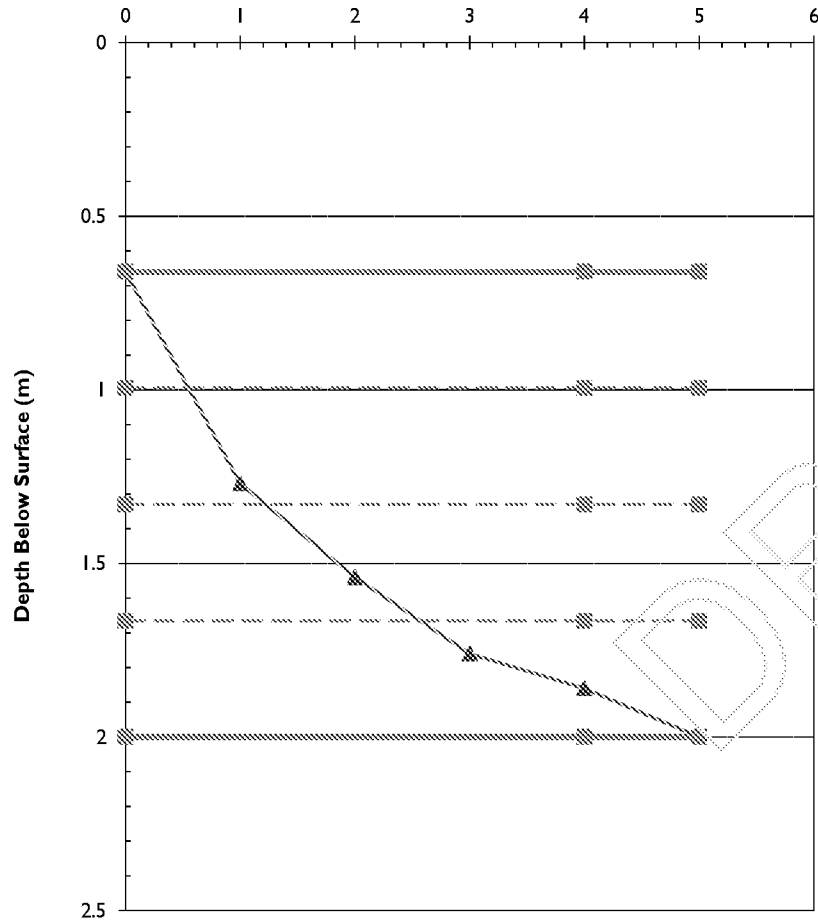
Test Hole No: TP401  
Test No: Test No 2

Filling to Max Water Depth (min)

| BRE Soil Infiltration Rate (m/sec) | 0.0004663 |

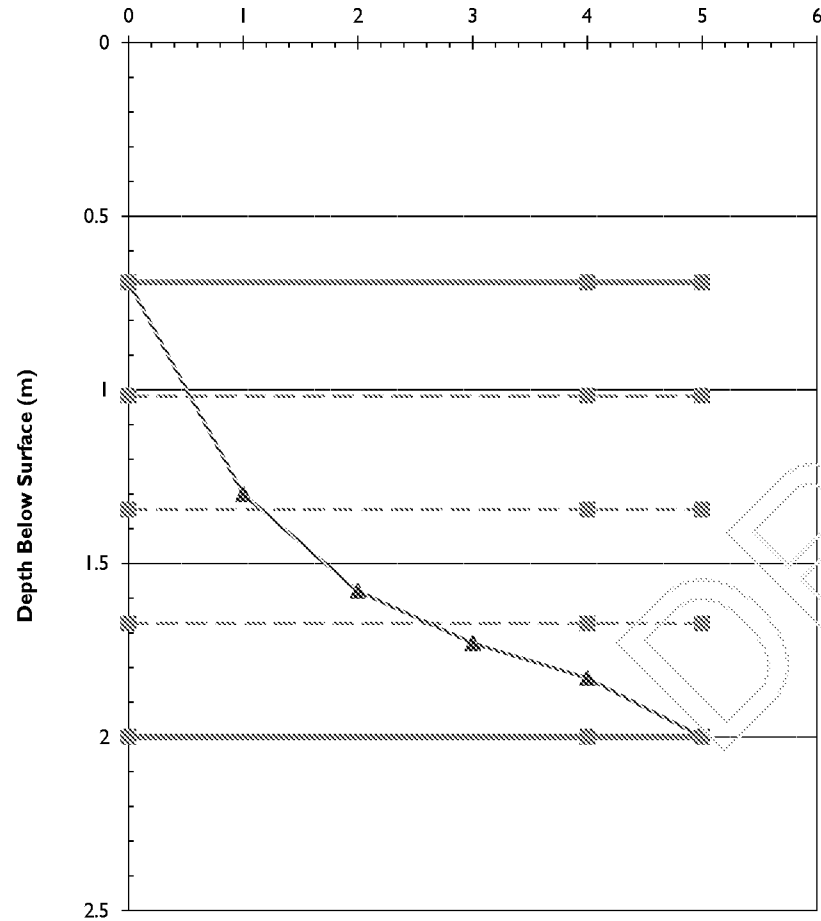
Test Hole No: TP401  
Test No: Test No 3

Filling to Max Water Depth (min)

| BRE Soil Infiltration Rate (m/sec) | 0.0004502 |

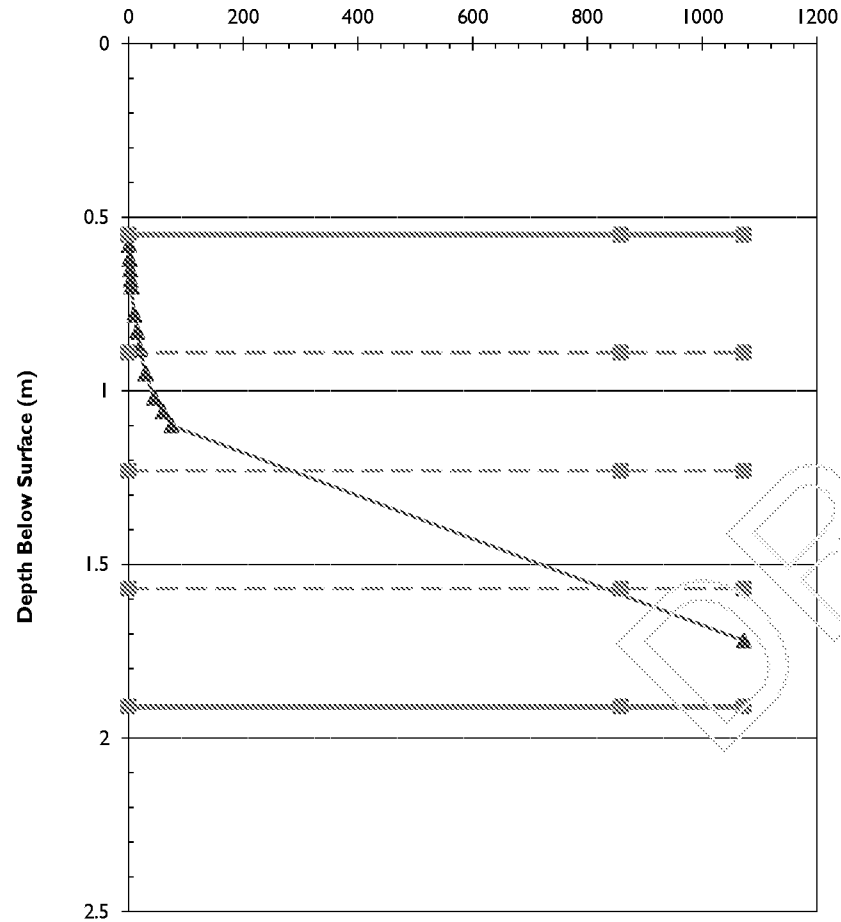
Test Hole No: TP402

Filling to Max Water Depth (min)

| BRE Soil Infiltration Rate (m/sec) | 1.169E-06 |

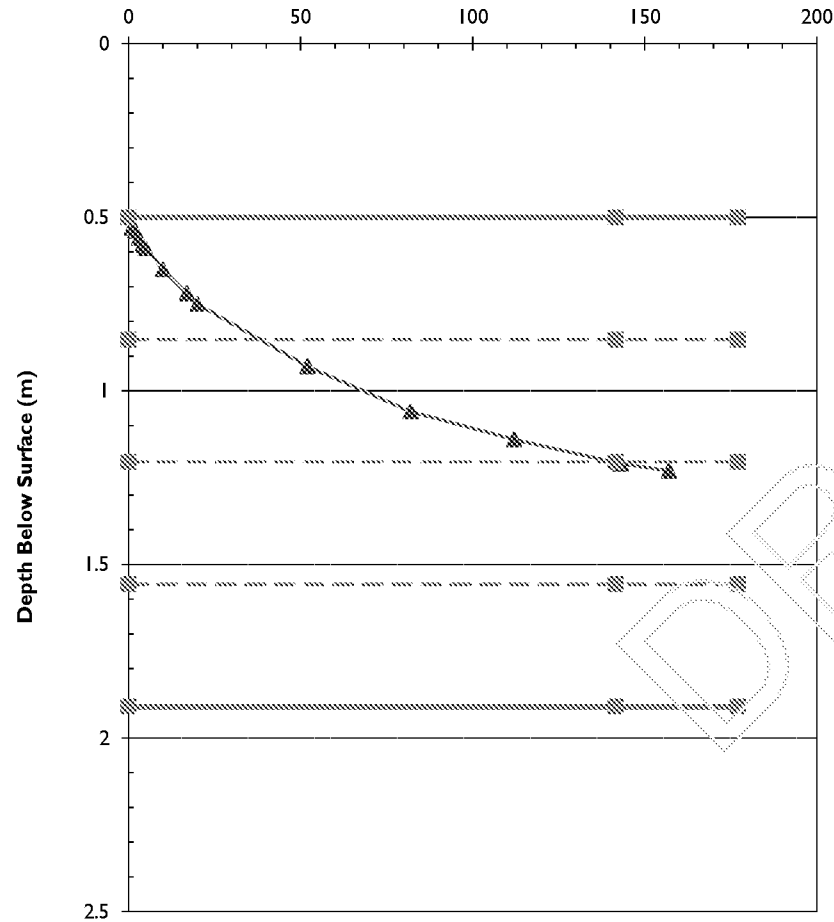
Test Hole No: TP402  
Test No: Test No 2

Filling to Max Water Depth (min)

| BRE Soil Infiltration Rate (m/sec) | 3.407E-06 |

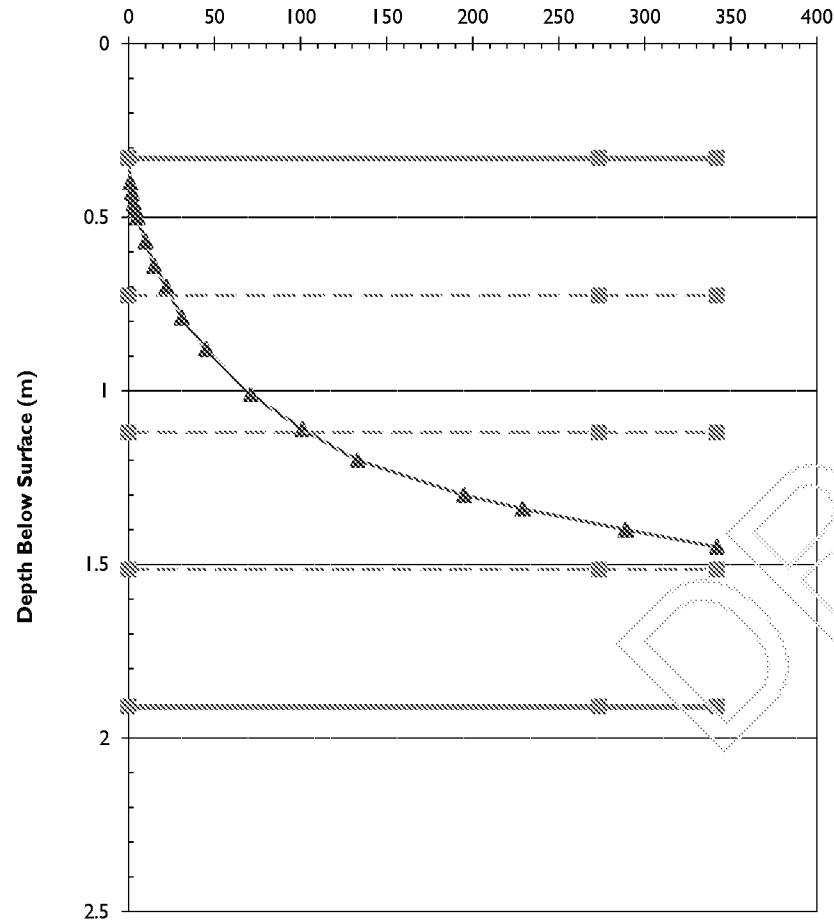
Test Hole No: TP402  
Test No: Test No 3

Filling to Max Water Depth (min)

| BRE Soil Infiltration Rate (m/sec) | 2.743E-06 |

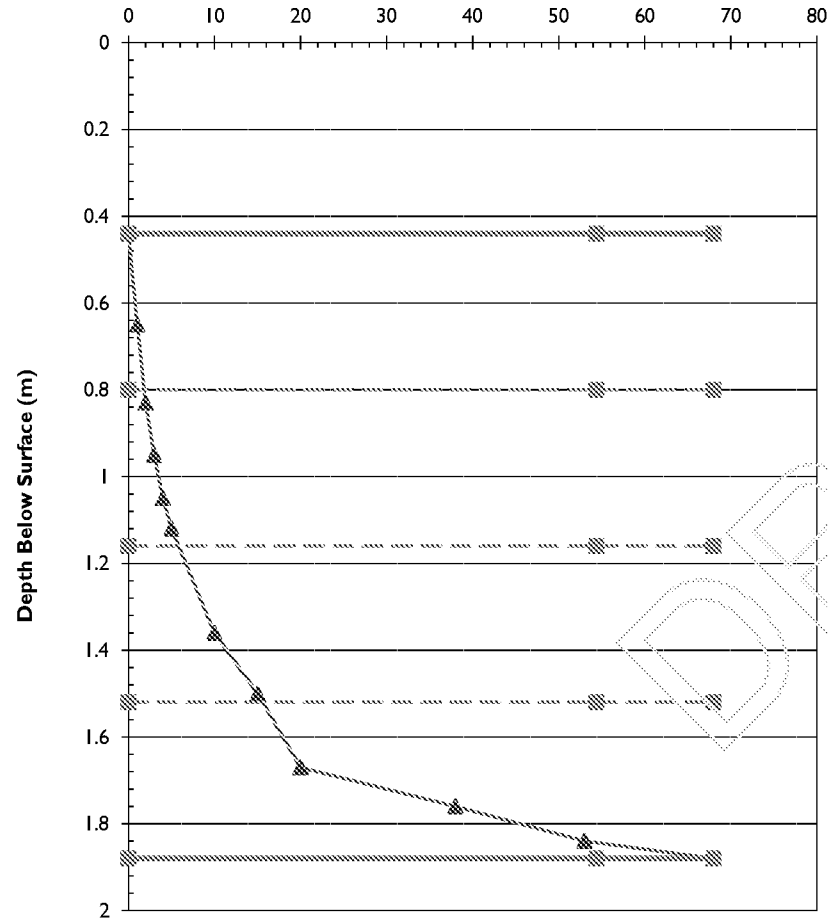
Test Hole No: TP403  
Test No: Test No 1

Filling to Max Water Depth (min)

| BRE Soil Infiltration Rate (m/sec) | 5.095E-05 |

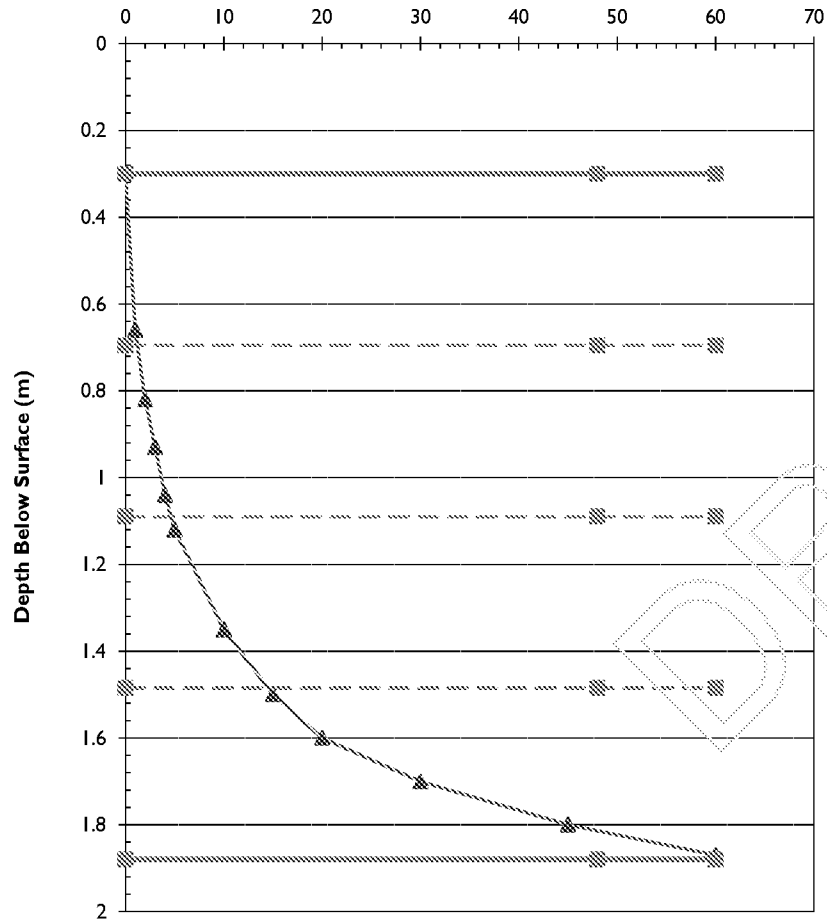
Test Hole No: TP403  
Test No: Test No 2

Filling to Max Water Depth (min)

| BRE Soil Infiltration Rate (m/sec) | 5.356E-05 |

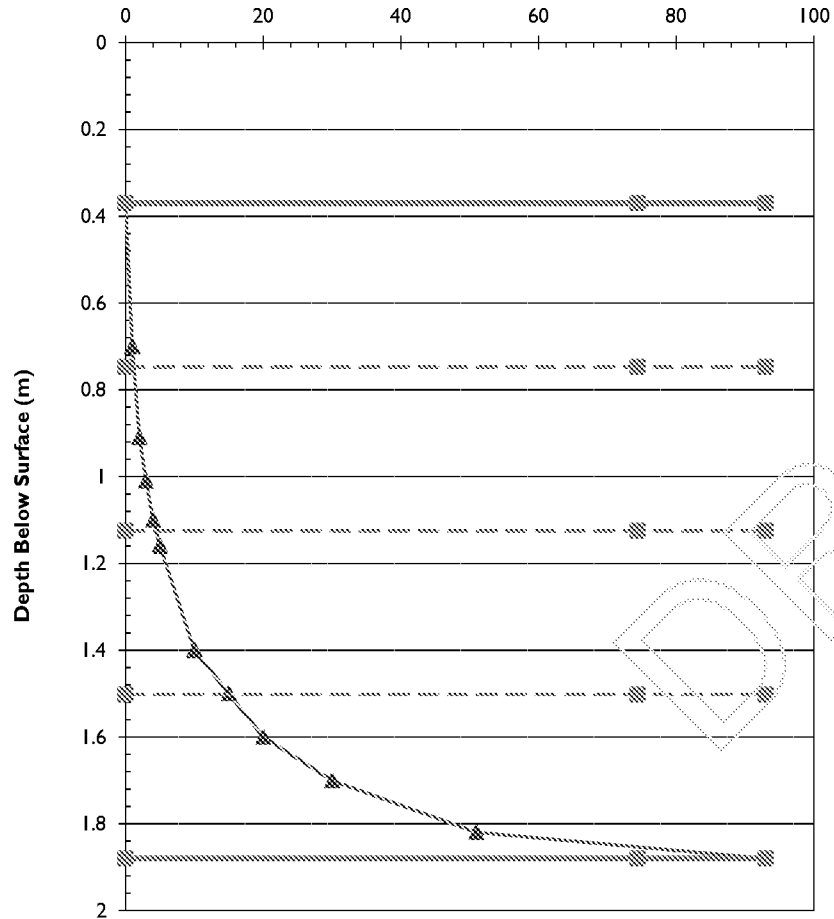
Test Hole No: TP403  
Test No: Test No 3

Filling to Max Water Depth (min)

| BRE Soil Infiltration Rate (m/sec) | 5.081E-05 |

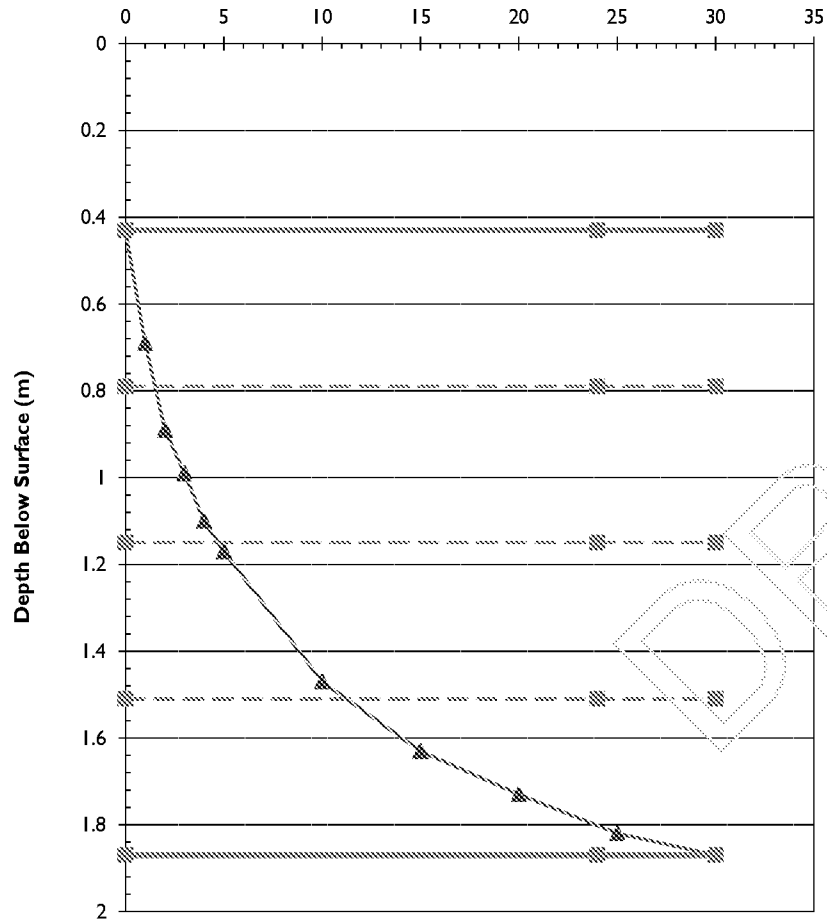
Test Hole No: TP404  
Test No: Test No 1

Filling to Max Water Depth (min)

| BRE Soil Infiltration Rate (m/sec) | 0.0001008 |

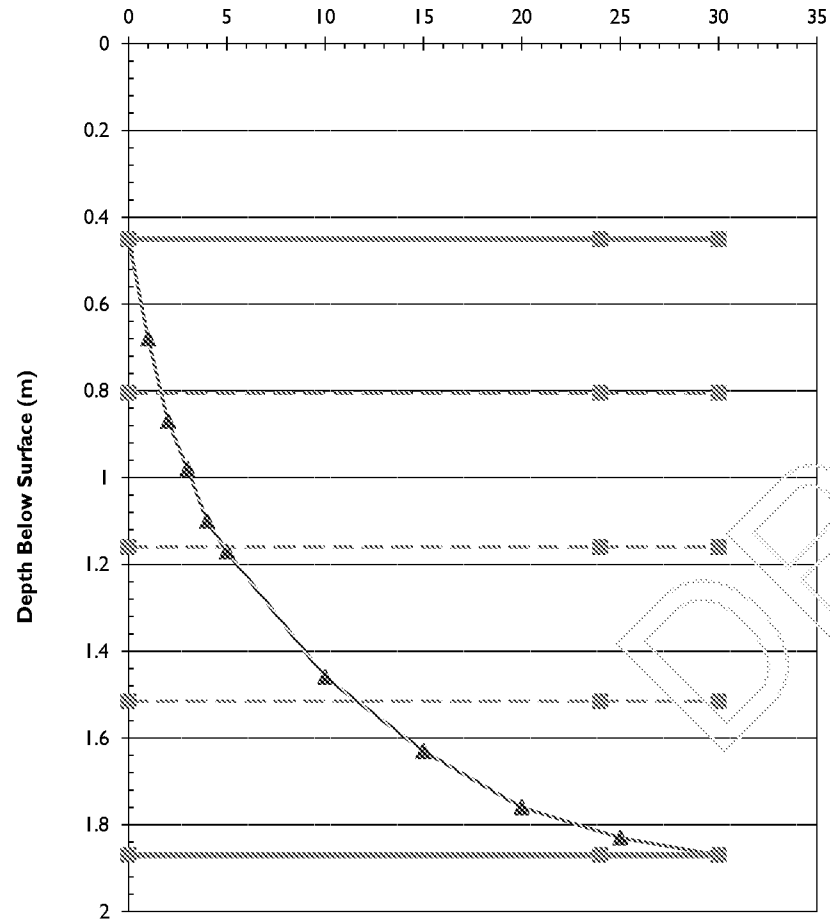
Test Hole No: TP404  
Test No: Test No 2

Filling to Max Water Depth (min)

| BRE Soil Infiltration Rate (m/sec) | 9.837E-05 |

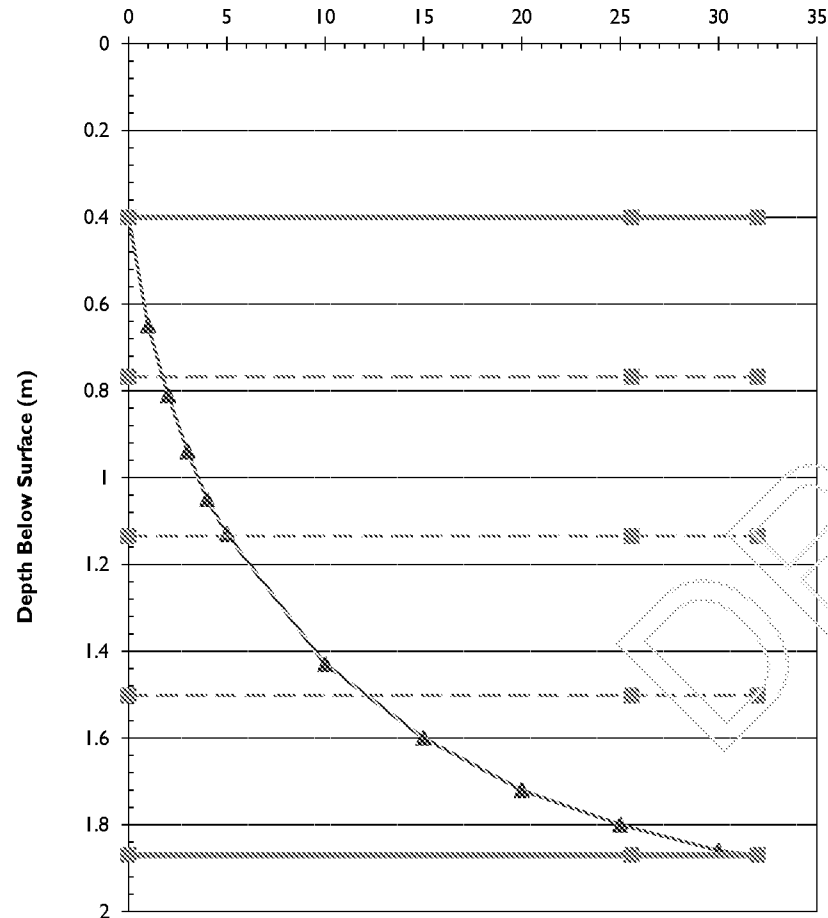
Test Hole No: TP404  
Test No: Test No 3

Filling to Max Water Depth (min)

| BRE Soil Infiltration Rate (m/sec) | 9.499E-05 |
