| Project Name: Fontwell Additional Shallow Soaks | | | | Project No.<br>LP01878 | | Co-ords: -<br>Level: | | Date<br>04/03/2019 | |
| Location: Land near Fontwell, BN18 0SW | | | | | | Dimensions (m):<br><div style="display: flex; align-items: center; justify-content: space-between;"> <div>Depth<br/>2.00</div> <div style="border: 1px solid black; width: 100px; height: 30px; display: flex; align-items: center; justify-content: center;"> <div style="writing-mode: vertical-rl; transform: rotate(180deg); font-size: 10px;">47</div> <div style="margin-left: 10px;">182</div> </div> </div> | | Scale<br>1:25<br>Logged<br>SN | |
| Client: Dandara Ltd | | | | | | | | | |

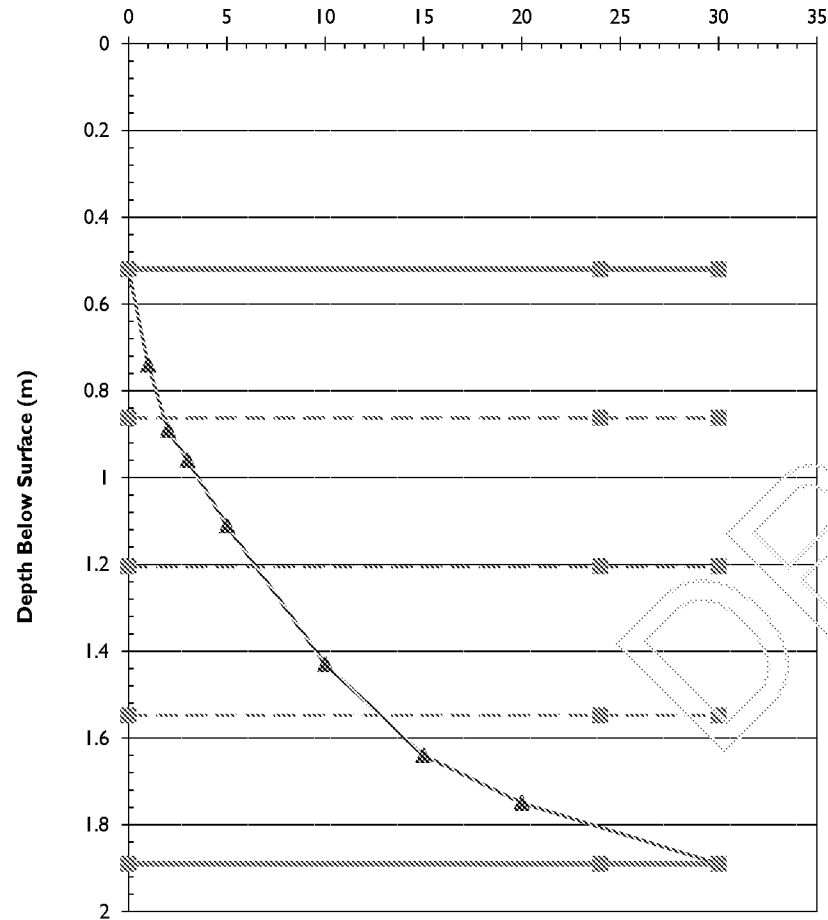
Test Hole No: TP405  
Test No: Test No 1

Filling to Max Water Depth (min)

| BRE Soil Infiltration Rate (m/sec) | 6.062E-05 |

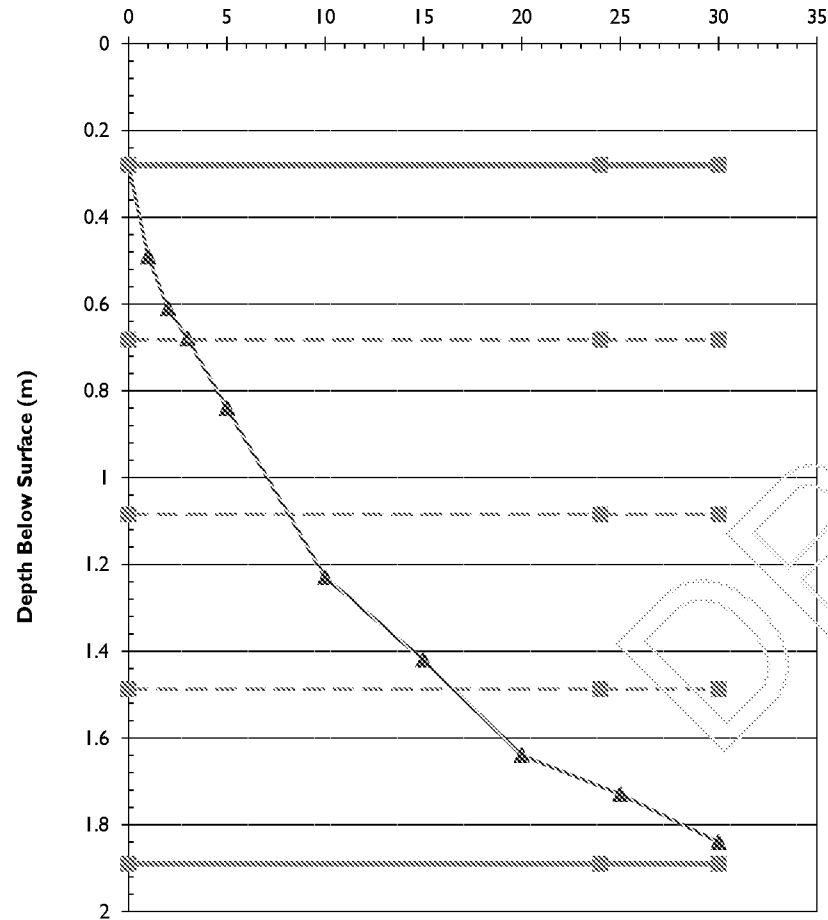
Test Hole No: TP405  
Test No: Test No 2

Filling to Max Water Depth (min)

| BRE Soil Infiltration Rate (m/sec) | 5.056E-05 |

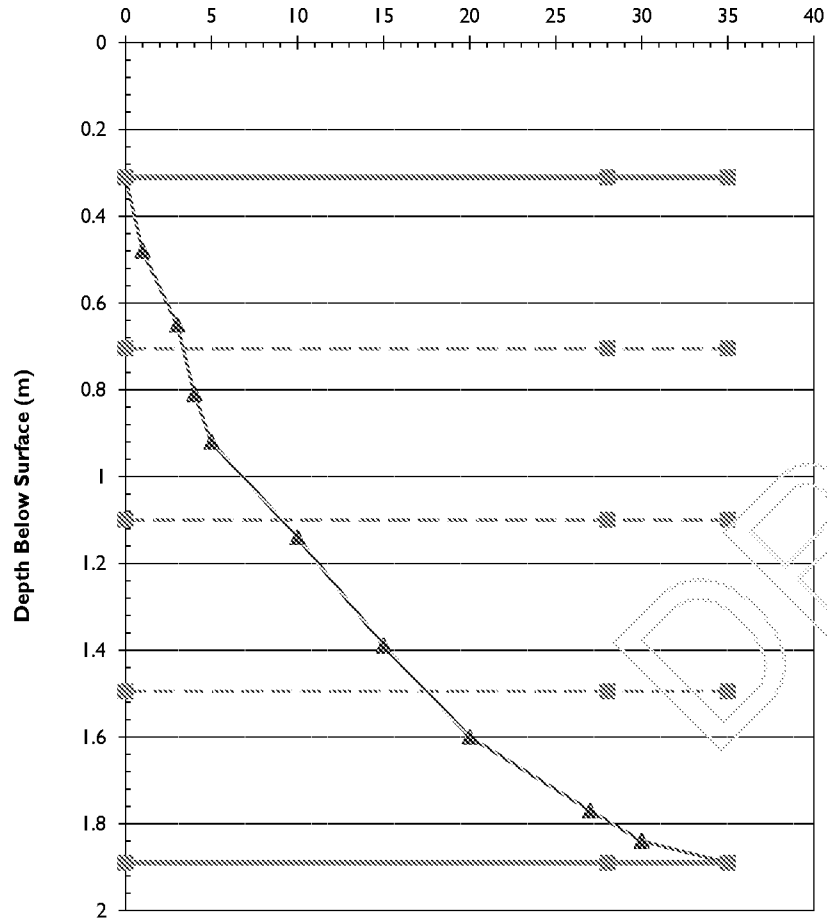
Test Hole No: TP405  
Test No: Test No 3

Filling to Max Water Depth (min)

| BRE Soil Infiltration Rate (m/sec) | 4.809E-05 |

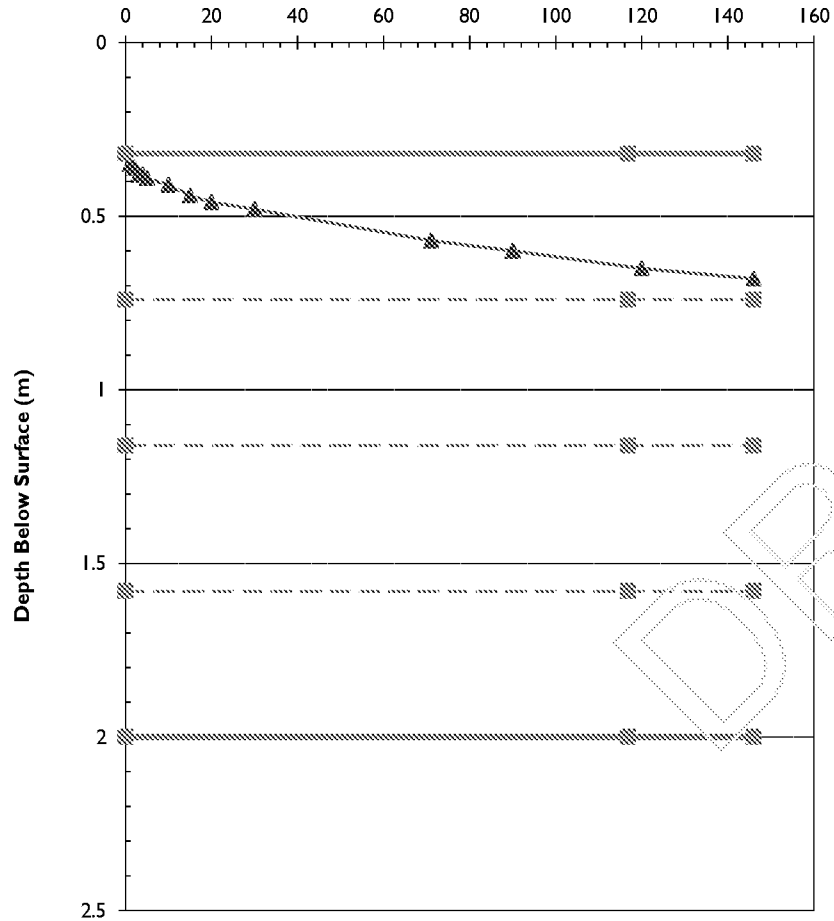
Test Hole No: TP406  
Test No: Test No 1

Filling to Max Water Depth (min)

| BRE Soil Infiltration Rate (m/sec) | 1.098E-06 |

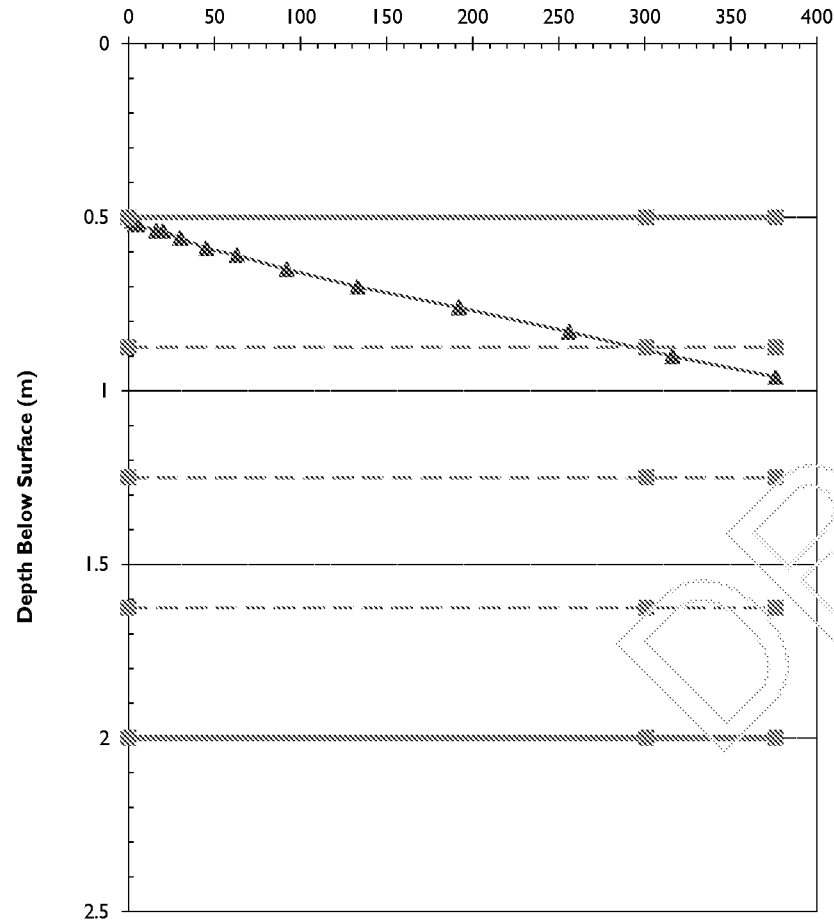
Test Hole No: TP406  
Test No: Test No 2

Filling to Max Water Depth (min)

| BRE Soil Infiltration Rate (m/sec) | 9.843E-07 |

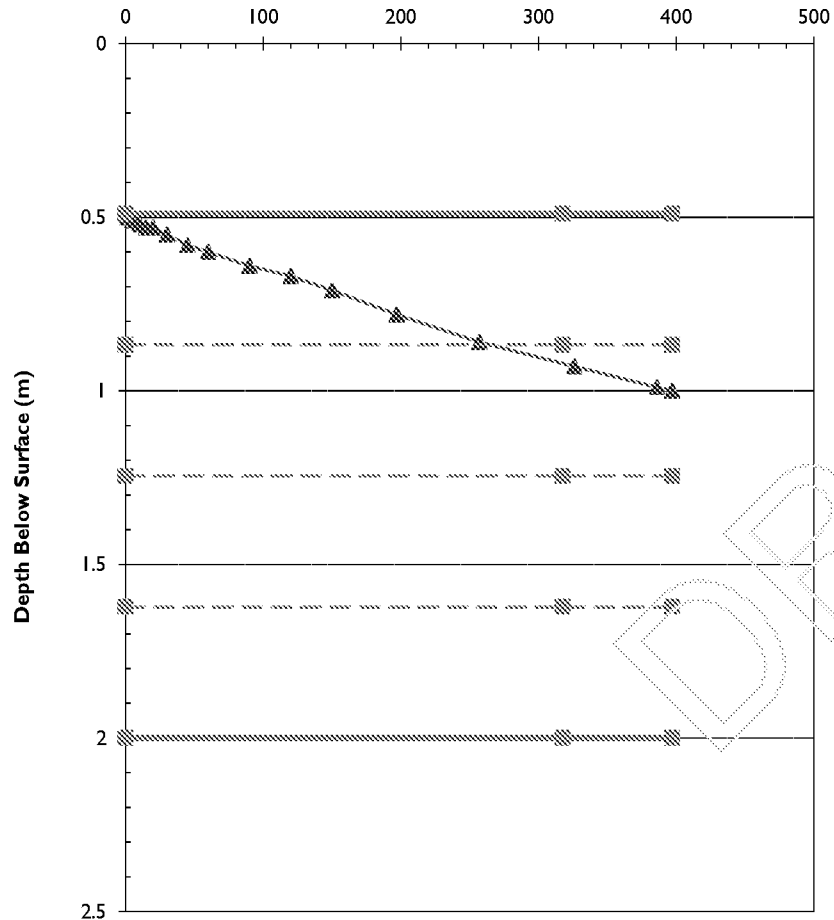
Test Hole No: TP406  
Test No: Test No 3

Filling to Max Water Depth (min)

| BRE Soil Infiltration Rate (m/sec) | 9.388E-07 |

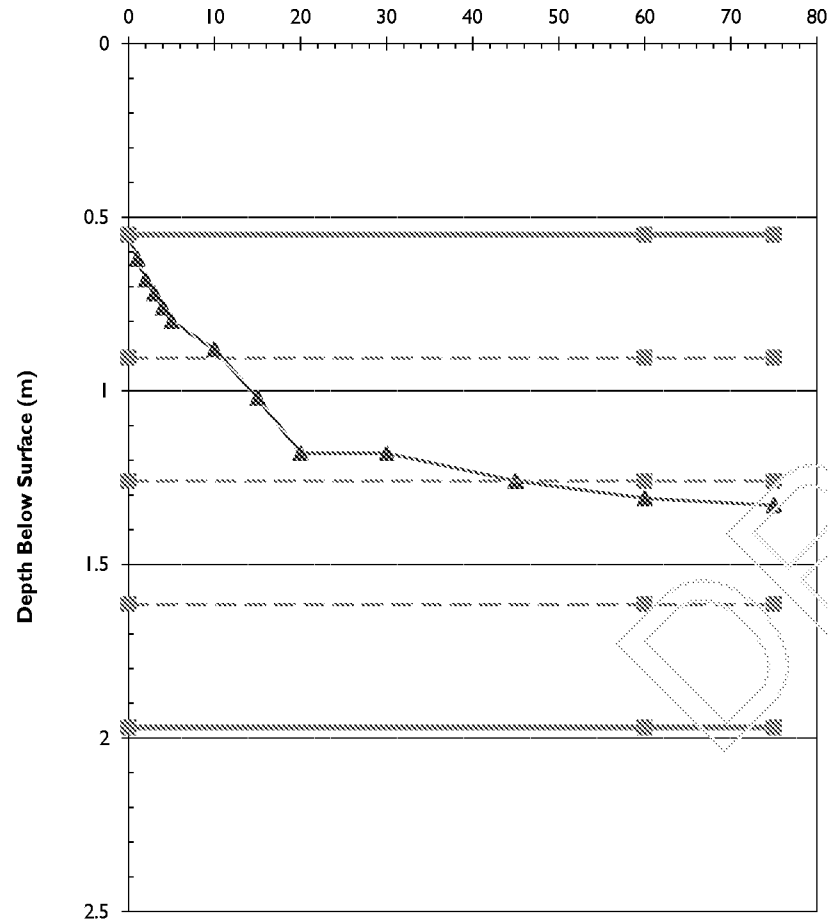
Test Hole No: TP407  
Test No: Test No 1

Filling to Max Water Depth (min)

| BRE Soil Infiltration Rate (m/sec) | 7.24E-06 |

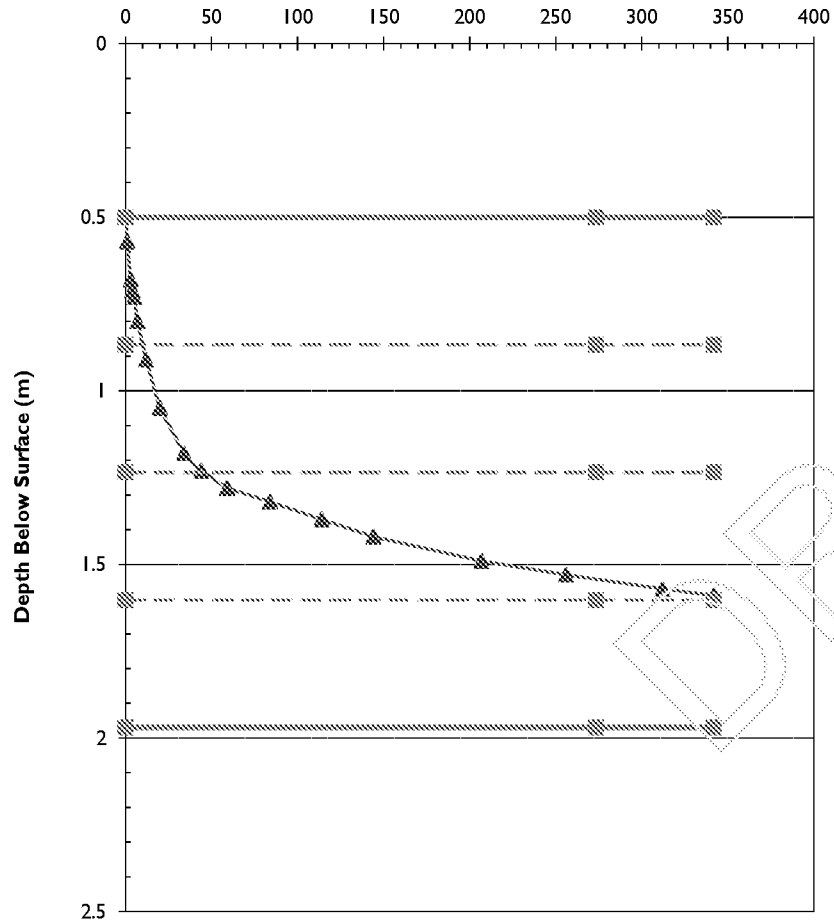
Test Hole No: TP407  
Test No: Test No 2

Filling to Max Water Depth (min)

| BRE Soil Infiltration Rate (m/sec) | 2.659E-06 |

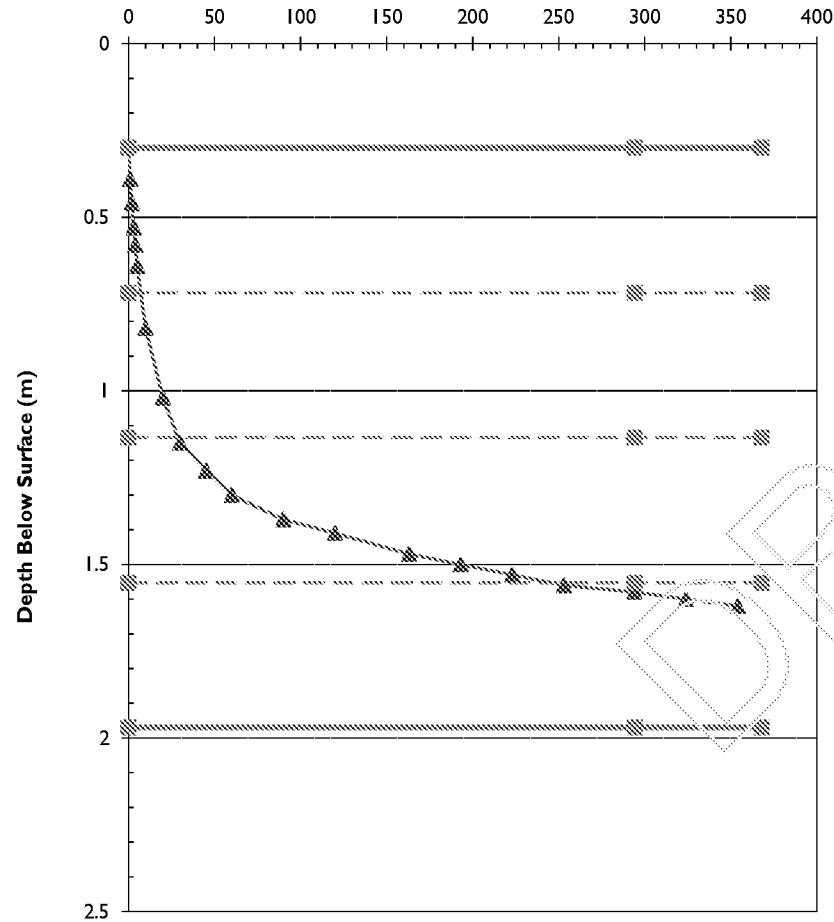
Test Hole No: TP407  
Test No: Test No 3

Filling to Max Water Depth (min)

| BRE Soil Infiltration Rate (m/sec) | 3.891E-06 |
