Exceedance routes

Fleurie Nursery  
Lake Lane  
Barnham

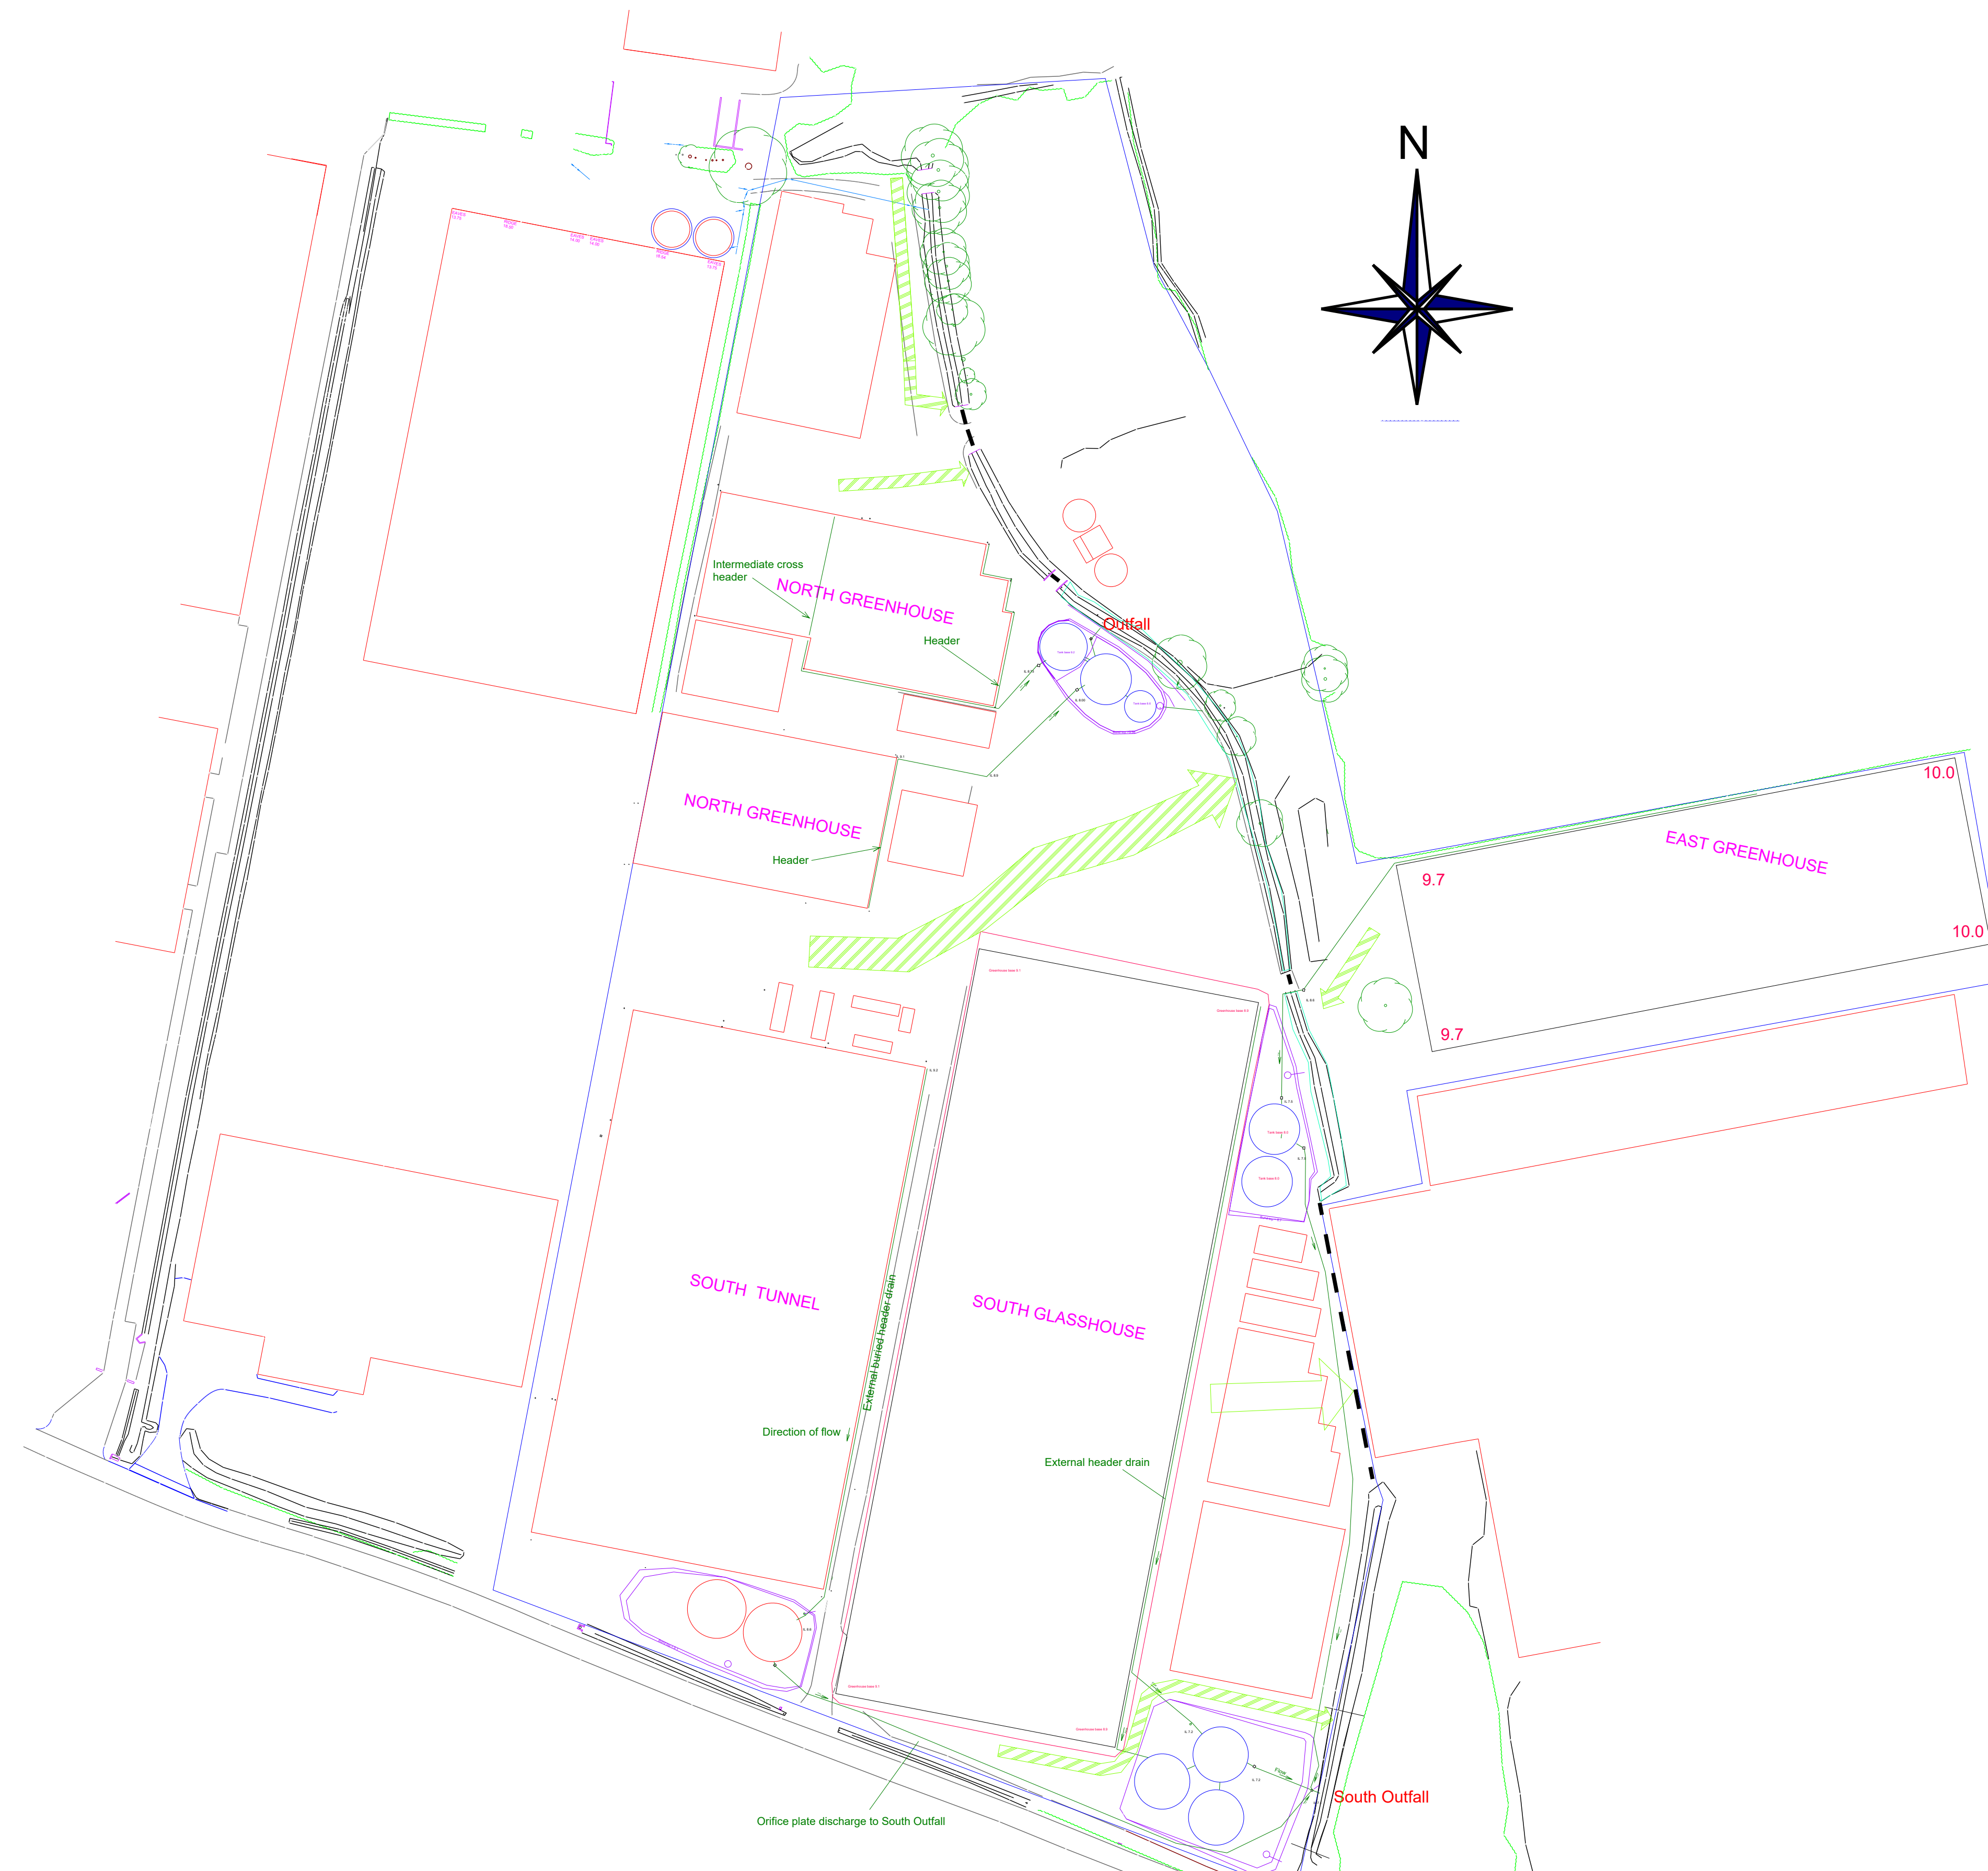
Attenuation contains 1:100 +40% CCA of the rainfall on the structures, which this application relates to.

Exceedance from the catastrophic failure of a tank is contained within the bunded exceedance areas. In the event of rainfall greater than 1:100 +40% this would be contained within the bunds with release from these through drains as shown on exceedance drawings (North, South Tunnels, South Glass, East).

Surface flows from non structure areas such as plant beds, permeable yard areas etc. greater than infiltration rate are shown by green hatched arrows.

These are based on the spot levels from the topo survey, following the contours.
