**Planning Application Ref:** WA/99/18/DOC

**Location:** Land East of Tye Lane, Walberton, Arun

**Description of works:** Application for approval of details reserved by conditions imposed on planning reference WA/44/17/OUT relating to conditions 5, 9, **10**, 11, 12 13, 16, 17, 24, 25, 27, 28, 30, 32, 33, **36**, 41 and 43

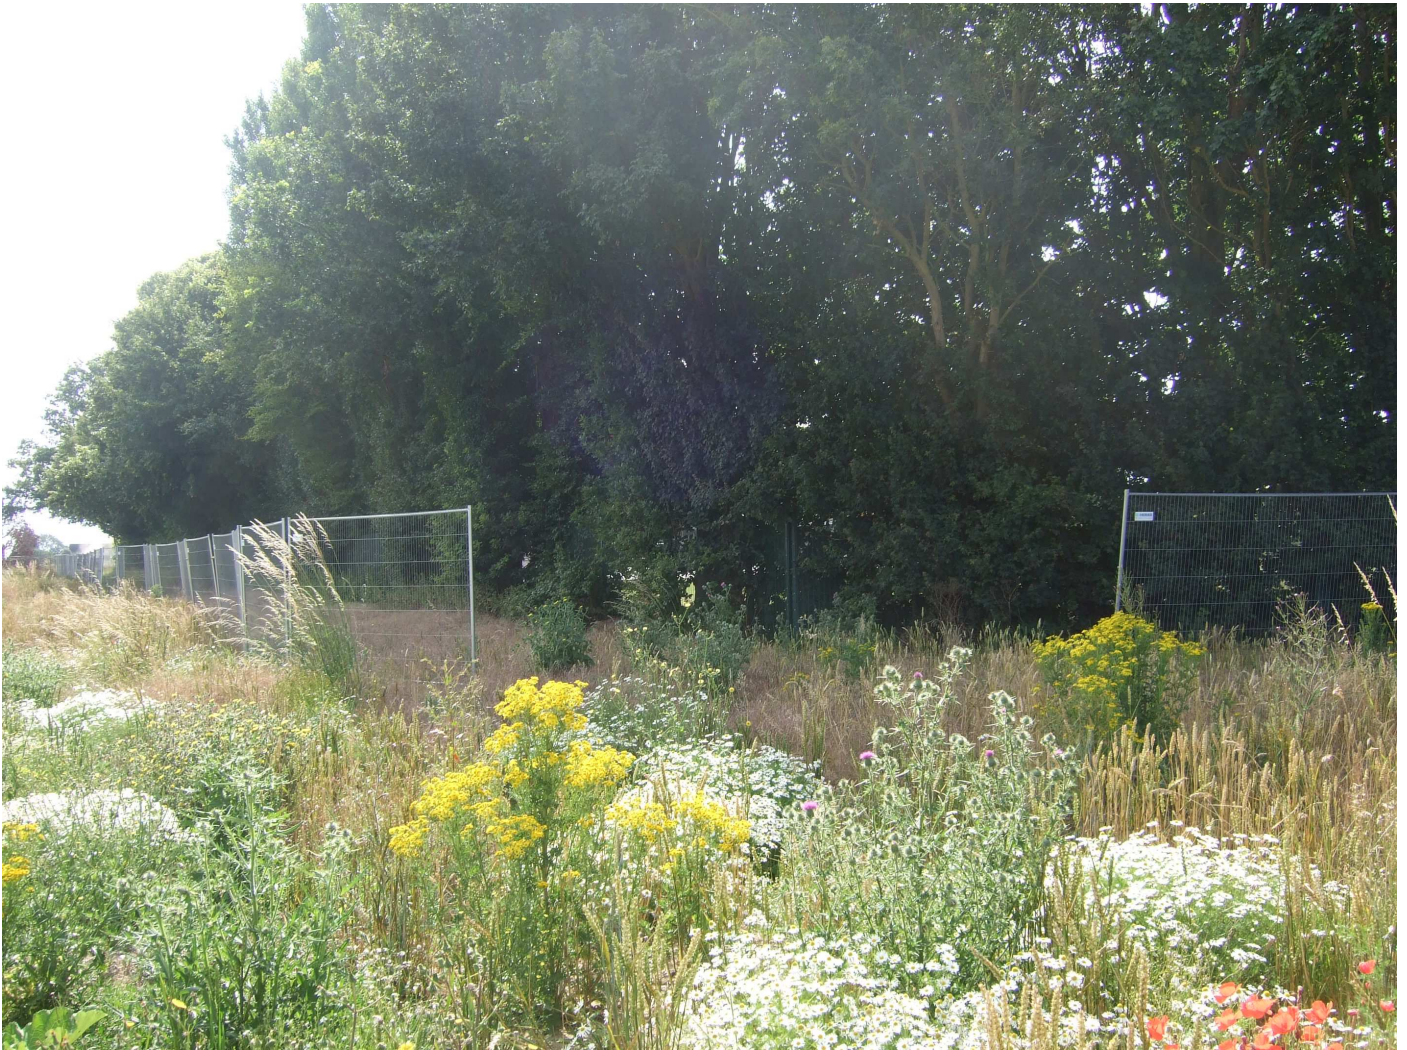
- Fencing appears to have been installed within the RPA of G13 – goat willow.
  - There is a gap (approximately 3 panel widths) in the perimeter fence at the north end of G15 (see photo fig.1).

Fig.1 – Location of gap in perimeter fence, immediately north of tree group 15

- There are no informative notices affixed to panels at regular intervals (Construction Exclusion Zone – Keep Out!).
  - Stabilising struts will need to be installed on perimeter fencing at regular intervals.

- I recommend we await photographic evidence and written confirmation from the project arboriculturist, which demonstrates that the above list of items have been satisfactorily addressed – before discharging conditions 10 and 36.
