## **Appendix (B)**

### **Geotechnical Information (Extract)**

| | Project | Fontwell Shallow Soaks | | Scale at | NTS | Fig No. | I |
| | Title | Shallow Soakage Positions | | A4 | | | |

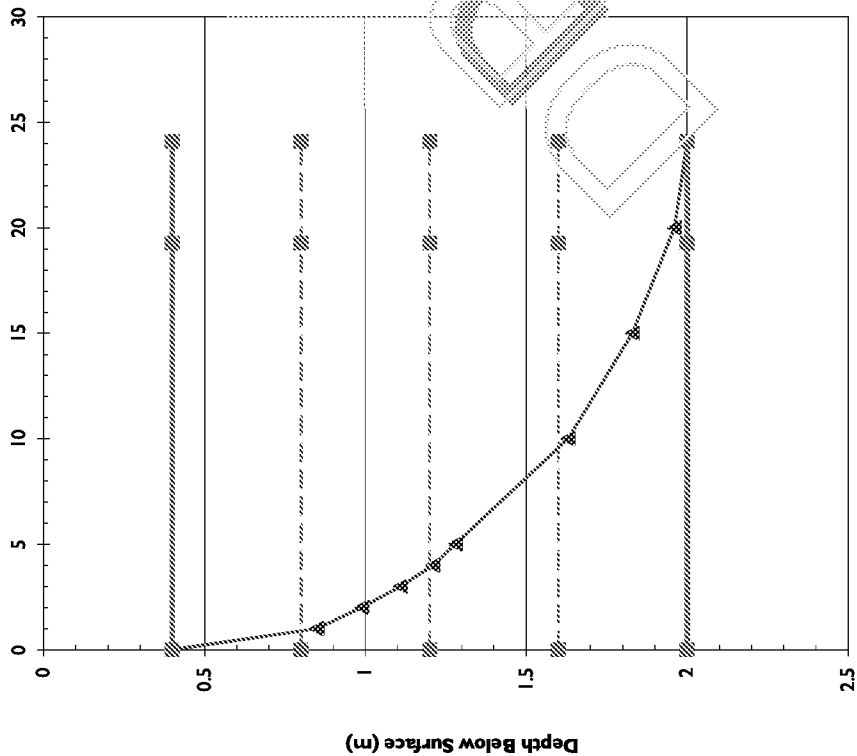
Test Hole No: TP301  
Test No: Test No 3

Filling to Max Water Depth (min)

| BRE Soil Infiltration Rate (m/sec) | 7.99E-05 |

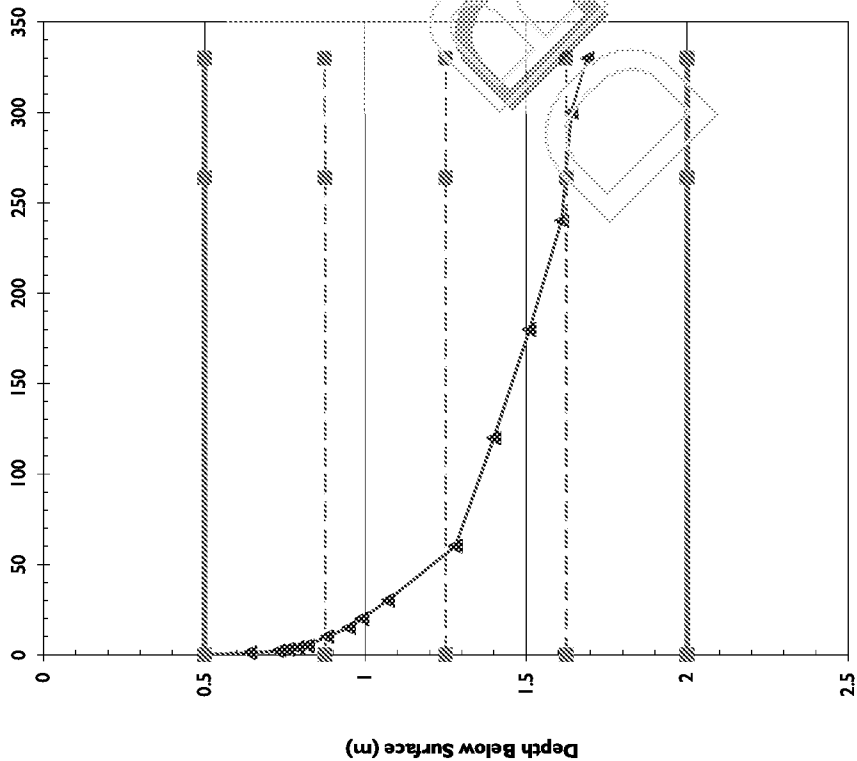
Test Hole No: TP302  
Test No: Test No 1

**Filling to Max Water Depth (min)**

| BRE Soil Infiltration Rate (m/sec) | 2.28E-06 |

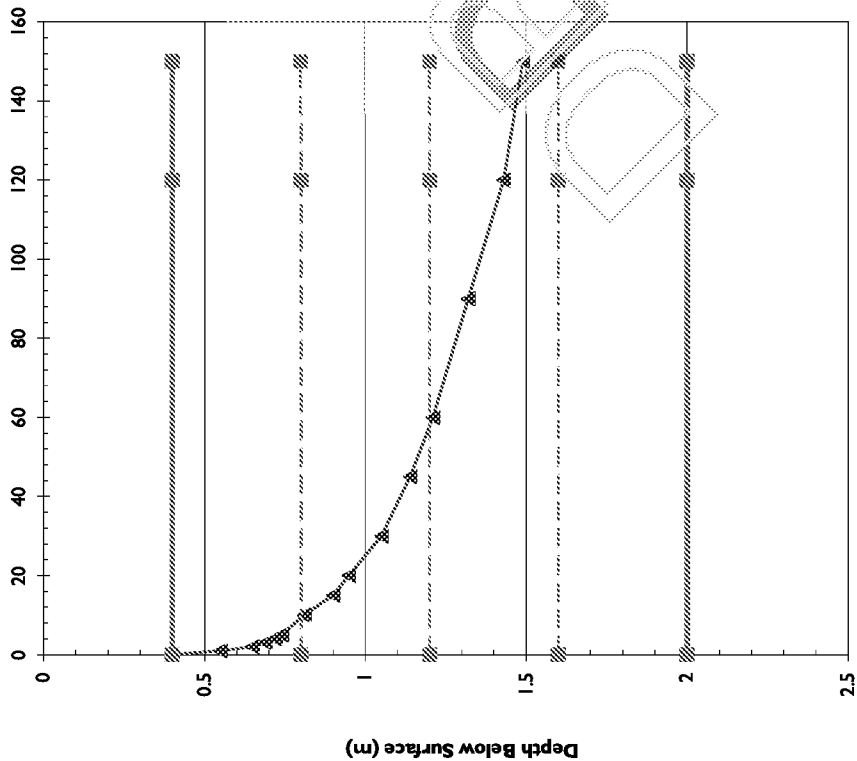
Test Hole No: TP302  
Test No: Test No 2

Filling to Max Water Depth (min)

| BRE Soil Infiltration Rate (m/sec) | 3.01E-06 |

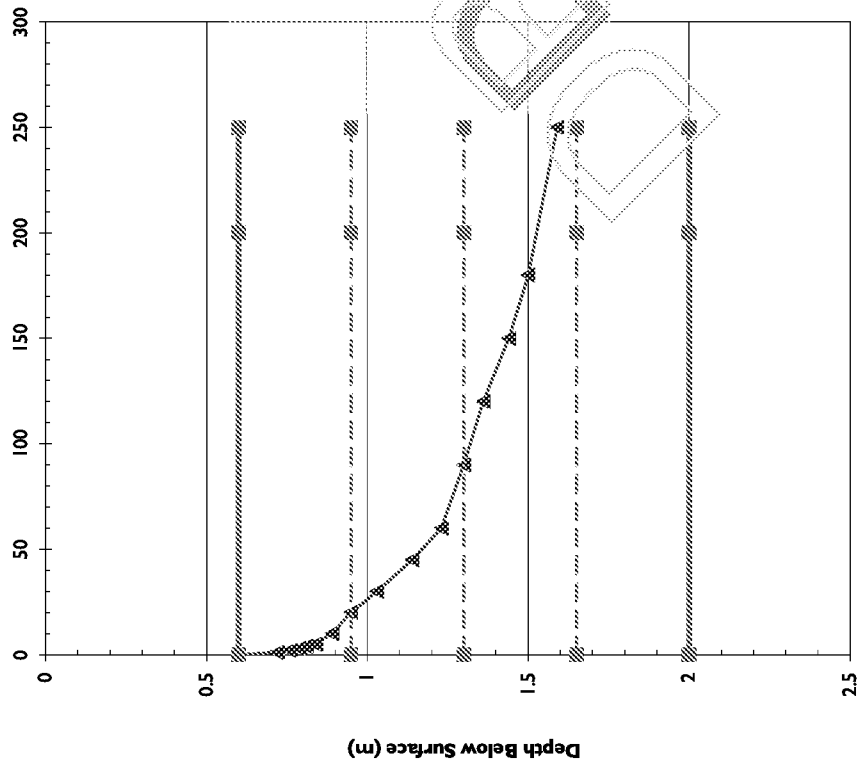
Test Hole No: TP302  
Test No: Test No 3

**Filling to Max Water Depth (min)**

| BRE Soil Infiltration Rate (m/sec) | 1.97E-06 |

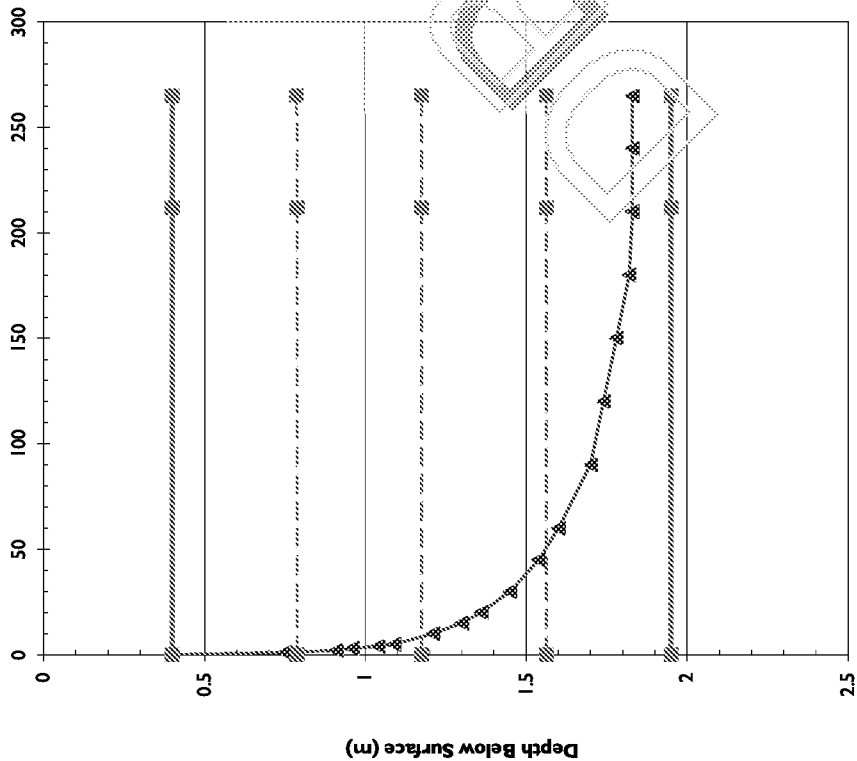
Test Hole No: TP303  
Test No: Test No 1

**Filling to Max Water Depth (min)**

| BRE Soil Infiltration Rate (m/sec) | 1.01E-05 |

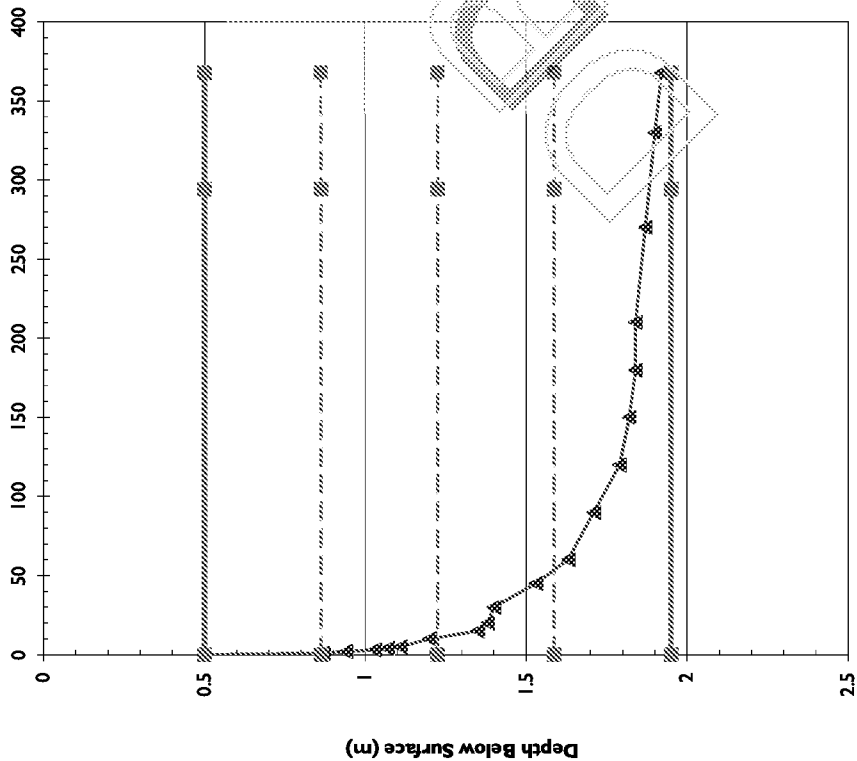
Test Hole No: TP303  
Test No: Test No 3

Filling to Max Water Depth (min)

| BRE Soil Infiltration Rate (m/sec) | 9.33E-06 |

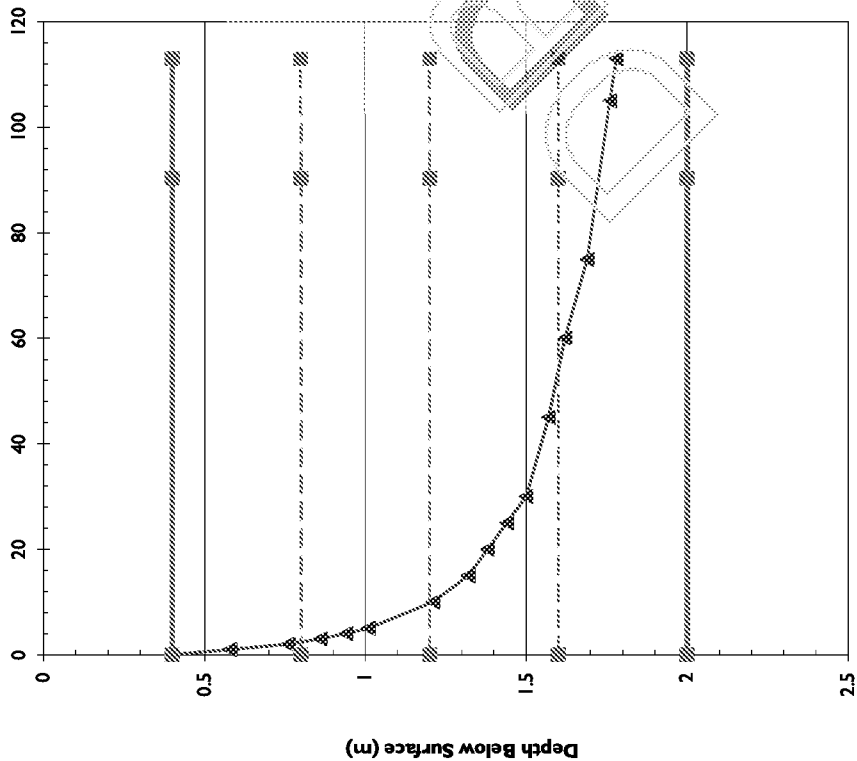
Test Hole No: TP304  
Test No: Test No 1

**Filling to Max Water Depth (min)**

| BRE Soil Infiltration Rate (m/sec) | 9.78E-06 |

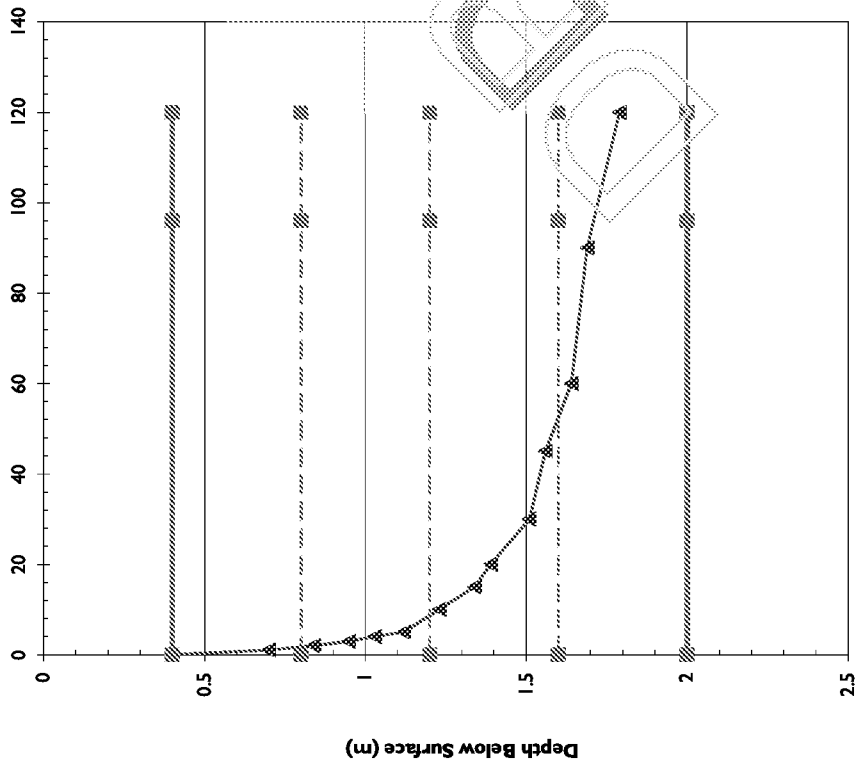
Test Hole No: TP304  
Test No: Test No 2

**Filling to Max Water Depth (min)**

| BRE Soil Infiltration Rate (m/sec) | 9.94E-06 |

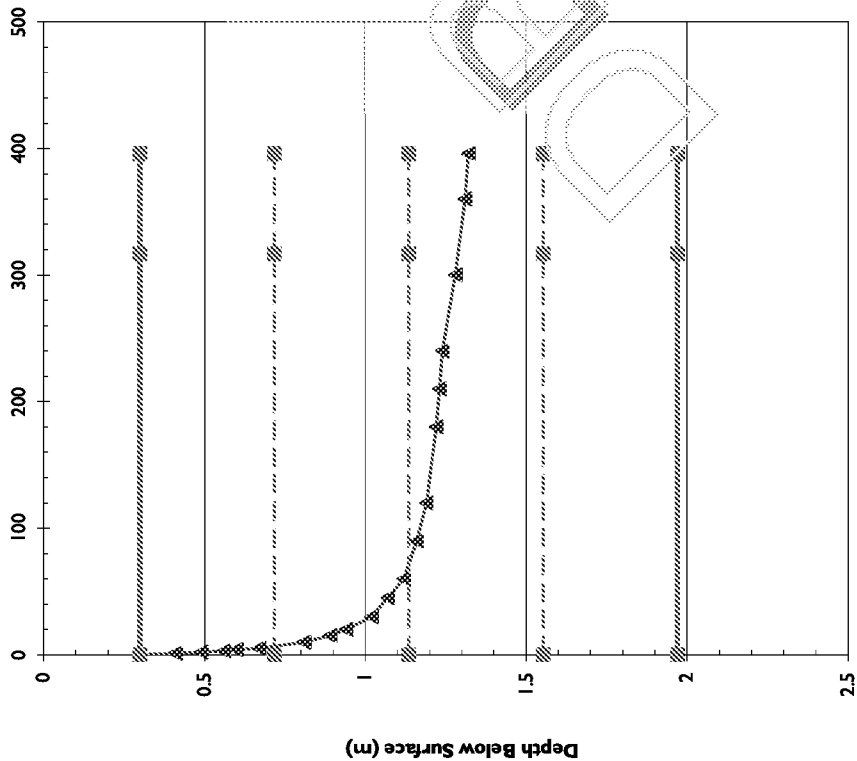
Test Hole No: TP305  
Test No: Test No 1

Filling to Max Water Depth (min)

| BRE Soil Infiltration Rate (m/sec) | 1.27E-06 |

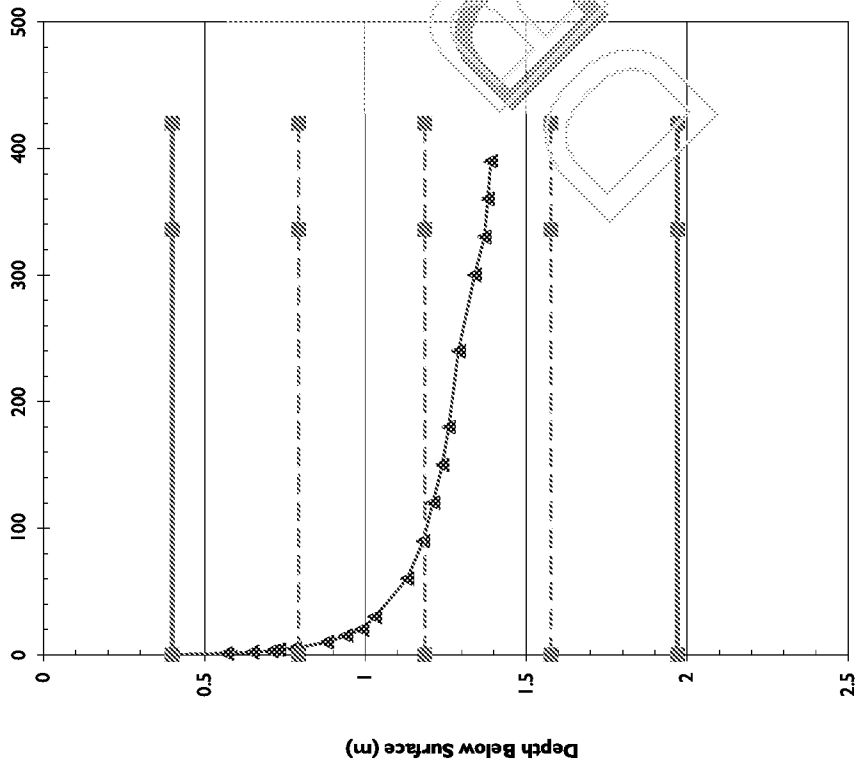
Test Hole No: TP305  
Test No: Test No 2

**Filling to Max Water Depth (min)**

| BRE Soil Infiltration Rate (m/sec) | 1.31E-06 |

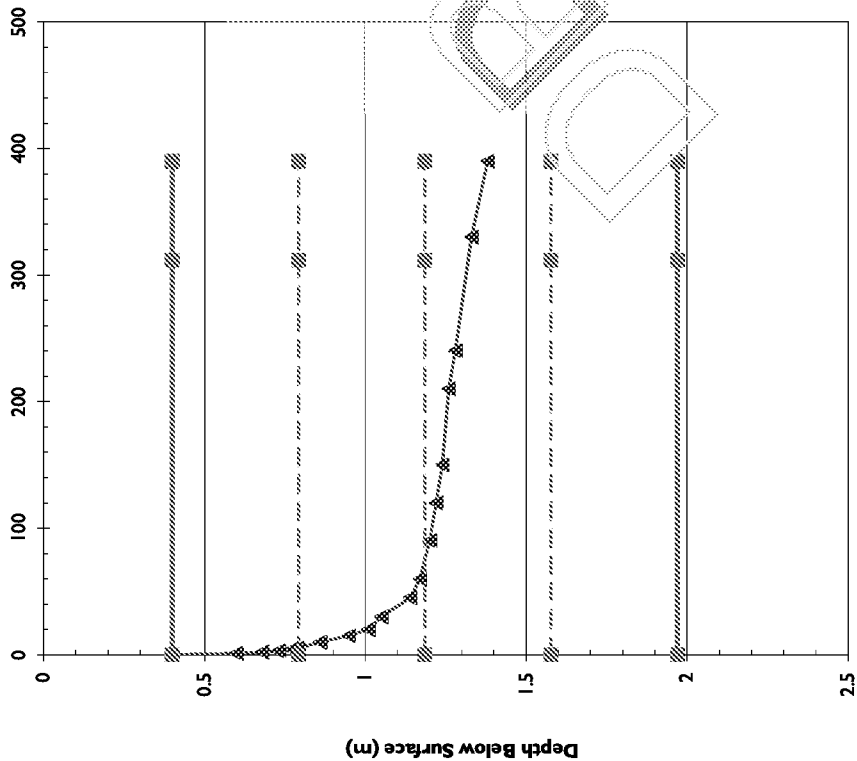
Test Hole No: TP305  
Test No: Test No 3

Filling to Max Water Depth (min)

| BRE Soil Infiltration Rate (m/sec) | 1.34E-06 |

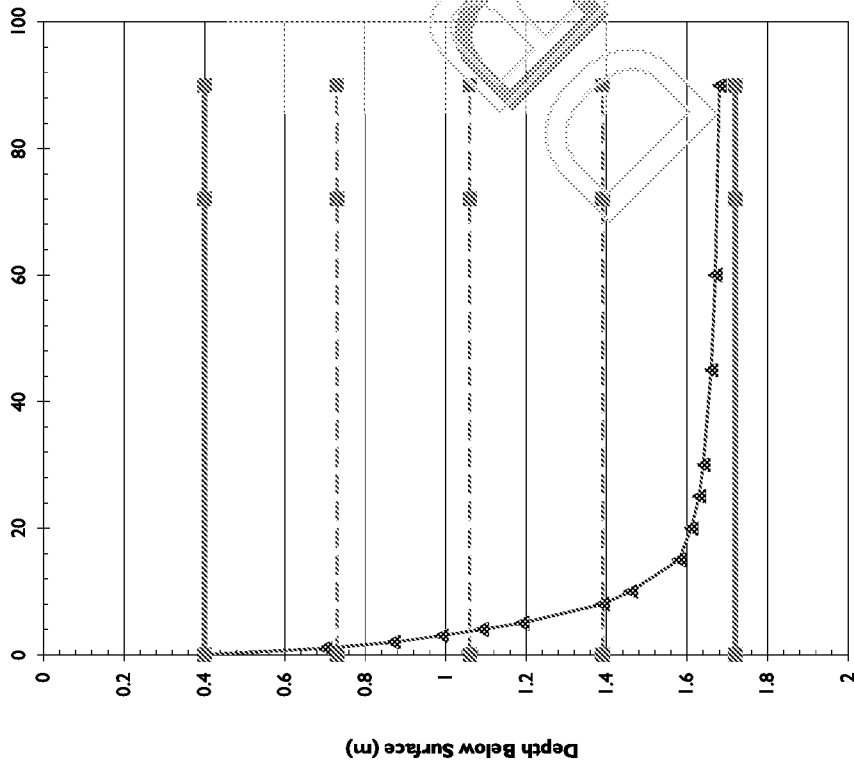
Test Hole No: TP310  
Test No: Test No 2

**Filling to Max Water Depth (min)**

| BRE Soil Infiltration Rate (m/sec) | 5.44E-05 |

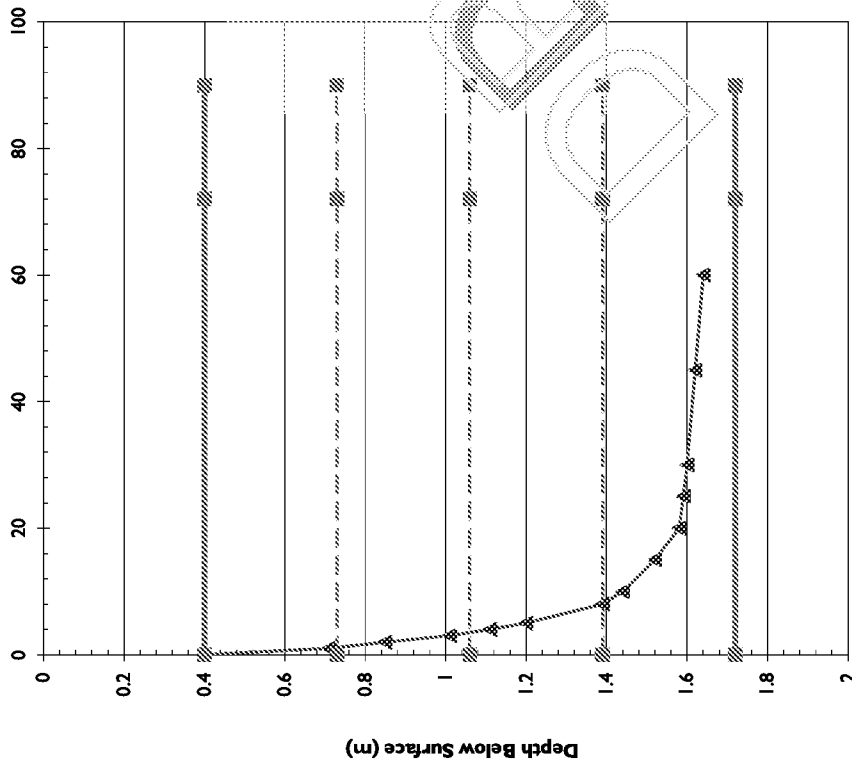
Test Hole No: TP310  
Test No: Test No 3

**Filling to Max Water Depth (min)**

| BRE Soil Infiltration Rate (m/sec) | 4.26E-05 |

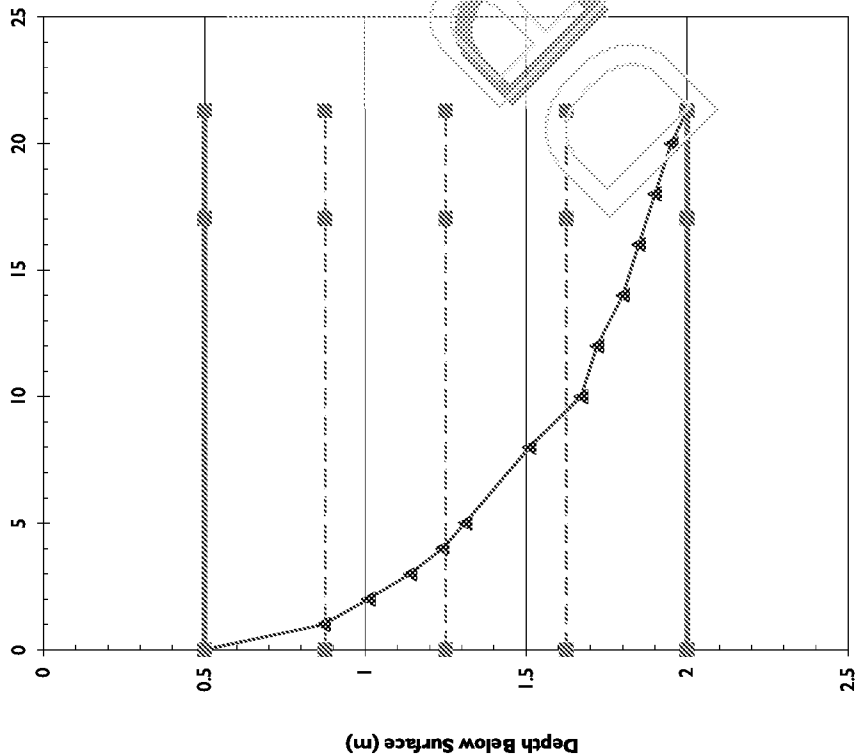
Test Hole No: TP311  
Test No: Test No 2

Filling to Max Water Depth (min)

| BRE Soil Infiltration Rate (m/sec) | 5.98E-05 |

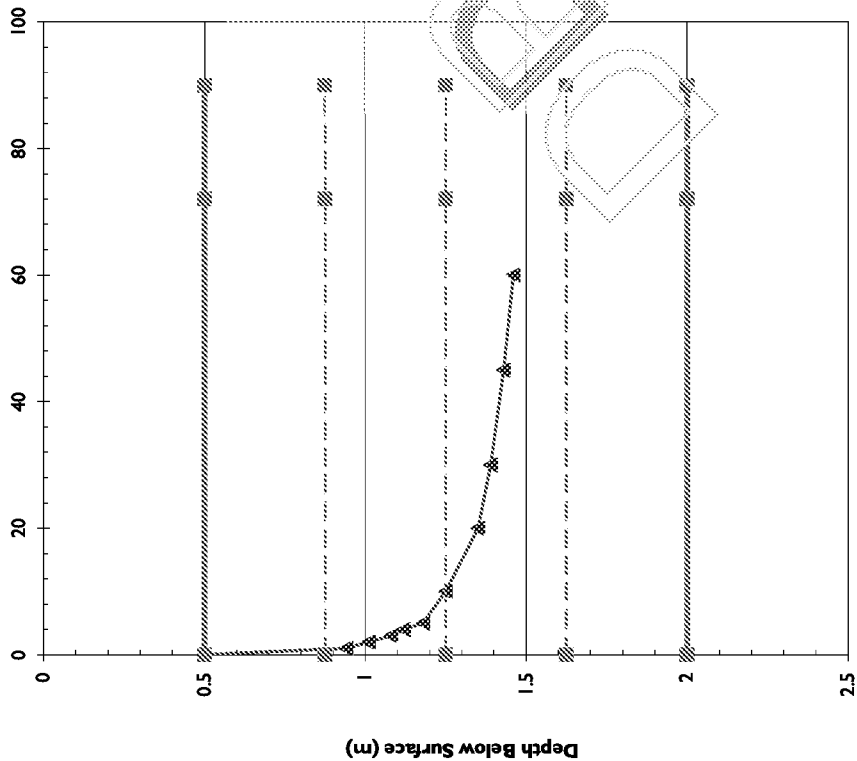
Test Hole No: TP311  
Test No: Test No 3

**Filling to Max Water Depth (min)**

| BRE Soil Infiltration Rate (m/sec) | 4.04E-06 |

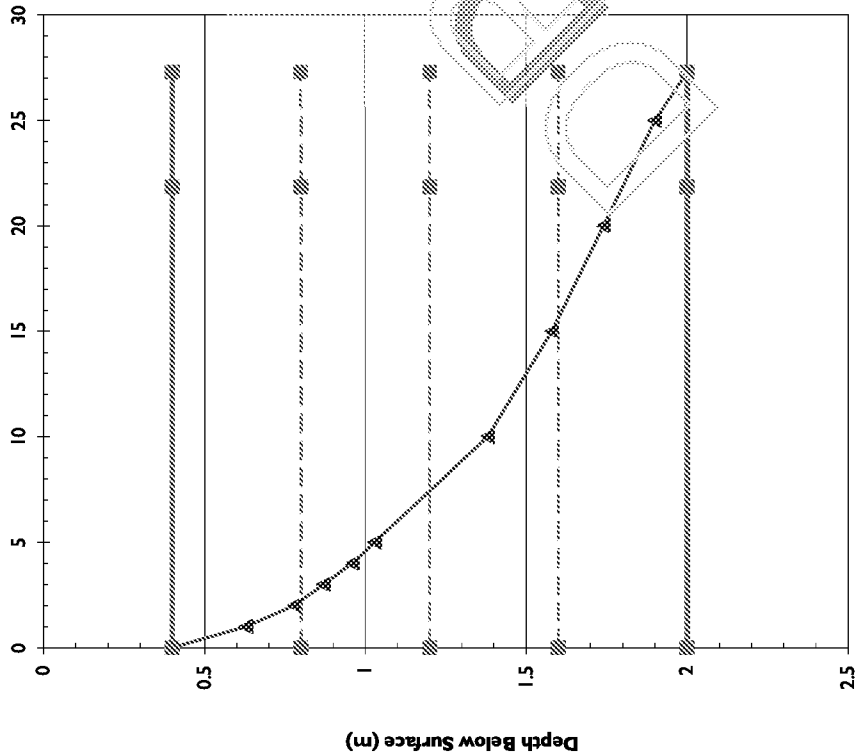
Test Hole No: TP312  
Test No: Test No 2

**Filling to Max Water Depth (min)**

| BRE Soil Infiltration Rate (m/sec) | 3.76E-05 |

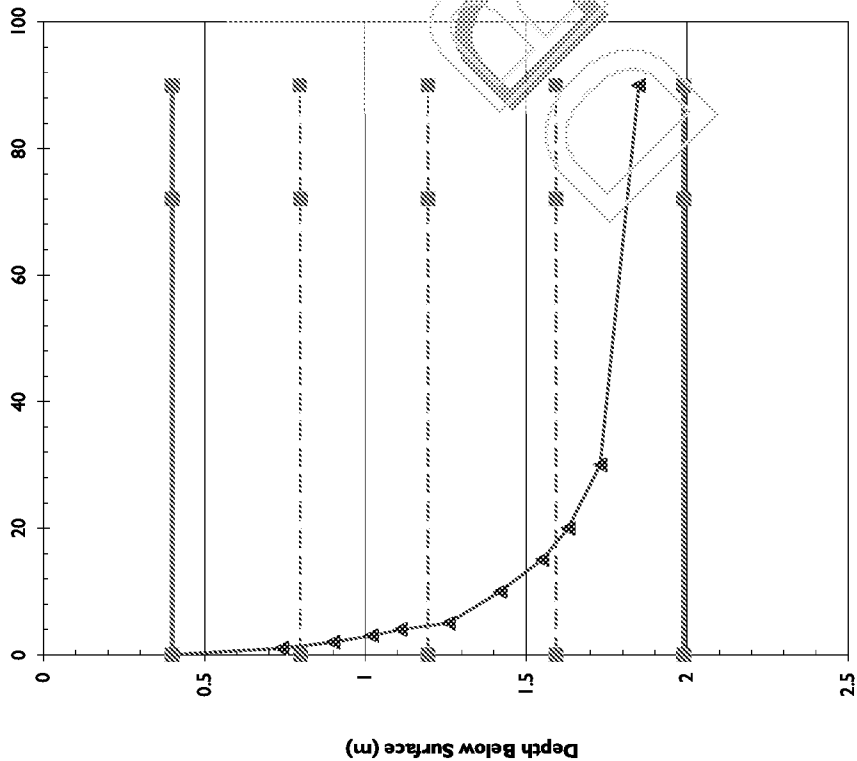
Test Hole No: TP316  
Test No: Test No 1

**Filling to Max Water Depth (min)**

| BRE Soil Infiltration Rate (m/sec) | 4.01E-05 |

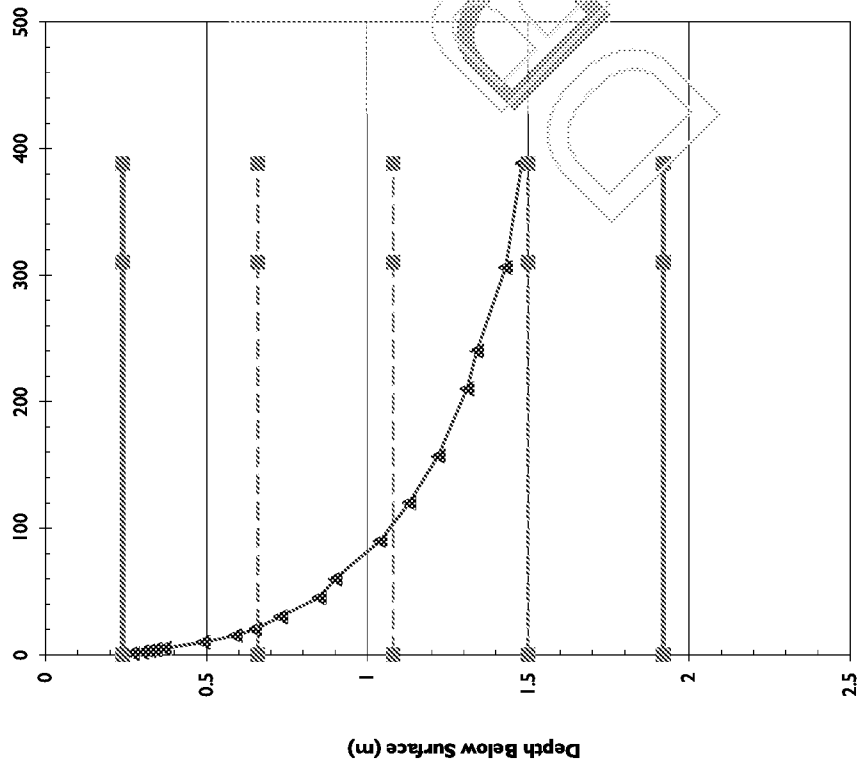
Test Hole No: TP319  
Test No: Test No 1

Filling to Max Water Depth (min)

| BRE Soil Infiltration Rate (m/sec) | 1.34E-06 |

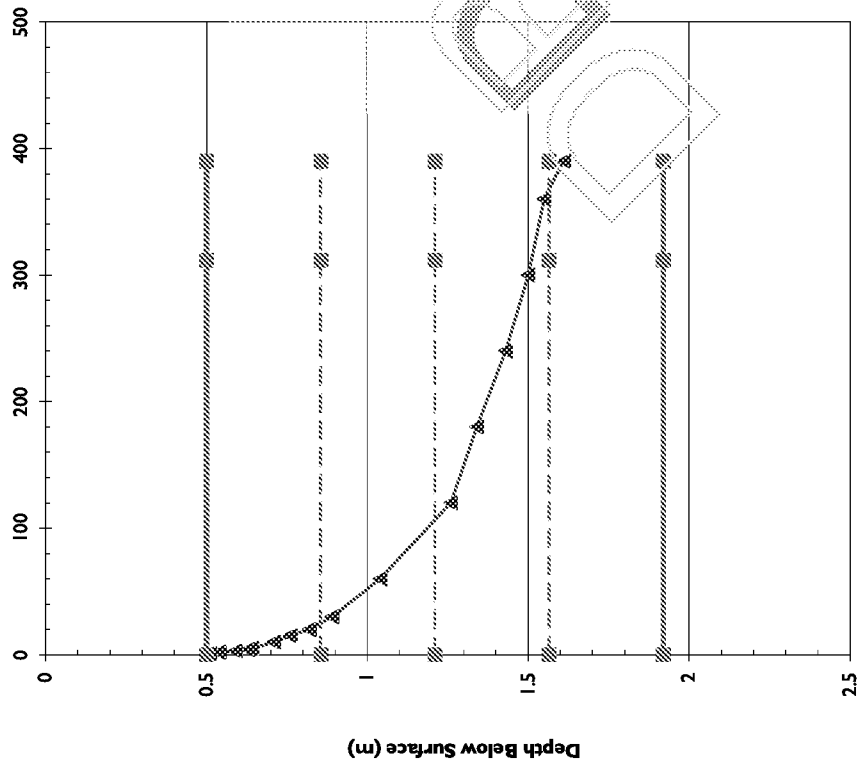
Test Hole No: TP319  
Test No: 3

**Filling to Max Water Depth (min)**

| BRE Soil Infiltration Rate (m/sec) | 1.43E-06 |

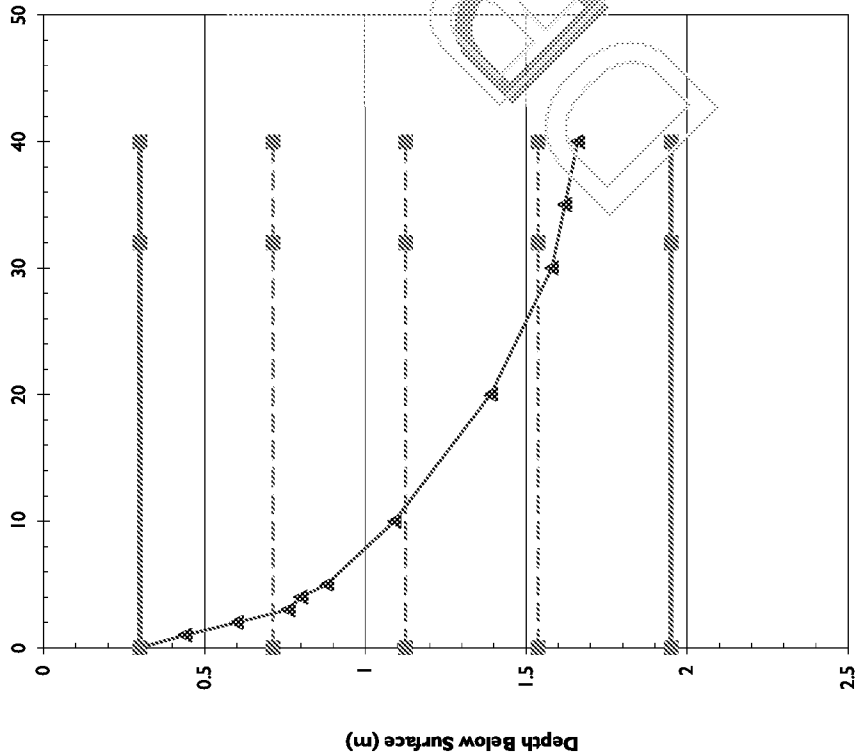
Test Hole No: TP321  
Test No: Test No 2

Filling to Max Water Depth (min)

| BRE Soil Infiltration Rate (m/sec) | 1.97E-05 |

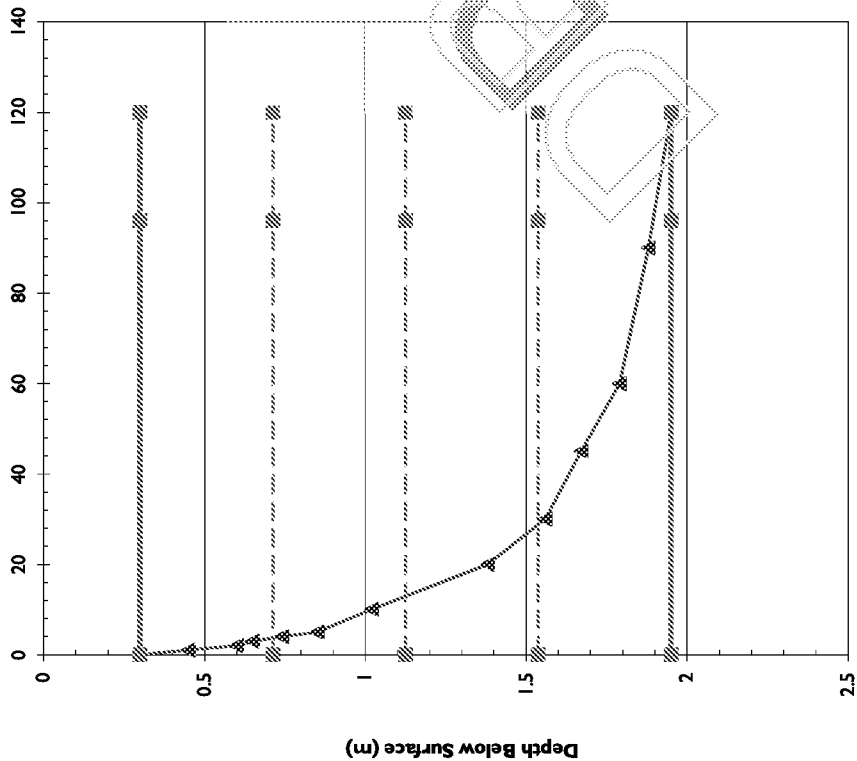
Test Hole No: TP321  
Test No: 3

Filling to Max Water Depth (min)

| BRE Soil Infiltration Rate (m/sec) | 1.97E-05 |

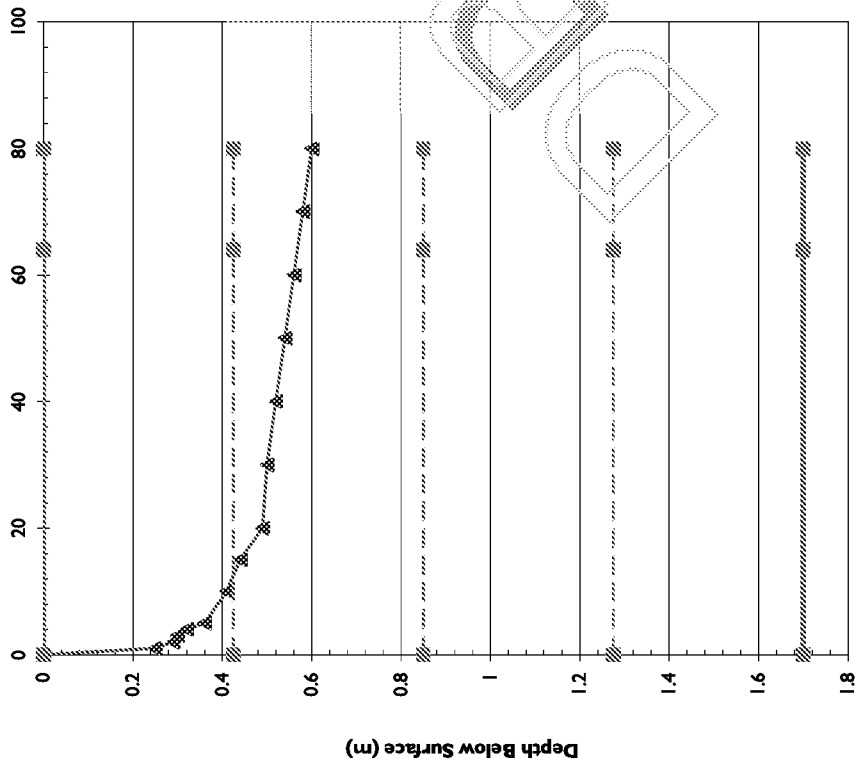
Test Hole No: TP323  
Test No: Test No 2

**Filling to Max Water Depth (min)**

| BRE Soil Infiltration Rate (m/sec) | 8.39E-06 |

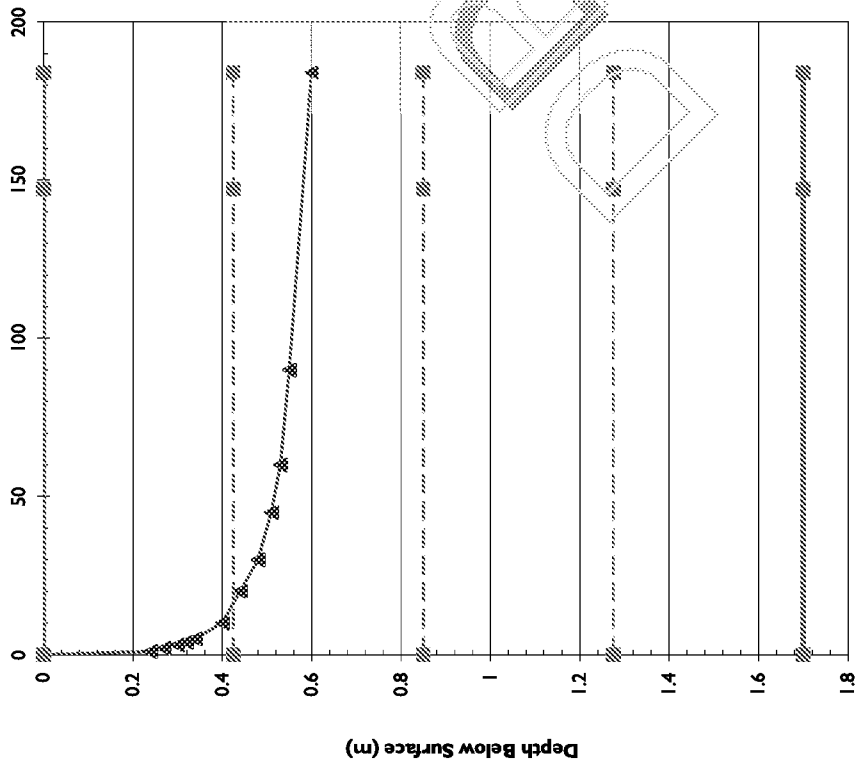
Test Hole No: TP323  
Test No: Test No 3

**Filling to Max Water Depth (min)**

| BRE Soil Infiltration Rate (m/sec) | 3.63E-06 |

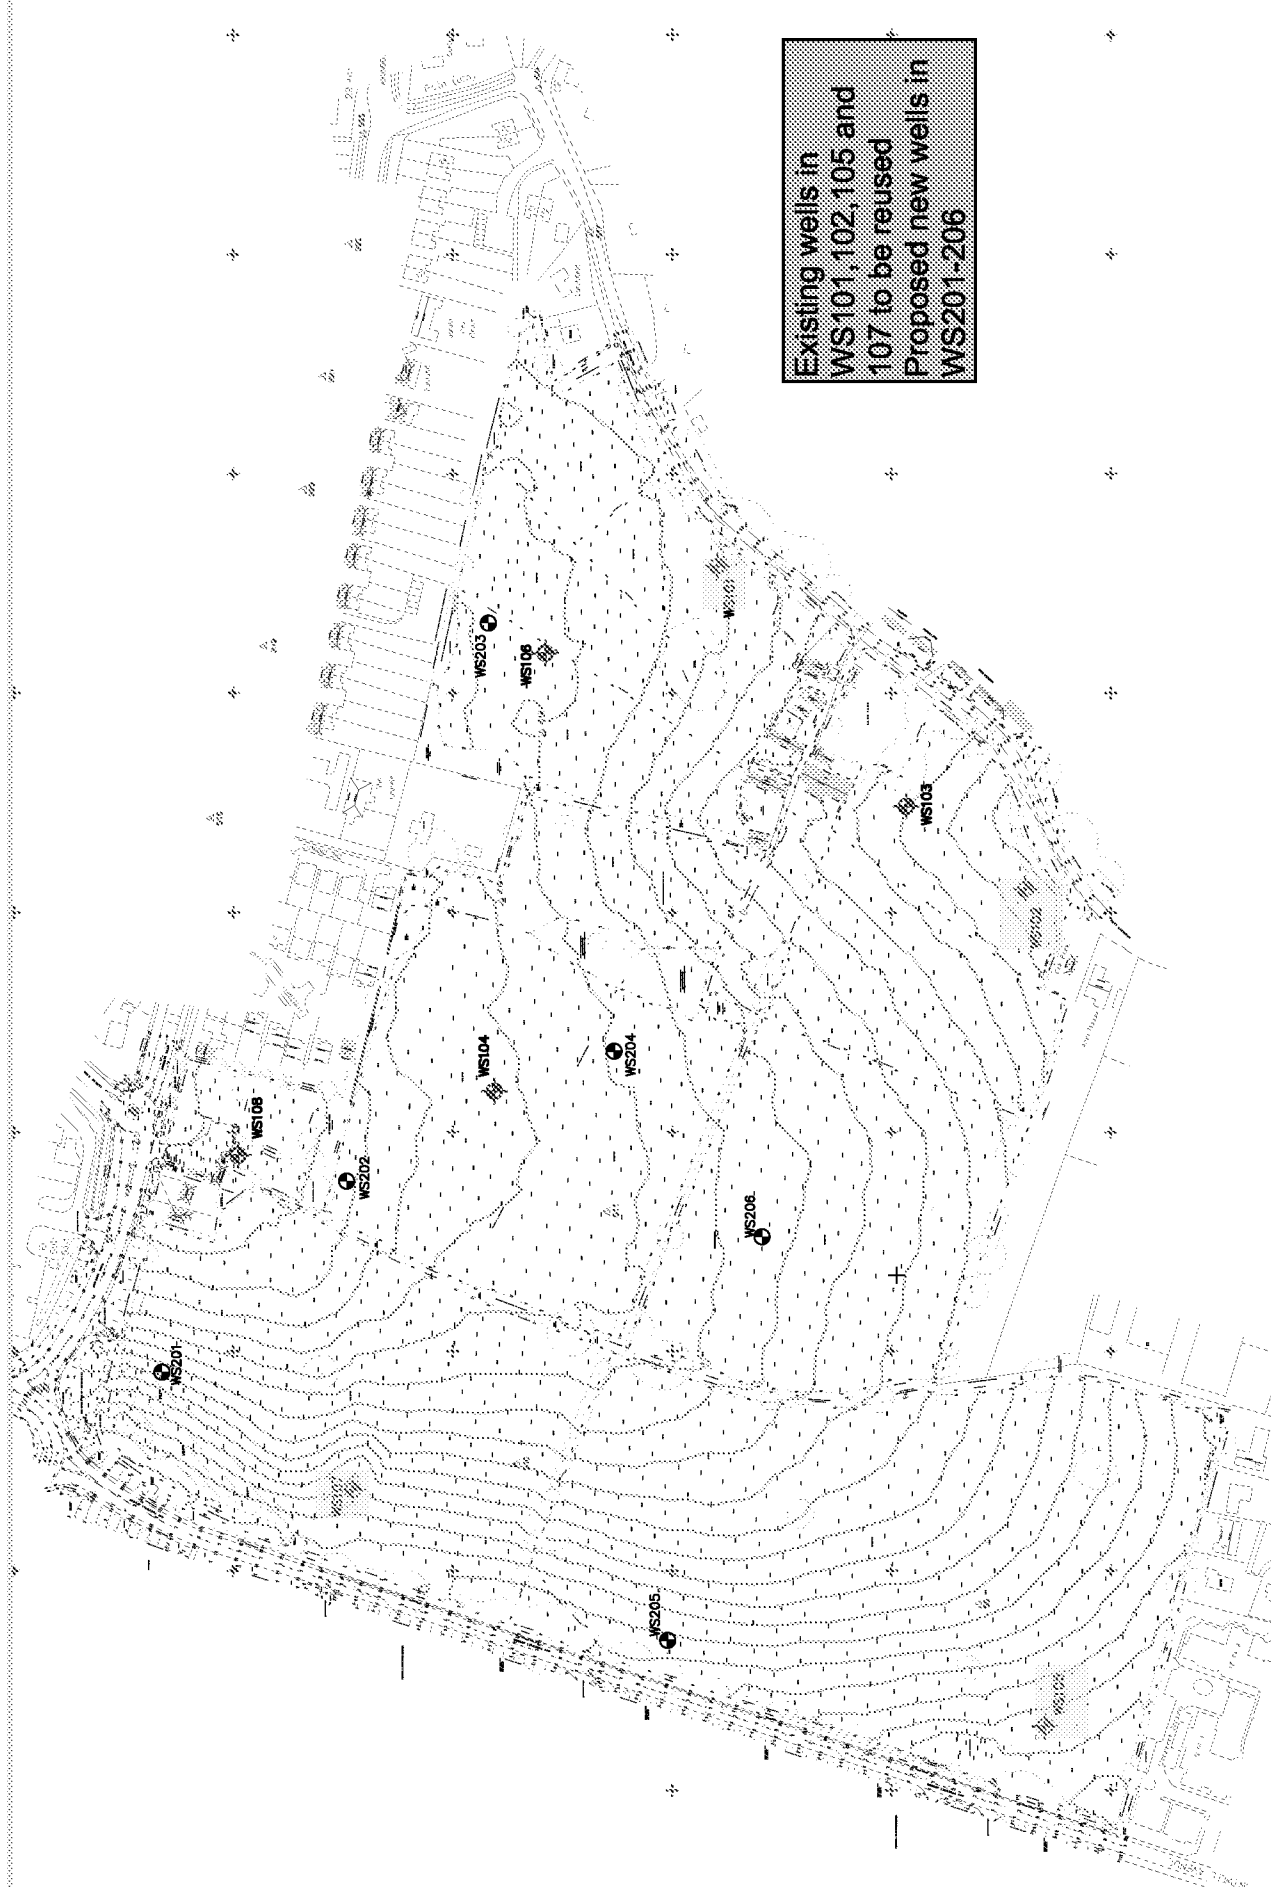
| | Project | Northfield Cottages, Fontwell | | Scale at | NTS | Fig No. | 2 |

Existing wells in  
WS101, 102, 105 and  
107 to be reused  
Proposed new wells in  
WS201-206

| | Title | Proposed Shallow Groundwater Monitoring Well Locations | | A4 | | | |

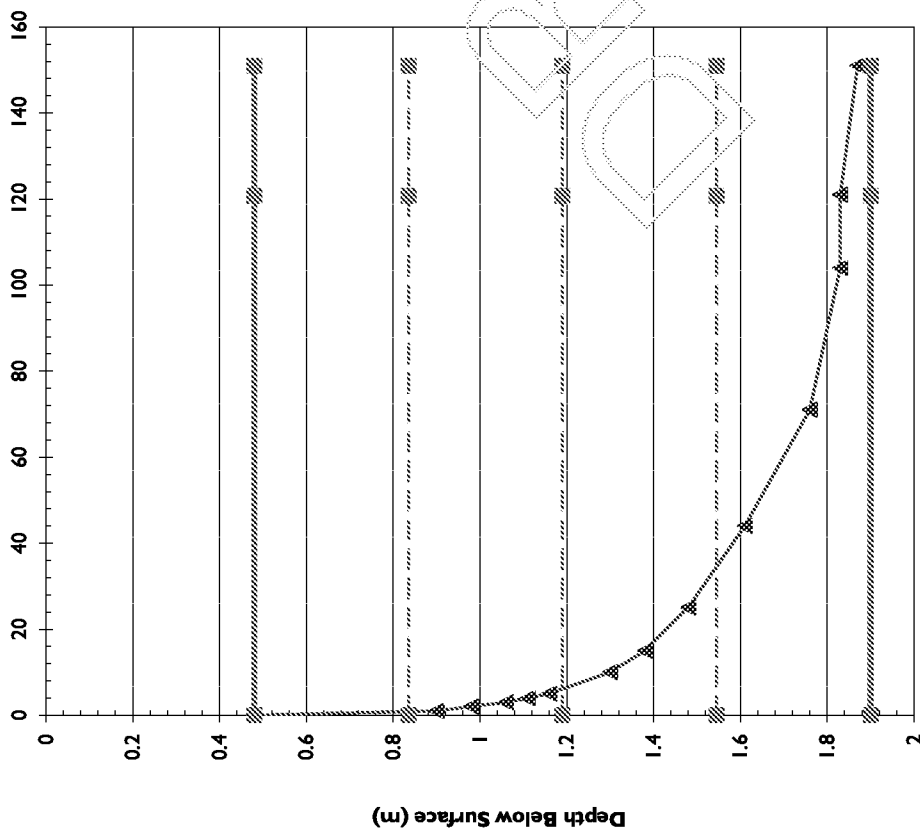
Test Hole No: TP303  
Test No: 1

Filling to Max Water Depth (min)

| BRE Soil Infiltration Rate (m/sec) | 2.544E-05 |

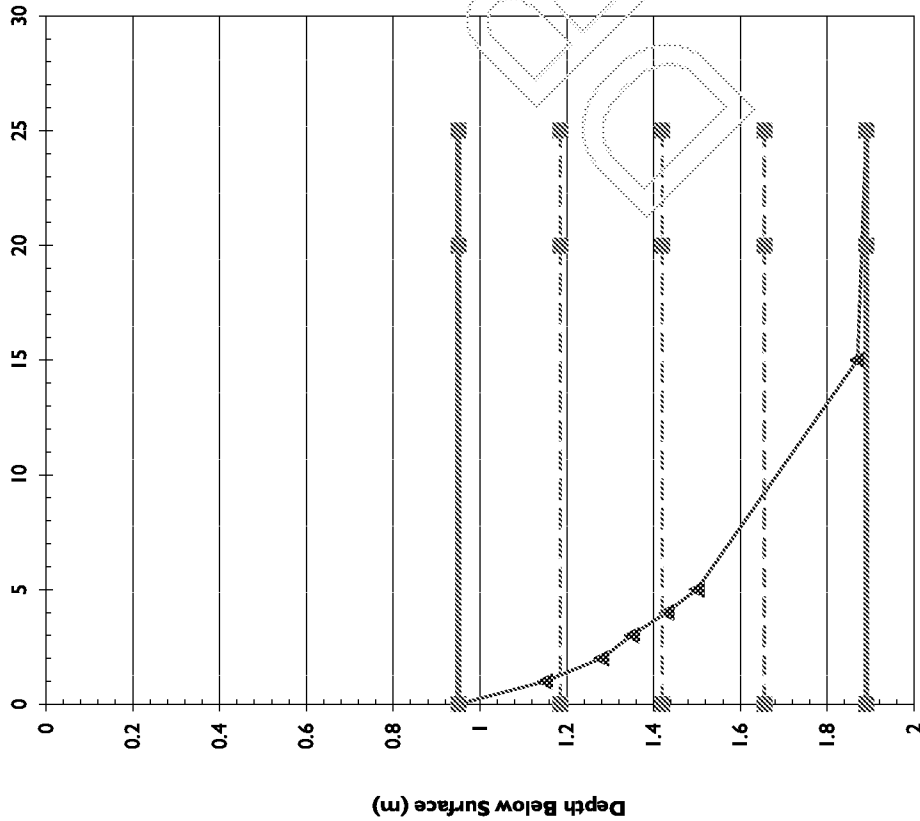
Test Hole No: TP304  
Test No: 1

Filling to Max Water Depth (min)

| BRE Soil Infiltration Rate (m/sec) | 9.84E-05 |

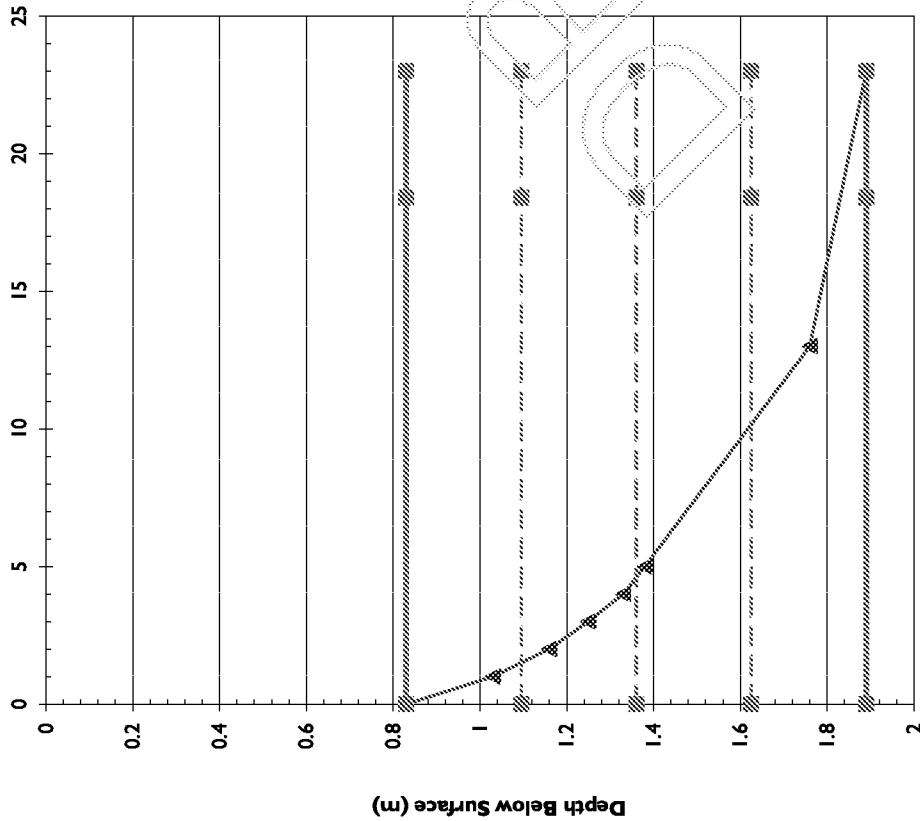
Test Hole No: TP304  
Test No: Test No 2

Filling to Max Water Depth (min)

| BRE Soil Infiltration Rate (m/sec) | 9.305E-05 |

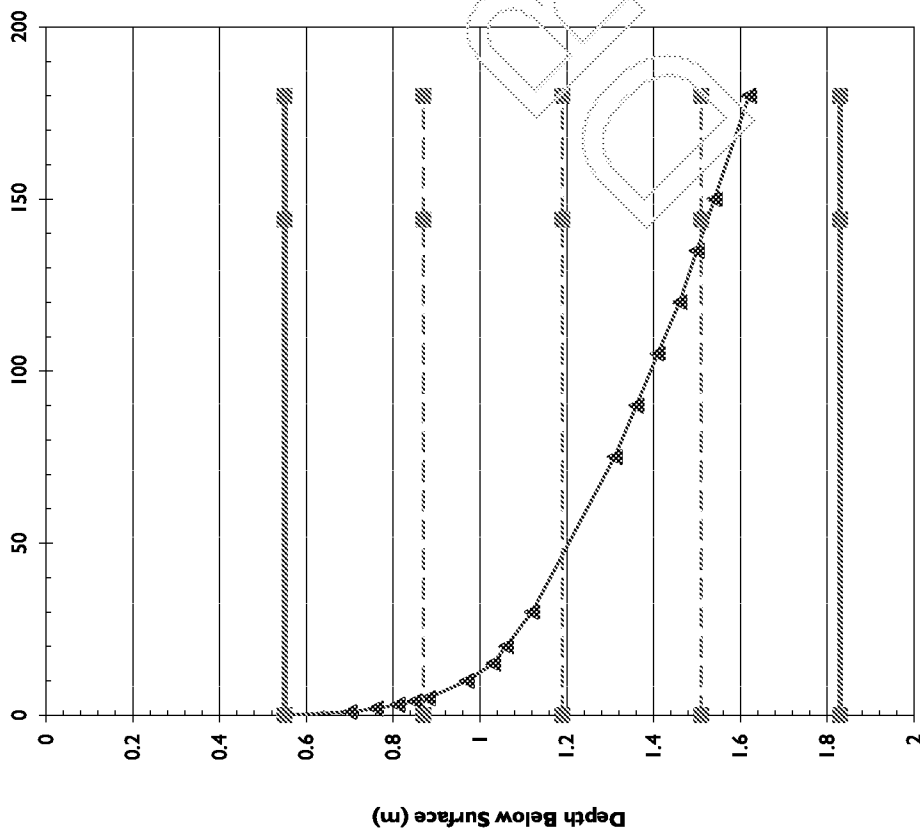
Test Hole No: TP305  
Test No: Test No 1

Filling to Max Water Depth (min)

| BRE Soil Infiltration Rate (m/sec) | 6.114E-06 |

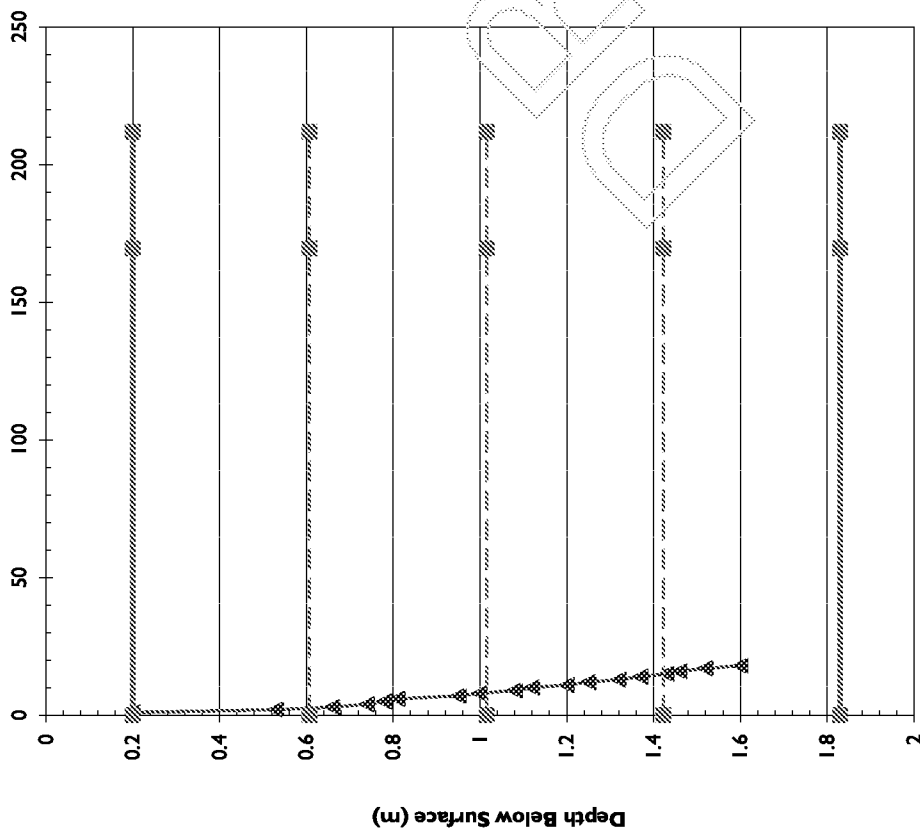
Test Hole No: TP305  
Test No: Test No 2

Filling to Max Water Depth (min)

| BRE Soil Infiltration Rate (m/sec) | 8.475E-06 |

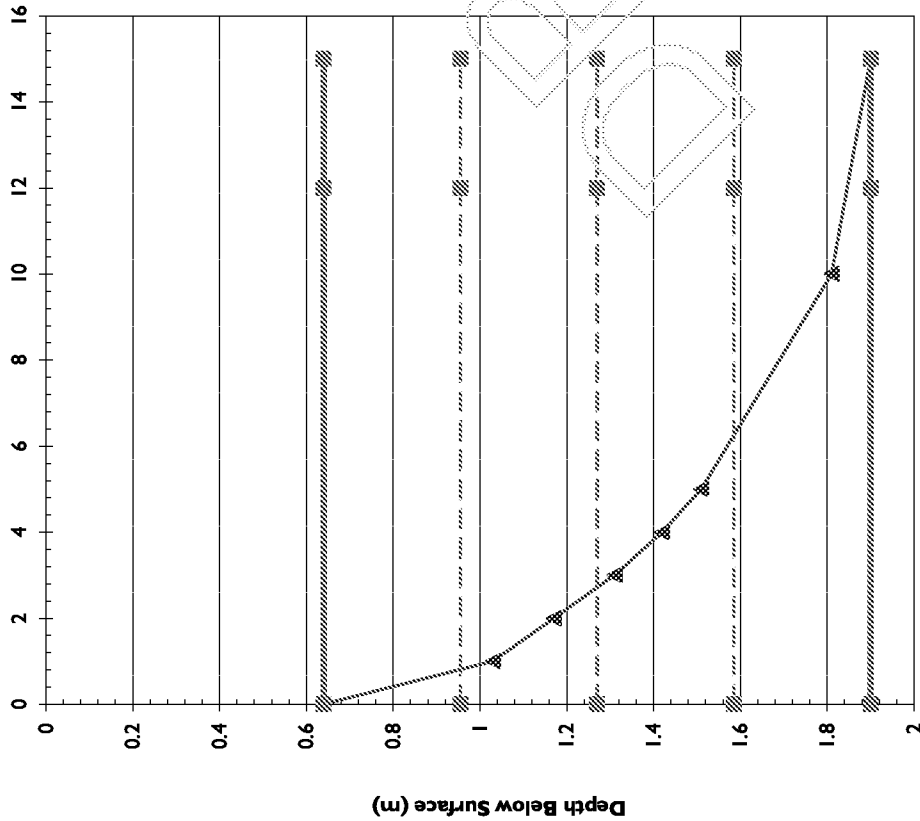
Test Hole No: TP311  
Test No: 1

Filling to Max Water Depth (min)

| BRE Soil Infiltration Rate (m/sec) | 0.0004449 |
