## **Appendix (B)**

### **Geotechnical Information (Extract)**

| | Project | Fontwell Shallow Soaks | | Scale at | NTS | Fig No. | I |
| | Title | Shallow Soakage Positions | | A4 | | | |

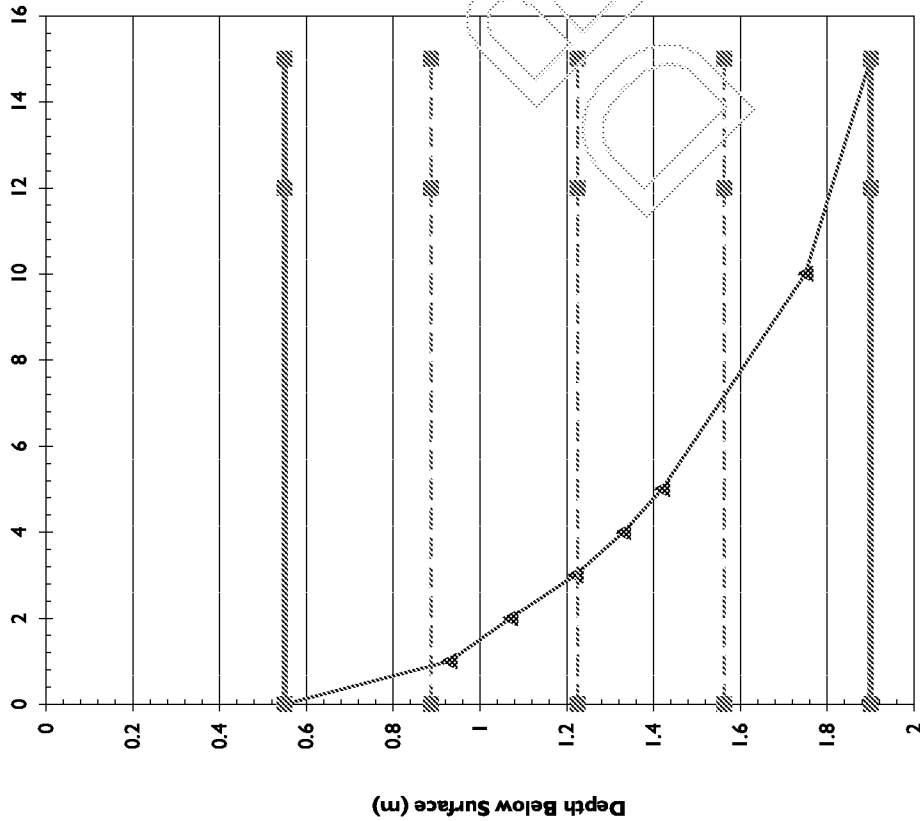
Test Hole No: TP311  
Test No: Test No 2

Filling to Max Water Depth (min)

| BRE Soil Infiltration Rate (m/sec) | 0.0003921 |

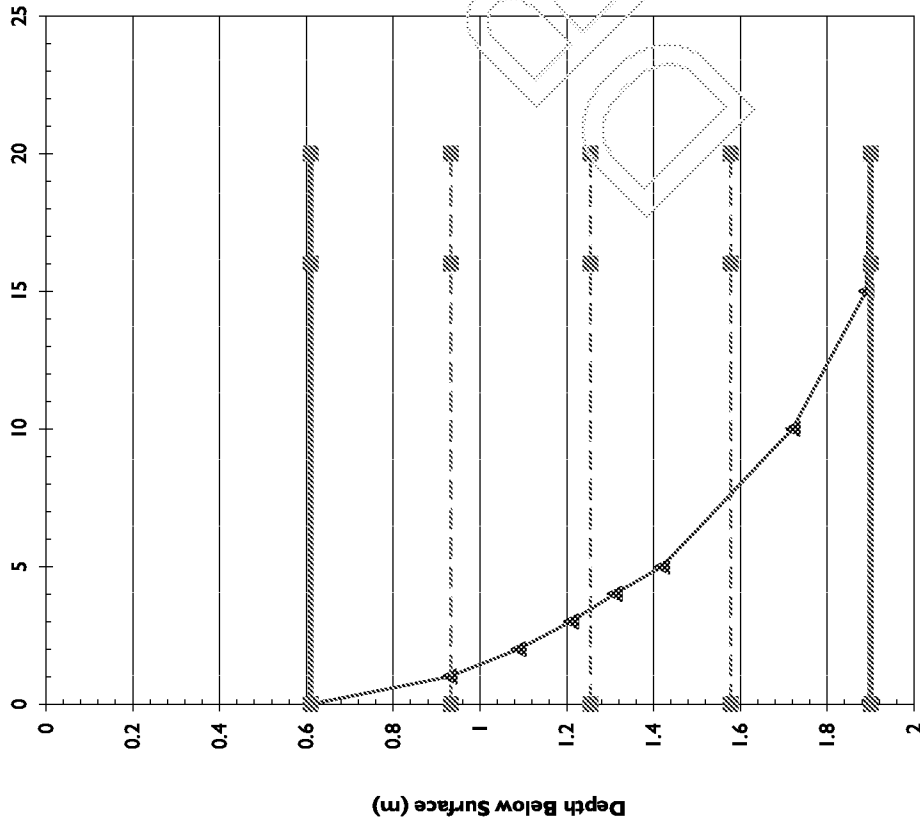
Test Hole No: TP311  
Test No: Test No 3

Filling to Max Water Depth (min)

| BRE Soil Infiltration Rate (m/sec) | 0.0003683 |

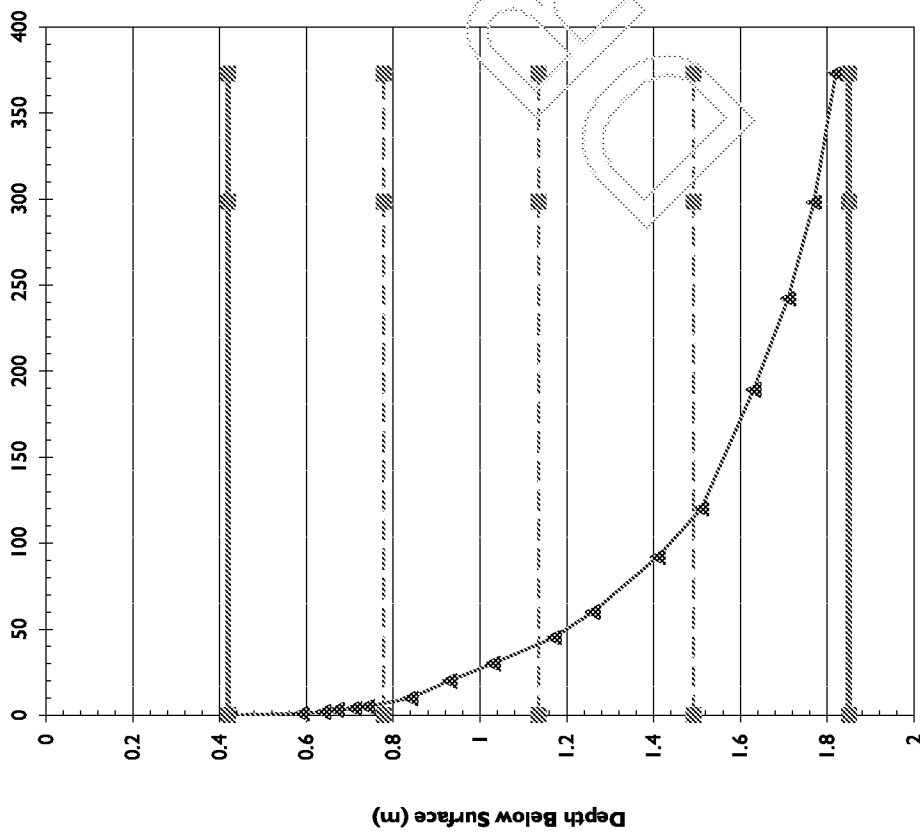
Test Hole No: TP319  
Test No: Test No 1

Filling to Max Water Depth (min)

| BRE Soil Infiltration Rate (m/sec) | 2.272E-05 |

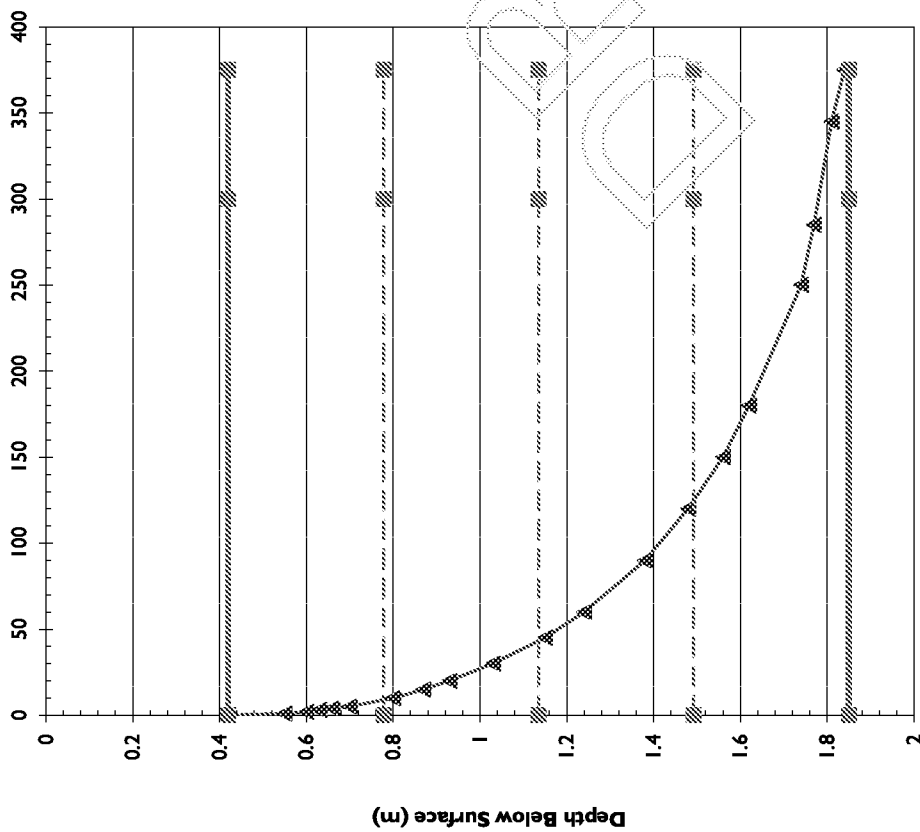
Test Hole No: TP319  
Test No: Test No 2

Filling to Max Water Depth (min)

| BRE Soil Infiltration Rate (m/sec) | 2.123E-05 |

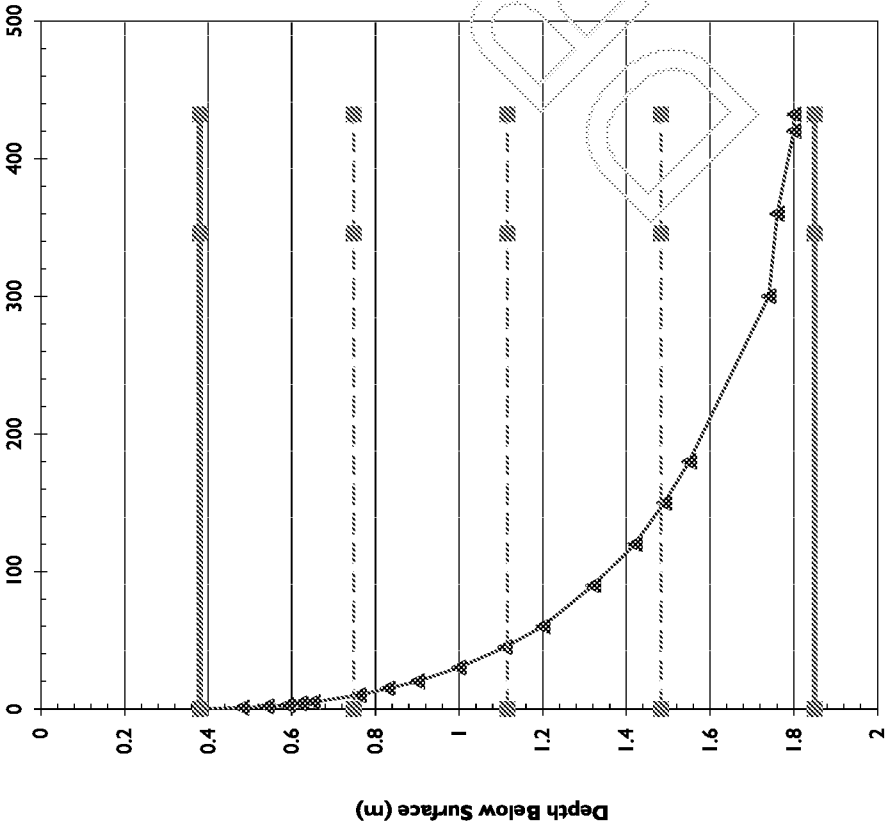
Test Hole No: TP319  
Test No: Test No 3

Filling to Max Water Depth (min)

| BRE Soil Infiltration Rate (m/sec) | 1.8E-05 |

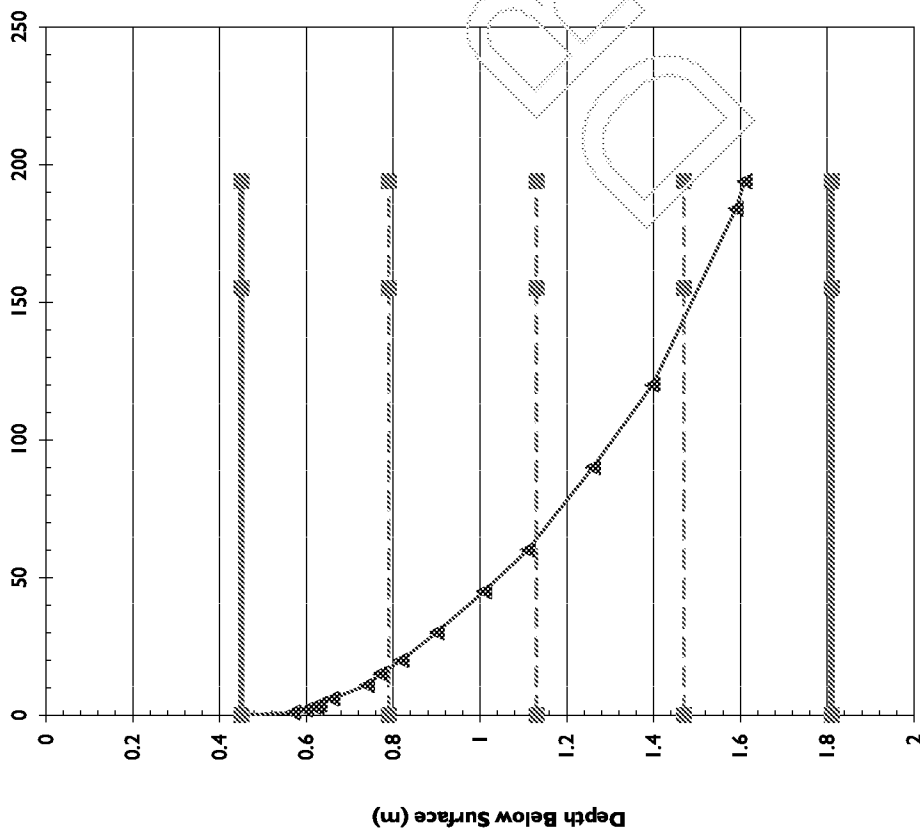
Test Hole No: TP323  
Test No: Test No 1

Filling to Max Water Depth (min)

| BRE Soil Infiltration Rate (m/sec) | 1.909E-05 |

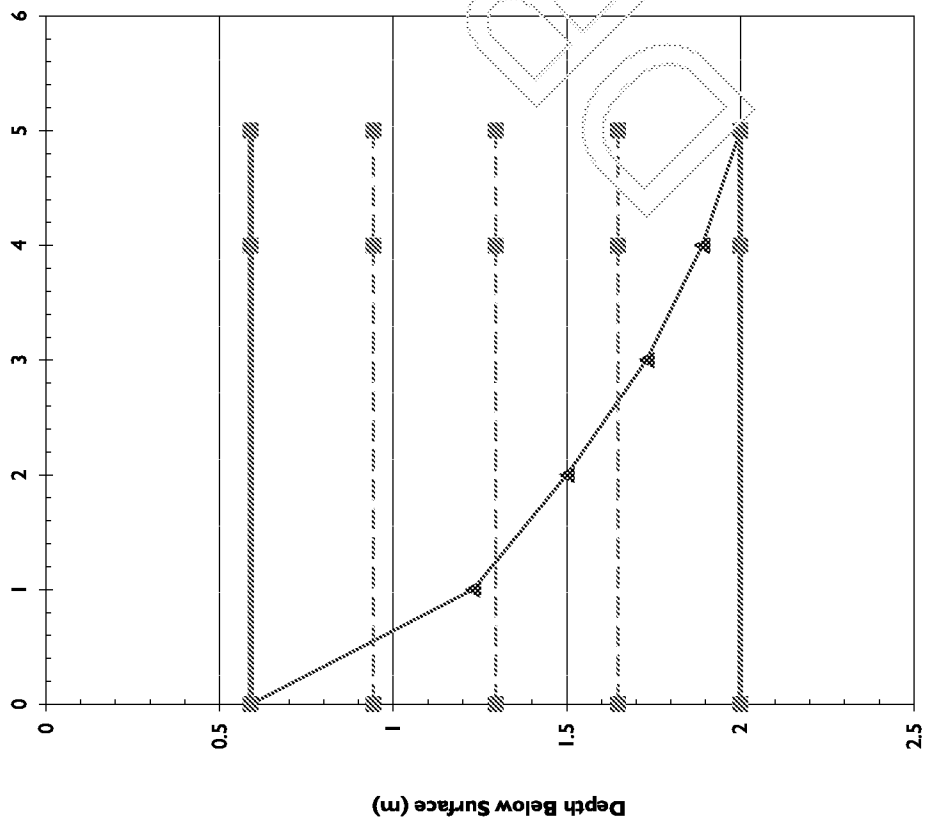
Test Hole No: TP401  
Test No: 1

Filling to Max Water Depth (min)

| BRE Soil Infiltration Rate (m/sec) | 0.0004558 |

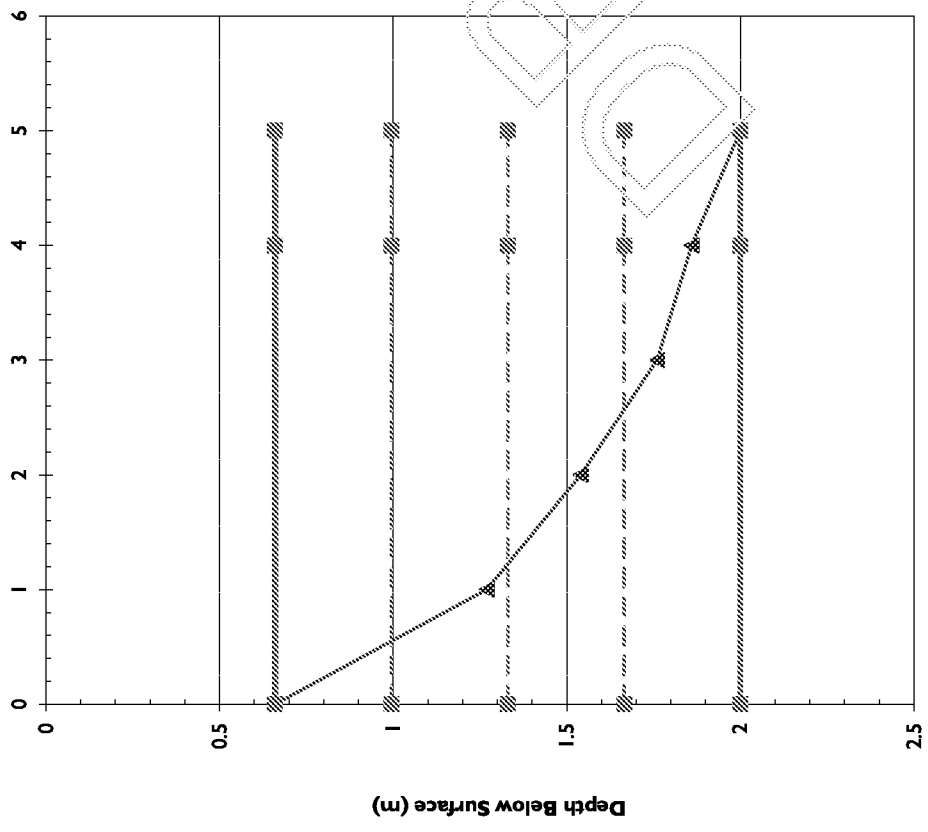
Test Hole No: TP401  
Test No: Test No 2

Filling to Max Water Depth (min)

| BRE Soil Infiltration Rate (m/sec) | 0.0004663 |

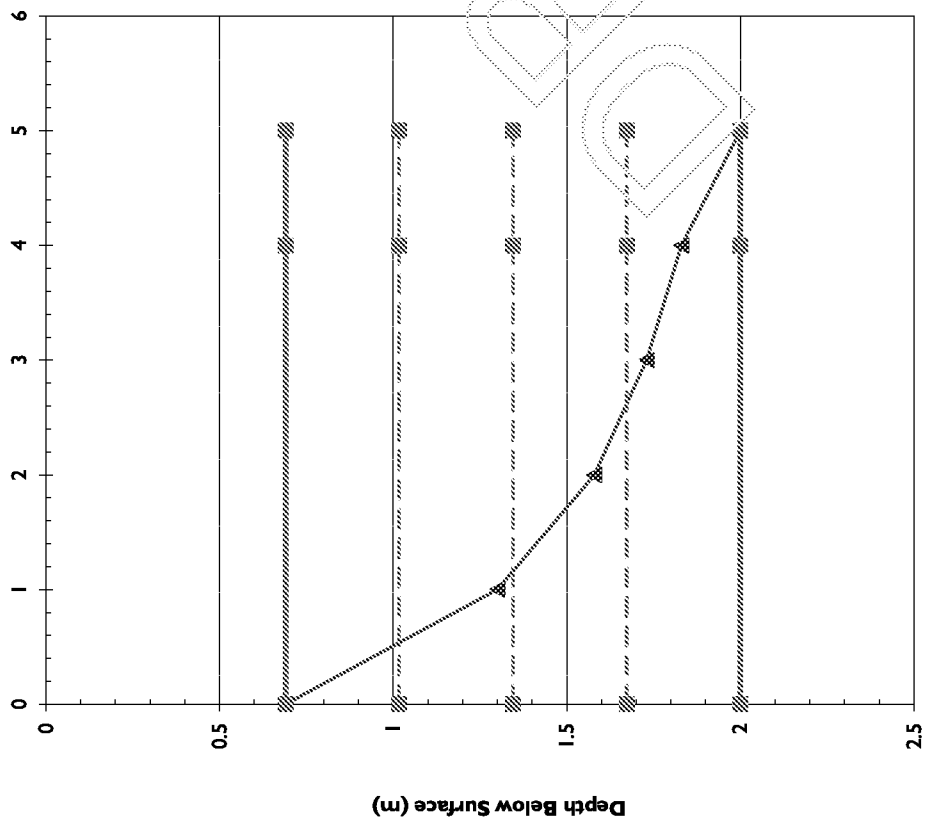
Test Hole No: TP401  
Test No: 3

Filling to Max Water Depth (min)

| BRE Soil Infiltration Rate (m/sec) | 0.0004502 |

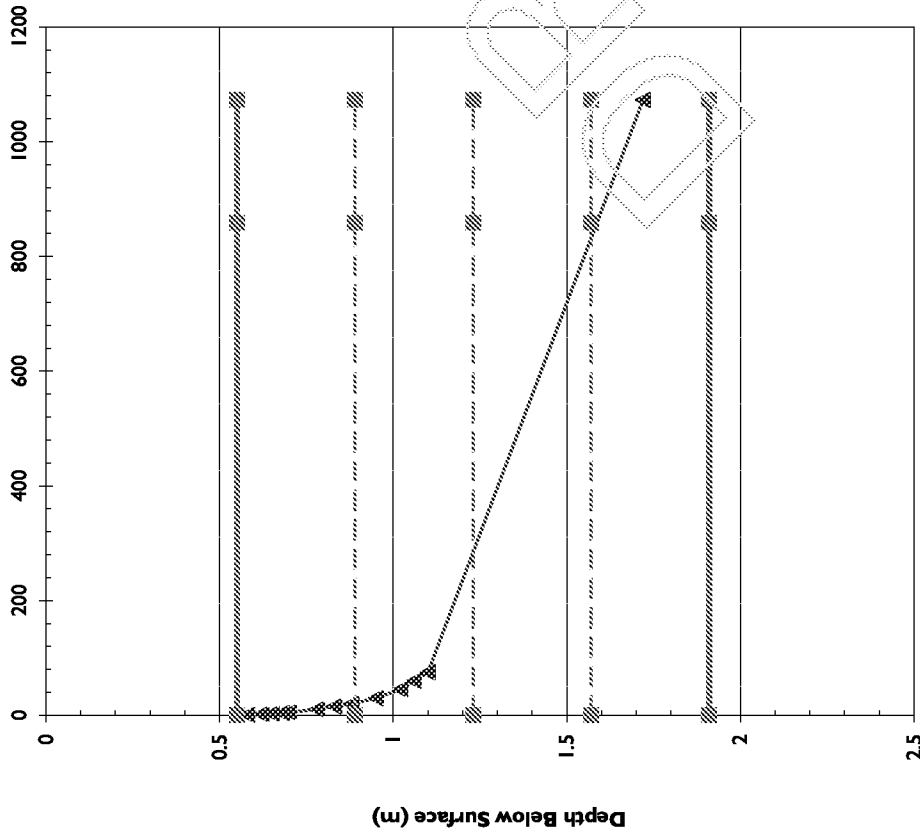
Test Hole No: TP402  
Test No: 1

Filling to Max Water Depth (min)

| BRE Soil Infiltration Rate (m/sec) | 1.169E-06 |

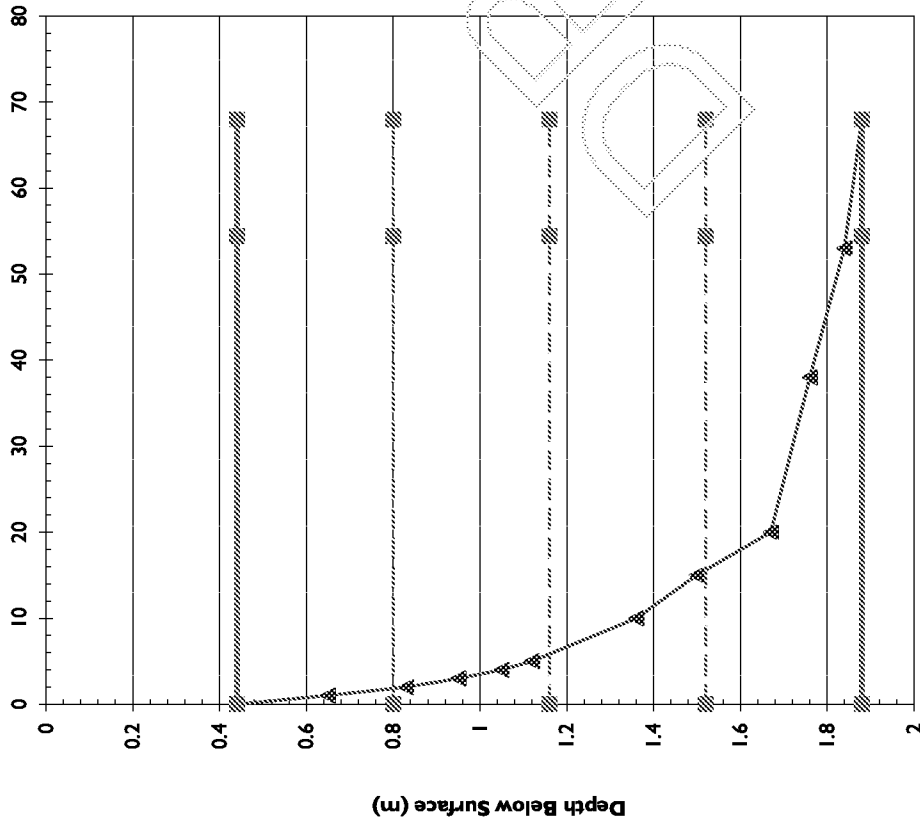
Test Hole No: TP403  
Test No: 1

Filling to Max Water Depth (min)

| BRE Soil Infiltration Rate (m/sec) | 5.095E-05 |

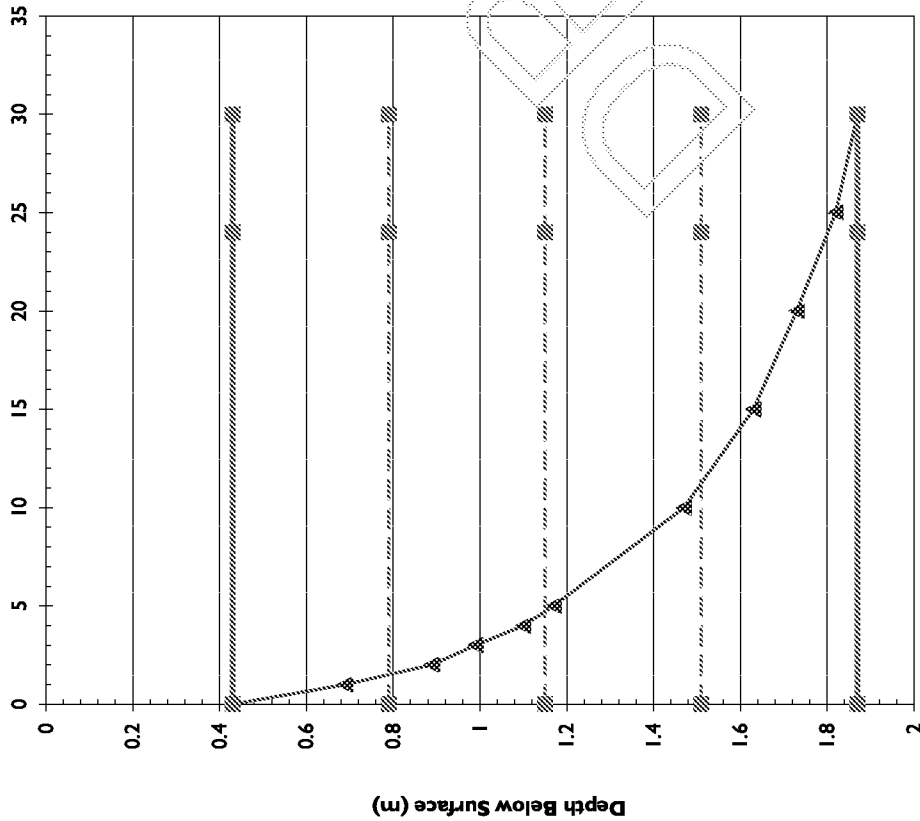
Test Hole No: TP404  
Test No: 1

Filling to Max Water Depth (min)

| BRE Soil Infiltration Rate (m/sec) | 0.0001008 |

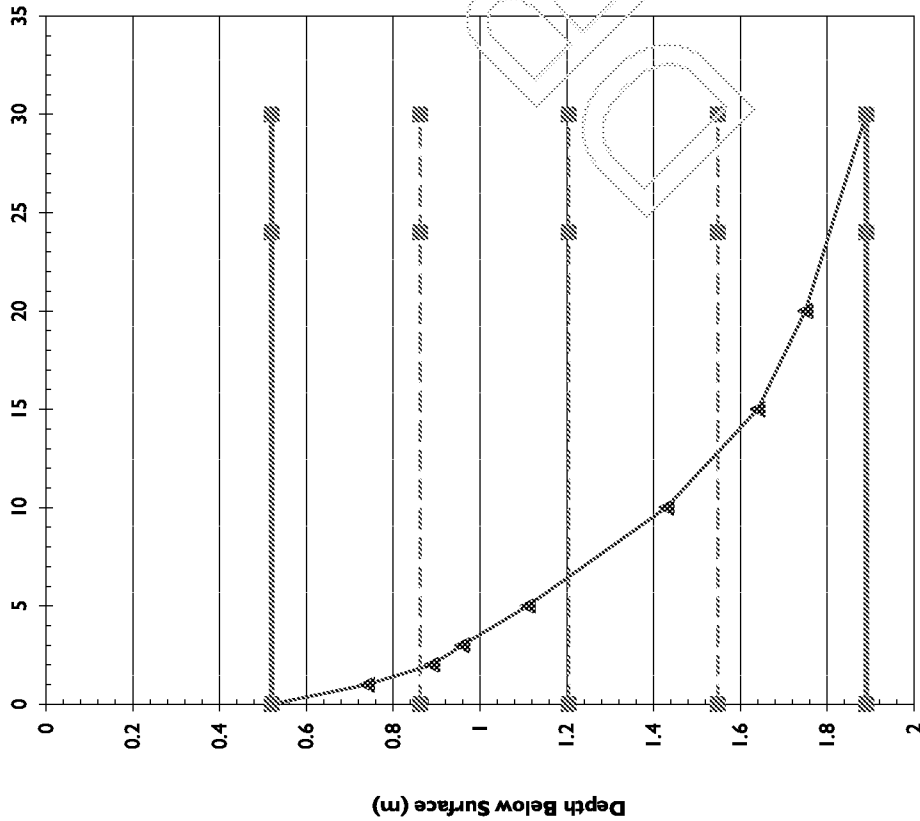
Test Hole No: TP405  
Test No: 1

Filling to Max Water Depth (min)

| BRE Soil Infiltration Rate (m/sec) | 6.062E-05 |

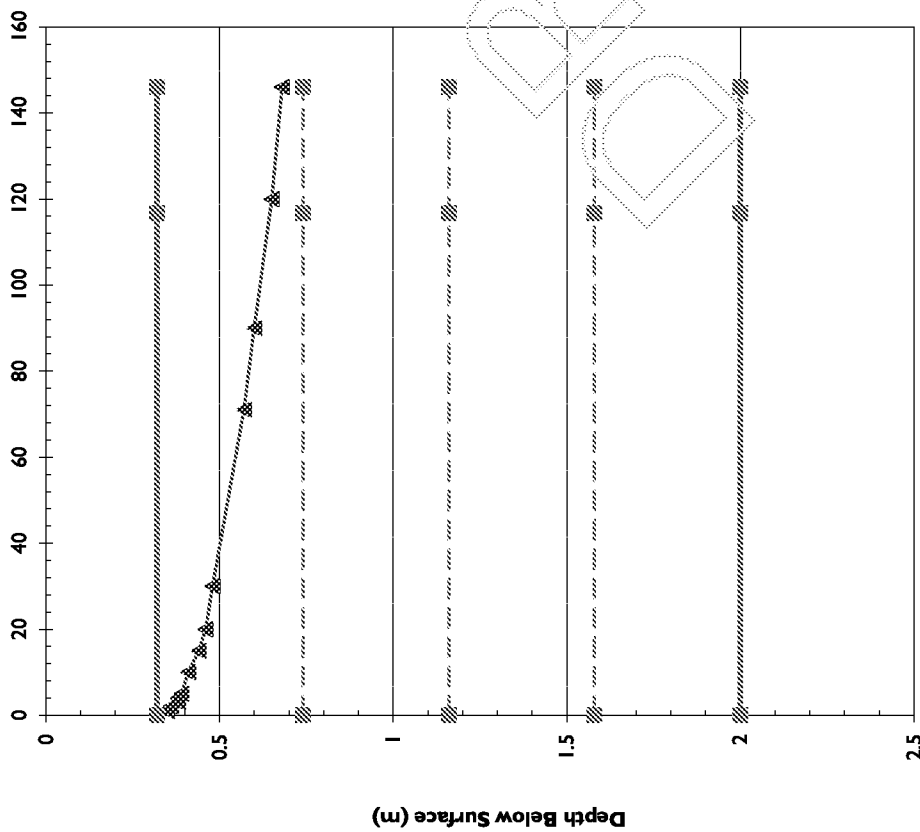
Test Hole No: TP406  
Test No: 1

Filling to Max Water Depth (min)

| BRE Soil Infiltration Rate (m/sec) | 1.098E-06 |

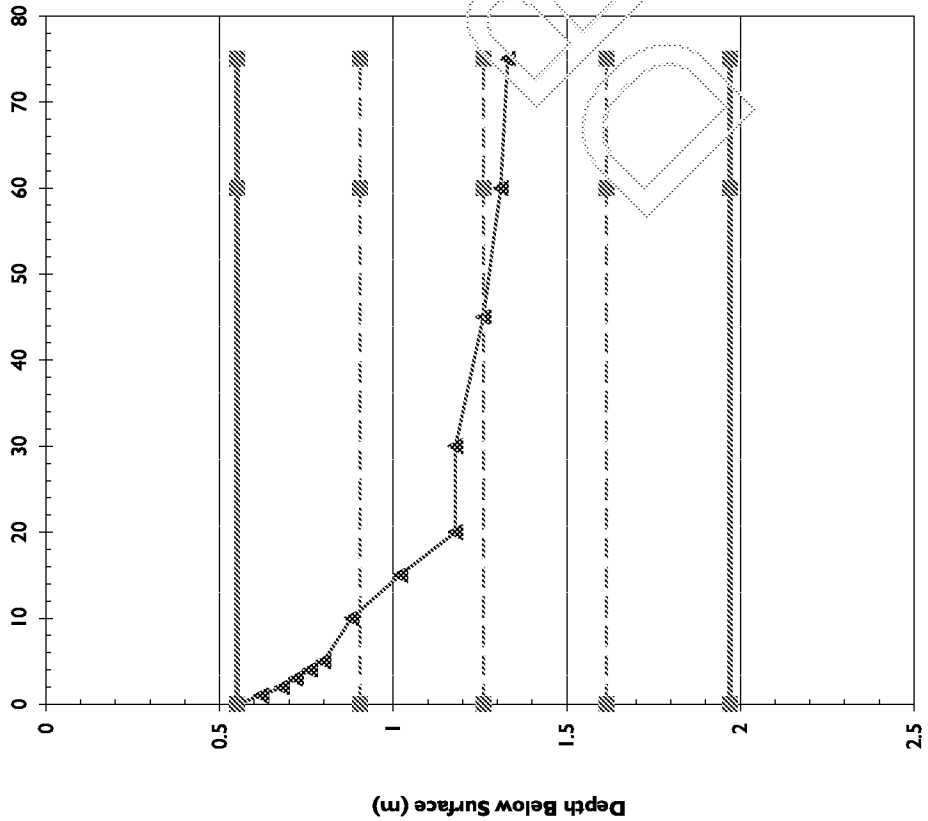
Test Hole No: TP407  
Test No: 1

Filling to Max Water Depth (min)

| BRE Soil Infiltration Rate (m/sec) | 7.24E-06 |

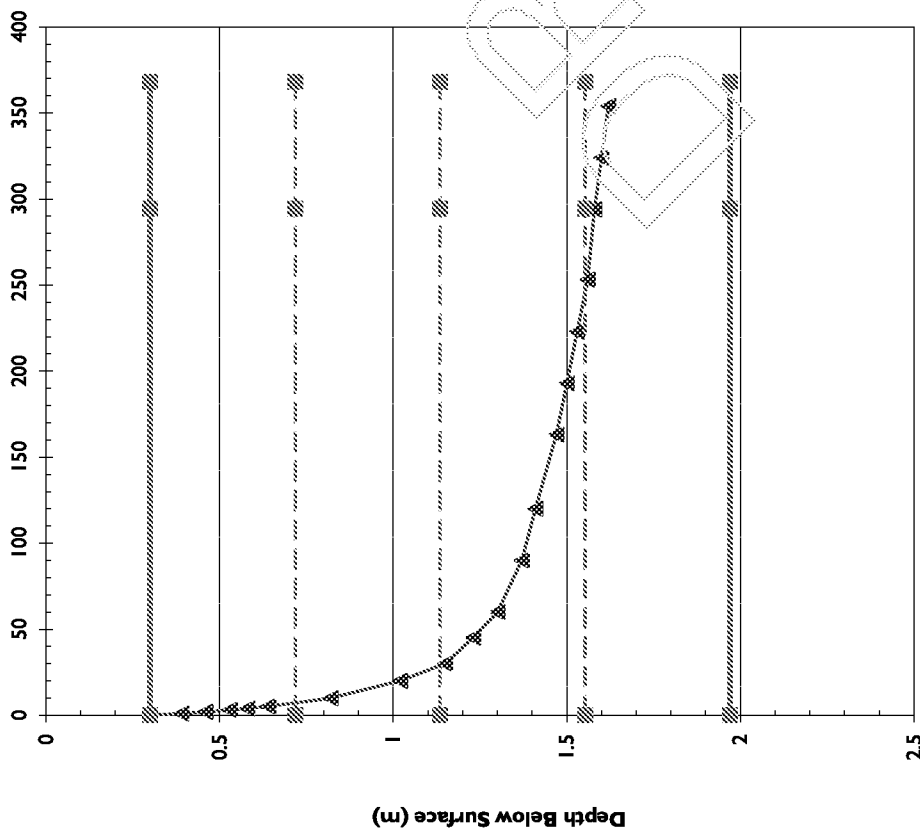
Test Hole No: TP407  
Test No: Test No 3

Filling to Max Water Depth (min)

| BRE Soil Infiltration Rate (m/sec) | 3.891E-06 |
