**Road Safety Audit Stage 1**

**Proposed Section 278 Works**

**North End Road**

**Yapton**

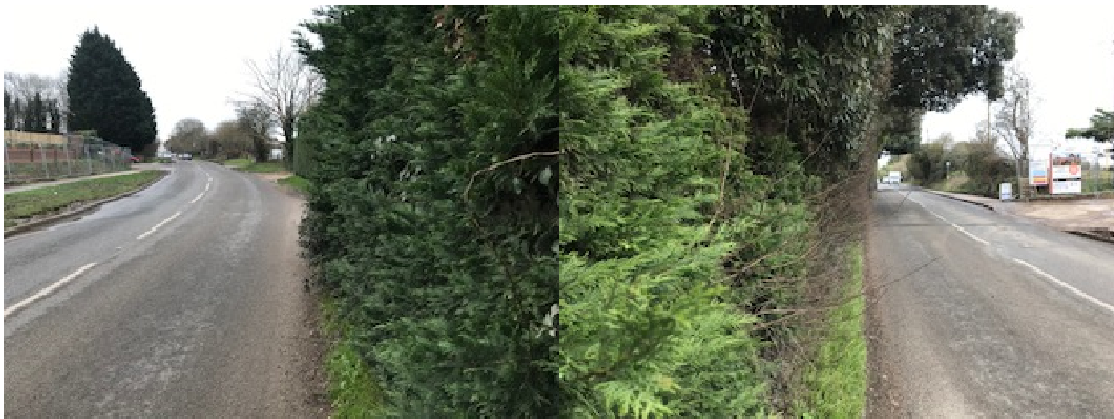
**Summary:** Restricted visibility could lead to side impact or rear end shunt collisions.

Visibility splays were provided for assessment where existing vegetation could restrict visibility splays- see figures 1 & 2 overleaf. Restricted visibility could lead to could lead to side impact or rear end shunt collisions.

Figures 1&2: Existing tree and hedge line on North End Road.

It is recommended that the visibility splays should be free of obstruction.

| Item. | Problem | Recommendation | Designer's Response |
|---|---|---|---|
| 3.3.1 | Visibility splays were provided for assessment where existing vegetation could restrict visibility splays- see figures 1 & 2 overleaf. Restricted visibility could lead to could lead to side impact or rear end shunt collisions. | It is recommended that the visibility splays should be free of obstruction | Visibility splays will be provided in accordance with the guidance contained in Manual for Streets. Visibility splays at the site access will be 2.4m. x 45m. in each direction along North end Road as illustrated on Dwg No. 0003 rev. P04. The visibility splays to be kept free of vegetation. |

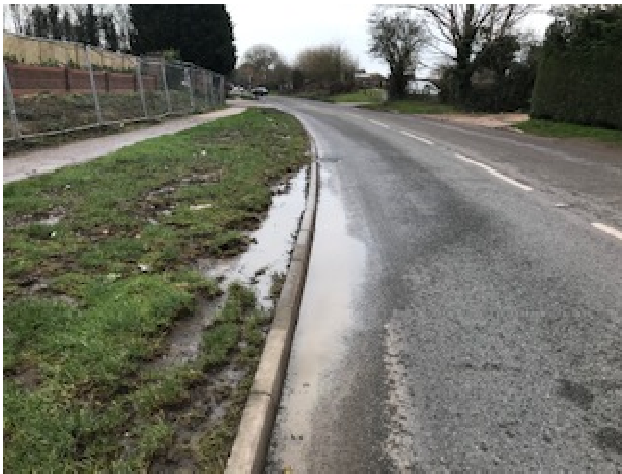
On the eastern side of North End Road ponding was observed close to a gully which appears to be in the vicinity of the proposed crossing point- see figure 3 overleaf.

The presence of ponding could lead to pedestrians not using the crossing point and crossing at less safe places and the presence of a gully grating could lead to pedestrian trips and falls.

Figure 3: Ponding on the eastern channel on North End Road.

- That carriageway should drain and not pond at the crossing point.
- That the gully should not be within the crossing area or that a pedestrian friendly gully cover should be installed.

| <p><b>3.4.2</b></p> | <p>On the eastern side of North End Road ponding was observed close to a gully which appears to be in the vicinity of the proposed crossing point- see figure 3 overleaf.</p> <p>The presence of ponding could lead to pedestrians not using the crossing point and crossing at less safe places and the presence of a gully grating could lead to pedestrian trips and falls</p> | <ul style="list-style-type: none"> <li>• That carriageway should drain and not pond at the crossing point.</li> <li>• That the gully should not be within the crossing area or that a pedestrian friendly gully cover should be installed.</li> </ul> | <p>Liaison with WSCC on the detailed design at the Section 278 Agreement stage will include a Stage 2 RSA, and would be expected to address any issues affecting drainage/ponding that are directly related to the proposed development.</p> |
