**Re: Orchard Business Park, North End Road, Yapton, West Sussex, BN18 0GA**

Appendix 1: Proposed Development Plan (Drawing No : 14\_16\_101 Rev B)

## **Remediation Method Statement (RMS) for Orchard Business Park, North End Road, Yapton, West Sussex, BN18 0GA**

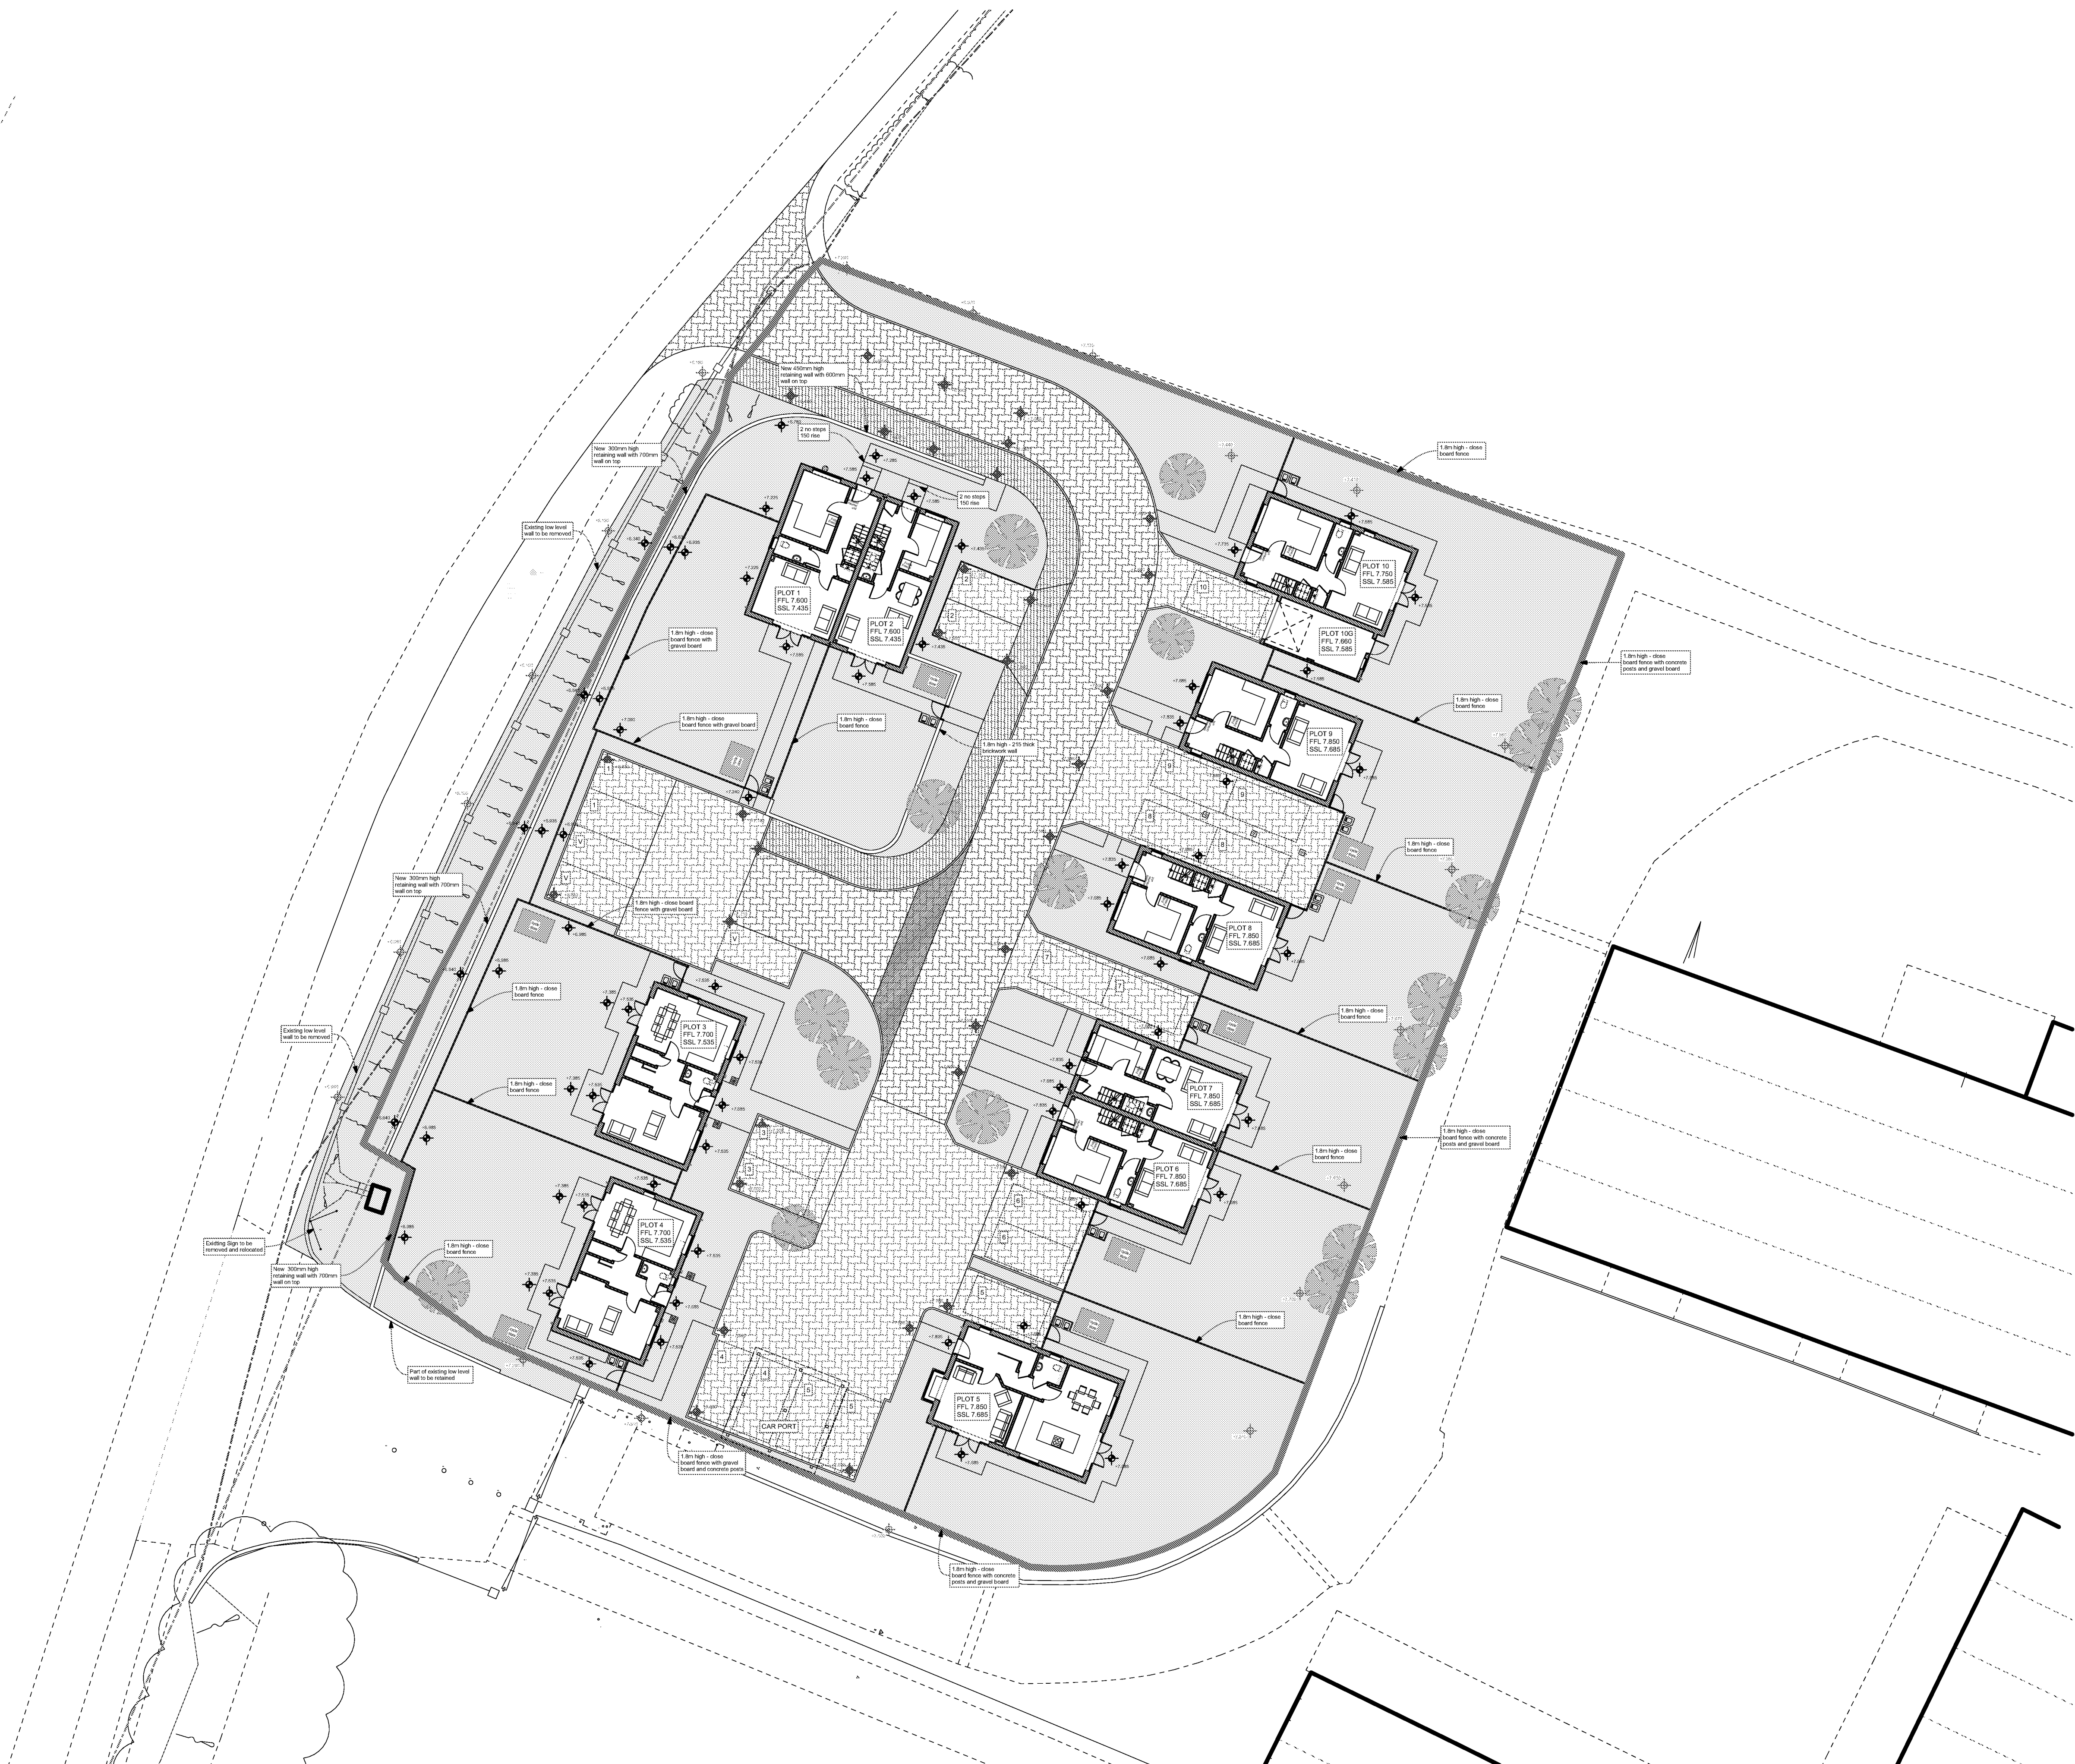
Scale : 1:200 @ A1 Date : OCT 18  
Drawing No : 14\_16\_101 Rev B

- Forterra Permeable Block Paving to drives and parking spaces laid herringbone pattern with bullnose kerbs. Colour - Red Brindle Engineer detail - Paving Detail 02

- Forterra Impermeable Block Paving to footpath and parking spaces laid herringbone pattern with bullnose kerbs. Colour - Red Brindle
- Forterra Permeable Block Paving to roads laid herringbone pattern with bullnose kerbs. Colour - Purbeck Engineer detail - Paving Detail 01

- Forterra Impermeable Block Paving laid herringbone pattern with bullnose kerbs. Colour - Purbeck
- Paving - Brett Bronte Random Pattern - Colour - Weathered Stone Engineer detail - Type 3

**SITE LAYOUT | PROPOSED DEVELOPMENT AT:**  
**ORCHARD BUSINESS PARK**  
**NORTH END ROAD**  
**YAPTON, BN18 0GA**

The following information has been supplied by the Client in regards to the proposed development (Drawing No : 14\_16\_101 Rev B) enclosed as Appendix 1. Any change or deviation from the scheme outlined in the drawing could invalidate the foundation design and remediation recommendations presented within this report. Soils Limited must be notified about any such changes.

The current plan indicates that this location (TP1) will lie below an area planned for the access road to the final development in the north western corner of the site. As such we would anticipate that either the material will be removed as part of the road emplacement works, so effectively no source will remain, or remain below the level of proposed hard standing (usually 0.30m) and so the potential linkage will be removed. As such the risk will be negligible as either no source and/or linkage to a vulnerable receptor will remain. However, the often sporadic and isolated nature of most site encountered ACM, indicates that it is possible that additional materials of this type may be located during the development. On this basis, Soils Limited would recommend a discovery-based RMS be emplaced combined with a raising of asbestos awareness within the site workforce.
