**Yapton Free Church, Main Road, Yapton**  
**Surface Water Maintenance Summary Sheet:**  
**For Church Management Team**

# Surface Water Drainage and Maintenance Statement

Project Yapton Free Church, Main Road, Yapton  
Project Number 22815  
By Tom Zajac  
Date 29 June 2017

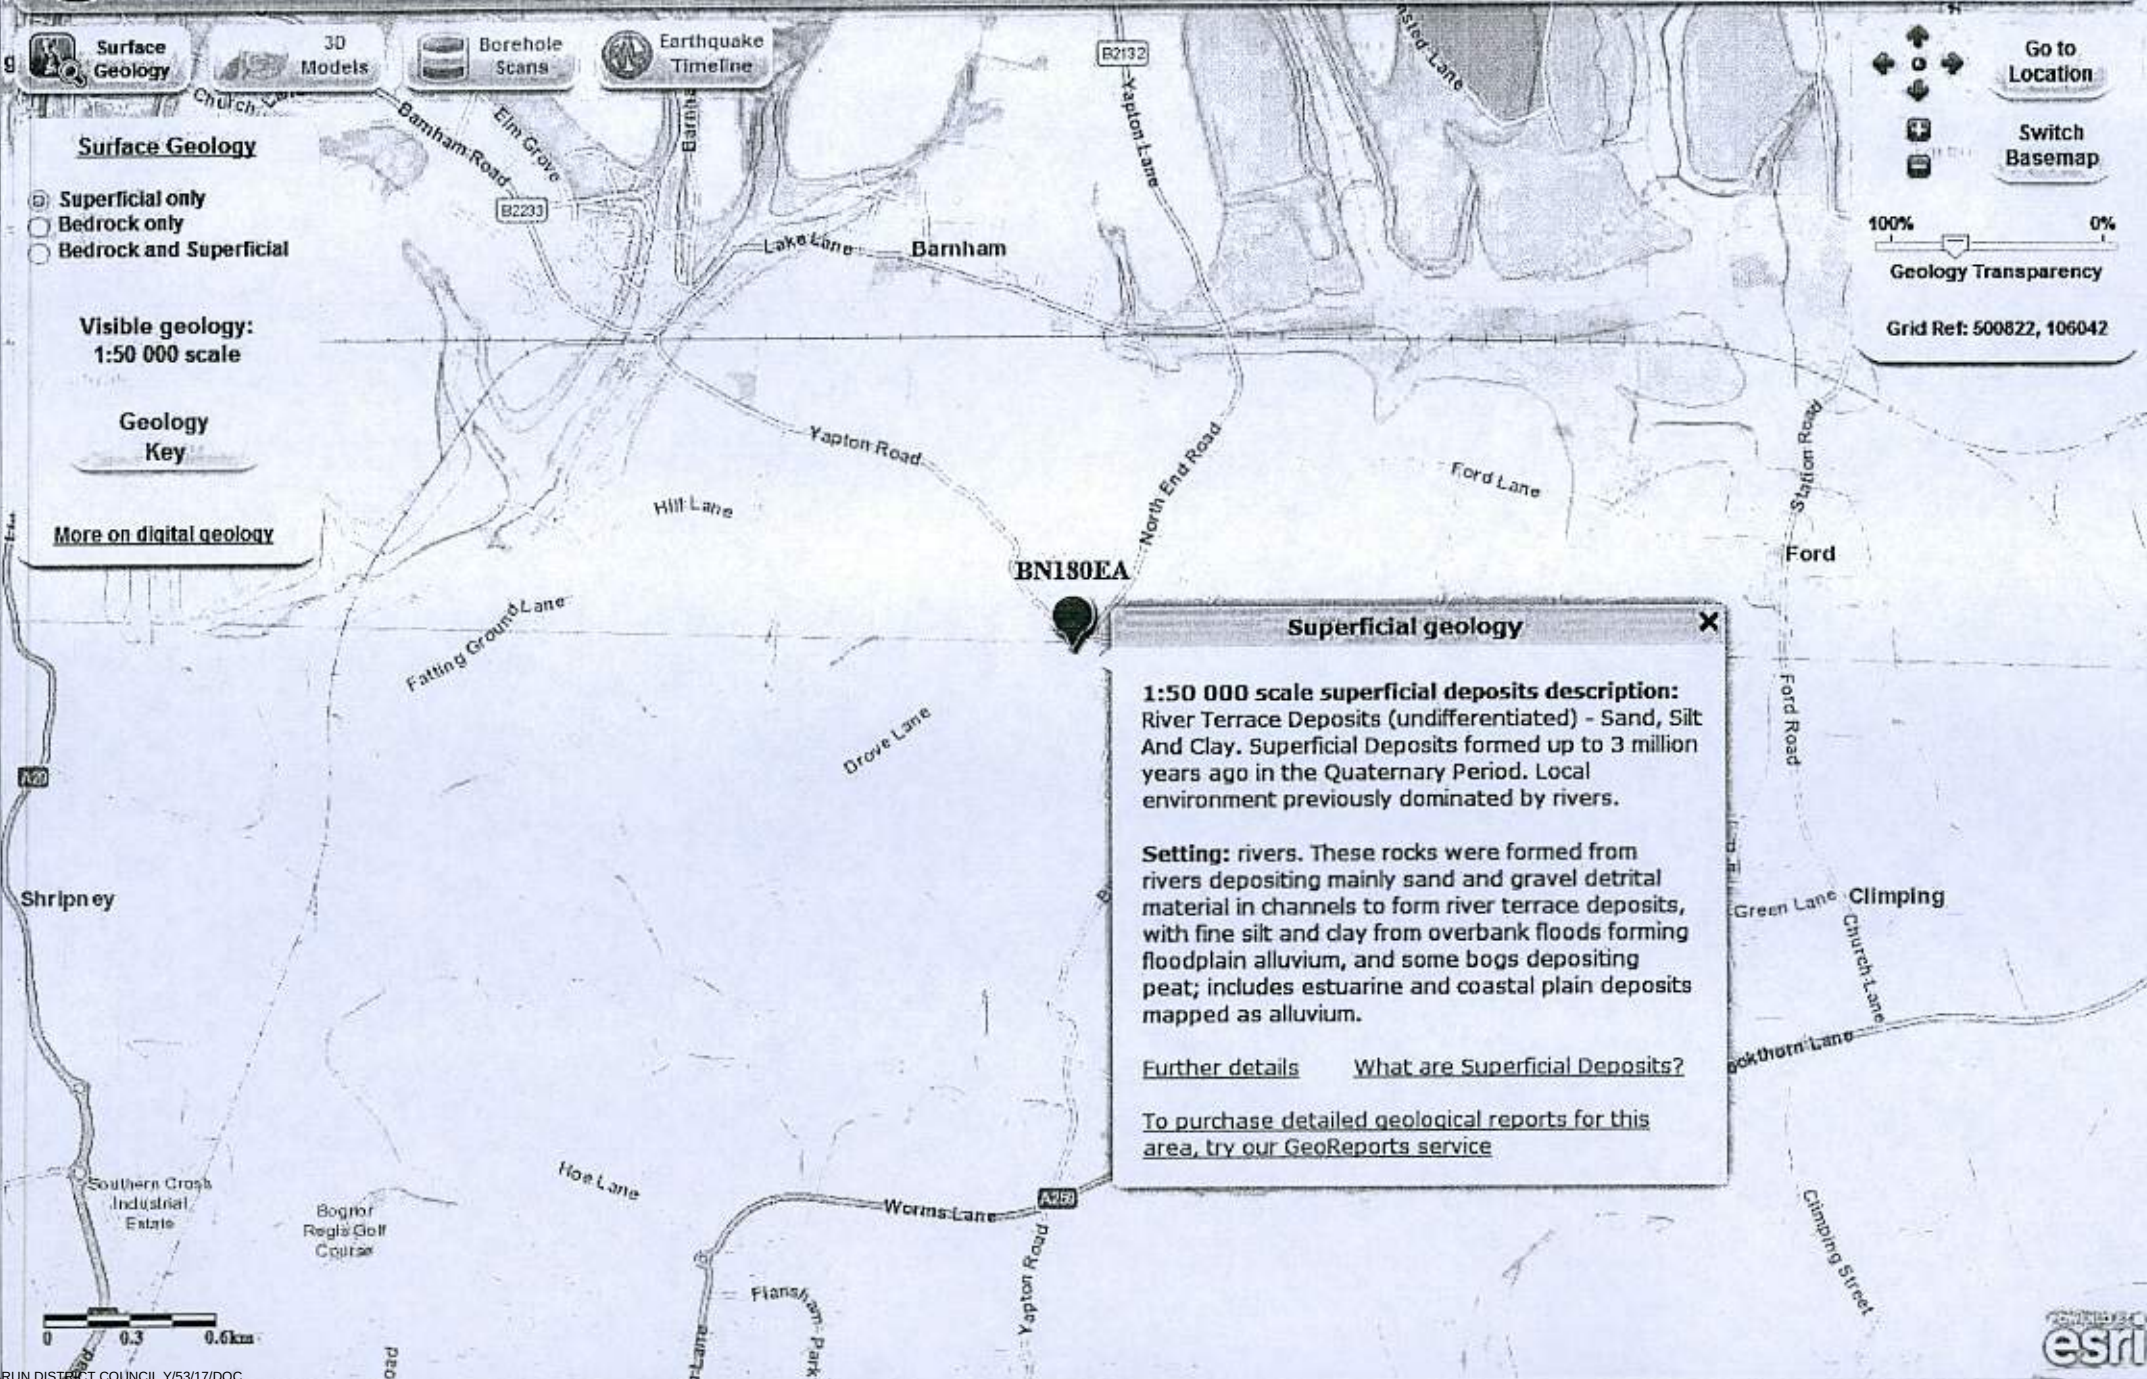
Geology Transparency

## Superficial geology

**1:50 000 scale superficial deposits description:**  
River Terrace Deposits (undifferentiated) - Sand, Silt And Clay. Superficial Deposits formed up to 3 million years ago in the Quaternary Period. Local environment previously dominated by rivers.

The information available from British Geological Survey (BGS) indicates that the proposed site is underlain by Lewes Nodular Chalk Formation overlaid by River Terrace Deposits.
