Our Ref.: 18935/RMSLR/RMSV

**Re: Orchard Nursery RMS Validation**

**Validation Investigation Works**

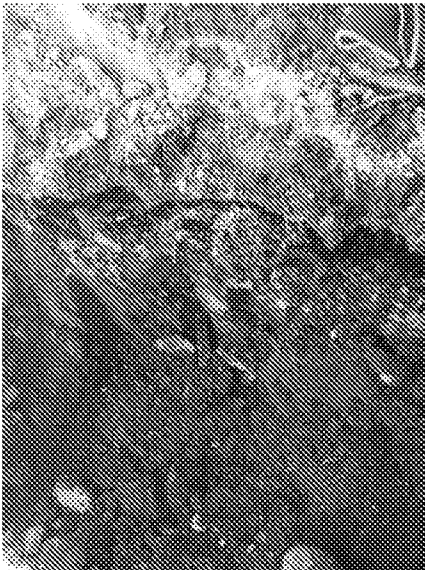
Photograph 1

Also of particular interest was a brick wall passing east to west which was noted to final depth across the trial pit and which apparently continues to the eastern end of the site and somewhat westwards underlying the access road. This wall also had noted fill materials including ash and clinker presumably emplaced contemporary with the installation and backfilling of this feature, reaching roughly 30cm each side as noted in the following photograph:

Sample V5 was deliberately taken from depth in the “reworked” ground adjacent to the wall and showed a very similar result to that from WS3 0.20m during the previous investigation at 539mg/kg for V5 compared to 522mg/kg for WS3. This strongly indicates that the material is probably of similar source and origin and that the original WS3 sample is indeed an outlier probably associated with the wall backfill. Unfortunately, as certain samples were deliberately targeted in a hotspot area, they should not technically be subject to statistical analysis under current guidance.

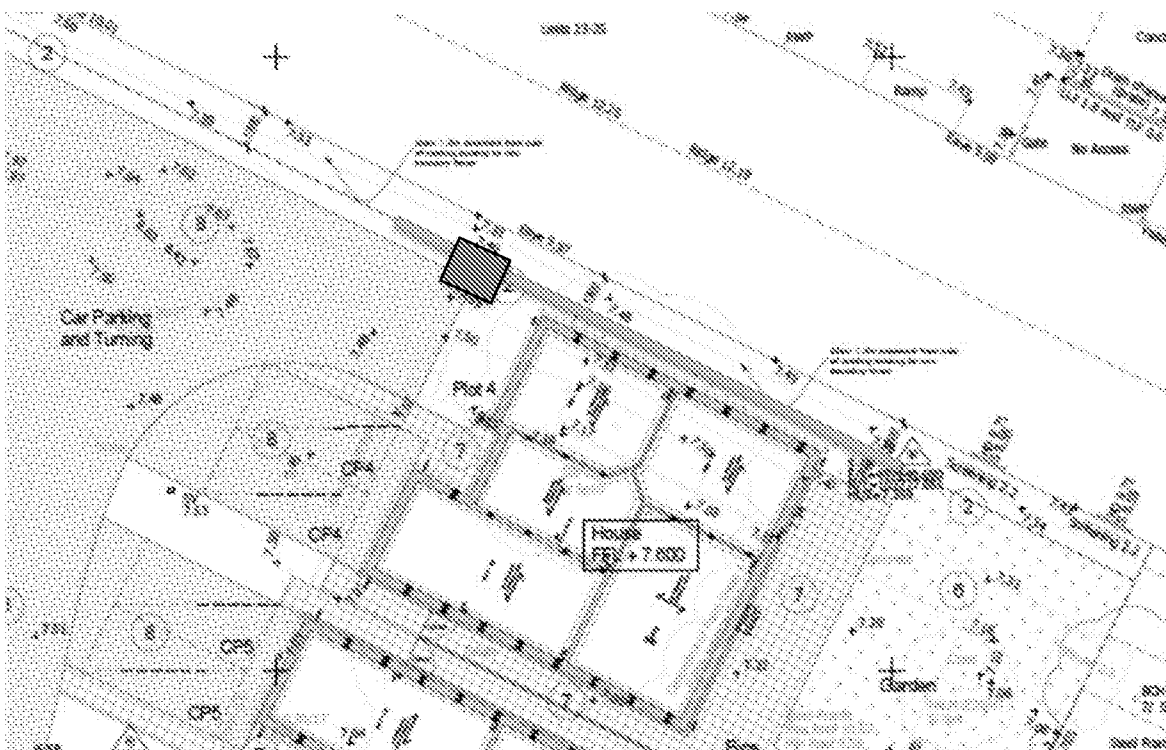
#### Plan 1

A Section of the latest site plan is enclosed as Plan 1 and has been annotated to include the area of the wall (in green) and the trial pit (in blue).

As can be noted, the area of the wall will lie below at least 300mm of overlying clean material, hard surfacing and/or at least 300mm of suitable growing medium which under BRE guidance for cover should be sufficient to mitigate the underlying risk. Elevated Lead levels associated with the wall will also be removed from direct access to human receptors through inhalation by the establishment of appropriate barriers (hard or soft) to over 200mm, though in theory ingestion may be possible in back garden areas (considered to be up to 600mm below ground level) if the wall extends further into those areas. If the infill is processed non depositional Lead (as considered likely given the source), its bioavailability will be of the order of only a couple of percent and a site-specific allowable C4SL guideline value of between 450-750mg/kg would typically be generated.

Validation on completion of works should therefore comprise confirmation of the depth of emplacement in the area of the wall (using engineers drawings/plans/notes/photographs/etc. and/or third-party depth confirmation by limited investigation) in addition to the discovery strategy confirmation already highlighted. In addition, presentation of appropriate documentation for any and all ground materials removed and imported to the site (a QS summary of the volumes is usually acceptable with an example waste ticket for disposal) and suitable certification to confirm suitability and fitness for purpose in context of its proposed use will be expected. Any additional requirements should be highlighted by the regulator after appropriate consultation.
