Subject: Tactile Paving and Standing Water

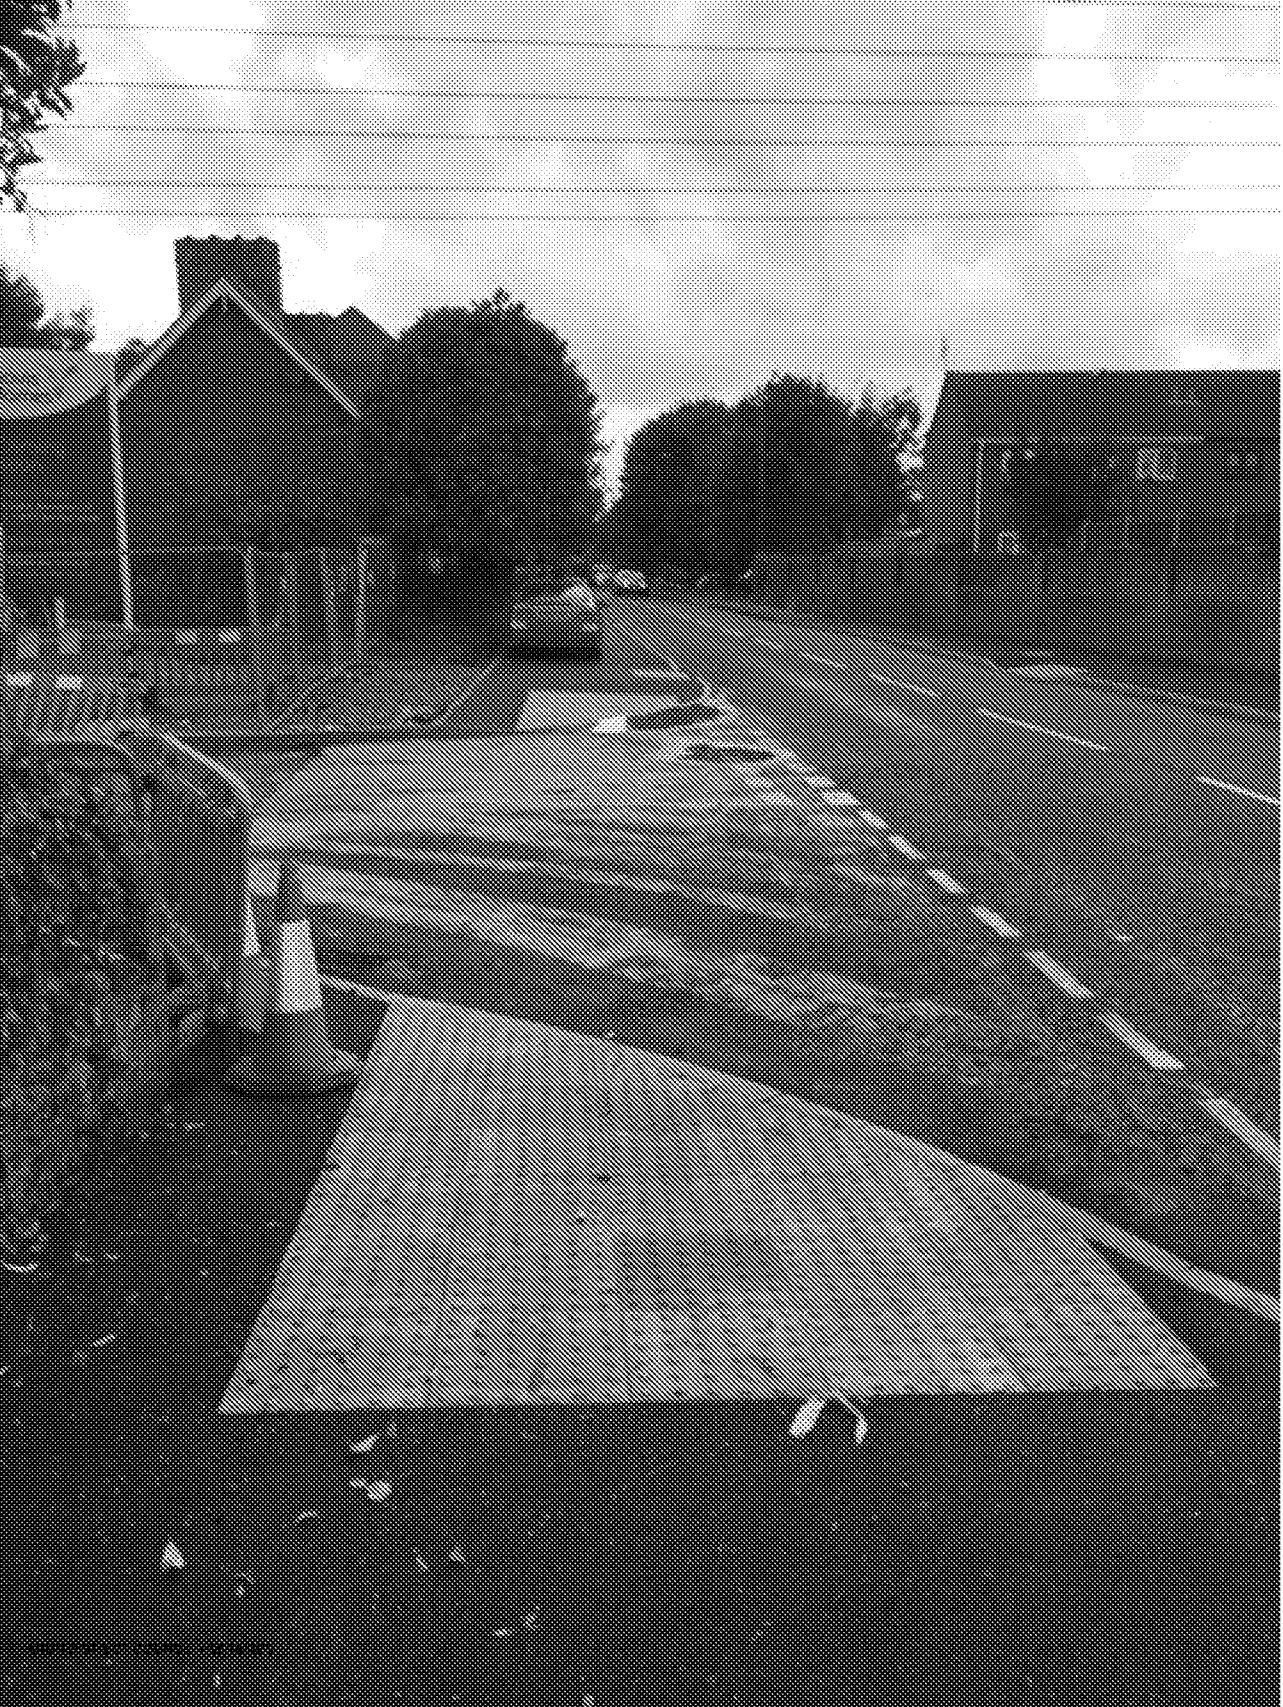
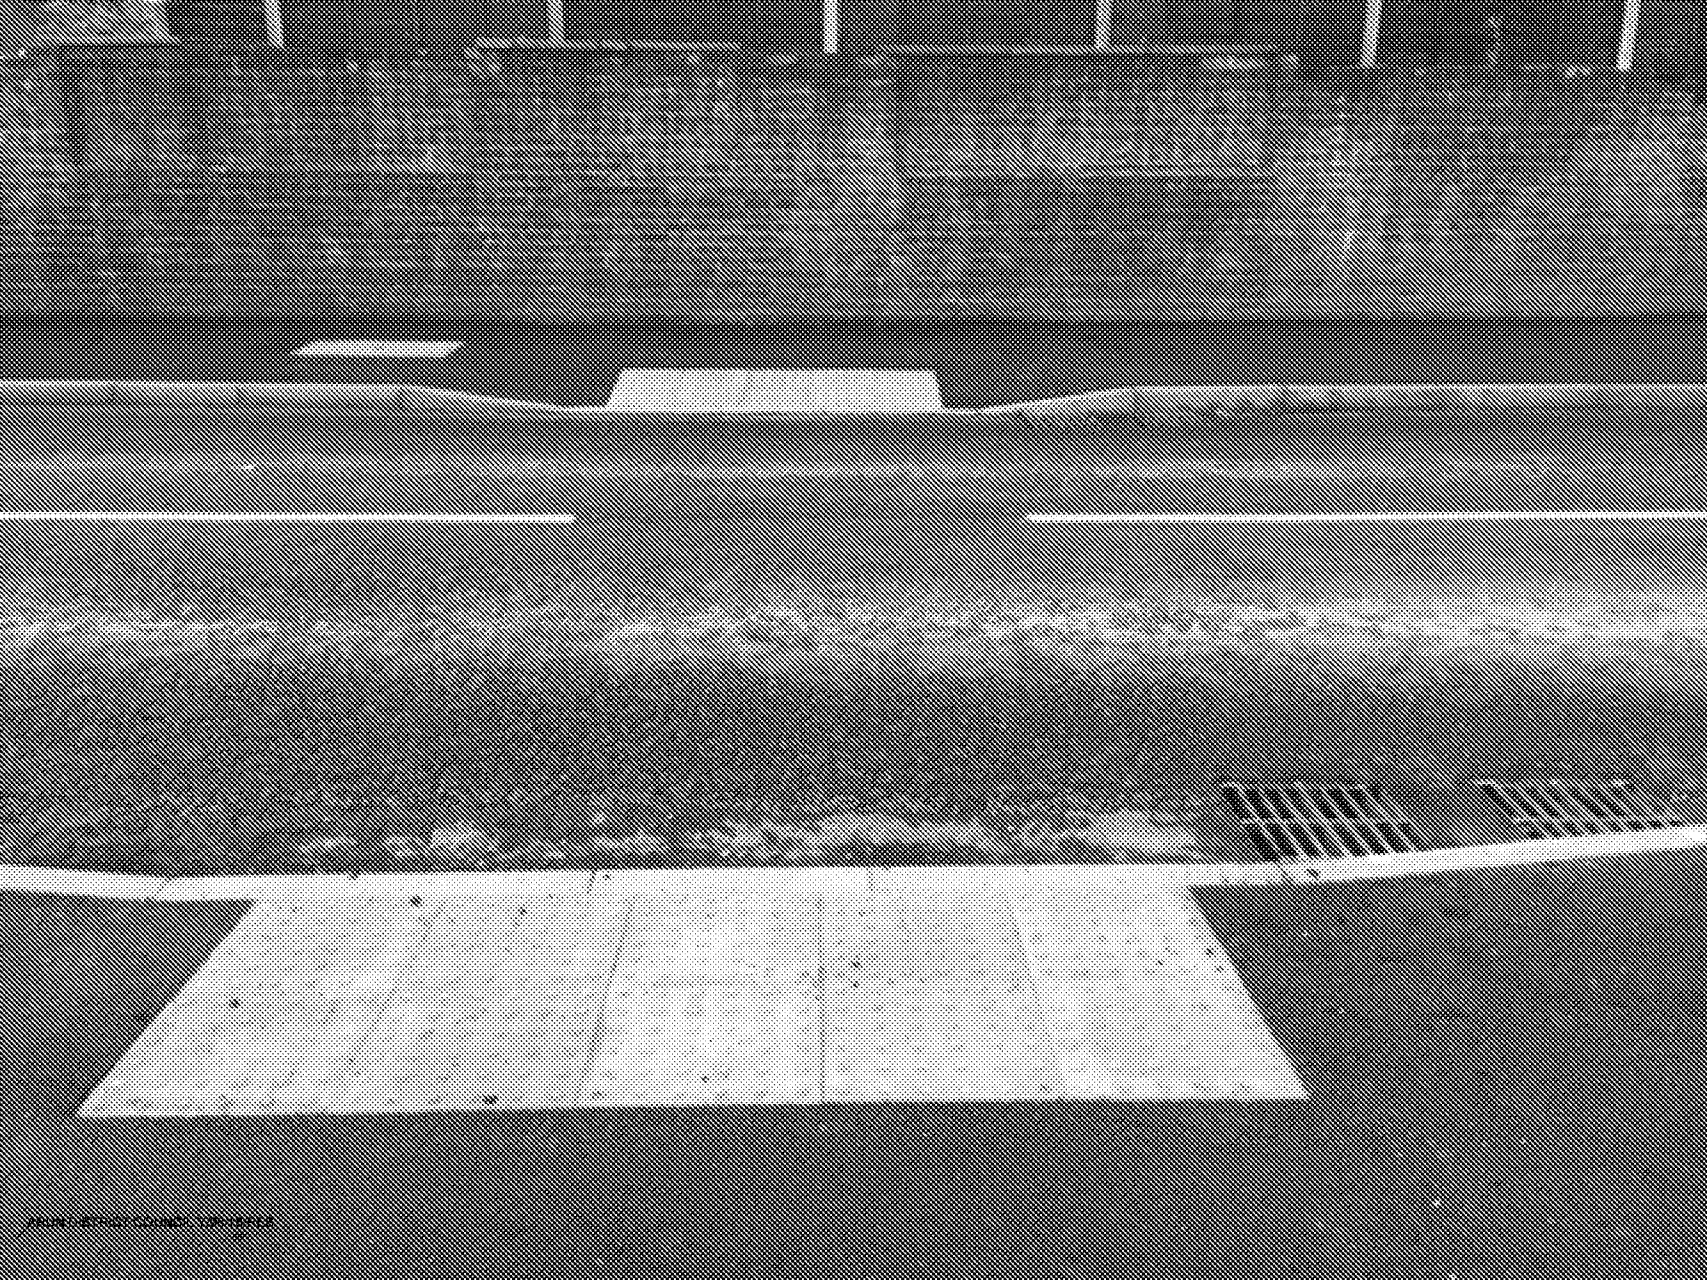
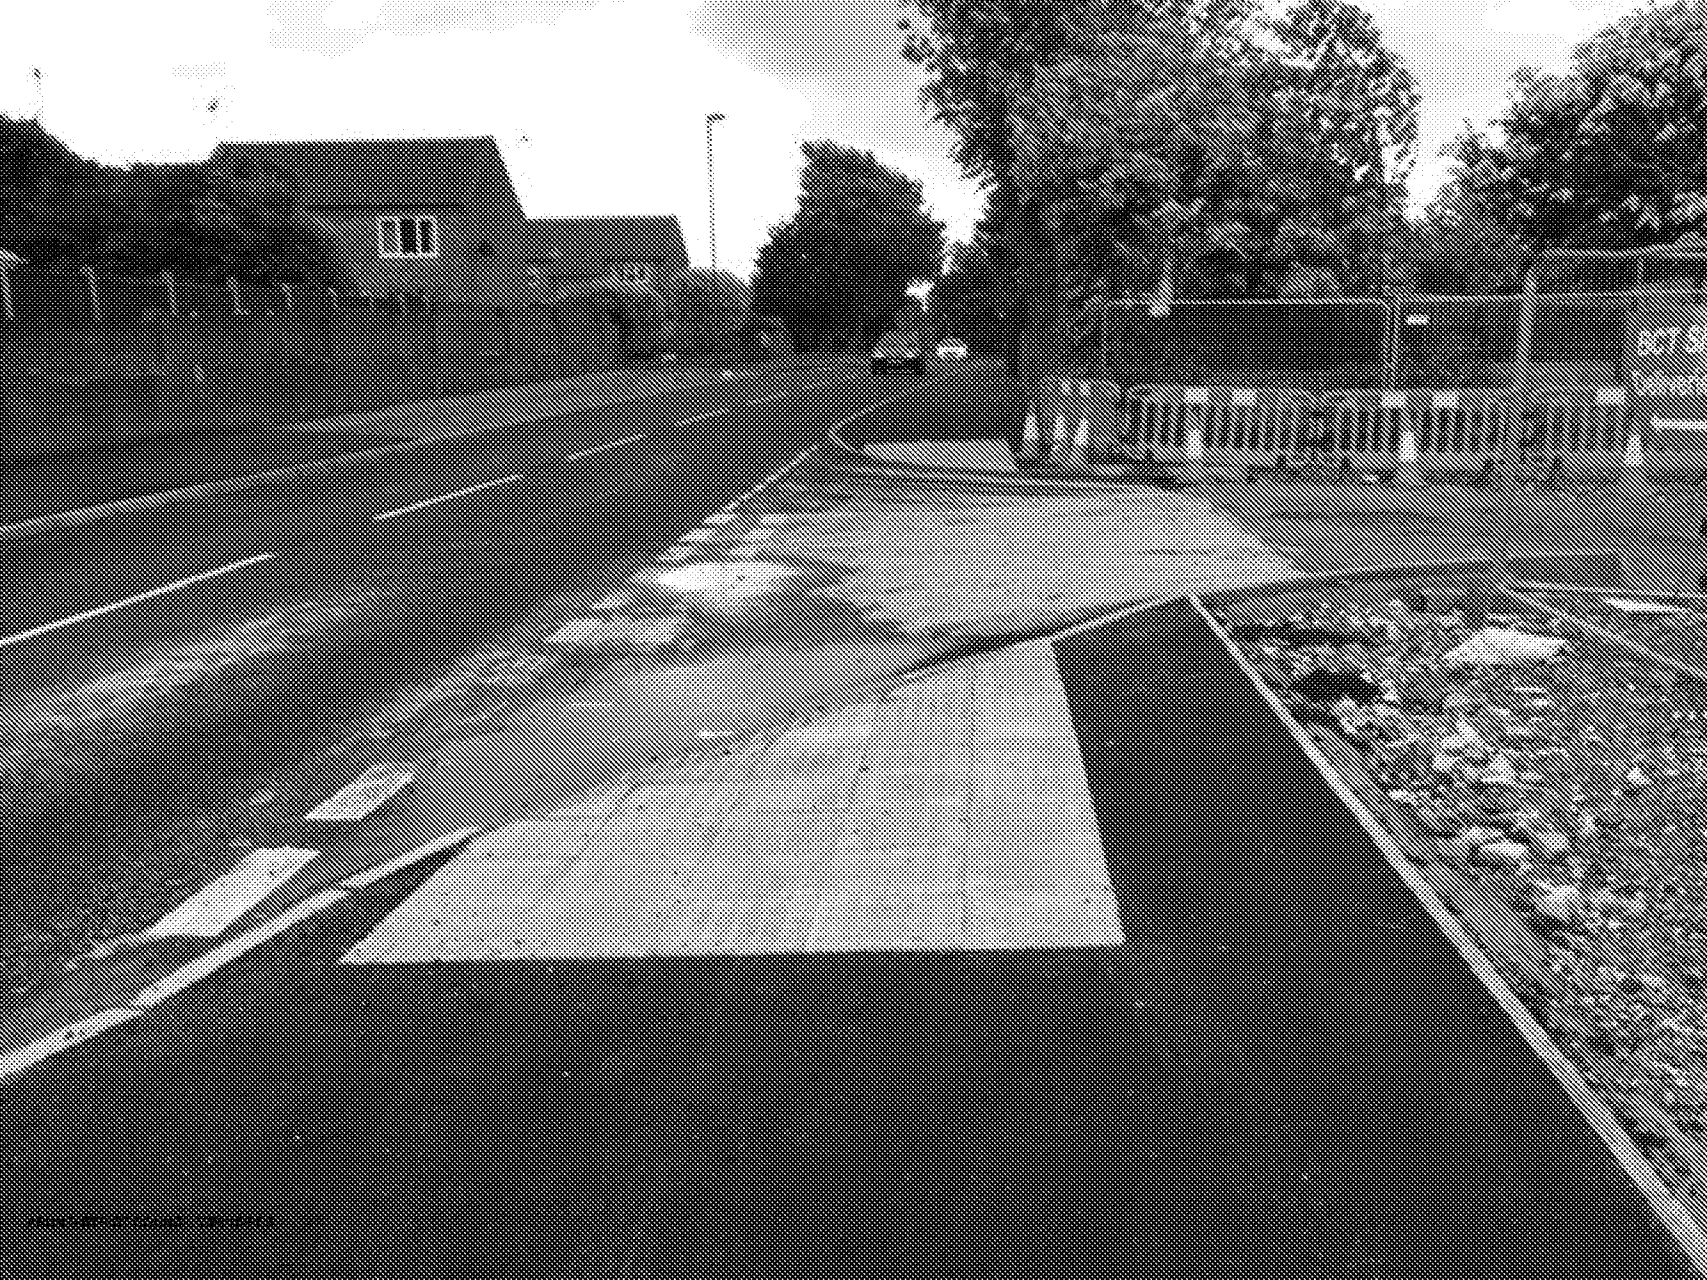
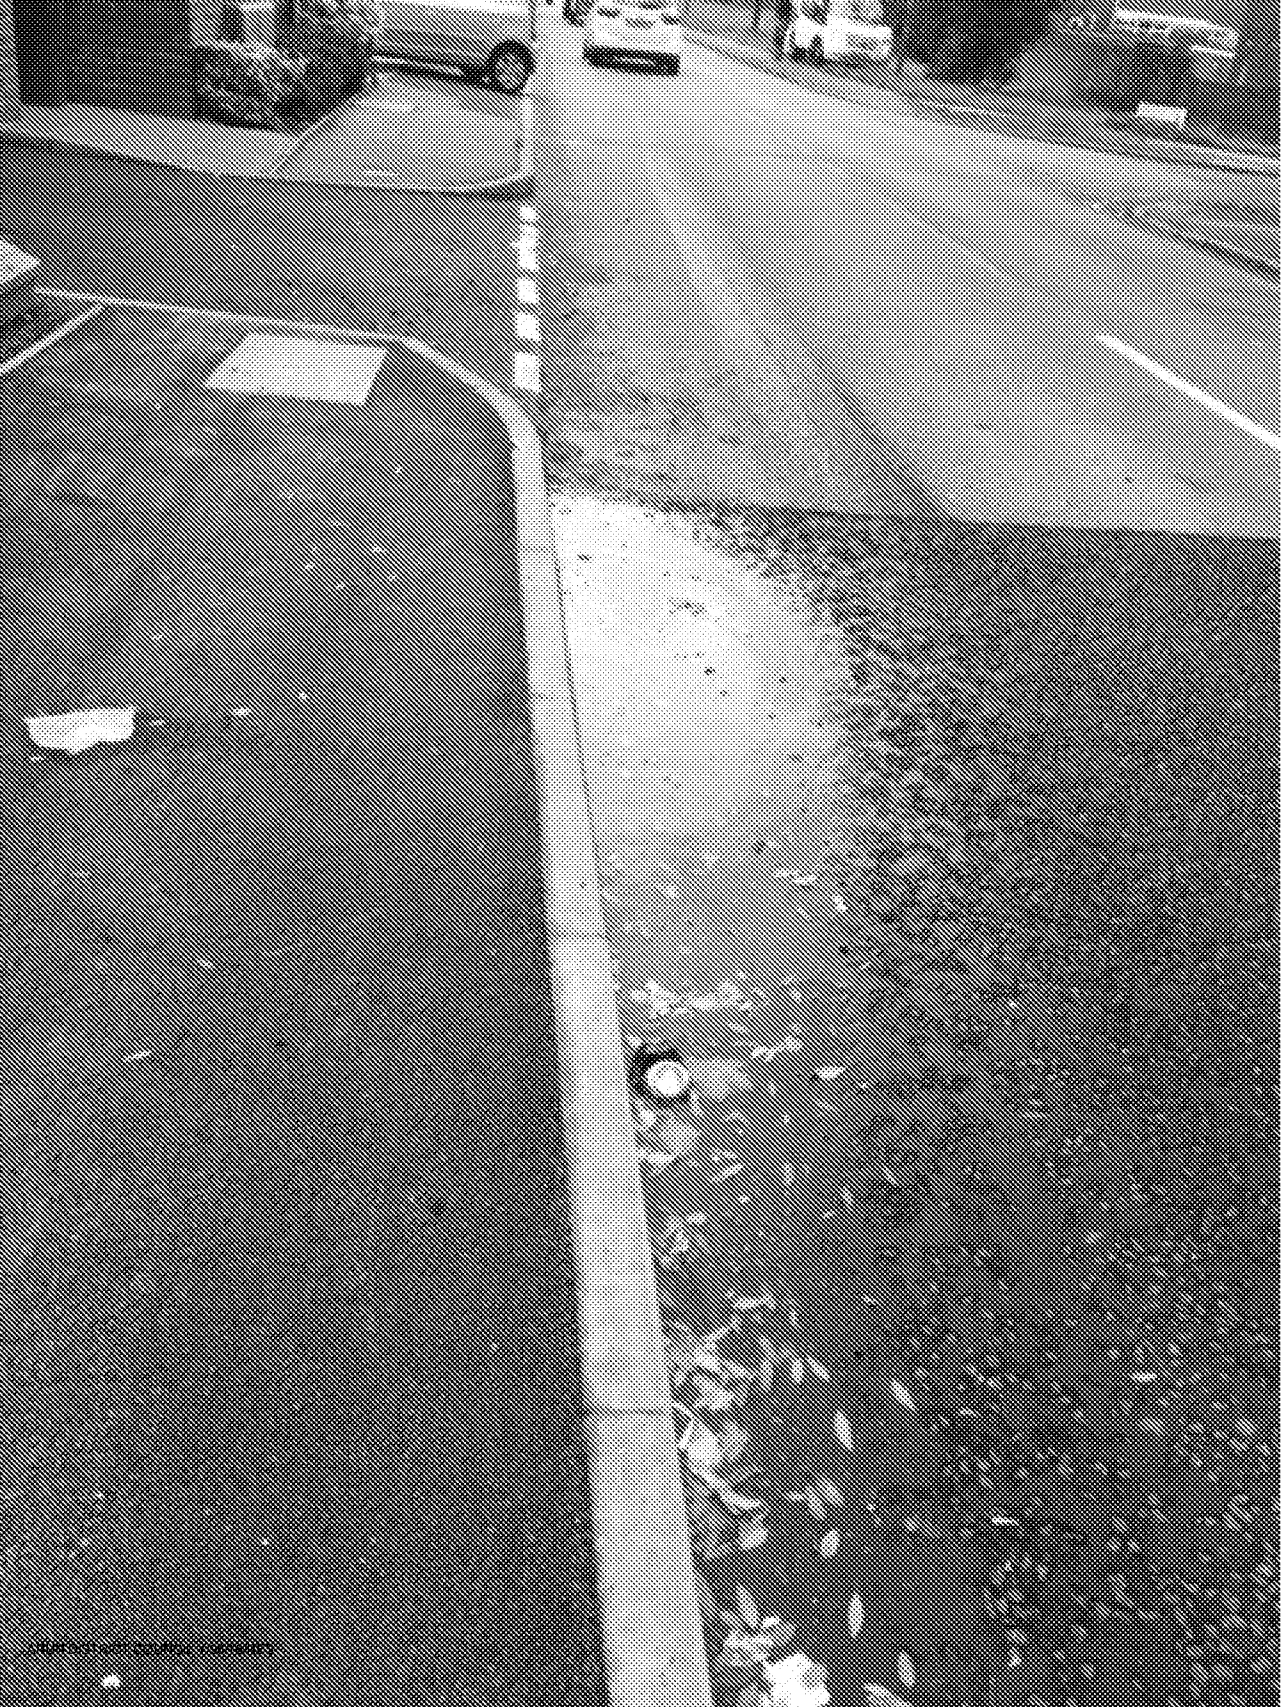
Whilst walking to the shops this morning I had a chance to look closer at the recent completed S278 works, unfortunately the tactile pedestrian crossing are not in specification, the radius kerbs should terminate at the blister paving and align fully, both will need to be rectified by adjusting the kerb line to full height to reach the paving.

The standing water is also a problem which is a shame as I witnessed the setting out engineer doing the levels survey for the surfacing so there should be no excuse.
