## Section Inspection - 25/05/2021 - SP5X

| Town or Village: | Angmering | Inspection Direction: | Upstream | Upstream Node: | SP5 |
| Road: | Dappers Lane | Inspected Length: | 4.40 m | Upstream Pipe Depth: | |

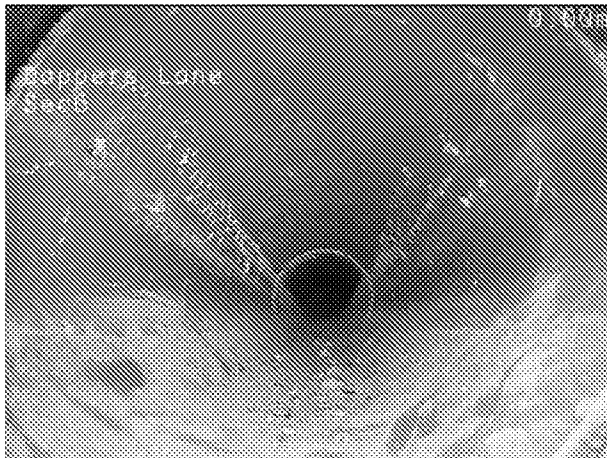
1, 00:00:05, 0.00 m  
Water level, 0% of the vertical dimension

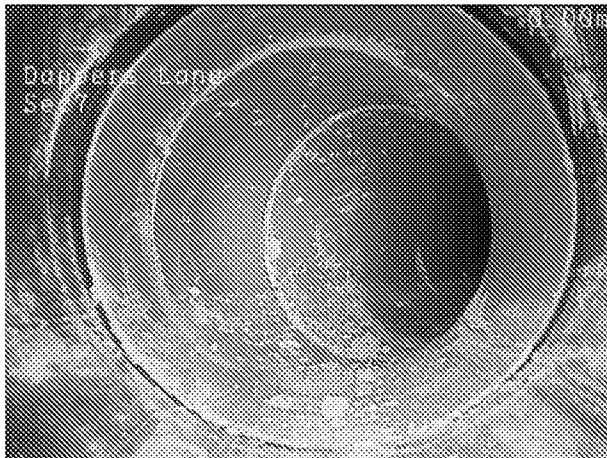
1, 00:00:09, 0.00 m  
Water level, 0% of the vertical dimension

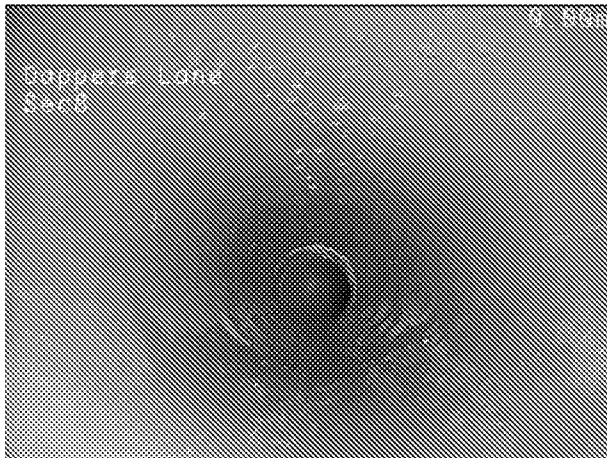
1, 00:00:00, 0.00 m  
Start node, manhole, reference: F17

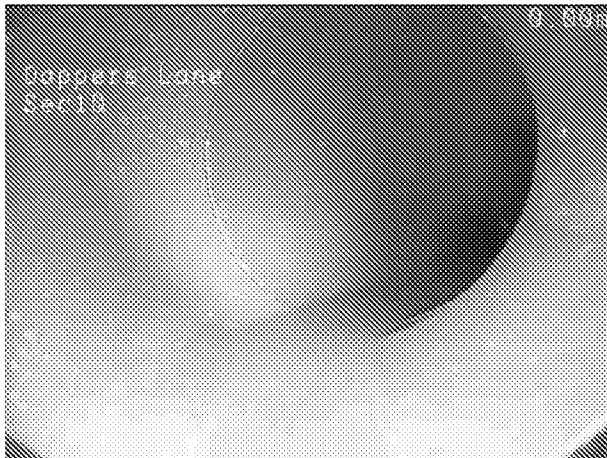
1, 00:00:00, 0.00 m  
Start node, manhole, reference: F19

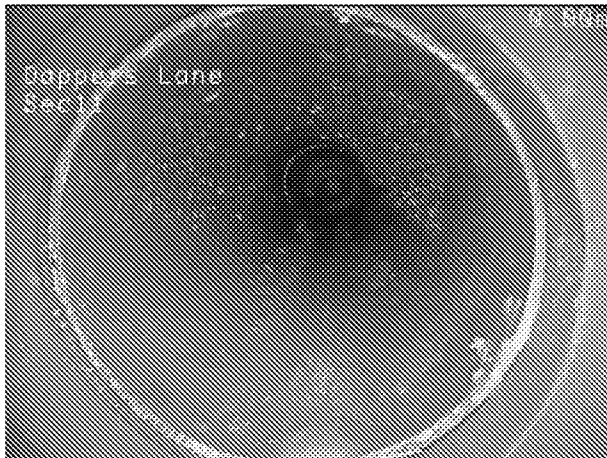
1, 00:00:06, 0.00 m  
Water level, 0% of the vertical dimension

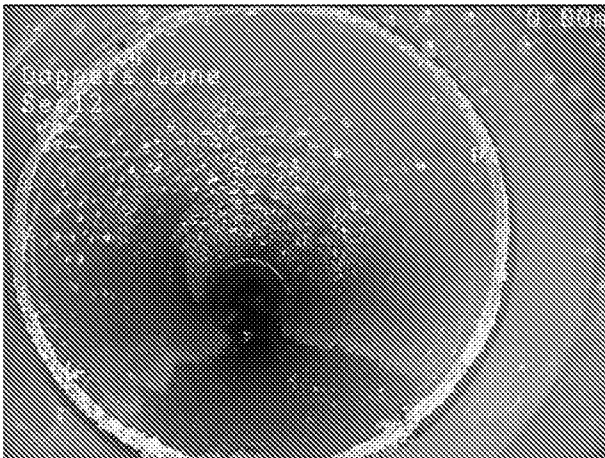
1, 00:00:00, 0.00 m  
Start node, manhole, reference: F19

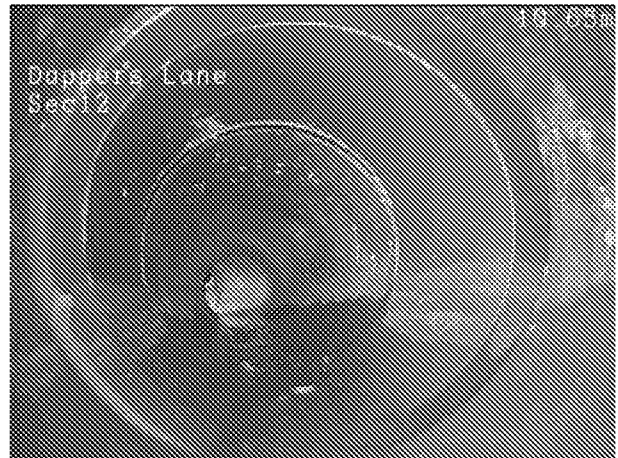
2, 00:00:46, 10.60 m  
Line deviates left

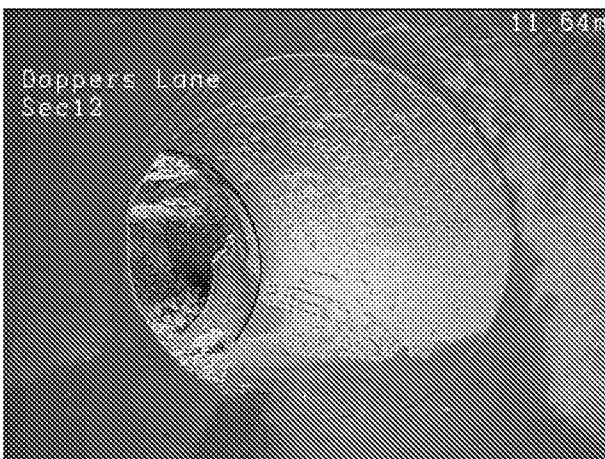
3, 00:00:55, 11.60 m  
Line deviates left

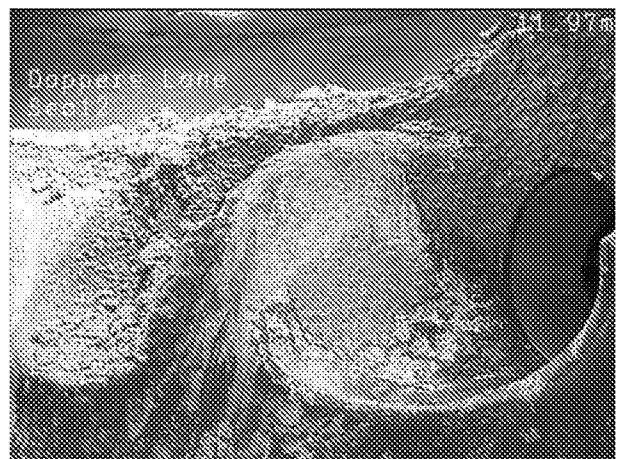
4, 00:01:00, 12.00 m  
Finish node, manhole, reference: F3, Not accessible

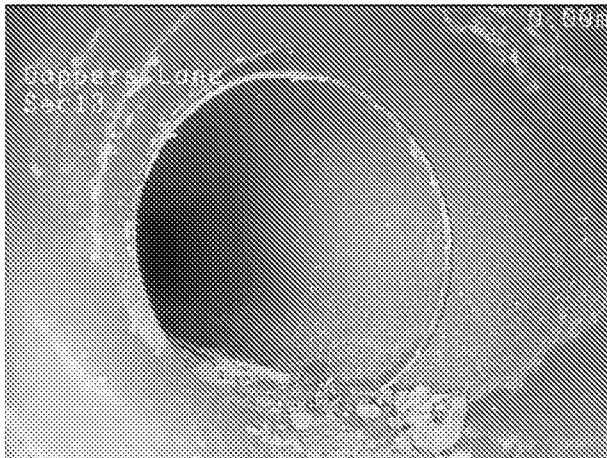
1, 00:00:08, 0.00 m  
Water level, 0% of the vertical dimension

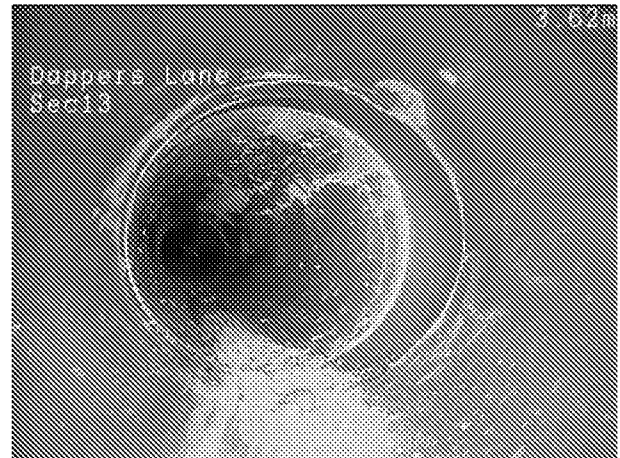
2, 00:00:27, 3.70 m  
Line deviates left

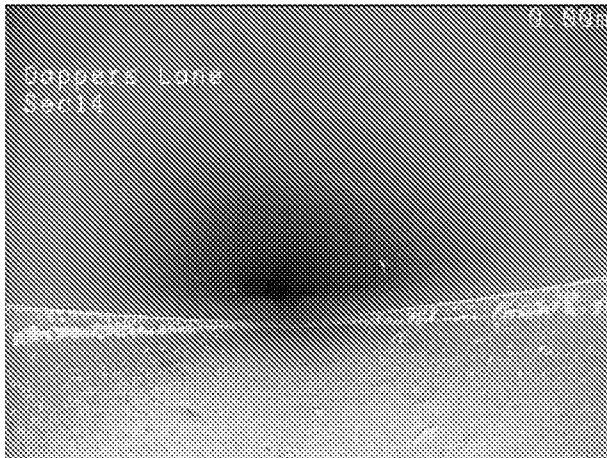
1, 00:00:00, 0.00 m  
Start node, manhole, reference: F16

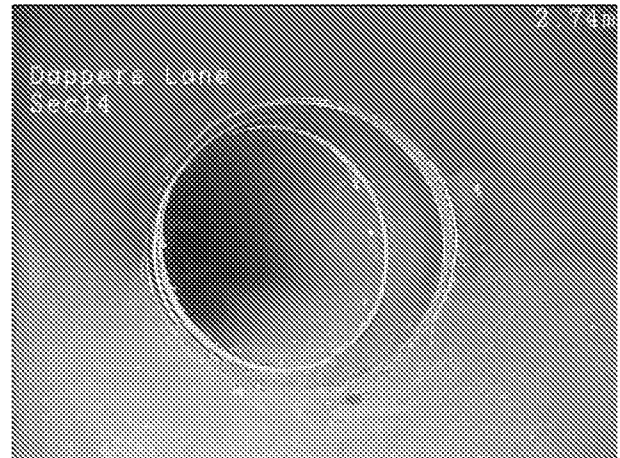
2, 00:00:18, 2.80 m  
Line deviates left

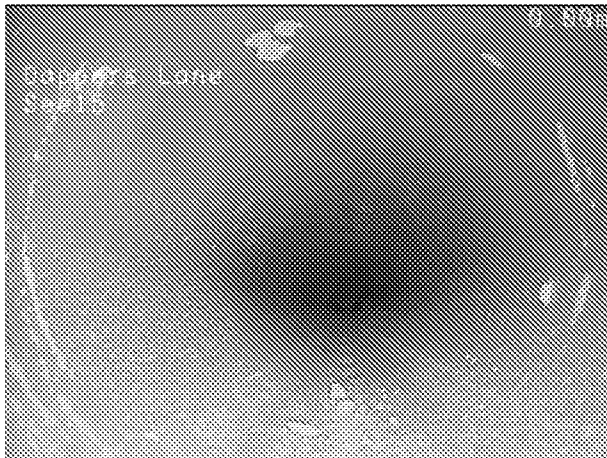
1, 00:00:00, 0.00 m  
Start node, manhole, reference: F16

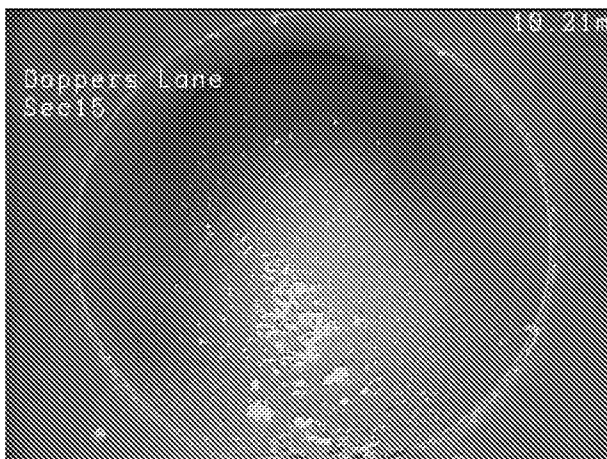
3, 00:00:40, 10.30 m  
Line deviates up

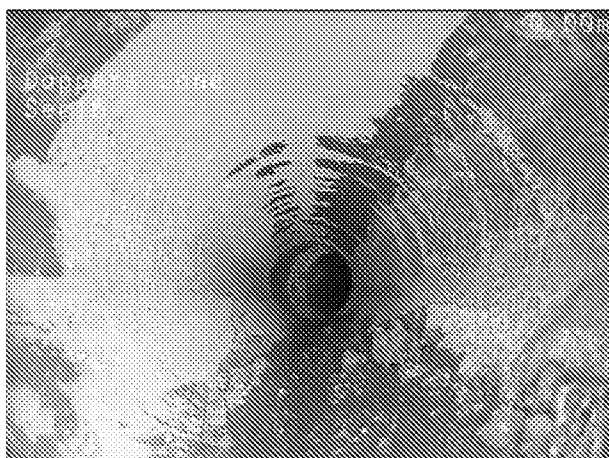
1, 00:00:00, 0.00 m  
Start node, manhole, reference: F16

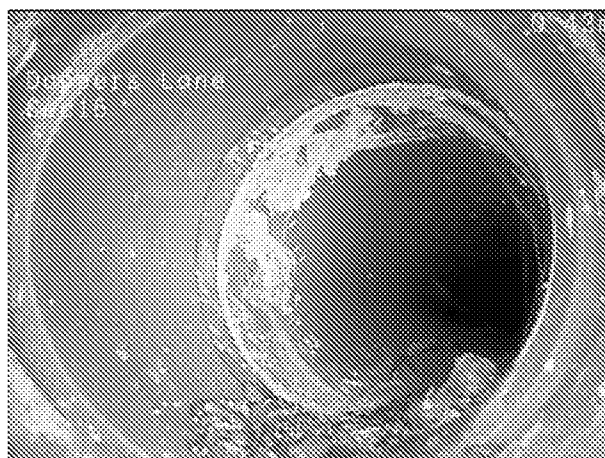
2, 00:00:10, 0.40 m  
Line deviates right

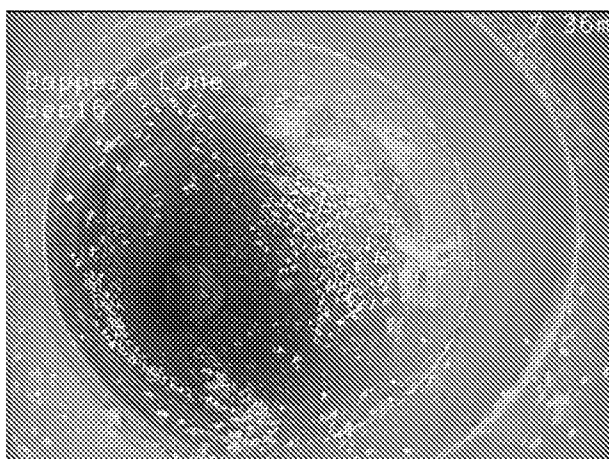
3, 00:00:36, 7.40 m  
Line deviates left

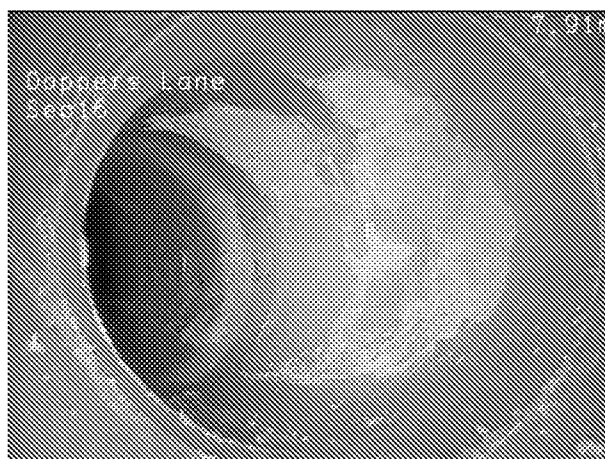
4, 00:00:39, 8.00 m  
Line deviates left

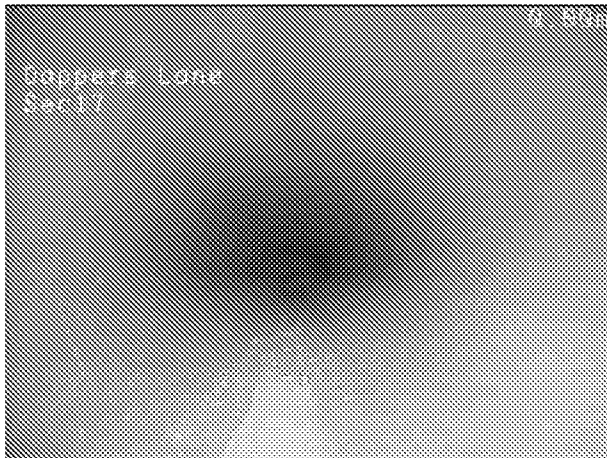
1, 00:00:00, 0.00 m  
Start node, manhole, reference: F15

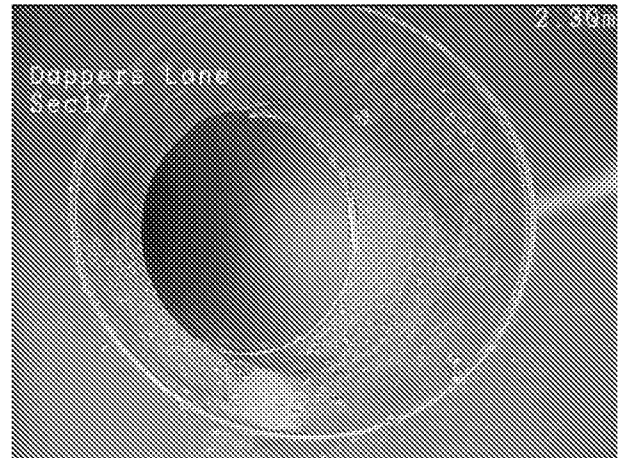
2, 00:00:14, 2.40 m  
Line deviates left

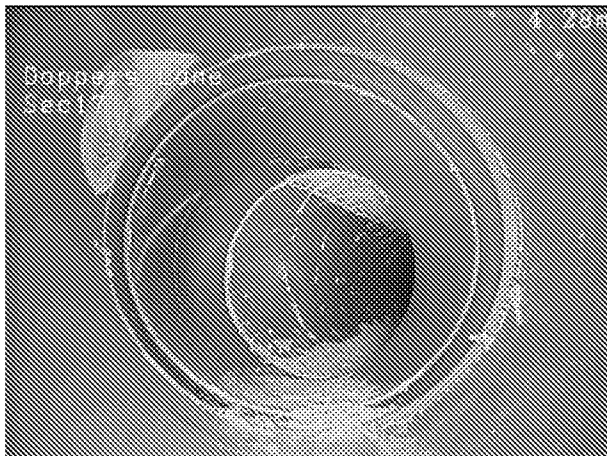
3, 00:00:25, 4.40 m  
Line deviates right

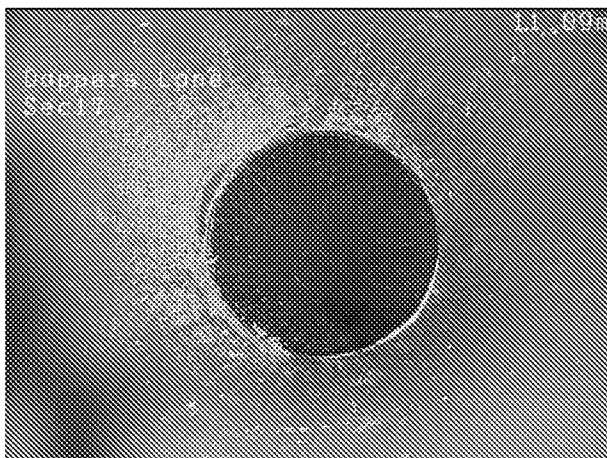
5, 00:01:25, 11.10 m  
Finish node, manhole, reference: SP13

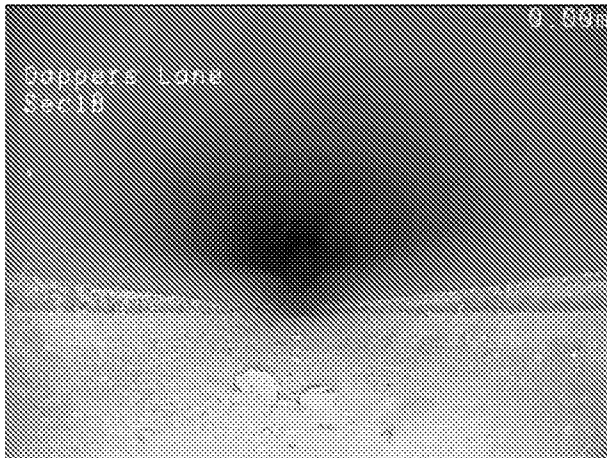
1, 00:00:00, 0.00 m  
Start node, manhole, reference: F15

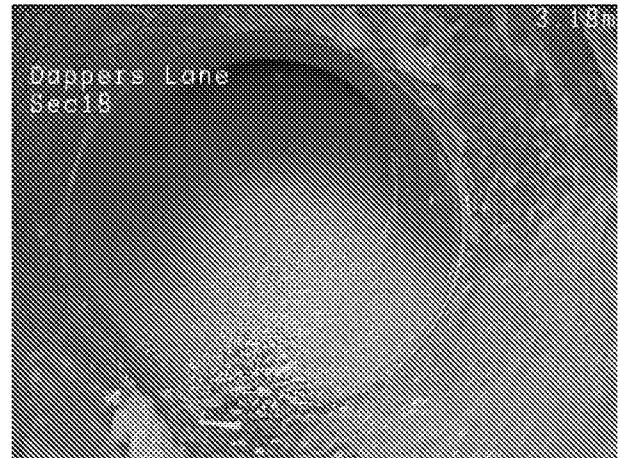
2, 00:00:22, 3.30 m  
Line deviates up

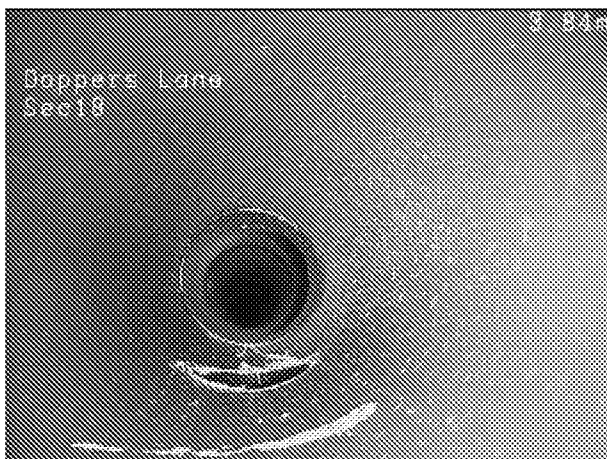
3, 00:00:27, 3.90 m  
Finish node, manhole, reference: SP14

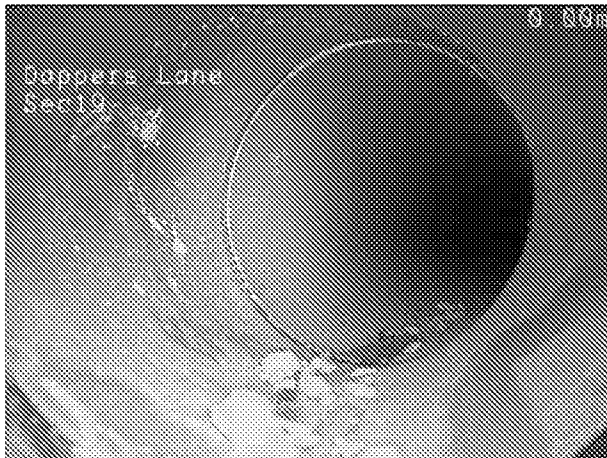
1, 00:00:07, 0.00 m  
Water level, 0% of the vertical dimension

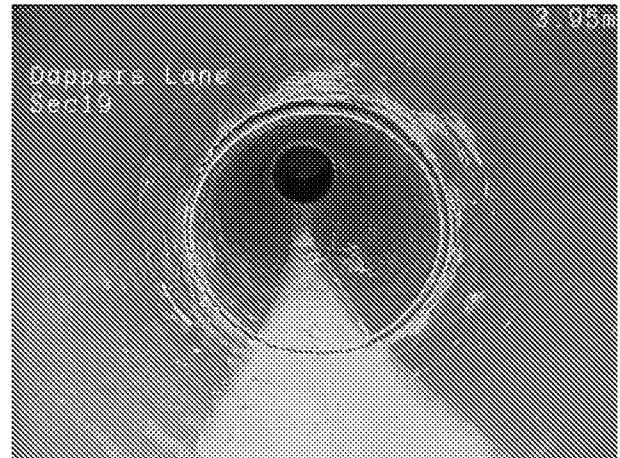
2, 00:00:26, 4.10 m  
Line deviates up

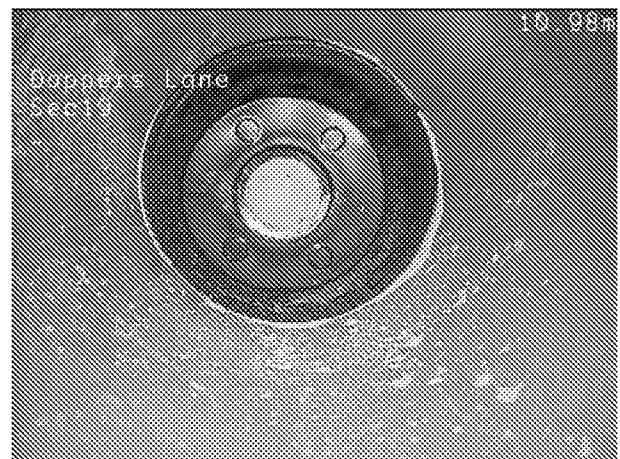
4, 00:01:07, 11.00 m  
Finish node, manhole, reference: SP15

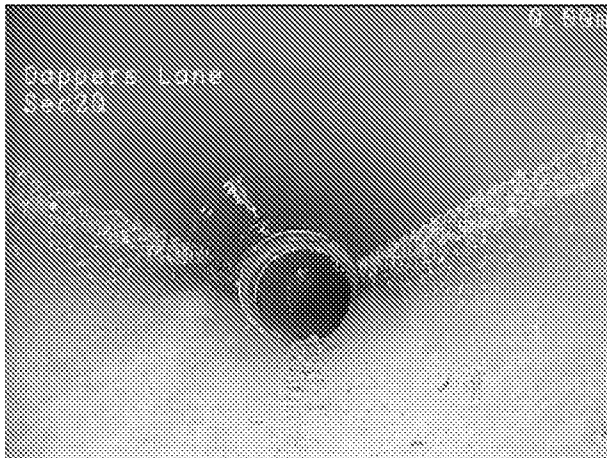
1, 00:00:00, 0.00 m  
Start node, manhole, reference: F15

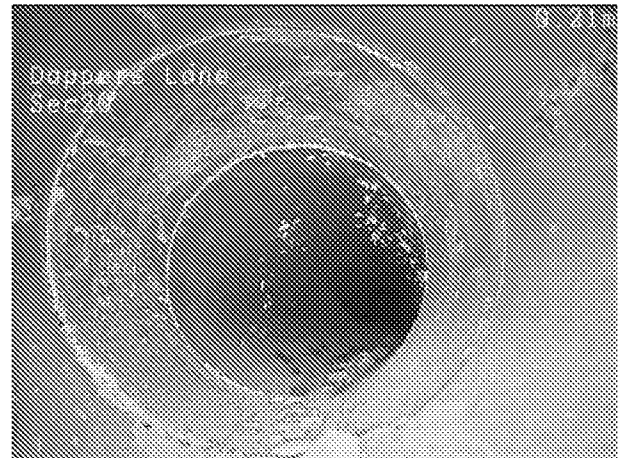
2, 00:00:09, 0.30 m  
Line deviates right

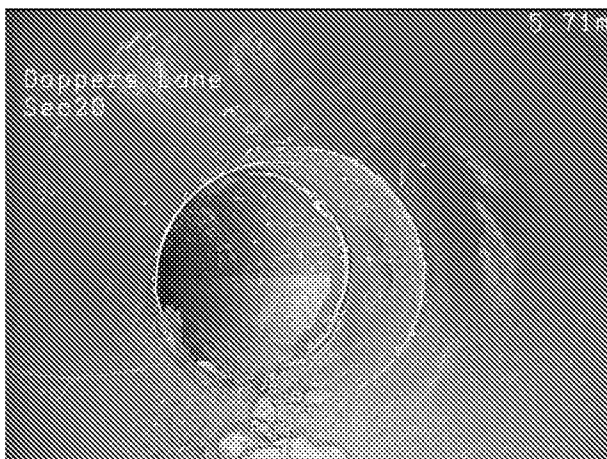
3, 00:00:32, 5.80 m  
Line deviates left

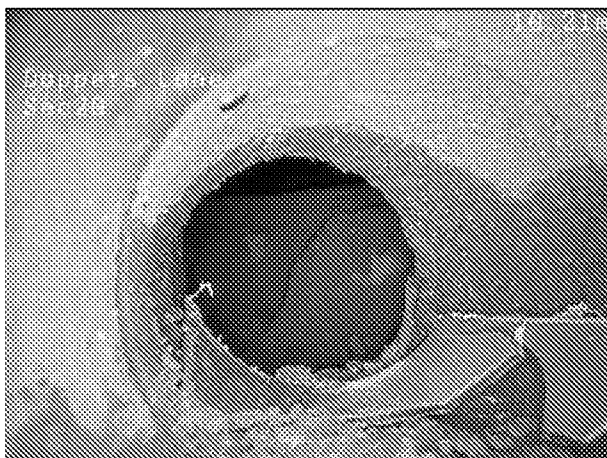
5, 00:00:55, 10.30 m  
General photograph taken at this point

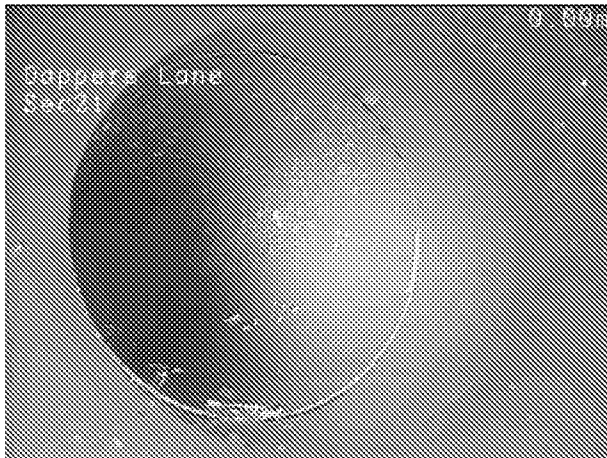
1, 00:00:00, 0.00 m  
Start node, manhole, reference: F13

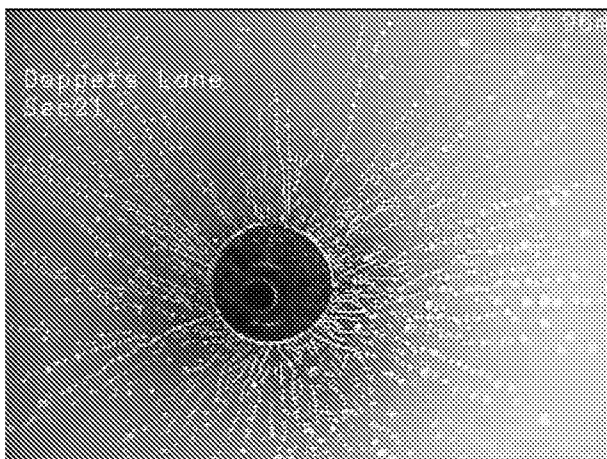
3, 00:00:44, 13.00 m  
Finish node, manhole, reference: SP16

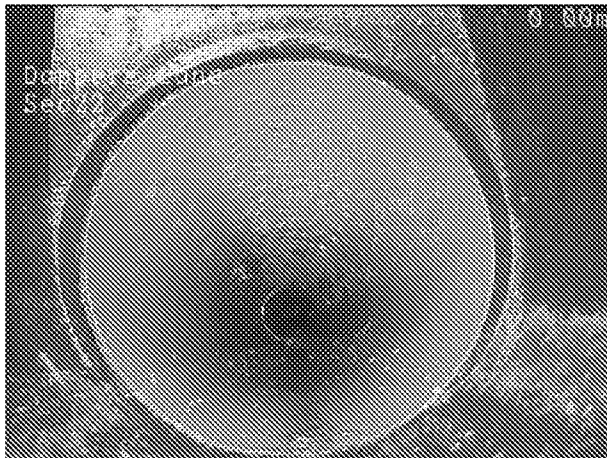
1, 00:00:00, 0.00 m  
Start node, manhole, reference: F13

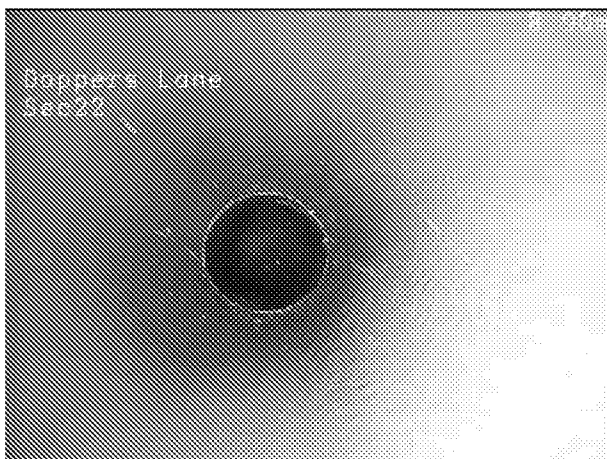
3, 00:00:35, 8.90 m  
Finish node, manhole, reference: SP17

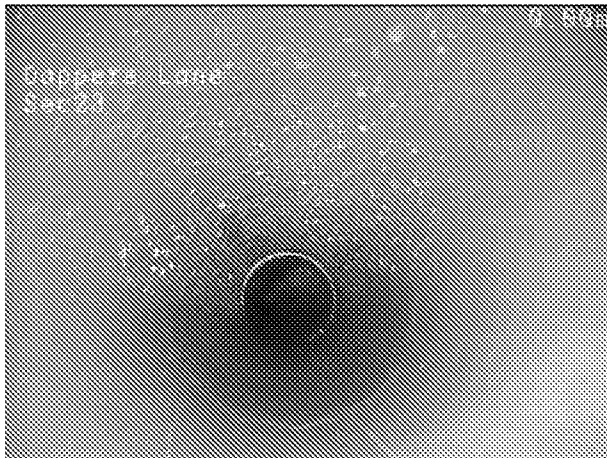
1, 00:00:00, 0.00 m  
Start node, manhole, reference: F13

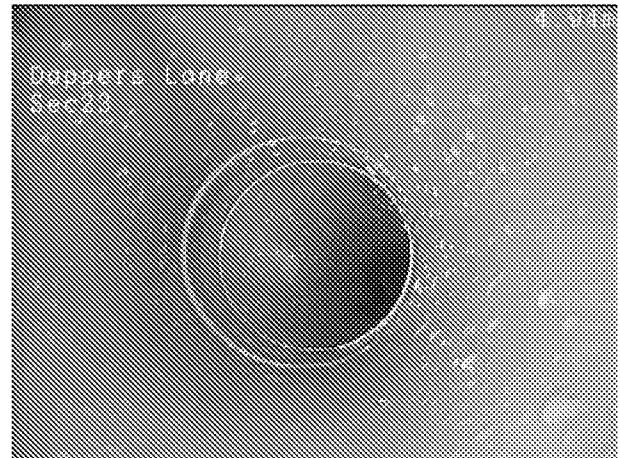
2, 00:00:25, 5.10 m  
Line deviates right

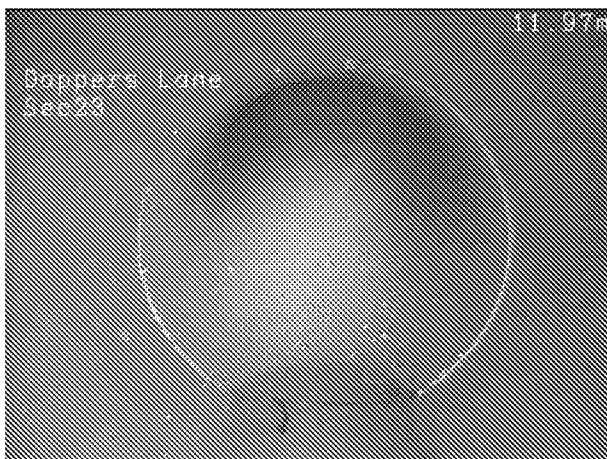
3, 00:00:45, 12.10 m  
Line deviates up

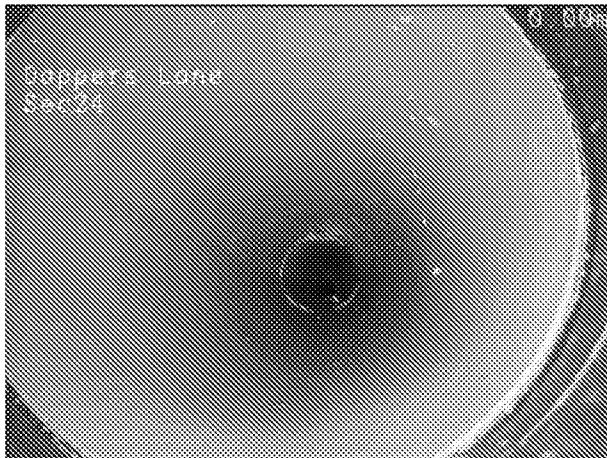
1, 00:00:00, 0.00 m  
Start node, manhole, reference: F13

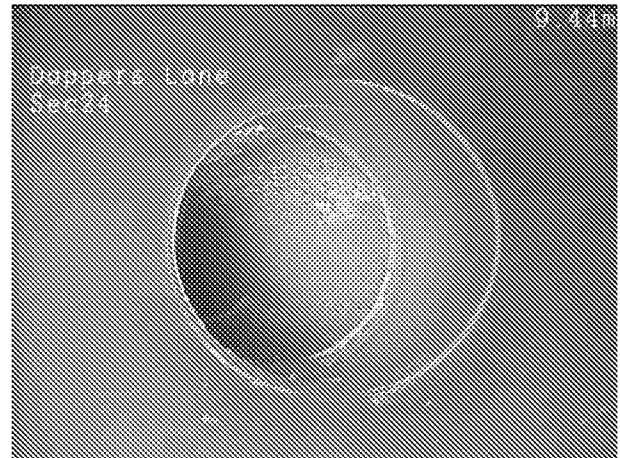
2, 00:00:28, 9.50 m  
Line deviates left

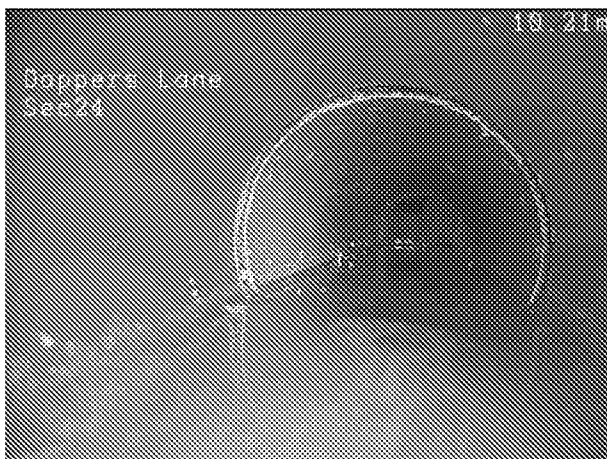
3, 00:00:36, 10.20 m  
Water level, 10% of the vertical dimension

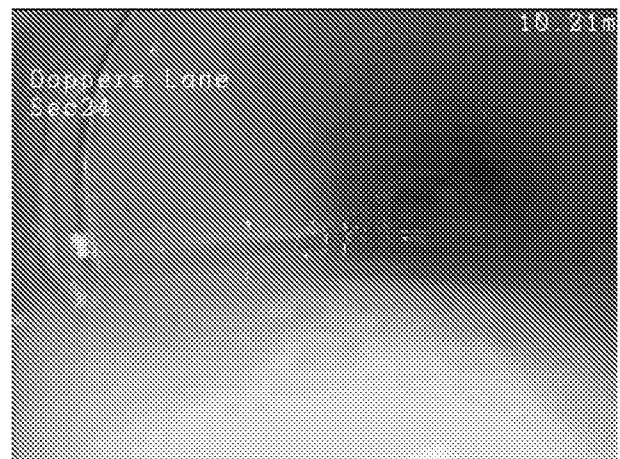
4, 00:00:39, 10.30 m  
Water level, 30% of the vertical dimension

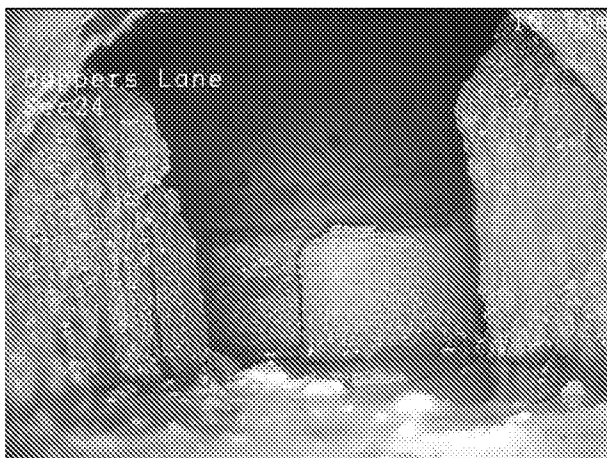
5, 00:00:52, 10.70 m  
Water level, 10% of the vertical dimension

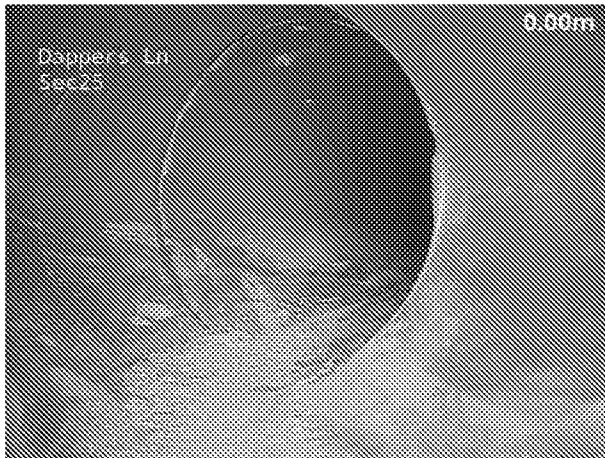
1, 00:00:49, 0.10 m  
Line deviates right

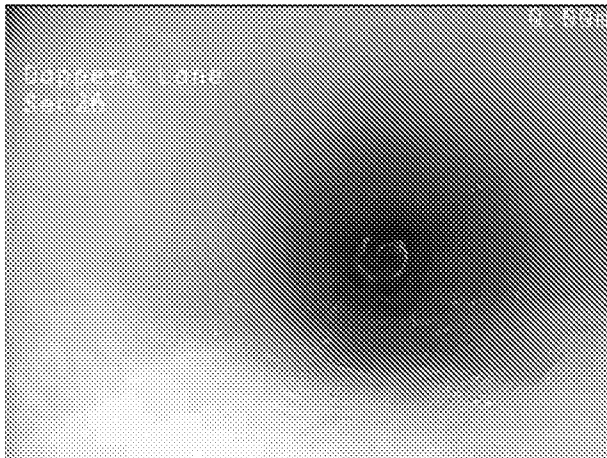
1, 00:00:00, 0.00 m  
Start node, manhole, reference: F12

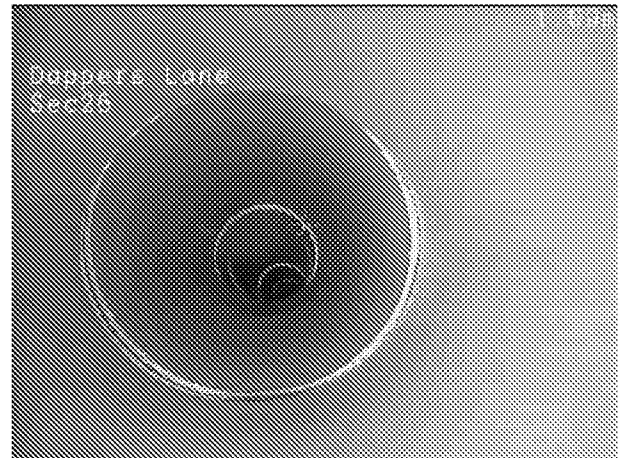
2, 00:00:09, 1.10 m  
Line deviates up

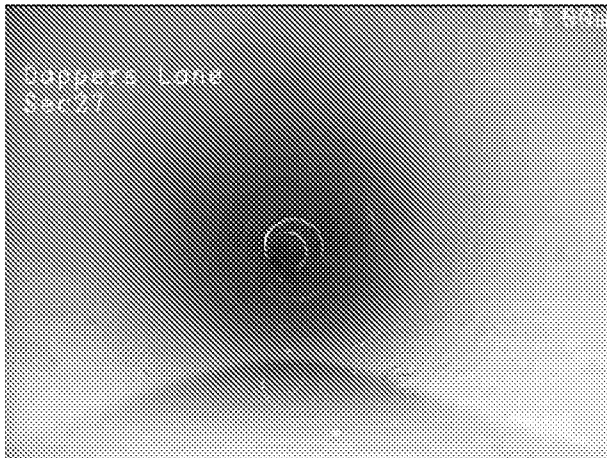
1, 00:00:00, 0.00 m  
Start node, manhole, reference: F12

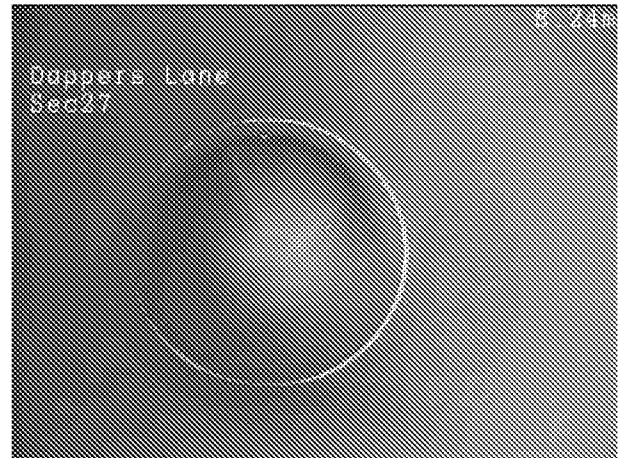
2, 00:00:34, 8.30 m  
Line deviates up

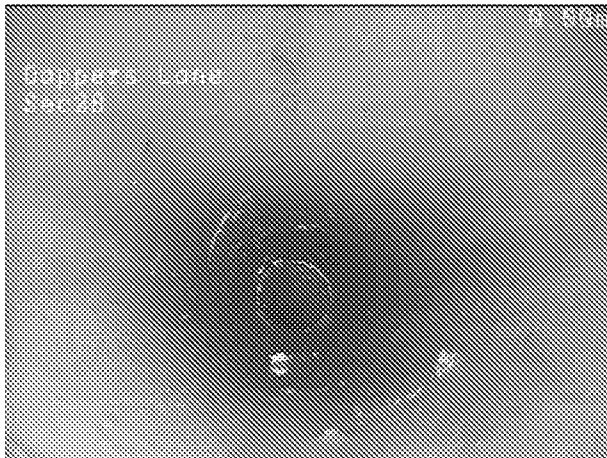
1, 00:00:00, 0.00 m  
Start node, manhole, reference: F12

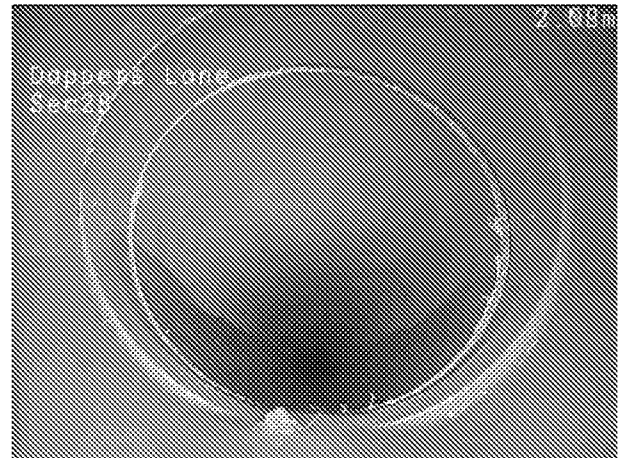
2, 00:00:16, 2.10 m  
Line deviates down

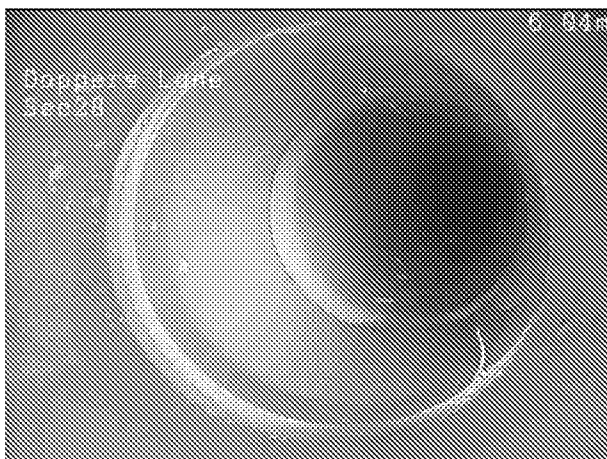
3, 00:00:39, 6.10 m  
Line deviates right

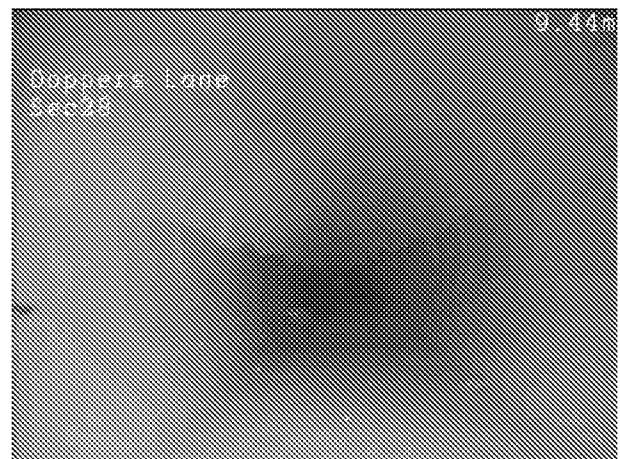
4, 00:00:58, 9.50 m  
Water level, 5% of the vertical dimension

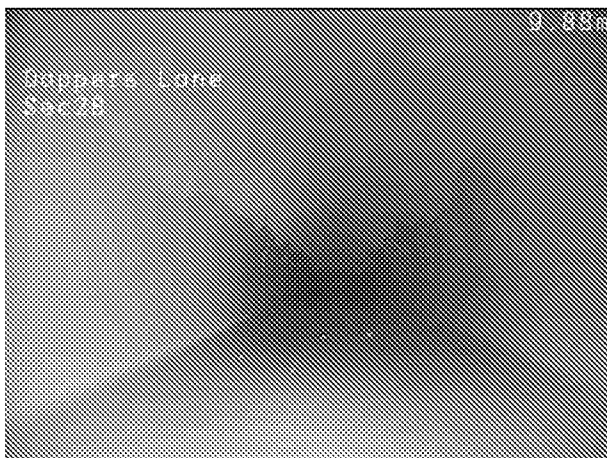
5, 00:01:04, 9.90 m  
Water level, 10% of the vertical dimension

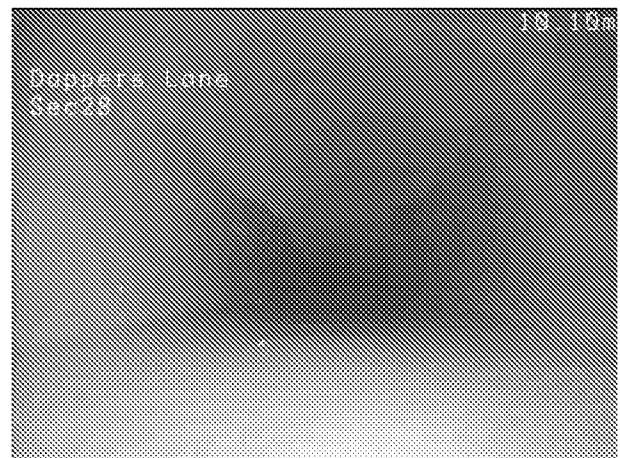
6, 00:01:07, 10.20 m  
Water level, 30% of the vertical dimension

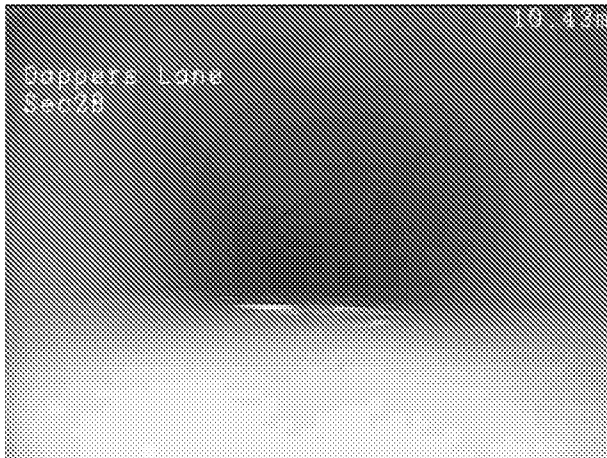
7, 00:01:12, 10.50 m  
Water level, 40% of the vertical dimension

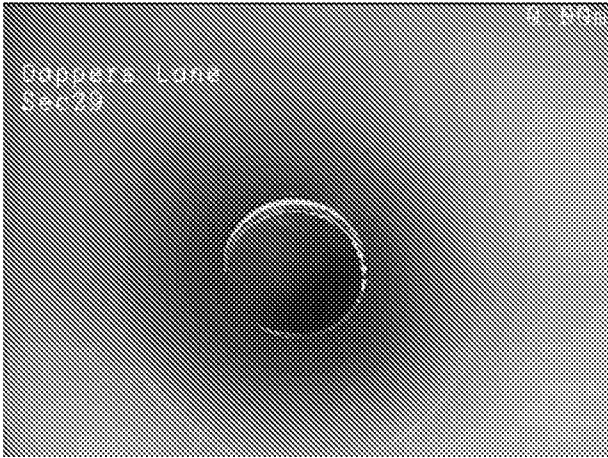
| <p>1, 00:00:11, 0.00 m<br/>Water level, 0% of the vertical dimension</p> | <p>2, 00:00:18, 0.90 m<br/>Water level, 5% of the vertical dimension</p> |

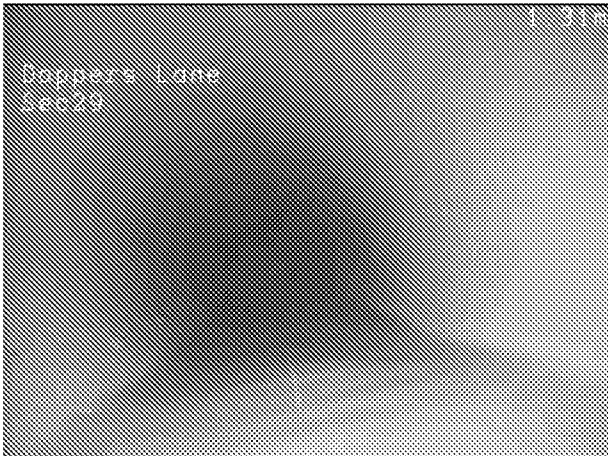
| <p>3, 00:00:32, 1.30 m<br/>Water level, 10% of the vertical dimension</p> | <p>4, 00:00:42, 2.30 m<br/>Water level, 5% of the vertical dimension</p> |

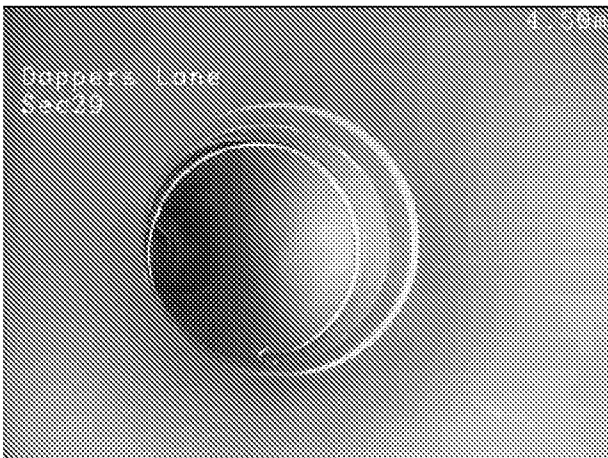
| <p>5, 00:00:54, 4.60 m<br/>Line deviates left</p> | <p>6, 00:01:04, 5.49 m<br/>Line deviates up</p> |
