## Section Inspection - 26/05/2021 - SP22X

| Town or Village: | Angmering | Inspection Direction: | Upstream | Upstream Node: | SP22 |
| Road: | Dappers Lane | Inspected Length: | 13.10 m | Upstream Pipe Depth: | |

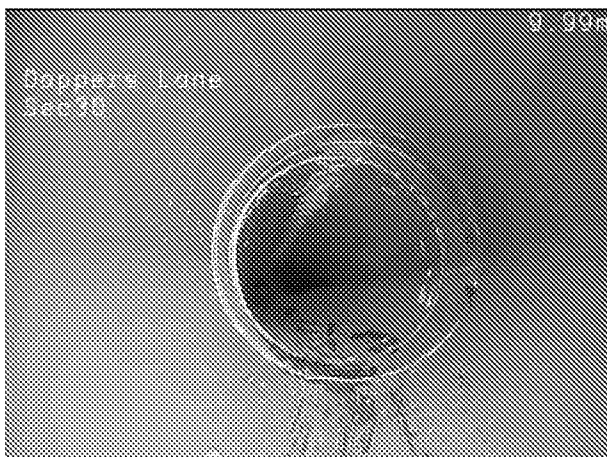
3, 00:00:42, 10.10 m  
Line deviates left

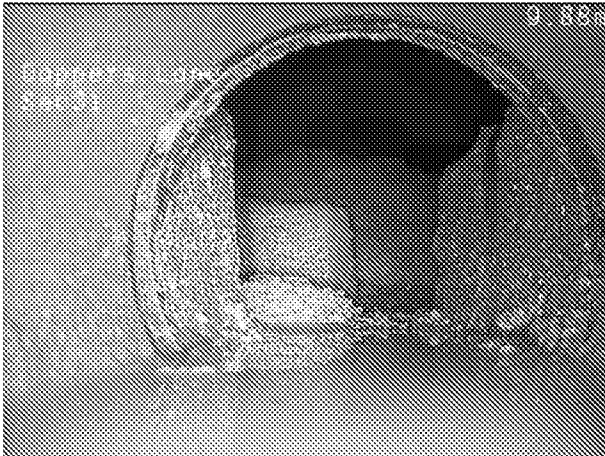
7, 00:01:26, 10.00 m  
Finish node, manhole, reference: F1, Debris in chamber

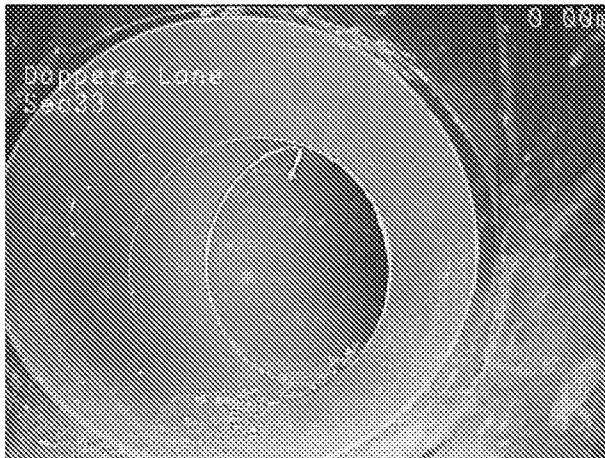
1, 00:00:00, 0.00 m  
Start node, manhole, reference: F32

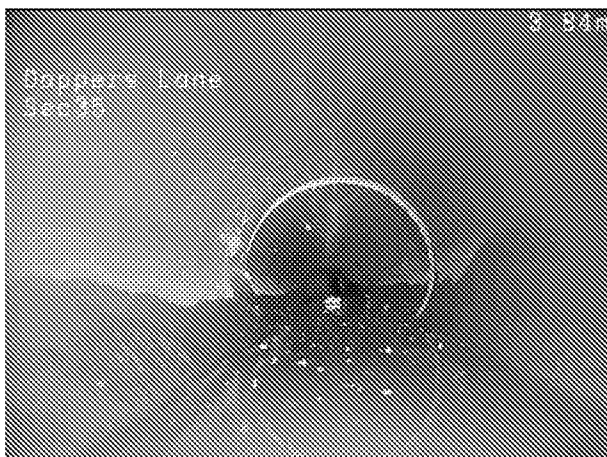
3, 00:00:29, 3.80 m  
Water level, 15% of the vertical dimension

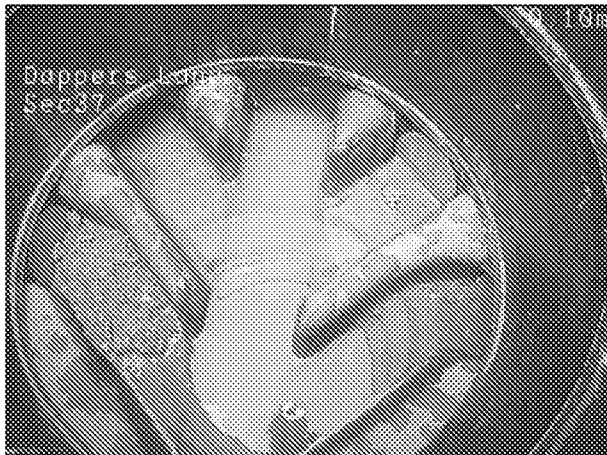
1, 00:00:00, 0.00 m  
General photograph taken at this point, Water level in chamber

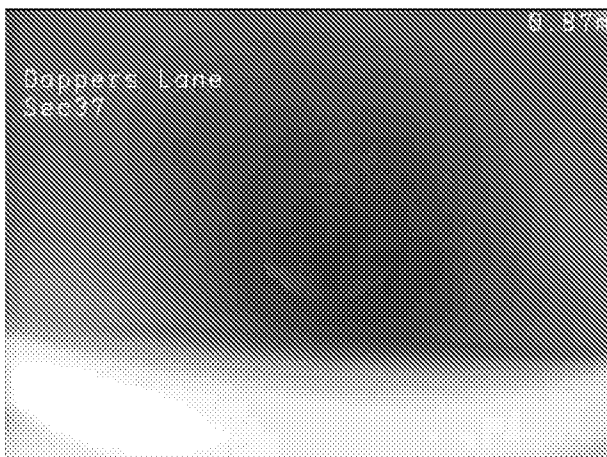
3, 00:00:33, 0.90 m  
Water level, 30% of the vertical dimension

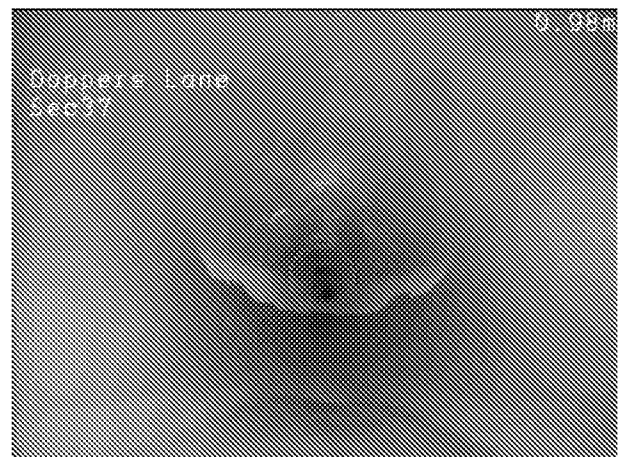
4, 00:00:40, 1.00 m  
Water level, 5% of the vertical dimension

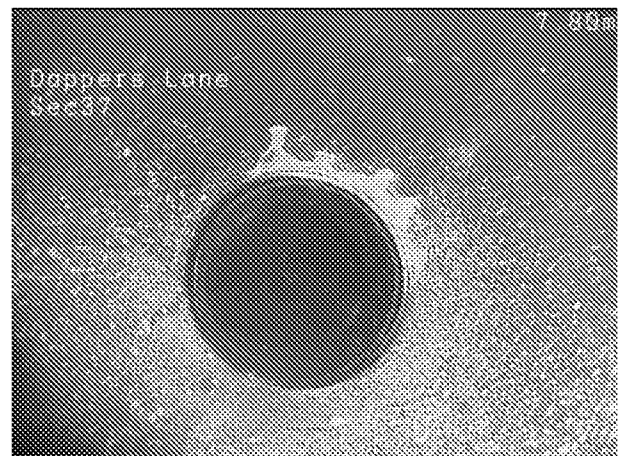
6, 00:01:27, 7.80 m  
Finish node, manhole, reference: SP25

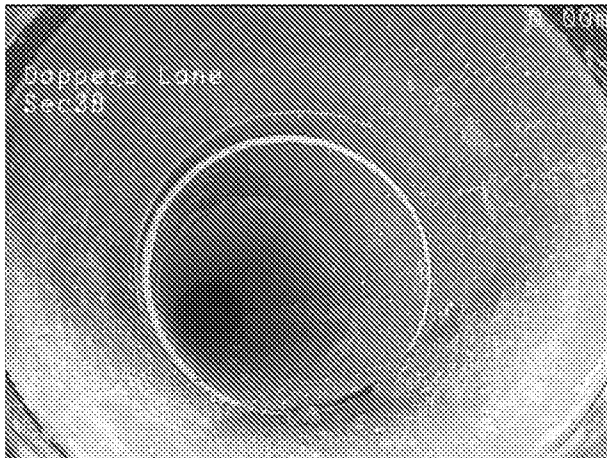
1, 00:00:00, 0.00 m  
Start node, manhole, reference: F22

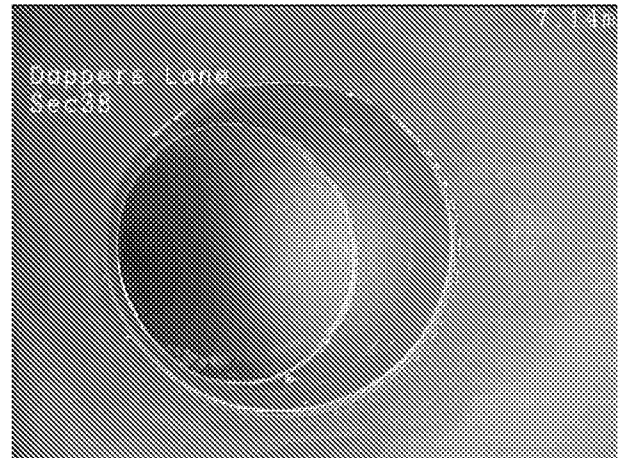
2, 00:00:25, 7.20 m  
Line deviates left

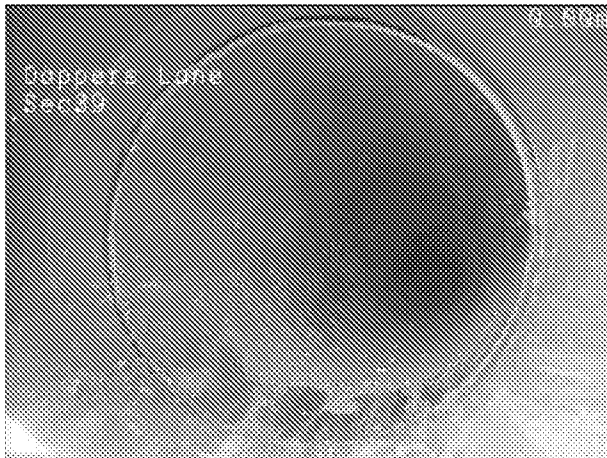
1, 00:00:00, 0.00 m  
Start node, manhole, reference: F22

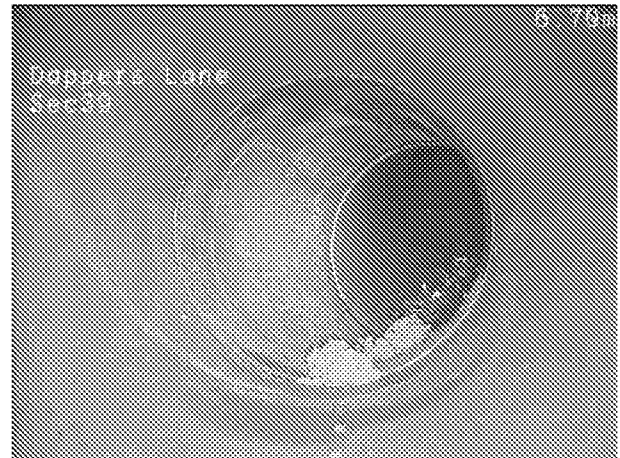
2, 00:00:38, 6.80 m  
Line deviates right

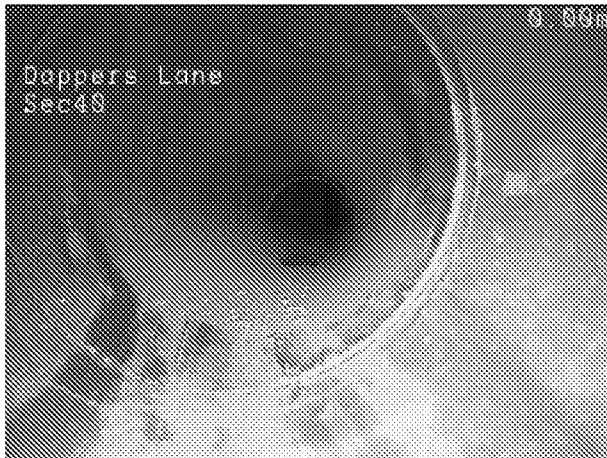
1, 00:00:10, 0.00 m  
Water level, 0% of the vertical dimension

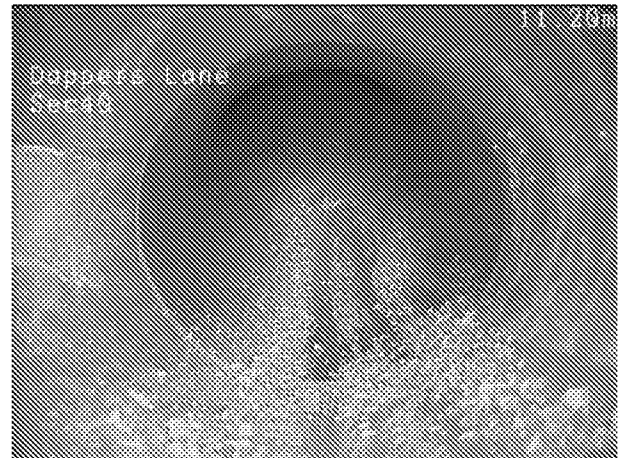
2, 00:00:48, 11.30 m  
Line deviates up

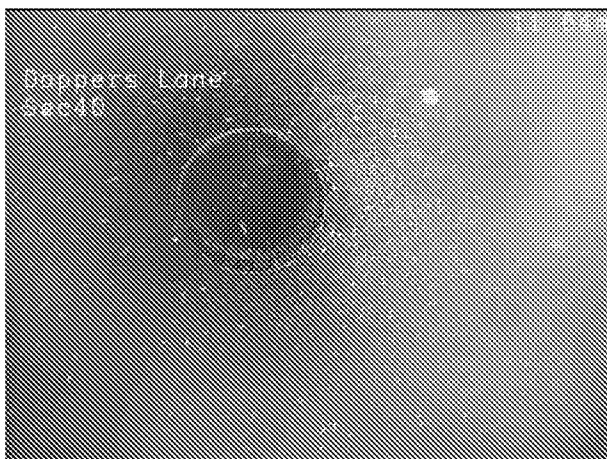
3, 00:00:41, 11.70 m  
Finish node, manhole, reference: SP28

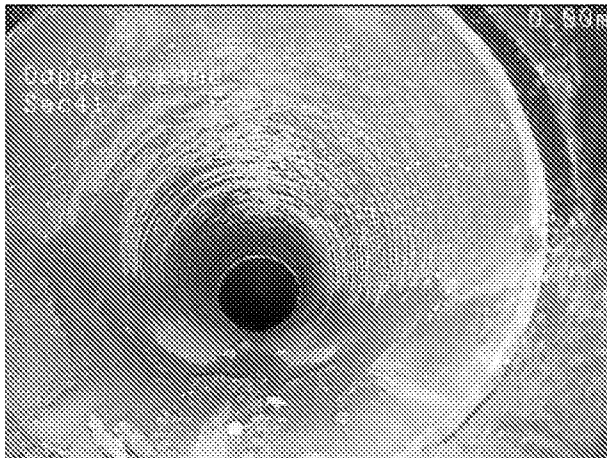
1, 00:00:00, 0.00 m  
Start node, manhole, reference: F22

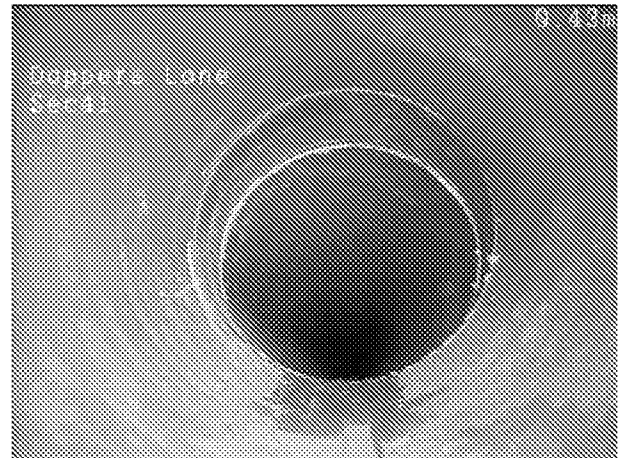
2, 00:00:11, 0.50 m  
Line deviates down

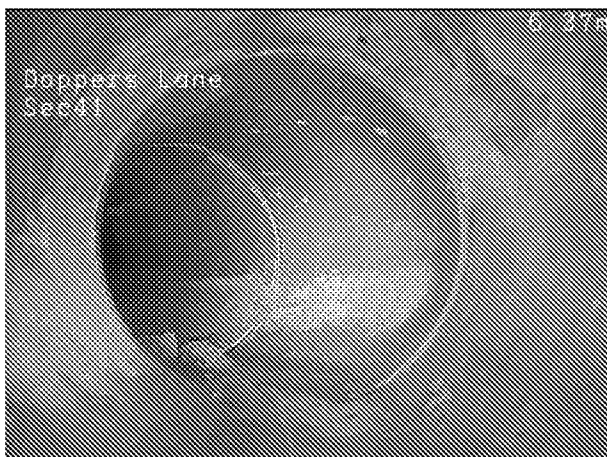
3, 00:00:46, 6.50 m  
Line deviates left

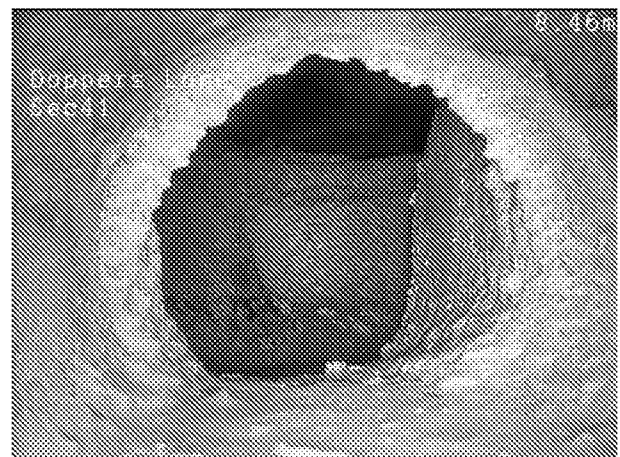
4, 00:01:04, 8.60 m  
Finish node, manhole, reference: F6, Buried under road

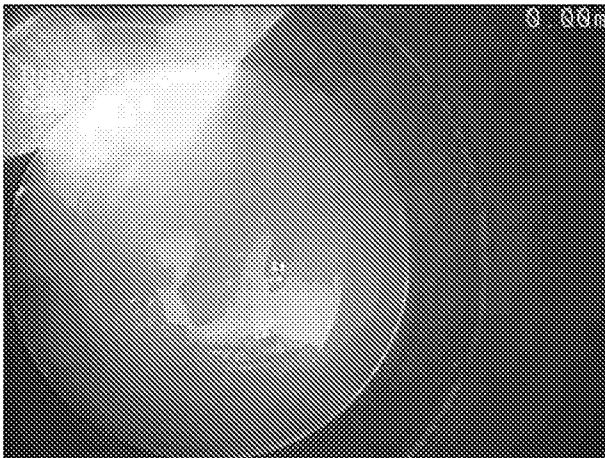
1, 00:00:00, 0.00 m  
General remark, Water level in chamber

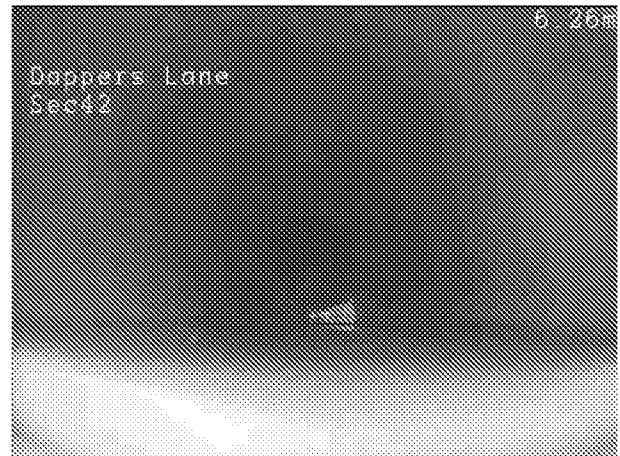
4, 00:00:47, 6.30 m  
Water level, 30% of the vertical dimension

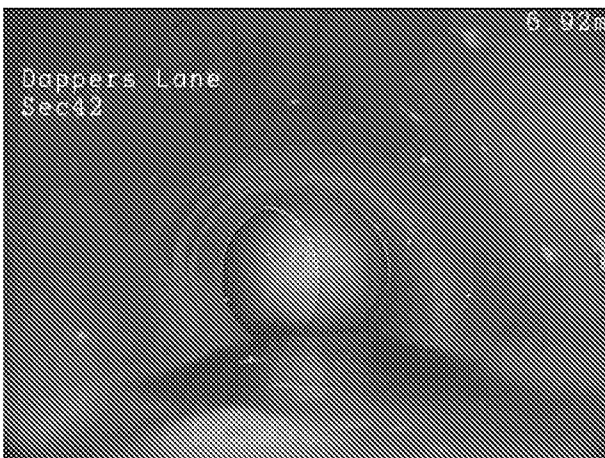
5, 00:00:57, 6.90 m  
Water level, 10% of the vertical dimension

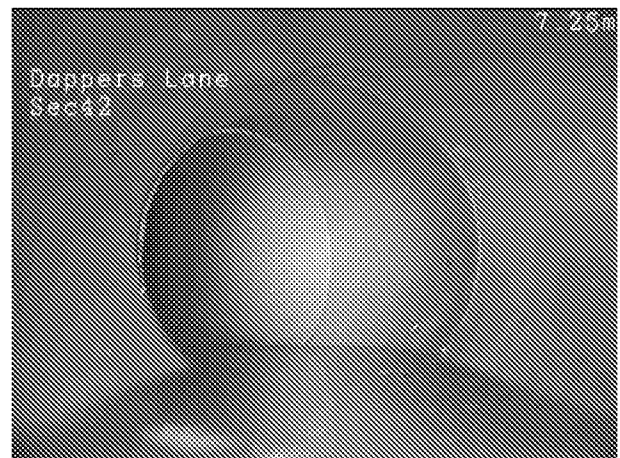
6, 00:01:01, 7.30 m  
Line deviates left

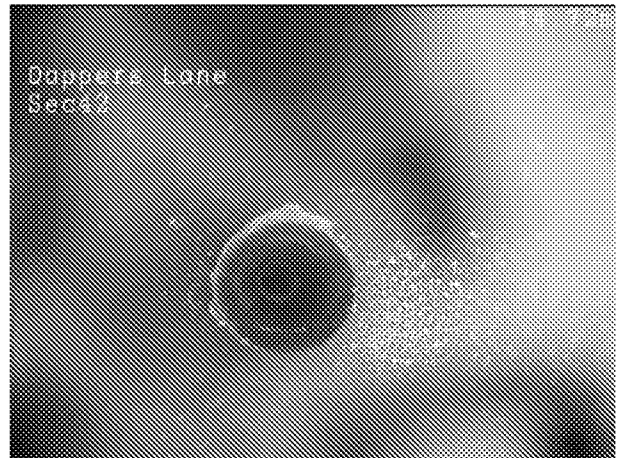
8, 00:01:42, 14.80 m  
Finish node, manhole, reference: SP29

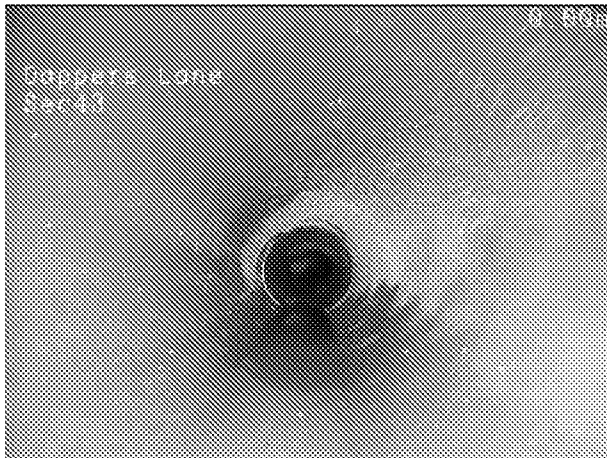
1, 00:00:00, 0.00 m  
Start node, manhole, reference: F21

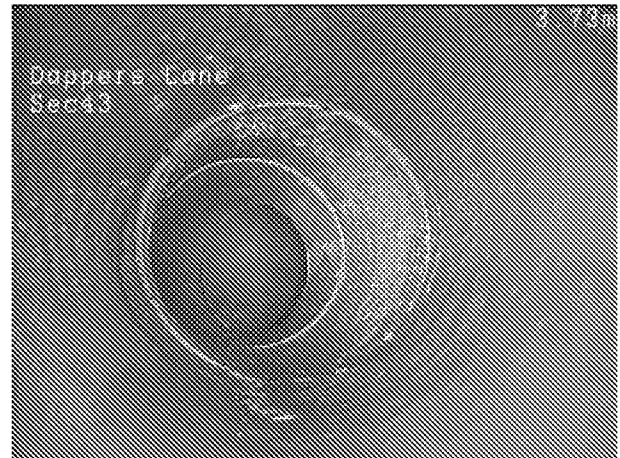
2, 00:00:23, 3.80 m  
Line deviates left

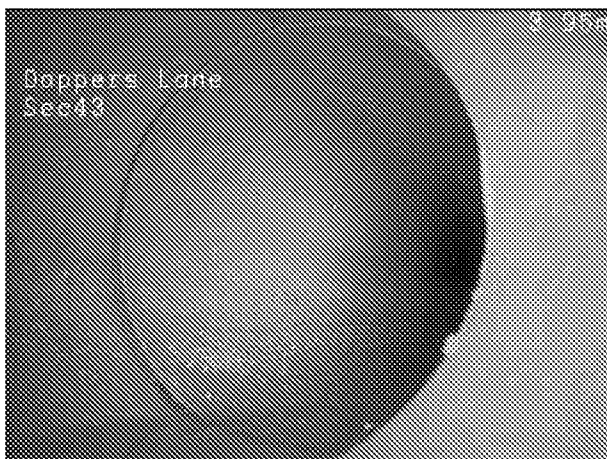
3, 00:00:25, 4.00 m  
Line deviates right

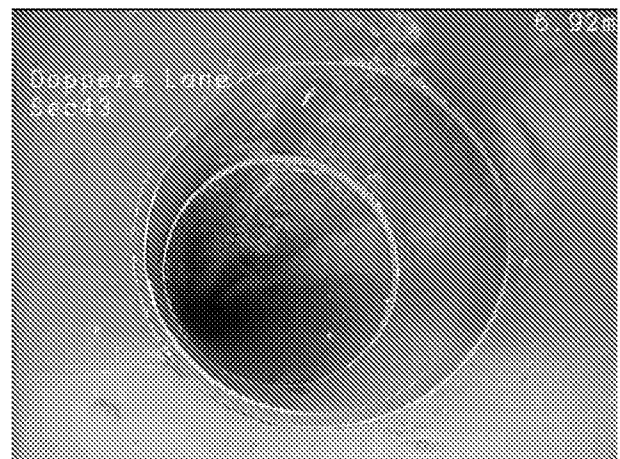
4, 00:00:36, 7.00 m  
Line deviates left

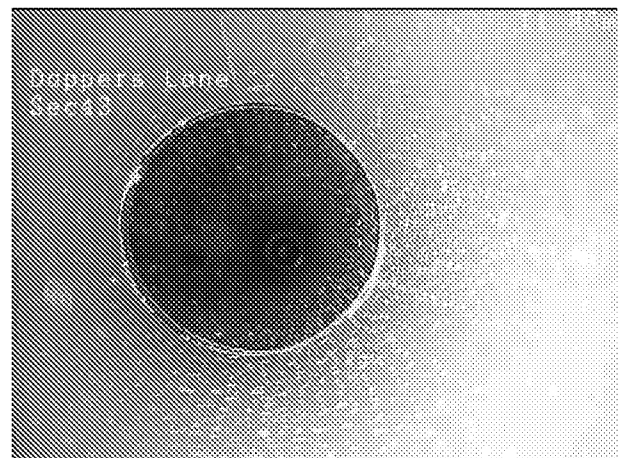
5, 00:00:47, 11.40 m  
Line deviates up

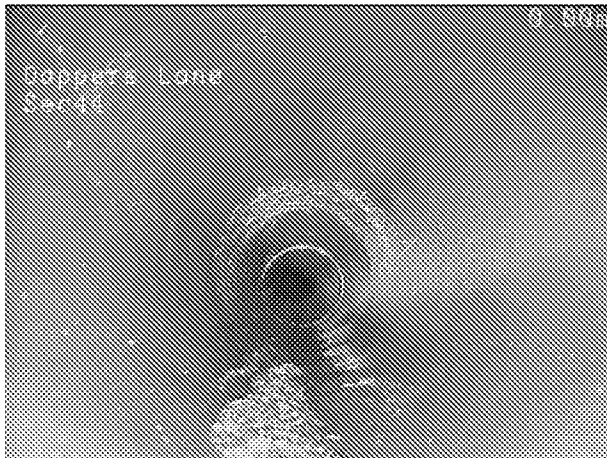
1, 00:00:00, 0.00 m  
Start node, manhole, reference: F21

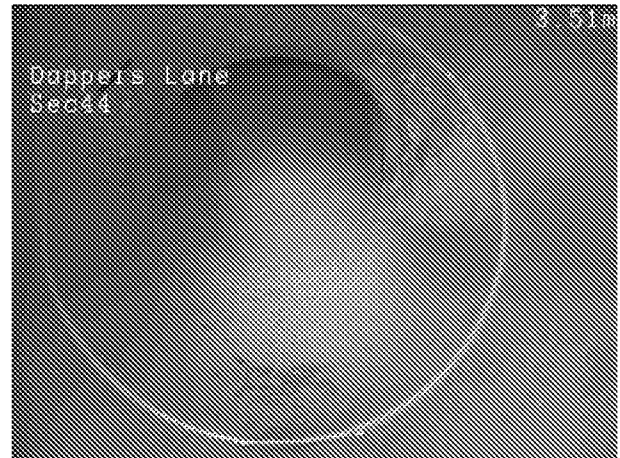
2, 00:00:40, 3.60 m  
Line deviates up

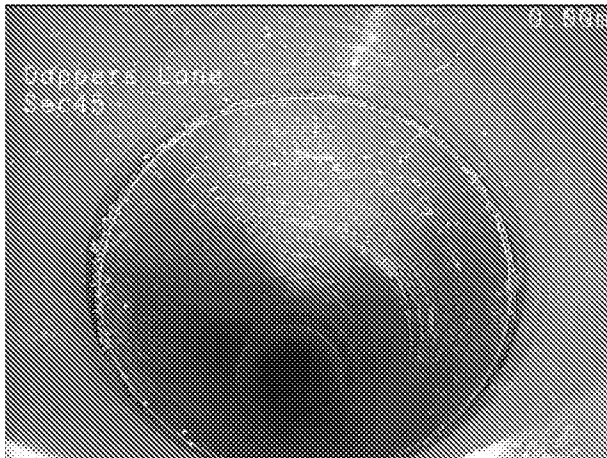
1, 00:00:00, 0.00 m  
Start node, manhole, reference: F21

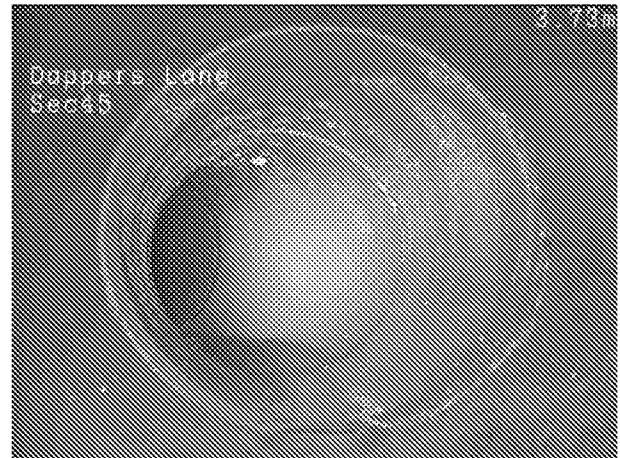
2, 00:00:22, 3.80 m  
Line deviates left

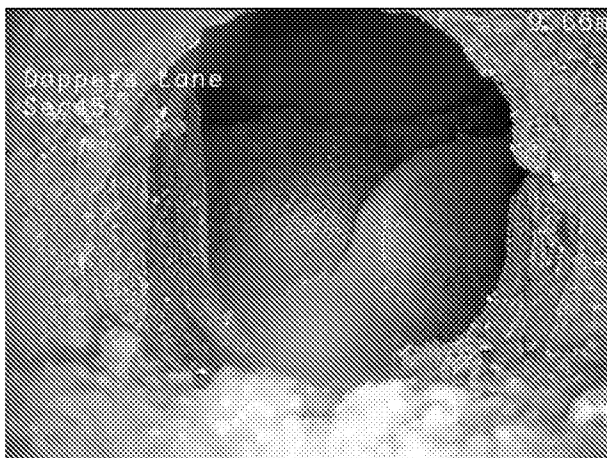
5, 00:01:07, 9.70 m  
Finish node, manhole, reference: FA, Buried

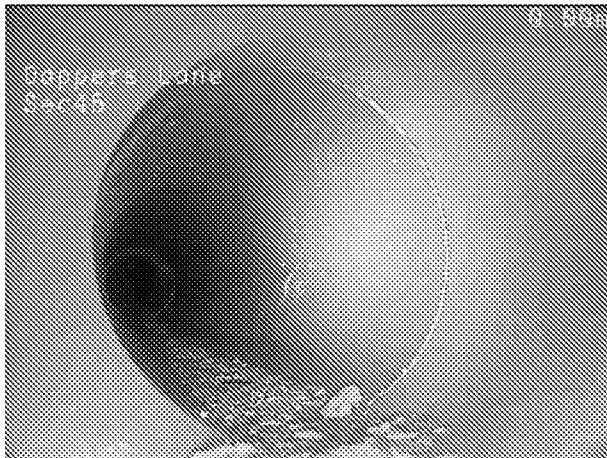
1, 00:00:00, 0.00 m  
Start node, manhole, reference: F21

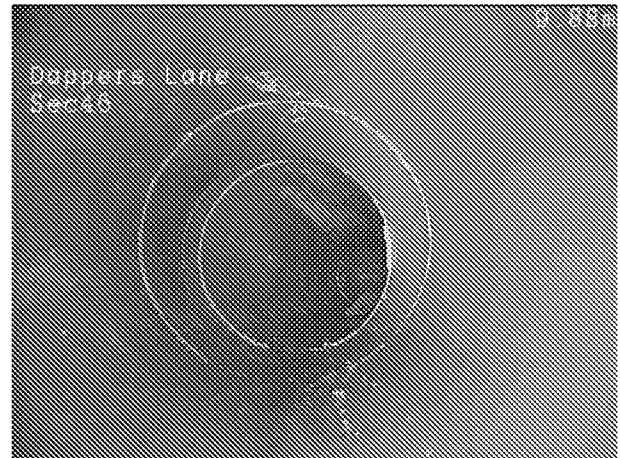
2, 00:00:41, 10.00 m  
Line deviates right

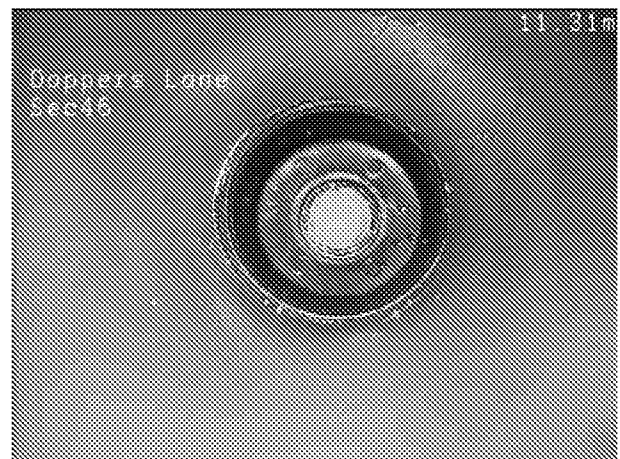
4, 00:00:57, 11.40 m  
Finish node, manhole, reference: SP32

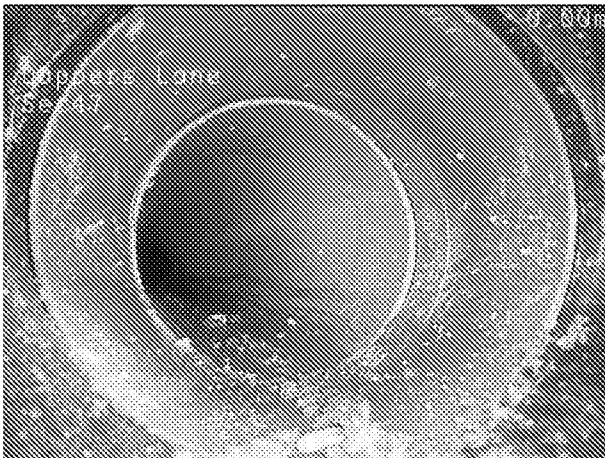
1, 00:00:00, 0.00 m  
Start node, manhole, reference: F23

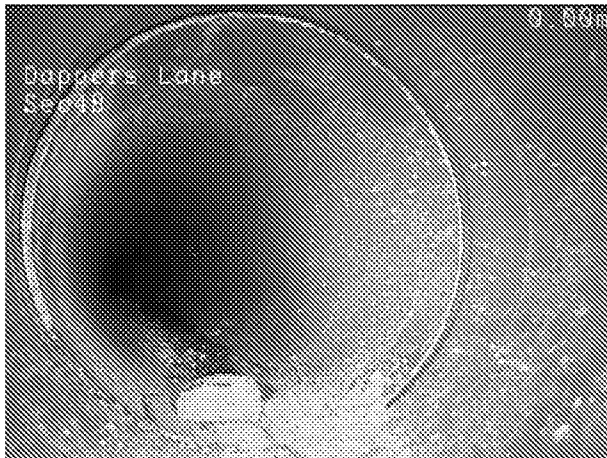
1, 00:00:00, 0.00 m  
Start node, manhole, reference: F23

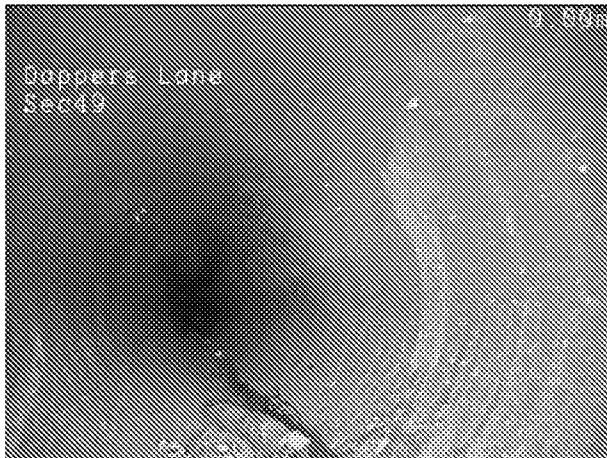
1, 00:00:10, 0.00 m  
Water level, 0% of the vertical dimension

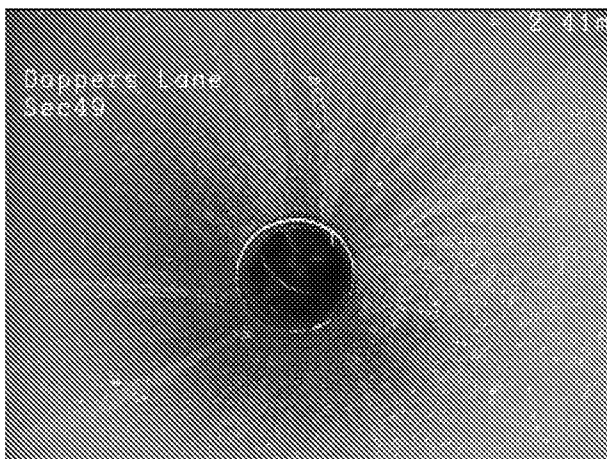
3, 00:00:37, 2.50 m  
Finish node, manhole, reference: SP35

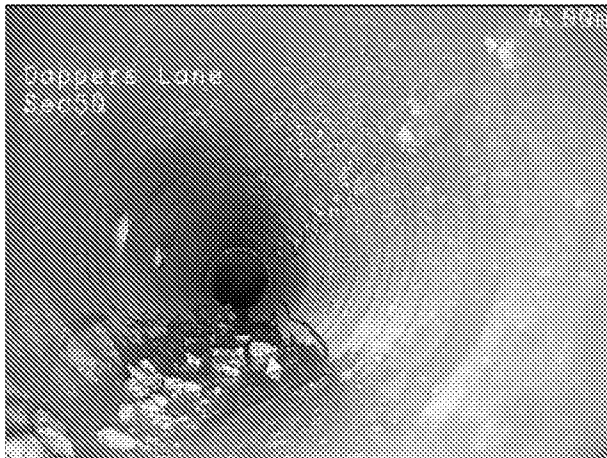
1, 00:00:00, 0.00 m  
Start node, manhole, reference: F23
