## Section Inspection - 26/05/2021 - SP36X

| Town or Village: | Angmering | Inspection Direction: | Upstream | Upstream Node: | SP36 |
| Road: | Dappers Lane | Inspected Length: | 4.00 m | Upstream Pipe Depth: | |

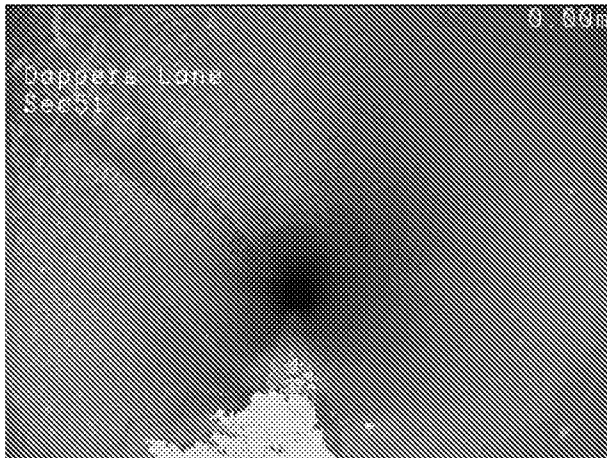
1, 00:00:00, 0.00 m  
Start node, manhole, reference: F24

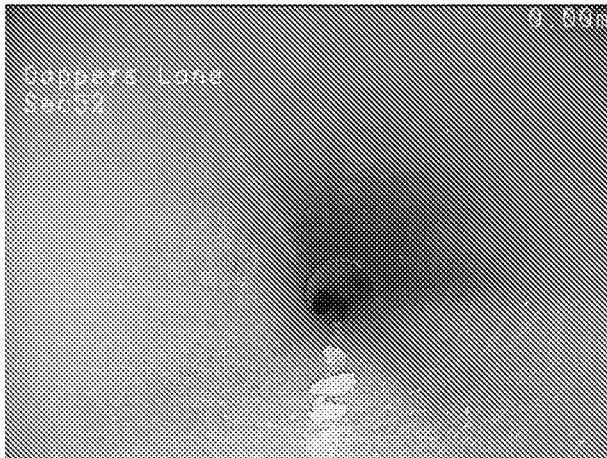
1, 00:00:00, 0.00 m  
Start node, manhole, reference: F24

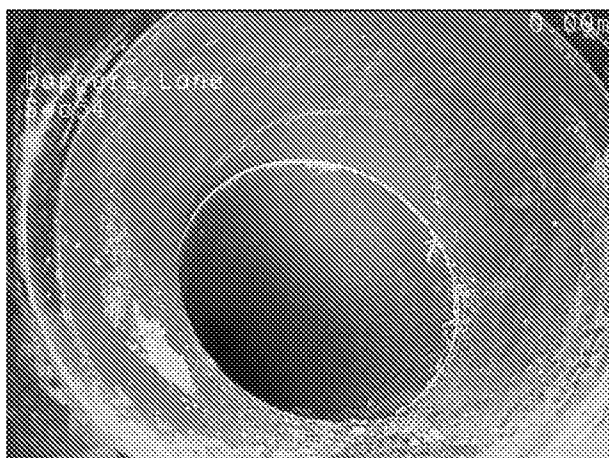
1, 00:00:00, 0.00 m  
Start node, manhole, reference: F24

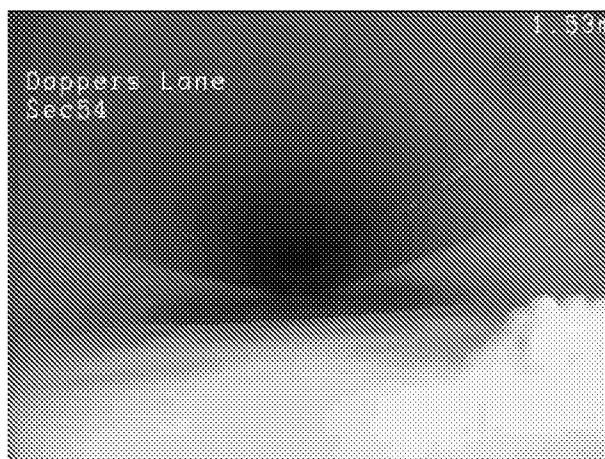
4, 00:00:20, 1.60 m  
Water level, 20% of the vertical dimension

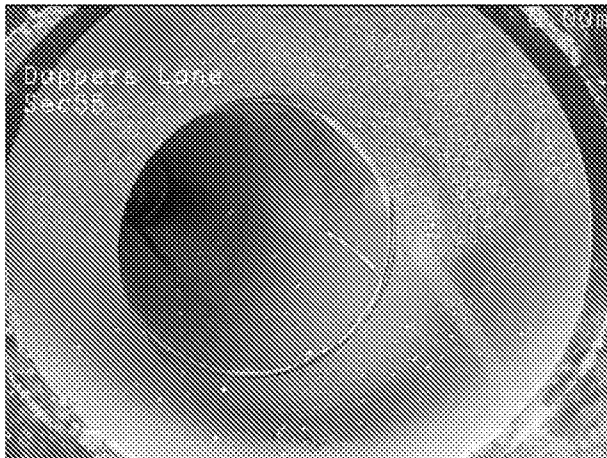
1, 00:00:00, 0.00 m  
Start node, manhole, reference: F26

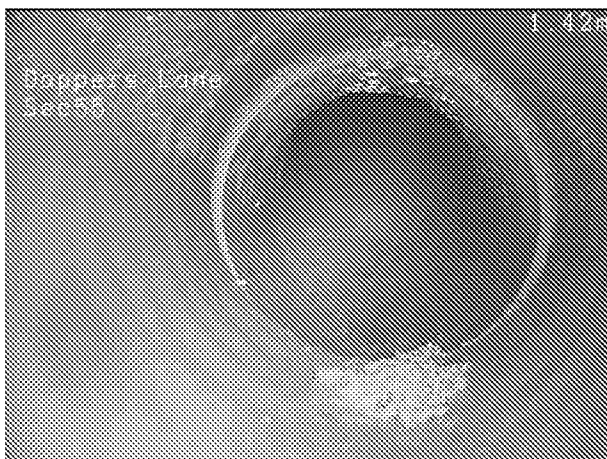
3, 00:00:19, 1.50 m  
Line deviates up

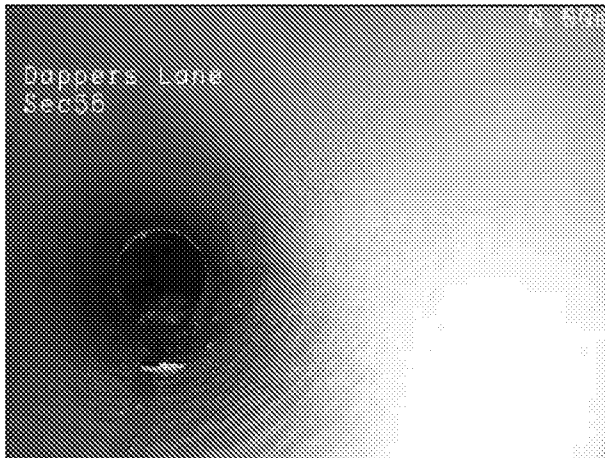
1, 00:00:00, 0.00 m  
Start node, manhole, reference: F26

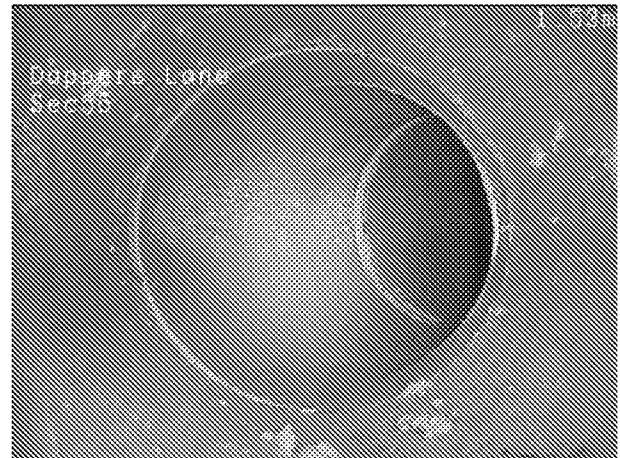
2, 00:00:25, 1.60 m  
Line deviates right

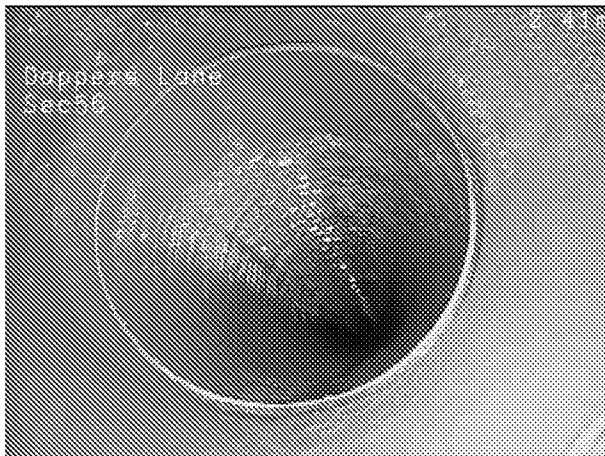
3, 00:00:32, 2.50 m  
Line deviates right

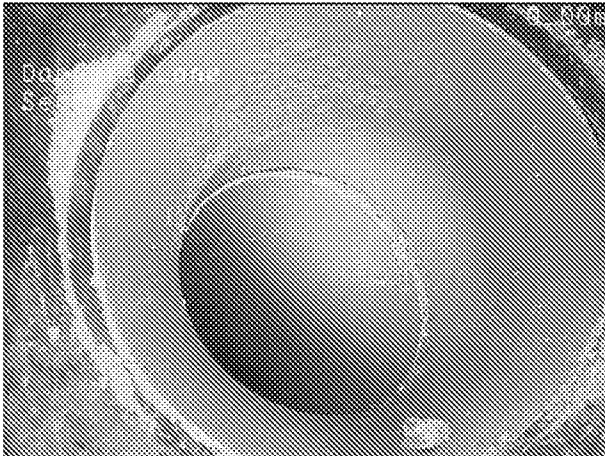
1, 00:00:01, 0.00 m  
Water level, 0% of the vertical dimension

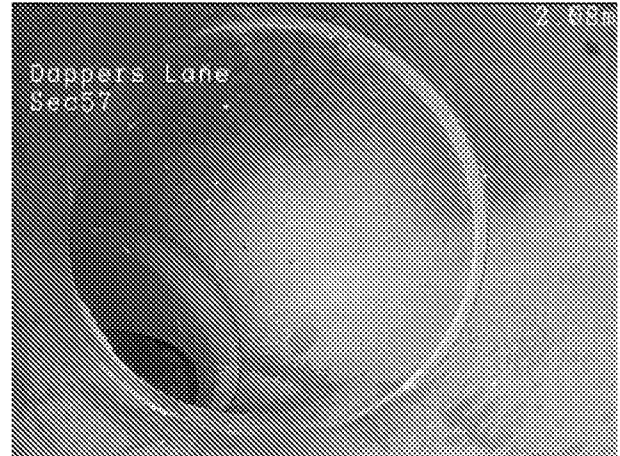
2, 00:00:22, 2.20 m  
Line deviates left

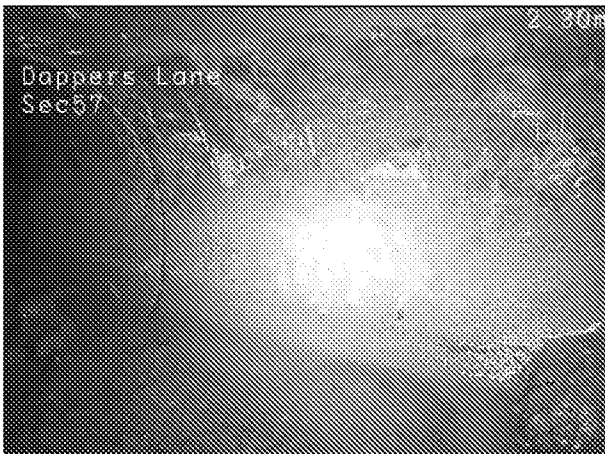
3, 00:00:27, 2.40 m  
Finish node, major connection without manhole, reference: JN

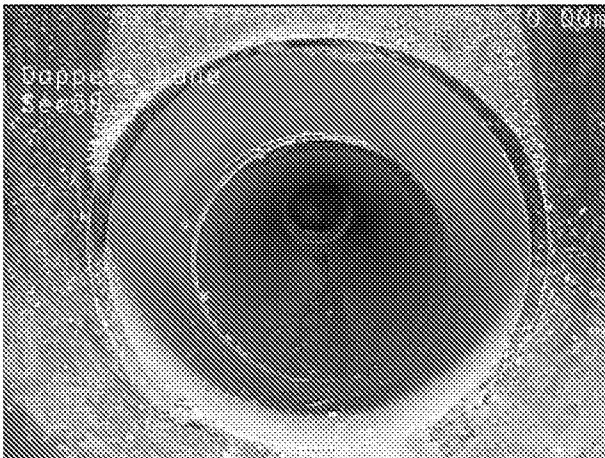
1, 00:00:00, 0.00 m  
Start node, manhole, reference: F27

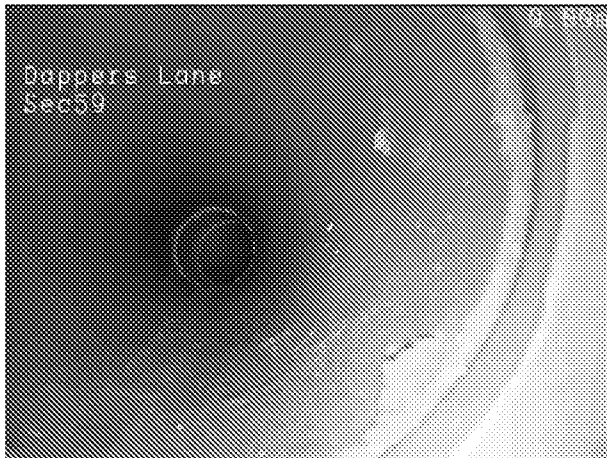
1, 00:00:00, 0.00 m  
Start node, manhole, reference: F27

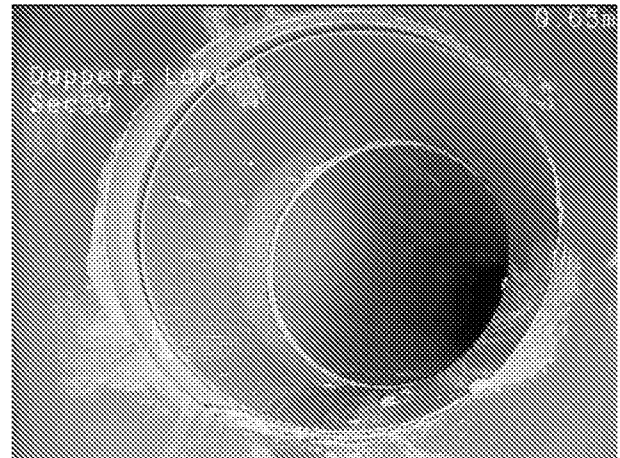
2, 00:00:16, 0.70 m  
Line deviates right

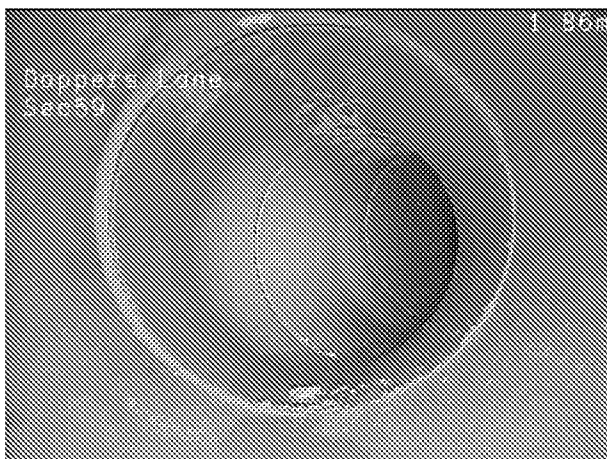
3, 00:00:26, 2.00 m  
Line deviates right

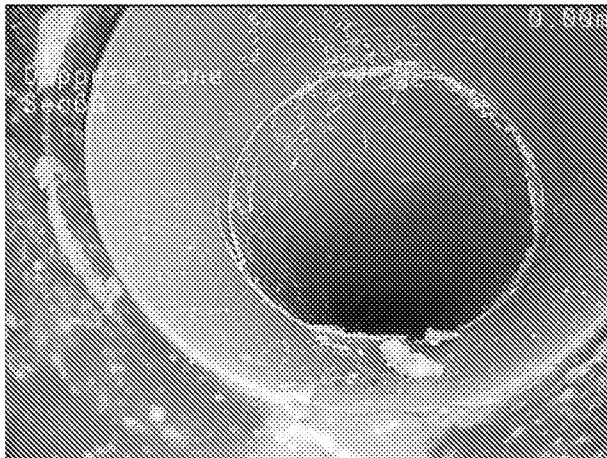
1, 00:00:00, 0.00 m  
Start node, manhole, reference: F27

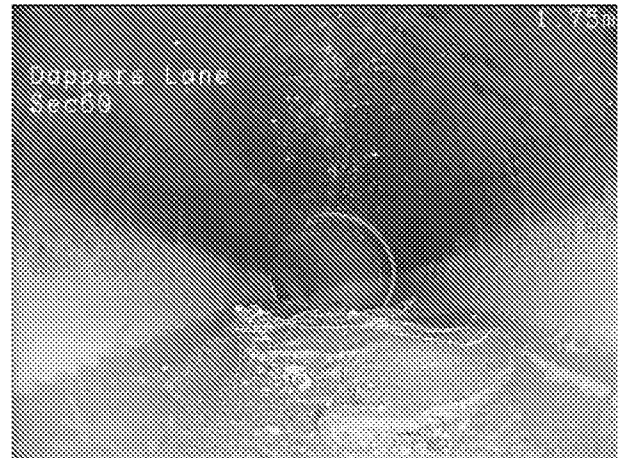
2, 00:00:23, 1.80 m  
Settled deposits, coarse, 15% cross-sectional area loss

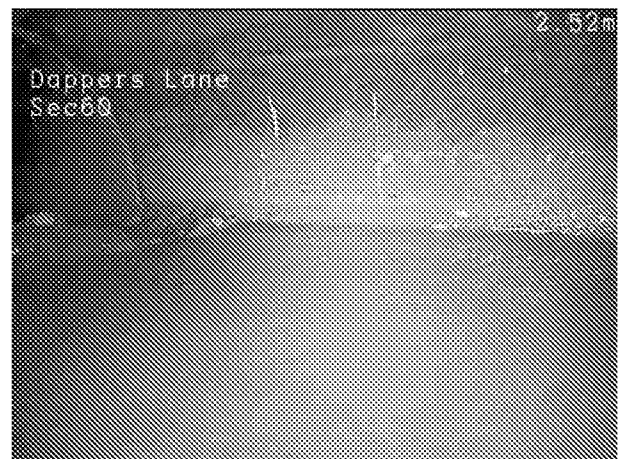
4, 00:00:44, 2.50 m  
Finish node, major connection without manhole, reference: JN

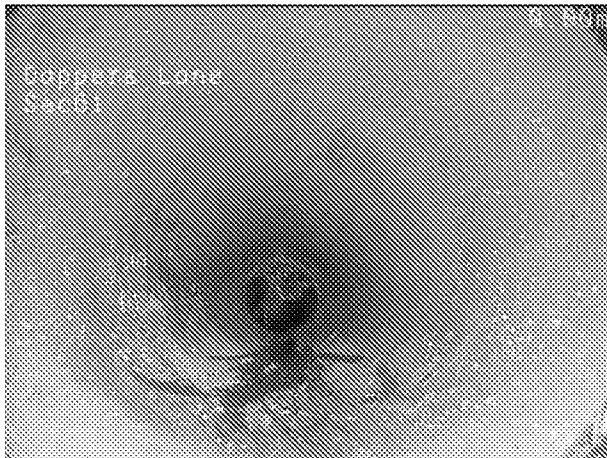
1, 00:00:00, 0.00 m  
Start node, manhole, reference: F28

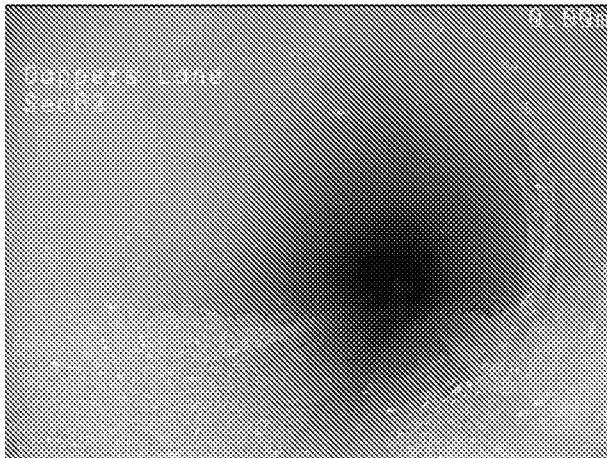
1, 00:00:00, 0.00 m  
Start node, manhole, reference: F28

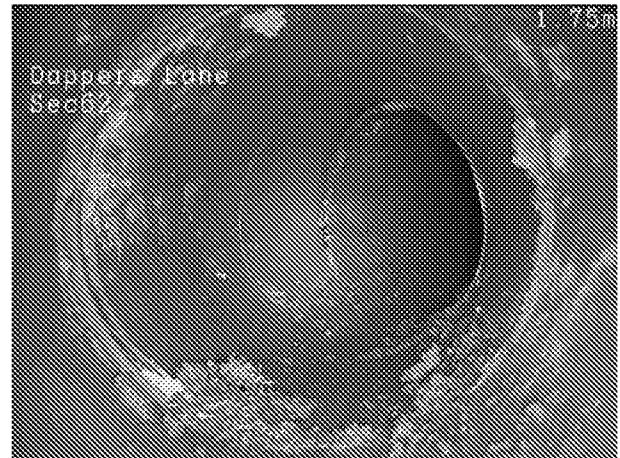
2, 00:00:20, 1.90 m  
Line deviates right

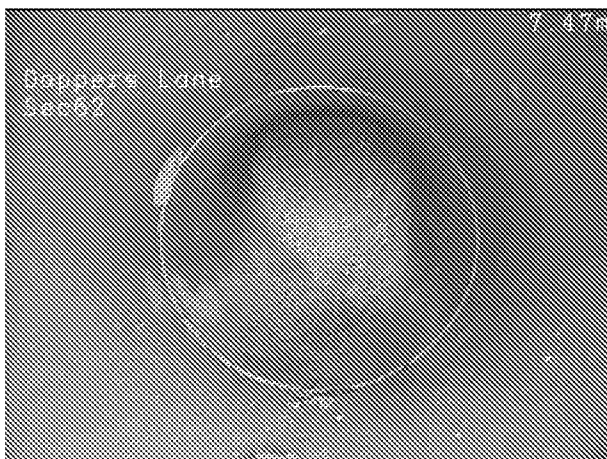
3, 00:00:36, 7.60 m  
Line deviates up

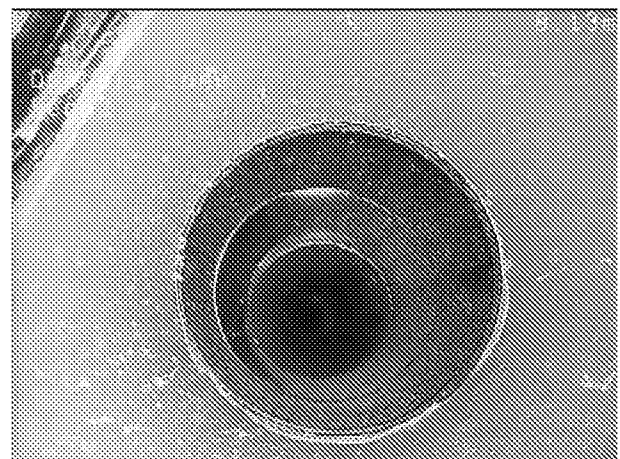
4, 00:00:40, 8.10 m  
Finish node, manhole, reference: SP44

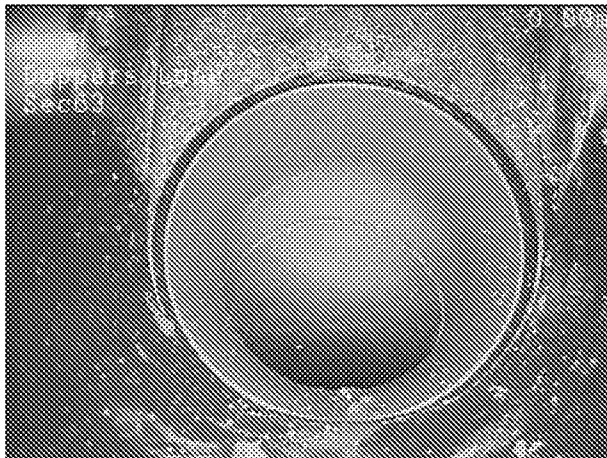
1, 00:00:00, 0.00 m  
Start node, manhole, reference: F28

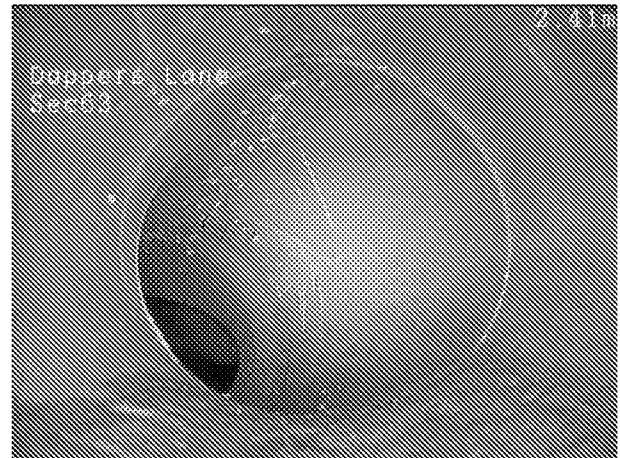
2, 00:00:33, 2.50 m  
Line deviates left

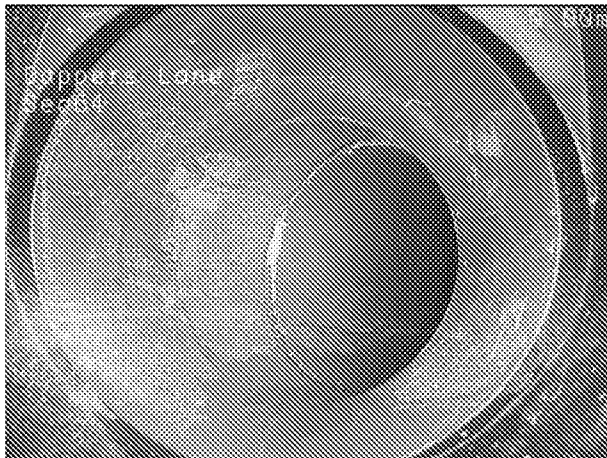
1, 00:00:00, 0.00 m  
Start node, manhole, reference: S15

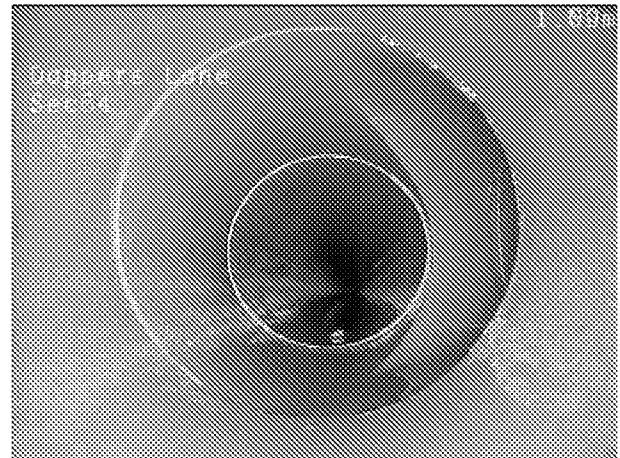
2, 00:00:13, 1.20 m  
Junction at 3 o'clock, 100mm dia

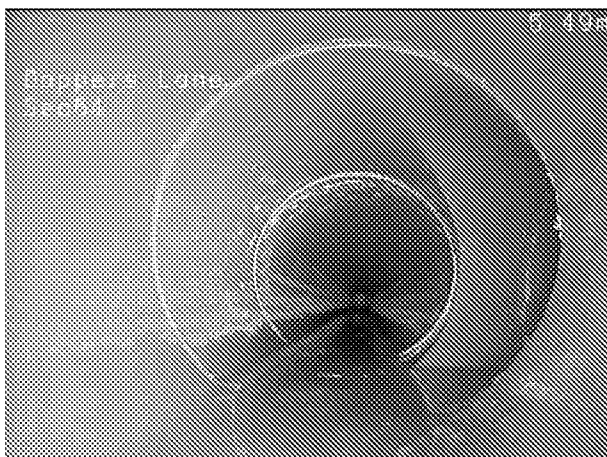
3, 00:00:47, 5.60 m  
Junction at 3 o'clock, 100mm dia

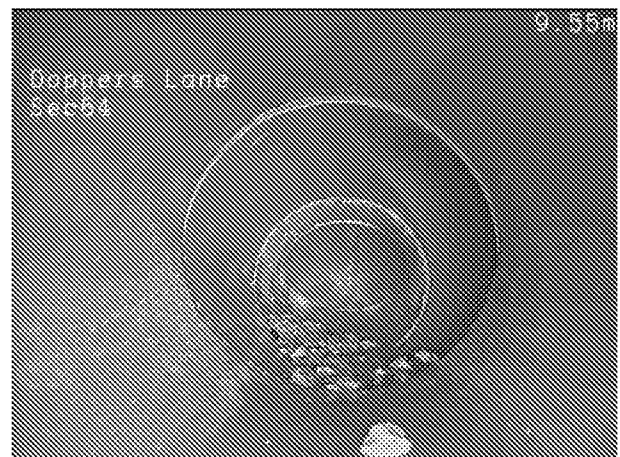
4, 00:01:09, 9.70 m  
Junction at 3 o'clock, 100mm dia

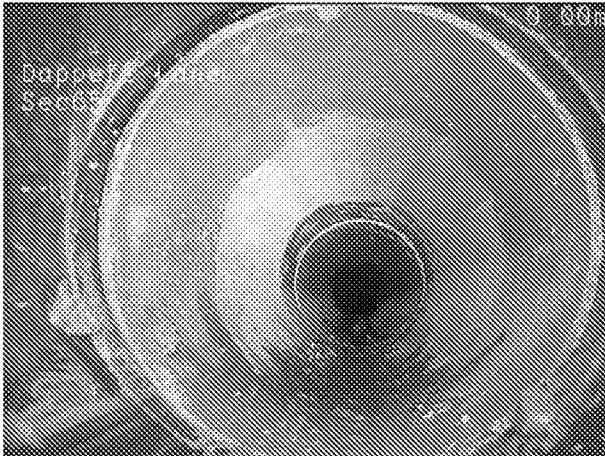
1, 00:00:03, 0.00 m  
Water level, 0% of the vertical dimension

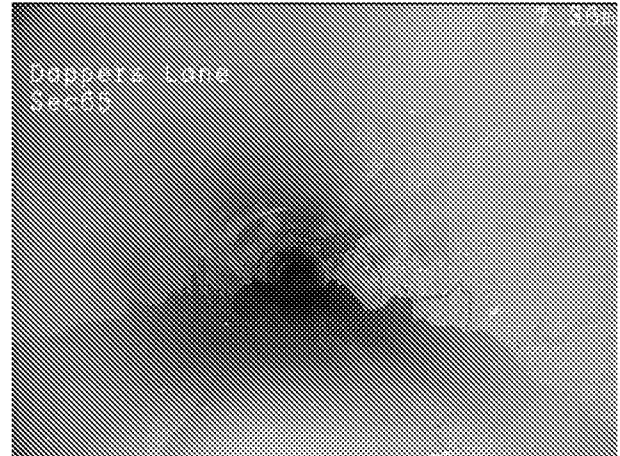
2, 00:00:36, 7.30 m  
Water level, 5% of the vertical dimension

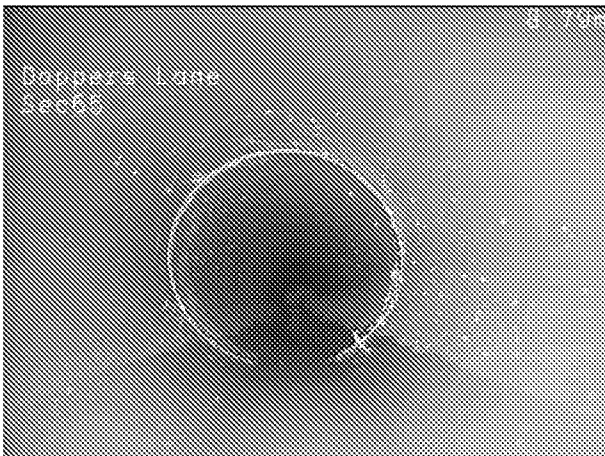
3, 00:00:49, 8.80 m  
Water level, 0% of the vertical dimension

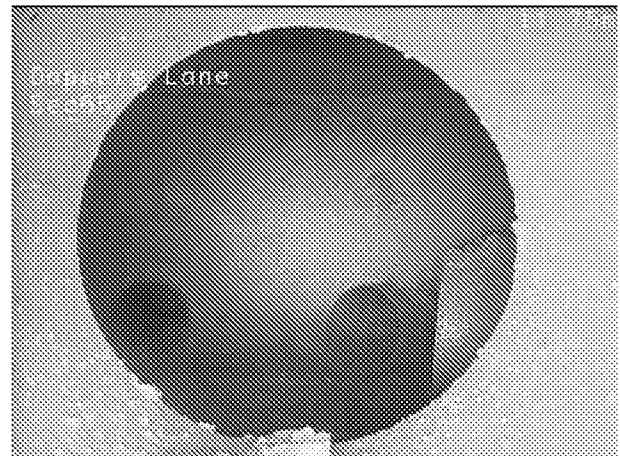
4, 00:01:06, 11.90 m  
Finish node, manhole, reference: S1

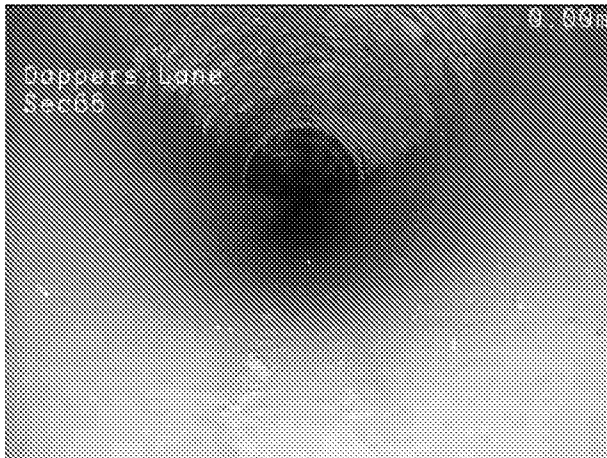
1, 00:00:13, 0.00 m  
Water level, 0% of the vertical dimension

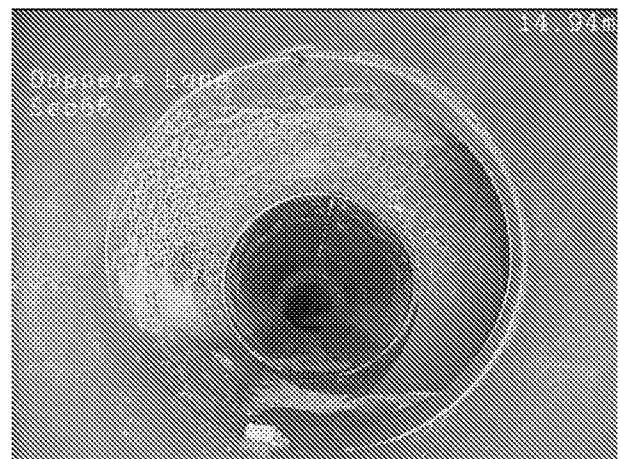
4, 00:01:11, 15.10 m  
Junction at 3 o'clock, 100mm dia

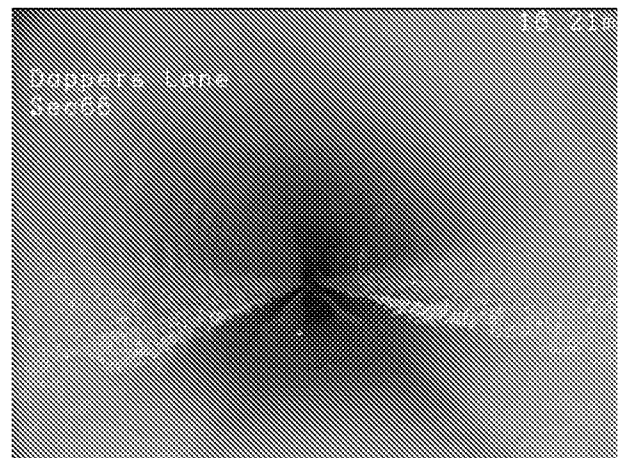
6, 00:01:19, 16.20 m  
Water level, 5% of the vertical dimension

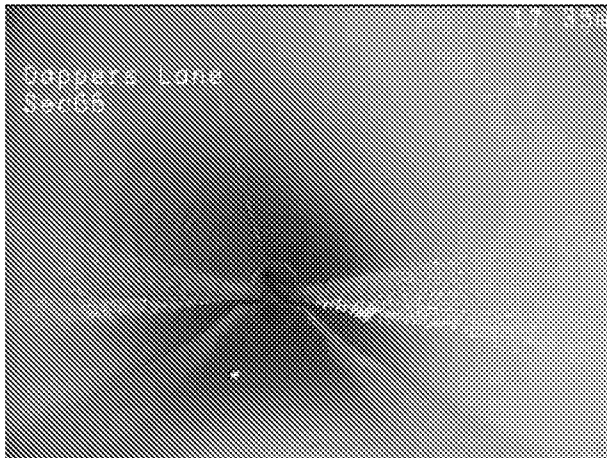
7, 00:01:27, 17.30 m  
Water level, 10% of the vertical dimension

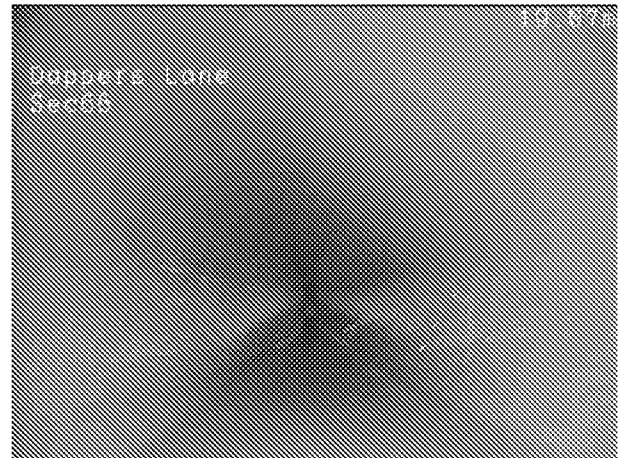
8, 00:01:41, 19.00 m  
Water level, 5% of the vertical dimension

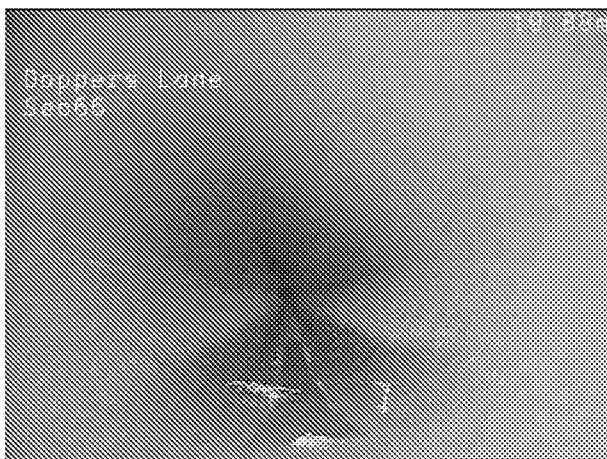
9, 00:01:51, 19.80 m  
Water level, 0% of the vertical dimension

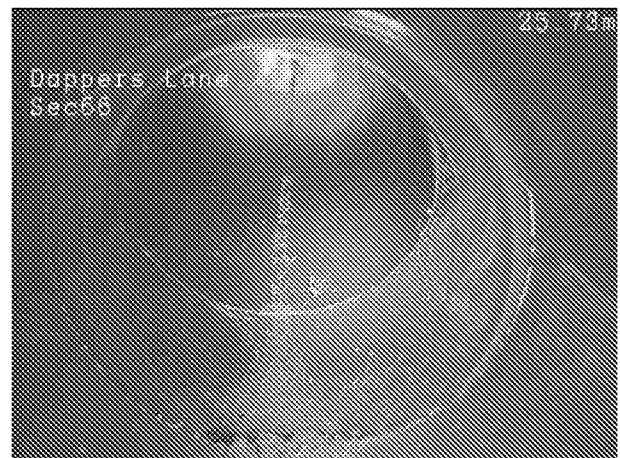
12, 00:02:22, 25.80 m  
Line deviates up

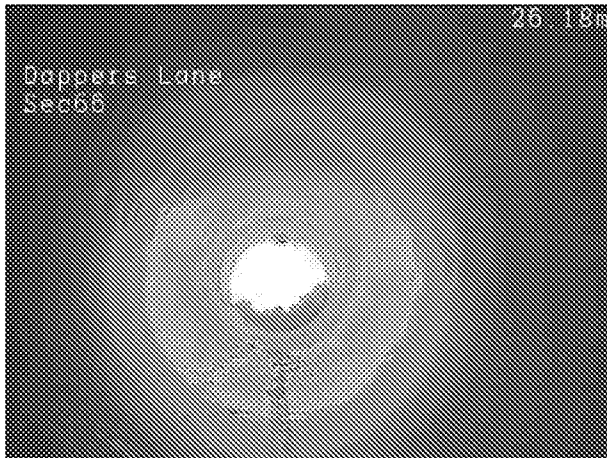
13, 00:02:28, 26.20 m  
Finish node, manhole, reference: RE6

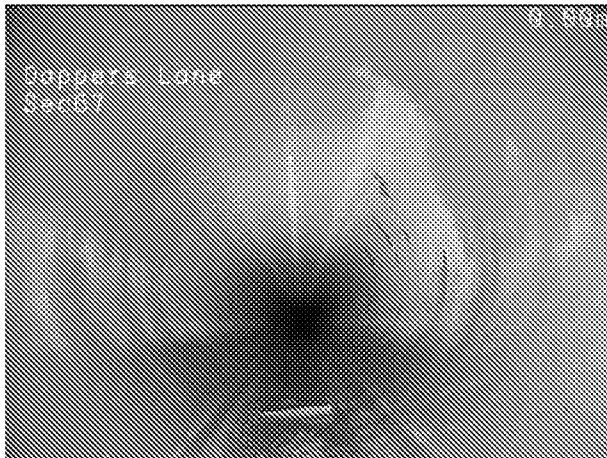
1, 00:00:26, 0.00 m  
Water level, 0% of the vertical dimension

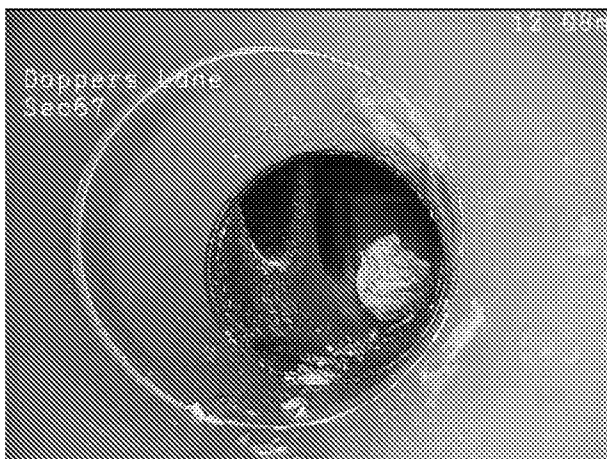
3, 00:01:20, 12.10 m  
Line deviates right

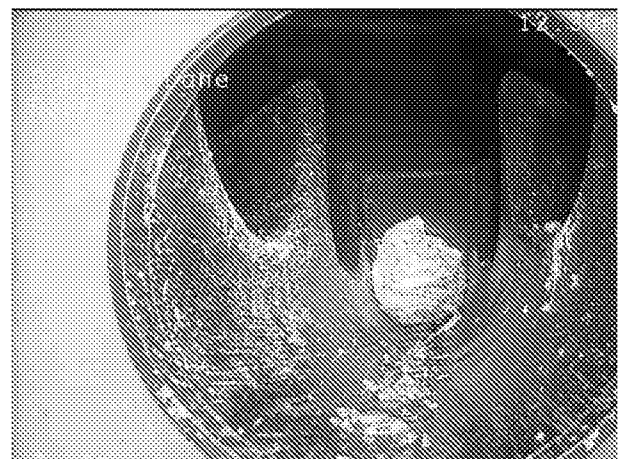
4, 00:01:27, 12.40 m  
Finish node, manhole, reference: S19

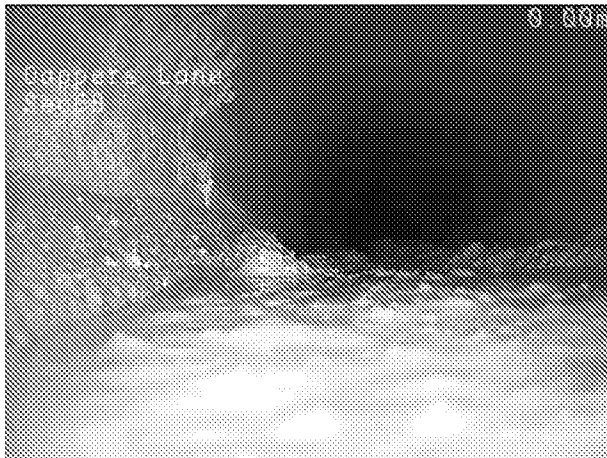
1, 00:00:00, 0.00 m  
Start node, manhole, reference: S1

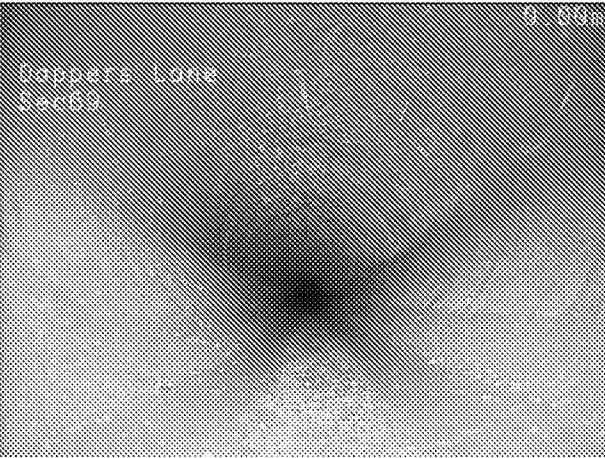
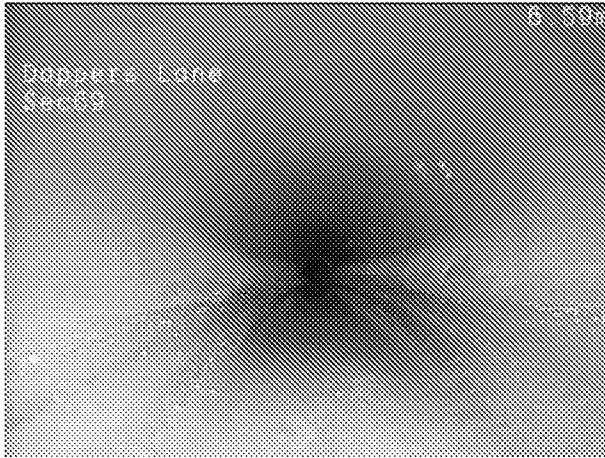
| <p>1, 00:00:01, 0.00 m<br/>Water level, 0% of the vertical dimension</p> | <p>2, 00:00:48, 6.60 m<br/>Water level, 5% of the vertical dimension</p> |

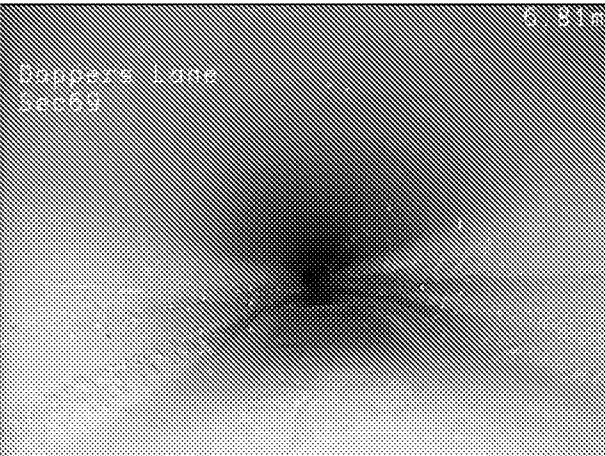
| <p>3, 00:00:50, 6.80 m<br/>Water level, 10% of the vertical dimension</p> | <p>4, 00:01:05, 8.20 m<br/>Water level, 5% of the vertical dimension</p> |

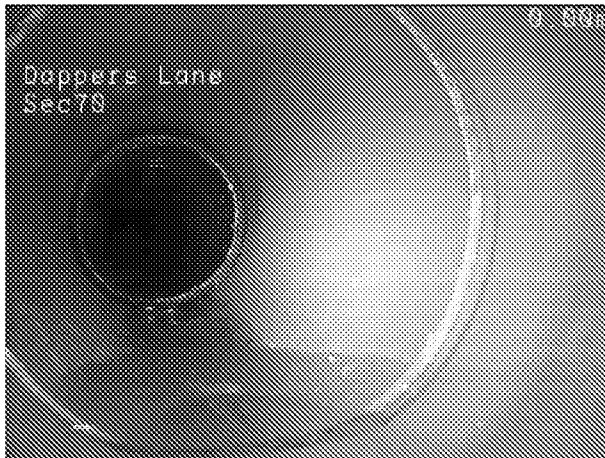
1, 00:00:00, 0.00 m  
Start node, manhole, reference: S22

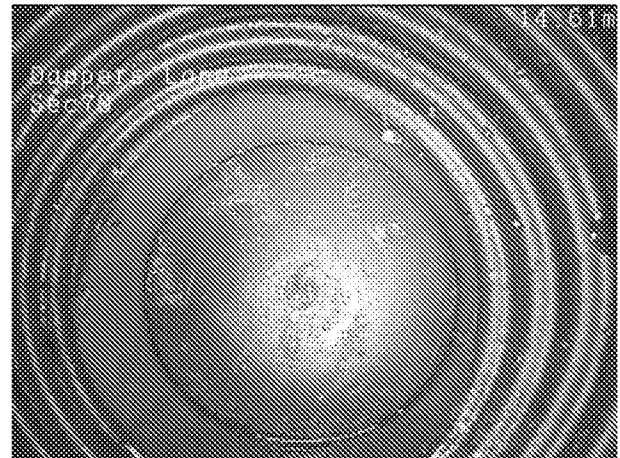
2, 00:01:11, 14.60 m  
Finish node, rodding eye, reference: LD, Assumed end point

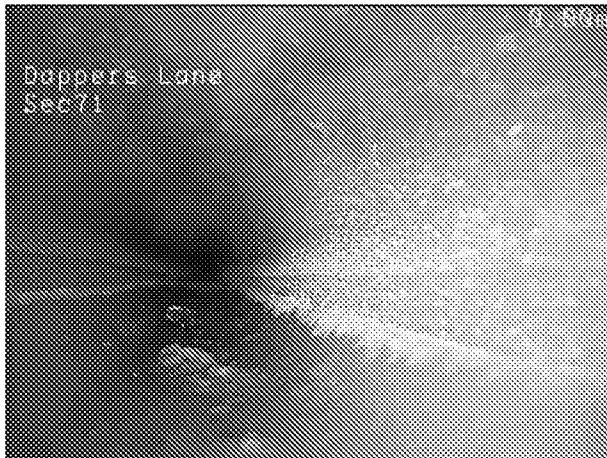
1, 00:00:00, 0.00 m  
Start node, manhole, reference: S22

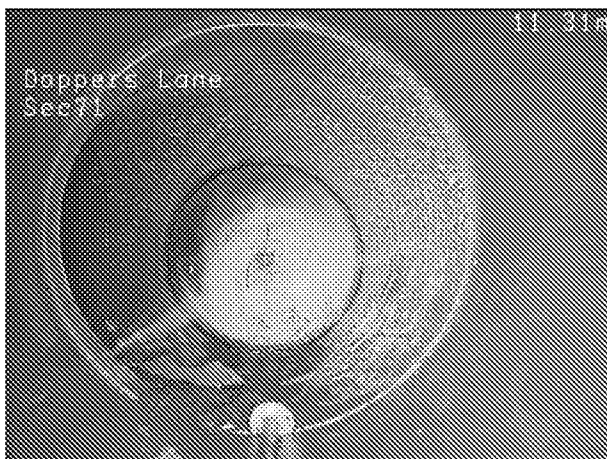
3, 00:00:33, 11.40 m  
Junction at 9 o'clock, 100mm dia

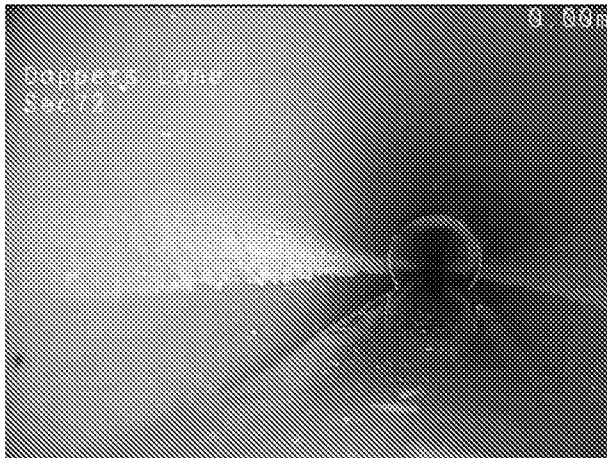
1, 00:00:11, 0.00 m  
Water level, 10% of the vertical dimension

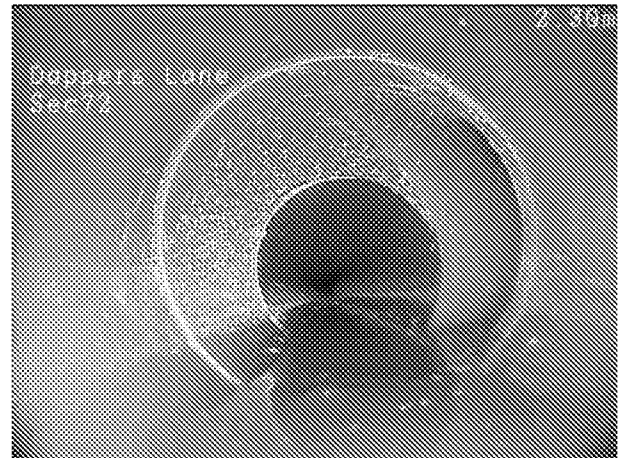
2, 00:00:39, 2.40 m  
Junction at 3 o'clock, 100mm dia

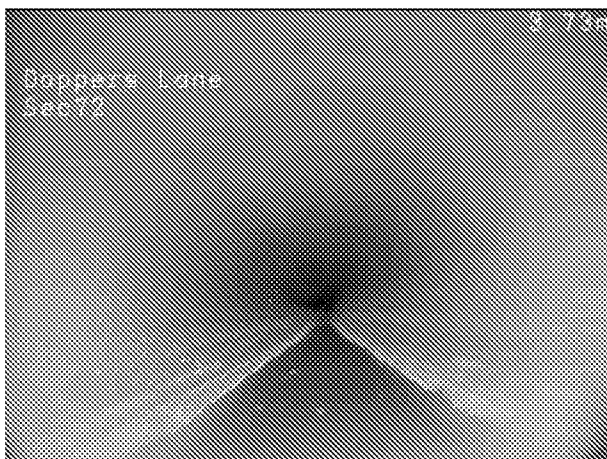
3, 00:00:48, 3.70 m  
Water level, 5% of the vertical dimension

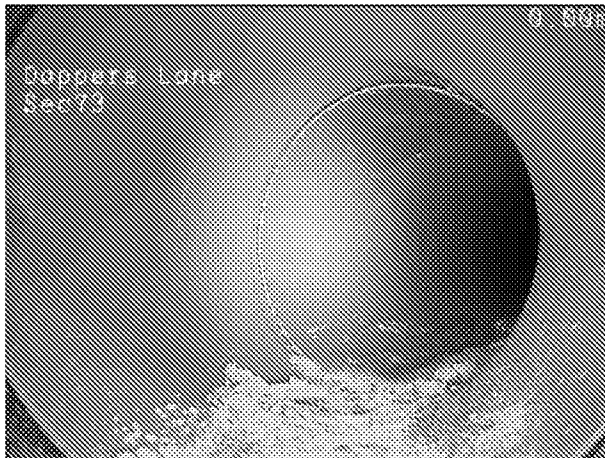
1, 00:00:00, 0.00 m  
Start node, manhole, reference: S22

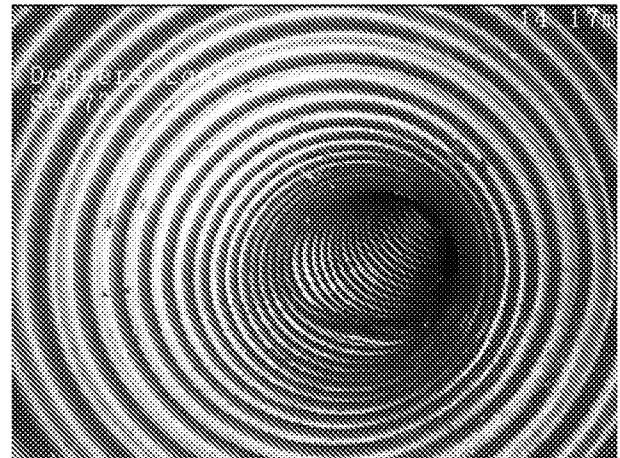
2, 00:01:43, 14.30 m  
Line deviates up

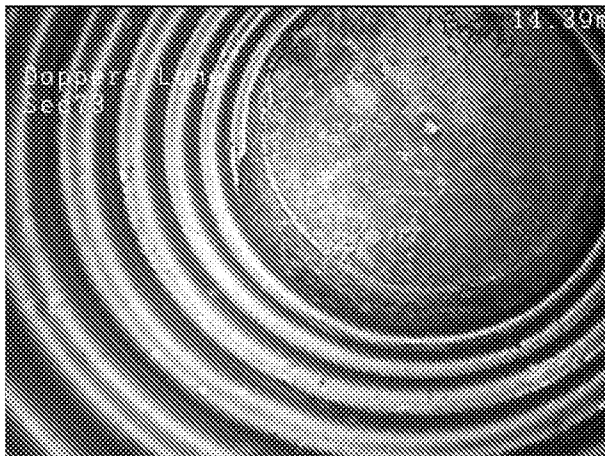
3, 00:01:50, 14.40 m  
Finish node, manhole, reference: LD 2

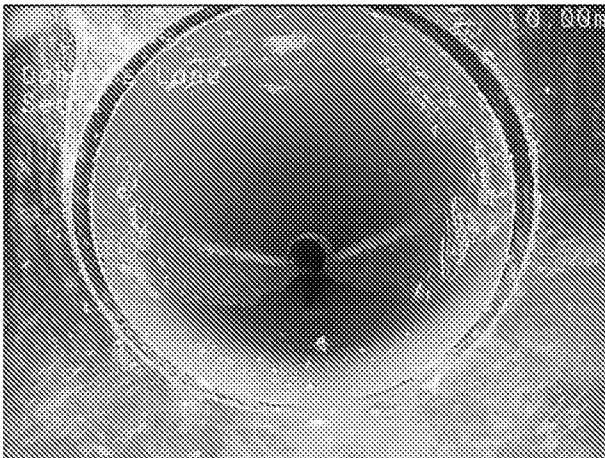
1, 00:00:00, 0.00 m  
Start node, manhole, reference: S22

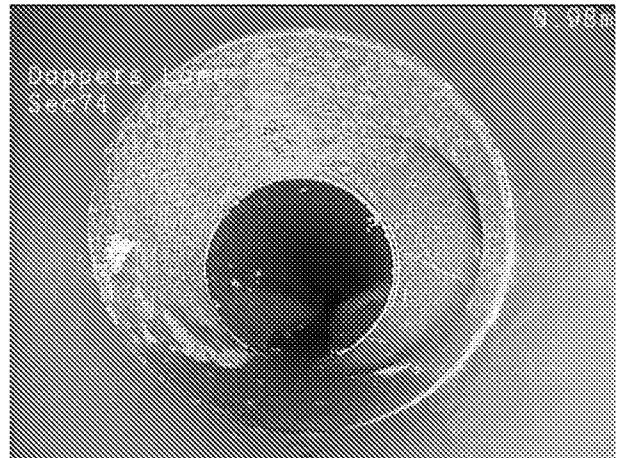
2, 00:00:13, 1.10 m  
Junction at 3 o'clock, 100mm dia

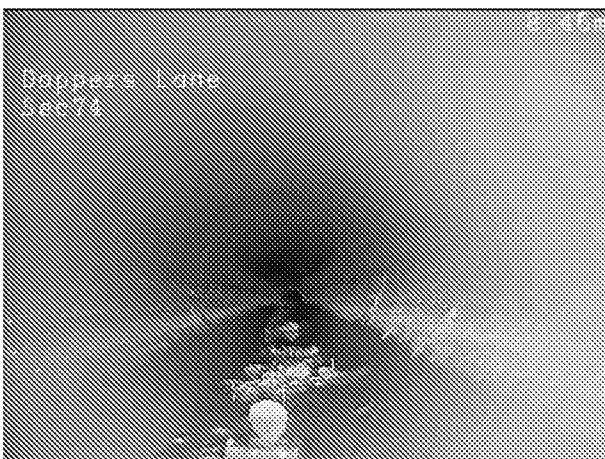
3, 00:00:48, 8.50 m  
Settled deposits, coarse, 5% cross-sectional area loss

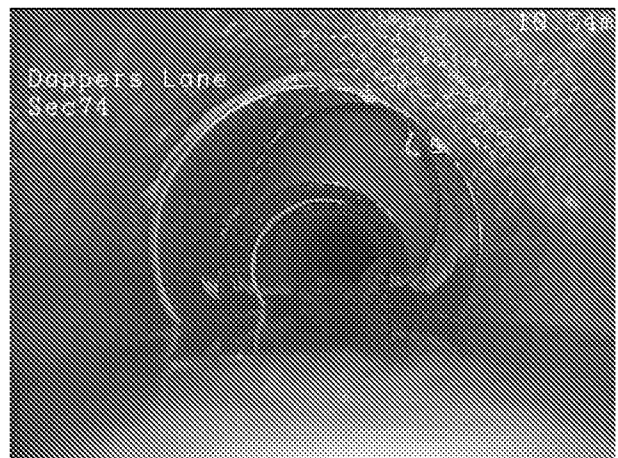
6, 00:01:06, 10.70 m  
Junction at 1 o'clock, 100mm dia

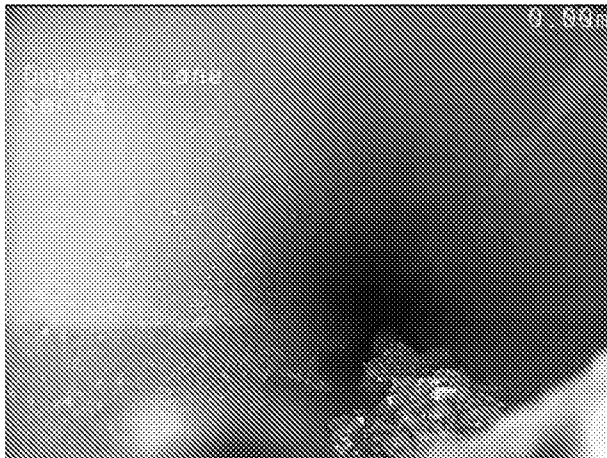
1, 00:00:00, 0.00 m  
Start node, manhole, reference: S2

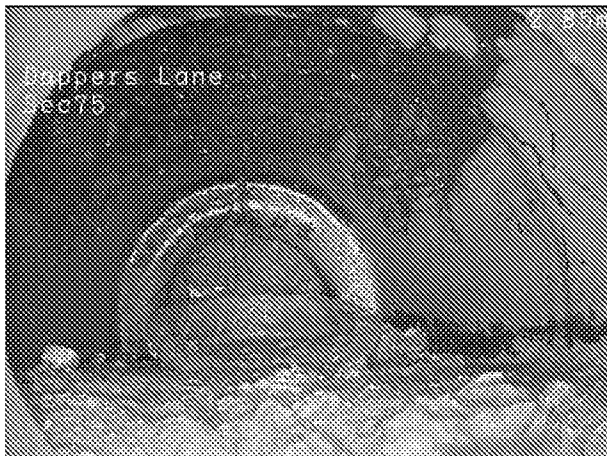
3, 00:01:09, 2.90 m  
Finish node, manhole, reference: RG, Road gully full

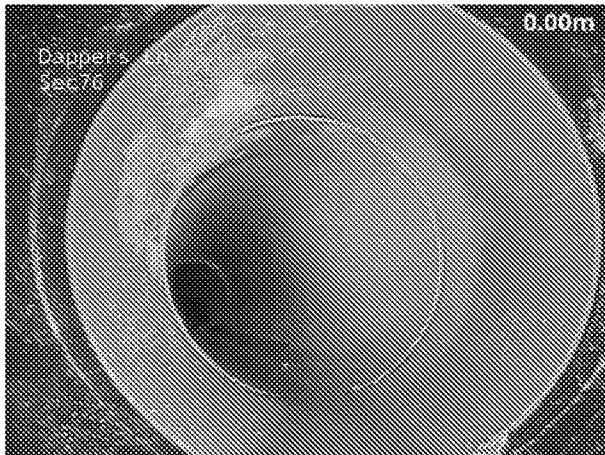
1, 00:00:02, 0.10 m  
Line deviates left

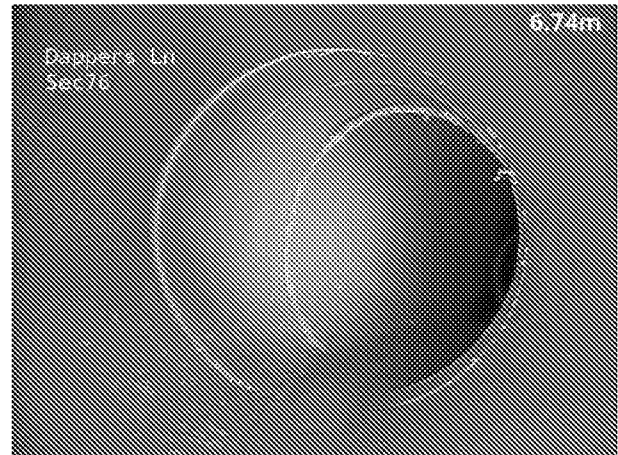
2, 00:00:21, 6.90 m  
Line deviates right

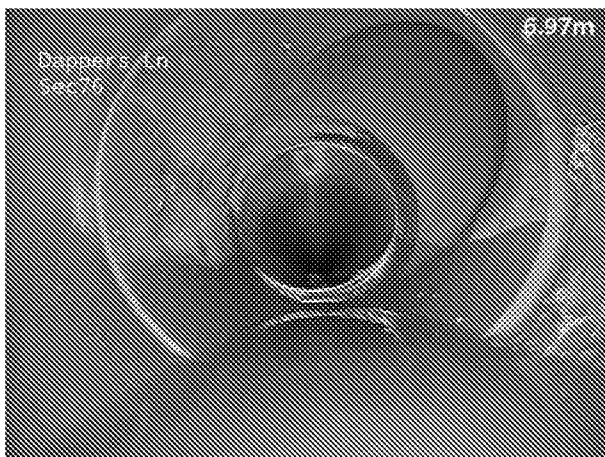
3, 00:00:28, 7.00 m  
Water level, 10% of the vertical dimension

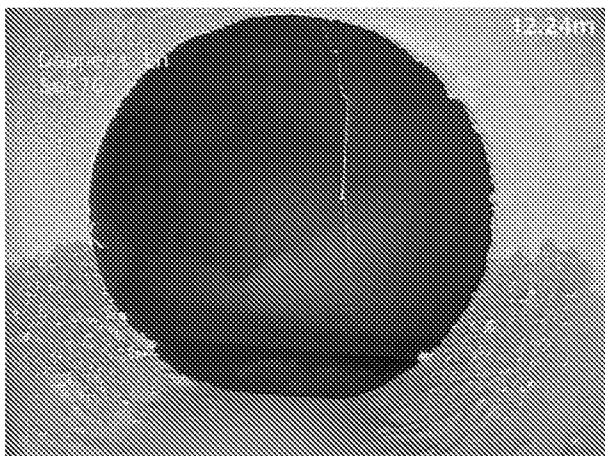
5, 00:00:53, 12.40 m  
Finish node, manhole, reference: S2

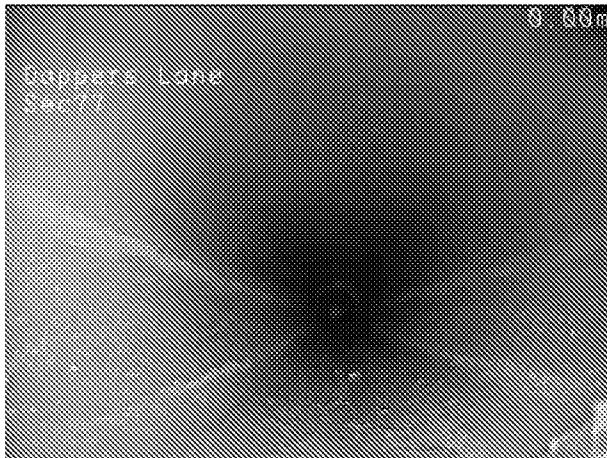
1, 00:00:20, 0.00 m  
Water level, 0% of the vertical dimension

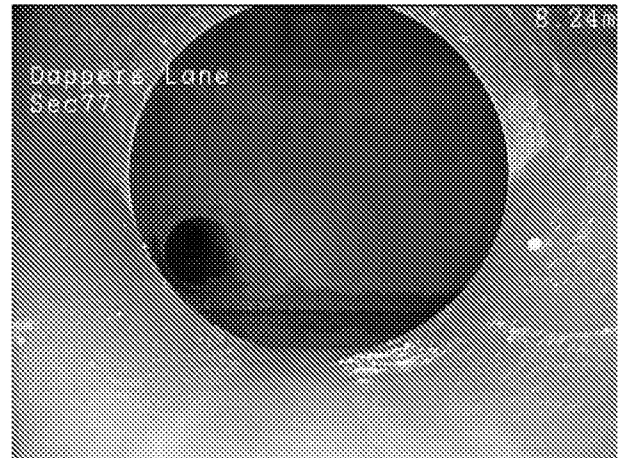
2, 00:01:14, 8.50 m  
Finish node, manhole, reference: S4

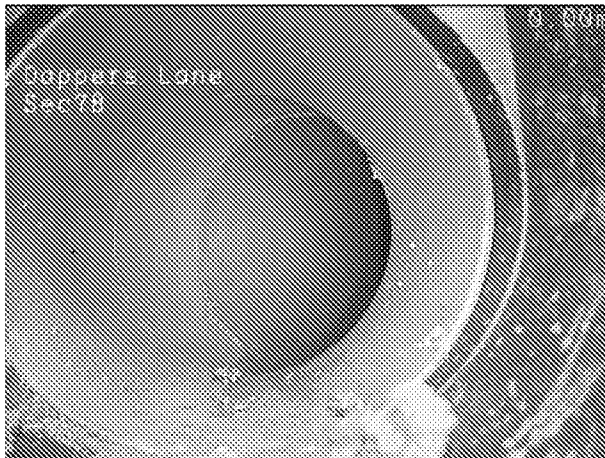
1, 00:00:00, 0.00 m  
Start node, manhole, reference: S26

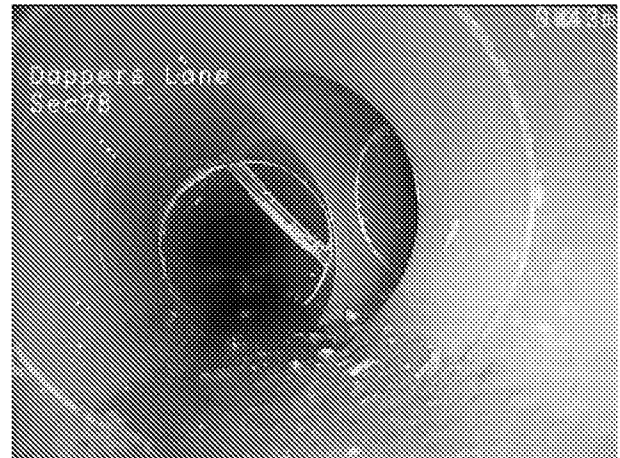
2, 00:00:17, 0.50 m  
Junction at 3 o'clock, 100mm dia

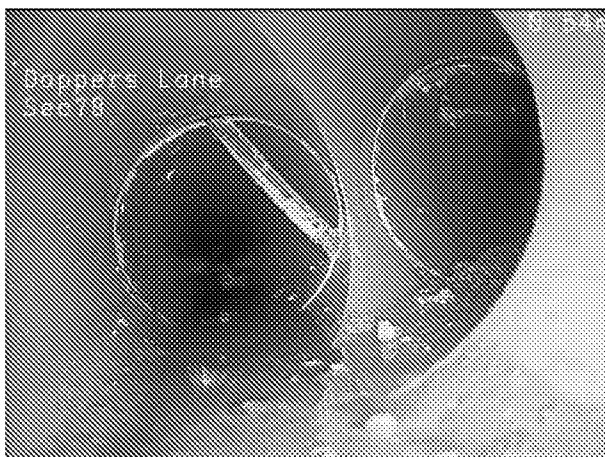
3, 00:00:22, 0.60 m  
Sealing ring intruding, loop hanging above centre from 12 o'clock to 3 o'clock

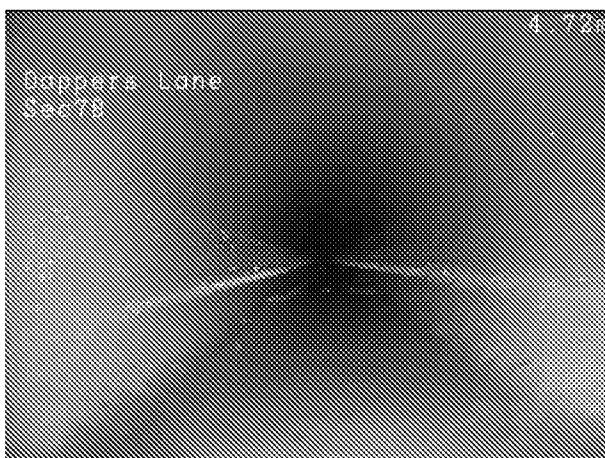
4, 00:00:47, 4.60 m  
Junction at 3 o'clock, 100mm dia
