## Section Inspection - 27/05/2021 - LDX

| Town or Village: | Angmering | Inspection Direction: | Upstream | Upstream Node: | LD |
| Road: | Dappers Lane | Inspected Length: | 14.10 m | Upstream Pipe Depth: | |

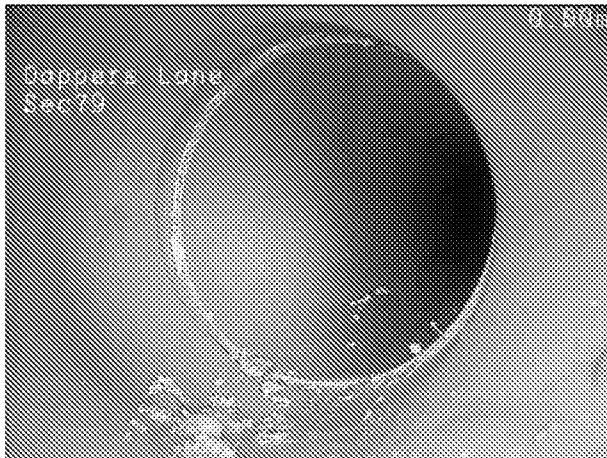
1, 00:00:00, 0.00 m  
Start node, manhole, reference: S26

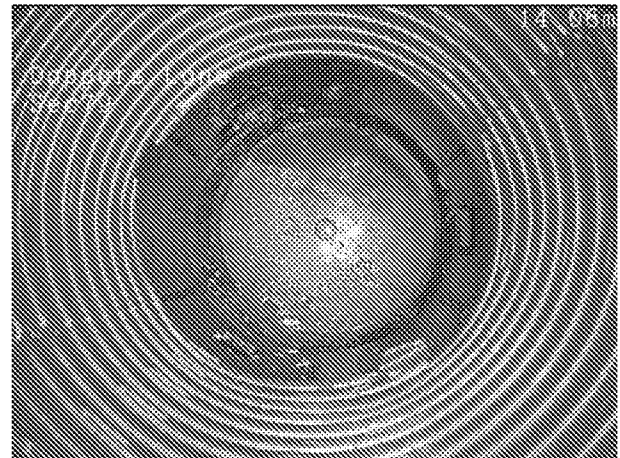
2, 00:01:03, 14.10 m  
Finish node, manhole, reference: LD, Assumed end point

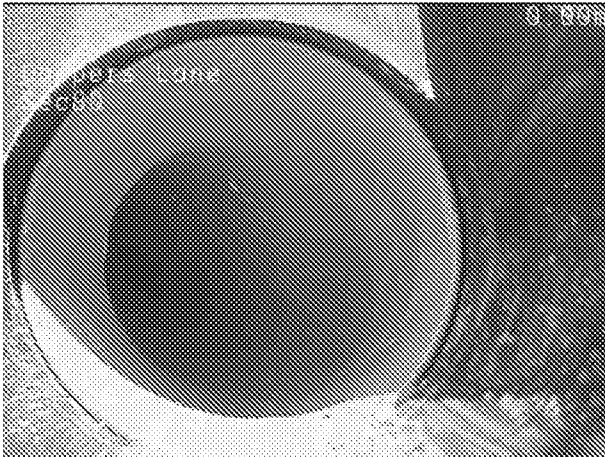
1, 00:00:01, 0.00 m  
 Water level, 0% of the vertical dimension

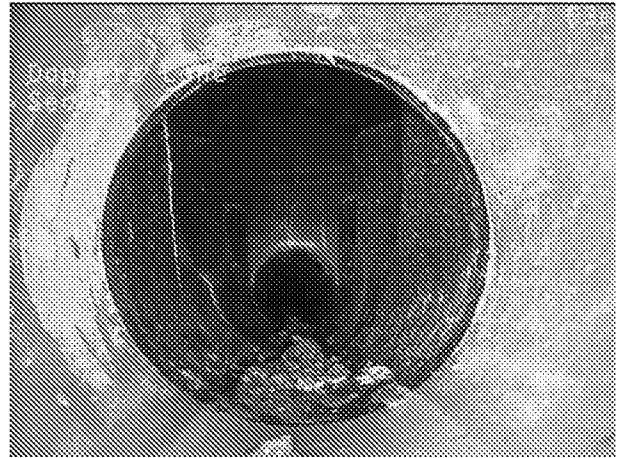
2, 00:00:34, 7.10 m  
 Finish node, manhole, reference: S27

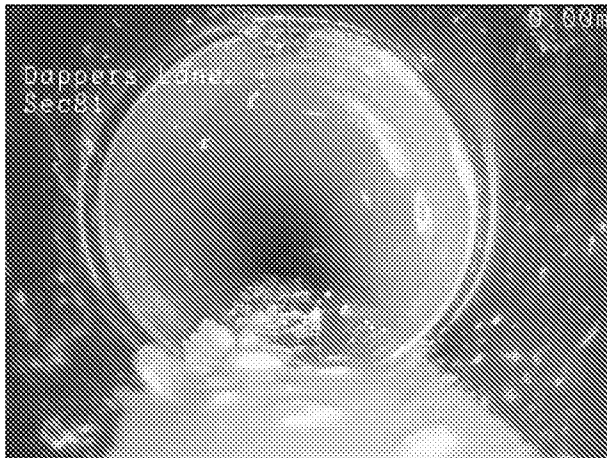
1, 00:01:10, 0.00 m  
Start node, manhole, reference: S27

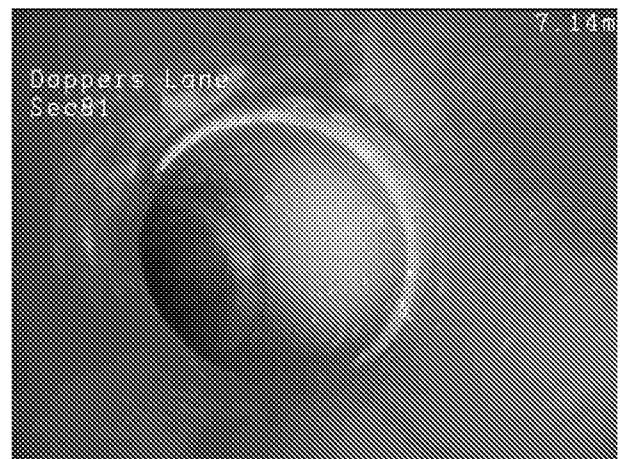
4, 00:00:23, 7.20 m  
Line deviates left

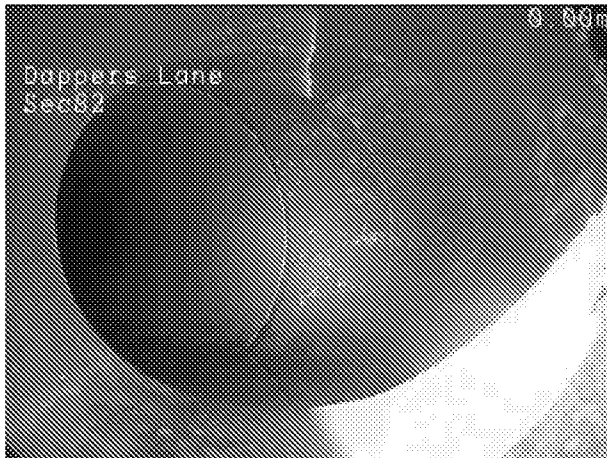
1, 00:00:00, 0.00 m  
Water level, 0% of the vertical dimension

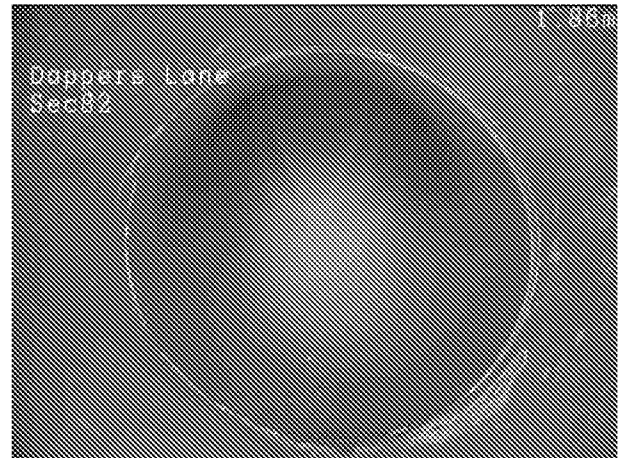
2, 00:00:19, 2.00 m  
Line deviates up

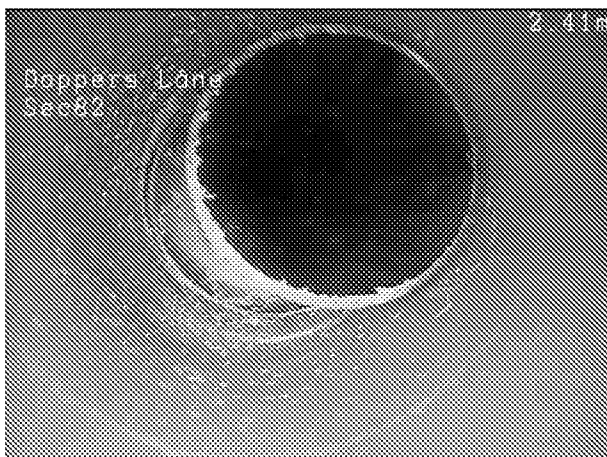
3, 00:00:30, 2.50 m  
Finish node, manhole, reference: RWP

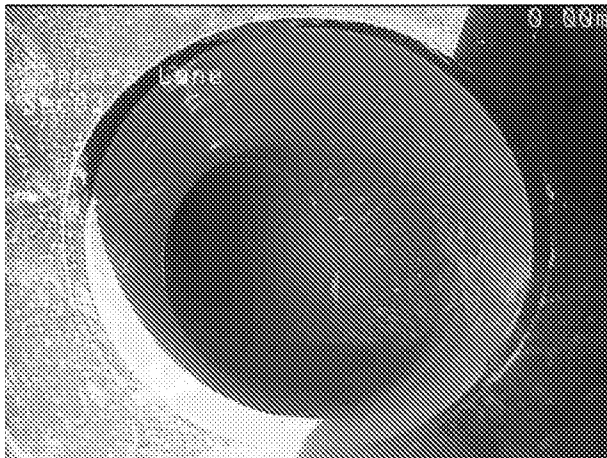
1, 00:00:00, 0.00 m  
Start node, manhole, reference: S25

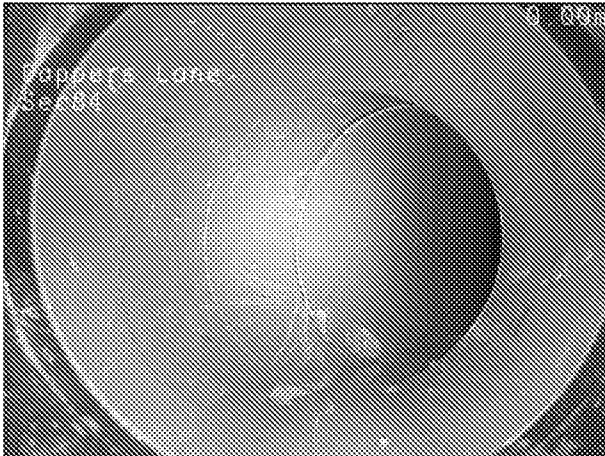
1, 00:00:08, 0.00 m  
Water level, 0% of the vertical dimension

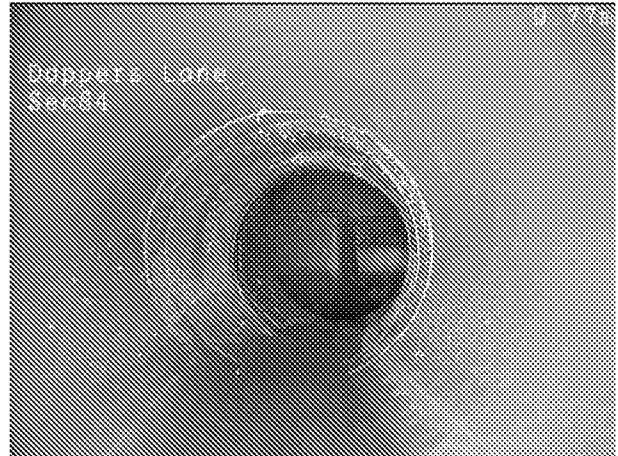
2, 00:00:43, 9.90 m  
Line deviates right

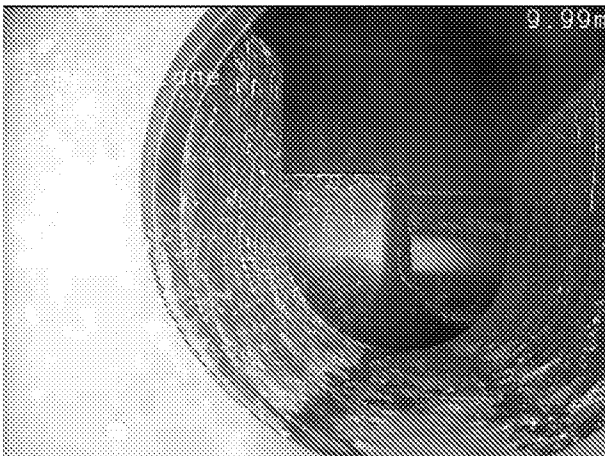
3, 00:00:46, 10.10 m  
Finish node, manhole, reference: S27

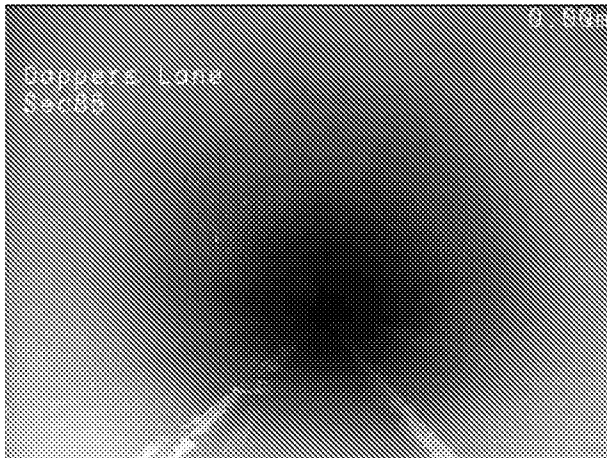
1, 00:00:00, 0.00 m  
Start node, manhole, reference: S4

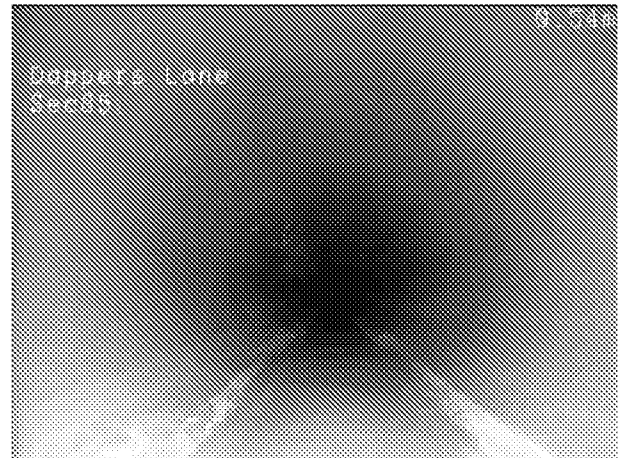
2, 00:00:10, 0.60 m  
Water level, 5% of the vertical dimension

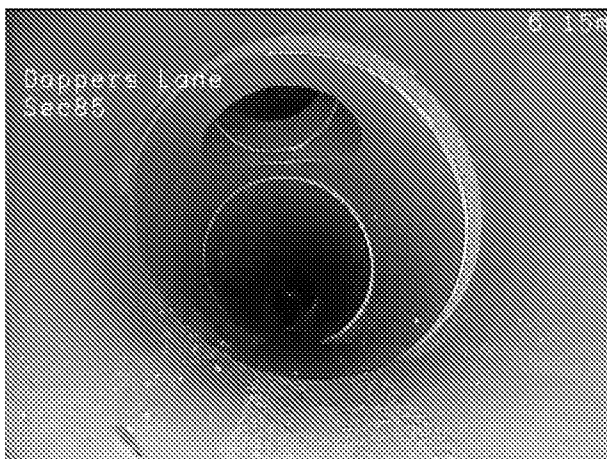
3, 00:00:35, 6.40 m  
Junction at 12 o'clock, 100mm dia

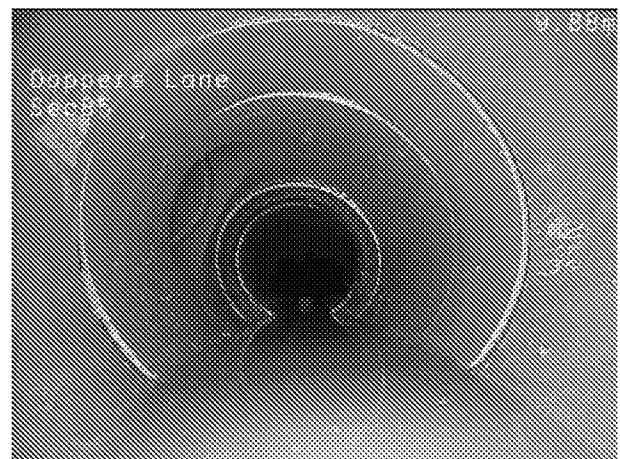
4, 00:00:55, 10.00 m  
Water level, 10% of the vertical dimension

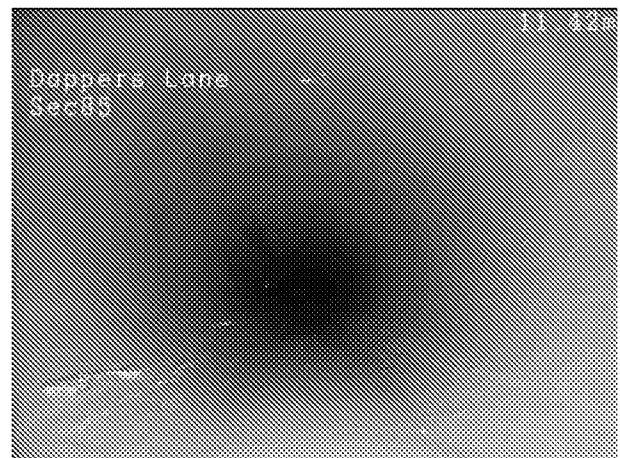
6, 00:01:13, 11.40 m  
Water level, 5% of the vertical dimension

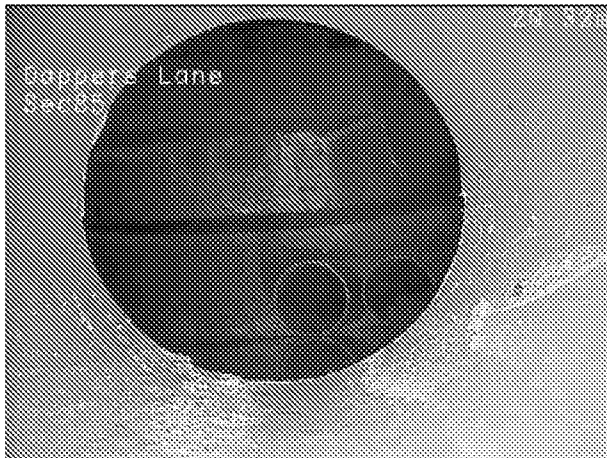
7, 00:01:45, 20.50 m  
Finish node, manhole, reference: S3

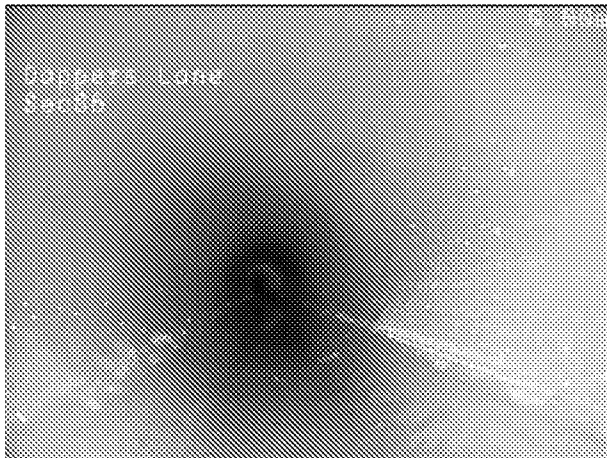
1, 00:00:00, 0.00 m  
Start node, manhole, reference: S29

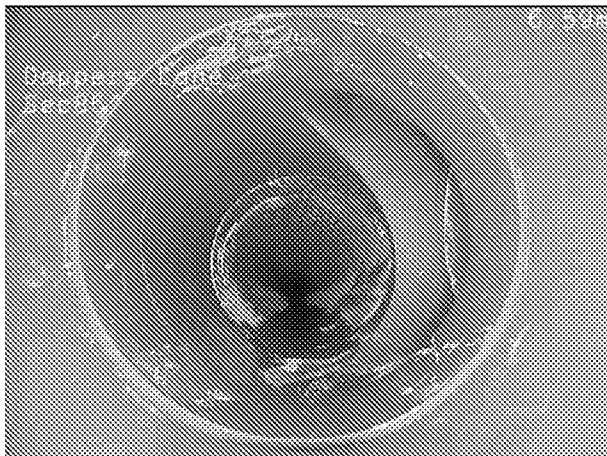
3, 00:00:35, 6.70 m  
Junction at 3 o'clock, 100mm dia

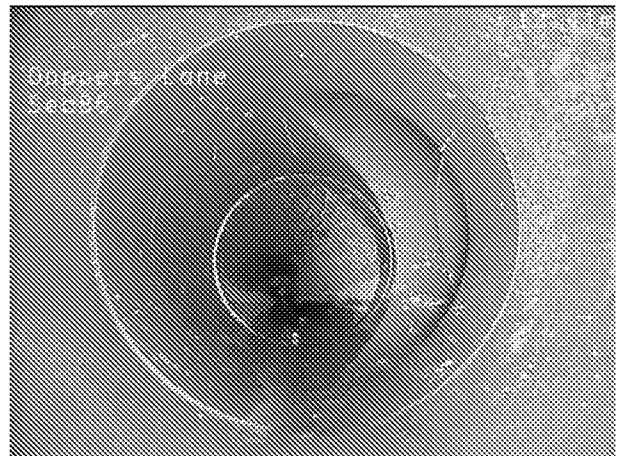
4, 00:00:53, 12.50 m  
Junction at 3 o'clock, 100mm dia

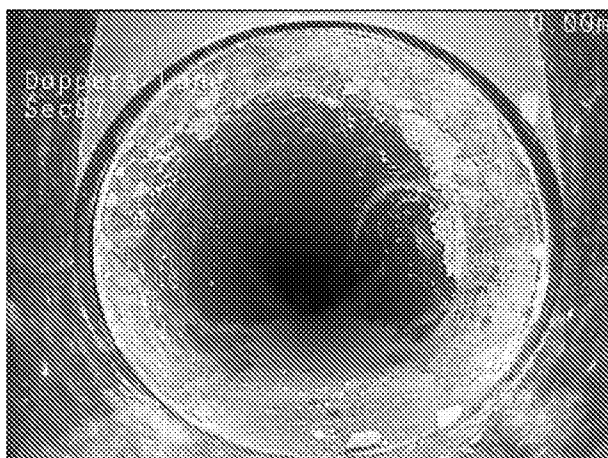
1, 00:00:00, 0.00 m  
Start node, manhole, reference: S29

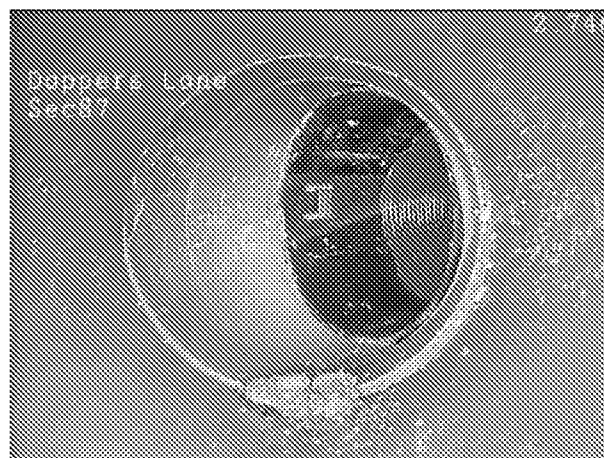
2, 00:00:22, 2.80 m  
Line deviates right

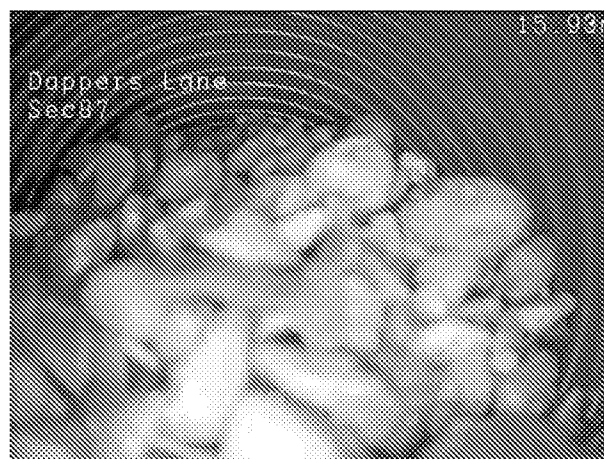
4, 00:00:59, 16.00 m  
Finish node, manhole, reference: LD, Assumed end point

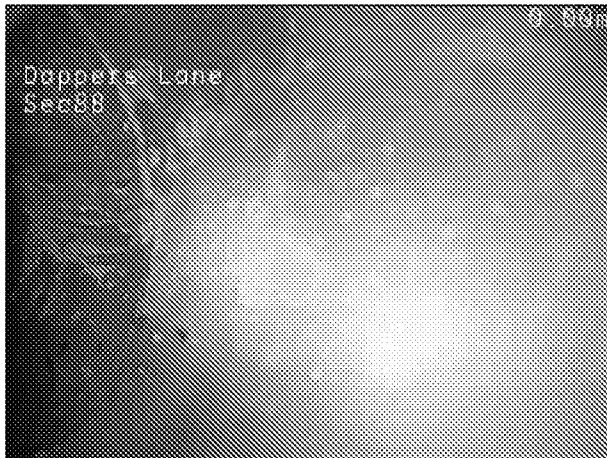
1, 00:00:00, 0.00 m  
Start node, manhole, reference: S29

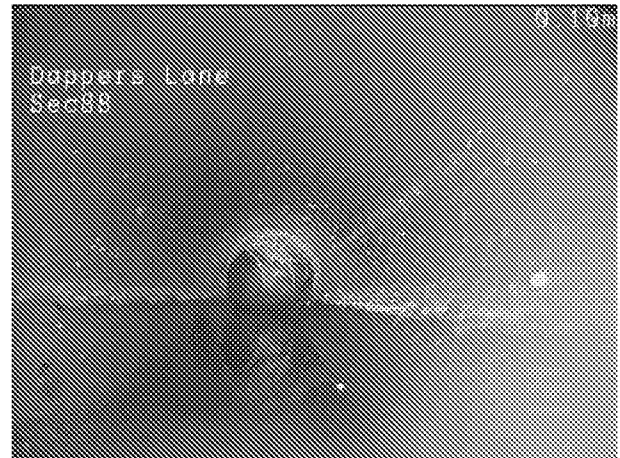
2, 00:00:13, 0.10 m  
Water level, 5% of the vertical dimension

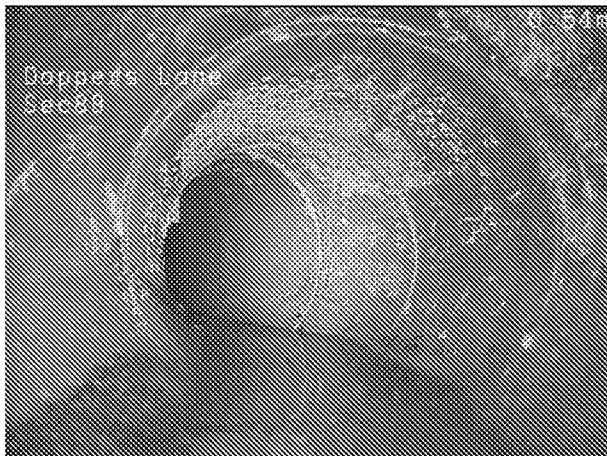
3, 00:00:18, 0.60 m  
Line deviates left

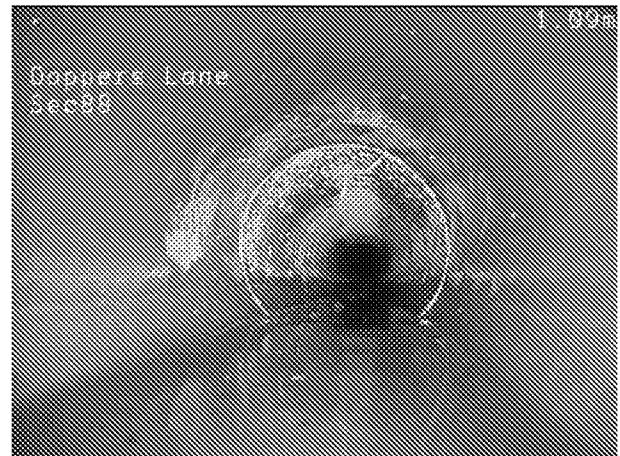
4, 00:00:23, 1.10 m  
Water level, 10% of the vertical dimension

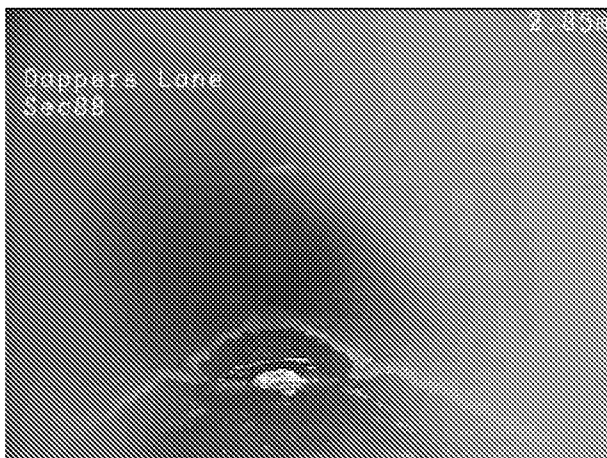
5, 00:00:35, 2.80 m  
Water level, 5% of the vertical dimension

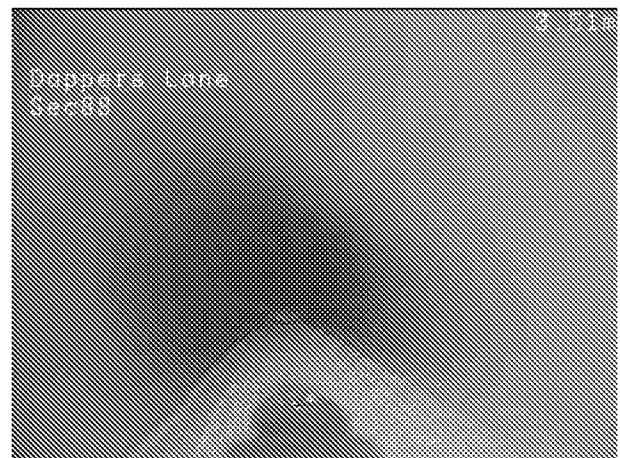
6, 00:00:38, 3.50 m  
Water level, 0% of the vertical dimension

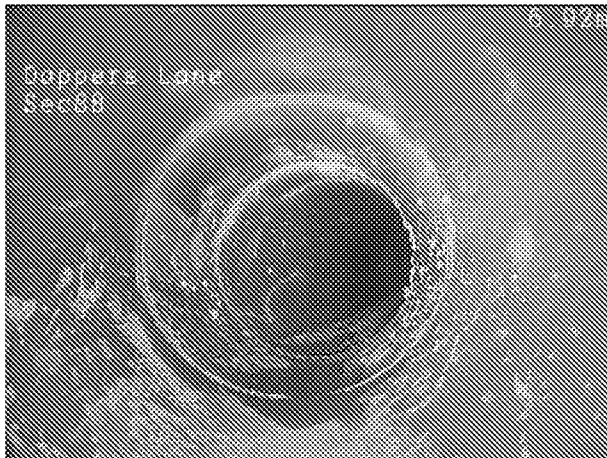
7, 00:00:51, 7.00 m  
Line deviates right

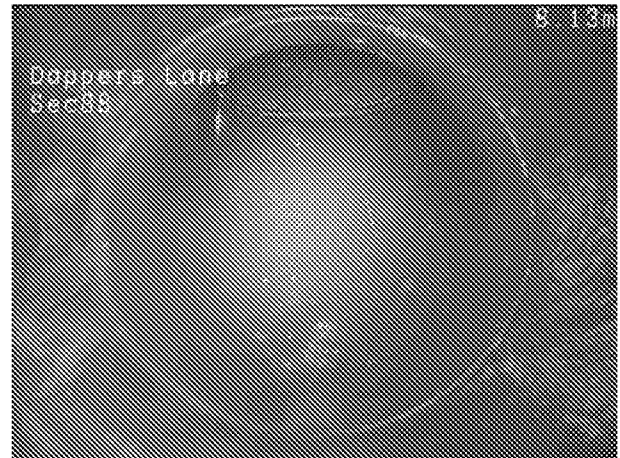
8, 00:00:55, 8.20 m  
Line deviates up

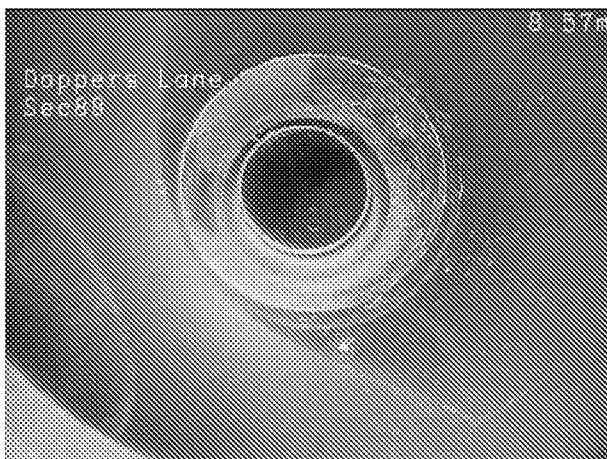
9, 00:01:09, 8.60 m  
Finish node, manhole, reference: RWP

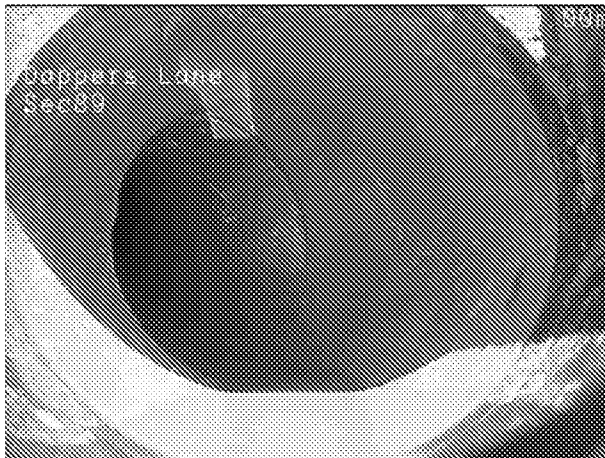
1, 00:00:00, 0.00 m  
Start node, manhole, reference: S29

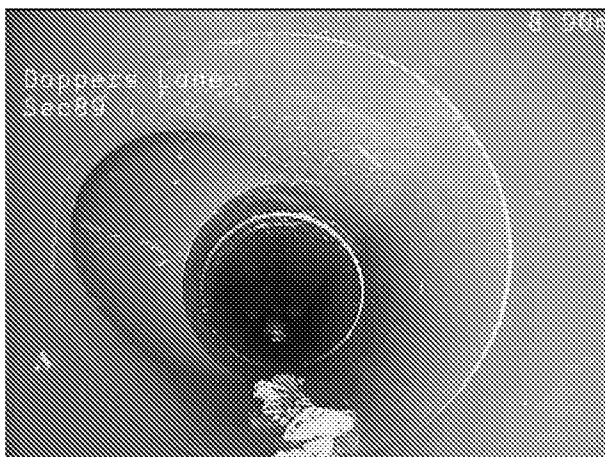
3, 00:00:36, 9.00 m  
Junction at 10 o'clock, 100mm dia

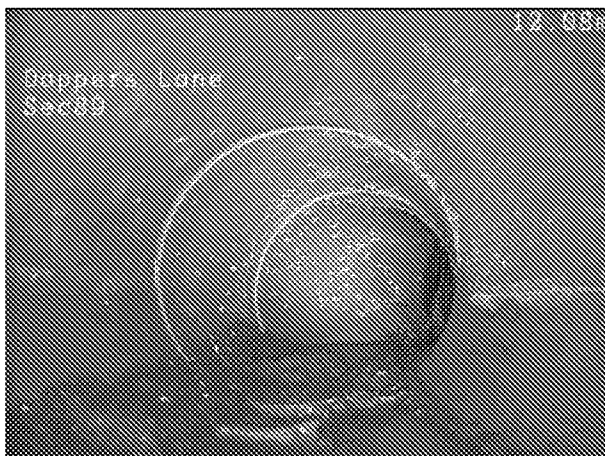
5, 00:00:57, 12.20 m  
Line deviates right

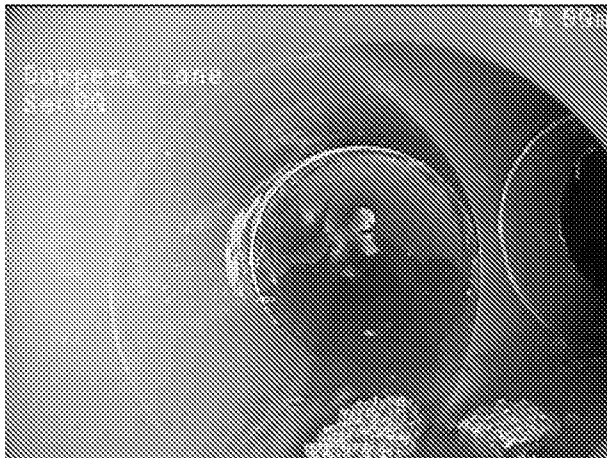
1, 00:00:11, 0.00 m  
Water level, 0% of the vertical dimension

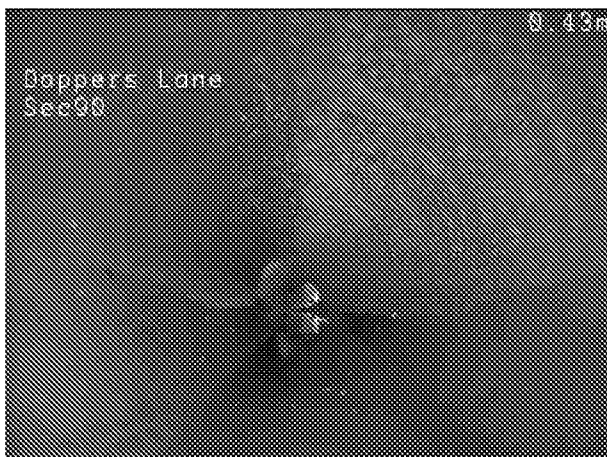
3, 00:00:21, 0.40 m  
Water level, 5% of the vertical dimension

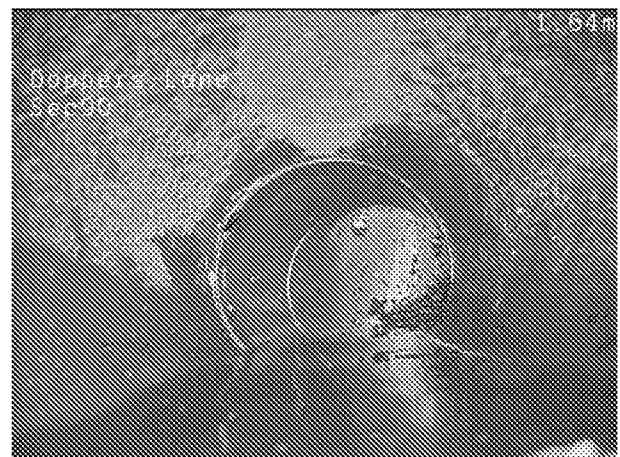
4, 00:00:32, 1.60 m  
Water level, 10% of the vertical dimension

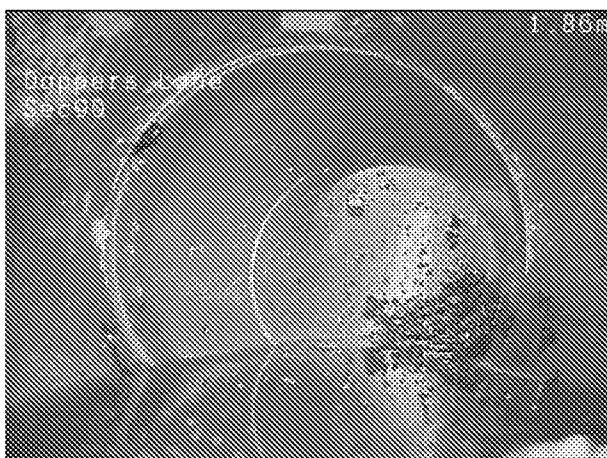
5, 00:00:35, 1.90 m  
Line deviates right

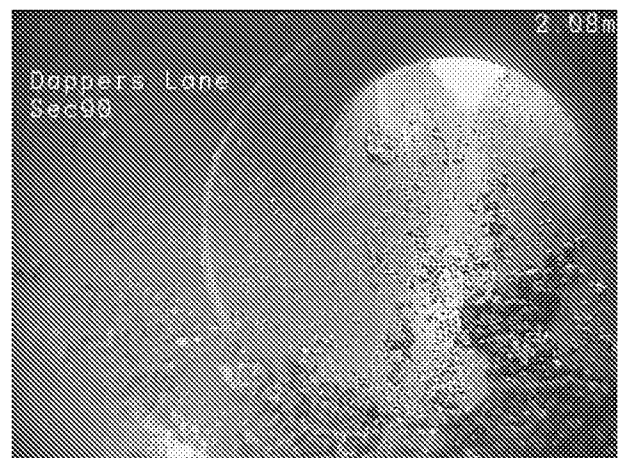
6, 00:01:15, 2.20 m  
Line deviates up

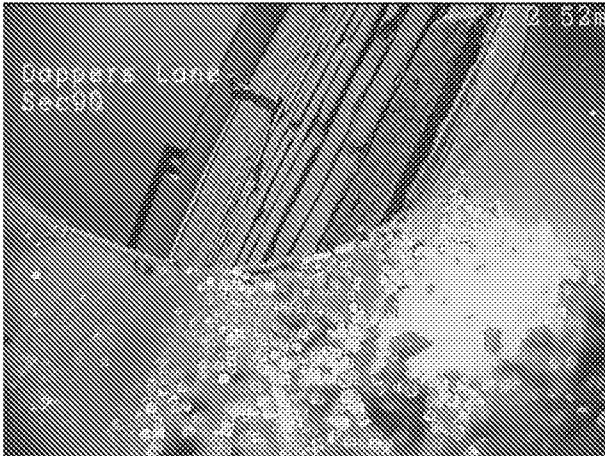
7, 00:01:03, 2.60 m  
Finish node, manhole, reference: RWP

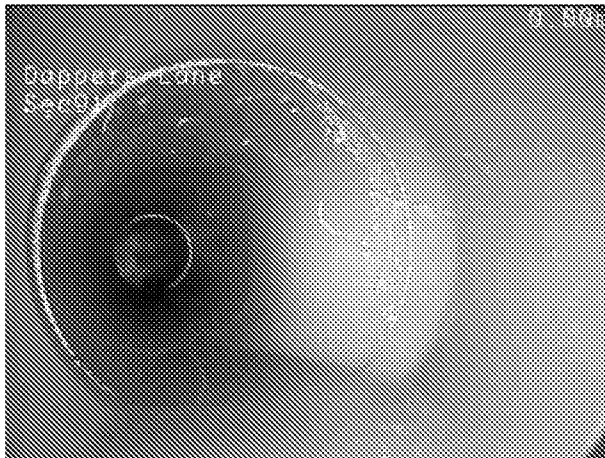
1, 00:00:05, 0.00 m  
Water level, 0% of the vertical dimension

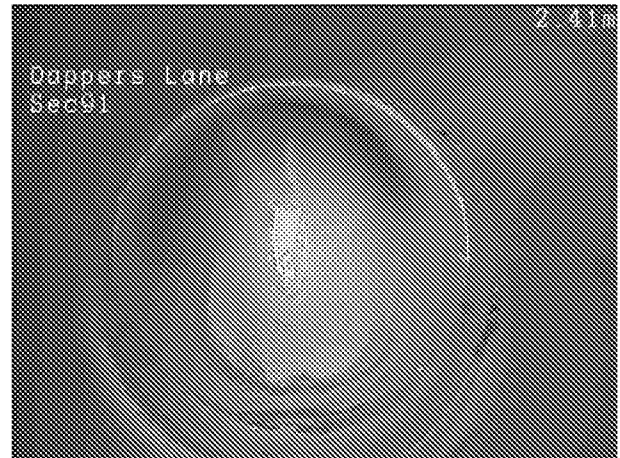
2, 00:00:26, 2.50 m  
Line deviates up

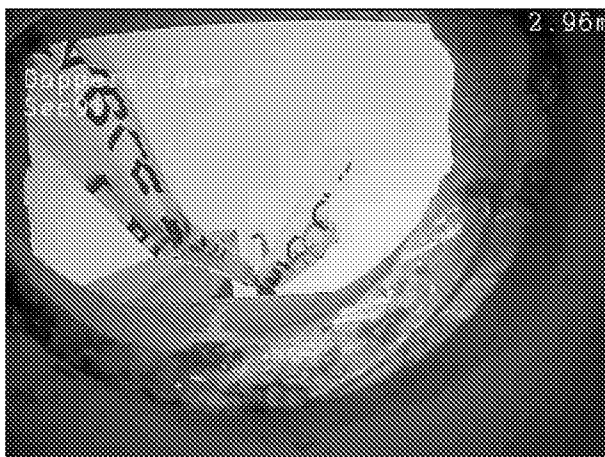
3, 00:00:33, 3.10 m  
Finish node, manhole, reference: ACO

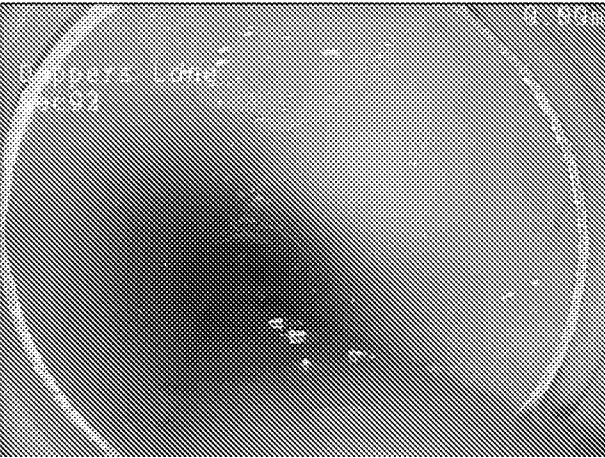
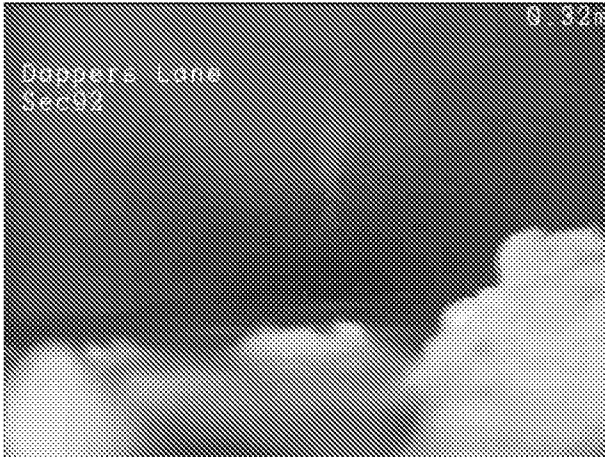
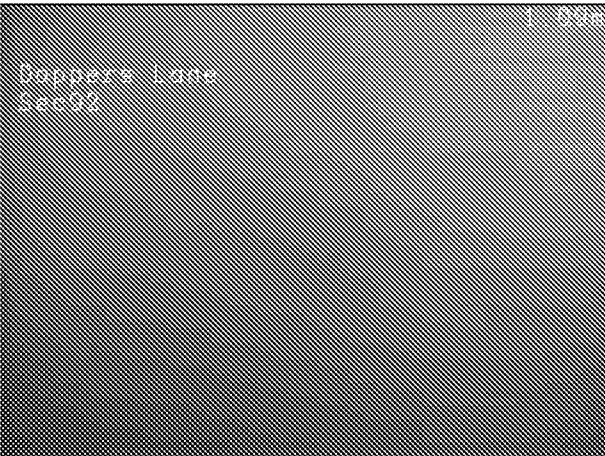
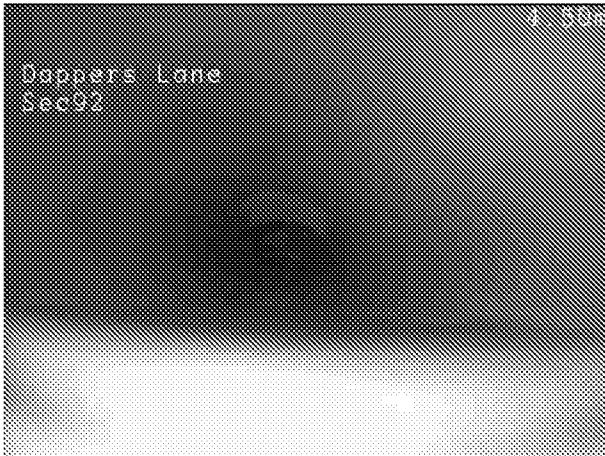
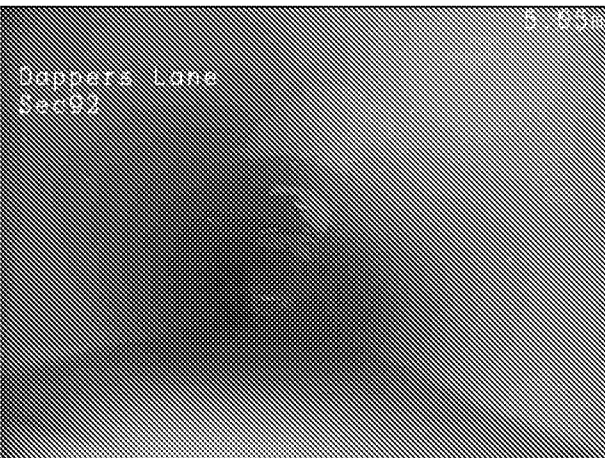
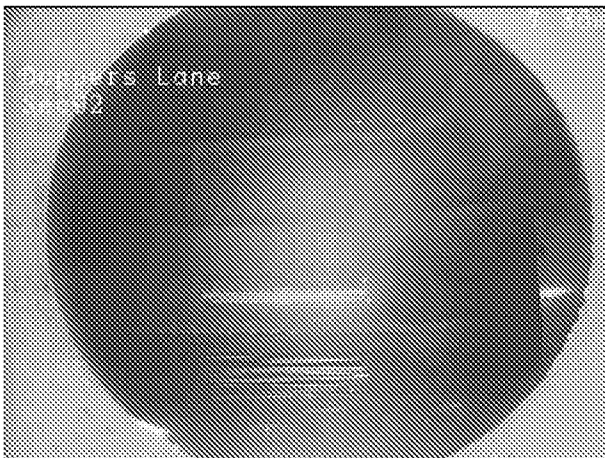
| 1, 00:00:00, 0.00 m<br>Start node, manhole, reference: S31 | 2, 00:00:09, 0.30 m<br>Water level, 30% of the vertical dimension |
| 3, 00:00:11, 1.00 m<br>Loss of vision, camera under water | 4, 00:00:27, 4.50 m<br>Water level, 30% of the vertical dimension |
| 5, 00:00:46, 5.00 m<br>Water level, 10% of the vertical dimension | 6, 00:01:03, 7.40 m<br>Finish node, manhole, reference: S3, Not accessible |

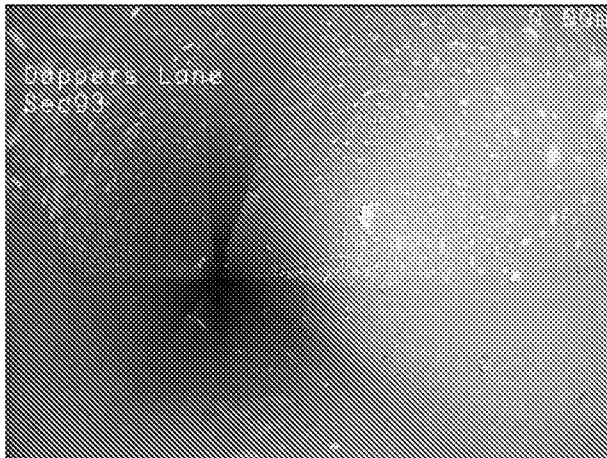
1, 00:00:00, 0.00 m  
Start node, manhole, reference: S31

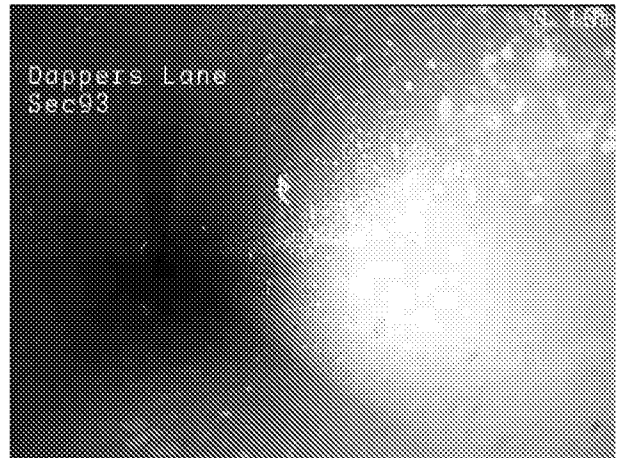
2, 00:00:07, 0.10 m  
Water level, 5% of the vertical dimension

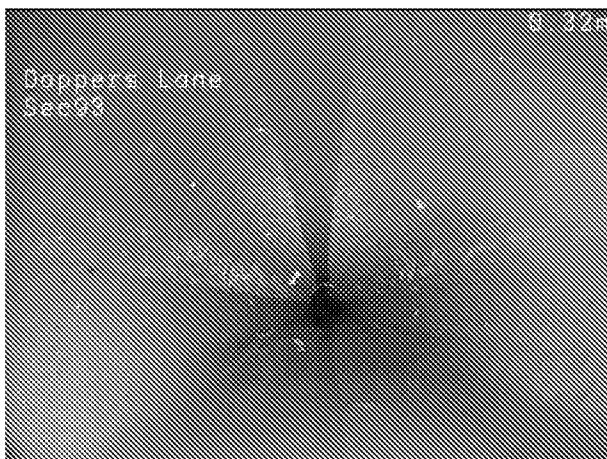
3, 00:00:14, 0.30 m  
Water level, 10% of the vertical dimension

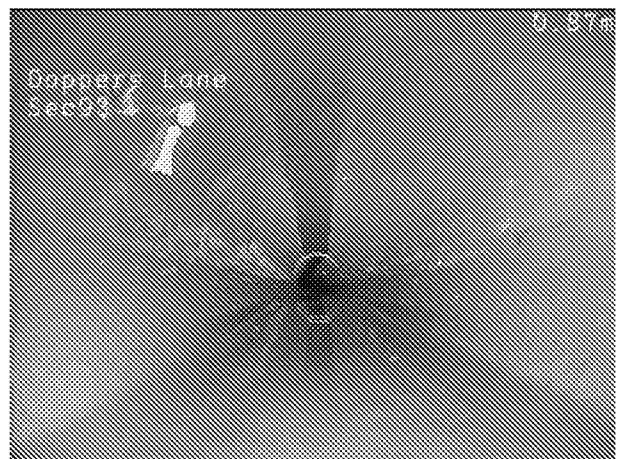
4, 00:00:20, 0.90 m  
Water level, 15% of the vertical dimension

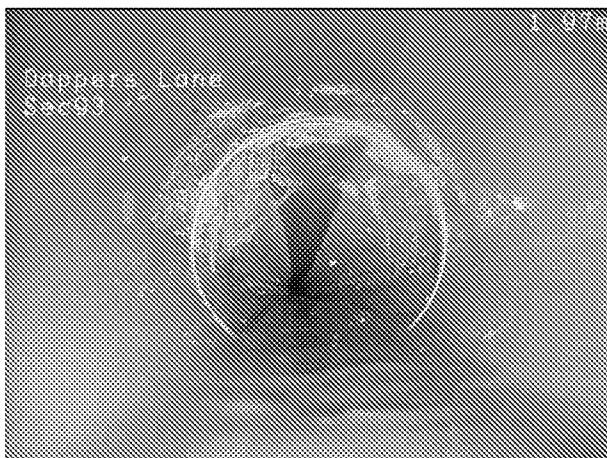
5, 00:00:28, 2.00 m  
Water level, 10% of the vertical dimension

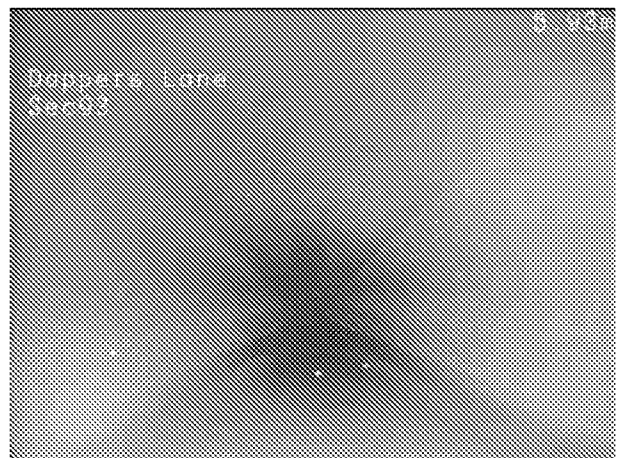
6, 00:00:44, 6.00 m  
Water level, 5% of the vertical dimension

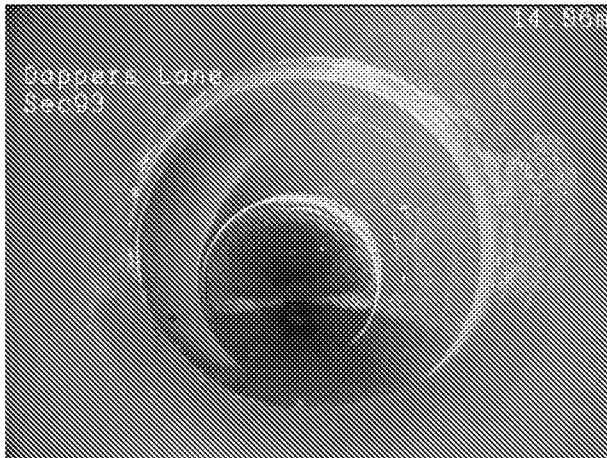
7, 00:01:01, 14.20 m  
Junction at 9 o'clock, 100mm dia

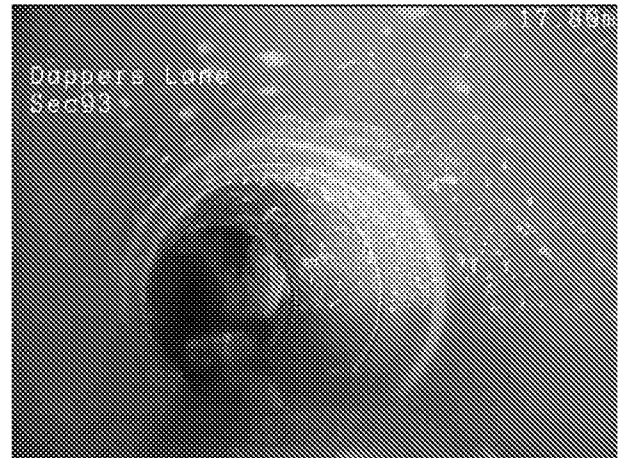
8, 00:01:16, 17.90 m  
Line deviates left

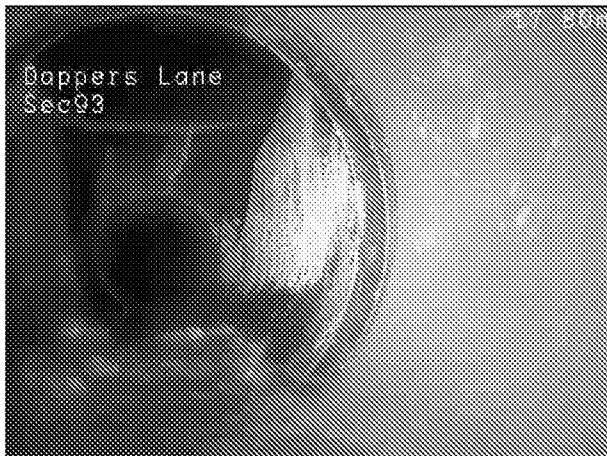
9, 00:01:22, 18.00 m  
Finish node, manhole, reference: S14

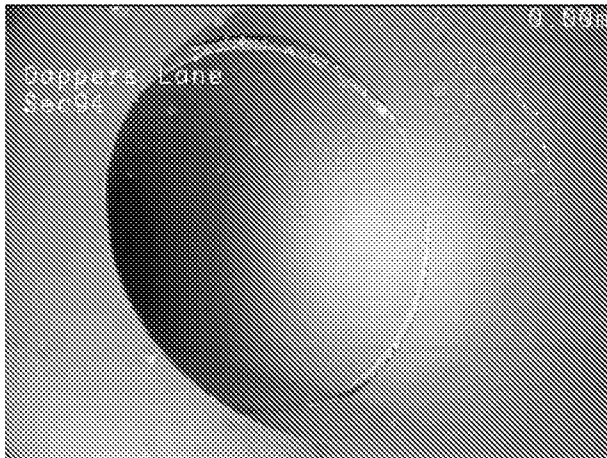
1, 00:00:09, 0.00 m  
Water level, 0% of the vertical dimension

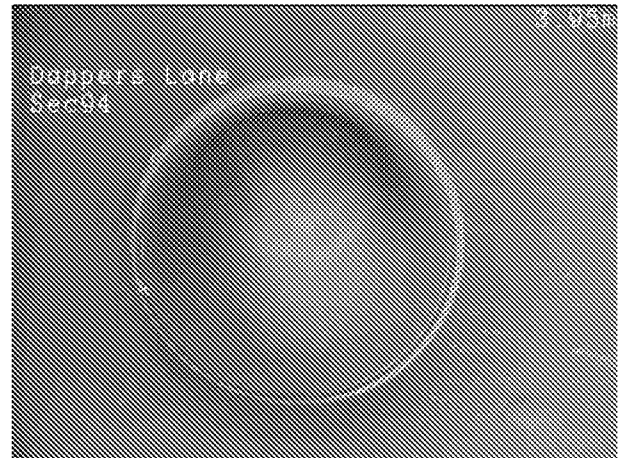
2, 00:00:32, 4.10 m  
Line deviates up

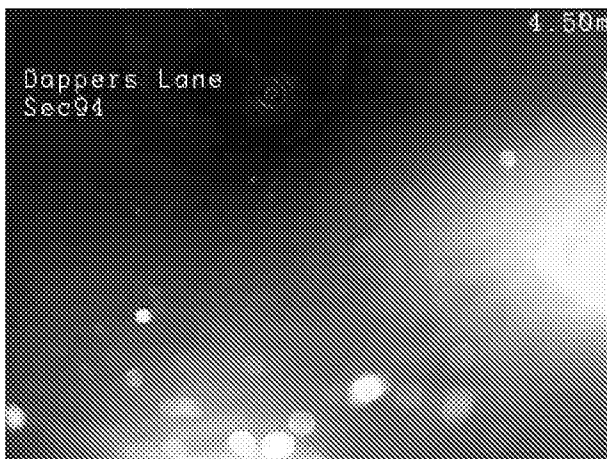
3, 00:00:37, 4.50 m  
Finish node, manhole, reference: RWP

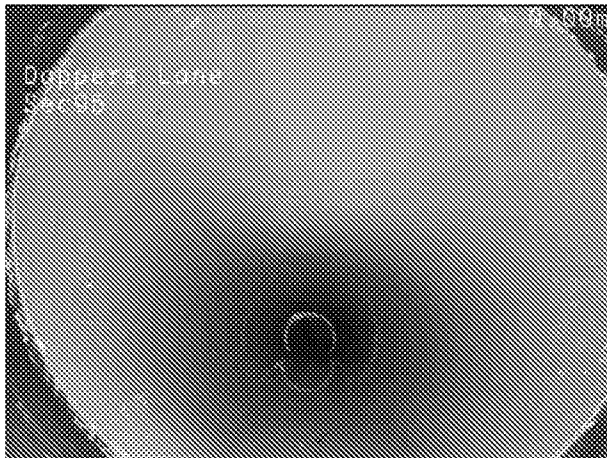
1, 00:00:04, 0.00 m  
Water level, 5% of the vertical dimension

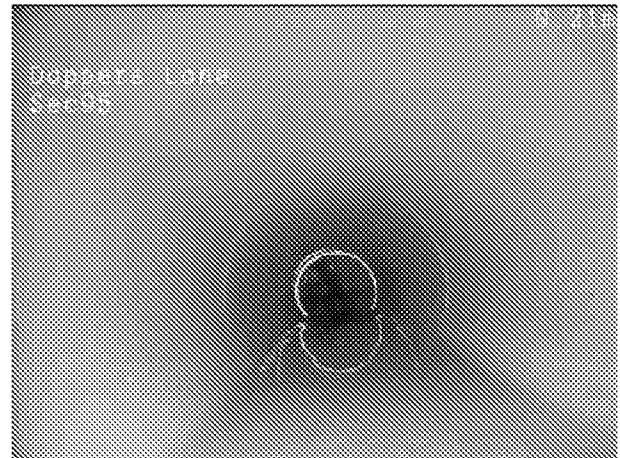
2, 00:00:11, 0.20 m  
Water level, 10% of the vertical dimension

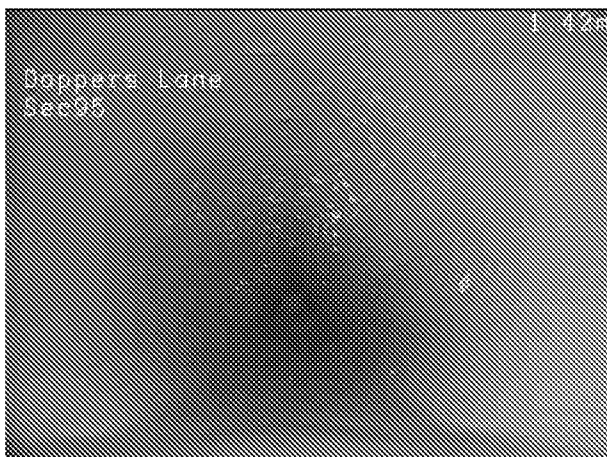
3, 00:00:27, 1.50 m  
Water level, 5% of the vertical dimension

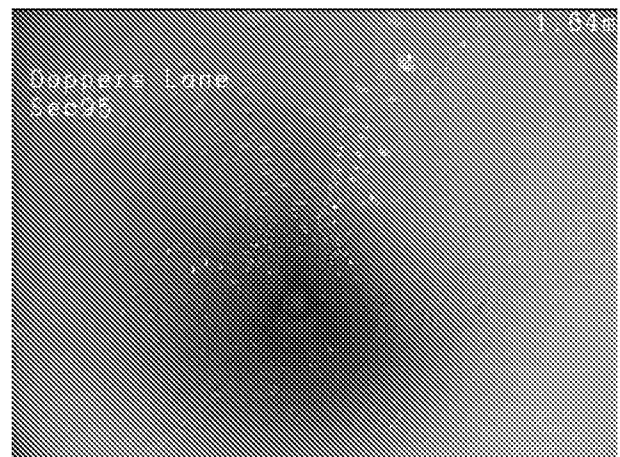
4, 00:00:32, 1.60 m  
Water level, 0% of the vertical dimension

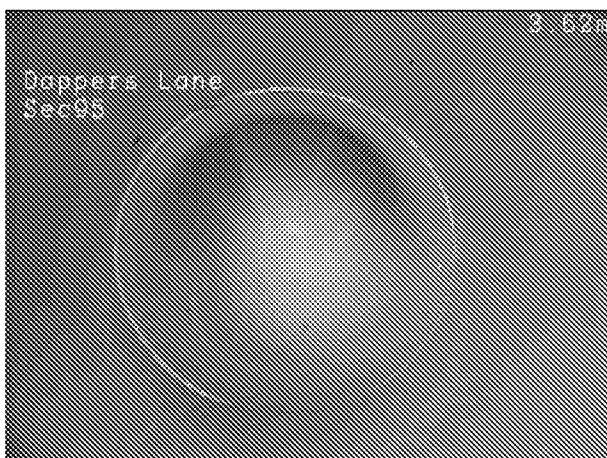
5, 00:00:43, 3.70 m  
Line deviates up

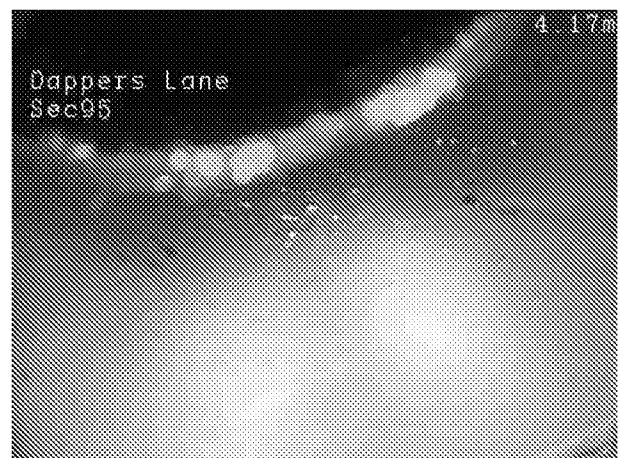
6, 00:00:48, 4.20 m  
Finish node, manhole, reference: RWP2

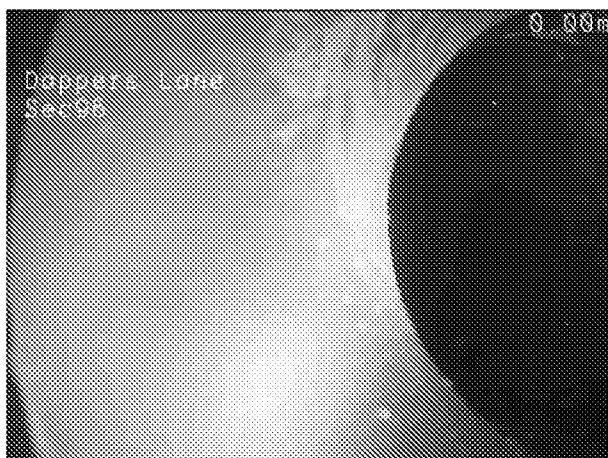
1, 00:00:00, 0.00 m  
Start node, manhole, reference: S32

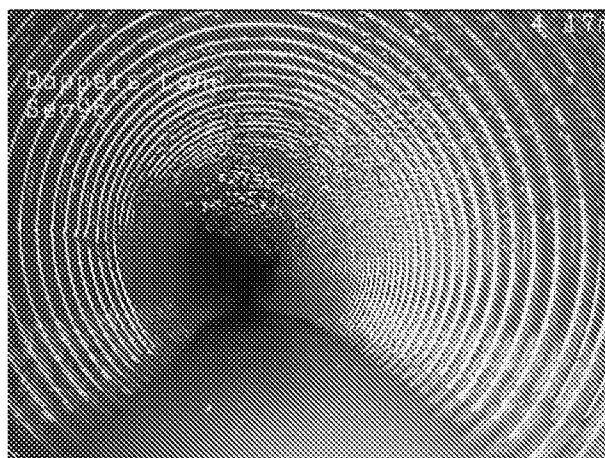
2, 00:00:40, 4.10 m  
Water level, 5% of the vertical dimension

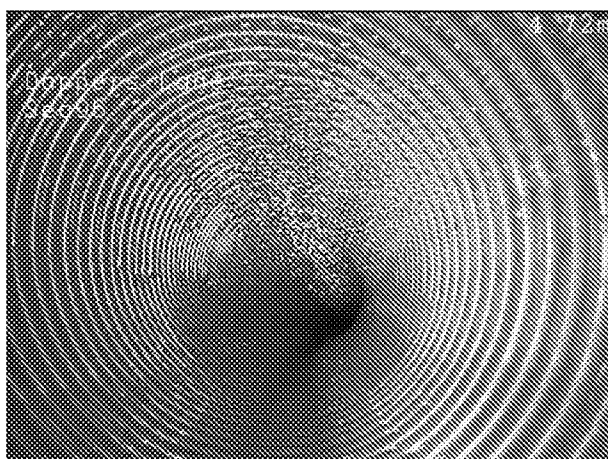
3, 00:00:45, 4.70 m  
Water level, 0% of the vertical dimension

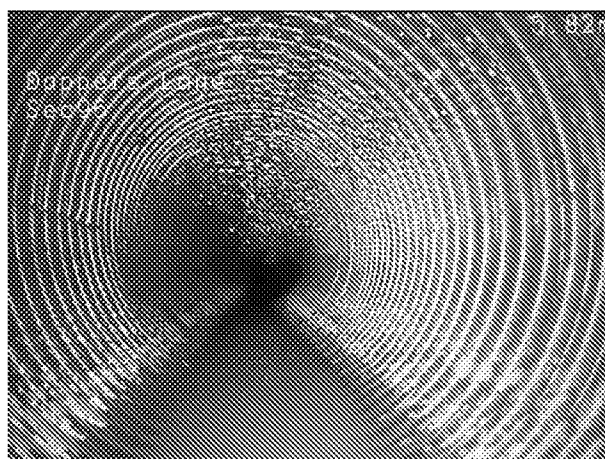
4, 00:00:52, 5.80 m  
Water level, 5% of the vertical dimension

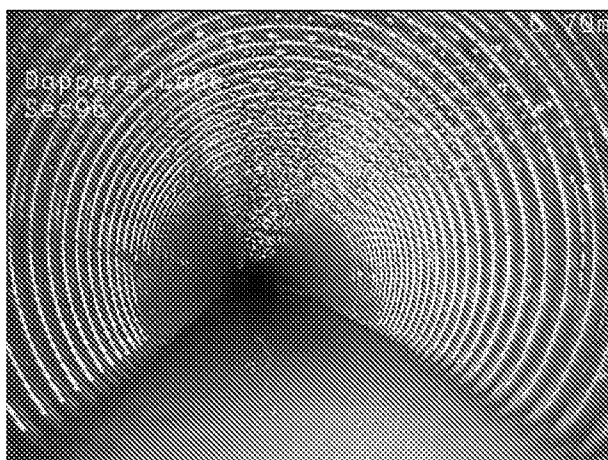
5, 00:00:58, 6.70 m  
Water level, 10% of the vertical dimension

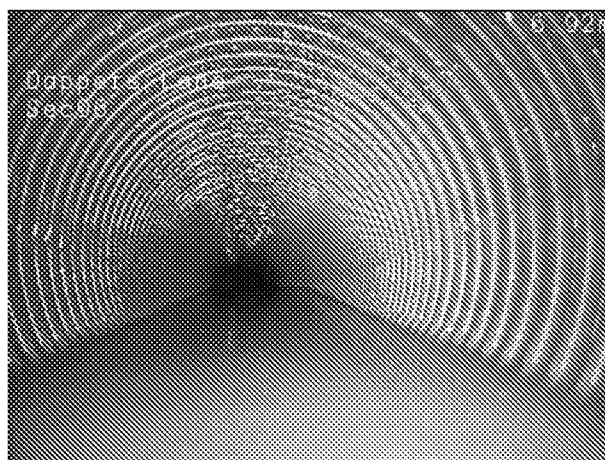
6, 00:01:02, 6.90 m  
Water level, 30% of the vertical dimension

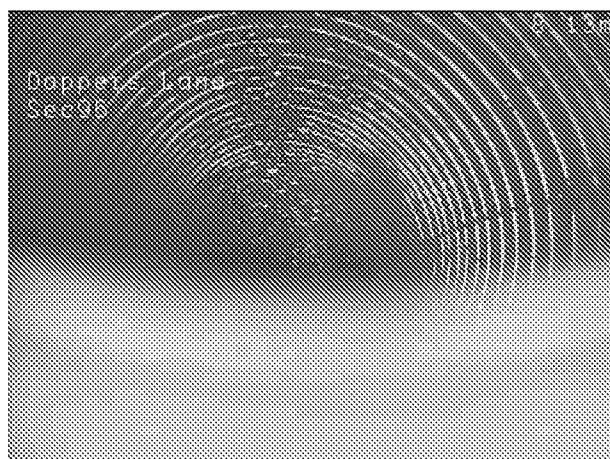
9, 00:01:16, 8.10 m  
Water level, 50% of the vertical dimension

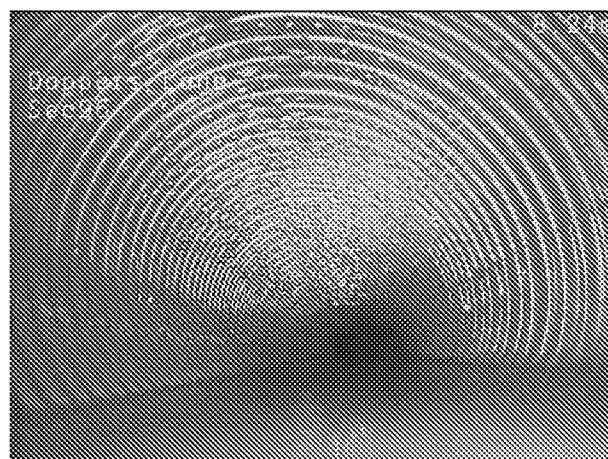
10, 00:01:23, 8.20 m  
Water level, 30% of the vertical dimension
