## Section Inspection - 27/05/2021 - LDX

| Town or Village: | Angmering | Inspection Direction: | Upstream | Upstream Node: | LD |
| Road: | Dappers Lane | Inspected Length: | 14.10 m | Upstream Pipe Depth: | |

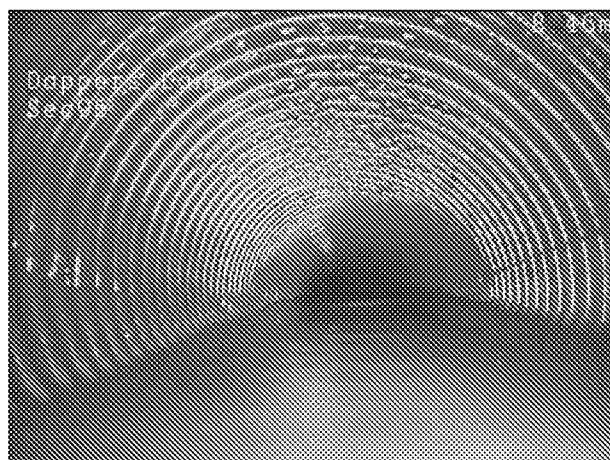
11, 00:01:25, 8.50 m  
Water level, 50% of the vertical dimension

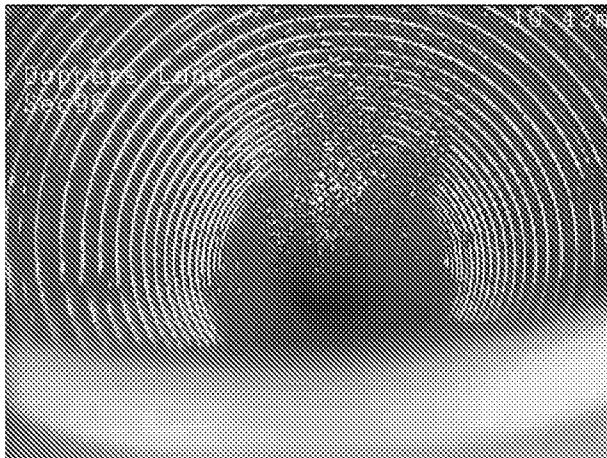
13, 00:01:54, 10.40 m  
Water level, 30% of the vertical dimension

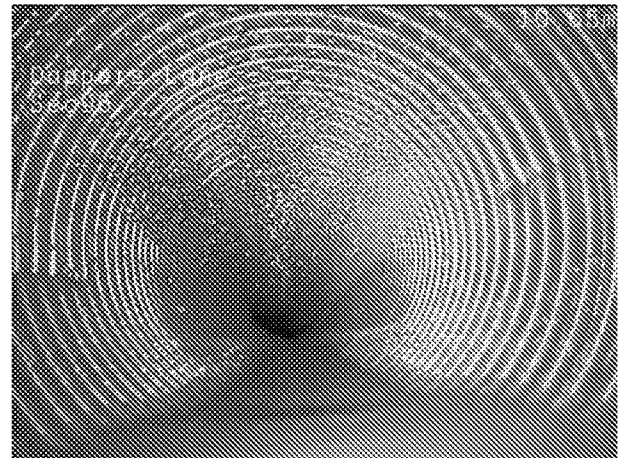
14, 00:01:59, 10.60 m  
Water level, 10% of the vertical dimension

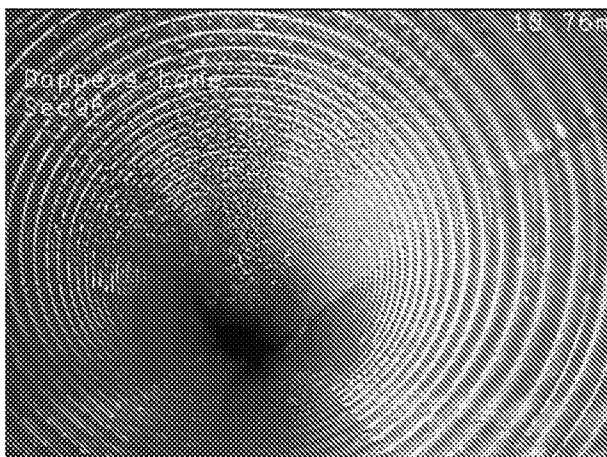
15, 00:02:02, 10.80 m  
Water level, 0% of the vertical dimension

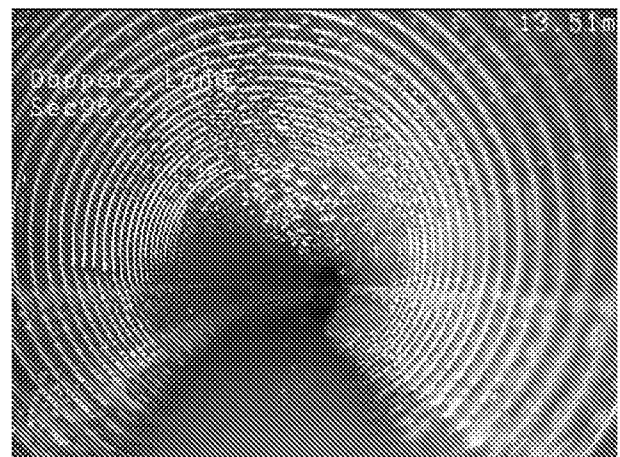
16, 00:02:12, 13.50 m  
Water level, 5% of the vertical dimension

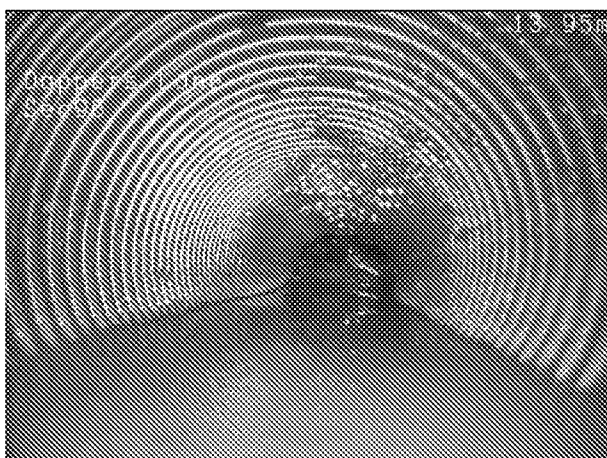
17, 00:02:17, 14.00 m  
Water level, 20% of the vertical dimension

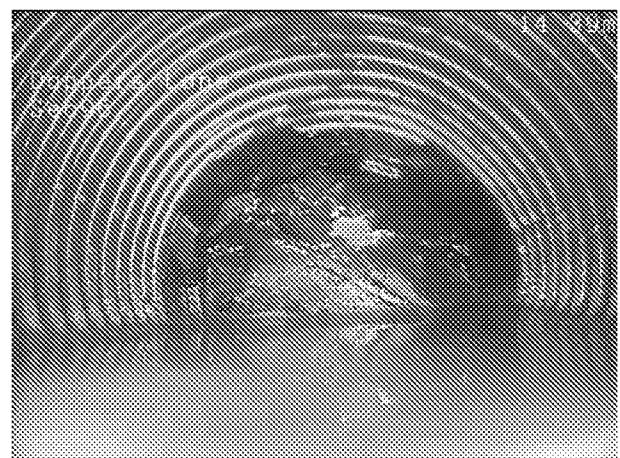
18, 00:02:30, 14.50 m  
Finish node, manhole, reference: Land Drain, Assumed end point

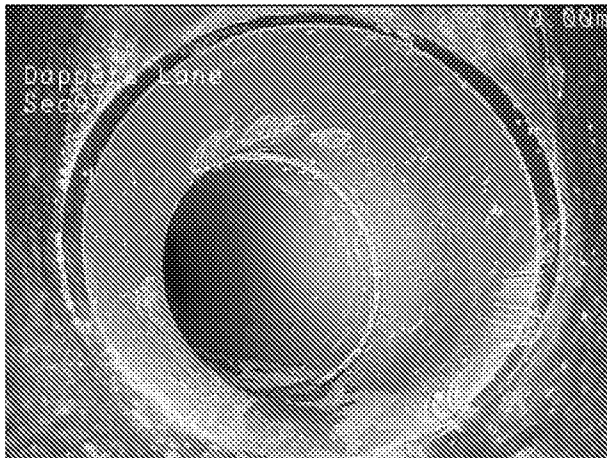
1, 00:00:00, 0.00 m  
Start node, manhole, reference: S32

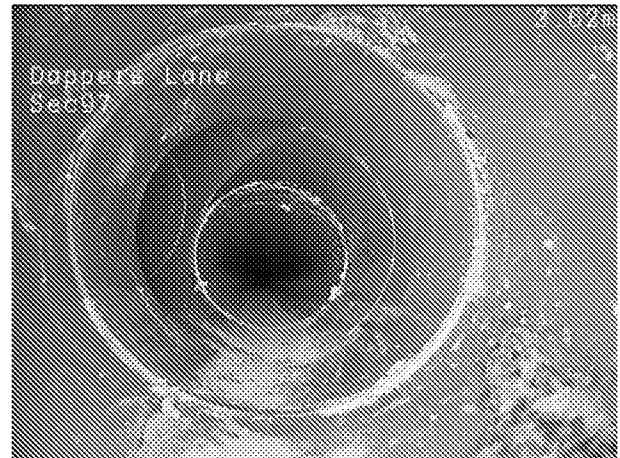
2, 00:00:18, 3.60 m  
Junction at 9 o'clock, 100mm dia

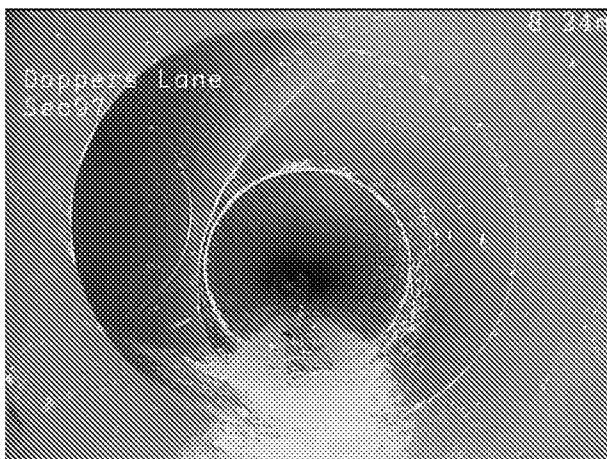
3, 00:00:31, 8.30 m  
Junction at 9 o'clock, 100mm dia

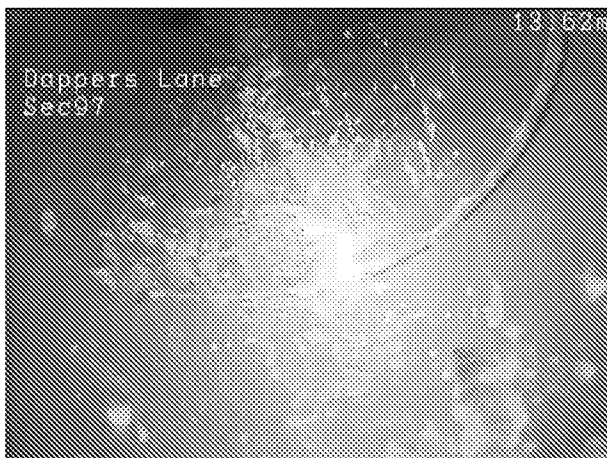
5, 00:00:47, 13.60 m  
Line deviates up

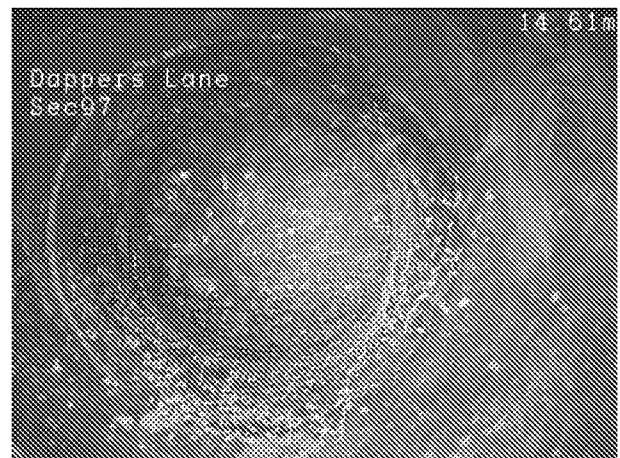
6, 00:00:54, 14.60 m  
Finish node, manhole, reference: RE14
