## Section Inspection - 28/05/2021 - RWPX

| Town or Village: | Angmering | Inspection Direction: | Upstream | Upstream Node: | RWP |
| Road: | Dappers Lane | Inspected Length: | 1.40 m | Upstream Pipe Depth: | |

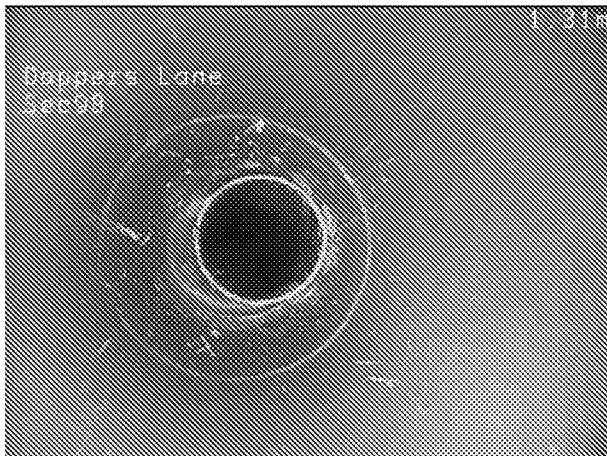
3, 00:00:16, 1.40 m  
Finish node, manhole, reference: RWP

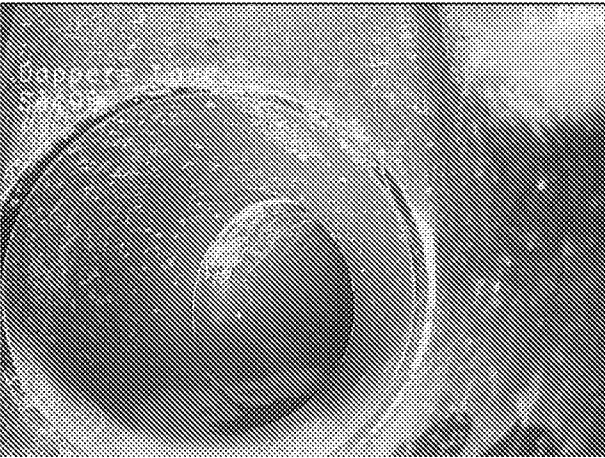
| <p>1, 00:00:00, 0.00 m<br/>Start node, manhole, reference: S32</p> | <p>2, 00:00:06, 0.20 m<br/>Line deviates right</p> |

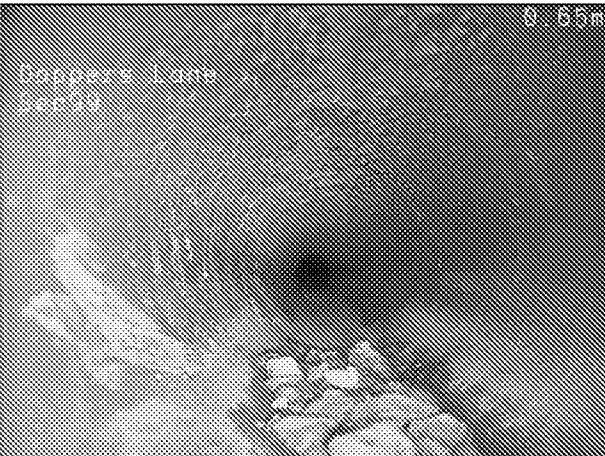
| Scale: 1:109 | Position [m] | Code | Observation | Grade |
|---|---|---|---|---|
| 0.60 | | DER | Settled deposits, coarse, 10% cross-sectional area loss | 3 |

| <p>3, 00:00:12, 0.60 m<br/>Settled deposits, coarse, 10% cross-sectional area loss</p> | <p>4, 00:00:17, 1.60 m<br/>Junction at 3 o'clock, 100mm dia</p> |

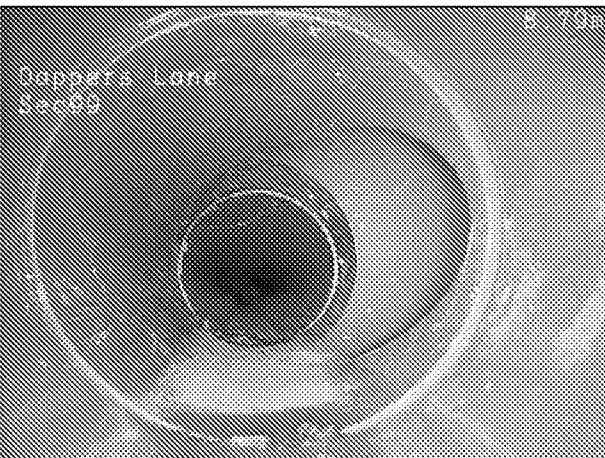
| <p>5, 00:00:33, 8.90 m<br/>Junction at 3 o'clock, 100mm dia</p> | <p>6, 00:00:44, 12.60 m<br/>Finish node, manhole, reference: S32A</p> |

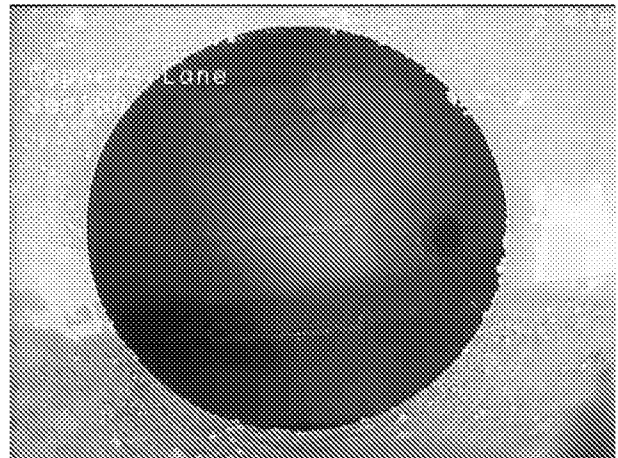
2, 00:00:18, 2.30 m  
Finish node, manhole, reference: S6

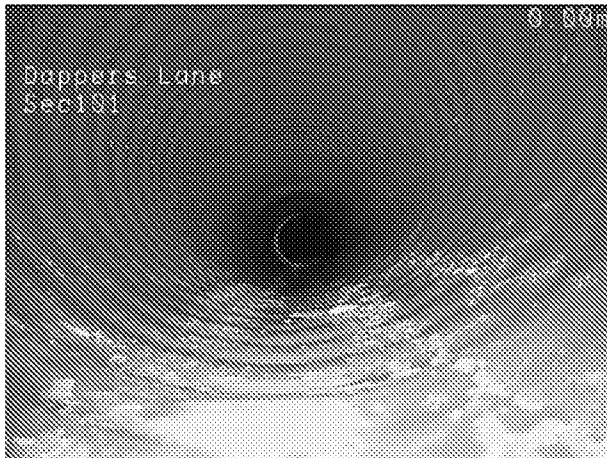
1, 00:00:00, 0.00 m  
Start node, manhole, reference: S4

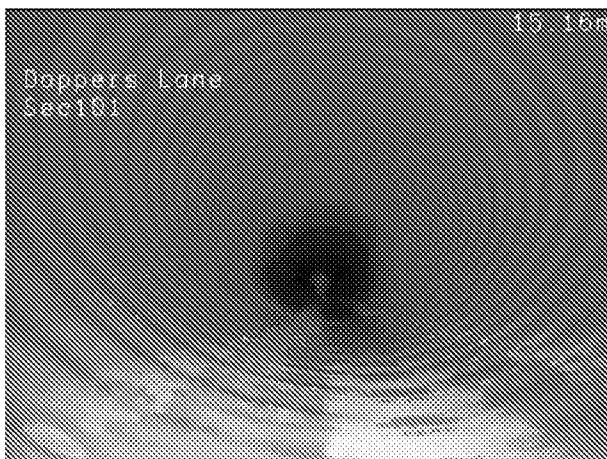
3, 00:01:28, 15.10 m  
Water level, 0% of the vertical dimension

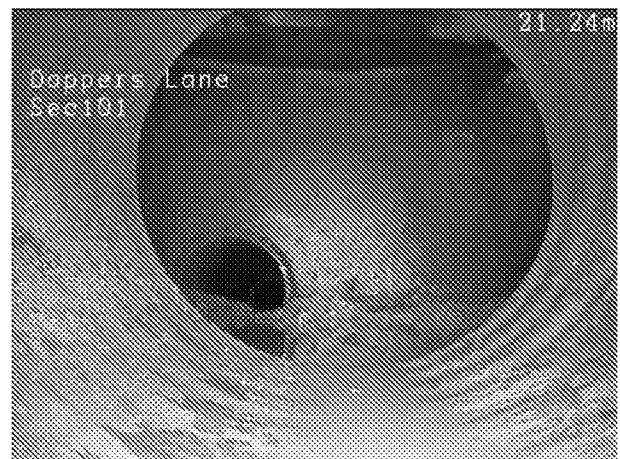
4, 00:02:00, 21.50 m  
Finish node, manhole, reference: S5

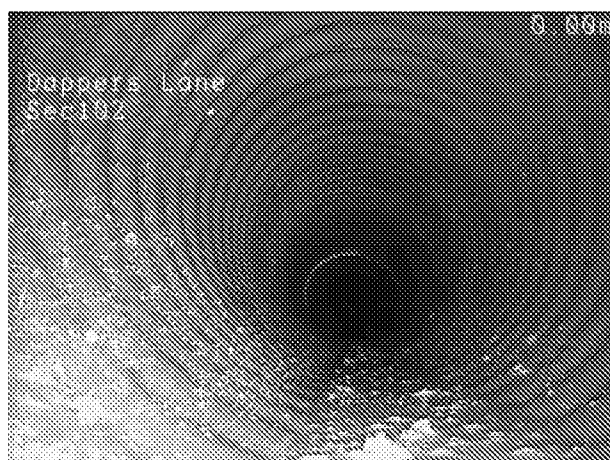
1, 00:00:00, 0.00 m  
Start node, manhole, reference: S5

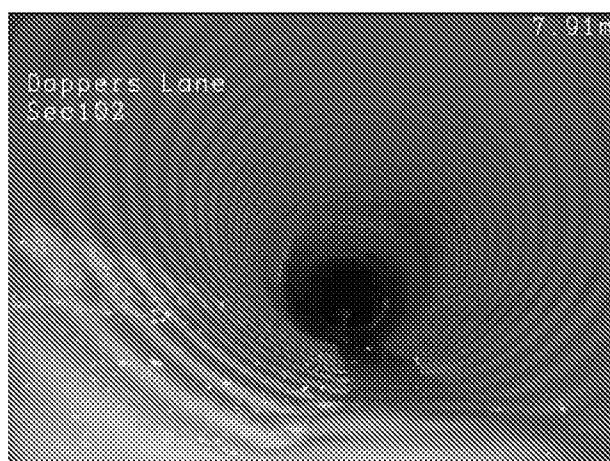
3, 00:01:03, 7.90 m  
Water level, 0% of the vertical dimension

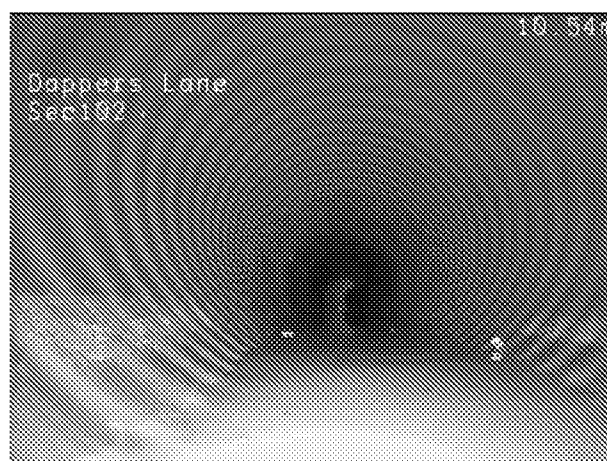
4, 00:01:16, 10.50 m  
Water level, 5% of the vertical dimension

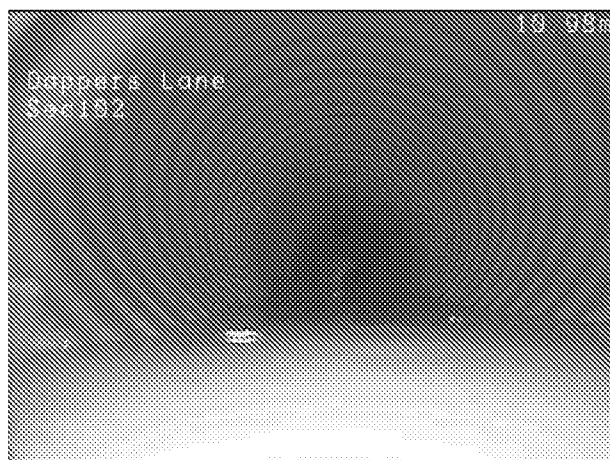
5, 00:01:21, 10.90 m  
Water level, 10% of the vertical dimension

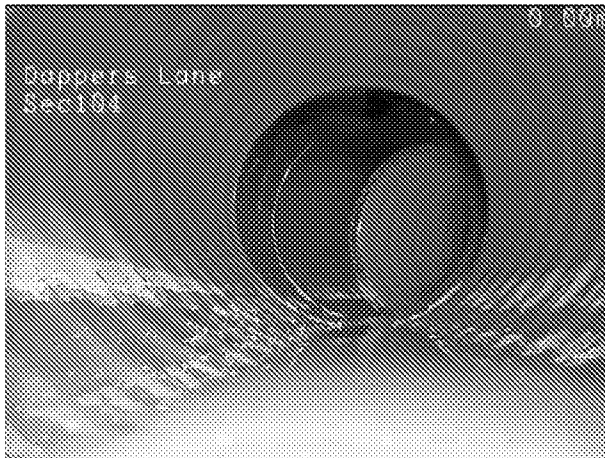
1, 00:00:00, 0.00 m  
Start node, manhole, reference: S8

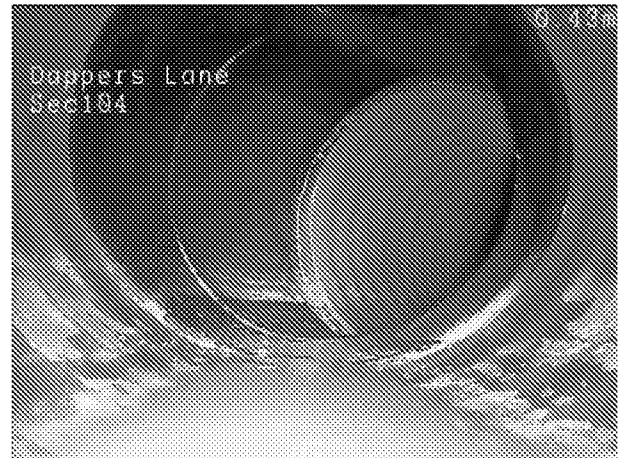
2, 00:00:12, 0.70 m  
Line deviates right

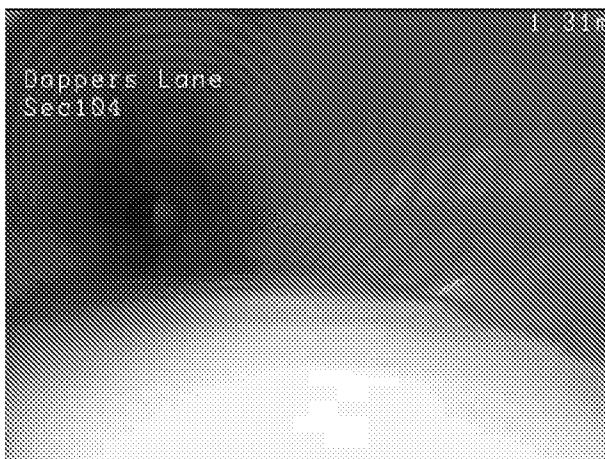
3, 00:00:21, 1.30 m  
Water level, 10% of the vertical dimension

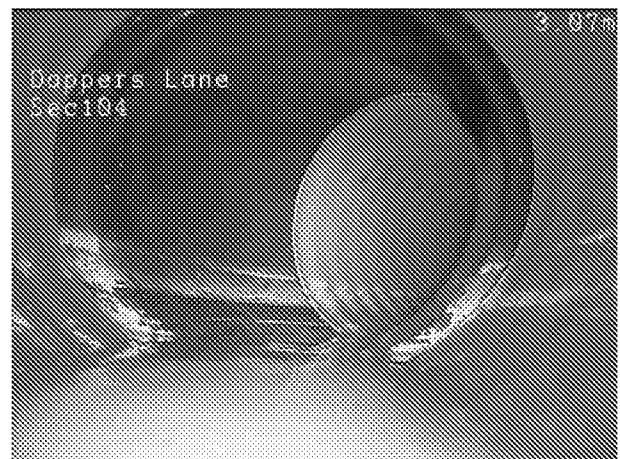
4, 00:00:34, 3.00 m  
Water level, 5% of the vertical dimension

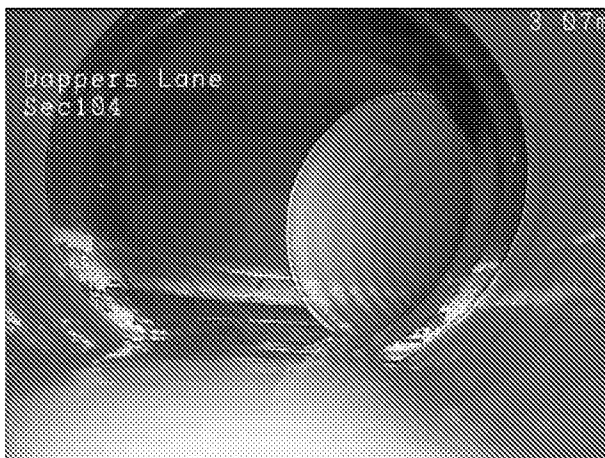
5, 00:00:34, 3.40 m  
Line deviates right

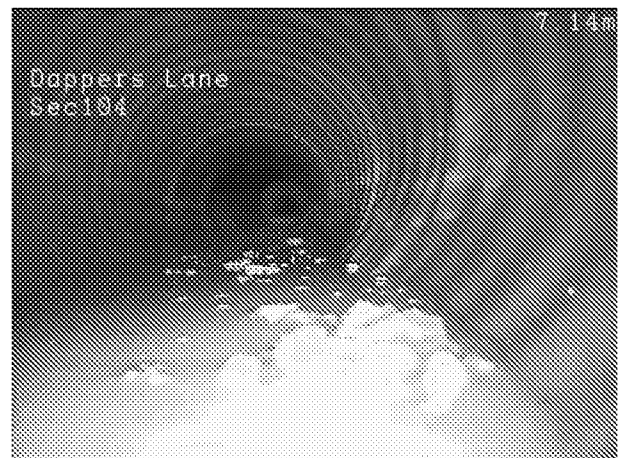
6, 00:00:50, 7.10 m  
Water level, 10% of the vertical dimension

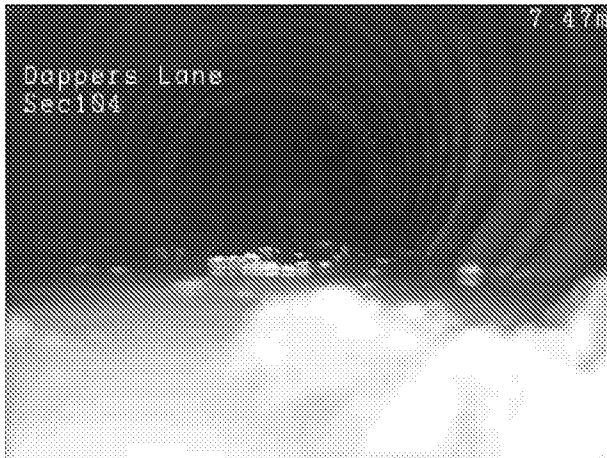
7, 00:00:53, 7.40 m  
Water level, 15% of the vertical dimension

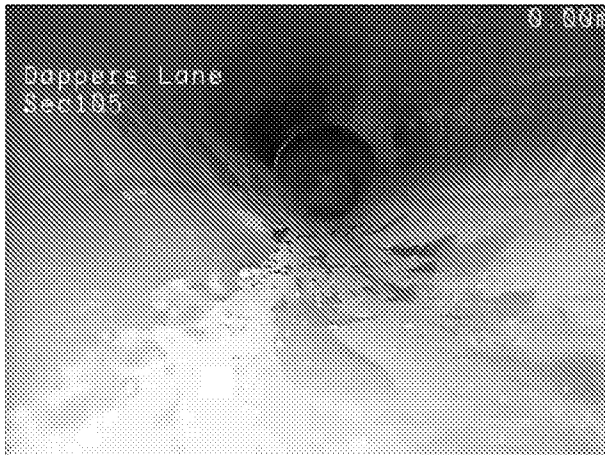
1, 00:00:00, 0.00 m  
Start node, manhole, reference: S8

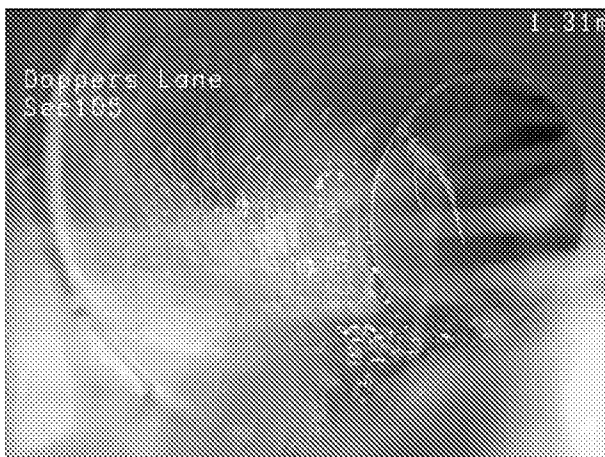
3, 00:00:12, 1.50 m  
Line deviates right

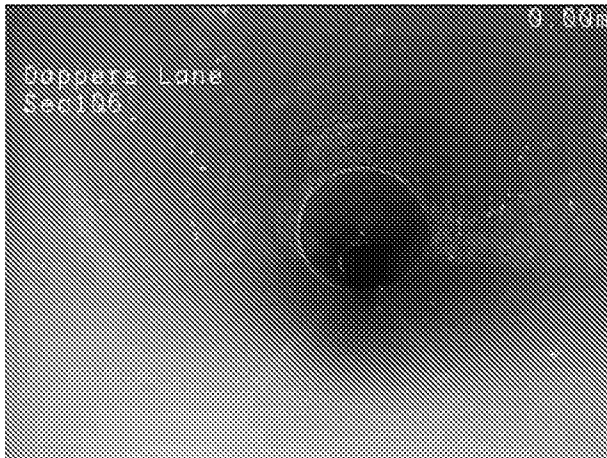
1, 00:00:04, 0.00 m  
Water level, 0% of the vertical dimension

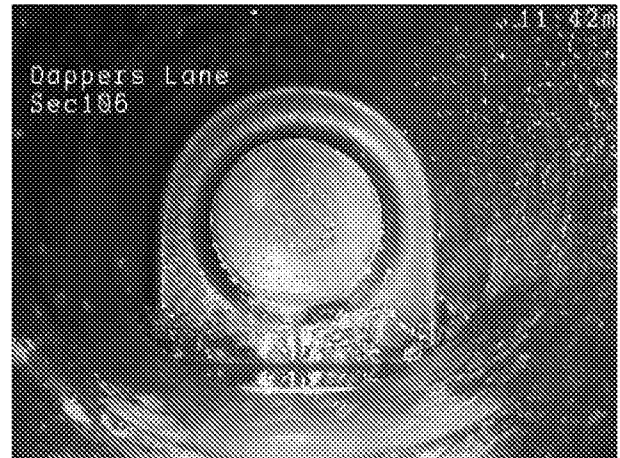
2, 00:00:42, 11.60 m  
Finish node, manhole, reference: RG2

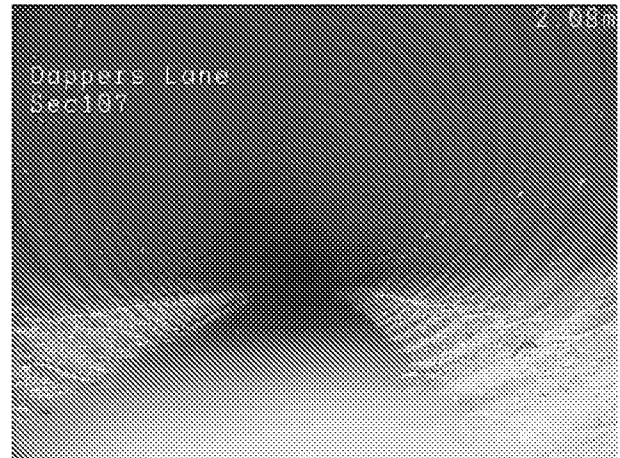
2, 00:00:15, 2.00 m  
Water level, 5% of the vertical dimension

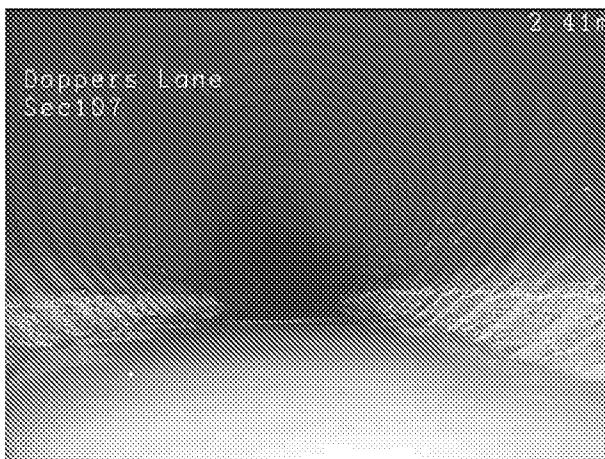
3, 00:00:17, 2.40 m  
Water level, 10% of the vertical dimension

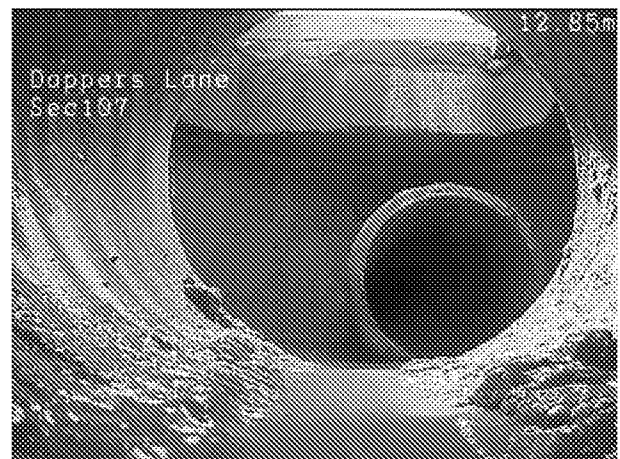
4, 00:00:44, 13.20 m  
Finish node, manhole, reference: S9

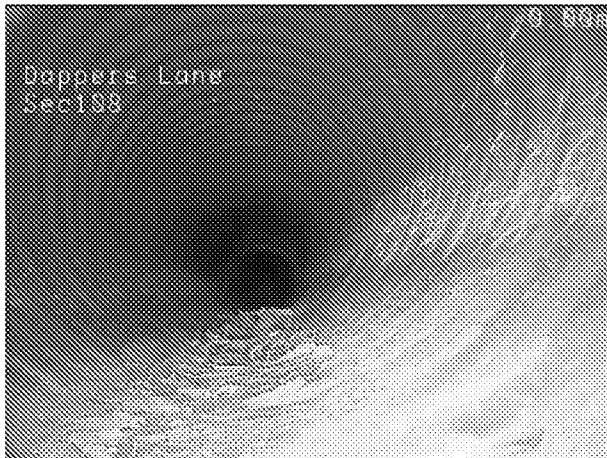
1, 00:00:00, 0.00 m  
Start node, manhole, reference: S9

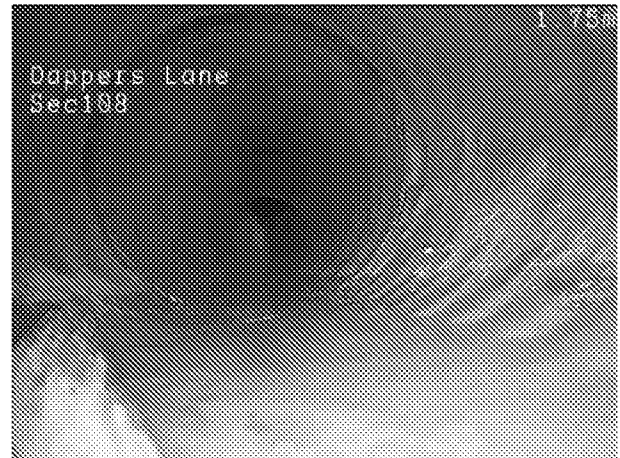
2, 00:00:15, 1.70 m  
Water level, 5% of the vertical dimension

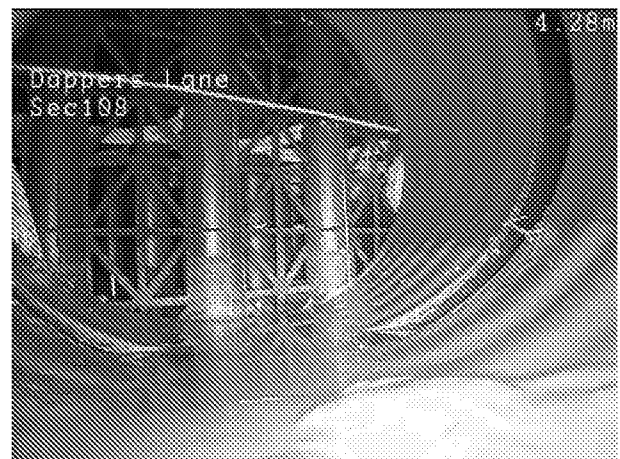
3, 00:00:28, 3.40 m  
Line deviates left

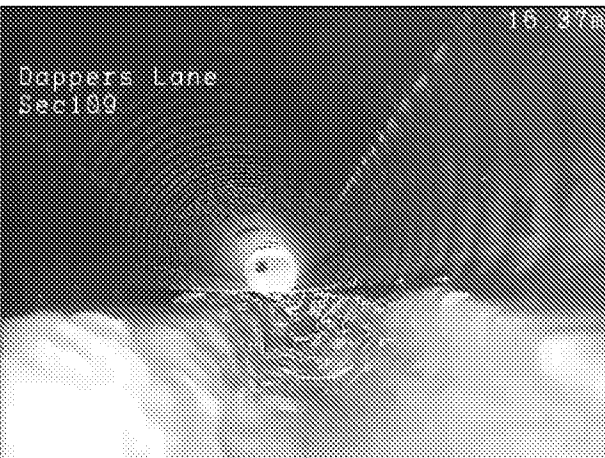
Settled deposits, fine, 20% cross-sectional area loss, start

| 5, 00:01:51, 16.40 m<br>Settled deposits, fine, 20% cross-sectional area loss, start | 6, 00:01:40, 19.70 m<br>Finish node, manhole, reference: S10 |

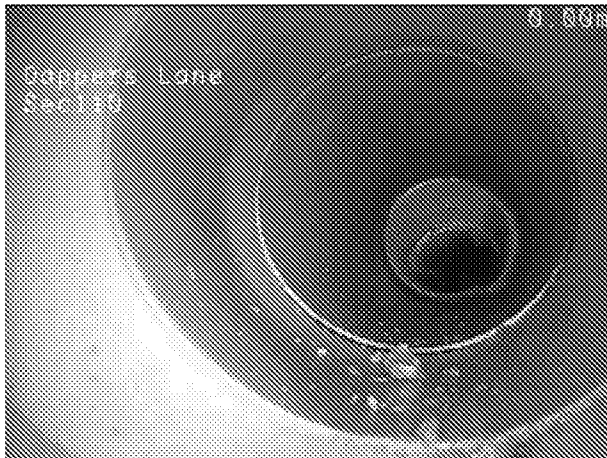
1, 00:00:01, 0.00 m  
Water level, 0% of the vertical dimension

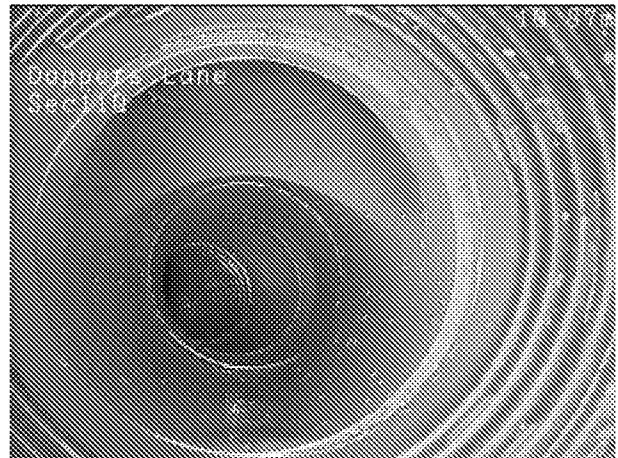
2, 00:00:49, 11.00 m  
Junction at 12 o'clock, 100mm dia

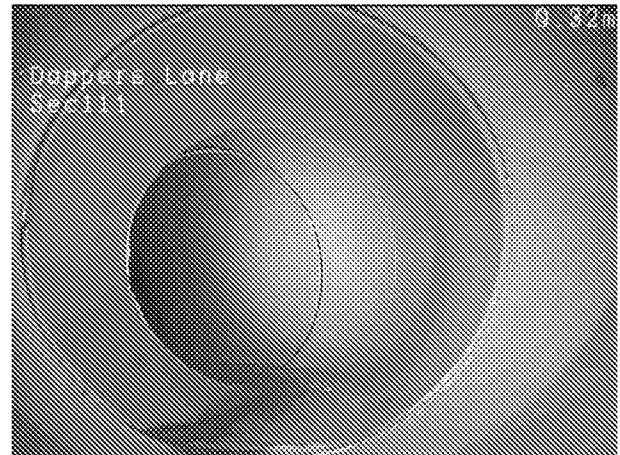
2, 00:00:12, 0.40 m  
Line deviates left

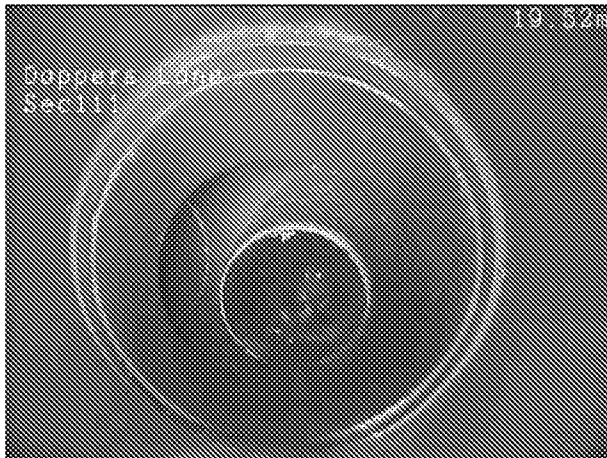
7, 00:01:13, 19.70 m  
Junction at 9 o'clock, 100mm dia

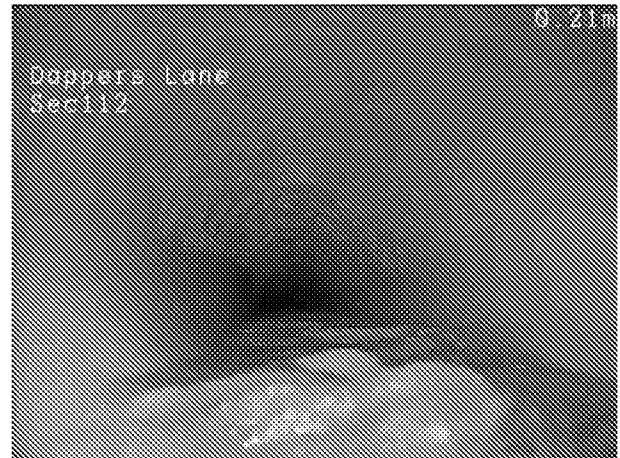
2, 00:00:11, 0.20 m  
Water level, 20% of the vertical dimension, Live

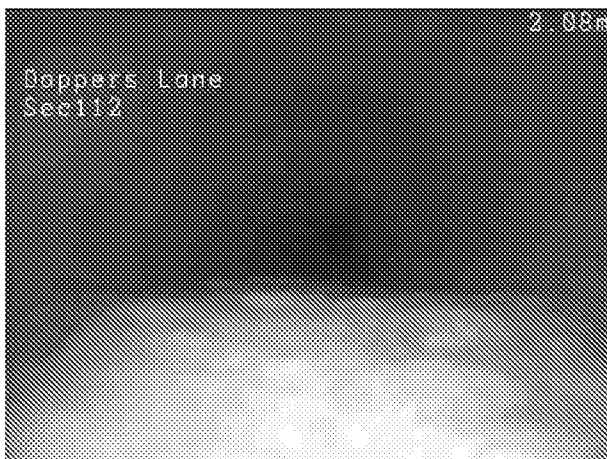
3, 00:00:24, 2.00 m  
Water level, 40% of the vertical dimension

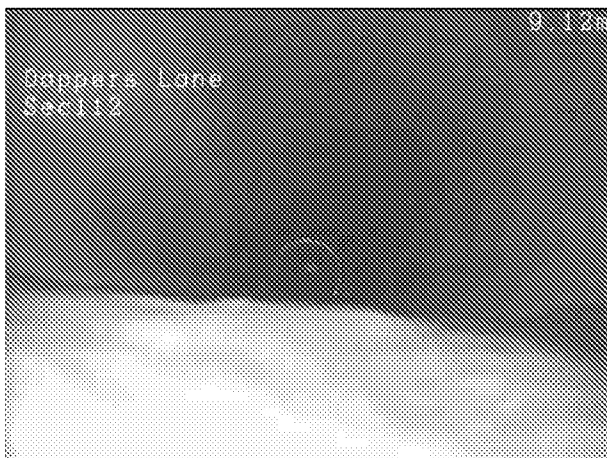
5, 00:00:48, 9.10 m  
Water level, 30% of the vertical dimension

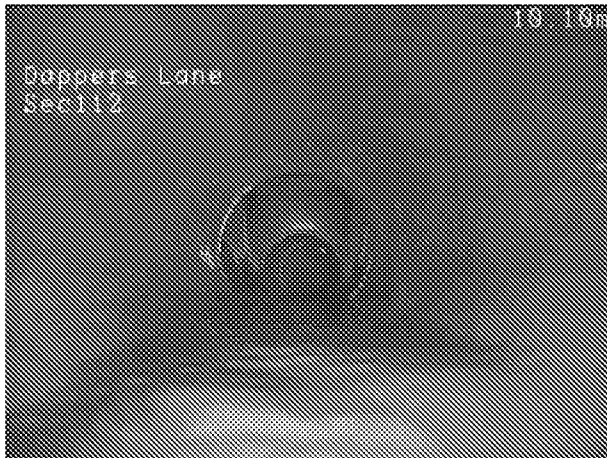
7, 00:00:56, 10.10 m  
Water level, 10% of the vertical dimension

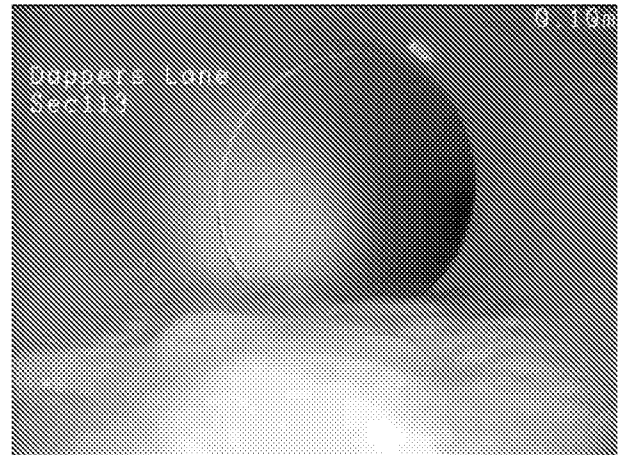
2, 00:00:07, 0.30 m  
Line deviates right

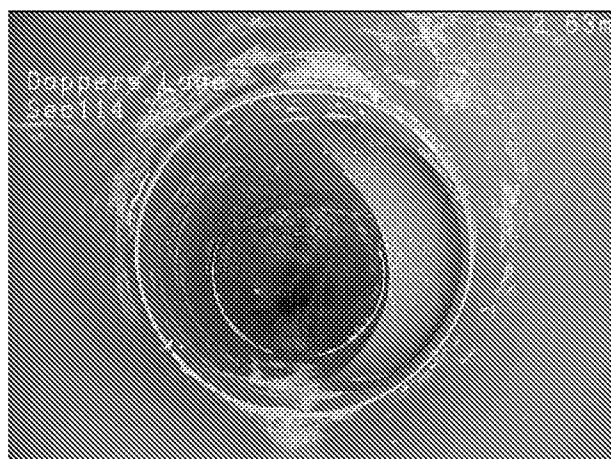
3, 00:00:27, 2.60 m  
Junction at 3 o'clock, 100mm dia

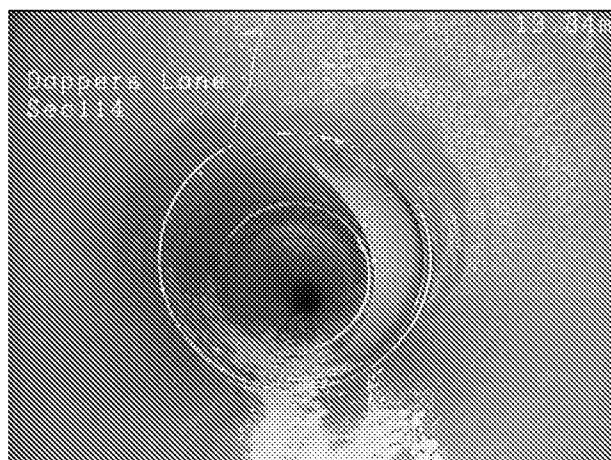
5, 00:00:52, 13.90 m  
Junction at 3 o'clock, 100mm dia

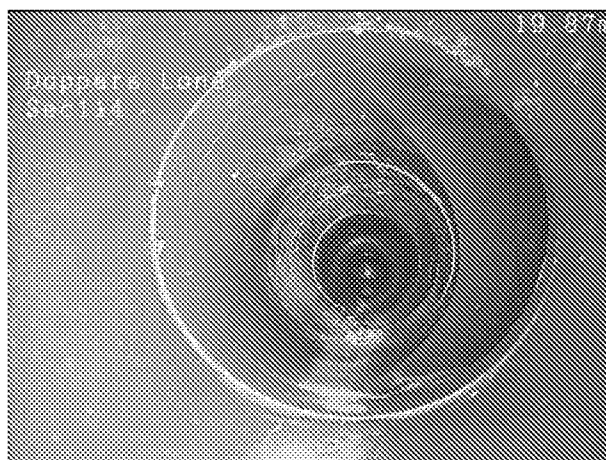
6, 00:01:05, 20.00 m  
Junction at 3 o'clock, 100mm dia

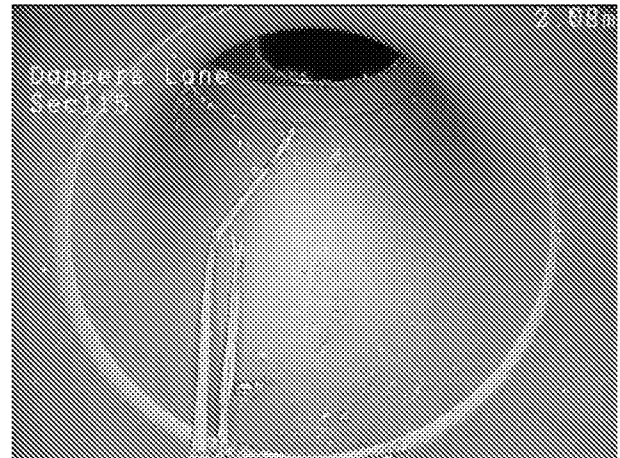
2, 00:00:13, 2.10 m  
Line deviates up

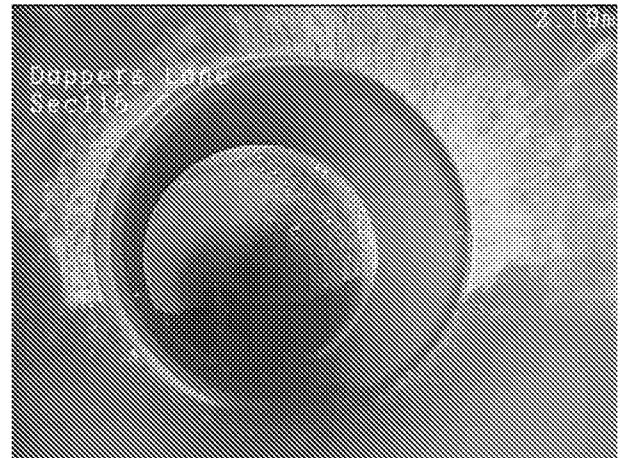
2, 00:00:17, 2.30 m  
Line deviates left

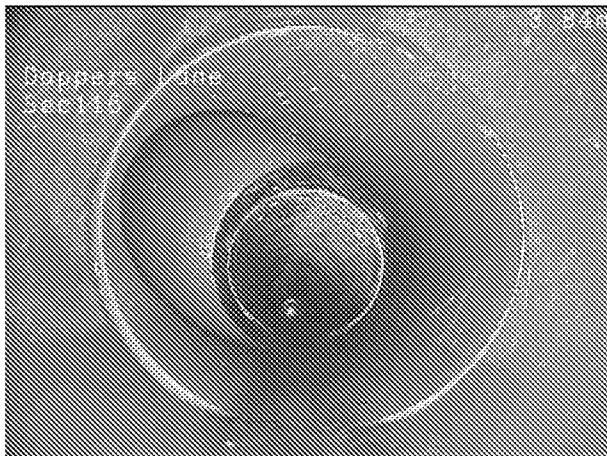
3, 00:00:24, 3.90 m  
Junction at 10 o'clock, 100mm dia

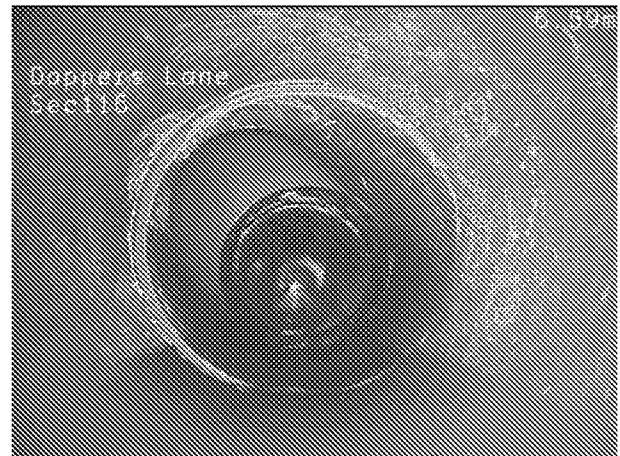
4, 00:00:34, 6.70 m  
Junction at 10 o'clock, 100mm dia

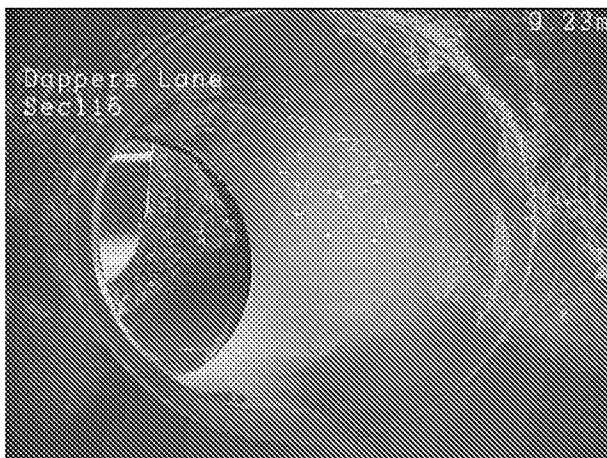
5, 00:00:43, 9.30 m  
Line deviates left

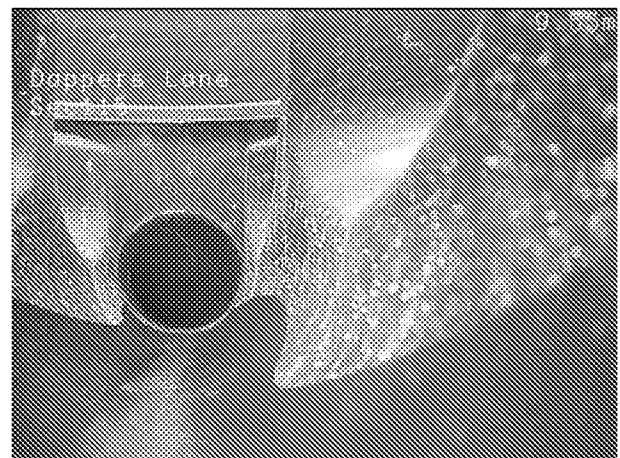
6, 00:00:45, 9.50 m  
Finish node, manhole, reference: S37

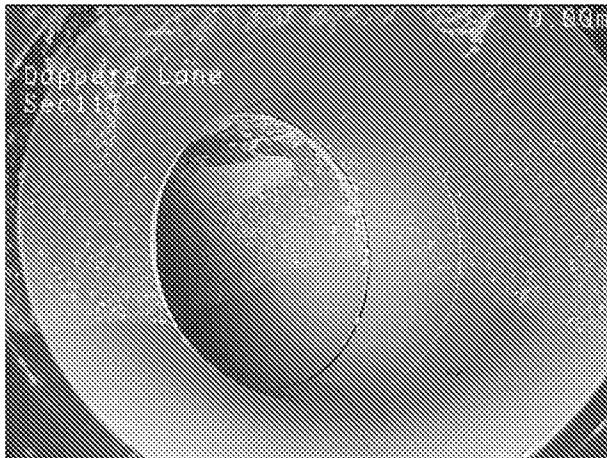
1, 00:00:00, 0.00 m  
Start node, manhole, reference: S37

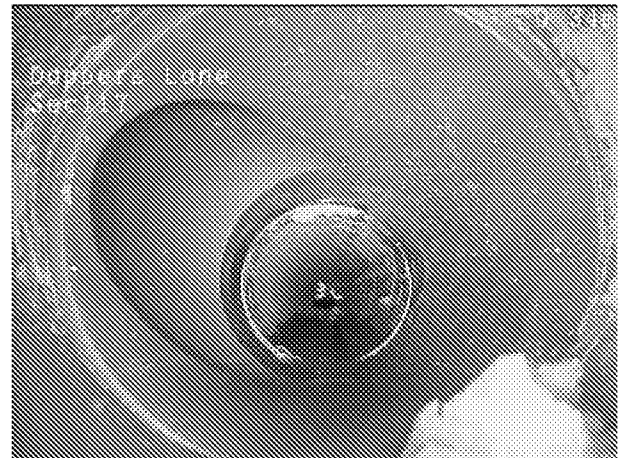
2, 00:00:32, 9.40 m  
Junction at 10 o'clock, 100mm dia

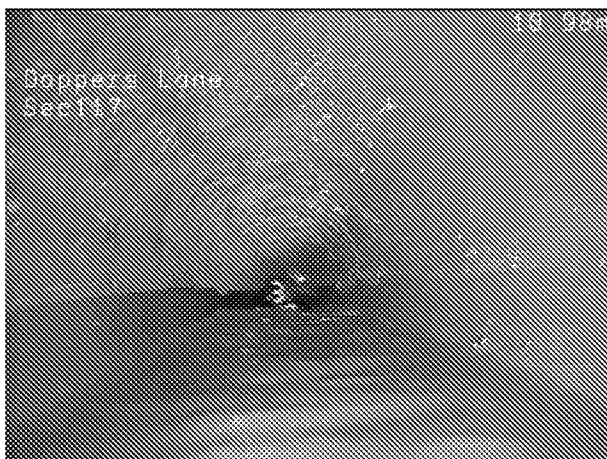
3, 00:00:38, 10.90 m  
Water level, 10% of the vertical dimension

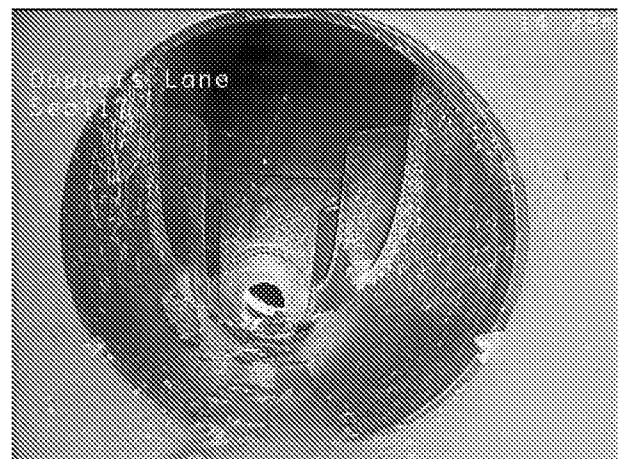
4, 00:00:58, 14.40 m  
Finish node, manhole, reference: S37B

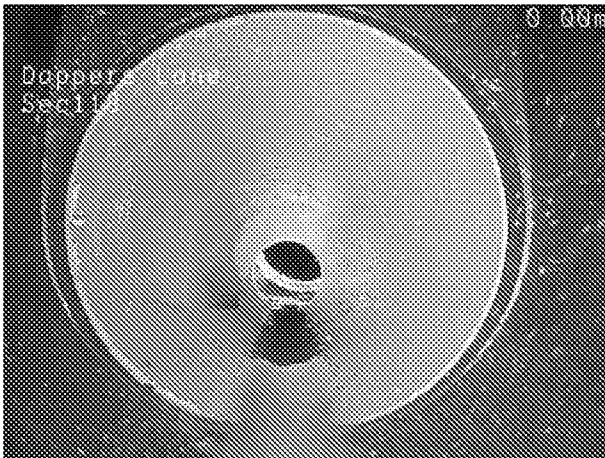
1, 00:00:00, 0.00 m  
Start node, manhole, reference: S37B

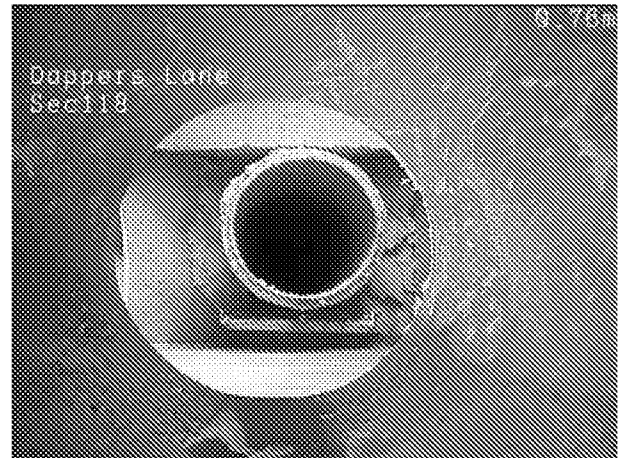
2, 00:00:16, 0.90 m  
Finish node, manhole, reference: S9

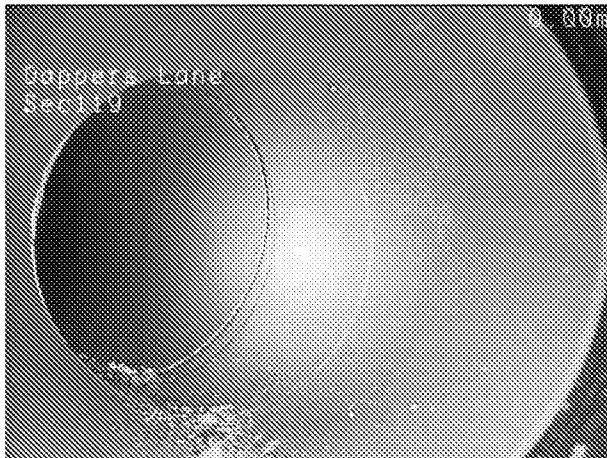
1, 00:00:00, 0.00 m  
Start node, manhole, reference: F29A

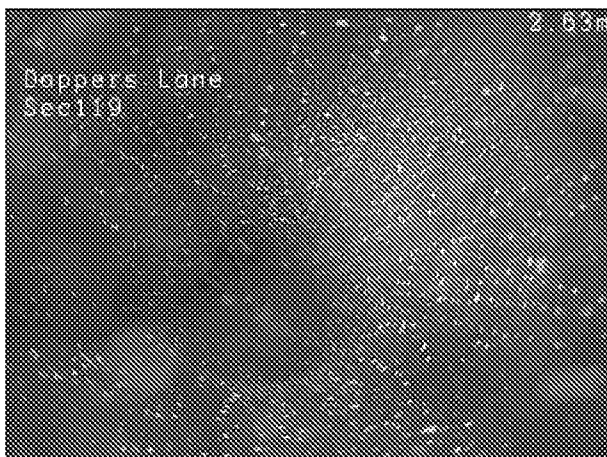
3, 00:00:18, 2.60 m  
Finish node, manhole, reference: SP
