## Section Pictures - 28/05/2021 - F29AX

| Town or Village: | Angmering | Inspection Direction: | Downstream | Upstream Node: | F29B |
| Road: | Dappers Lane | Inspected Length: | 2.30 m | Upstream Pipe Depth: | |

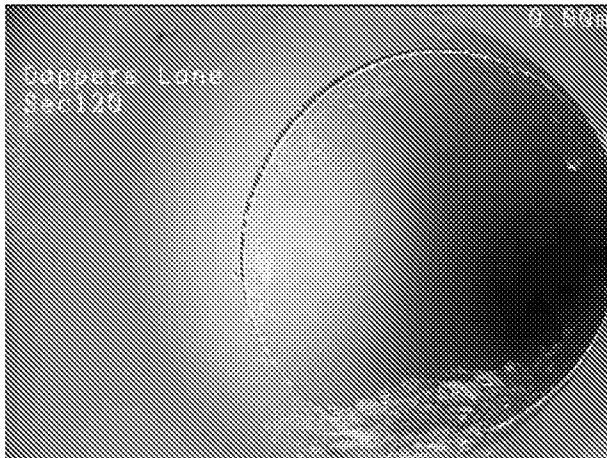
1, 00:00:00, 0.00 m  
Start node, manhole, reference: F29A

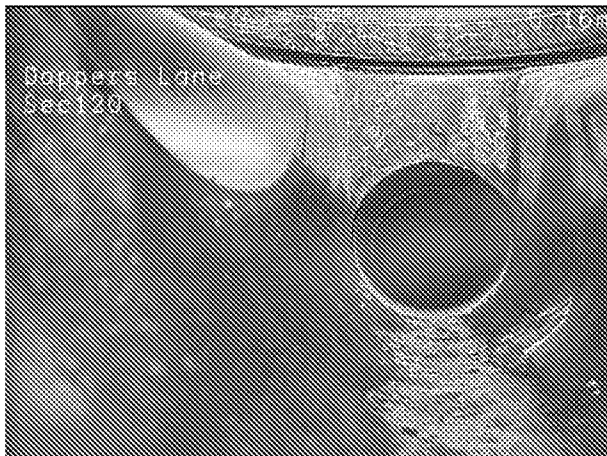
3, 00:00:32, 5.10 m  
Finish node, manhole, reference: F29B

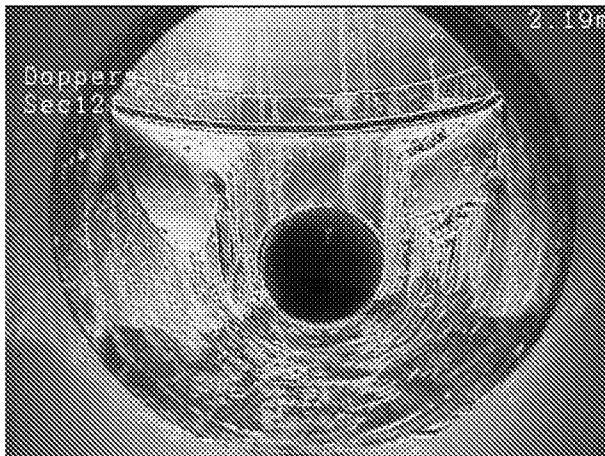
3, 00:00:18, 2.30 m  
Finish node, manhole, reference: F29C

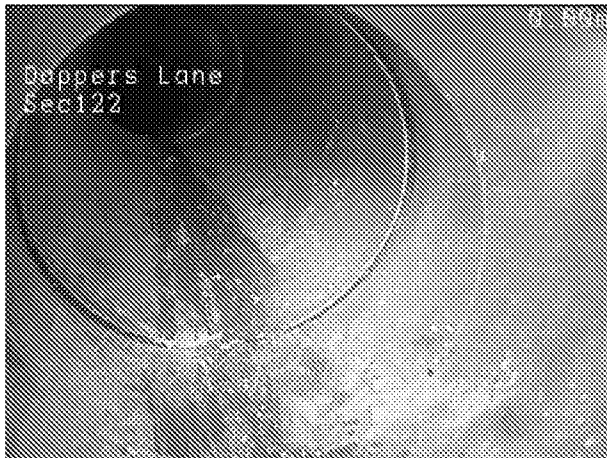
1, 00:00:00, 0.00 m  
Start node, manhole, reference: F29C

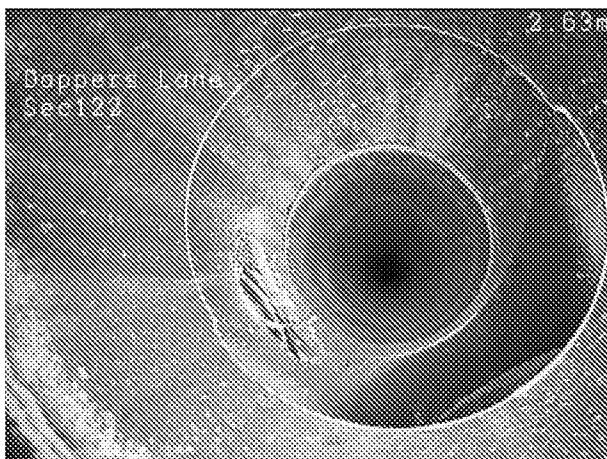
3, 00:00:37, 2.60 m  
Finish node, manhole, reference: SP

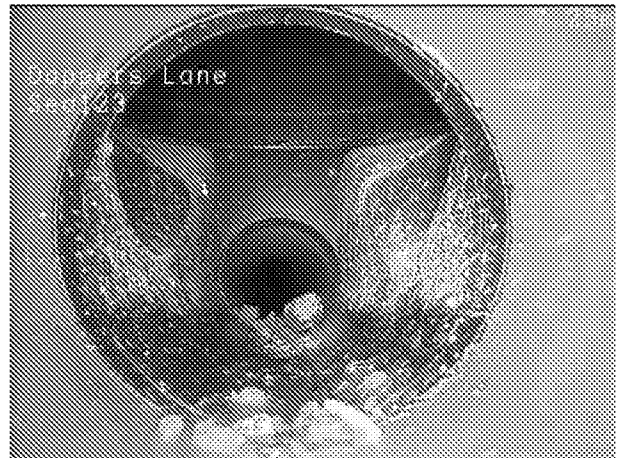
2, 00:00:31, 7.30 m  
Finish node, manhole, reference: F29D

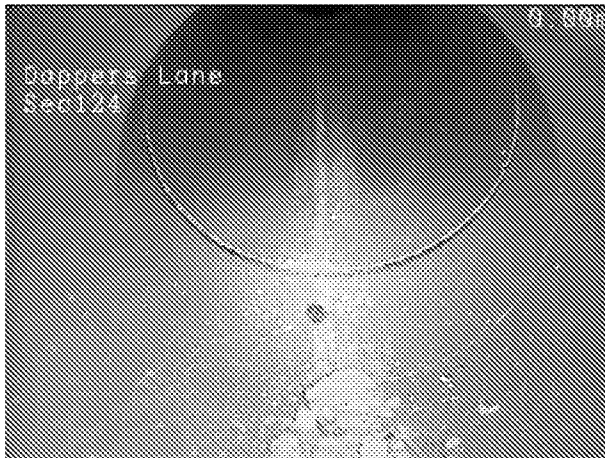
1, 00:00:00, 0.00 m  
Start node, manhole, reference: F29D

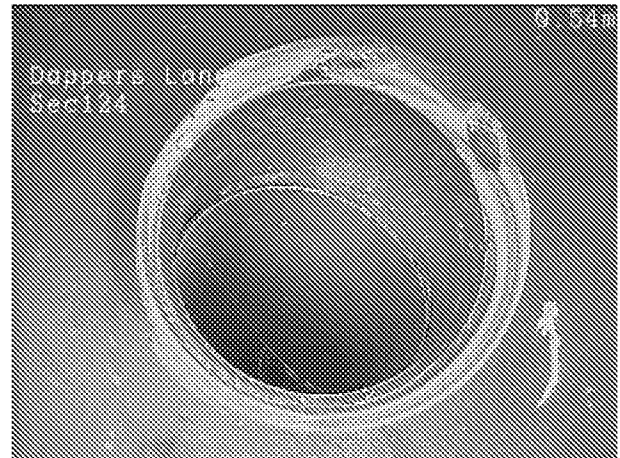
2, 00:00:26, 0.60 m  
Line deviates left

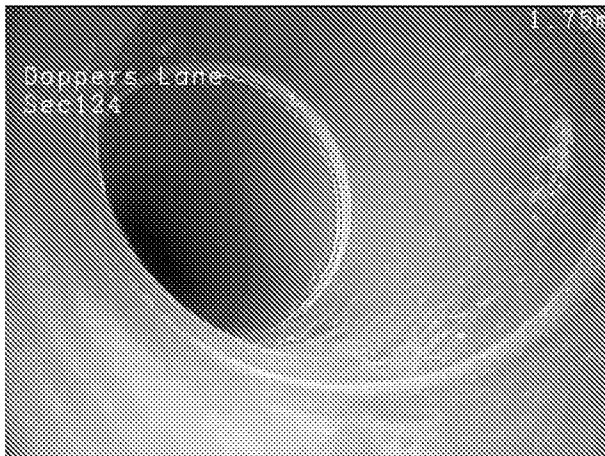
3, 00:00:33, 1.80 m  
Line deviates left

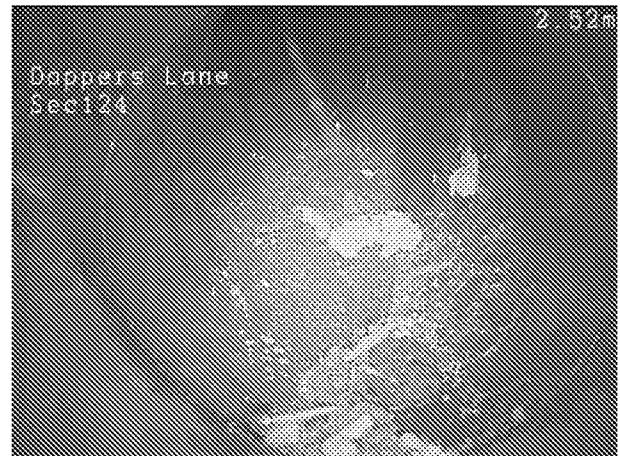
4, 00:00:38, 2.60 m  
Line deviates up

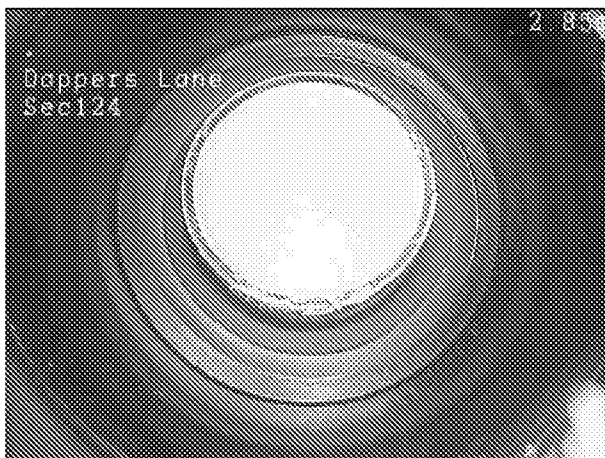
5, 00:00:44, 2.80 m  
Finish node, manhole, reference: SP

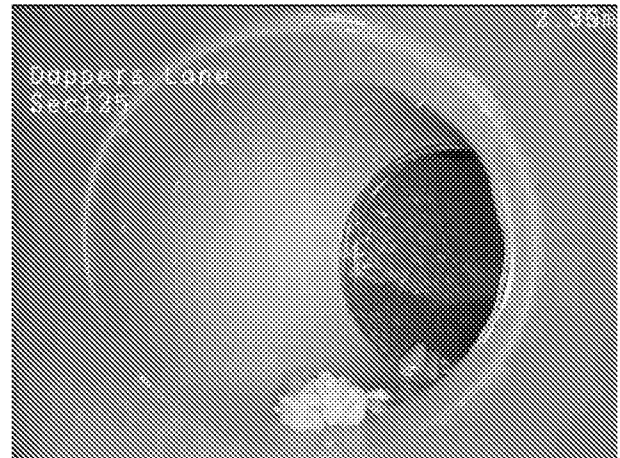
2, 00:00:15, 2.40 m  
Line deviates right

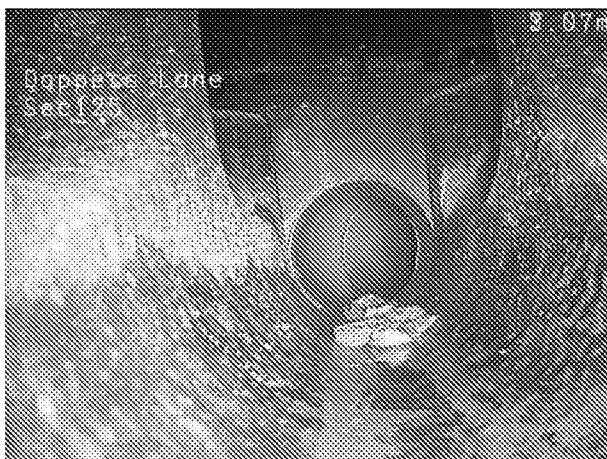
3, 00:00:19, 3.00 m  
Finish node, manhole, reference: F29E

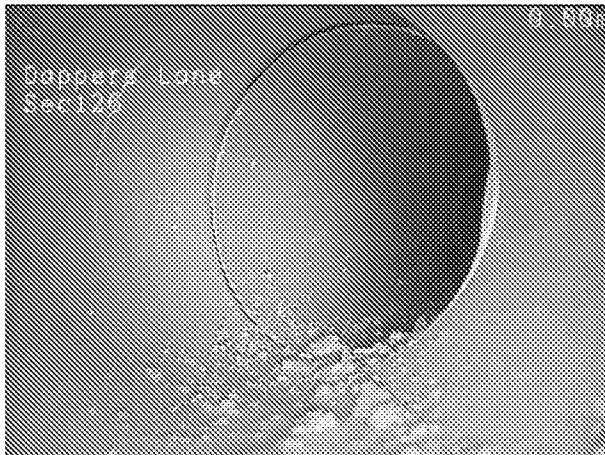
1, 00:00:00, 0.00 m  
Start node, manhole, reference: F29E

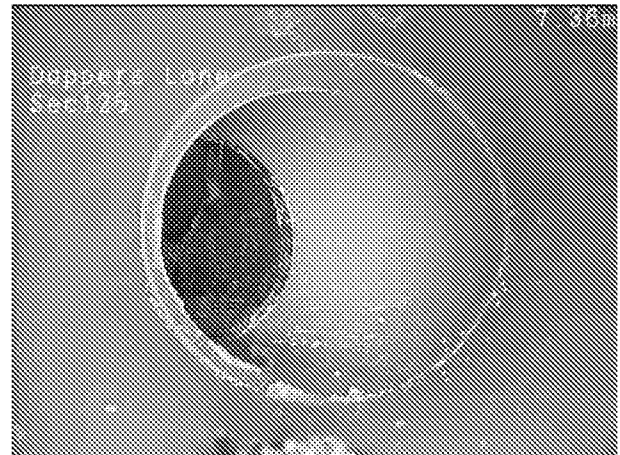
2, 00:00:25, 7.40 m  
Line deviates left

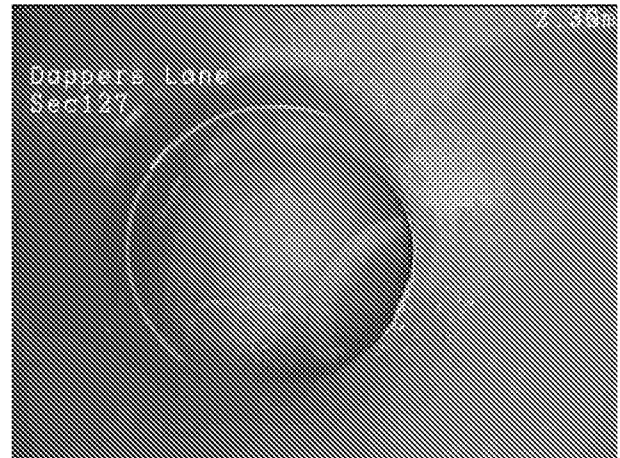
2, 00:00:15, 2.40 m  
Line deviates right

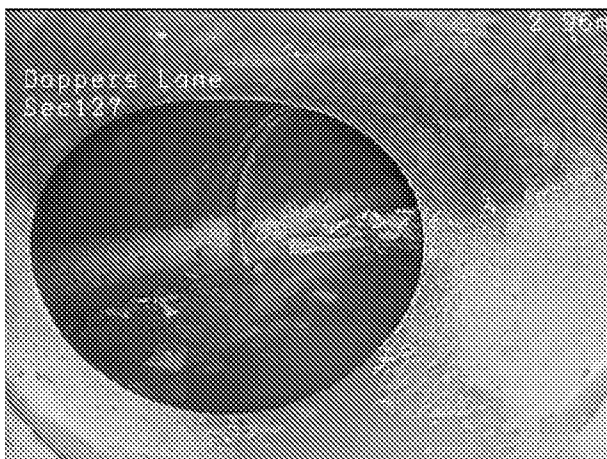
3, 00:00:22, 3.10 m  
Finish node, major connection without manhole, reference: JN

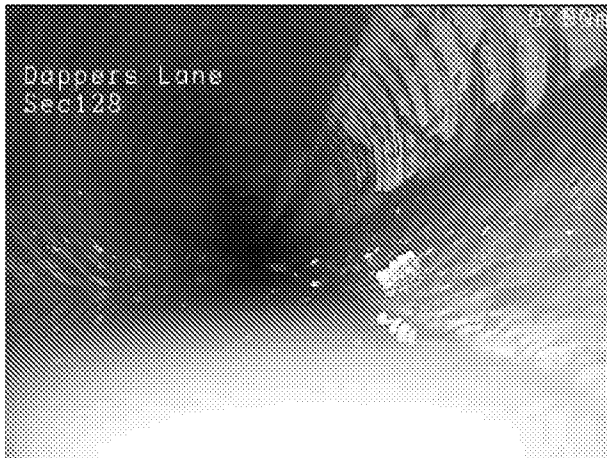
1, 00:00:00, 0.00 m  
Start node, manhole, reference: S10

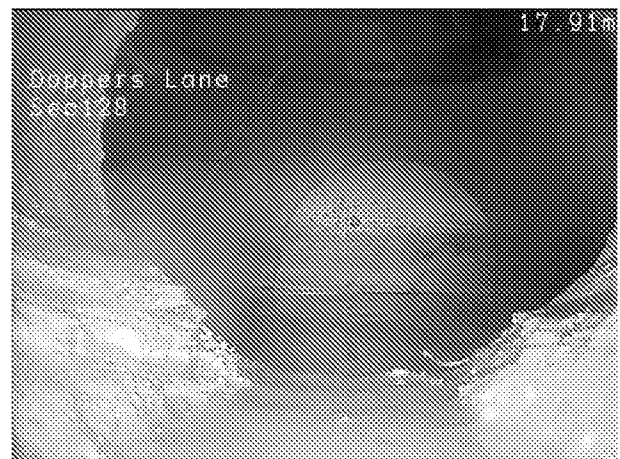
4, 00:02:09, 18.20 m  
Finish node, catchpit, reference: S11

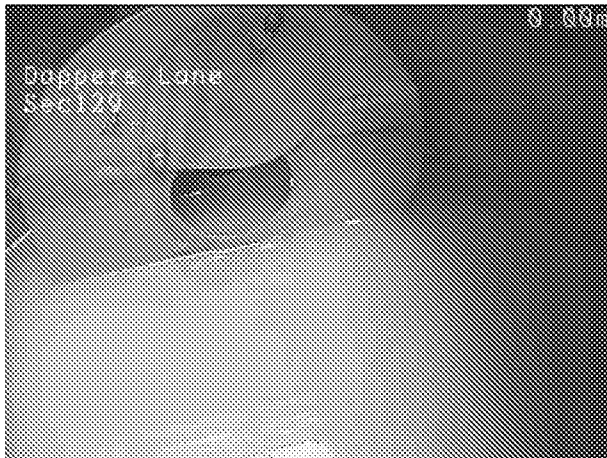
1, 00:00:29, 0.00 m  
Start node, manhole, reference: S11

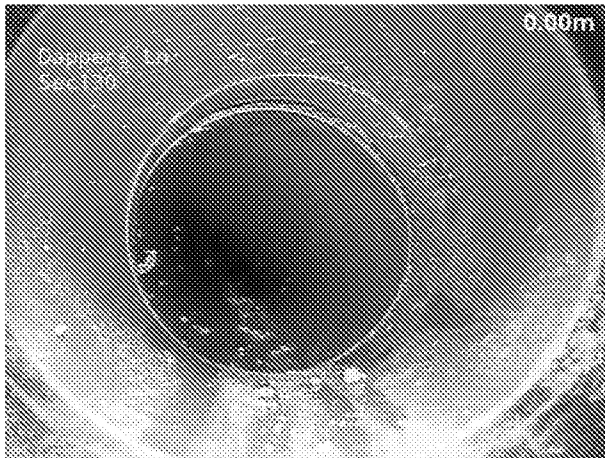
1, 00:00:01, 0.00 m  
Water level, 0% of the vertical dimension

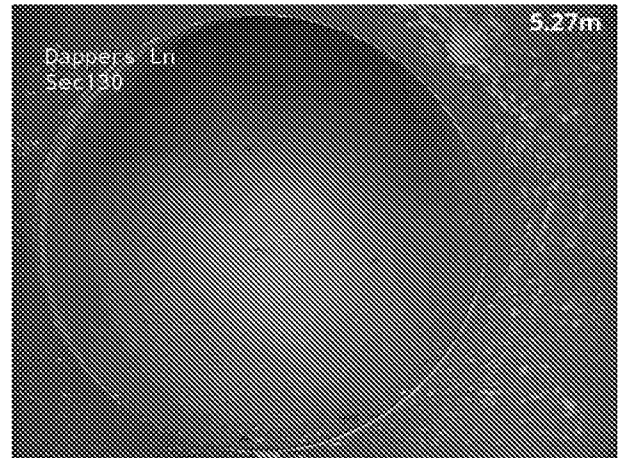
2, 00:00:29, 5.40 m  
Line deviates up

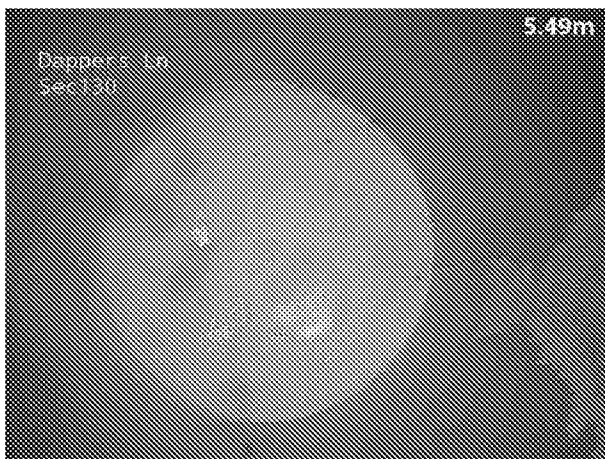
3, 00:00:34, 5.60 m  
Finish node, manhole, reference: RWP1

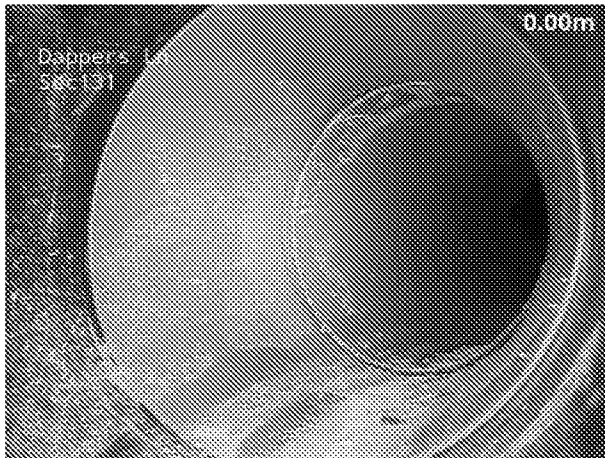
1, 00:00:09, 0.10 m  
Line deviates right

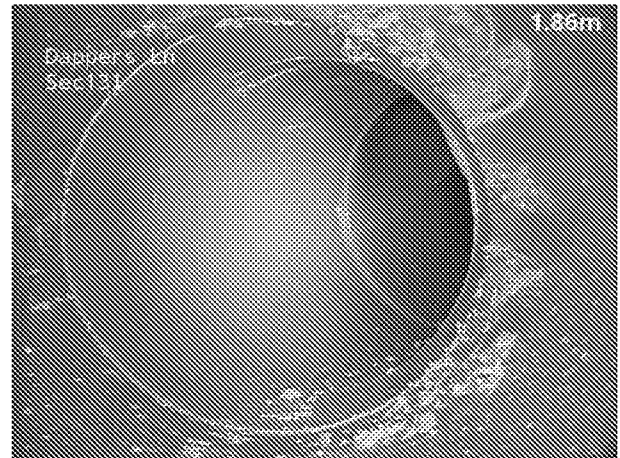
2, 00:00:23, 2.00 m  
Line deviates right

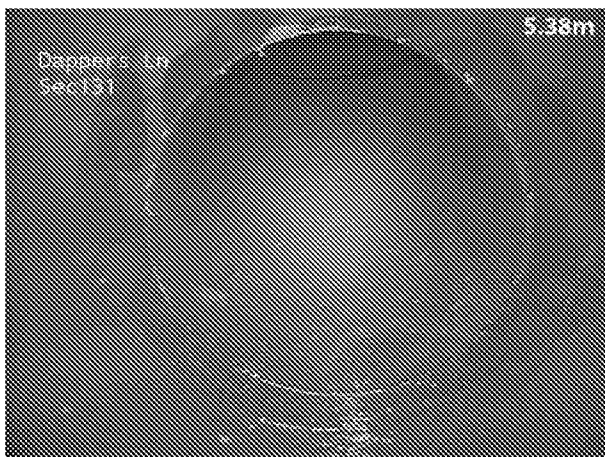
3, 00:00:46, 5.50 m  
Line deviates up

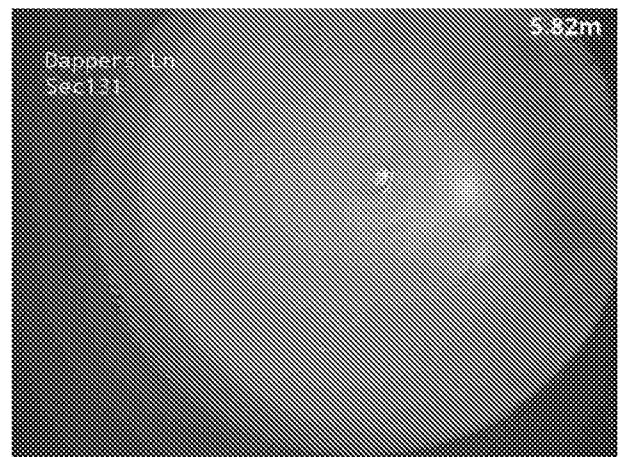
4, 00:00:51, 5.80 m  
Finish node, manhole, reference: RWP2

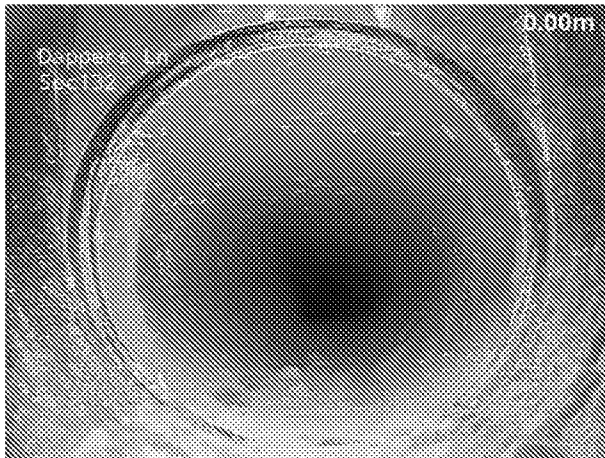
1, 00:00:02, 0.00 m  
Water level, 0% of the vertical dimension

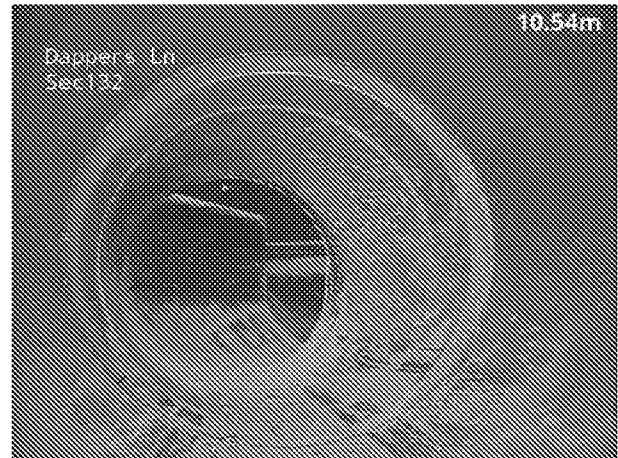
2, 00:00:46, 10.60 m  
Line deviates left

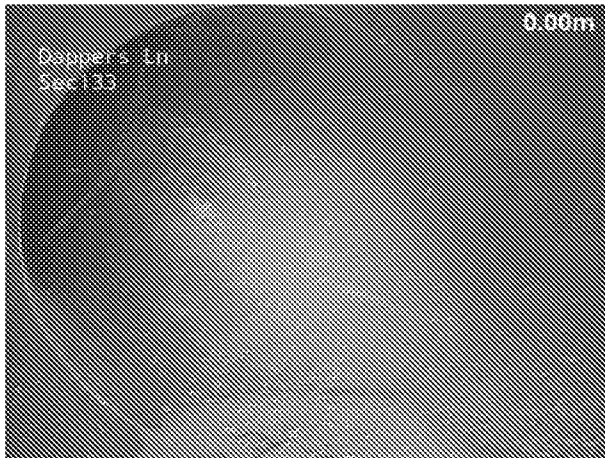
1, 00:00:07, 0.10 m  
Line deviates left

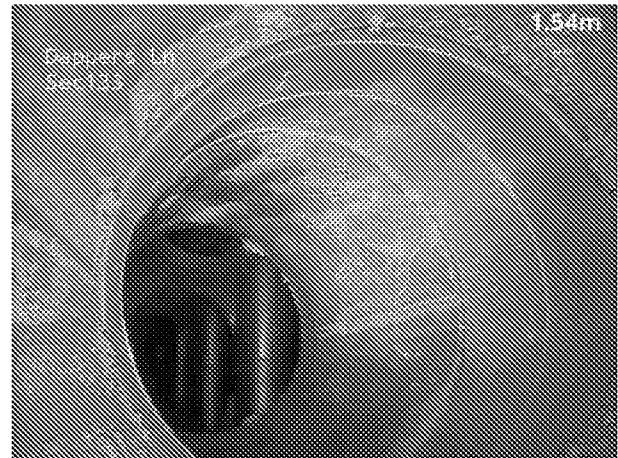
2, 00:00:31, 1.60 m  
Line deviates left

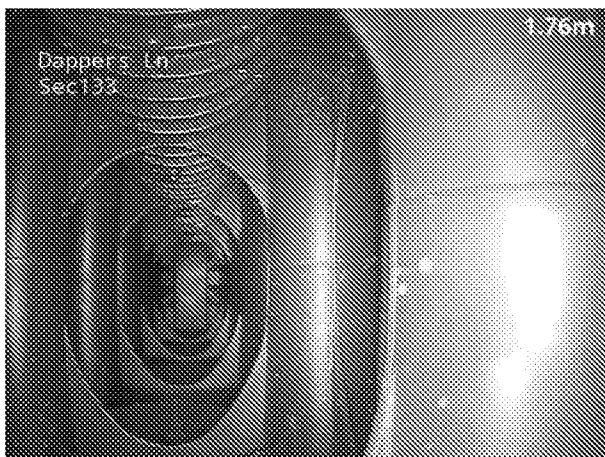
3, 00:00:37, 1.90 m  
Finish node, other special chamber, reference: A, Assumed attenuation

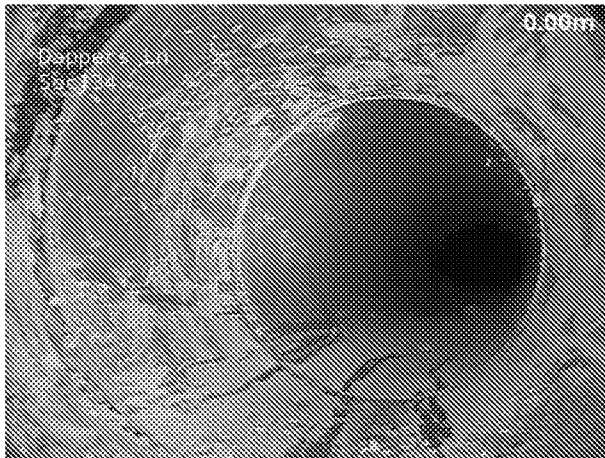
1, 00:00:03, 0.10 m  
Line deviates right

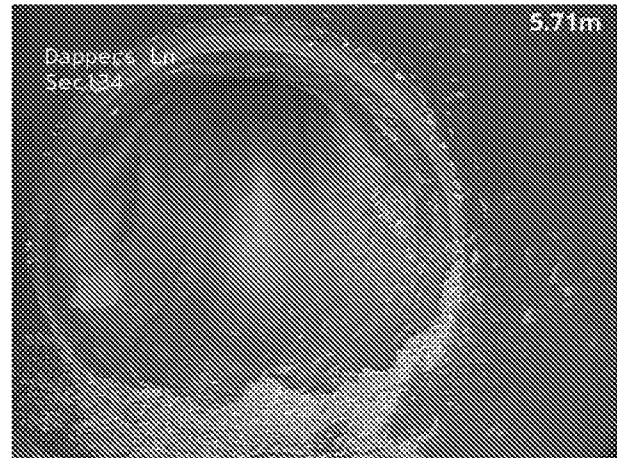
2, 00:00:29, 5.80 m  
Line deviates up

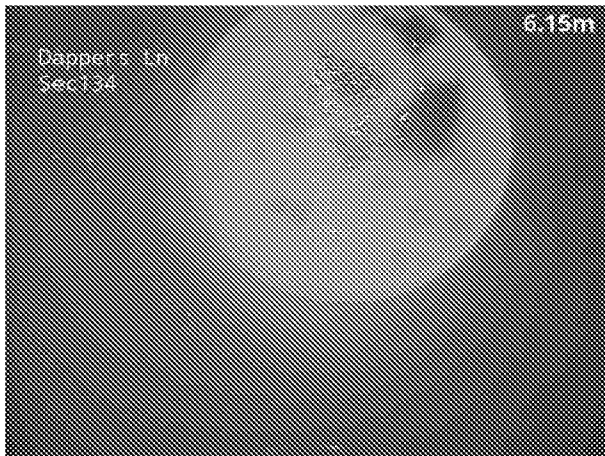
3, 00:00:28, 6.20 m  
Finish node, manhole, reference: RWP

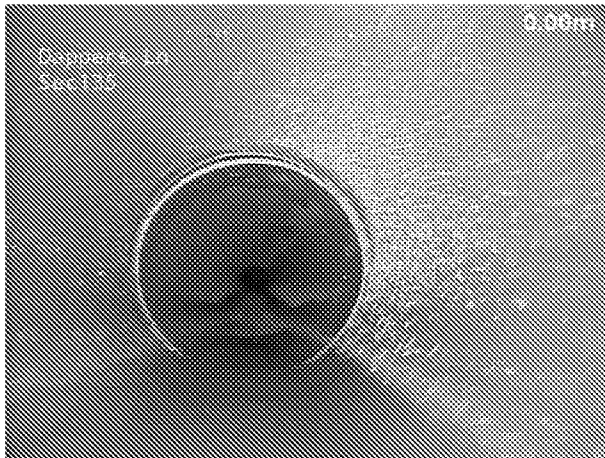
1, 00:00:06, 0.00 m  
Water level, 0% of the vertical dimension

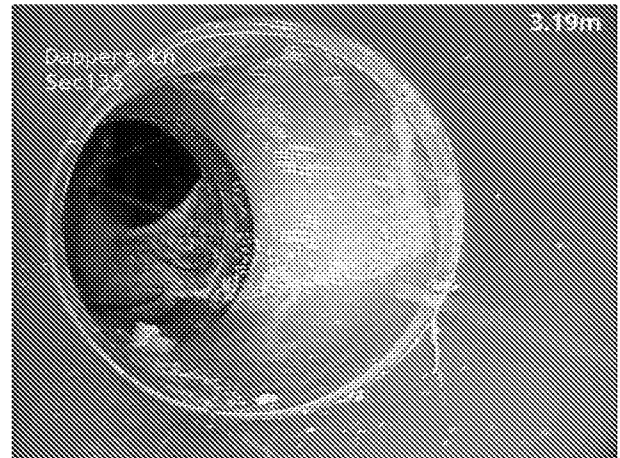
2, 00:00:21, 3.30 m  
Line deviates left

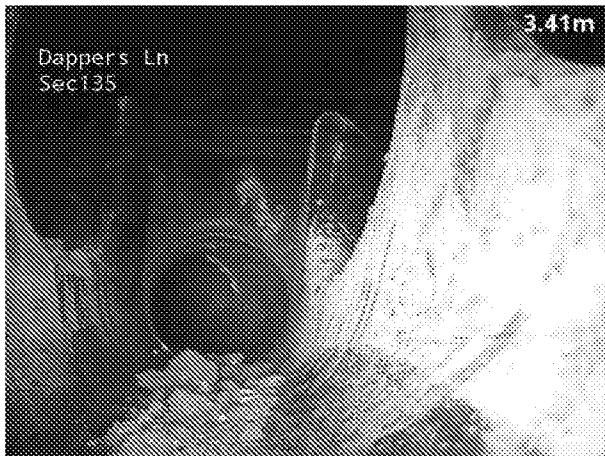
3, 00:00:28, 3.40 m  
Finish node, manhole, reference: S17

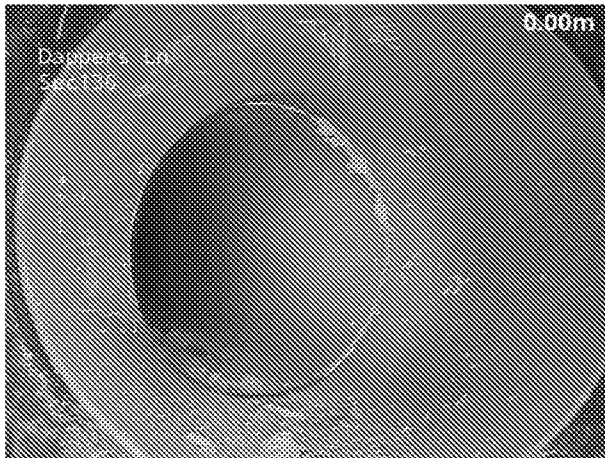
1, 00:00:00, 0.00 m  
Water level, 0% of the vertical dimension

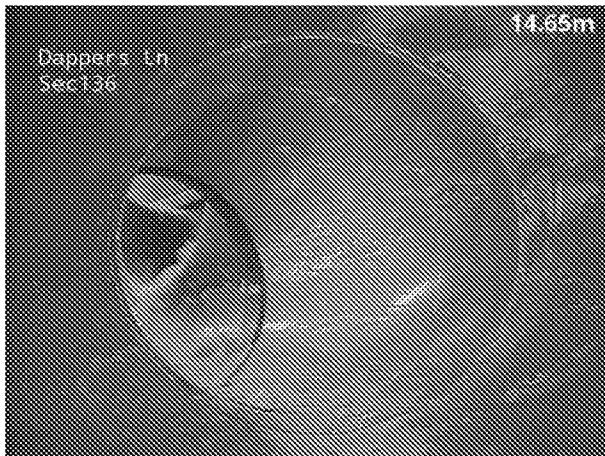
3, 00:00:52, 14.80 m  
Line deviates left

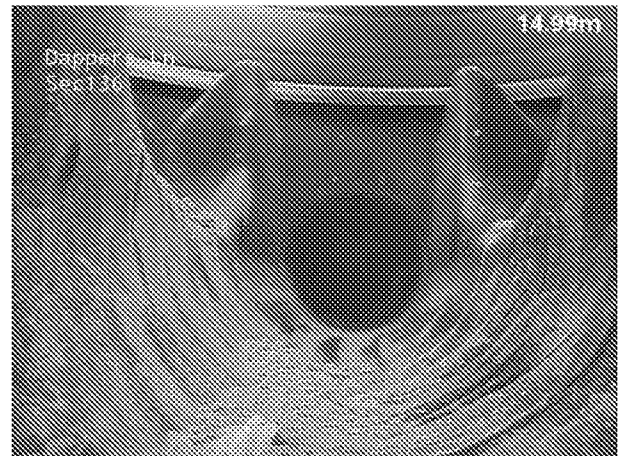
4, 00:00:57, 15.00 m  
Finish node, manhole, reference: S17.1

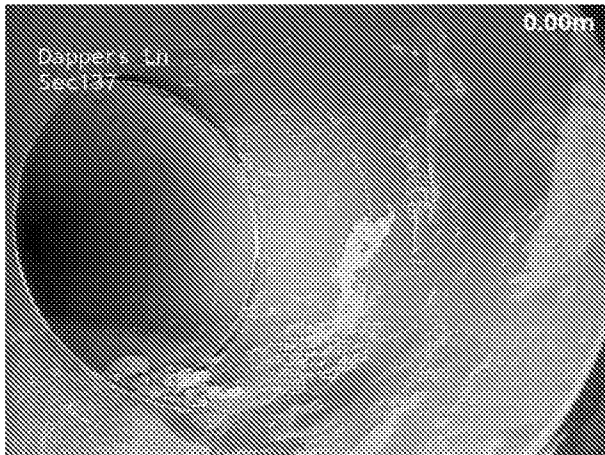
1, 00:00:07, 0.10 m  
Line deviates left

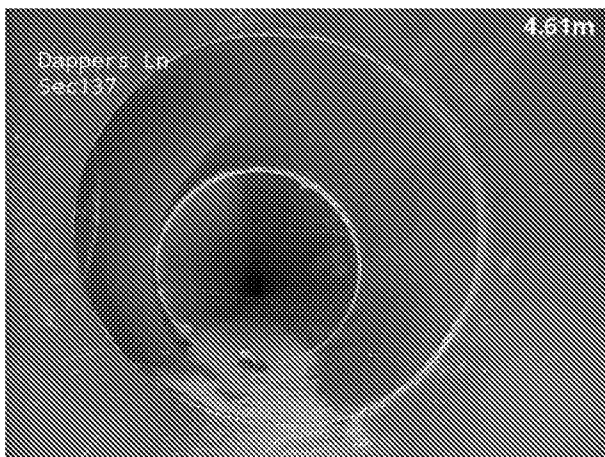
3, 00:00:39, 4.70 m  
Junction at 9 o'clock, 100mm dia

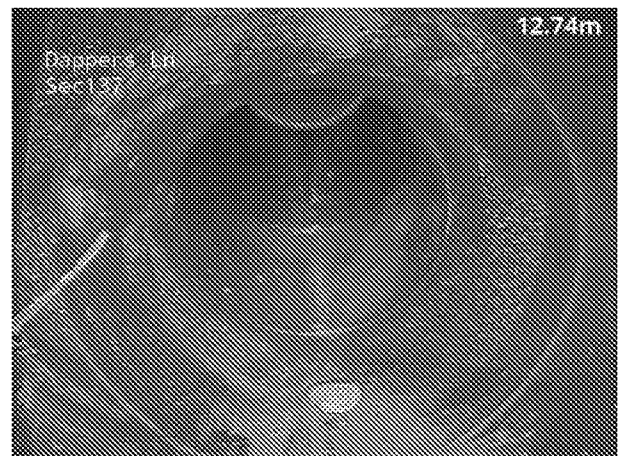
6, 00:01:16, 12.90 m  
Line deviates up

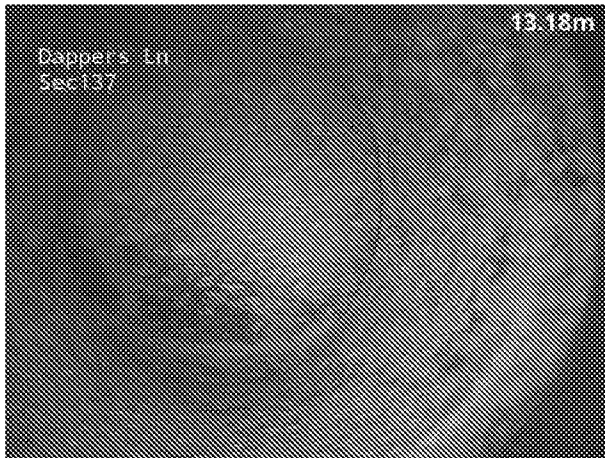
7, 00:01:14, 13.30 m  
Finish node, rodding eye, reference: RE

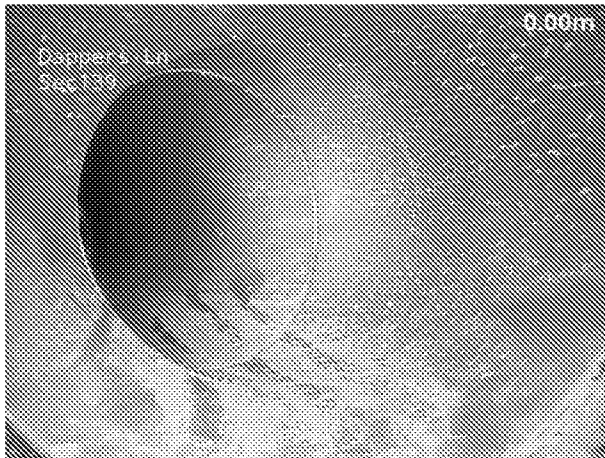
1, 00:00:04, 0.10 m  
Line deviates left

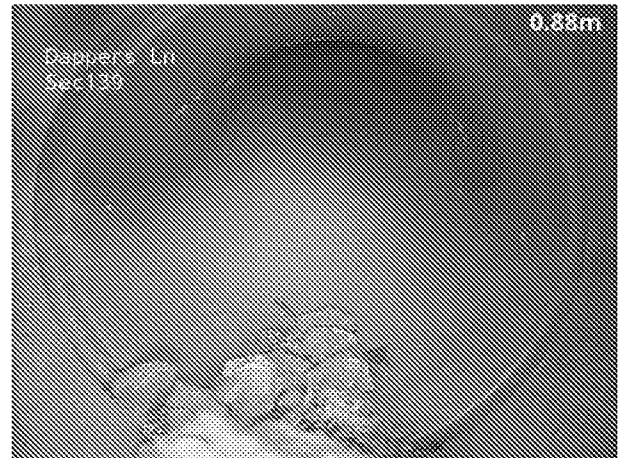
2, 00:00:13, 1.00 m  
Line deviates up

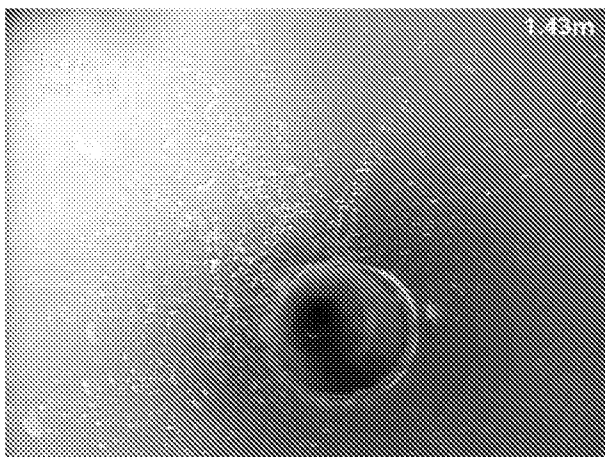
3, 00:00:20, 1.50 m  
Finish node, manhole, reference: SP45

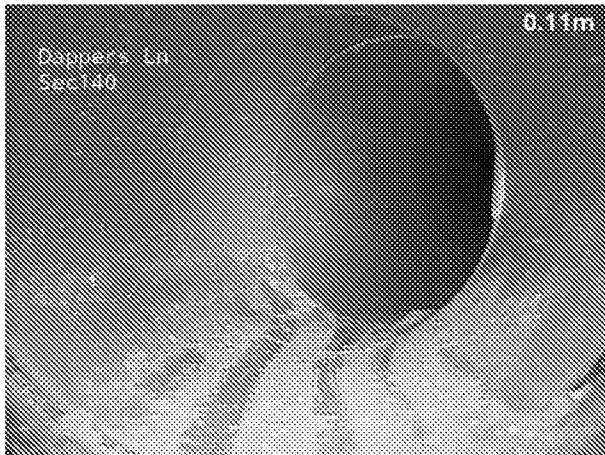
1, 00:00:04, 0.10 m  
Line deviates right

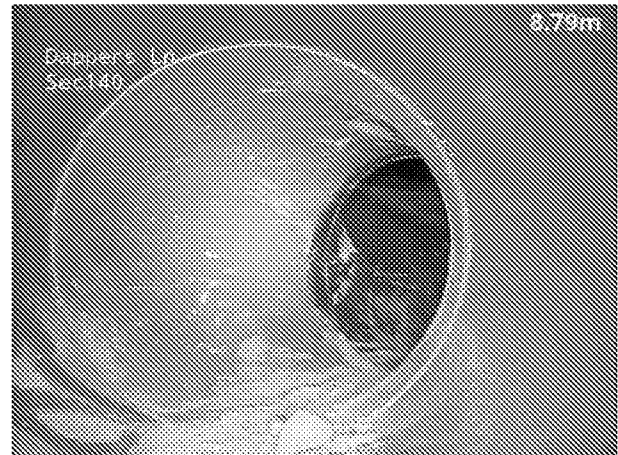
2, 00:00:42, 8.90 m  
Line deviates right

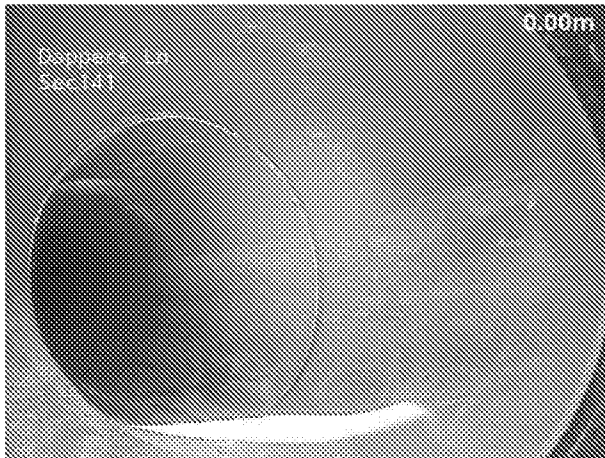
1, 00:00:03, 0.10 m  
Line deviates left

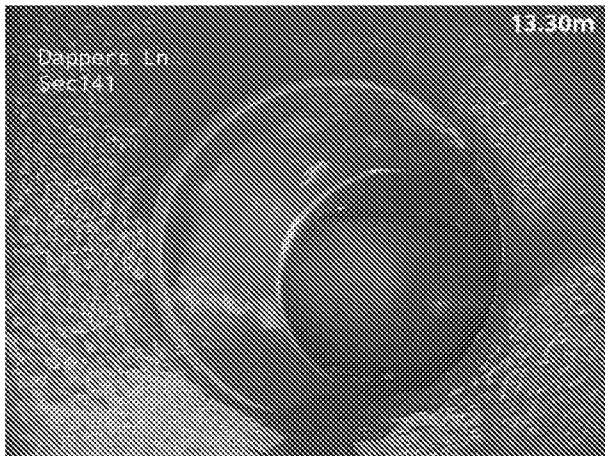
3, 00:00:55, 13.40 m  
Line deviates right

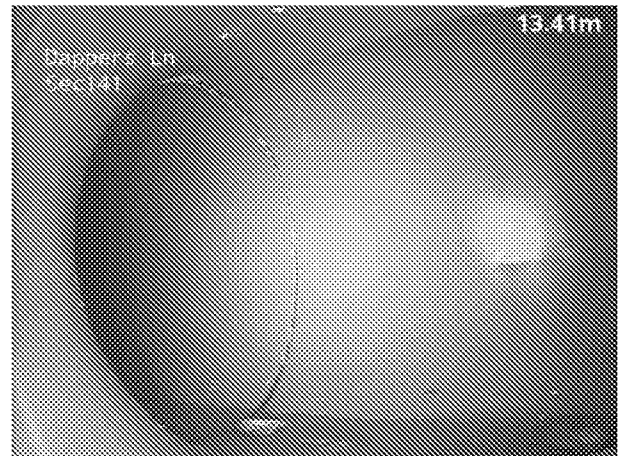
4, 00:00:58, 13.50 m  
Finish node, major connection without manhole, reference: JN

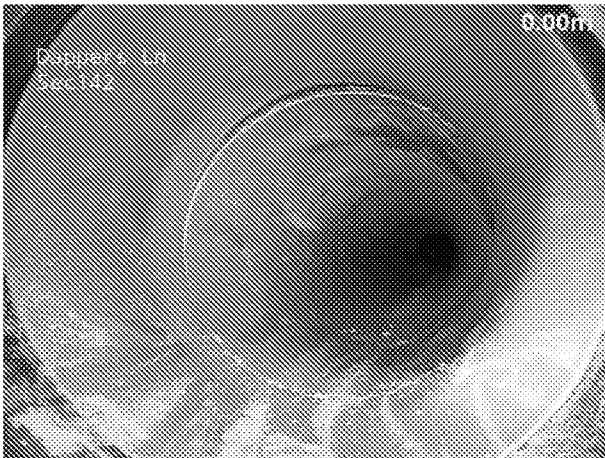
1, 00:00:03, 0.00 m  
Water level, 0% of the vertical dimension

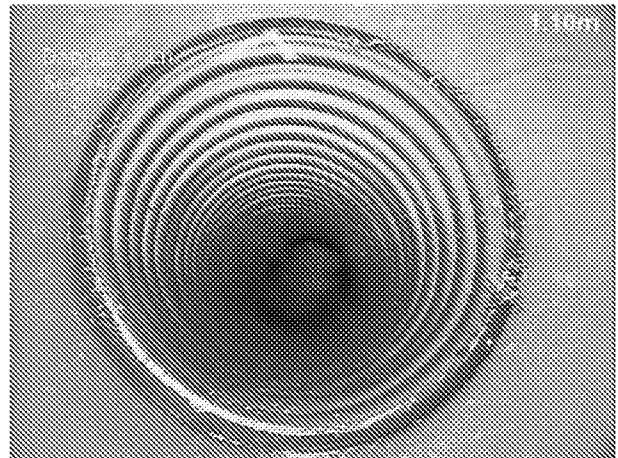
2, 00:00:12, 1.20 m  
Finish node, manhole, reference: LD

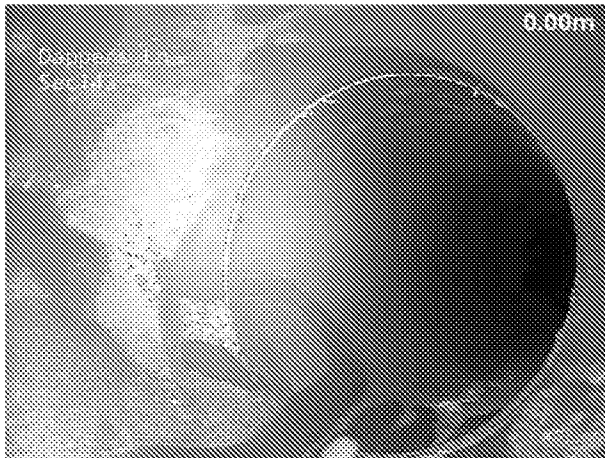
1, 00:00:02, 0.10 m  
Line deviates right

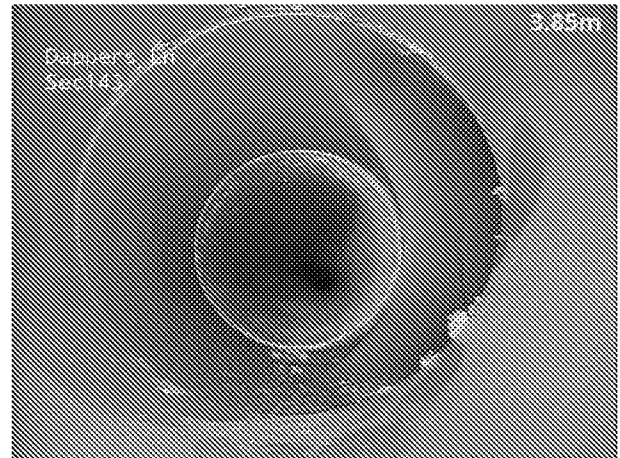
2, 00:00:23, 4.00 m  
Junction at 3 o'clock, 100mm dia

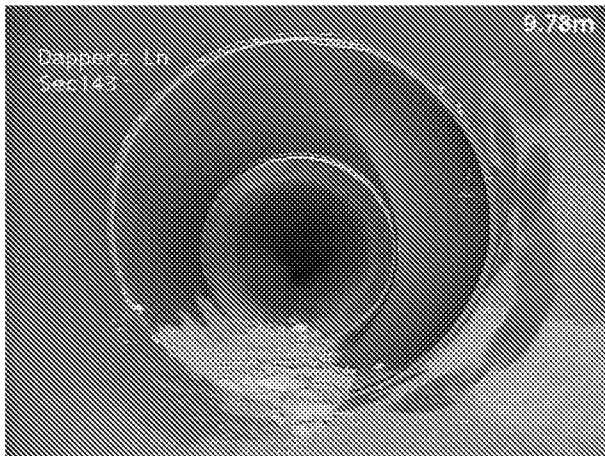
3, 00:00:43, 9.90 m  
Junction at 3 o'clock, 100mm dia

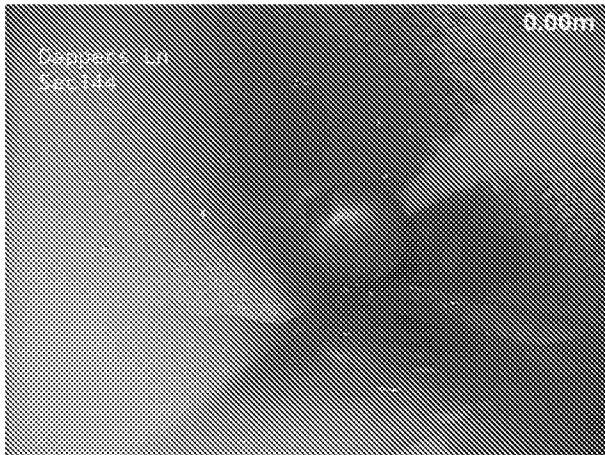
1, 00:00:12, 0.00 m  
Water level, 0% of the vertical dimension

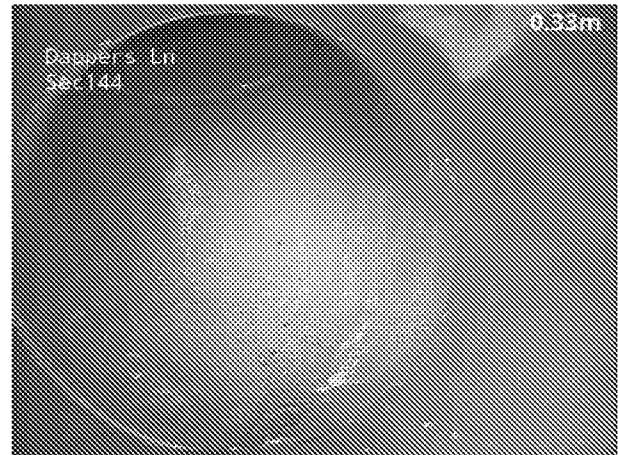
2, 00:00:19, 0.50 m  
Line deviates up

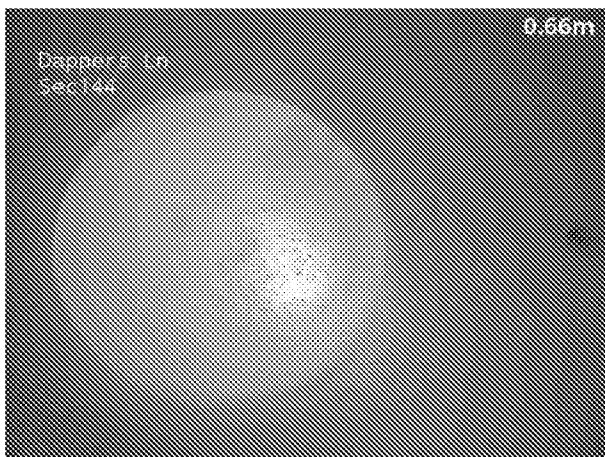
3, 00:00:26, 0.80 m  
Finish node, manhole, reference: RWP
