## Section Inspection - 20/07/2021 - S18X

| Town or Village: | Angmering | Inspection Direction: | Downstream | Upstream Node: | S18 |
| Road: | Dappers Lane | Inspected Length: | 14.00 m | Upstream Pipe Depth: | |

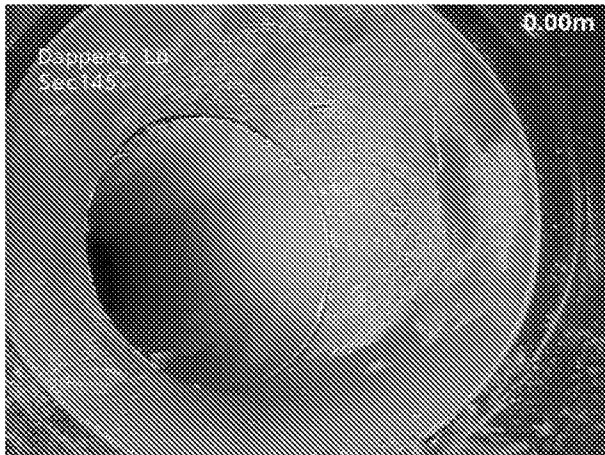
1, 00:00:03, 0.10 m  
Line deviates left

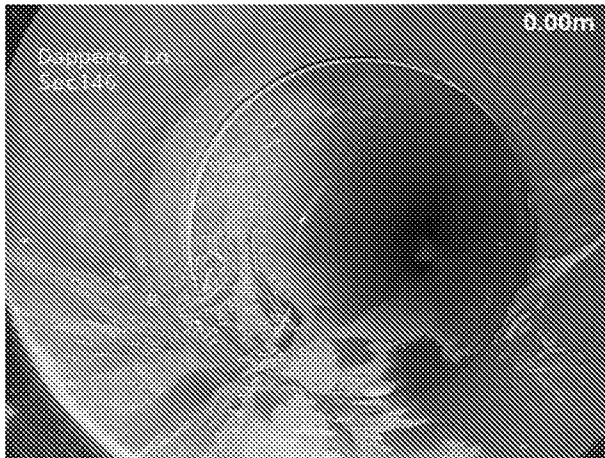
1, 00:00:06, 0.00 m  
Water level, 0% of the vertical dimension

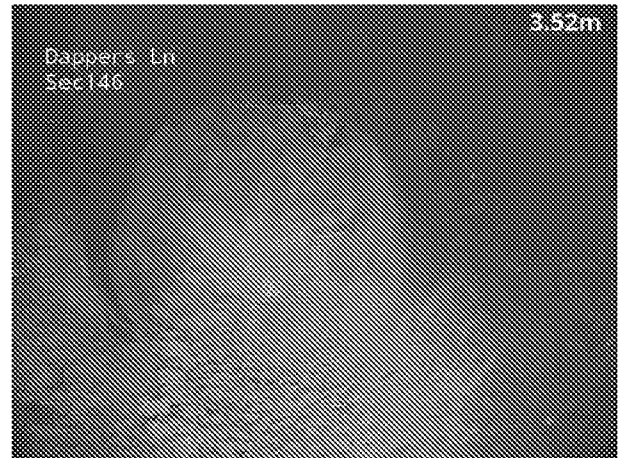
2, 00:00:22, 3.60 m  
Line deviates up

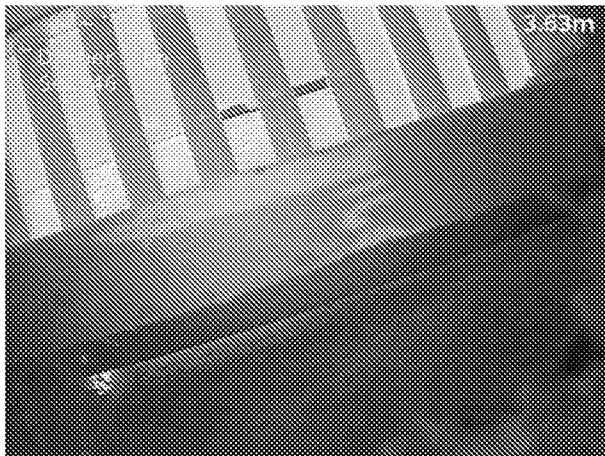
3, 00:00:26, 3.80 m  
Finish node, gully, reference: ACO

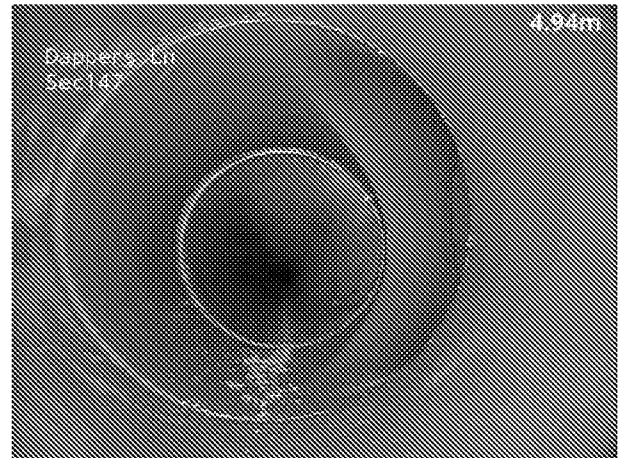
2, 00:00:24, 5.10 m  
Junction at 3 o'clock, 100mm dia

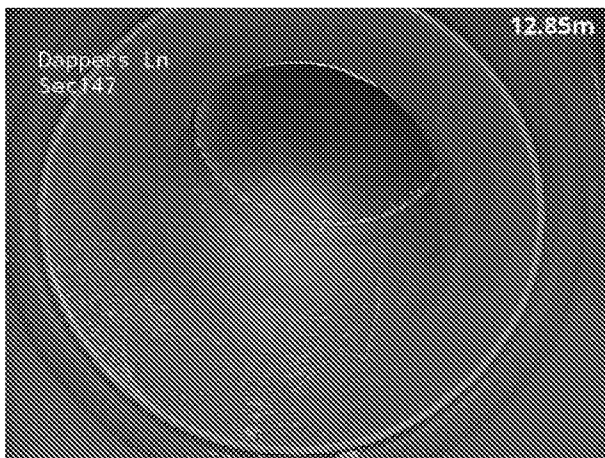
5, 00:00:52, 13.00 m  
Line deviates up

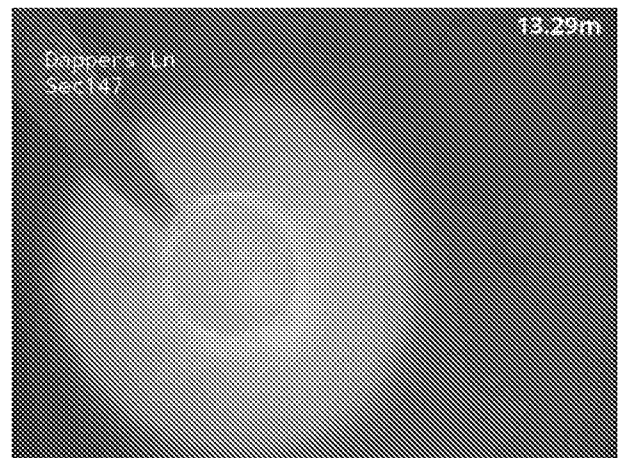
6, 00:00:56, 13.50 m  
Finish node, rodding eye, reference: RE

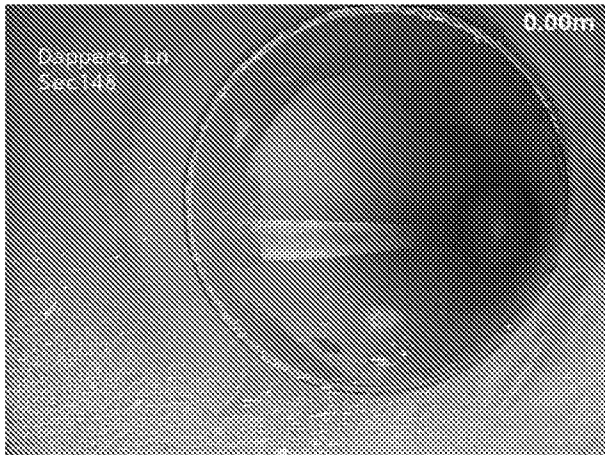
1, 00:00:03, 0.10 m  
Line deviates right

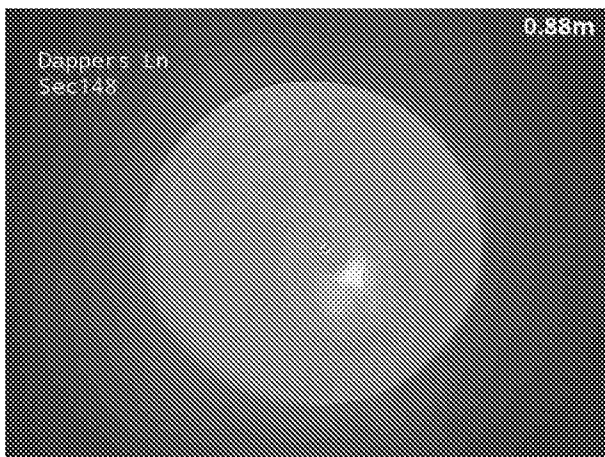
3, 00:00:16, 1.00 m  
Finish node, manhole, reference: RWP

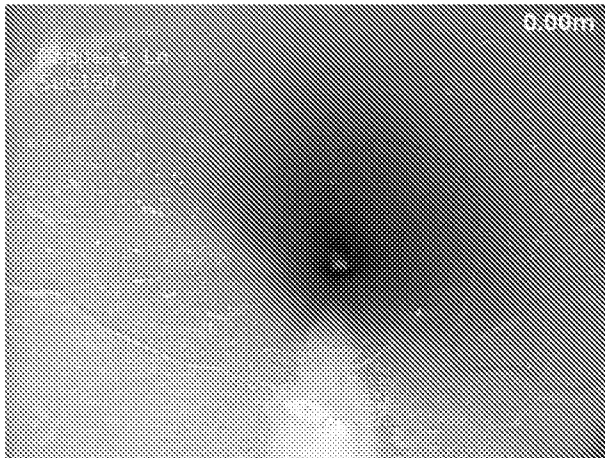
1, 00:00:02, 0.00 m  
Water level, 0% of the vertical dimension

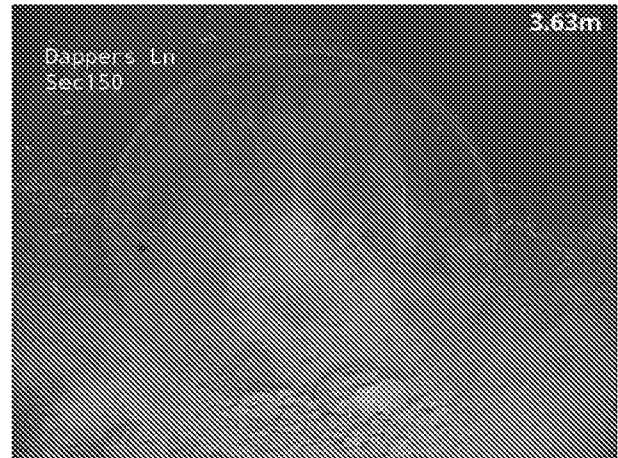
2, 00:00:16, 3.70 m  
Line deviates up

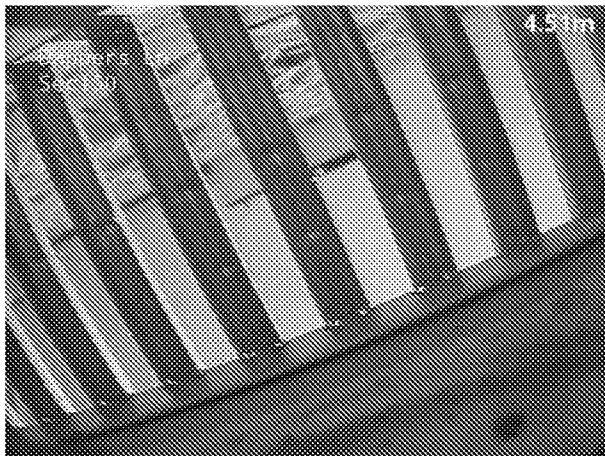
3, 00:00:14, 4.50 m  
Finish node, gully, reference: ACO

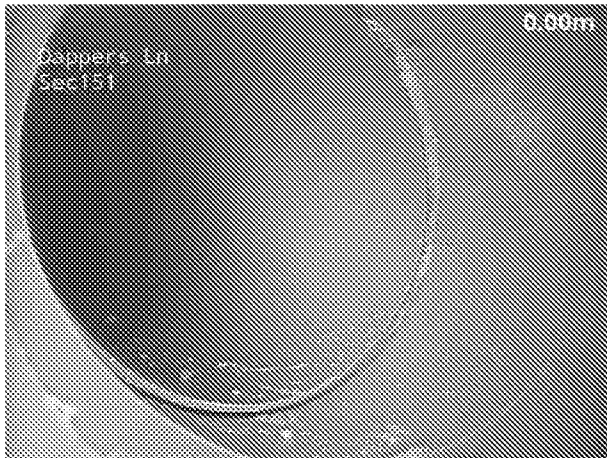
1, 00:00:02, 0.10 m  
Line deviates left

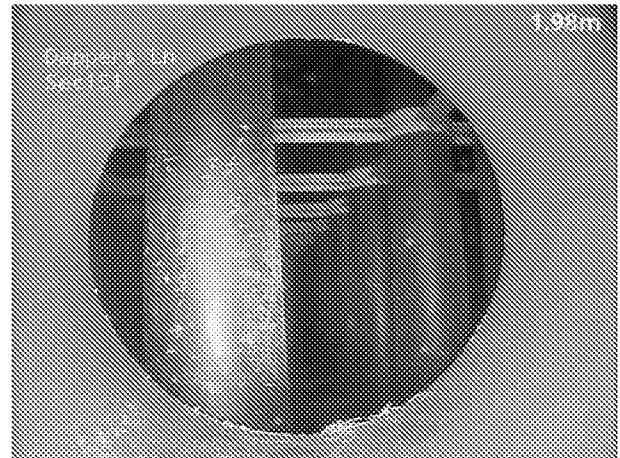
2, 00:00:22, 2.10 m  
Finish node, manhole, reference: A, Assumed attenuation

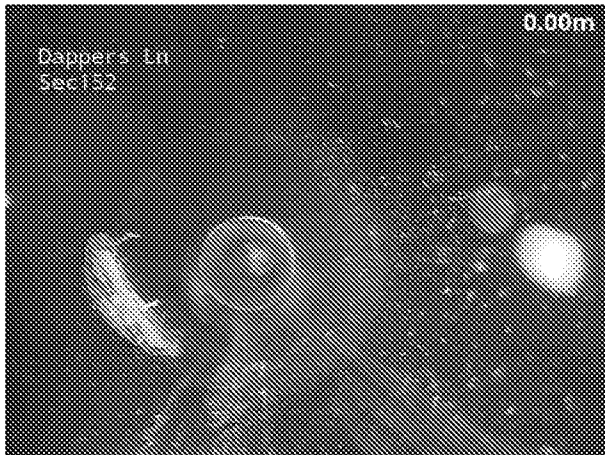
1, 00:01:34, 0.00 m  
Water level, 0% of the vertical dimension

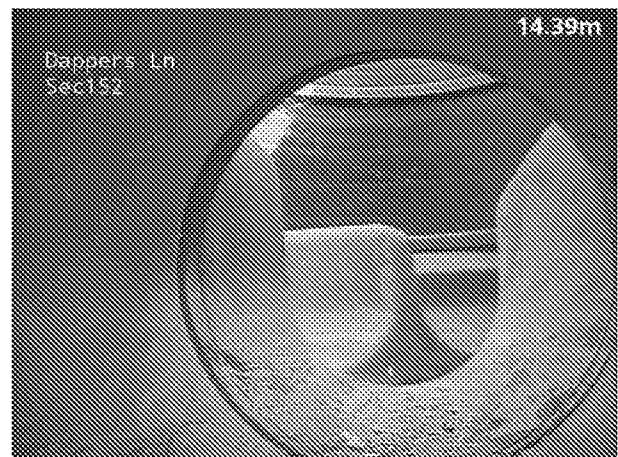
4, 00:00:04, 14.40 m  
Finish node, manhole, reference: F14

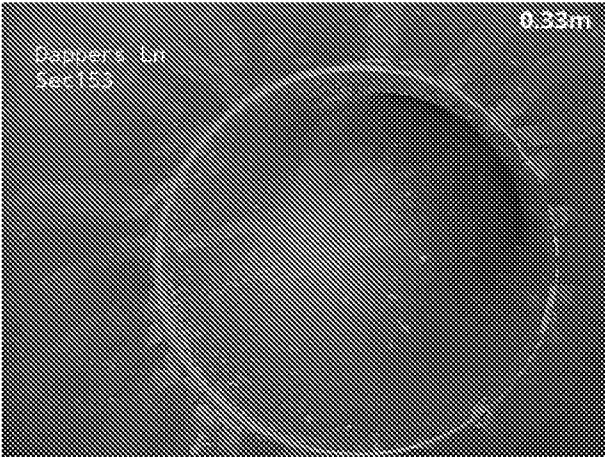
| <p>1, 00:00:02, 0.00 m<br/>Water level, 0% of the vertical dimension</p> | <p>2, 00:00:06, 0.60 m<br/>General remark, Rest bend</p> |

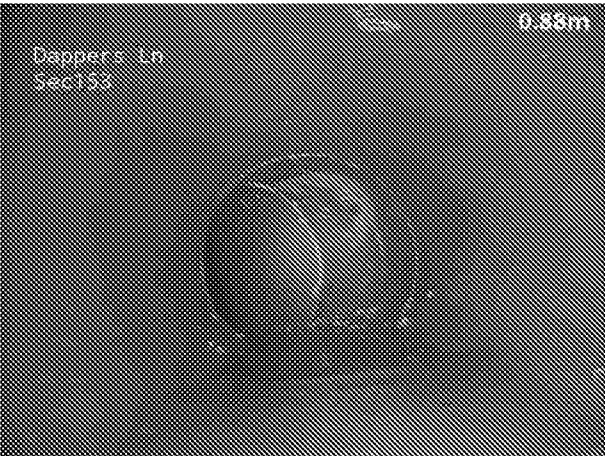
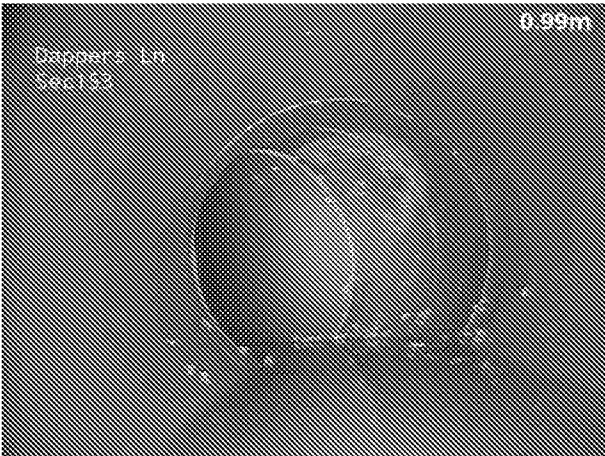
| <p>3, 00:00:13, 0.80 m<br/>Water level, 5% of the vertical dimension</p> | <p>4, 00:00:17, 1.10 m<br/>Line deviates left</p> |

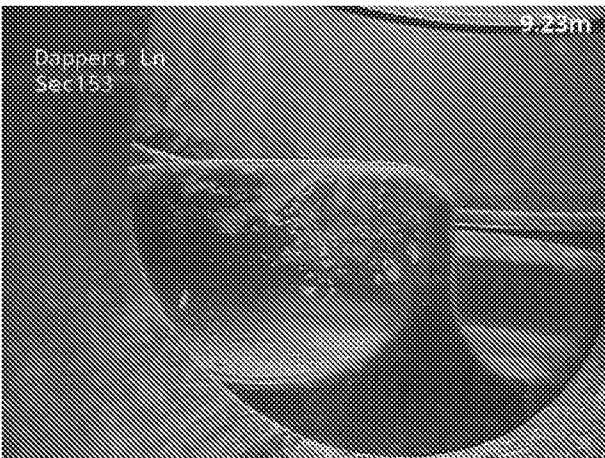
| <p>5, 00:00:43, 5.80 m<br/>Line deviates left</p> | <p>6, 00:01:07, 9.40 m<br/>Finish node, manhole, reference: F20</p> |

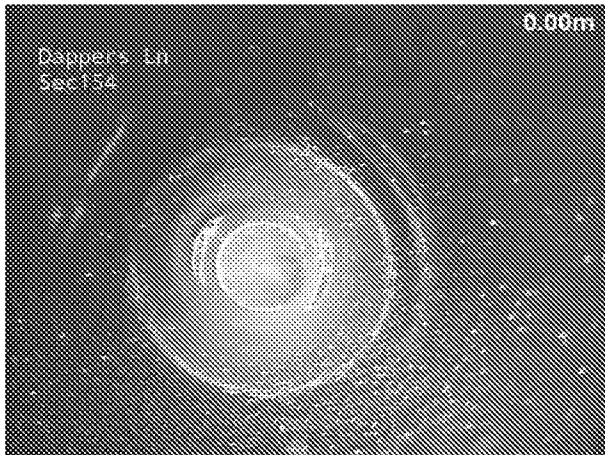
1, 00:00:03, 0.00 m  
Water level, 0% of the vertical dimension

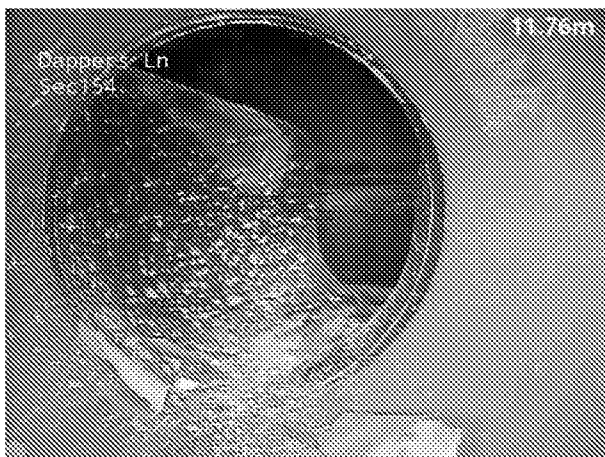
3, 00:01:03, 12.00 m  
Finish node, manhole, reference: F20

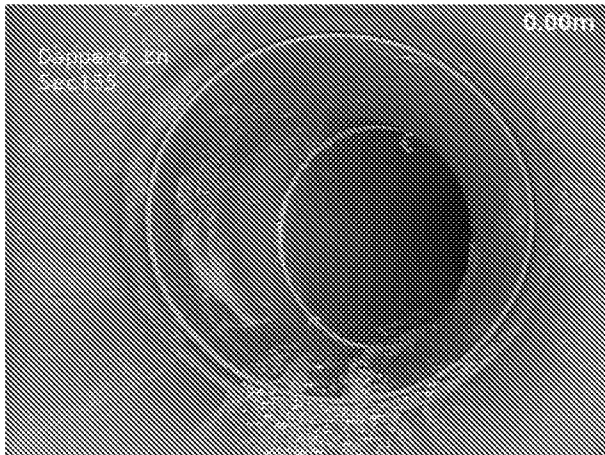
1, 00:00:50, 0.10 m  
Line deviates right

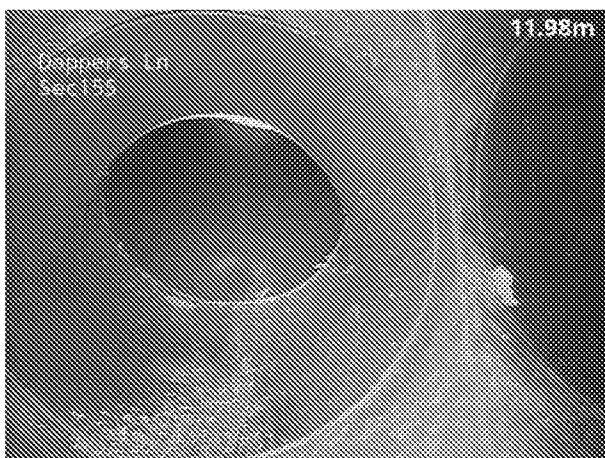
5, 00:00:06, 12.20 m  
Line deviates up

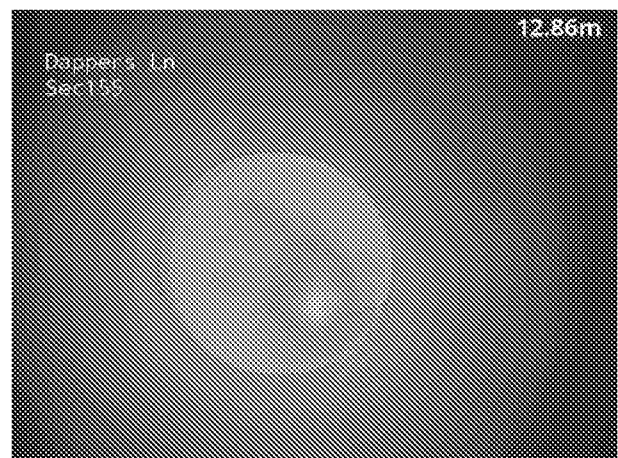
6, 00:00:01, 13.00 m  
Finish node, rodding eye, reference: RE

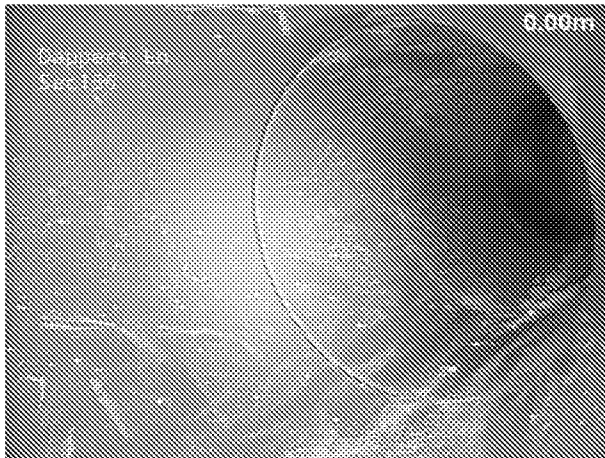
1, 00:00:06, 0.10 m  
Line deviates right

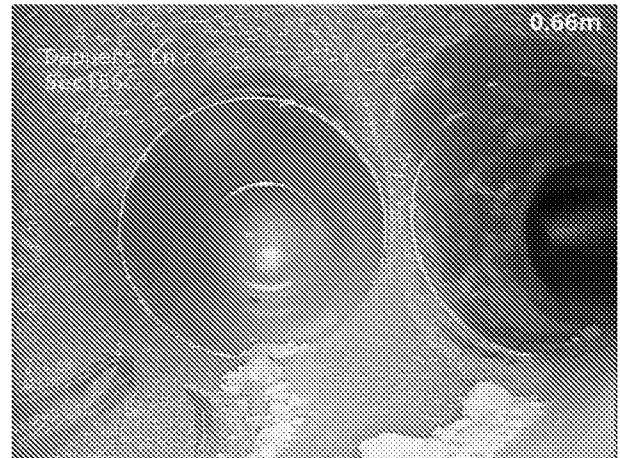
2, 00:00:18, 0.40 m  
Junction at 3 o'clock, 100mm dia

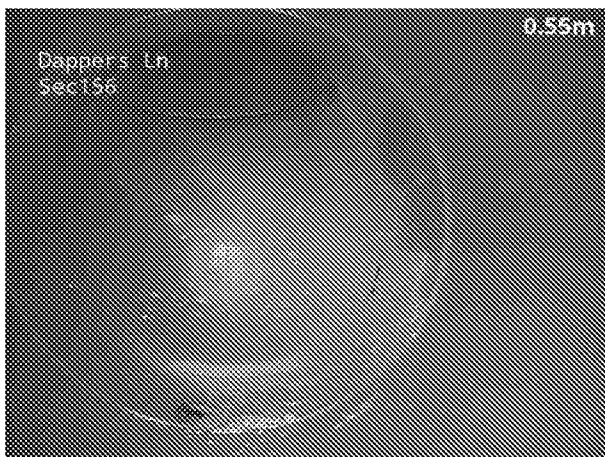
3, 00:00:29, 0.80 m  
Line deviates up

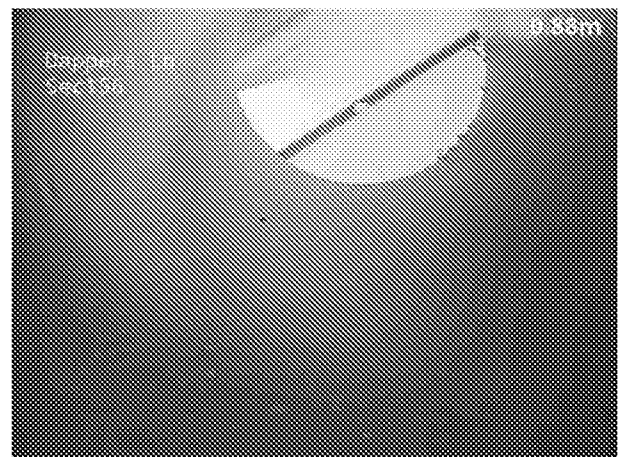
4, 00:00:35, 1.00 m  
Finish node, manhole, reference: RWP

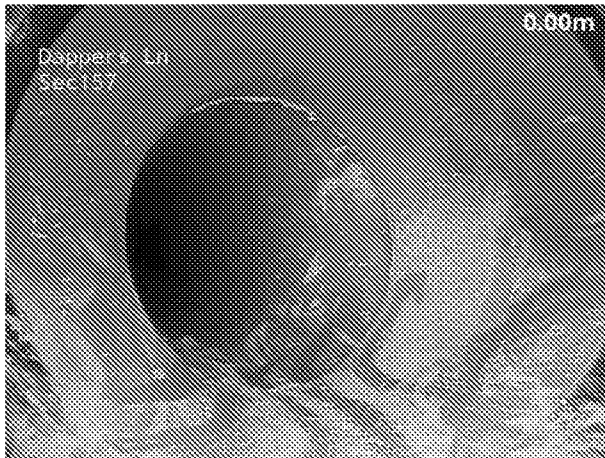
1, 00:00:02, 0.10 m  
Line deviates left

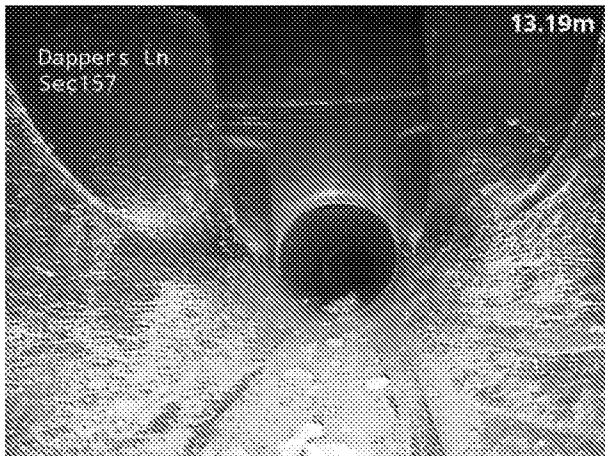
3, 00:00:40, 13.20 m  
Finish node, manhole, reference: S36

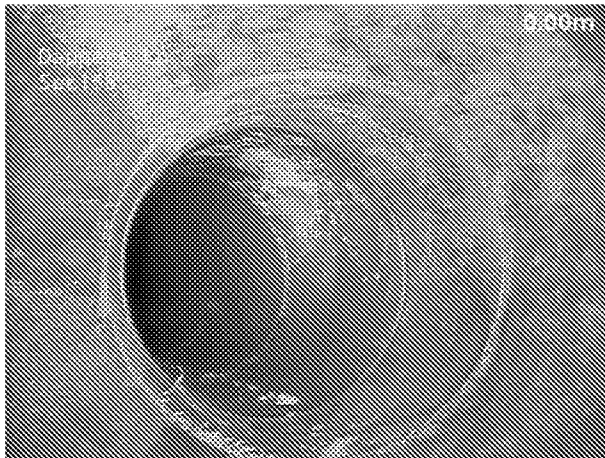
1, 00:00:04, 0.10 m  
Line deviates left

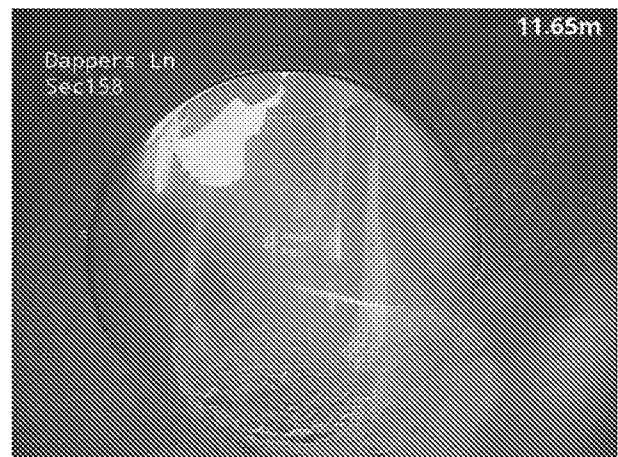
4, 00:00:33, 11.80 m  
Line deviates up

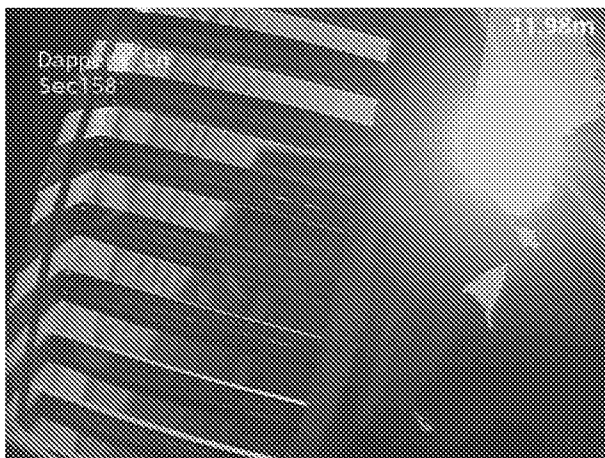
5, 00:00:38, 12.00 m  
Finish node, gully, reference: ACO

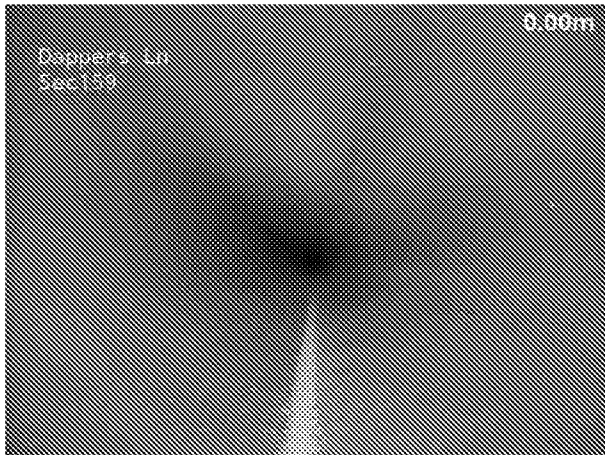
1, 00:00:00, 0.00 m  
Water level, 0% of the vertical dimension

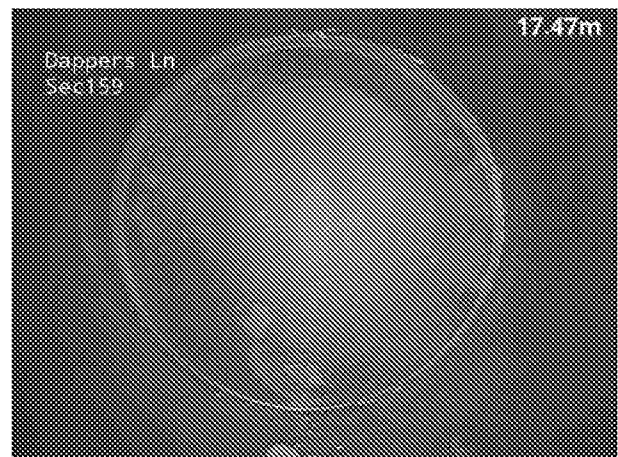
4, 00:00:44, 17.60 m  
Line deviates up

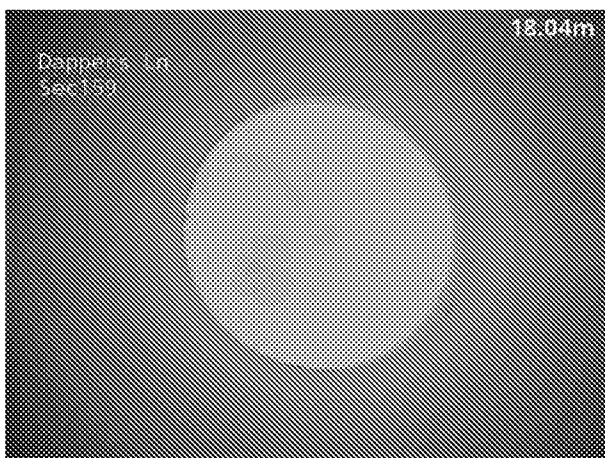
5, 00:00:50, 18.10 m  
Finish node, manhole, reference: RWP

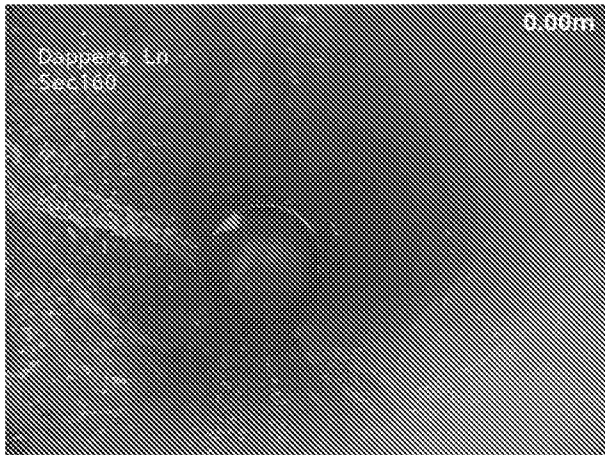
1, 00:00:00, 0.00 m  
Water level, 0% of the vertical dimension

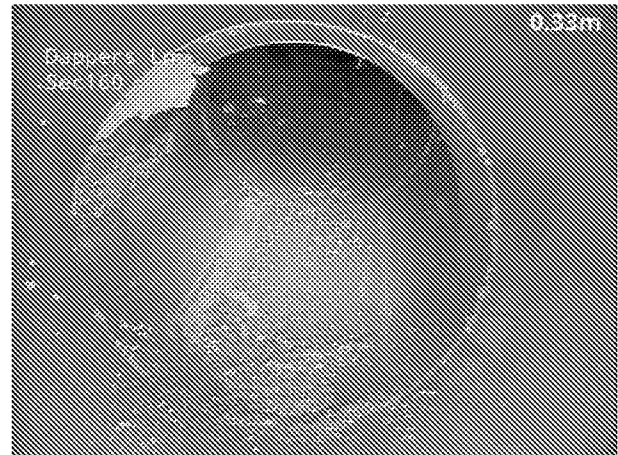
2, 00:00:05, 0.50 m  
General remark, Line reverts horizontal

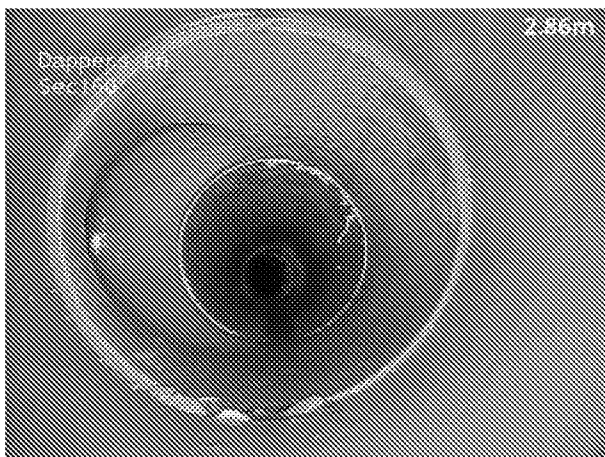
3, 00:00:14, 3.00 m  
Junction at 9 o'clock, 100mm dia

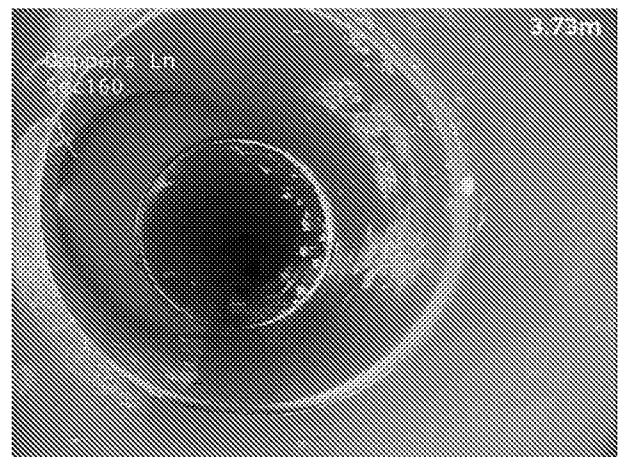
4, 00:00:18, 4.00 m  
Line deviates left

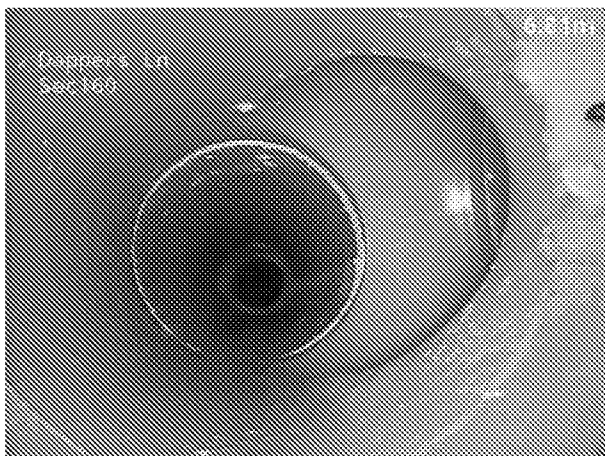
5, 00:00:27, 7.00 m  
Junction at 3 o'clock, 100mm dia

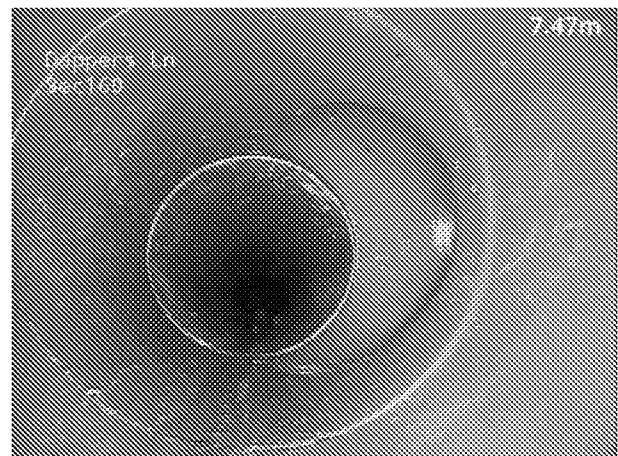
6, 00:00:35, 7.60 m  
Junction at 3 o'clock, 100mm dia

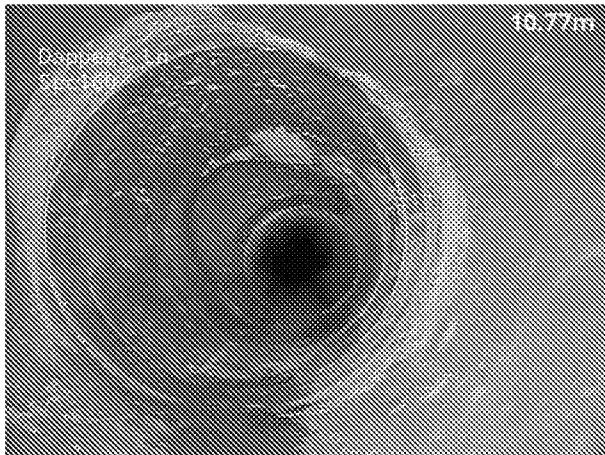
7, 00:00:49, 10.90 m  
Line deviates right

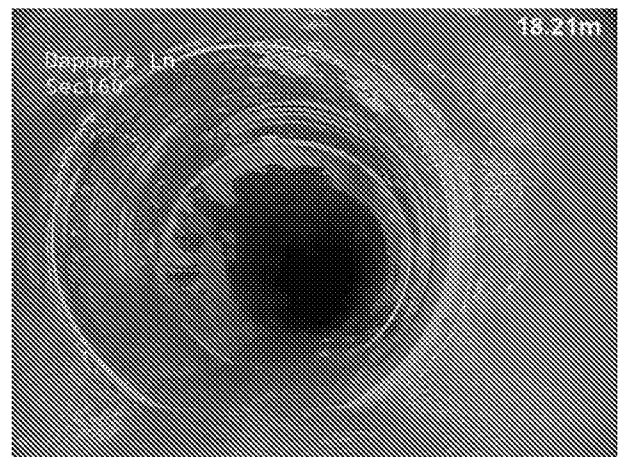
10, 00:01:16, 18.40 m  
Line deviates right

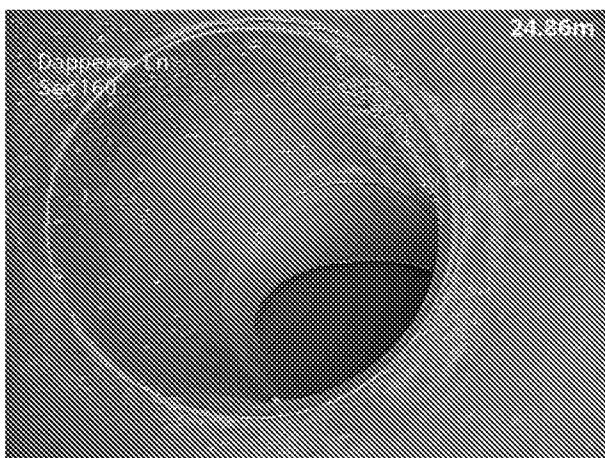
11, 00:01:39, 25.00 m  
Line deviates down

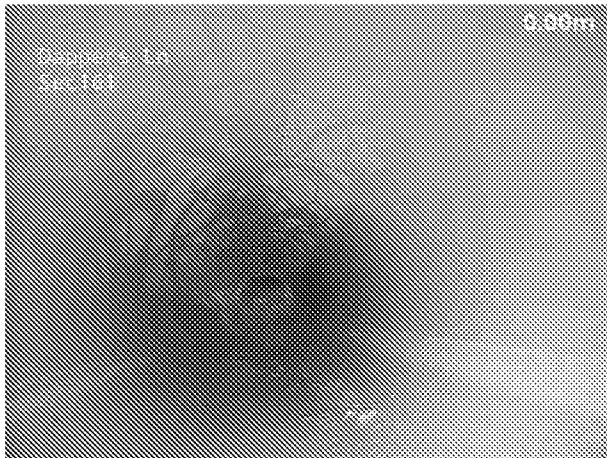
1, 00:00:00, 0.00 m  
Water level, 0% of the vertical dimension

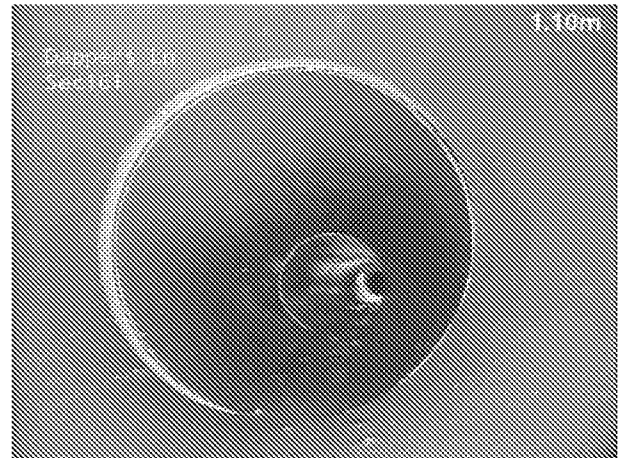
2, 00:00:08, 1.20 m  
Line deviates right

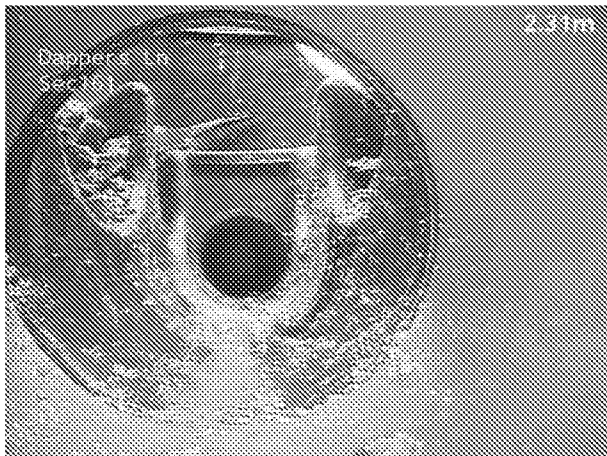
3, 00:00:15, 2.50 m  
Finish node, manhole, reference: S41

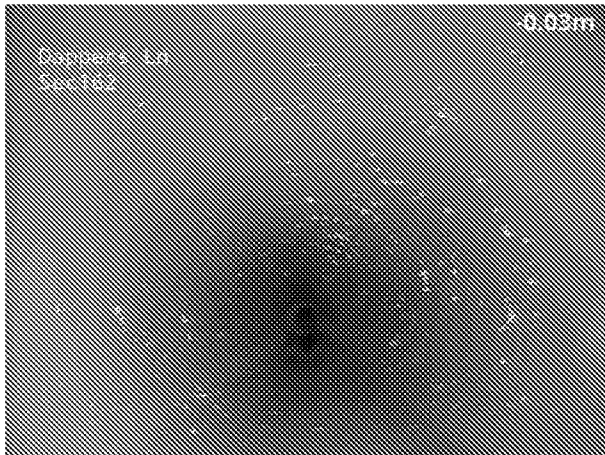
1, 00:00:01, 0.00 m  
Water level, 0% of the vertical dimension

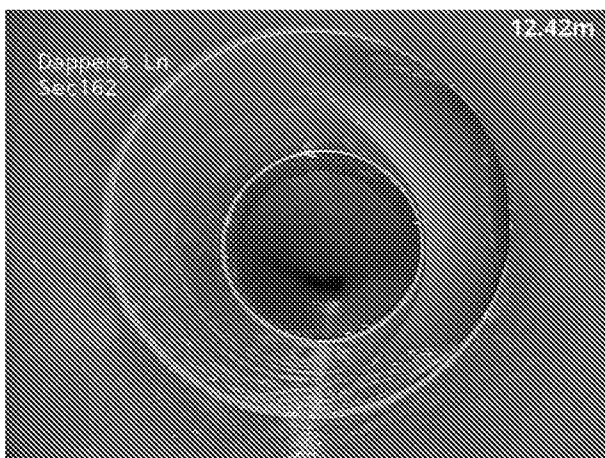
5, 00:00:51, 12.60 m  
Junction at 3 o'clock, 100mm dia

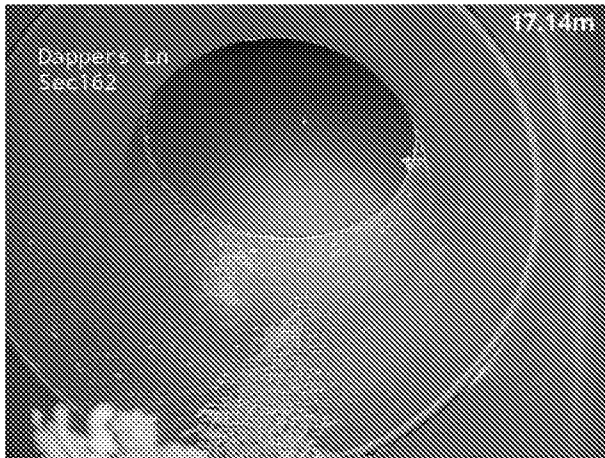
7, 00:01:08, 17.20 m  
Line deviates up

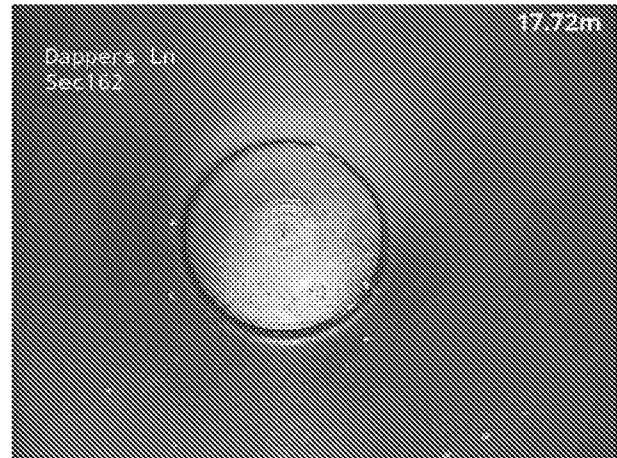
8, 00:01:12, 17.90 m  
Finish node, rodding eye, reference: RE10
