**Project Name:** Mackoy Ltd - Langmead Place Angmering

**Project Date:** 04/11/2025

**Inspection Standard:** MSCC5 Sewers & Drainage GB (SRM5 Scoring)

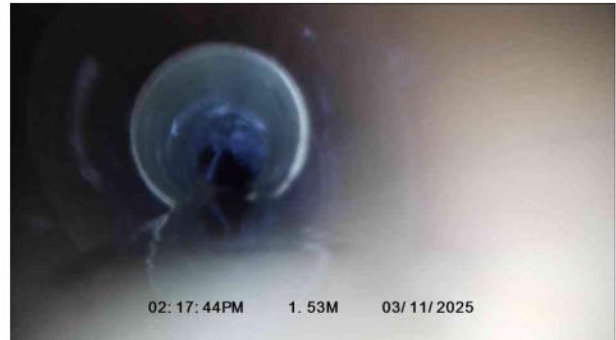
| Scale: | 1:95 | Position [m] | Code | Observation | MPEG | Photo | Grade |
|---|---|---|---|---|---|---|---|
| | 1.53 | S01 | RPL | Point repair, localised lining from 12 o'clock to 11 o'clock, start | 00:00:18 | 2 | |

2, 00:00:18, 1.53 m  
Point repair, localised lining from 12 o'clock to 11 o'clock, start

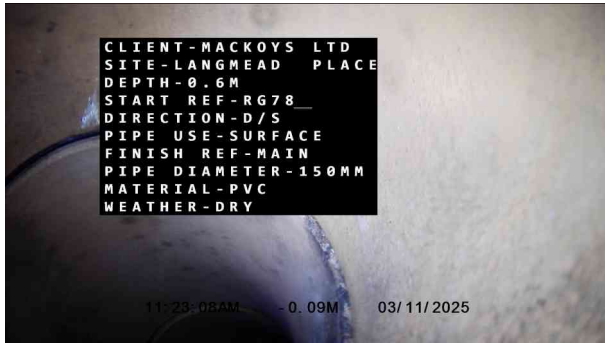
1, 00:00:00, 0.00 m  
Start node, gully, reference: RG78

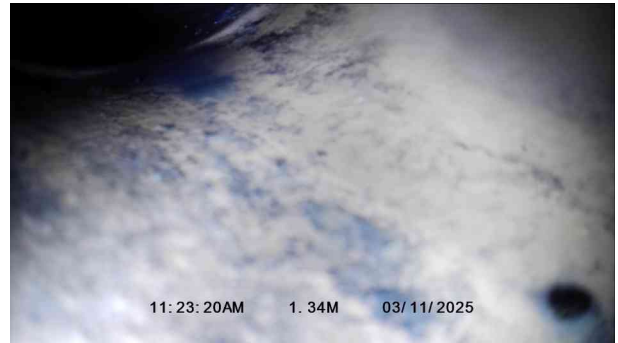
2, 00:00:12, 1.35 m  
Finish node, major connection without manhole, reference:  
MAIN

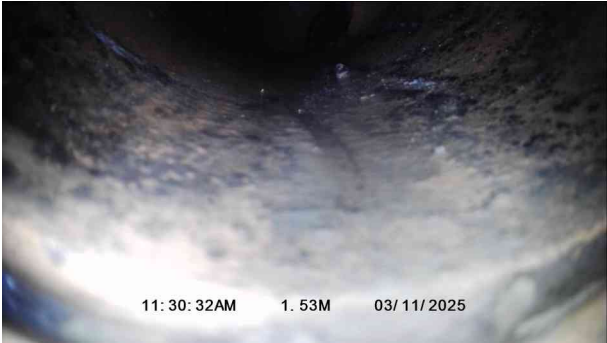
2, 00:00:31, 1.53 m  
Finish node, major connection without manhole, reference: MAIN

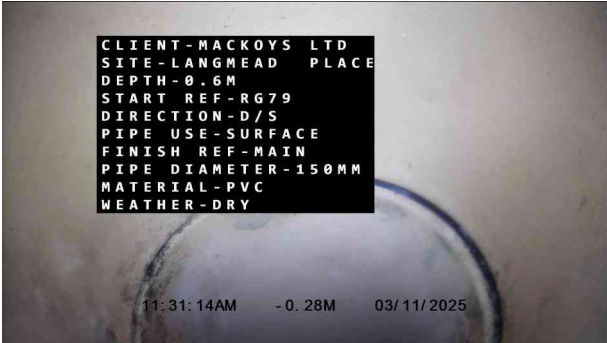
1, 00:00:00, 0.00 m  
Start node, gully, reference: RG79

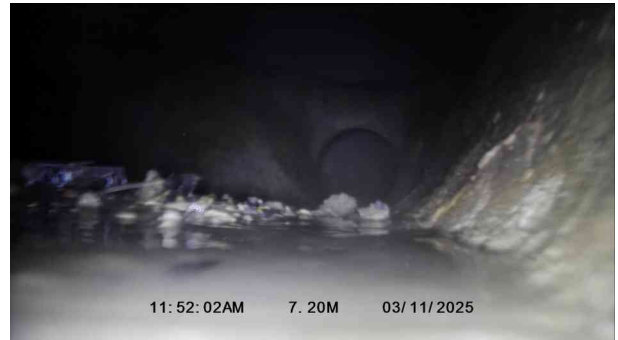
2, 00:00:29, 7.20 m  
Finish node, manhole, reference: MAIN

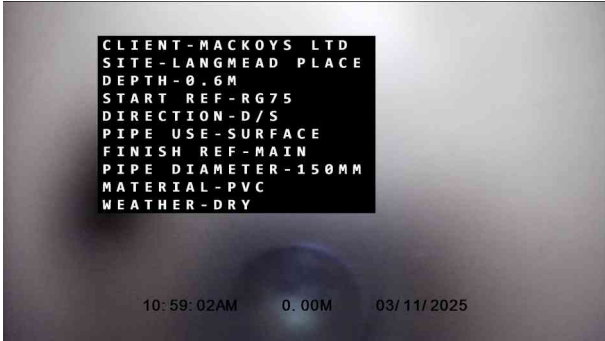
1, 00:00:00, 0.00 m  
Start node, gully, reference: RG75

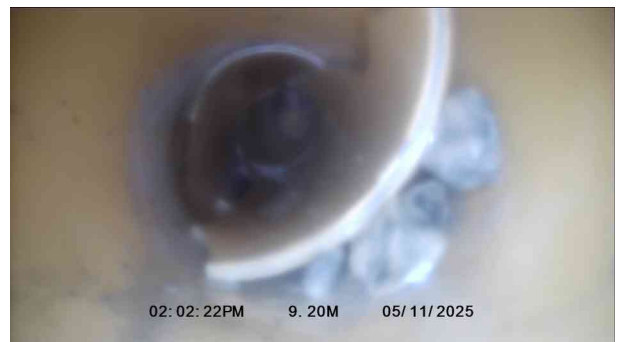
4, 00:00:55, 9.20 m  
Finish node, rodding eye, reference: RE373

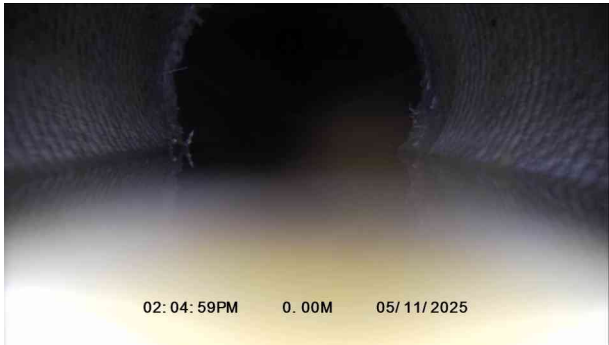
| Scale: | 1:63 | Position [m] | Code | Observation | MPEG | Photo | Grade |
|---|---|---|---|---|---|---|---|
| | | 0.00 | S01 | RPL Point repair, localised lining from 12 o'clock to 11 o'clock, start | 00:00:08 | 2 | |
| | | 0.32 | F01 | RPL Point repair, localised lining from 12 o'clock to 11 o'clock, finish | 00:00:45 | | |

2, 00:00:08, 0.00 m  
Point repair, localised lining from 12 o'clock to 11 o'clock, start

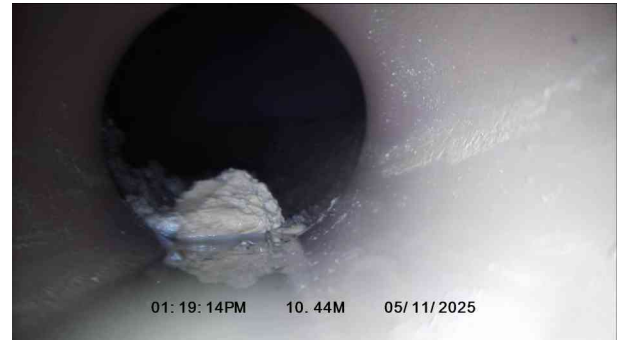
2, 00:00:38, 10.44 m  
Finish node, manhole, reference: 337

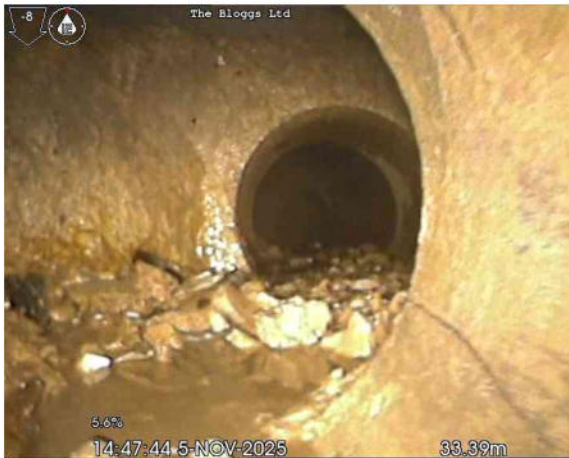
1, 00:03:39, 33.39 m  
Finish node, manhole, reference: S217

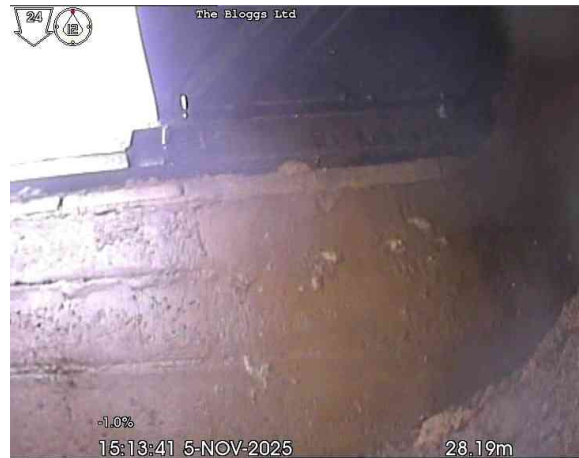
2, 00:02:13, 28.19 m  
Finish node, manhole, reference: 324

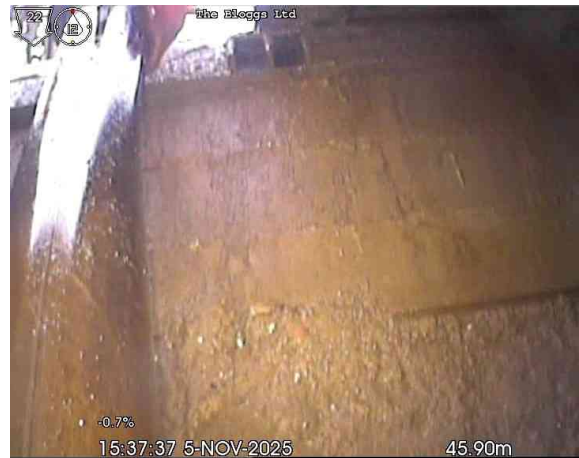
2, 00:05:30, 45.97 m  
Finish node, manhole, reference: 326

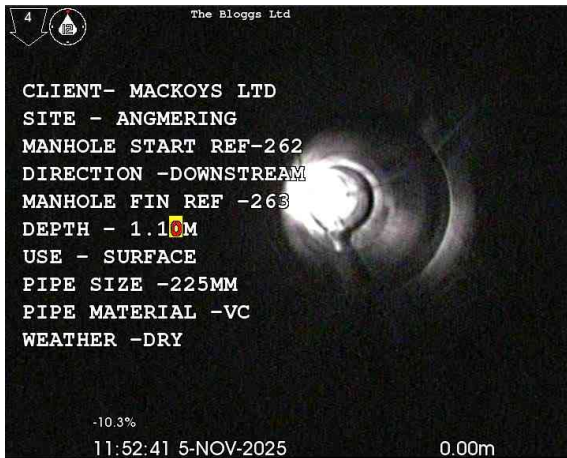
1, 00:00:00, 0.00 m  
Start node, manhole, reference: 262

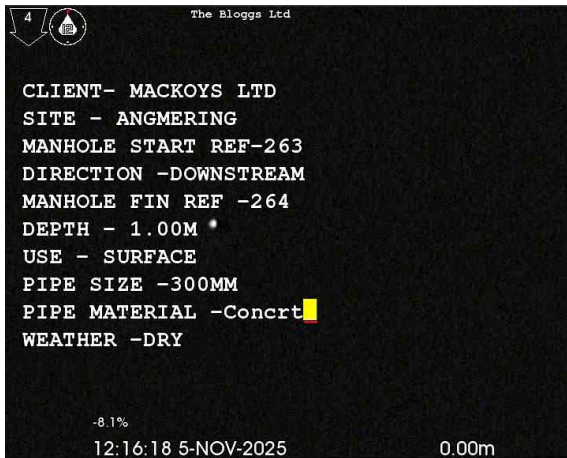
1, 00:00:00, 0.00 m  
Start node, manhole, reference: 263

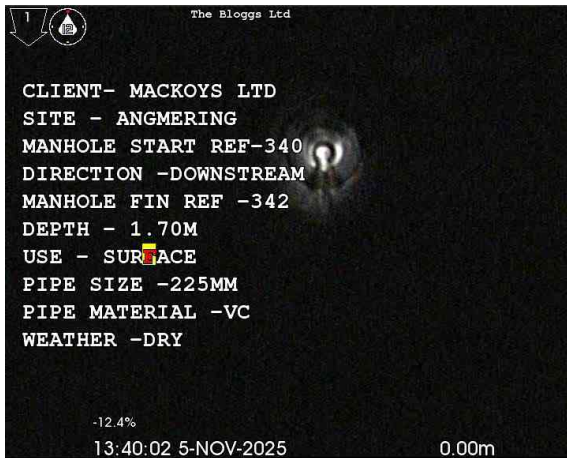
1, 00:00:00, 0.00 m  
Start node, manhole, reference: 340

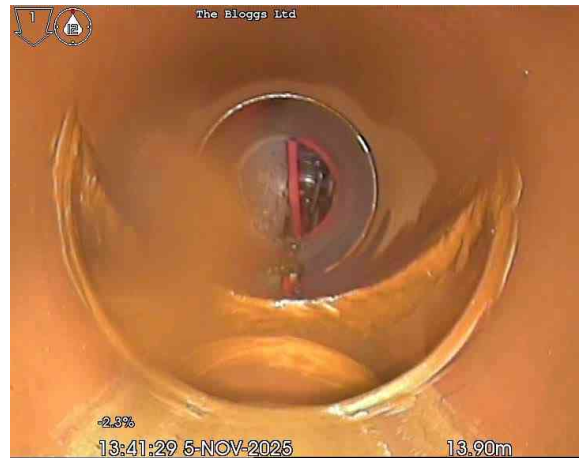
2, 00:01:26, 13.90 m  
Finish node, manhole, reference: 342

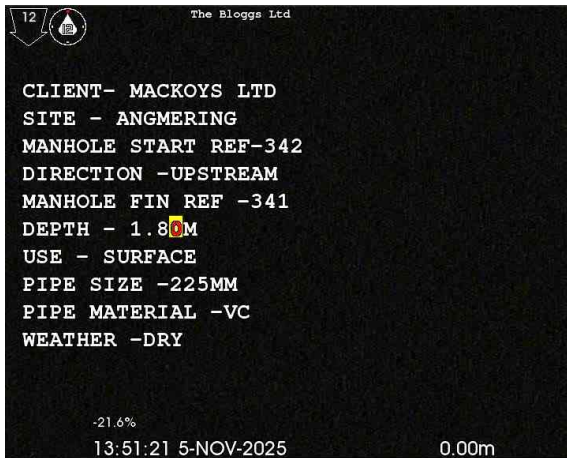
1, 00:00:00, 0.00 m  
Start node, manhole, reference: 342

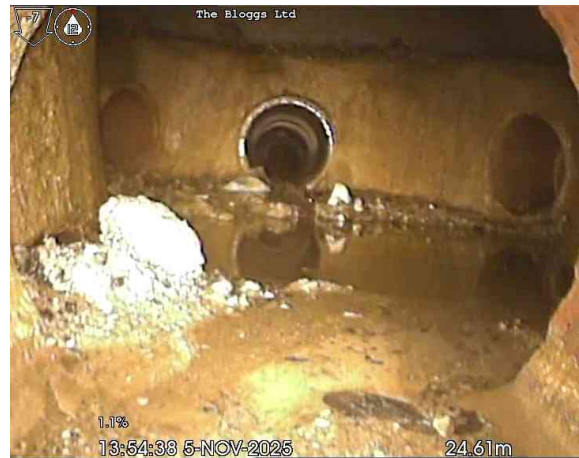
2, 00:03:17, 24.61 m  
Finish node, manhole, reference: 341

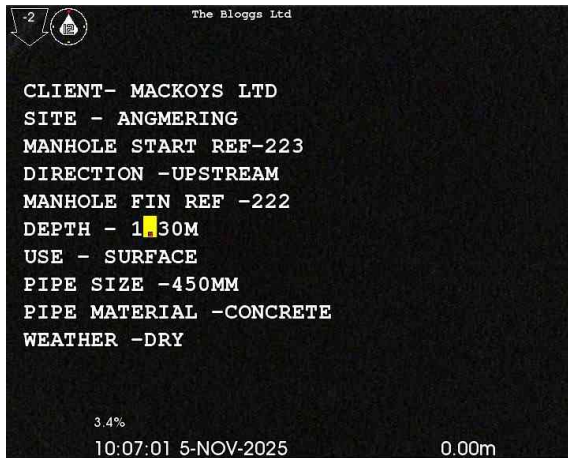
1, 00:00:00, 0.00 m  
Start node, manhole, reference: 223

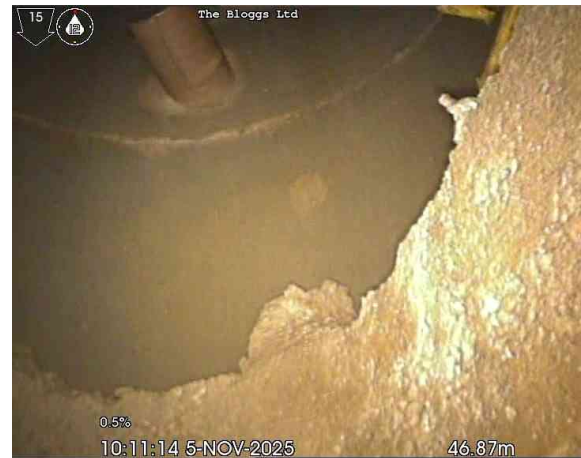
2, 00:04:15, 46.87 m  
Finish node, manhole, reference: 222

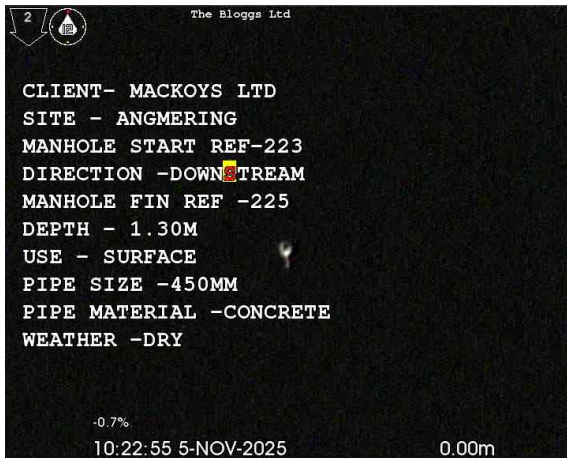
1, 00:00:00, 0.00 m  
Start node, manhole, reference: 223

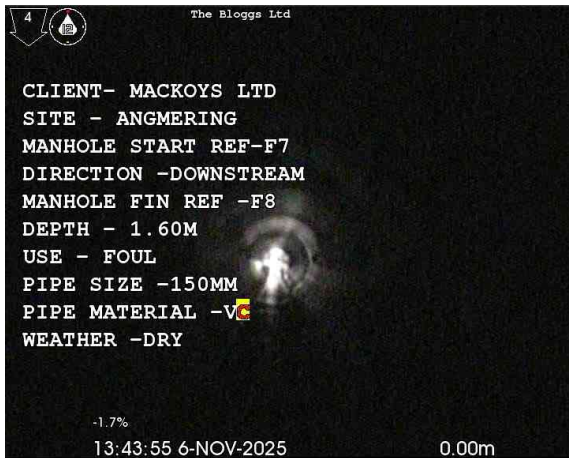
1, 00:00:00, 0.00 m  
Start node, manhole, reference: F7

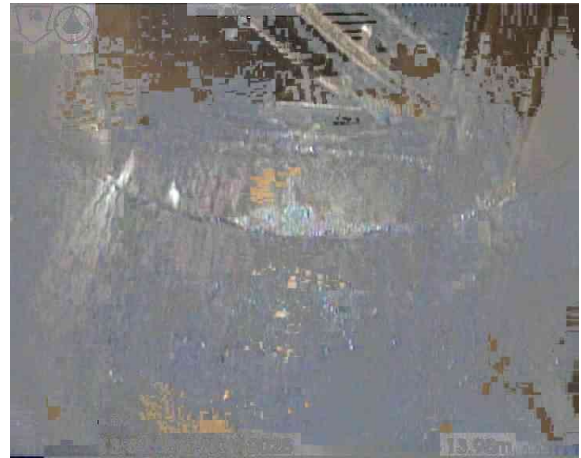
2, 00:02:18, 14.01 m  
Finish node, manhole, reference: F22

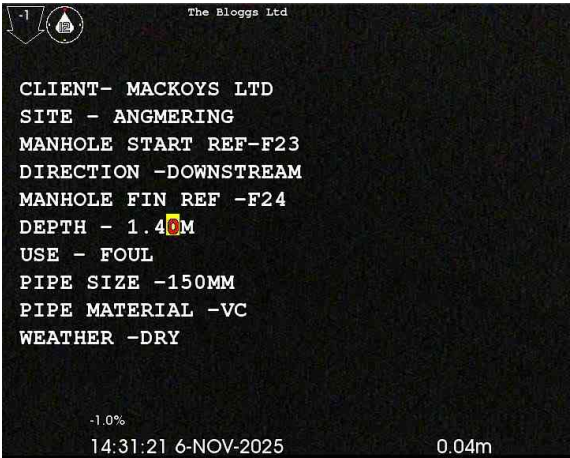
1, 00:00:00, 0.00 m  
Start node, manhole, reference: F23

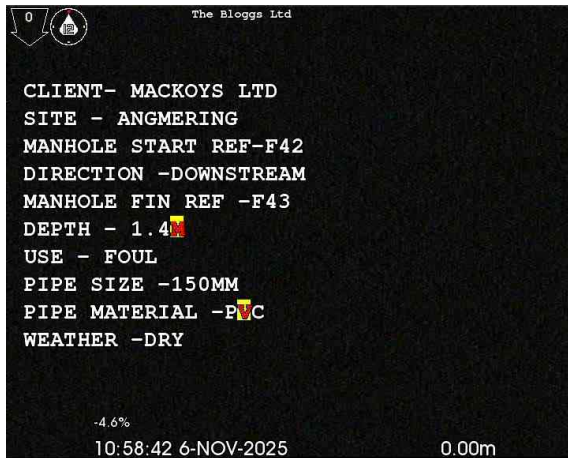
1, 00:00:00, 0.00 m  
Start node, manhole, reference: F42

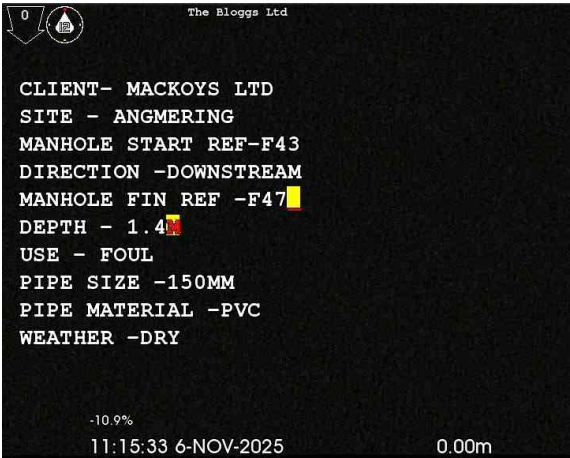
1, 00:00:00, 0.00 m  
Start node, manhole, reference: F43

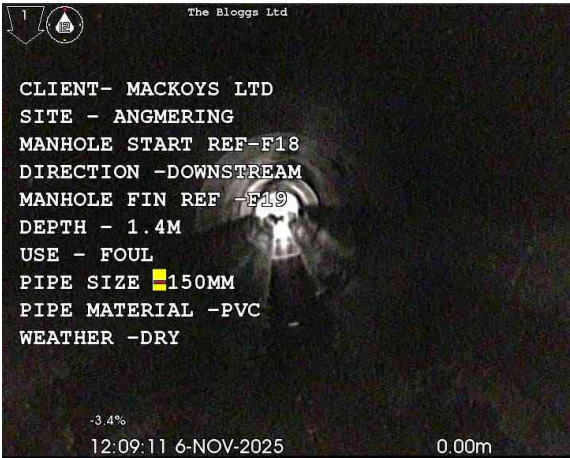
1, 00:00:00, 0.00 m  
Start node, manhole, reference: F18

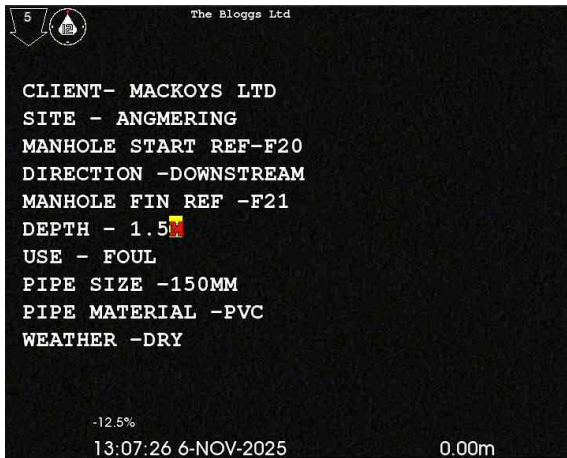
1, 00:00:00, 0.00 m  
Start node, manhole, reference: F20

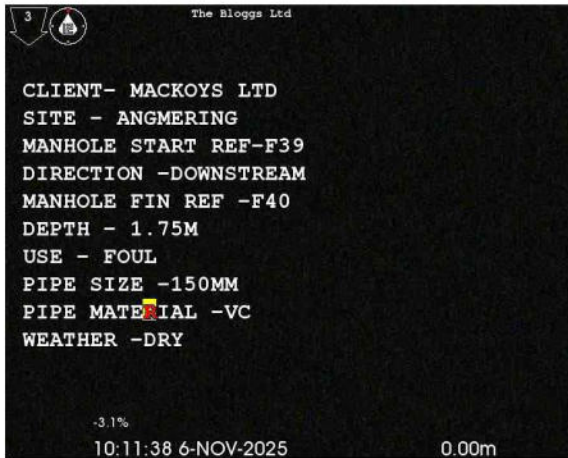
1, 00:00:00, 0.00 m  
Start node, manhole, reference: F39

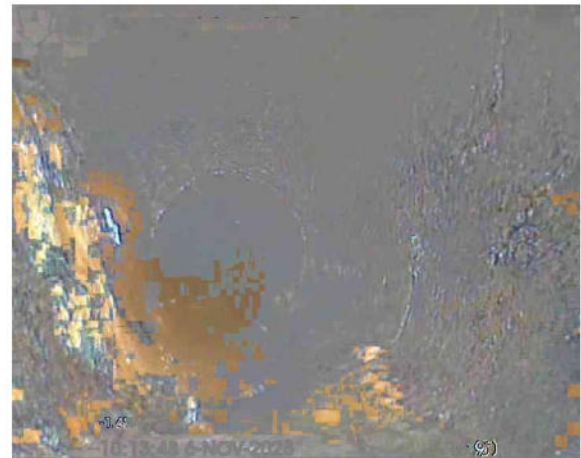
2, 00:02:03, 16.91 m  
Finish node, manhole, reference: F40

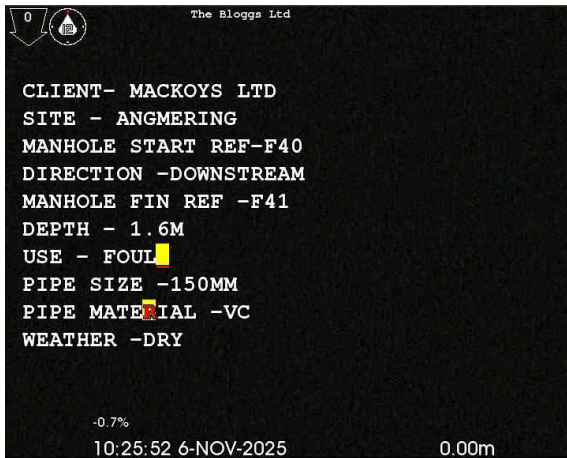
1, 00:00:00, 0.00 m  
Start node, manhole, reference: F40

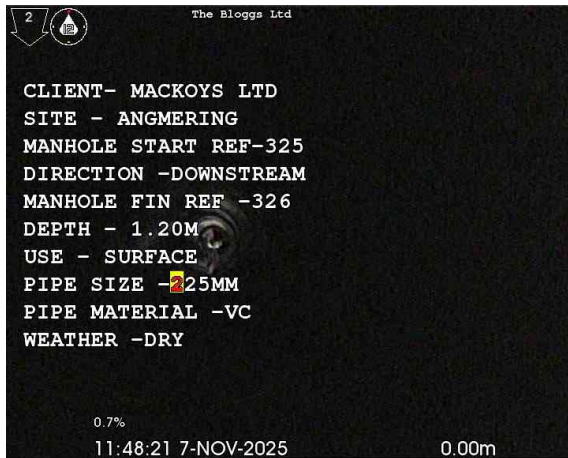
1, 00:00:00, 0.00 m  
Start node, manhole, reference: 325

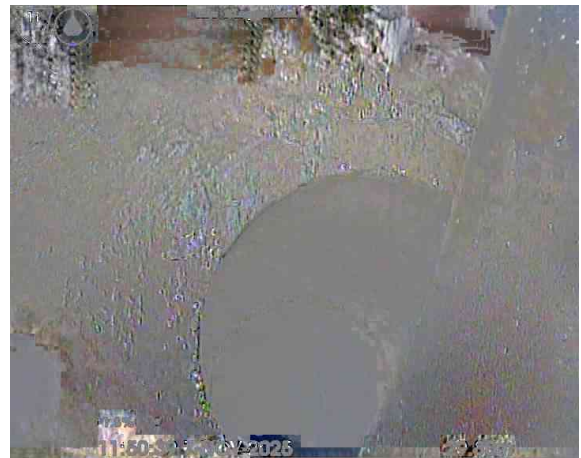
2, 00:02:20, 29.80 m  
Finish node, manhole, reference: 326

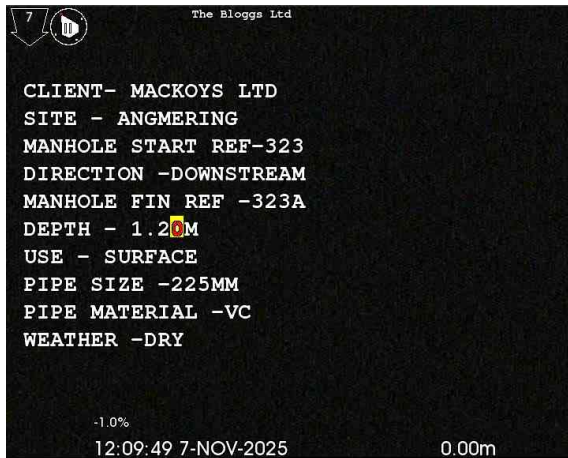
1, 00:00:00, 0.00 m  
Start node, manhole, reference: 323

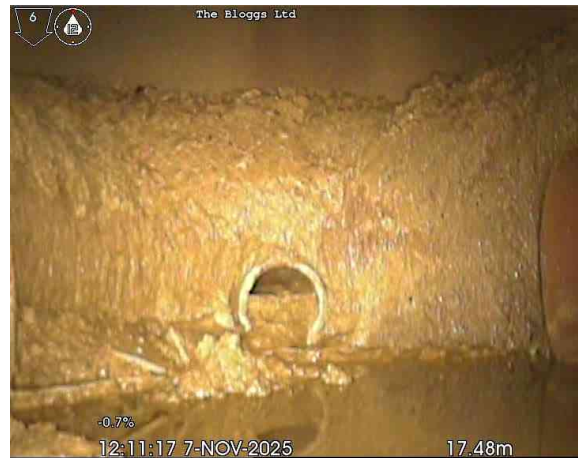
2, 00:01:28, 17.48 m  
Finish node, manhole, reference: 323A

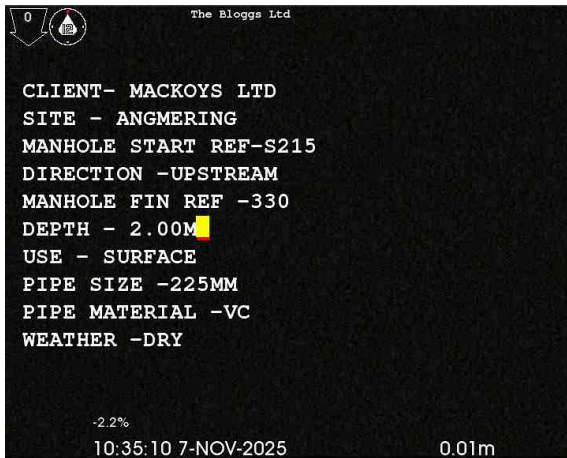
1, 00:00:00, 0.00 m  
Start node, manhole, reference: S215

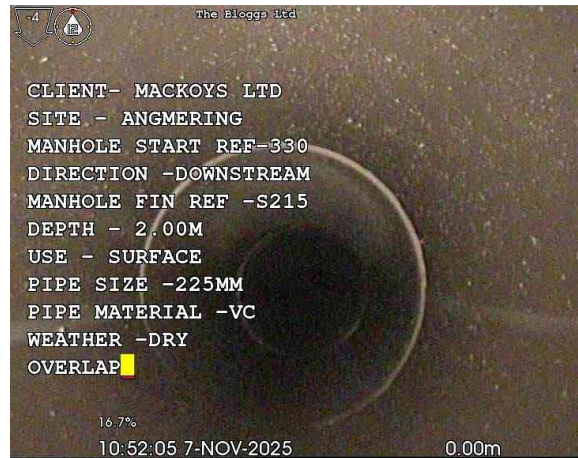
2, 00:00:08, 0.00 m  
General remark, overlap

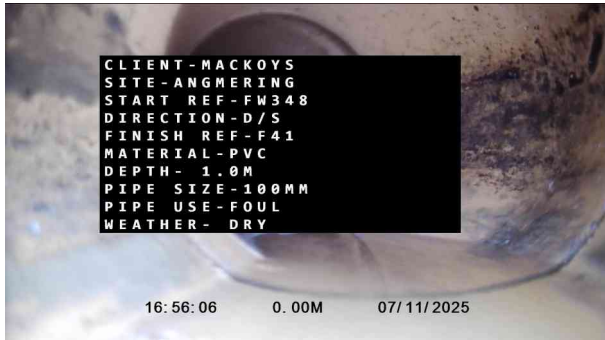
1, 00:00:00, 0.00 m  
Start node, manhole, reference: FW348

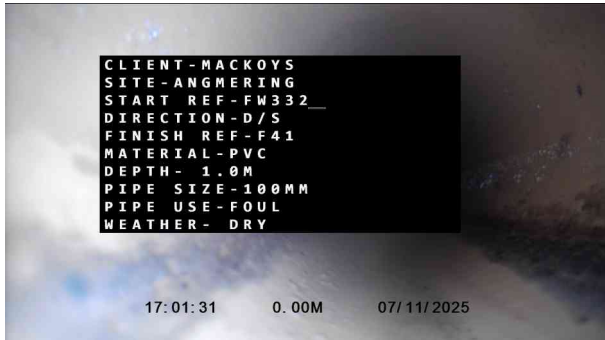
1, 00:00:00, 0.00 m  
Start node, manhole, reference: FW332

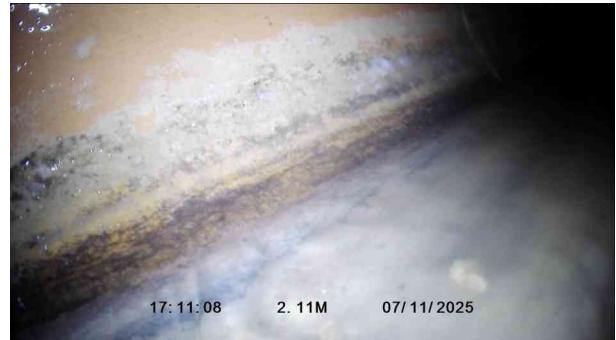
2, 00:00:15, 2.11 m  
Finish node, major connection without manhole, reference:  
MAIN

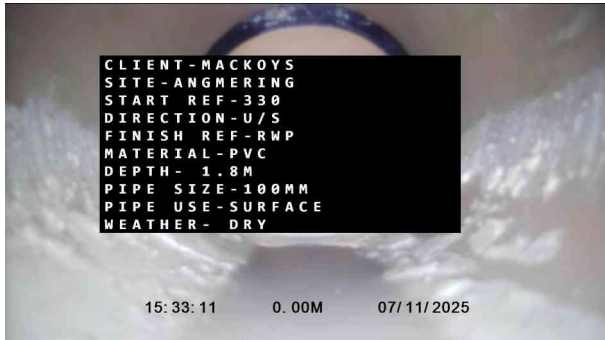
1, 00:00:00, 0.00 m  
Start node, manhole, reference: 330

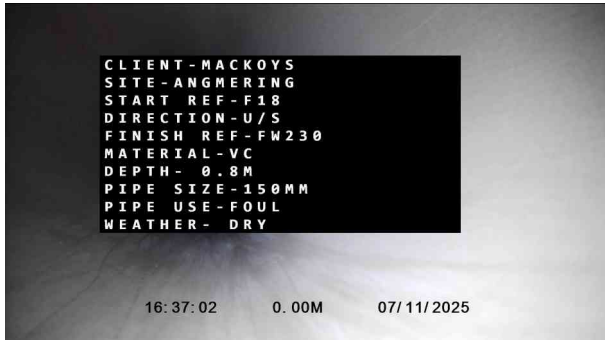
1, 00:00:00, 0.00 m  
Start node, manhole, reference: F18

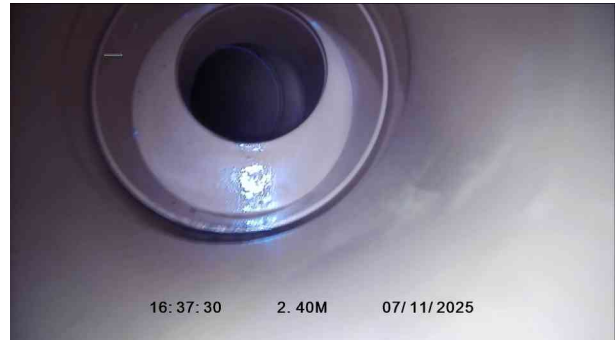
2, 00:00:28, 2.40 m  
Pipe size changes, new size(s), 100mm high

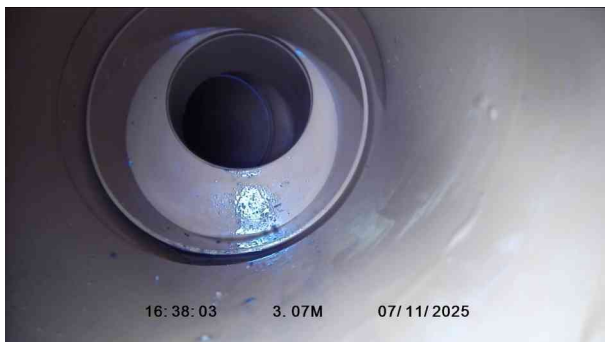
3, 00:01:02, 3.07 m  
Finish node, manhole, reference: FW230

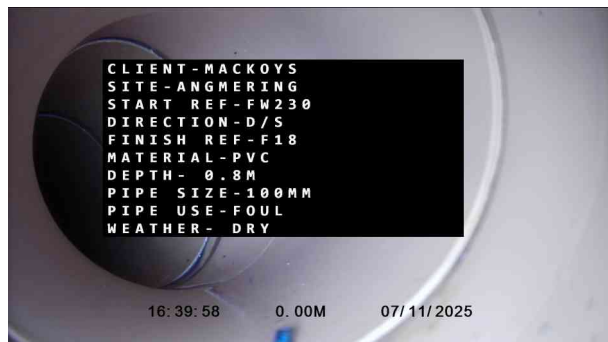
1, 00:00:00, 0.00 m  
Start node, manhole, reference: FW230

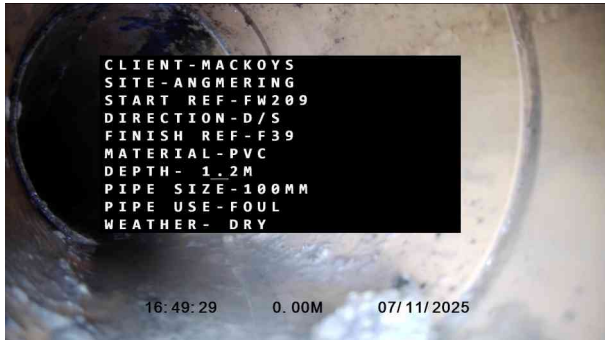
1, 00:00:00, 0.00 m  
Start node, manhole, reference: FW209

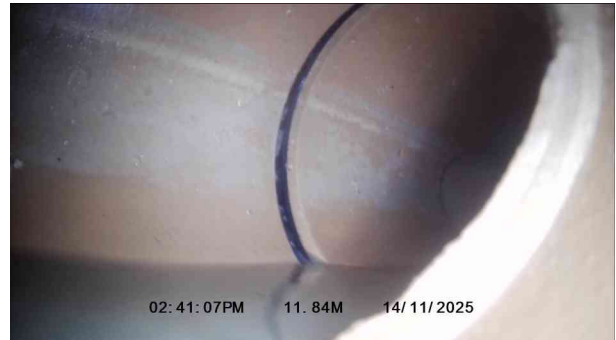
2, 00:00:56, 11.84 m  
Finish node, major connection without manhole, reference:  
MAIN

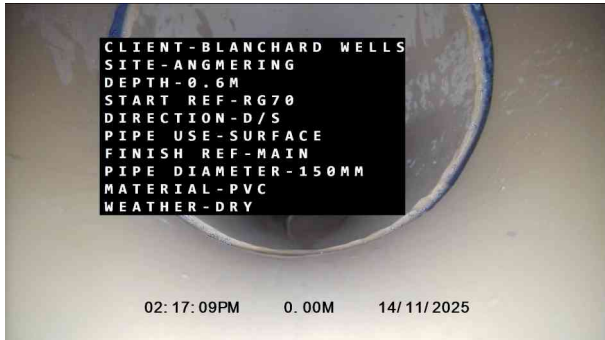
1, 00:00:00, 0.00 m  
Start node, gully, reference: RG70

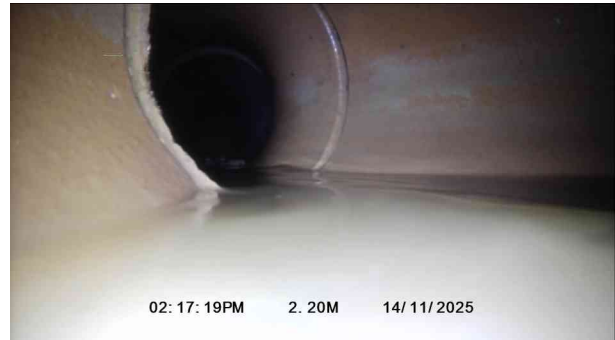
2, 00:00:13, 2.20 m  
Finish node, major connection without manhole, reference:  
MAIN

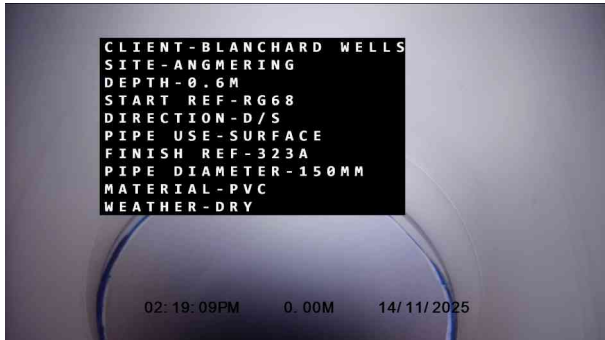
1, 00:00:00, 0.00 m  
Start node, gully, reference: RG68

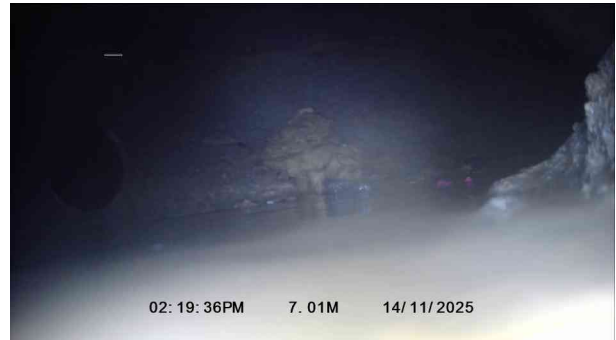
2, 00:00:27, 7.01 m  
Finish node, manhole, reference: 323A

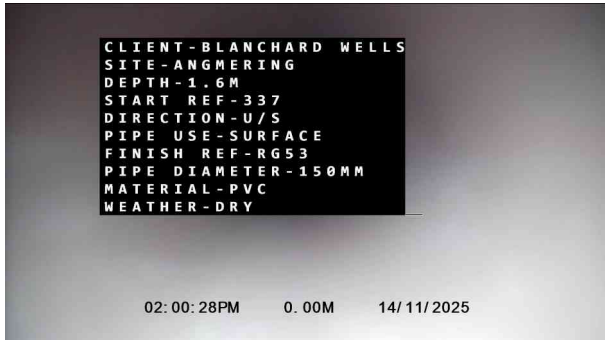
1, 00:00:00, 0.00 m  
Start node, manhole, reference: 337

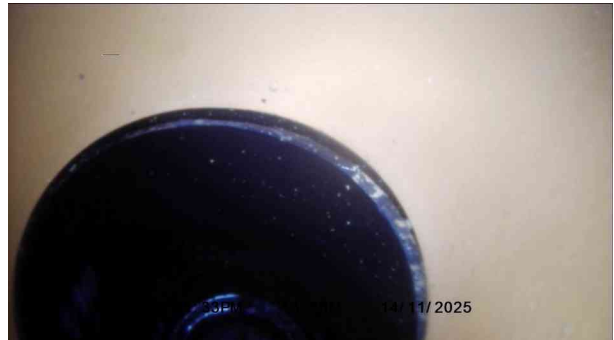
2, 00:01:04, 15.56 m  
Finish node, gully, reference: RG53

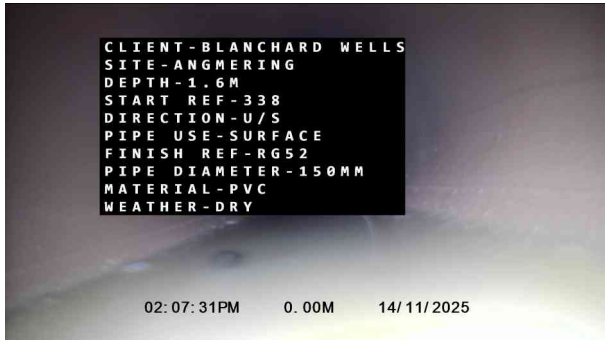
1, 00:00:00, 0.00 m  
Start node, gully, reference: 338

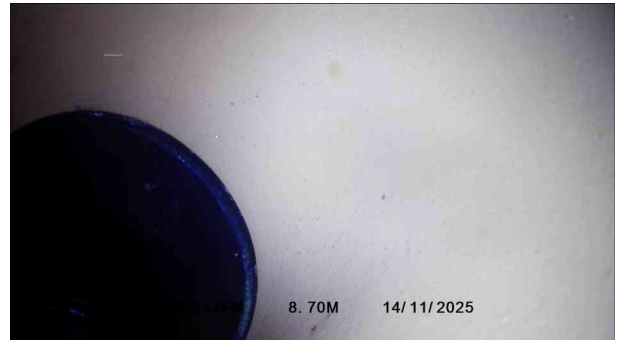
2, 00:01:07, 8.70 m  
Finish node, gully, reference: RG52

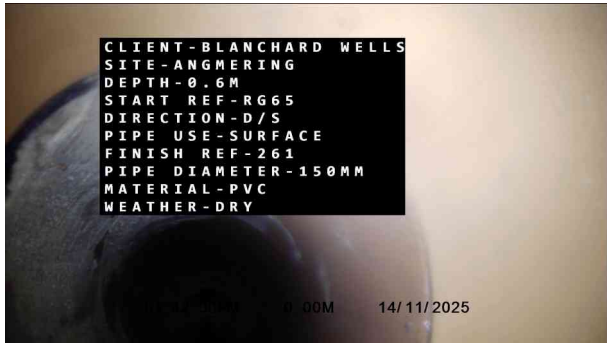
1, 00:00:00, 0.00 m  
Start node, gully, reference: RG65
