**Project Name:** Mackoy Ltd - Langmead Place Angmering

**Project Date:** 04/11/2025

**Inspection Standard:** MSCC5 Sewers & Drainage GB (SRM5 Scoring)

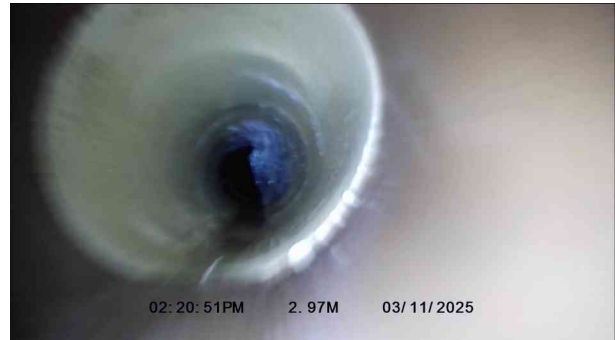
2, 00:00:11, 2.97 m  
Point repair, localised lining from 12 o'clock to 11 o'clock, start

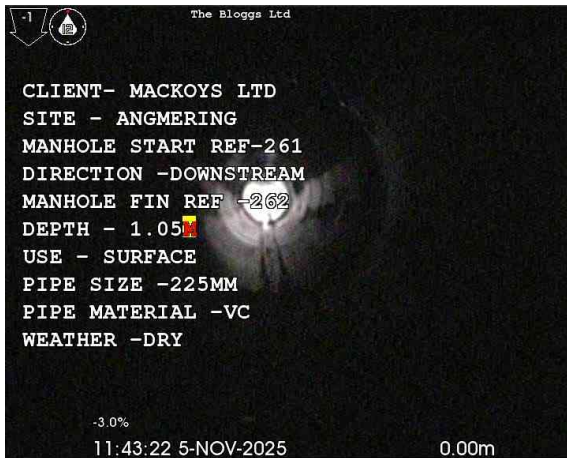
1, 00:00:00, 0.00 m  
Start node, manhole, reference: 261

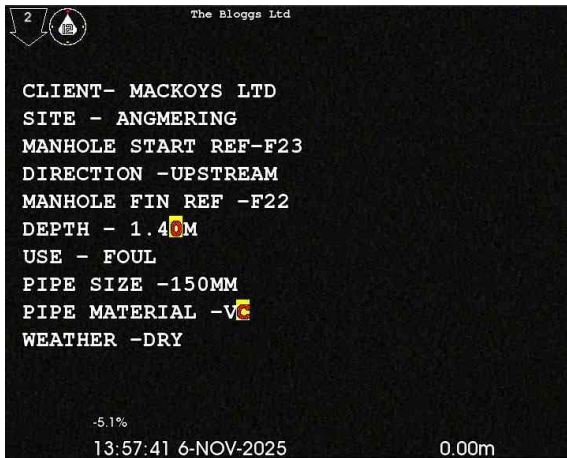
1, 00:00:00, 0.00 m  
Start node, manhole, reference: F23

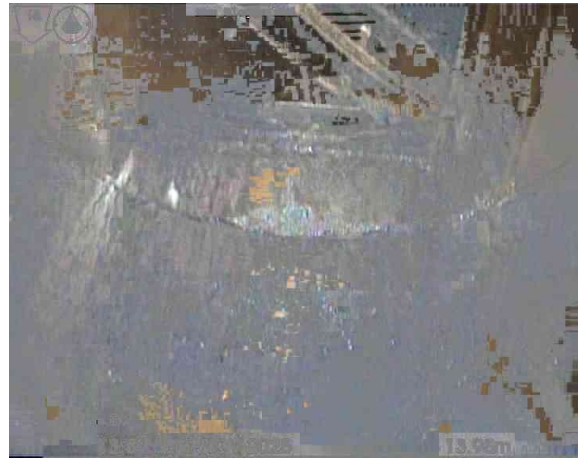
2, 00:02:18, 14.01 m  
Finish node, manhole, reference: F22

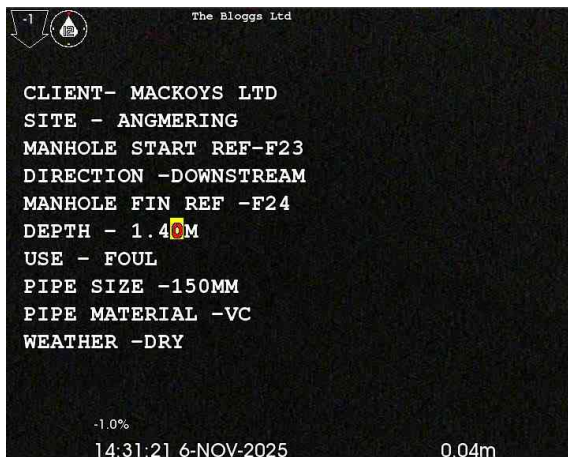
1, 00:00:00, 0.00 m  
Start node, manhole, reference: F23

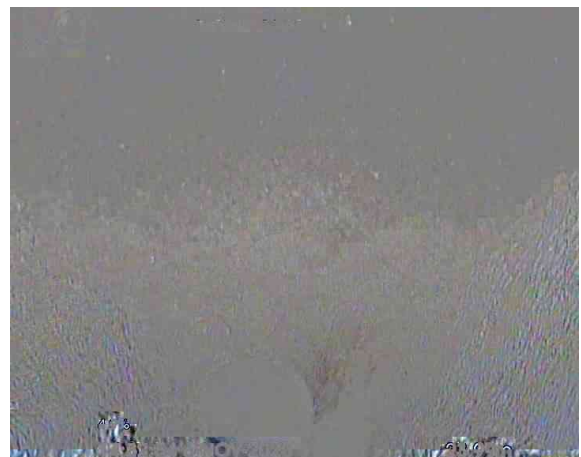
2, 00:01:32, 24.05 m  
Finish node, manhole, reference: F24

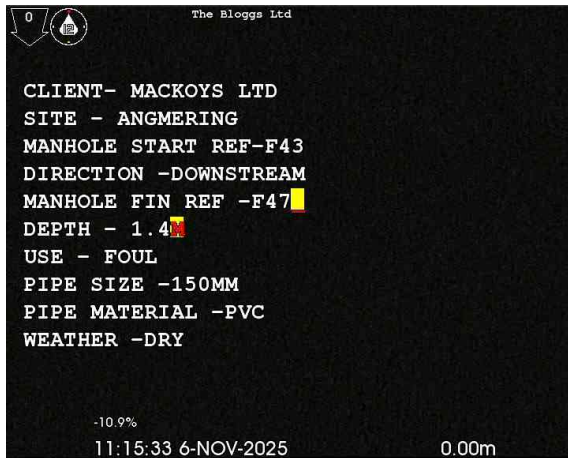
1, 00:00:00, 0.00 m  
Start node, manhole, reference: F43

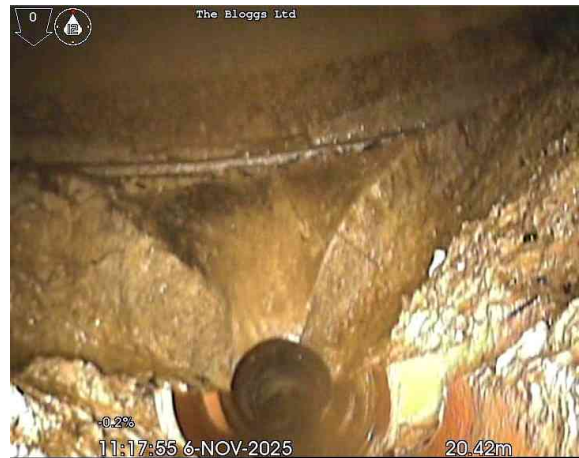
2, 00:02:25, 20.42 m  
Finish node, manhole, reference: F47

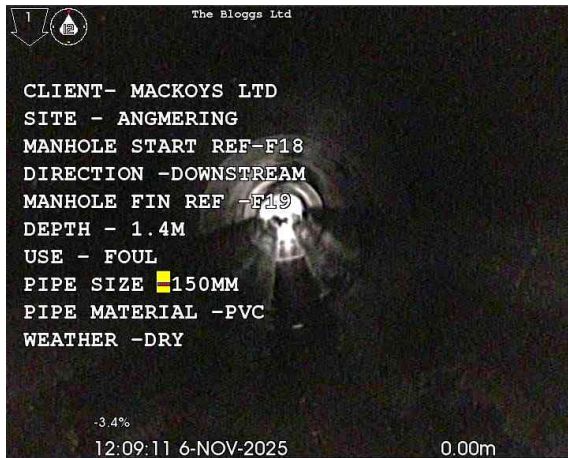
1, 00:00:00, 0.00 m  
Start node, manhole, reference: F18

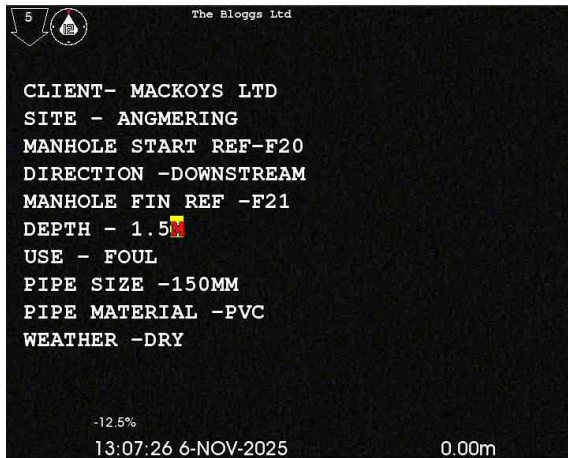
1, 00:00:00, 0.00 m  
Start node, manhole, reference: F20

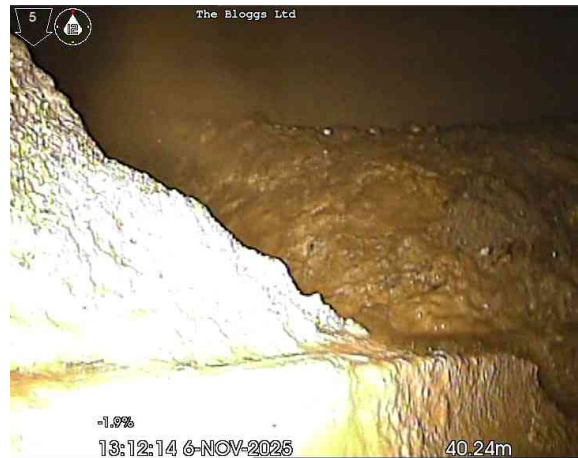
2, 00:04:51, 40.24 m  
Finish node, manhole, reference: F21

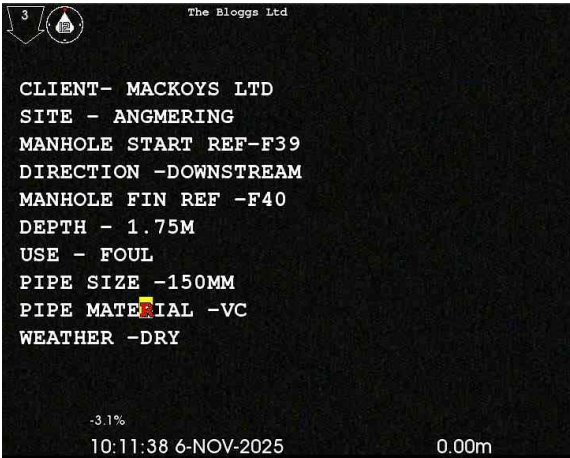
1, 00:00:00, 0.00 m  
Start node, manhole, reference: F39

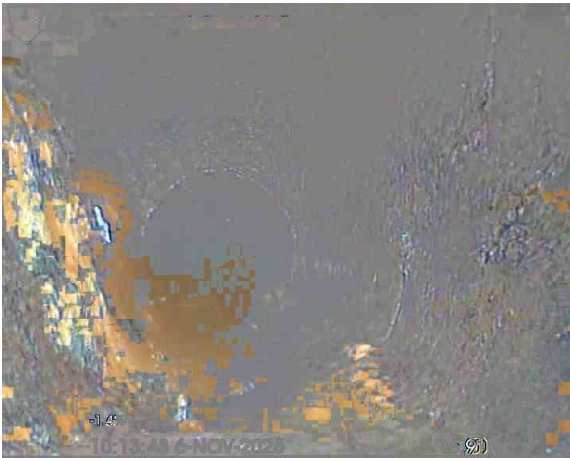
2, 00:02:03, 16.91 m  
Finish node, manhole, reference: F40

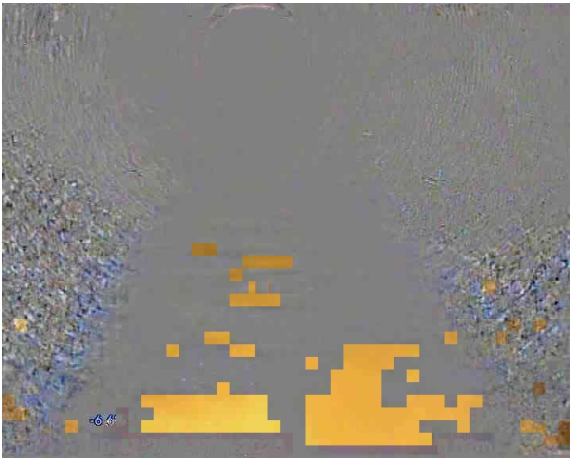
2, 00:00:08, 0.00 m  
Point repair, localised lining from 12 o'clock to 11 o'clock, start

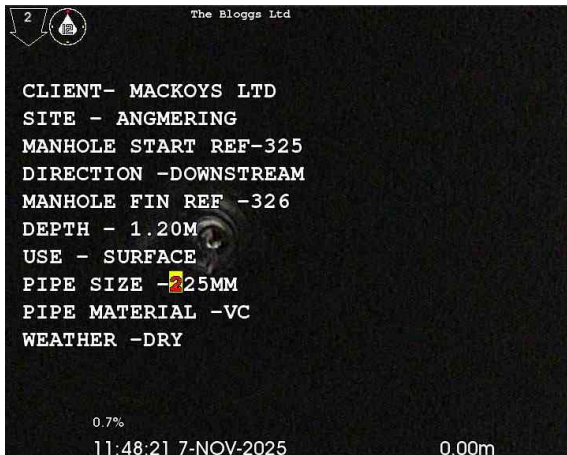
1, 00:00:00, 0.00 m  
Start node, manhole, reference: 325

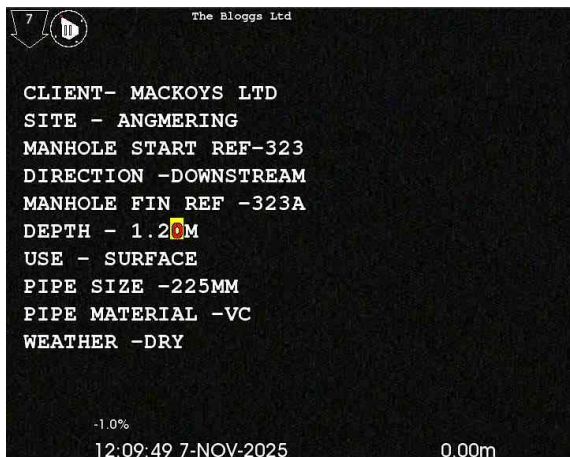
1, 00:00:00, 0.00 m  
Start node, manhole, reference: 323

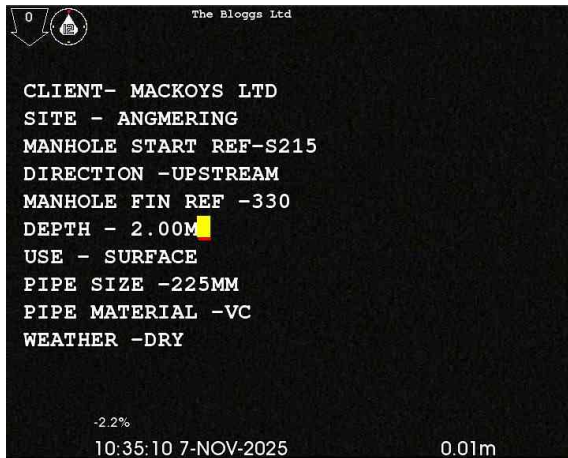
1, 00:00:00, 0.00 m  
Start node, manhole, reference: S215

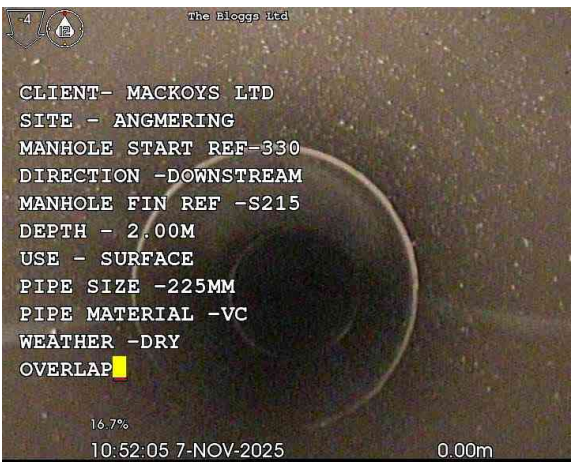
2, 00:00:08, 0.00 m  
General remark, overlap

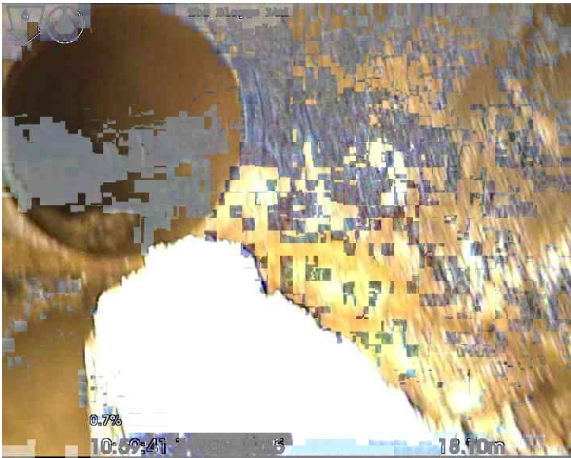
2, 00:01:22, 18.10 m  
Finish node, manhole, reference: 332B

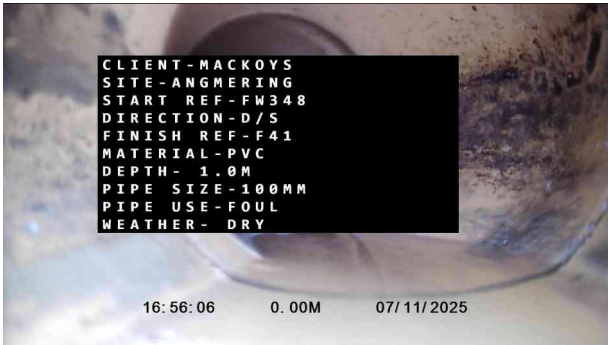
1, 00:00:00, 0.00 m  
Start node, manhole, reference: FW348

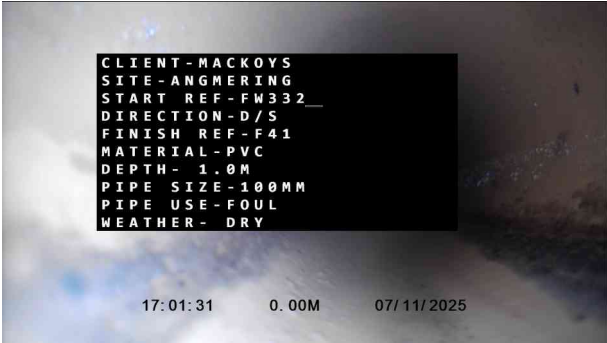
1, 00:00:00, 0.00 m  
Start node, manhole, reference: FW332

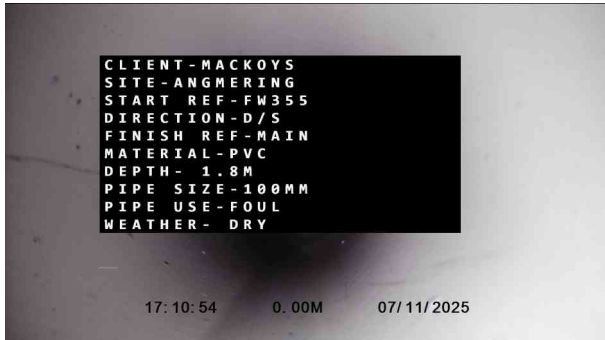
1, 00:00:00, 0.00 m  
Start node, manhole, reference: FW355

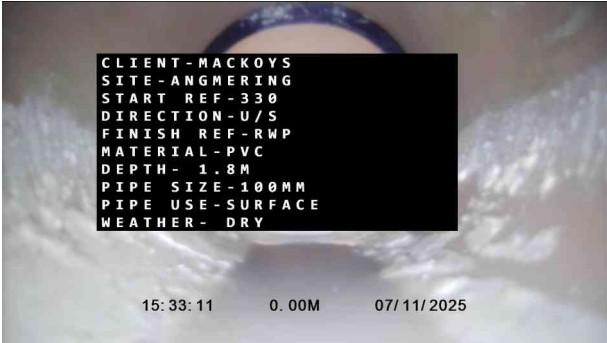
1, 00:00:00, 0.00 m  
Start node, manhole, reference: 330

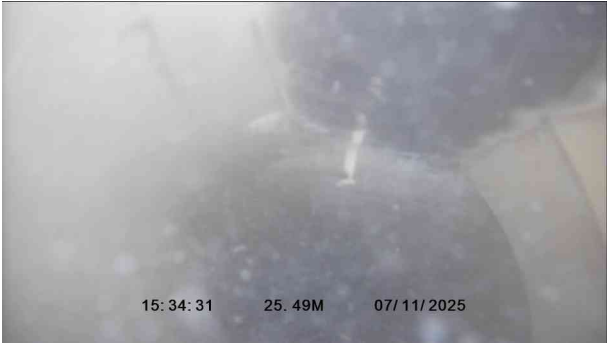
2, 00:01:23, 25.49 m  
Finish node, manhole, reference: RWP

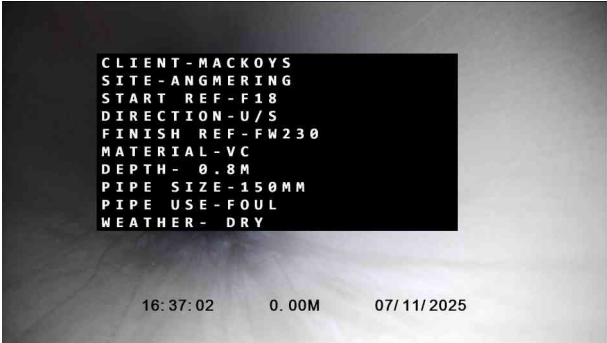
1, 00:00:00, 0.00 m  
Start node, manhole, reference: F18

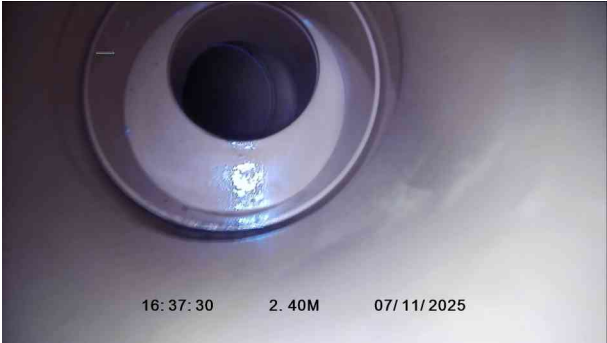
2, 00:00:28, 2.40 m  
Pipe size changes, new size(s), 100mm high

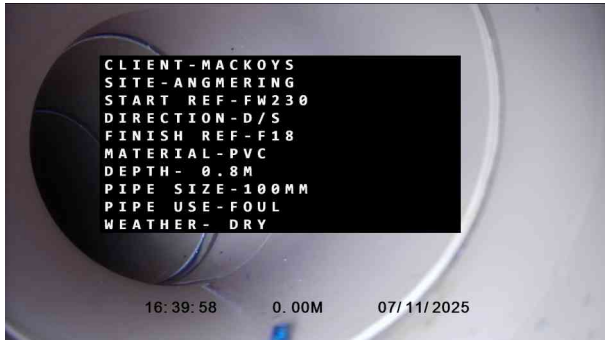
1, 00:00:00, 0.00 m  
Start node, manhole, reference: FW230

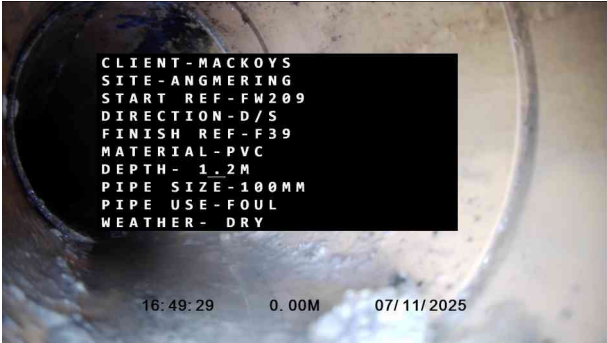
1, 00:00:00, 0.00 m  
Start node, manhole, reference: FW209

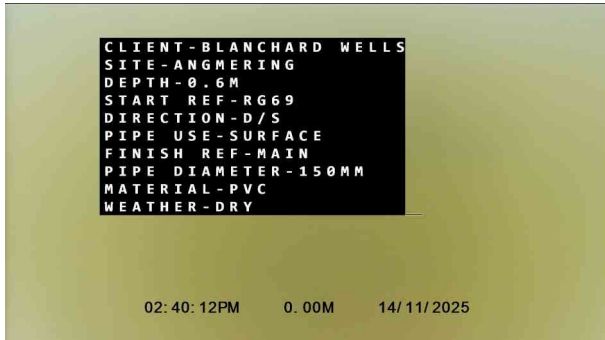
1, 00:00:00, 0.00 m  
Start node, gully, reference: RG69

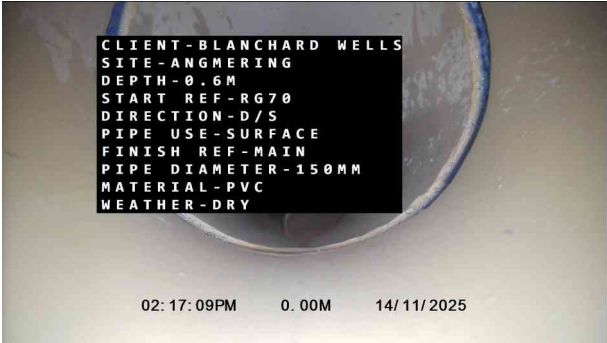
1, 00:00:00, 0.00 m  
Start node, gully, reference: RG70

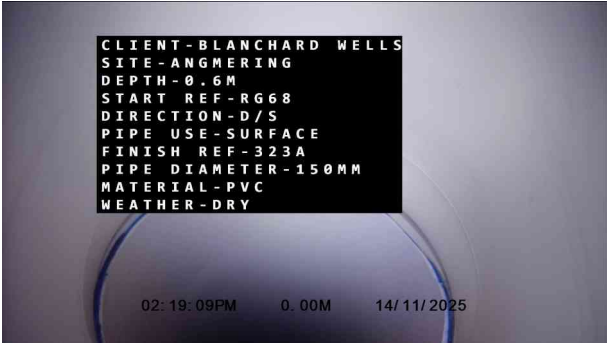
1, 00:00:00, 0.00 m  
Start node, gully, reference: RG68

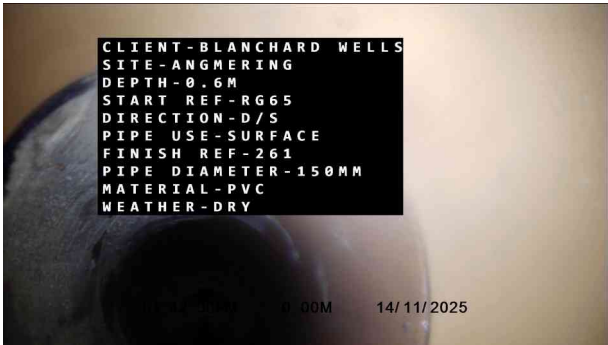
1, 00:00:00, 0.00 m  
Start node, gully, reference: RG65

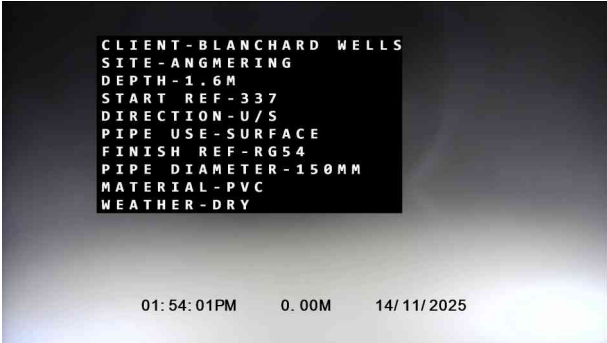
1, 00:00:00, 0.00 m  
Start node, gully, reference: 337
