# Surface Water Drainage Verification Report

Former Bartons Infant School, North Bersted Bognor  
Regis PO22 9BD

Lovell Partnerships

Ref: 11642

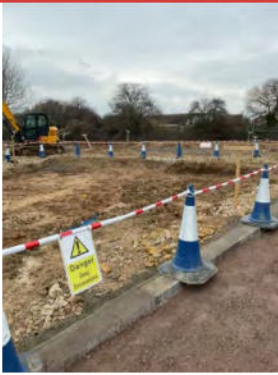
## **START OF ATTENUATION TANK EXCAVATION**

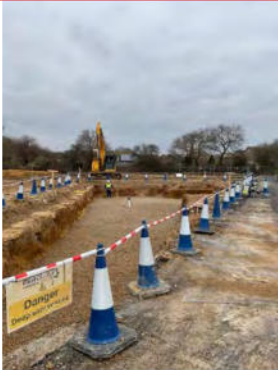
## **ATTENUATION TANK EXCAVATED AND BLINDED WITH 20MM SHINGLE**

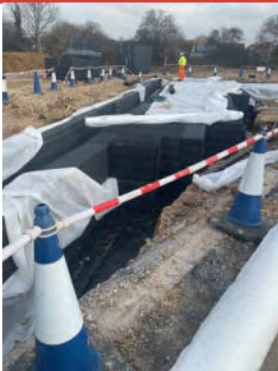
## **CRATES INSTALLED ON MEMBRANES**

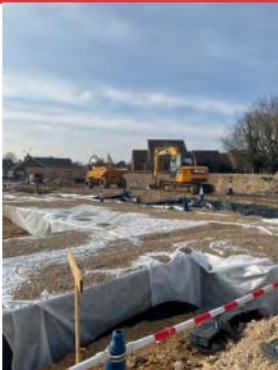
## **MEMBRANE WRAPPED AROUND TANK**

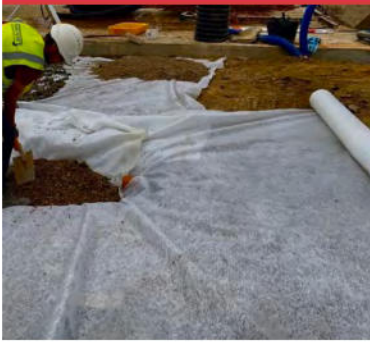
## **EXCAVATING FOR THE DT, CONNECTION TO STORM LINE AND GEOTEXTILE**

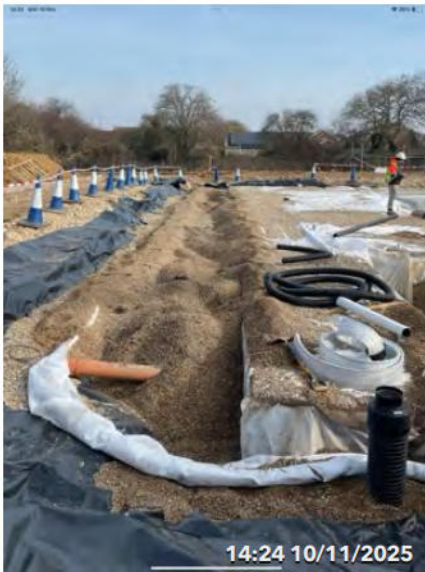
Swale On The outside of The Attenuation Tank  
Assigned To Lovells  
Membrane laid out to the kerb, shingle fill.  
.100mm land drain wrapped in terram,

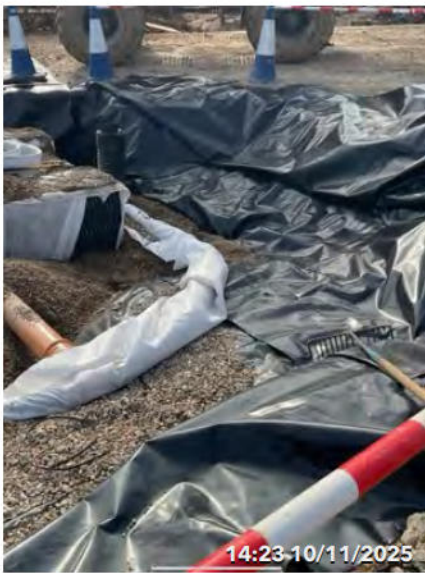
Swale On The outside of The Attenuation Tank  
Assigned To Lovells  
Membrane laid out to the kerb, shingle fill.  
.100mm land drain wrapped in terram,

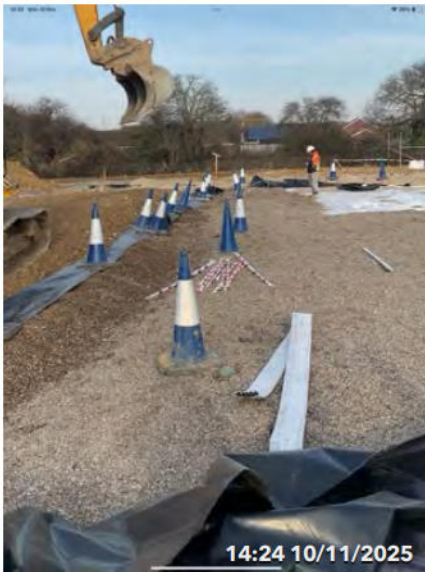
Swale Outside Of The Attenuation Tank  
Assigned To Lovells  
Back fill over the wraparound.  
Level with stone.

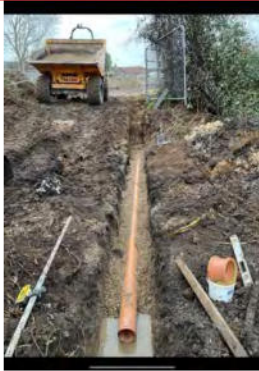
### **150MM DRAINPIPE LAID TO HEAD WALL**

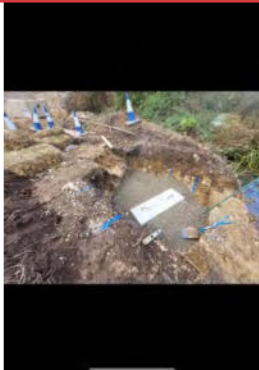
### **500MM CONCRETE TOE INSTALLED**

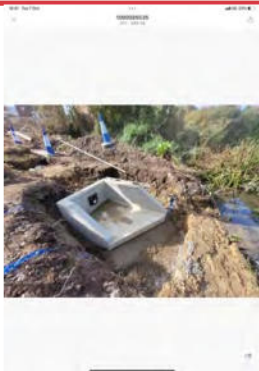
### **HEADWALL PLACED ON CONCRETE BEDDING**

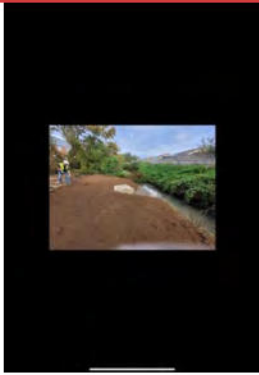
## **HEADWALL COMPLETE AND THE STREAM CLEANED OUT**
