## **PHOTOGRAPHIC APPENDICES I**

**Climping Mill, Littlehampton**  
**External**

DGC (Historic Buildings) Consultants  
Limited

REF: DGC21732  
Date of Issue: 15/08/2017  
Web: [www.dgc-consultants.com](http://www.dgc-consultants.com)

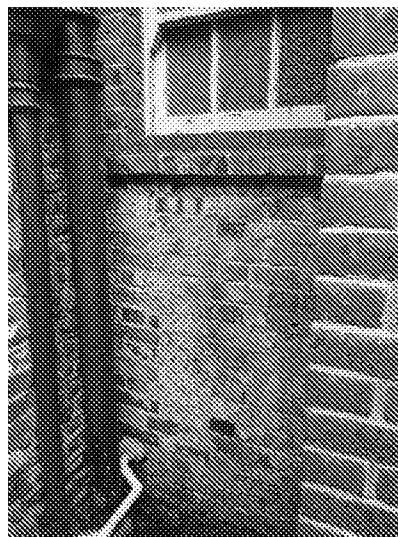
DSC03171 South courtyard wall the Mill House south of the early 20<sup>th</sup> century addition

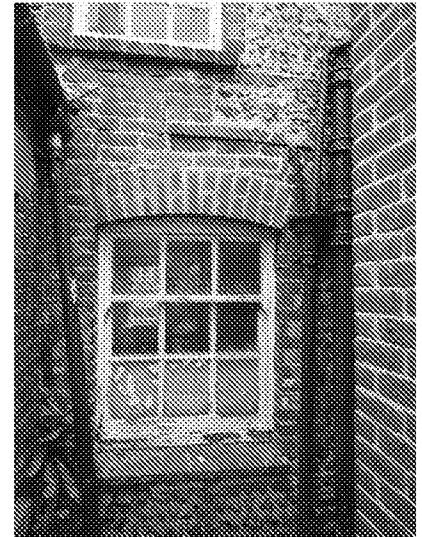
DSC03172 East courtyard wall the Mill House south of the early 20<sup>th</sup> century addition

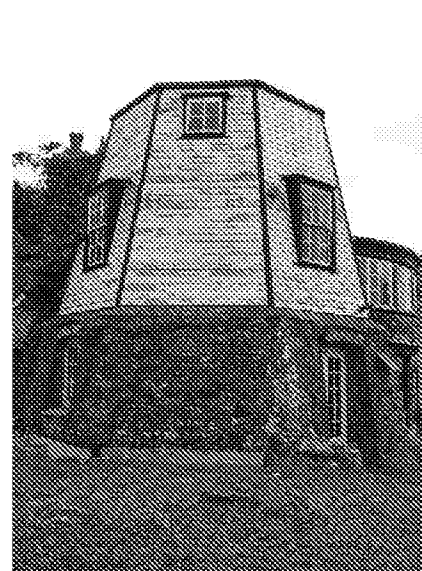
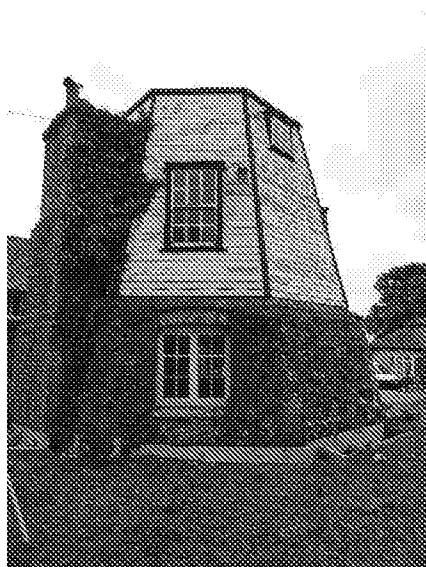
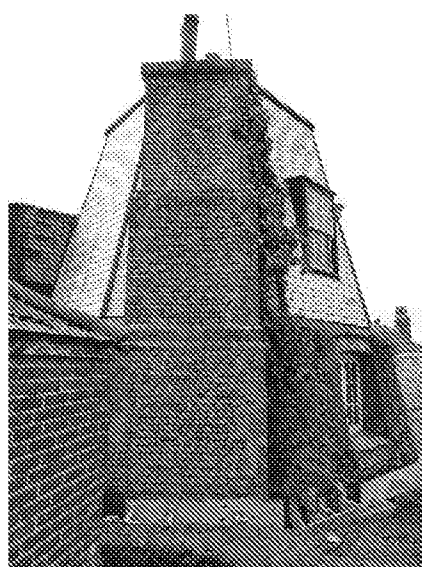
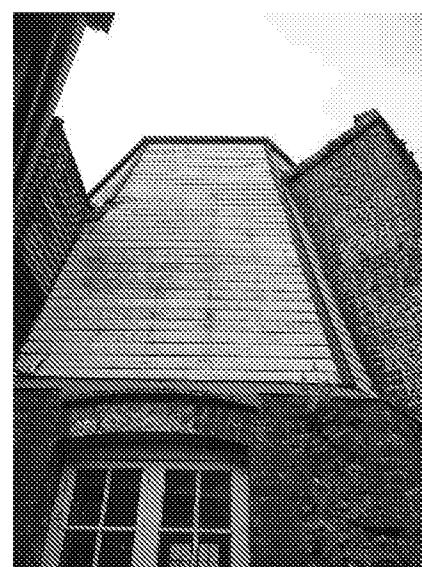
General views showing the elevation of The Mill

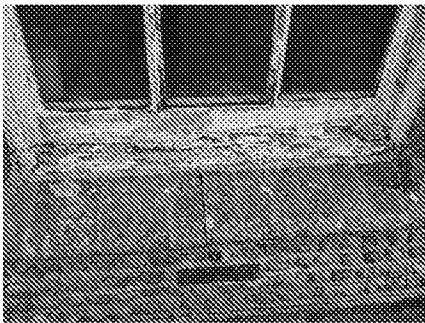
DSC03140 Decay cill and bottom rail of sash window

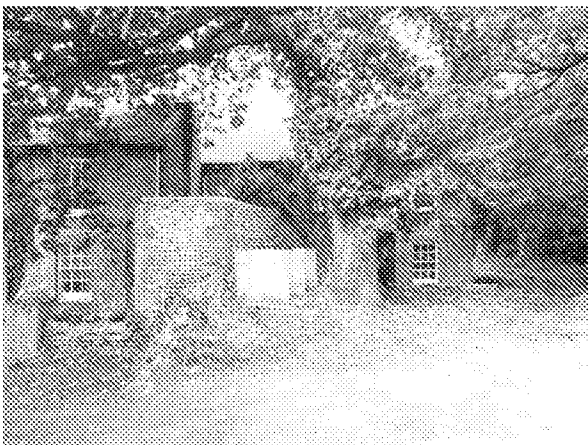
DSC02710 View of Flint wall integral to the Outbuildings

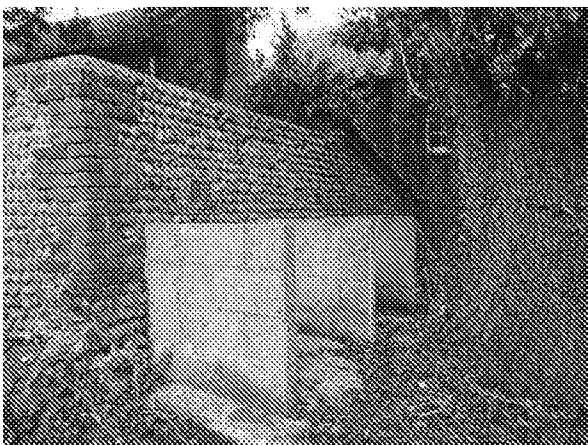
DSC03188 View looking South West showing parapet rear wall of Outbuilding (OB1)

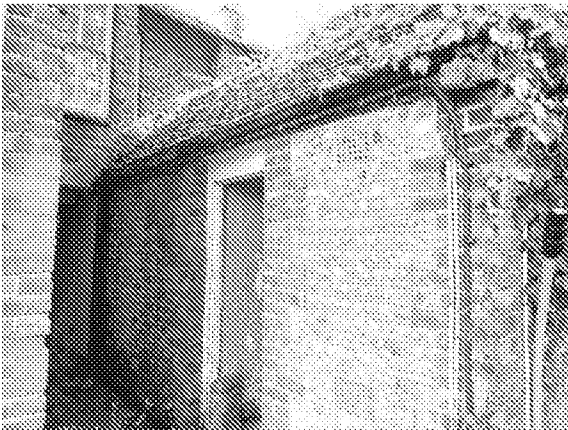
DSC02712 South Elevation of Workshop / Boiler room (OB02)

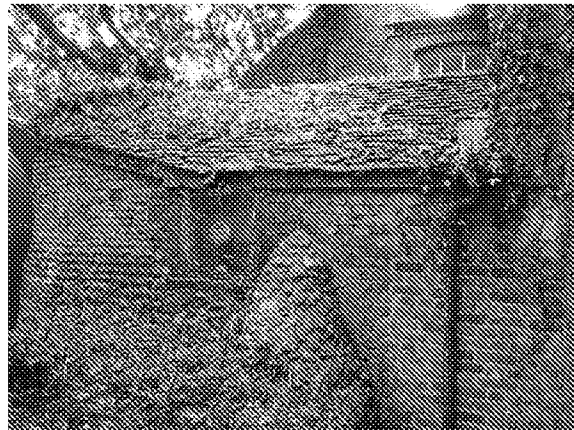
DSC03187 North Elevation of Workshop / Boiler room (OB02)

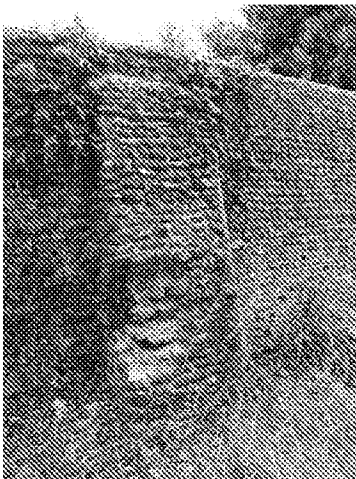
DSC03190

General views showing construction arrangement including flint contracted buttresses, brick dressing to change of directions and openings and general defects associated with Mill wall
