**PHOTOGRAPHIC APPENDICES I**

**Climping Mill, Littlehampton**  
**External**

REF: DGC21732

Date of Issue: 15/08/2017

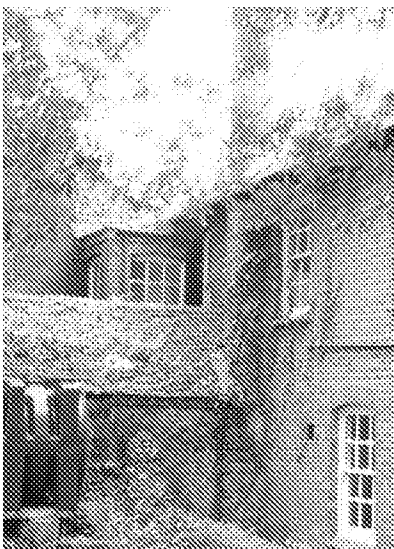
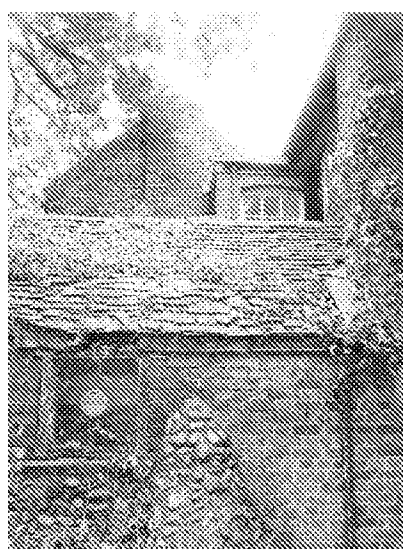
DSC02701 & DSC02704 Rear elevation of Outbuildings and first floor 20<sup>th</sup> century flat roof link connecting the Mill House with the modern northern extension.

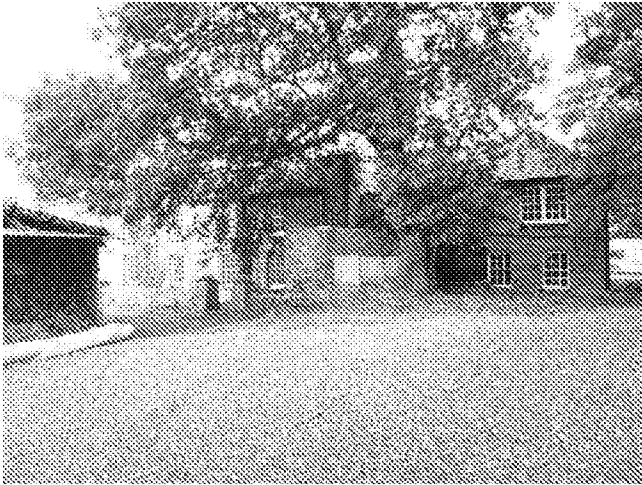
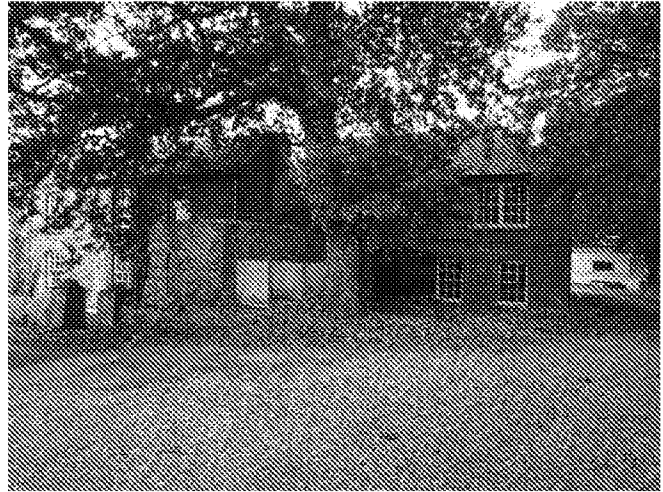
DSC02708 & DSC03118 East Elevation showing Mill House, Historic Outbuildings & Mid-20<sup>th</sup> Century extension

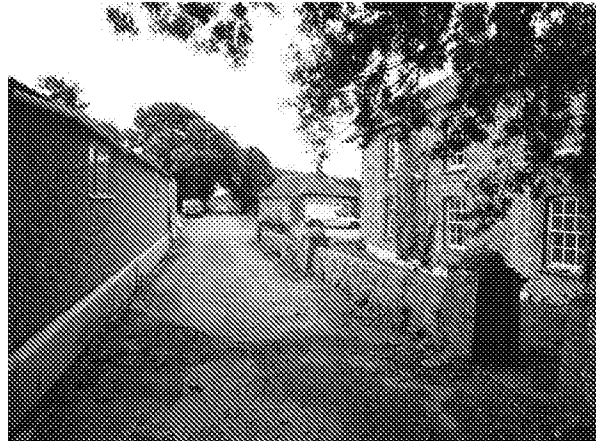
DSC03117 Garden wall to East Elevation

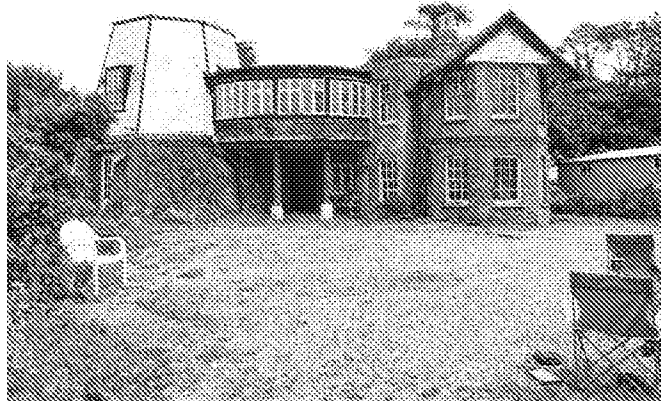
DSC02772 South elevation showing Mill, first floor link and Mill House

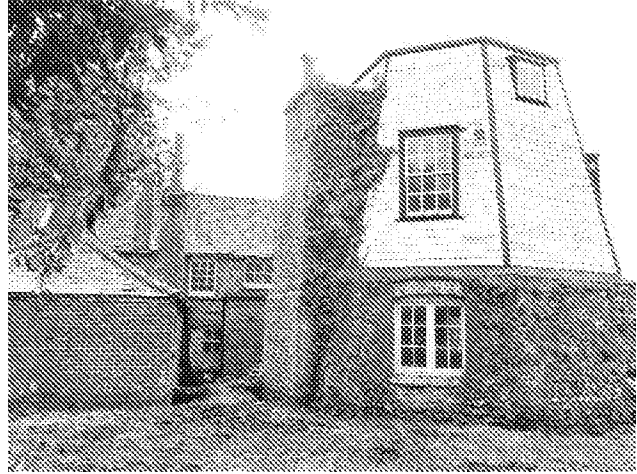
DSC02733 General view

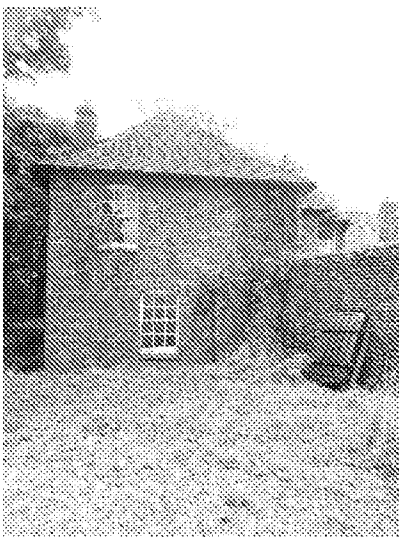
DSC02698 Hipped end North of the curtilage listed Mill flint wall

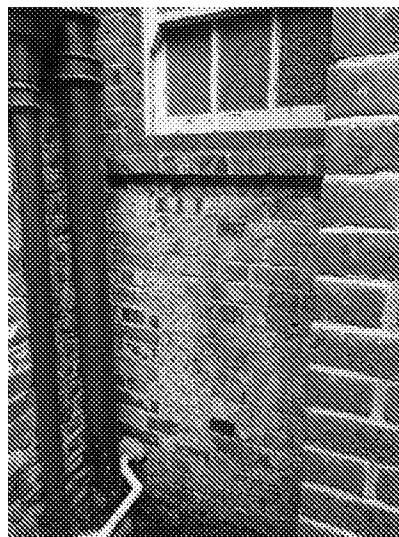
DSC03171 South courtyard wall the Mill House south of the early 20<sup>th</sup> century addition

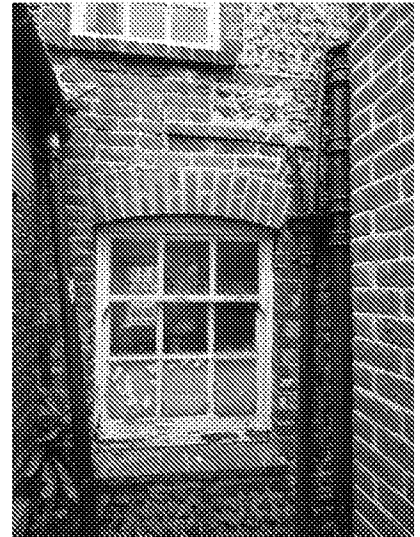
DSC03172 East courtyard wall the Mill House south of the early 20<sup>th</sup> century addition

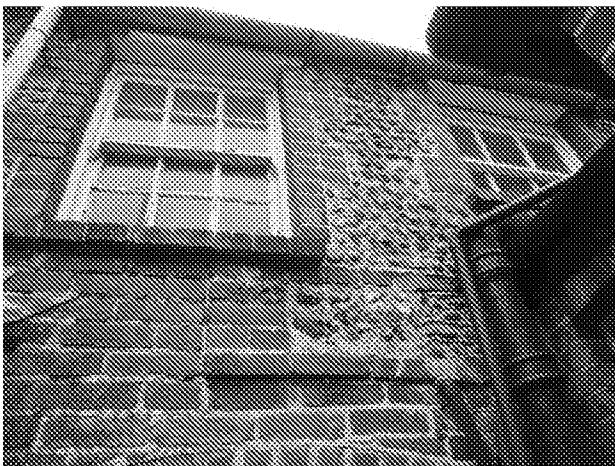
DSC03173 First Floor East courtyard wall of Mill House

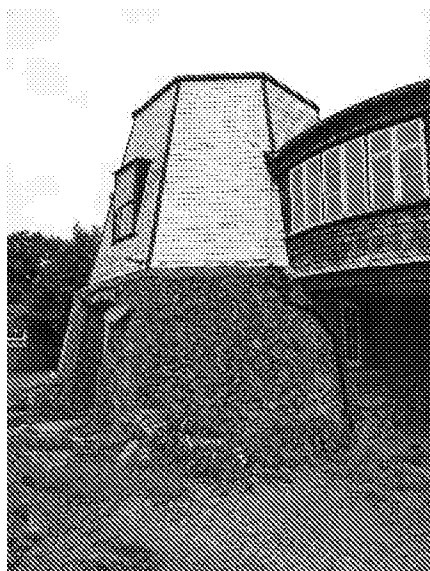
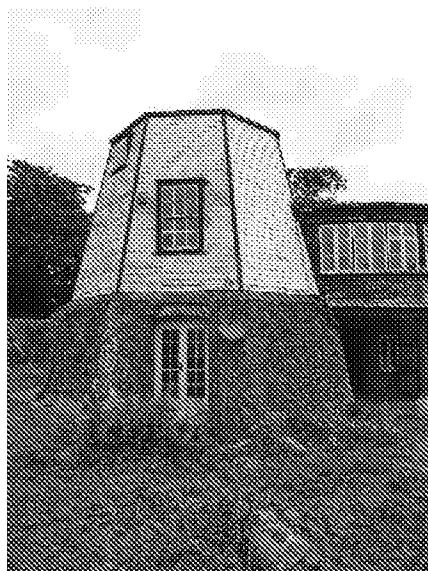
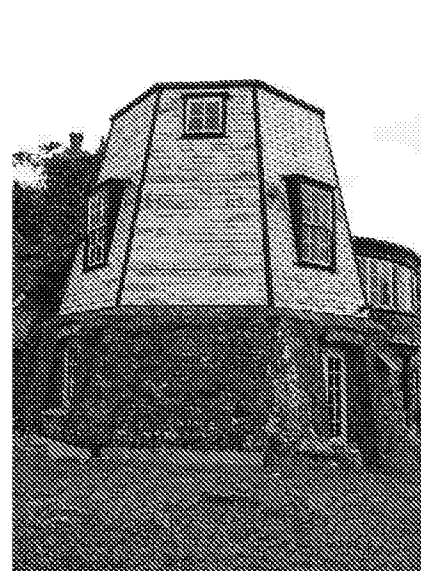
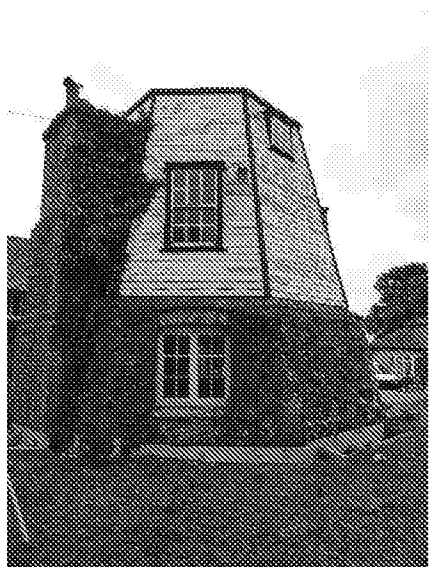
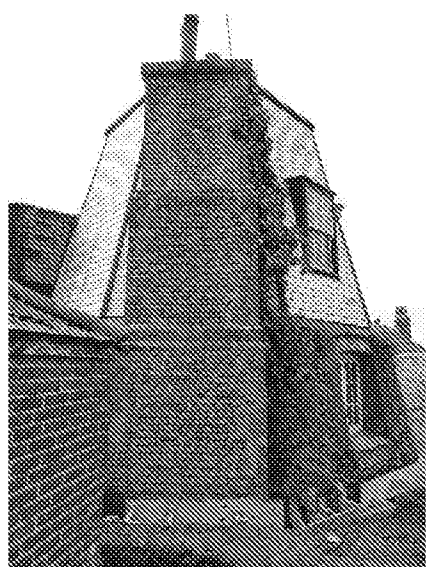
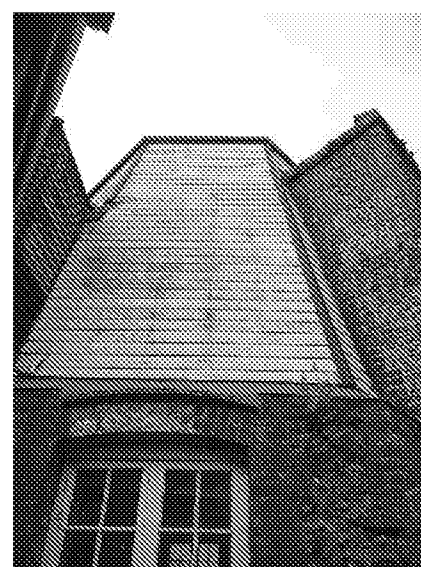
General views showing the elevation of The Mill

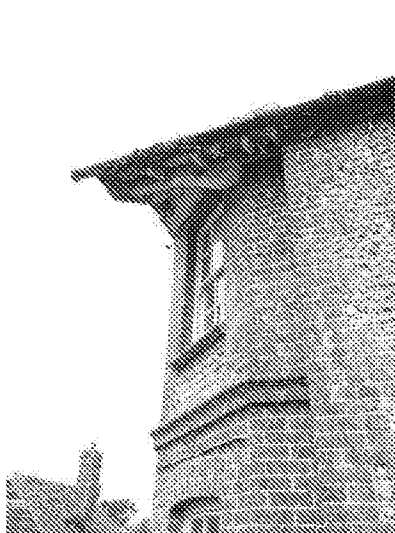
DSC02720 Roof detail above canted bay

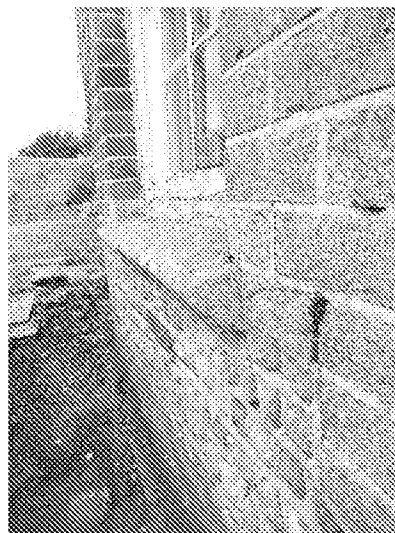
DSC02719 Typical brick cill detail

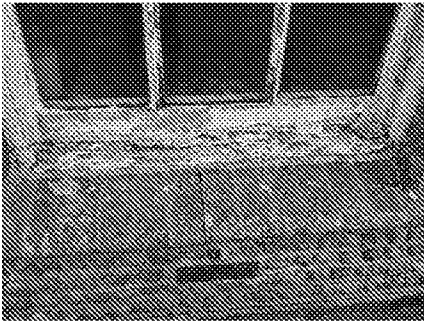
DSC03140 Decay cill and bottom rail of sash window

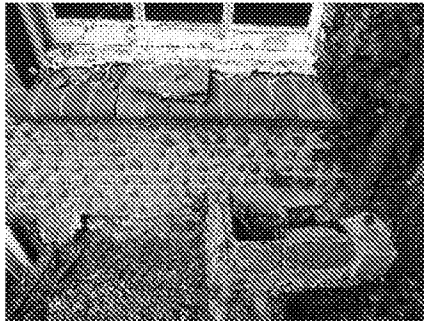
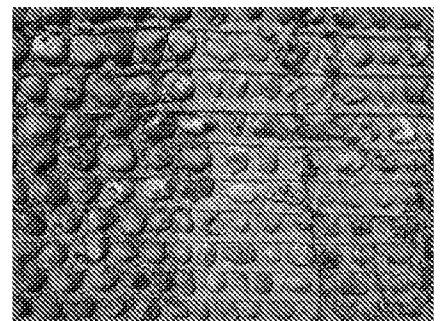
DSC03144 Repointing of flintwork using cementitious mortar

DSC03144 Comparative between the original lime mortar (with coal inclusion) and cementitious mortar

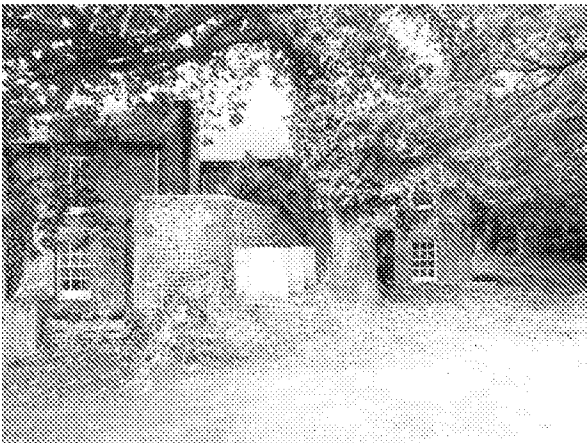
DSC02710 View of Flint wall integral to the Outbuildings

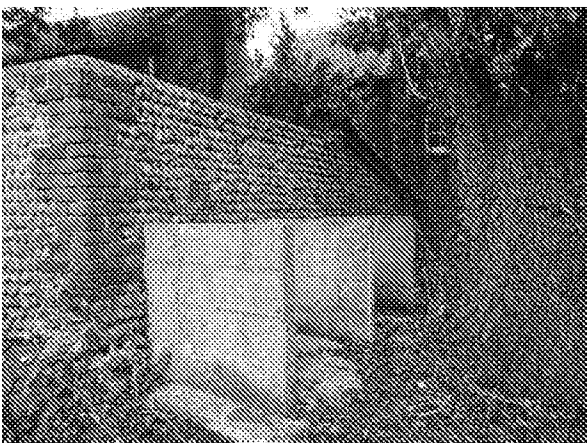
DSC03188 View looking South West showing parapet rear wall of Outbuilding (OB1)

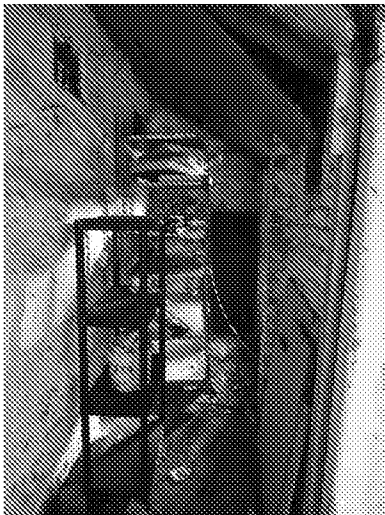
DSC03123 Internal view looking East (OB01)

DSC03123 Vertical cracking to North wall internally (OB01)

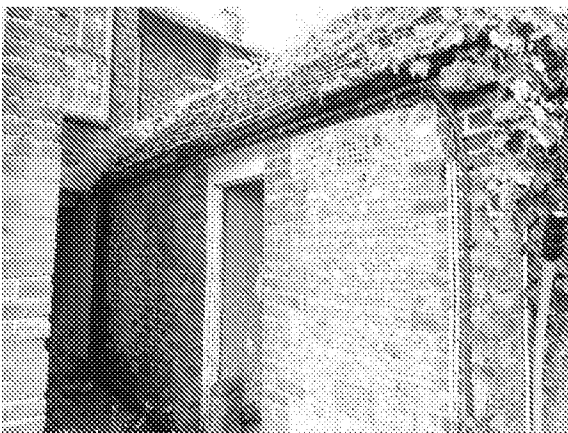
DSC02712 South Elevation of Workshop / Boiler room (OB02)

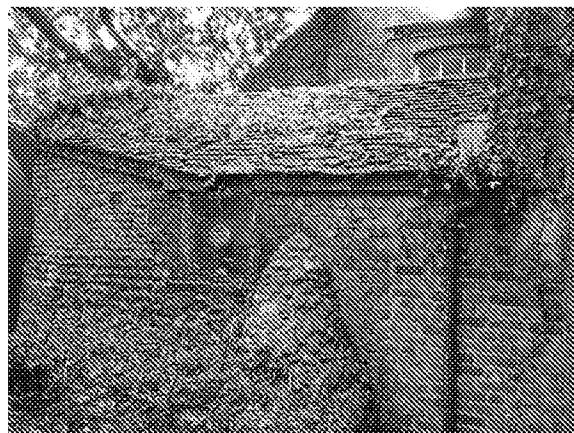
DSC03187 North Elevation of Workshop / Boiler room (OB02)

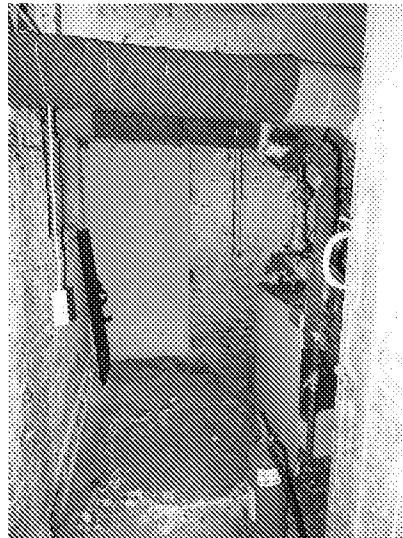
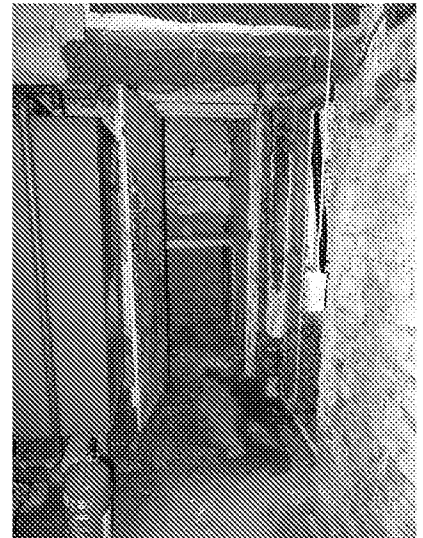
General views showing construction arrangement including flint contracted buttresses, brick dressing to change of directions and openings and general defects associated with Mill wall

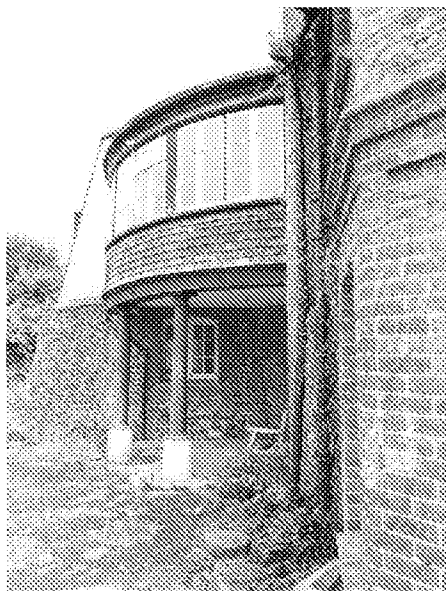
DSC02722 View looking West

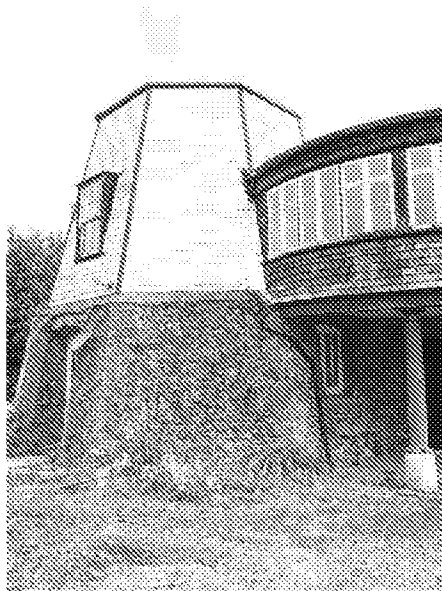
DSC02722 View looking North West

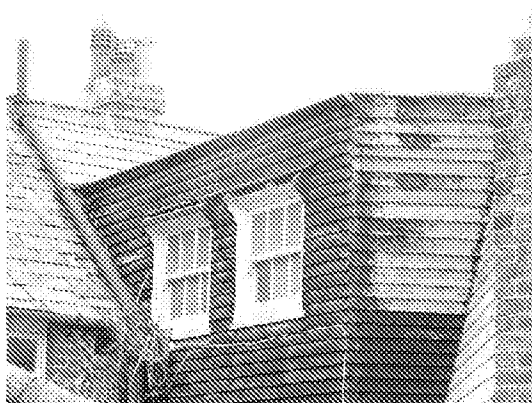
DSC02749 North Elevation of link

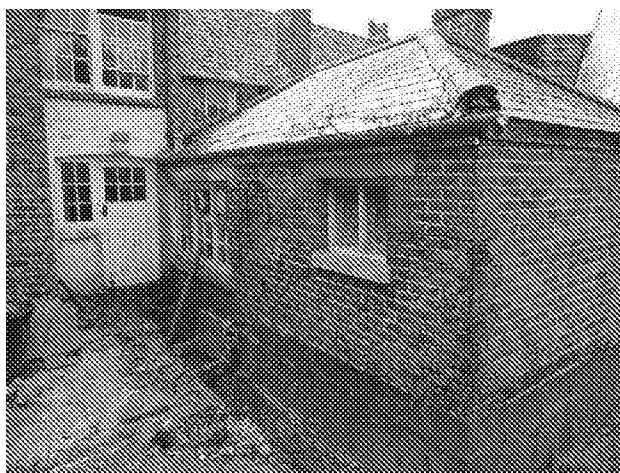
DSC03178 North Elevation

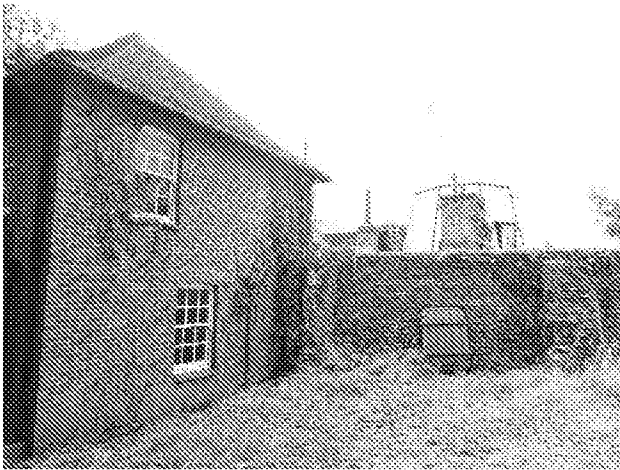
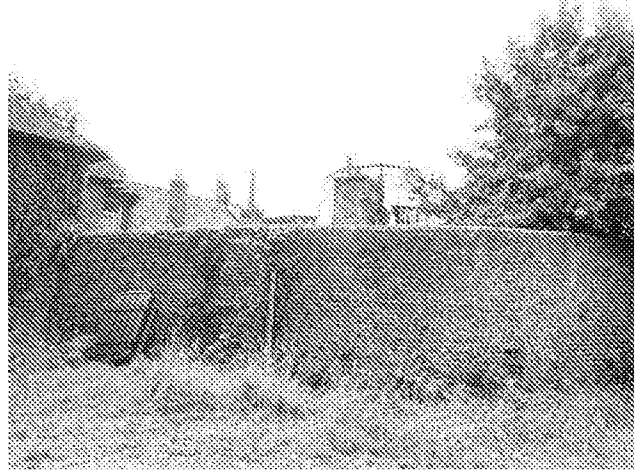
DSC02695 External view looking South East showing truncated mill and curtilage listed flint wall

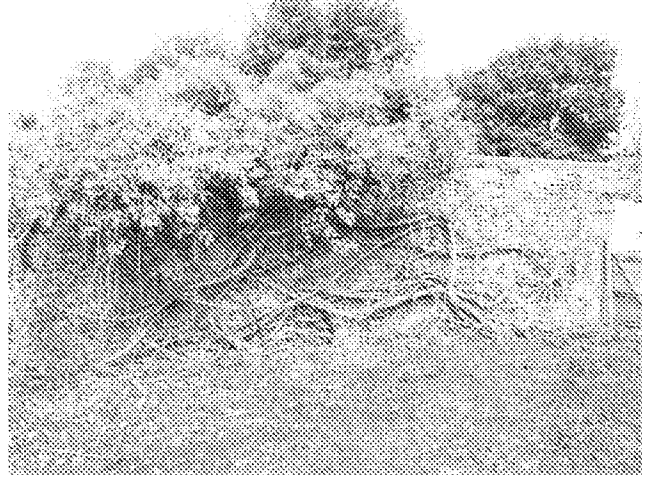
DSC02727 Internal view looking West by The Mill
