## PHOTOGRAPHIC APPENDICES I

**Climping Mill, Littlehampton**  
**External**

DGC (Historic Buildings) Consultants  
Limited

REF: DGC21732 Rev A

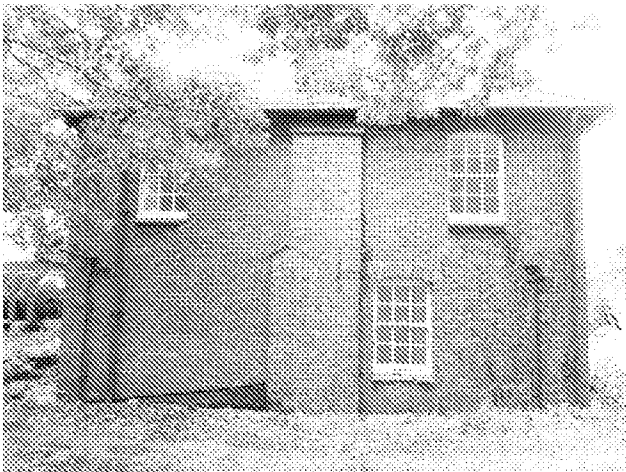
DSC02699 Mid-20<sup>th</sup> Century extension to Mill House

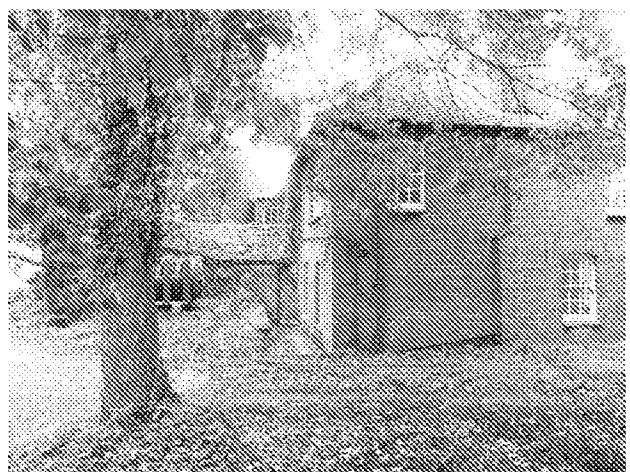
DSC02700 Mid-20<sup>th</sup> century extension in context with historic form

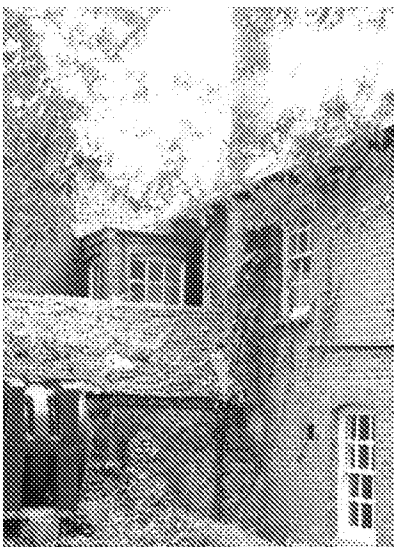
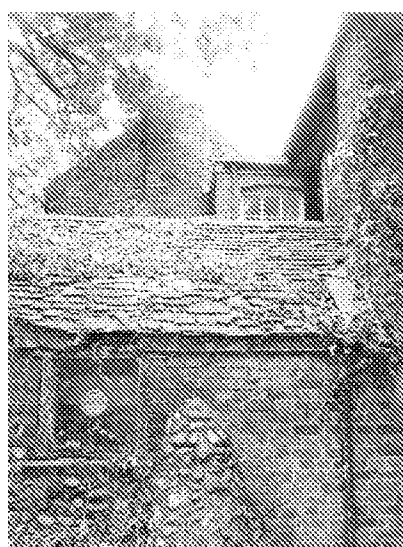
DSC02701 & DSC02704 Rear elevation of Outbuildings and first floor 20<sup>th</sup> century flat roof link connecting the Mill House with the modern northern extension.

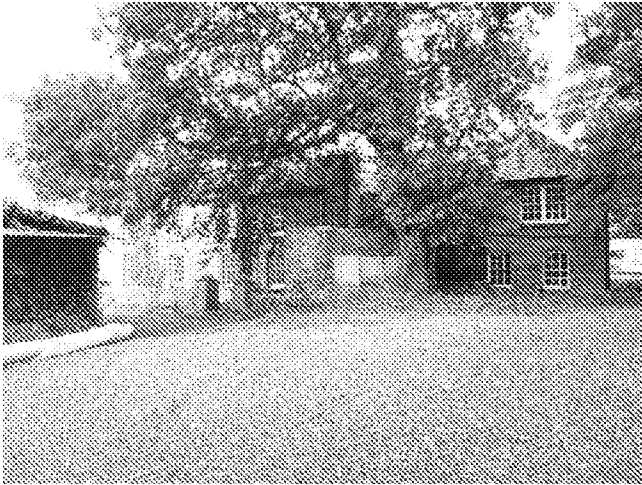
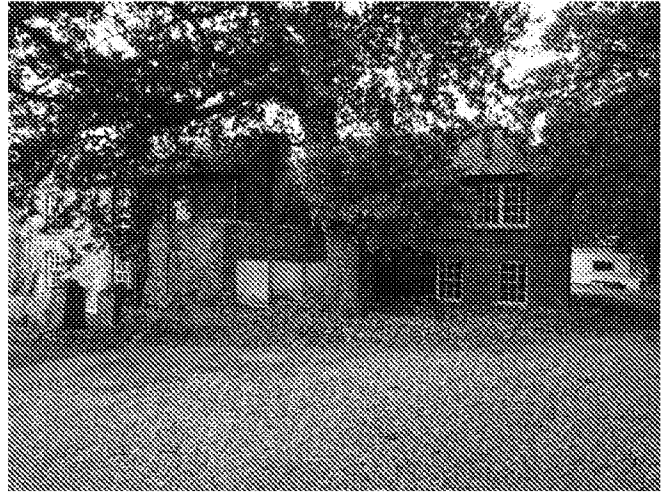
DSC02708 & DSC03118 East Elevation showing Mill House, Historic Outbuildings & Mid-20<sup>th</sup> Century extension

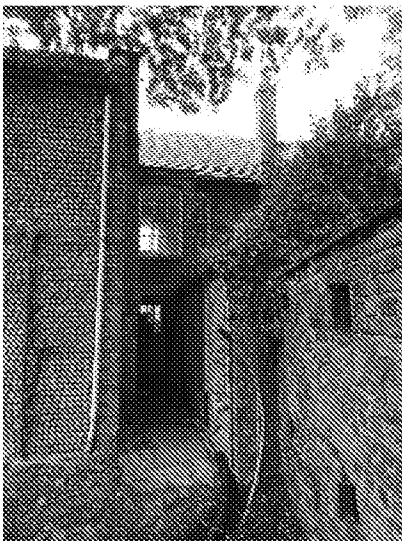
DSC03133 East elevation of first floor link in context

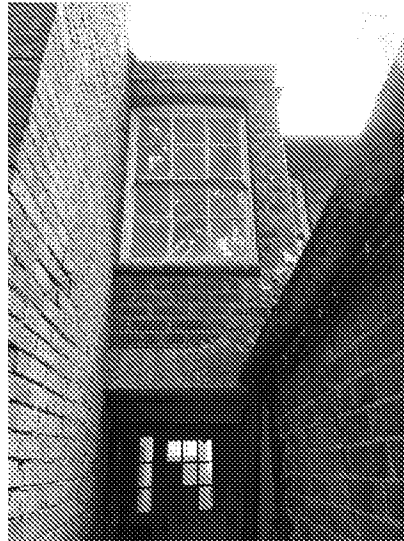
DSC03126 Close up of first floor link

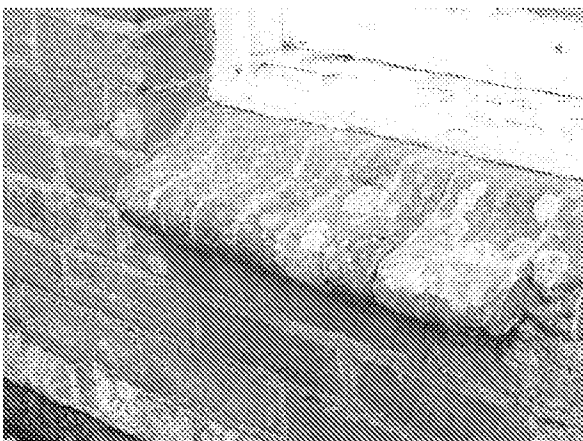
DSC02703 Brick cill detail to replicate the historic form

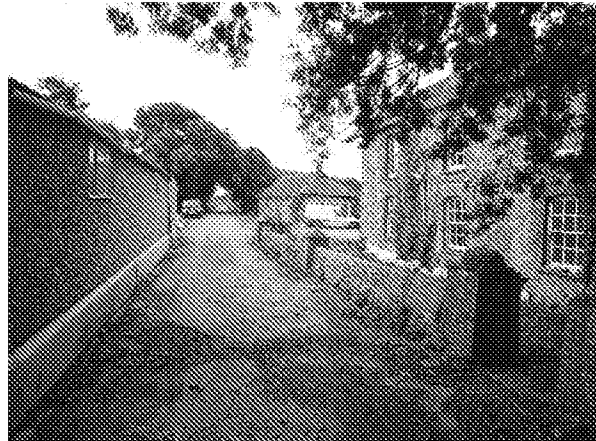
DSC03117 Garden wall to East Elevation

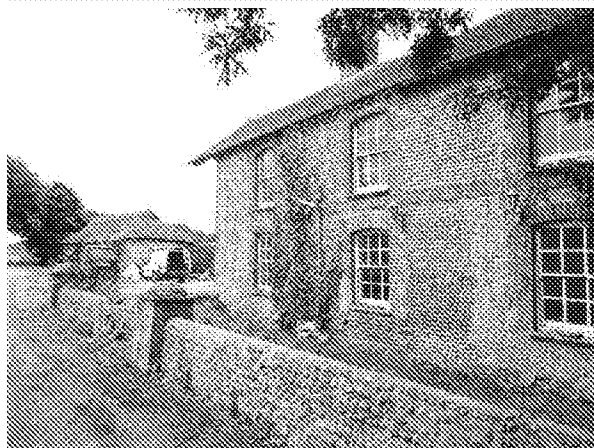
DSC02716 Garden wall to East Elevation

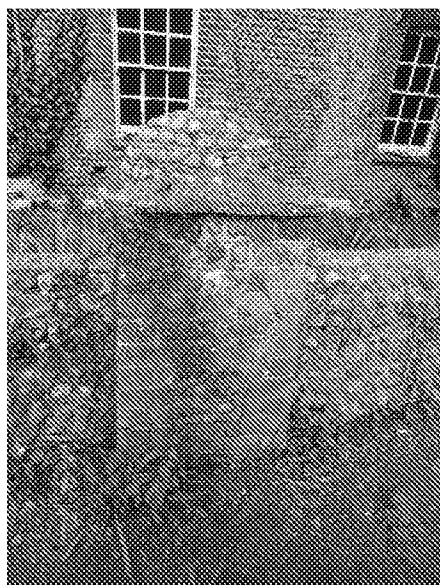
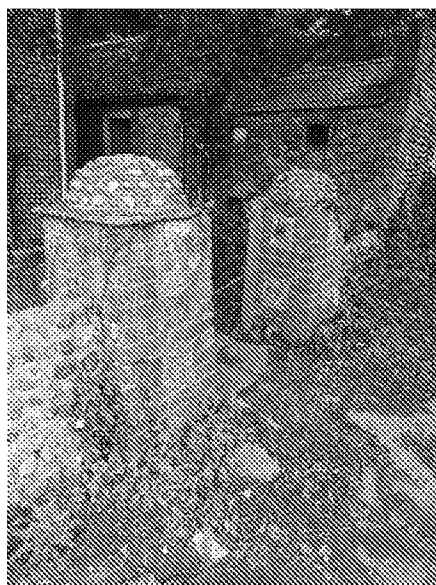
DSC03113 & DSC3114 Images of the curtilage listed garden wall to Mill House

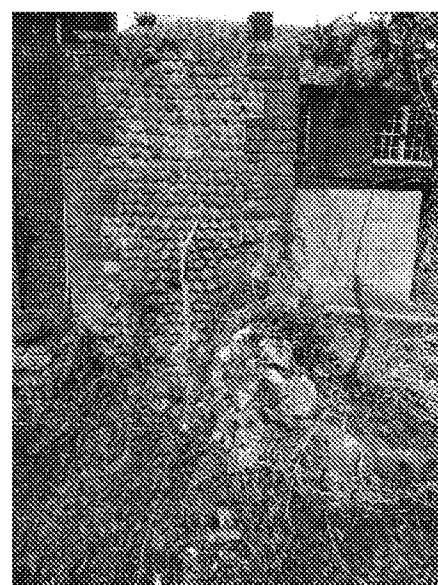
DSC3116 East elevation of flint wall with brick dressing associated with outbuildings

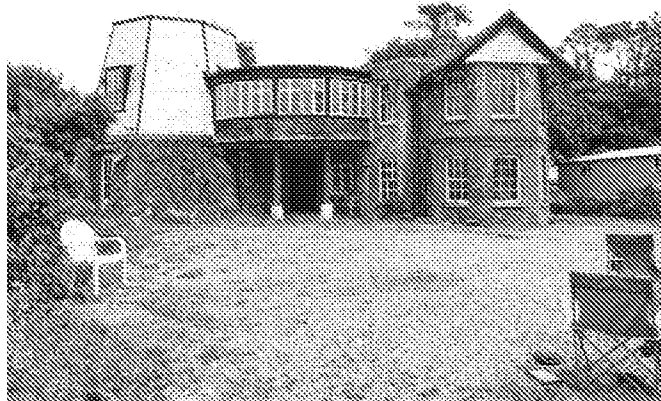
DSC02772 South elevation showing Mill, first floor link and Mill House

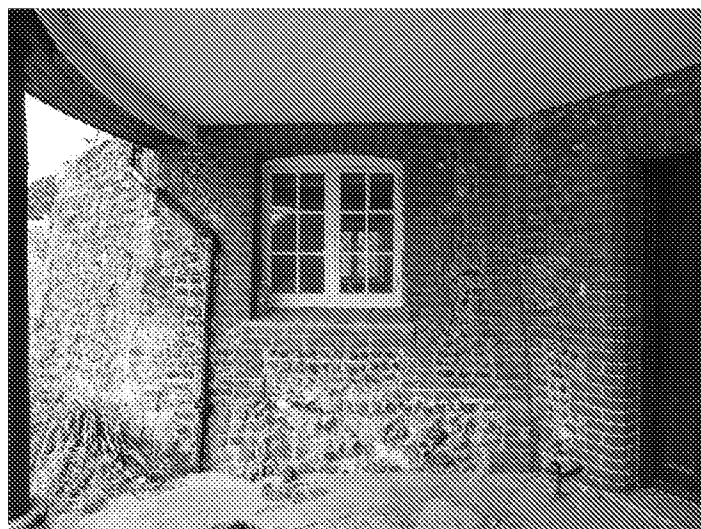
DSC03143 Masonry wall of Mill contained under first floor sun room link

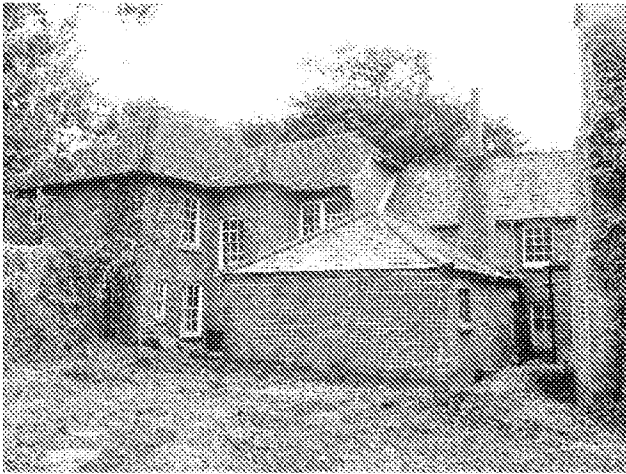
DSC02734 General view of extensions to Mill House

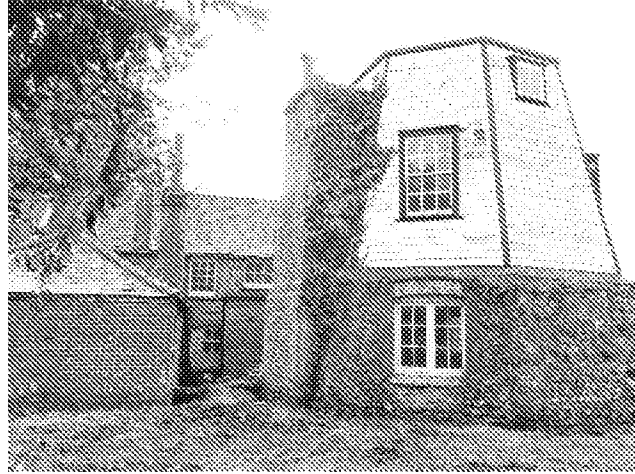
DSC02733 General view

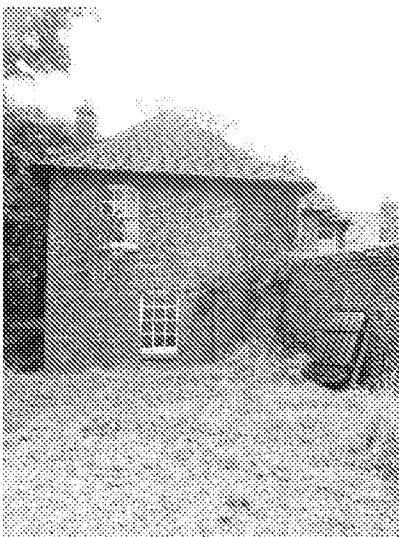
DSC02698 Hipped end North of the curtilage listed Mill flint wall

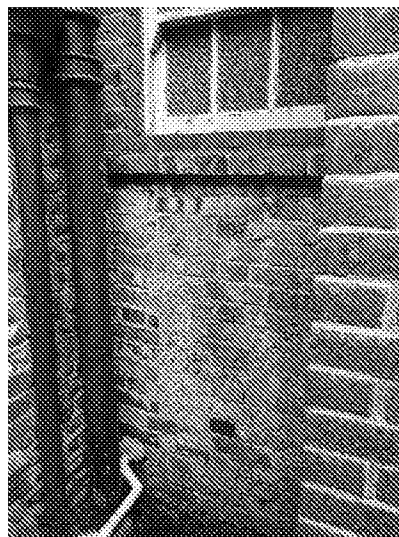
DSC03171 South courtyard wall the Mill House south of the early 20<sup>th</sup> century addition

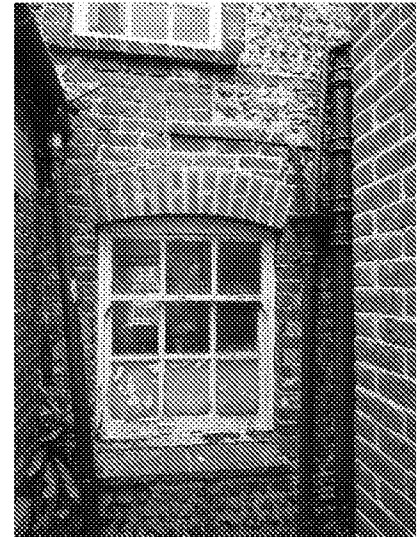
DSC03172 East courtyard wall the Mill House south of the early 20<sup>th</sup> century addition

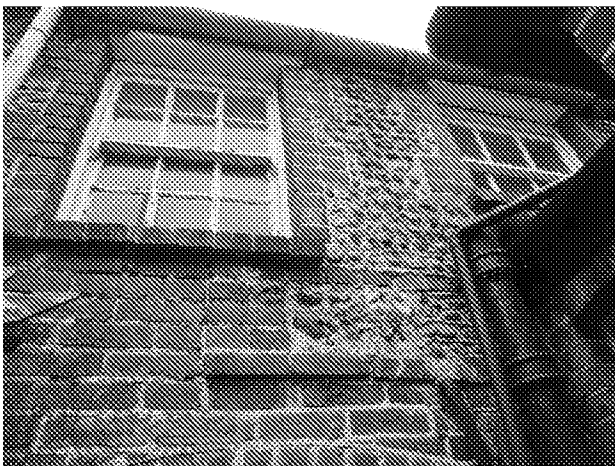
DSC03173 First Floor East courtyard wall of Mill House

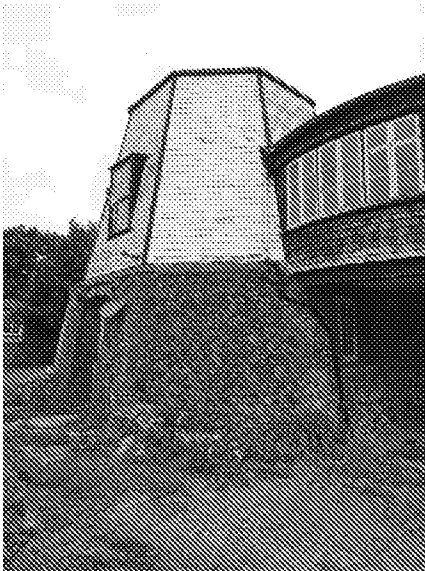
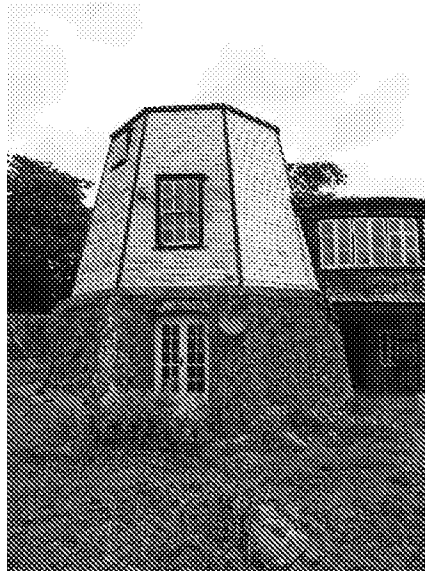
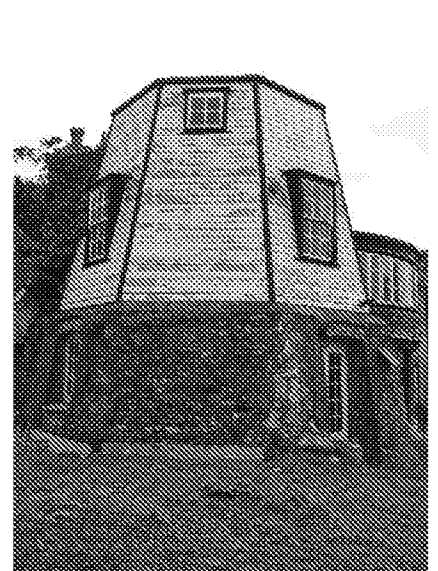
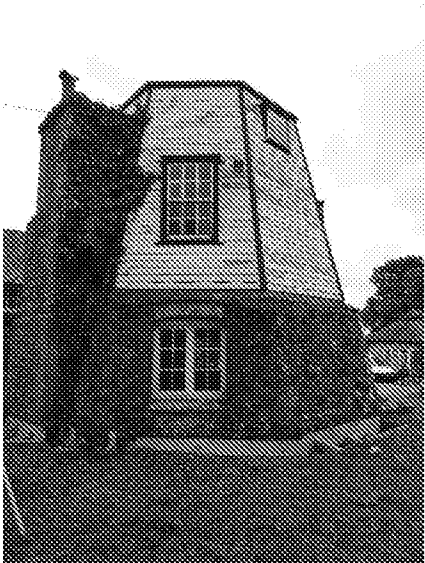
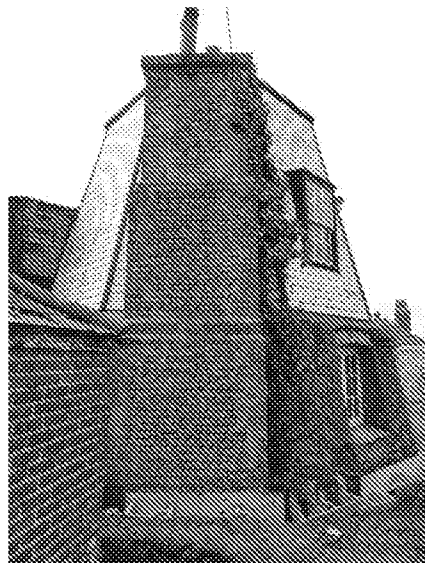
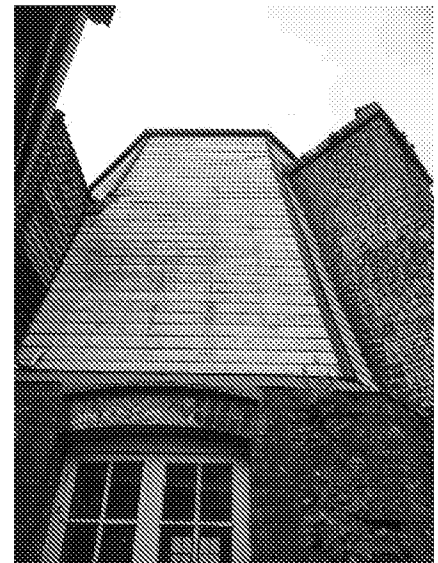
General views showing the elevation of The Mill

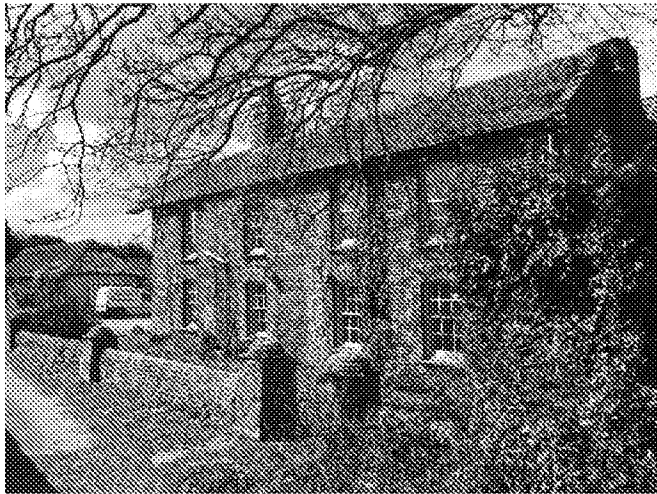
2017-04-26 11.48.49 East / Principal Façade

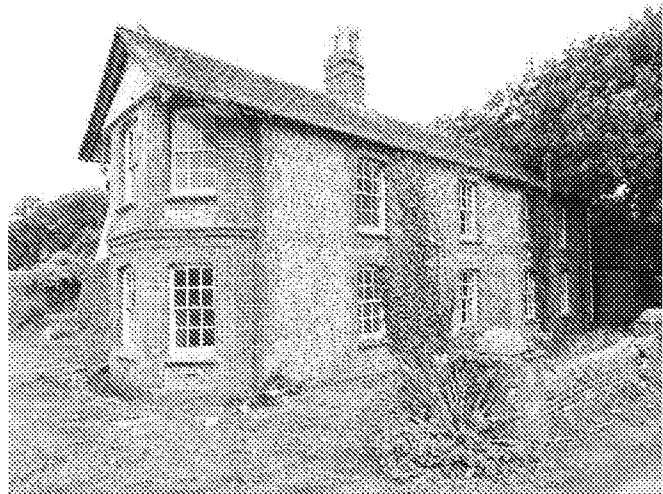
DSC02718 East & South Elevations, view looking North West

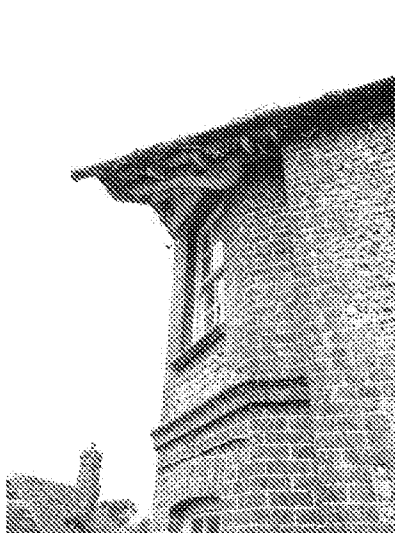
DSC02720 Roof detail above canted bay

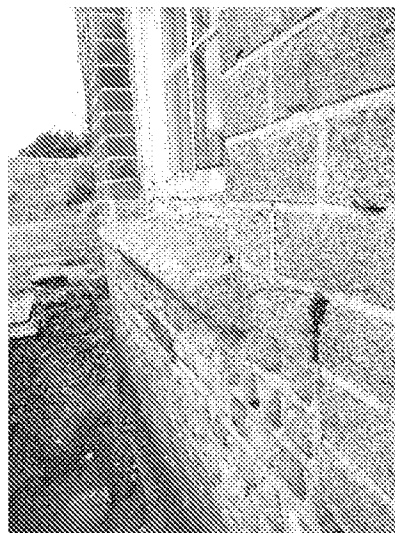
DSC02719 Typical brick cill detail

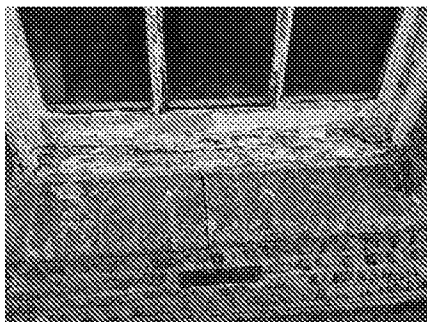
DSC03140 Decay cill and bottom rail of sash window

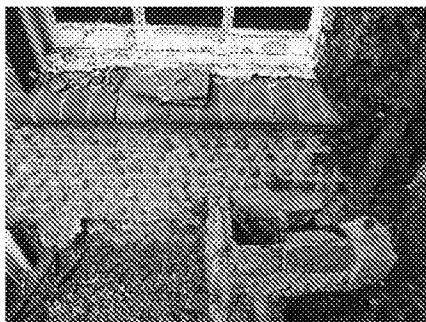
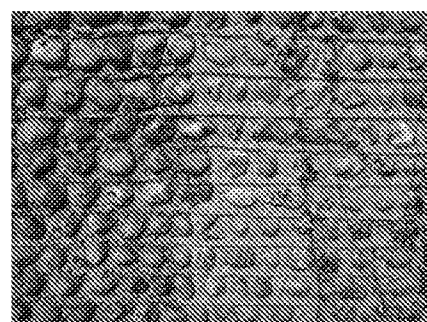
DSC03144 Repointing of flintwork using cementitious mortar

DSC03144 Comparative between the original lime mortar (with coal inclusion) and cementitious mortar

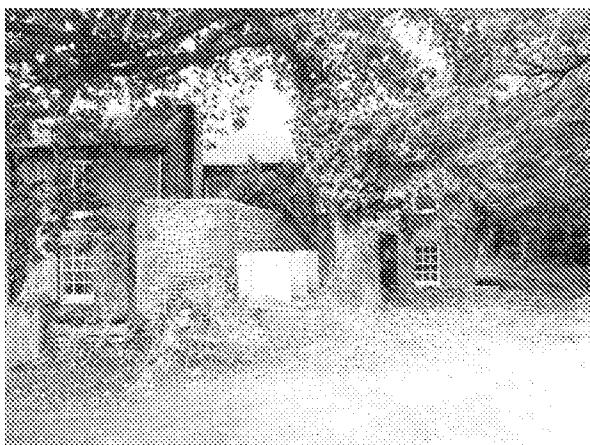
DSC02710 View of Flint wall integral to the Outbuildings

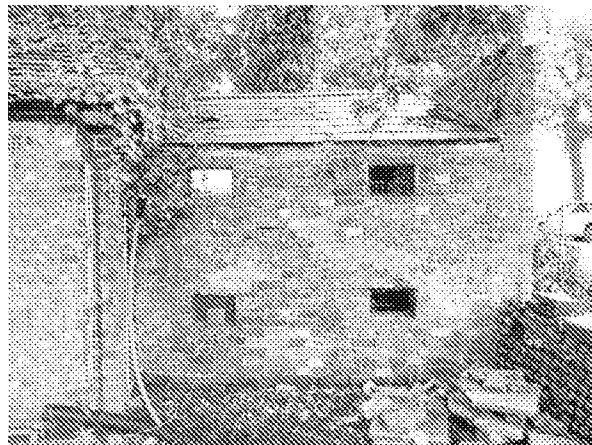
DSC02711 South Elevation of External Store (OB01)

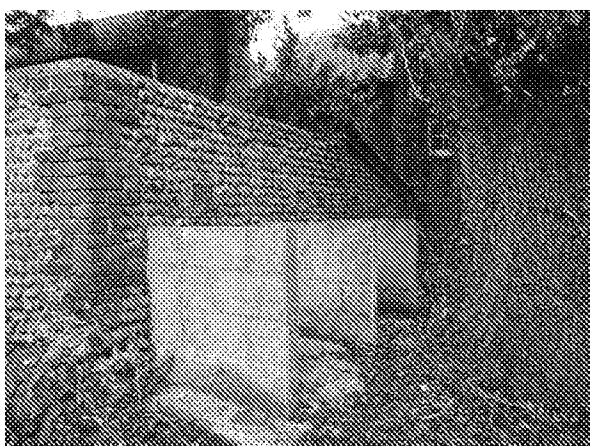
DSC03188 View looking South West showing parapet rear wall of Outbuilding (OB1)

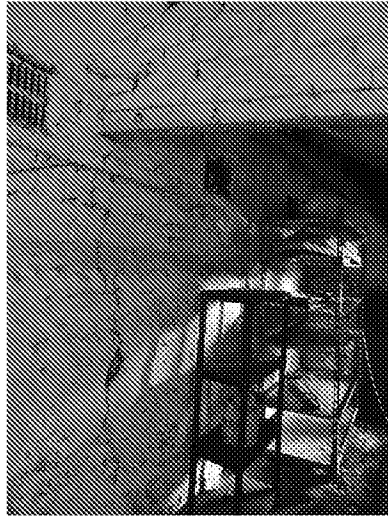
DSC03128

DSC03123 Vertical cracking to North wall internally (OB01)

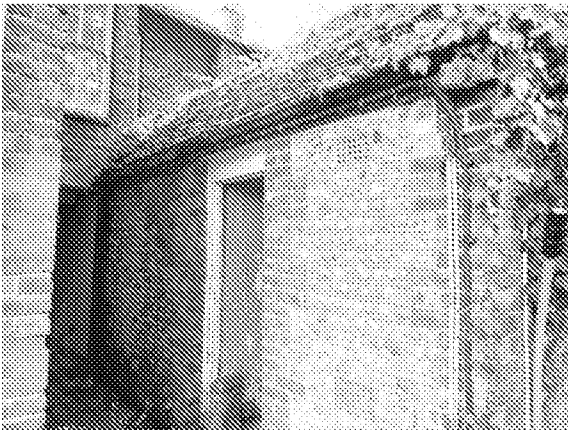
DSC02712 South Elevation of Workshop / Boiler room (OB02)

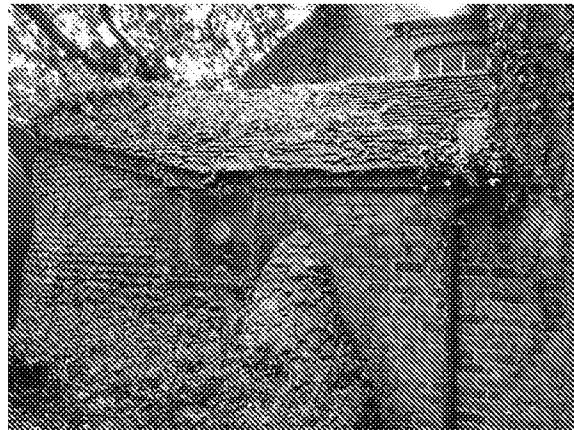
DSC03187 North Elevation of Workshop / Boiler room (OB02)

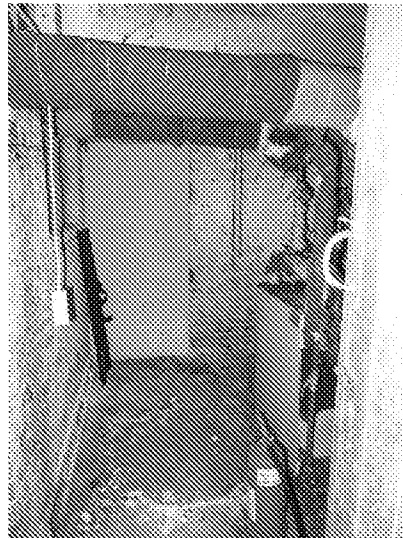
DSC03127 View looking North (OB02)

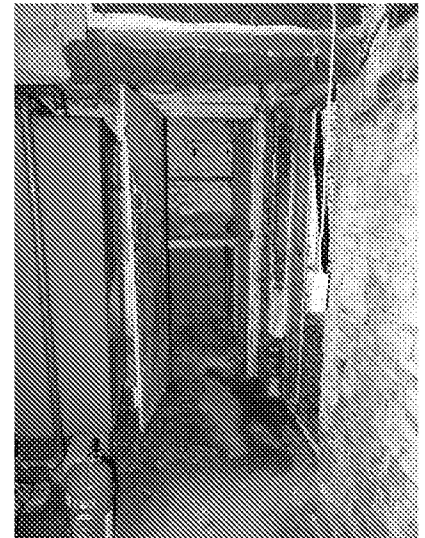
DSC03128

DSC03127 View looking East (OB02)

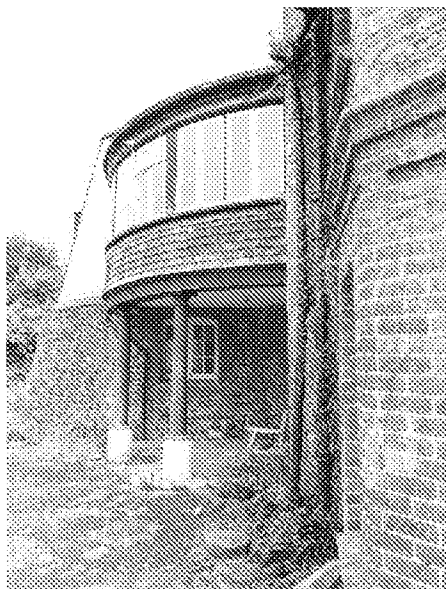
DSC02722 View looking West

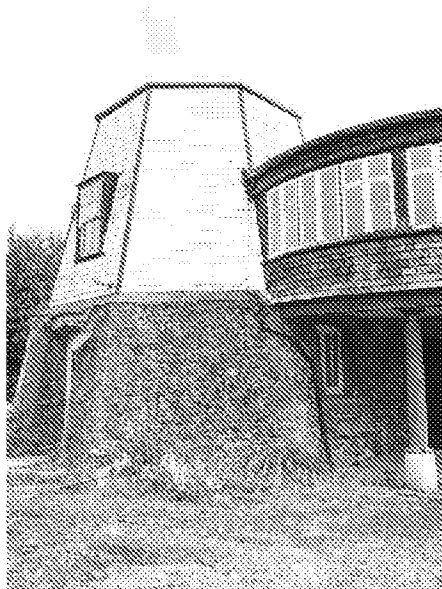
DSC02722 View looking North West

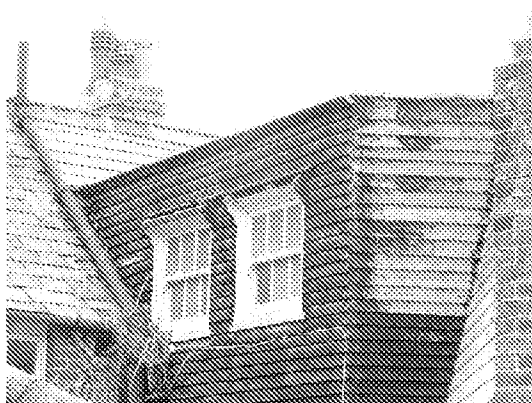
DSC02749 North Elevation of link

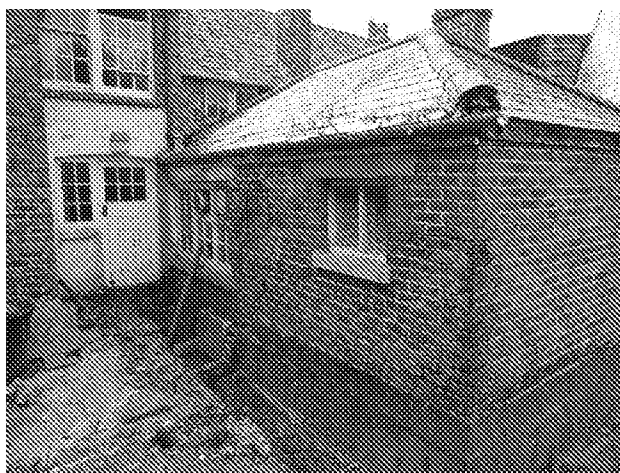
DSC03178 North Elevation

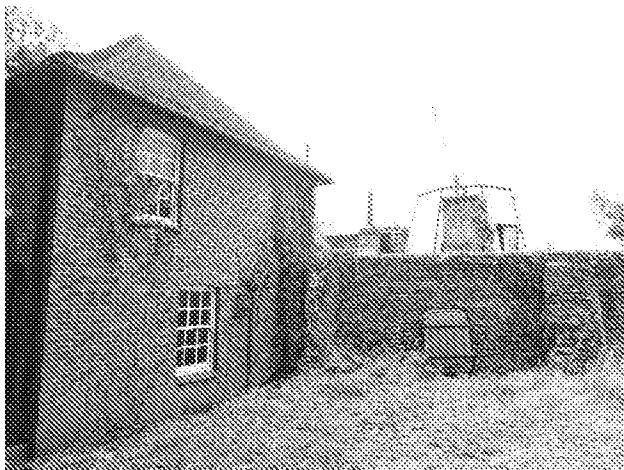
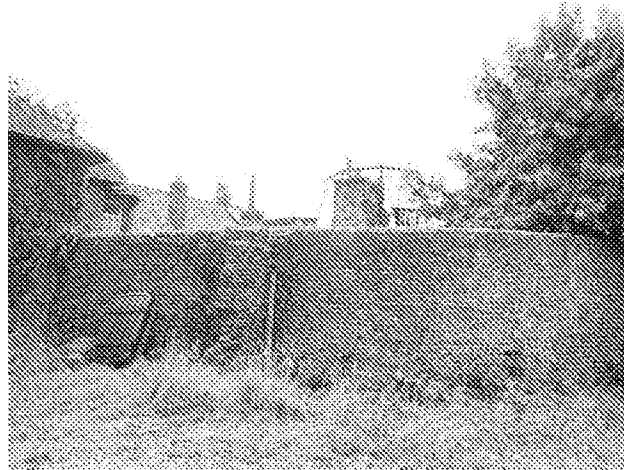
DSC02695 External view looking South East showing truncated mill and curtilage listed flint wall

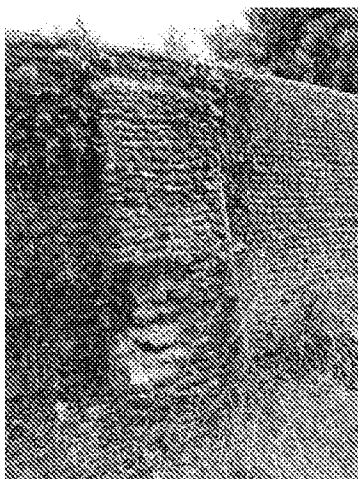
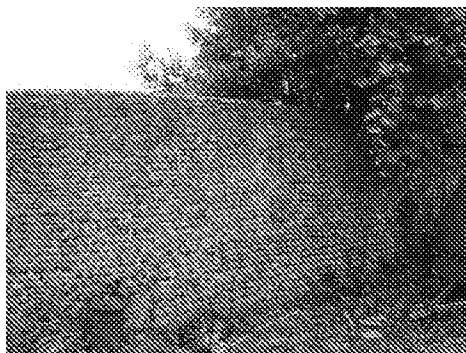
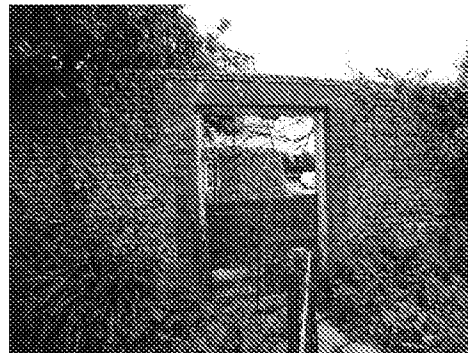
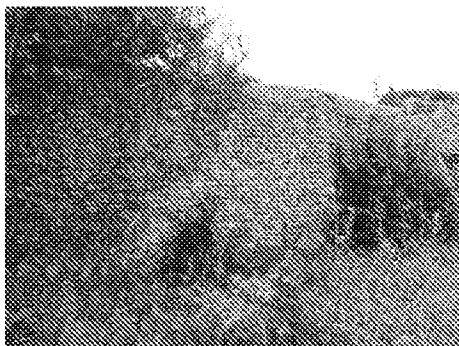
General views showing construction arrangement including flint contracted buttresses, brick dressing to change of directions and openings and general defects associated with Mill wall
