**ALL HOURS PLUMBING**

| Project Name:<br><b>468</b> | Contract Number: | Contact:<br><b>Parchow Groundworks</b> | Date:<br><b>05/05/2026</b> |

Client: **Parchow Groundworks**  
Contact:  
Position:  
Road: **Widley Farm, New Down Lane**  
Town: **Purbrook**  
Post Code: **PO7 5SE**  
County: **Hampshire**  
Telephone:

Inspection Report

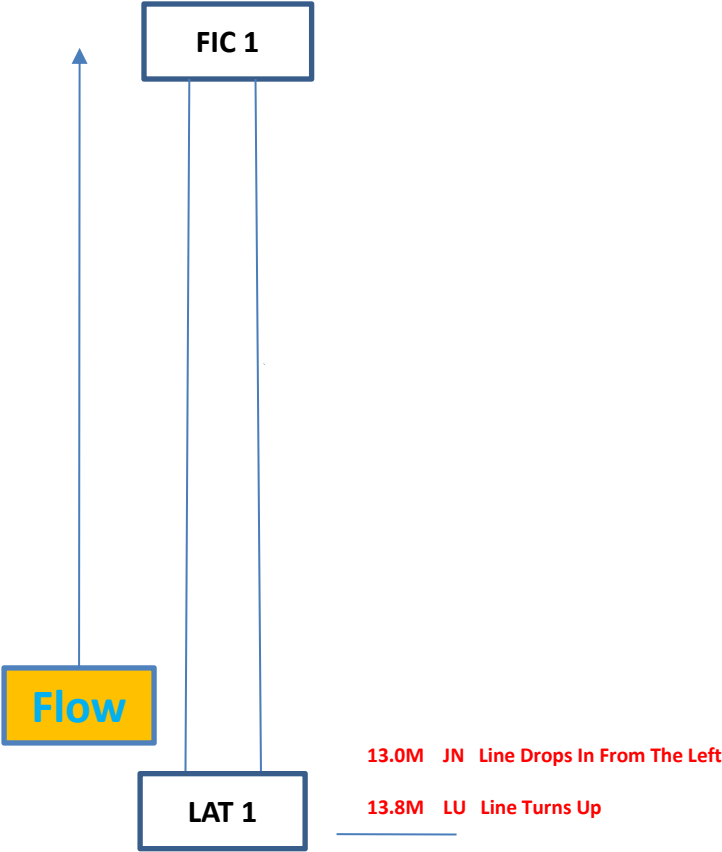
0.0M ST Start Of Survey  
0.0M WL Water Level 0 %

REM ; THERE ARE NO MAJOR PROBLEMS WITH THIS SECTION OF PIPE

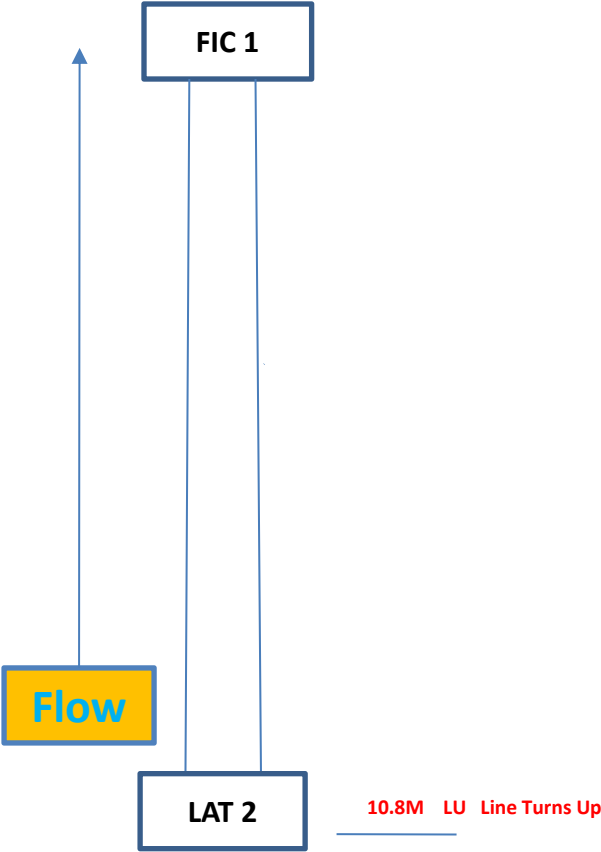
0.0M ST Start Of Survey  
0.0M WL Water Level 0 %

REM ; THERE ARE NO MAJOR PROBLEMS WITH THIS SECTION OF PIPE

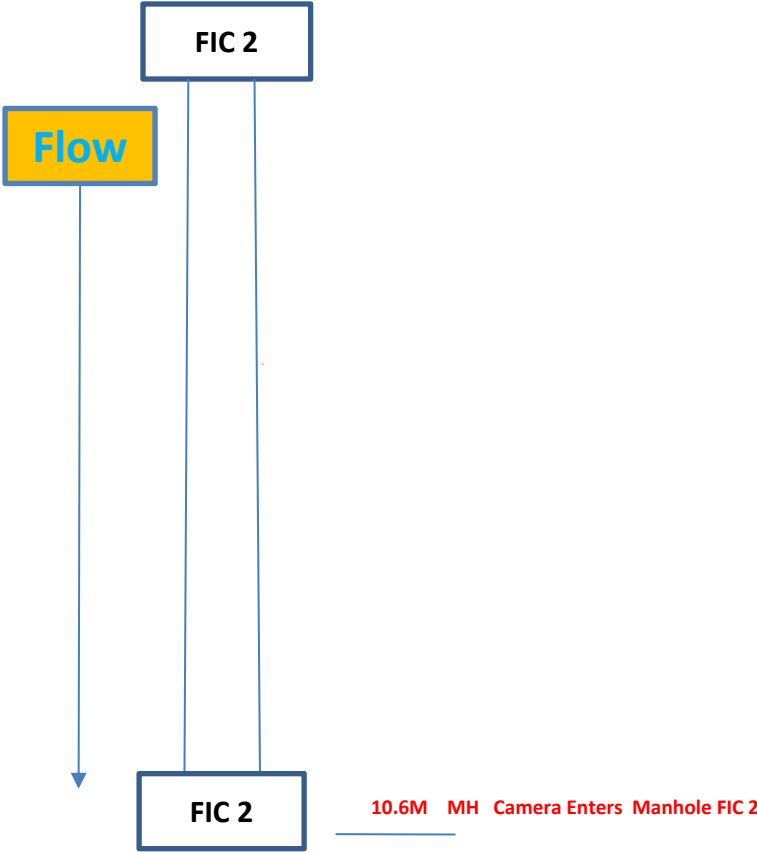
0.0M ST Start Of Survey  
0.0M WL Water Level 0 %

REM ; THERE ARE NO MAJOR PROBLEMS WITH THIS SECTION OF PIPE

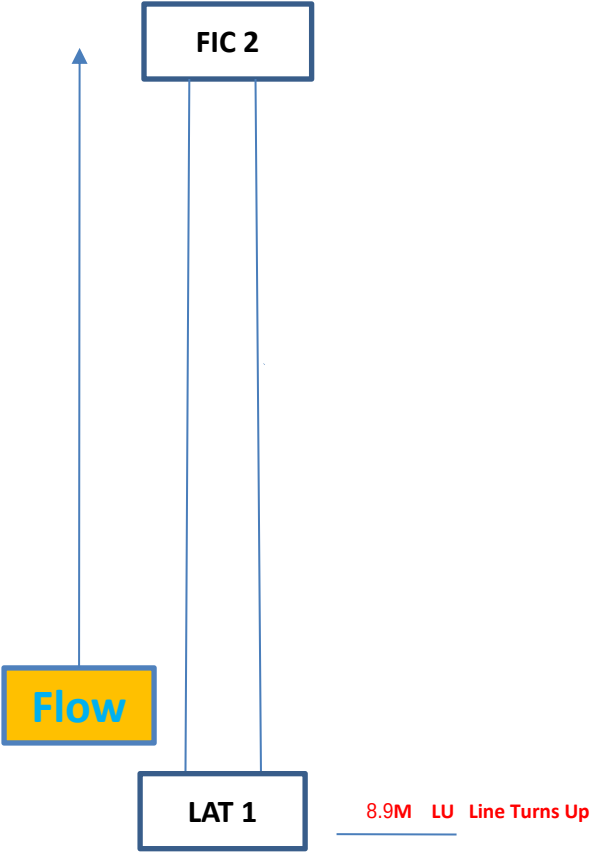
0.0M ST Start Of Survey  
0.0M WL Water Level 0 %

REM ; THERE ARE NO MAJOR PROBLEMS WITH THIS SECTION OF PIPE

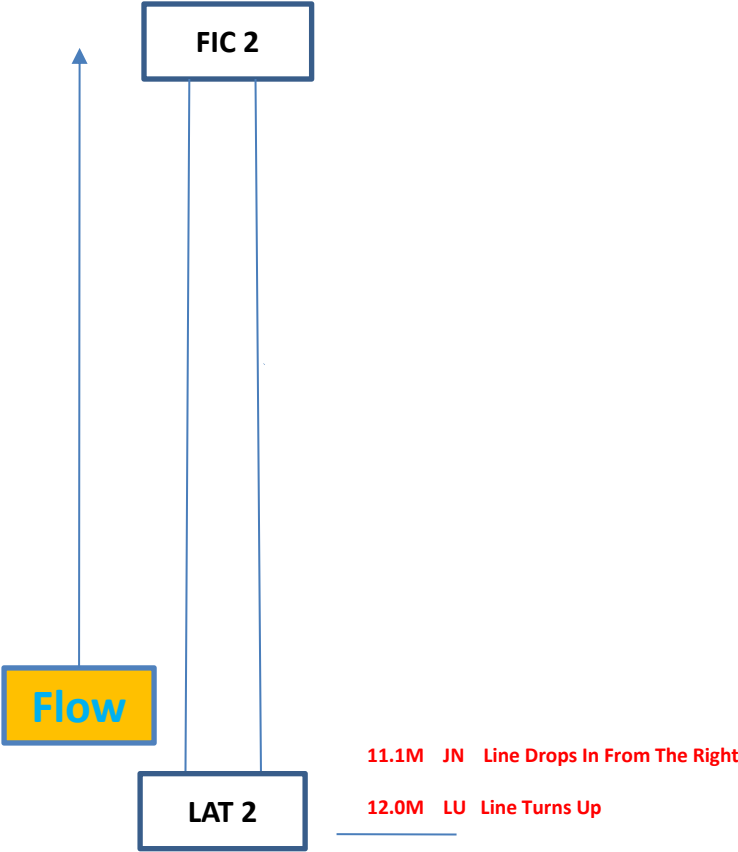
0.0M ST Start Of Survey  
0.0M WL Water Level 0 %

REM ; THERE ARE NO MAJOR PROBLEMS WITH THIS SECTION OF PIPE

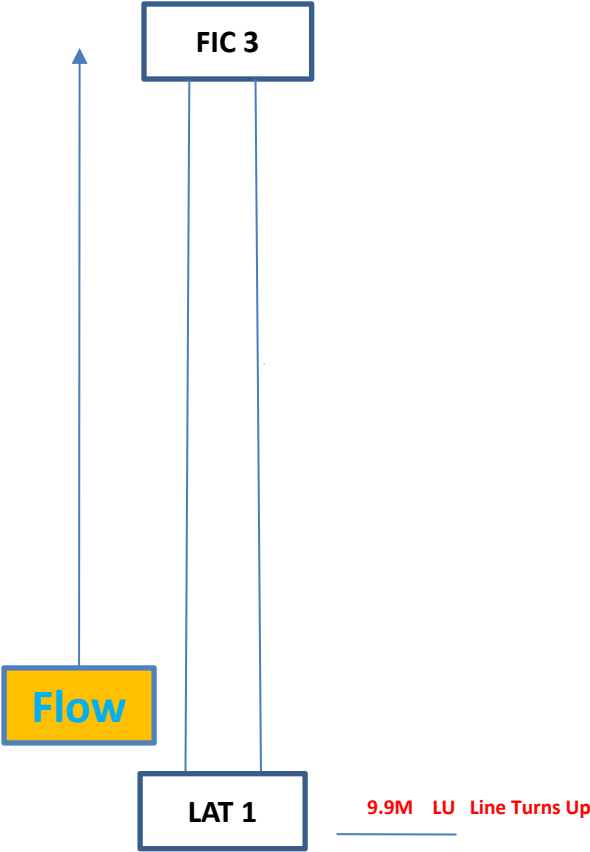
0.0M ST Start Of Survey  
0.0M WL Water Level 0 %

REM ; THERE ARE NO MAJOR PROBLEMS WITH THIS SECTION OF PIPE

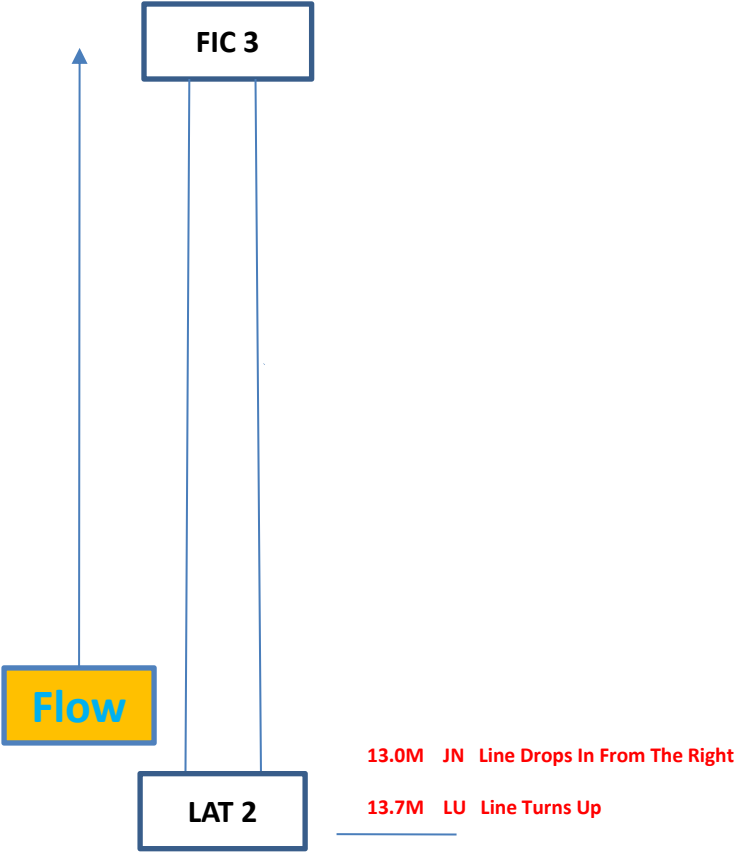
0.0M ST Start Of Survey  
0.0M WL Water Level 0 %

REM ; THERE ARE NO MAJOR PROBLEMS WITH THIS SECTION OF PIPE

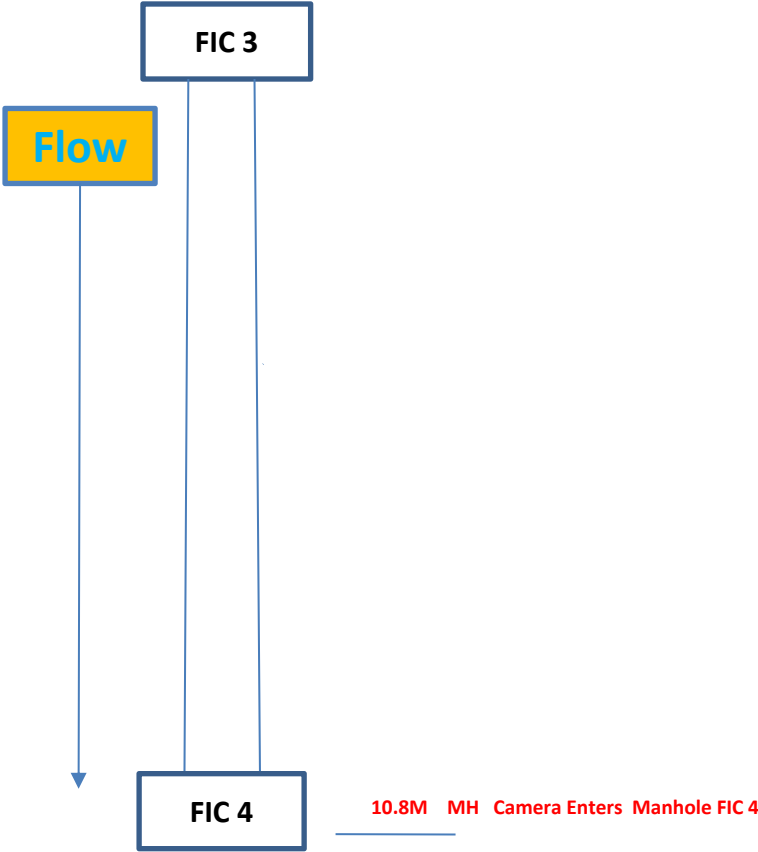
0.0M ST Start Of Survey  
0.0M WL Water Level 0 %

REM ; THERE ARE NO MAJOR PROBLEMS WITH THIS SECTION OF PIPE

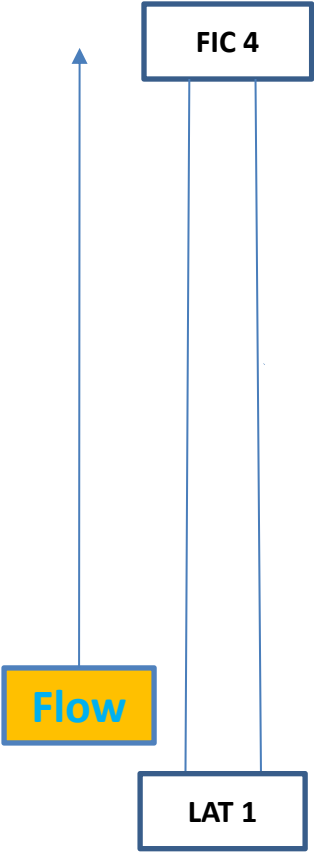
0.0M ST Start Of Survey  
0.0M WL Water Level 0 %

12.1M JN Line Drops In From The Right  
14.0M JN Line Drops In From The Left  
14.6M LU Line Turns Up

REM ; THERE ARE NO MAJOR PROBLEMS WITH THIS SECTION OF PIPE

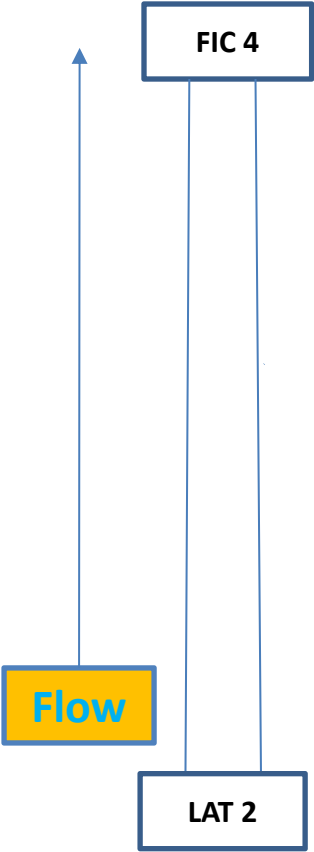
0.0M ST Start Of Survey  
0.0M WL Water Level 0 %

REM ; THERE ARE NO MAJOR PROBLEMS WITH THIS SECTION OF PIPE

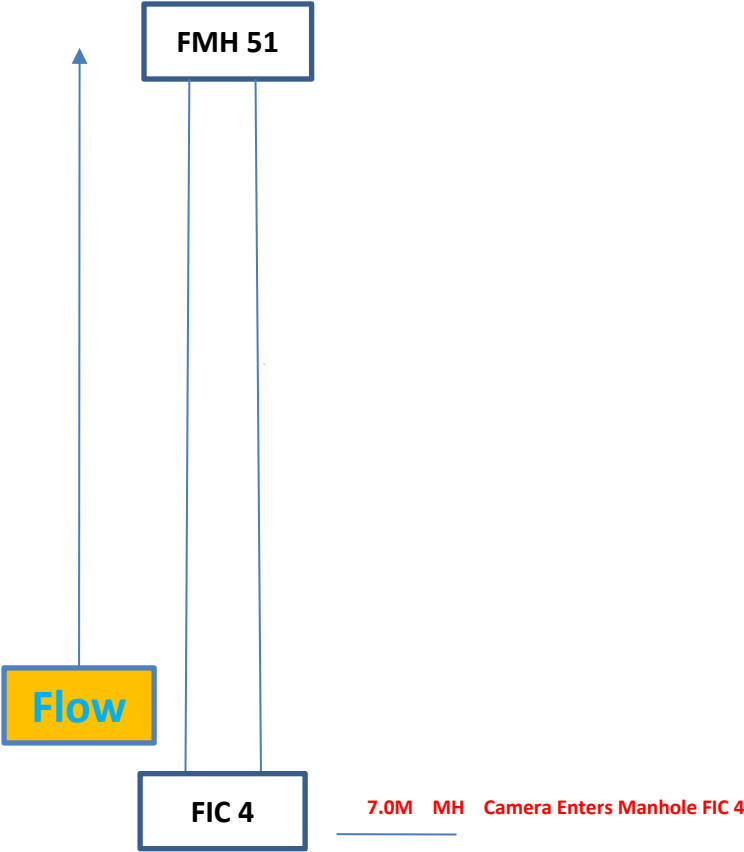
0.0M ST Start Of Survey  
0.0M WL Water Level 0 %

REM ; THERE ARE NO MAJOR PROBLEMS WITH THIS SECTION OF PIPE

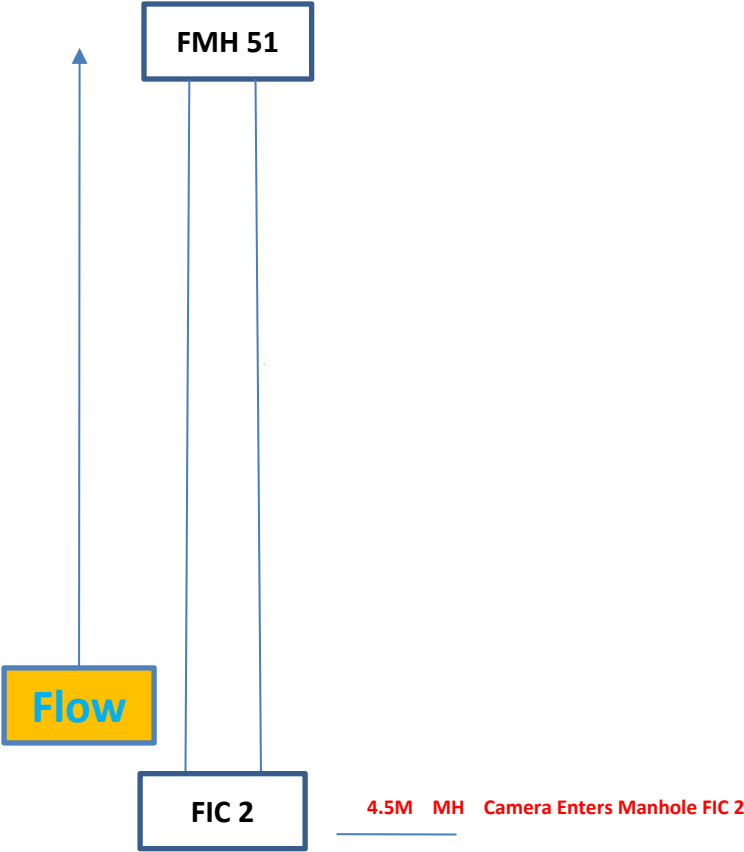
0.0M ST Start Of Survey  
0.0M WL Water Level 0 %

REM ; THERE ARE NO MAJOR PROBLEMS WITH THIS SECTION OF PIP

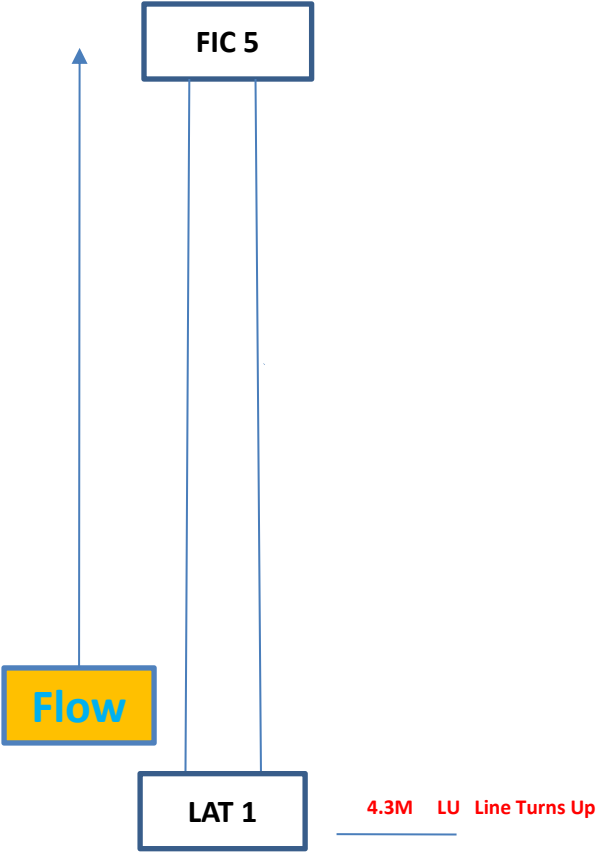
0.0M ST Start Of Survey  
0.0M WL Water Level 0 %

REM ; THERE ARE NO MAJOR PROBLEMS WITH THIS SECTION OF PIP

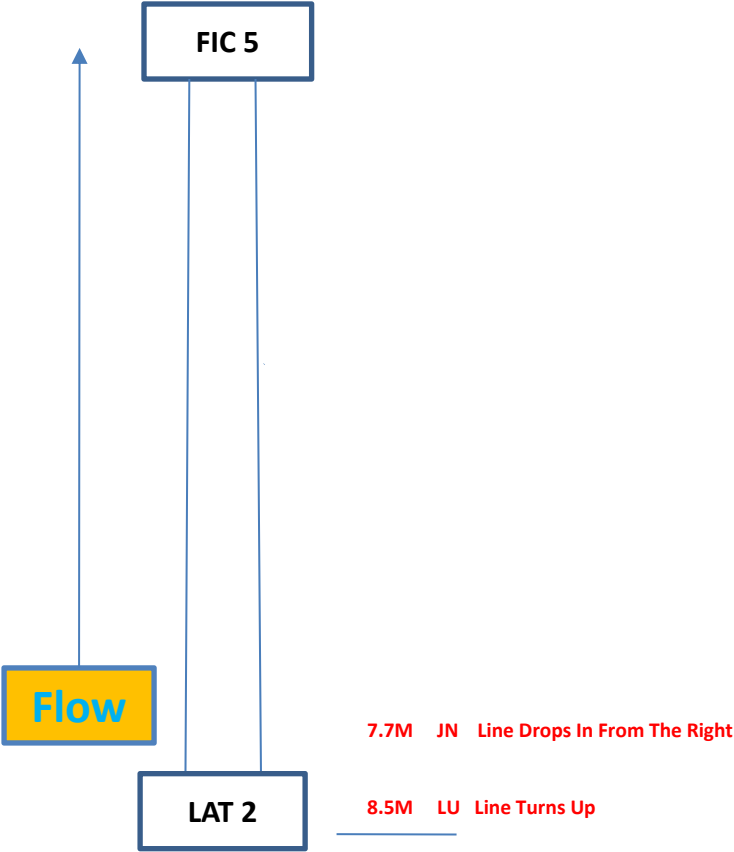
0.0M ST Start Of Survey  
0.0M WL Water Level 0 %

REM ; THERE ARE NO MAJOR PROBLEMS WITH THIS SECTION OF PIP

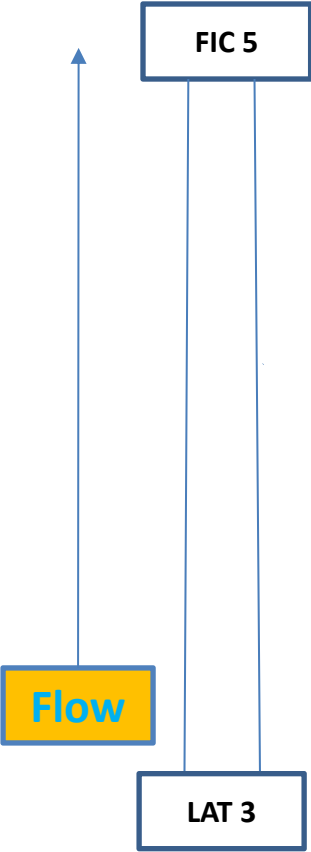
0.0M ST Start Of Survey  
0.0M WL Water Level 0 %

4.2M JN Line Drops In From The Right

8.8M JN Line Drops In From The Left

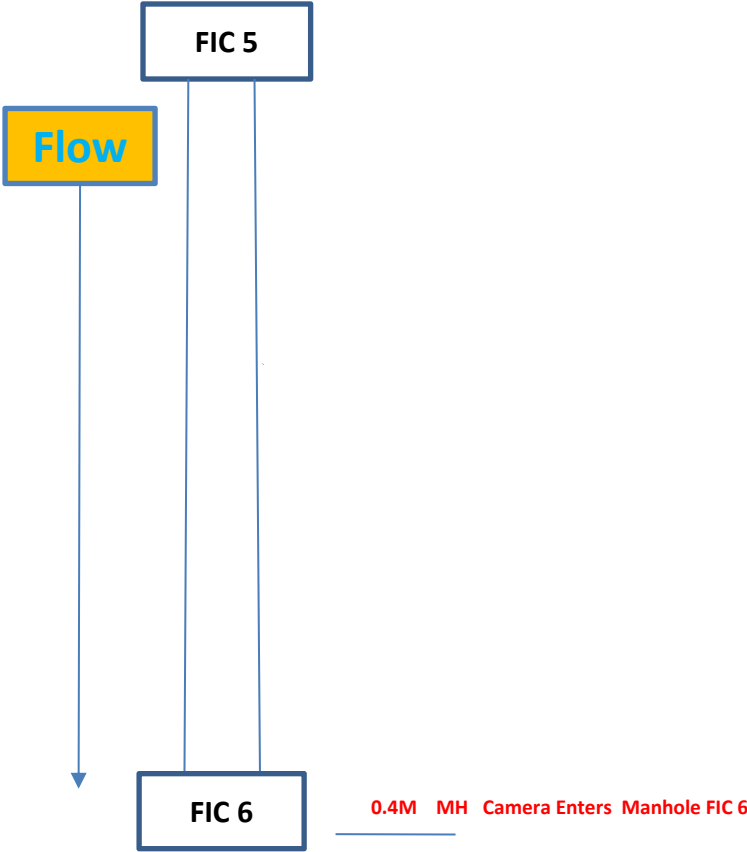
0.0M ST Start Of Survey  
0.0M WL Water Level 0 %

REM ; THERE ARE NO MAJOR PROBLEMS WITH THIS SECTION OF PIPE

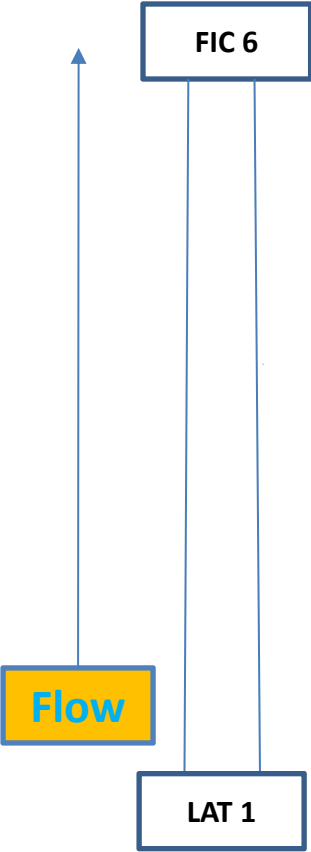
0.0M ST Start Of Survey  
0.0M WL Water Level 0 %

4.5M JN Line Drops In From The Right

9.0M JN Line Drops In From The Right

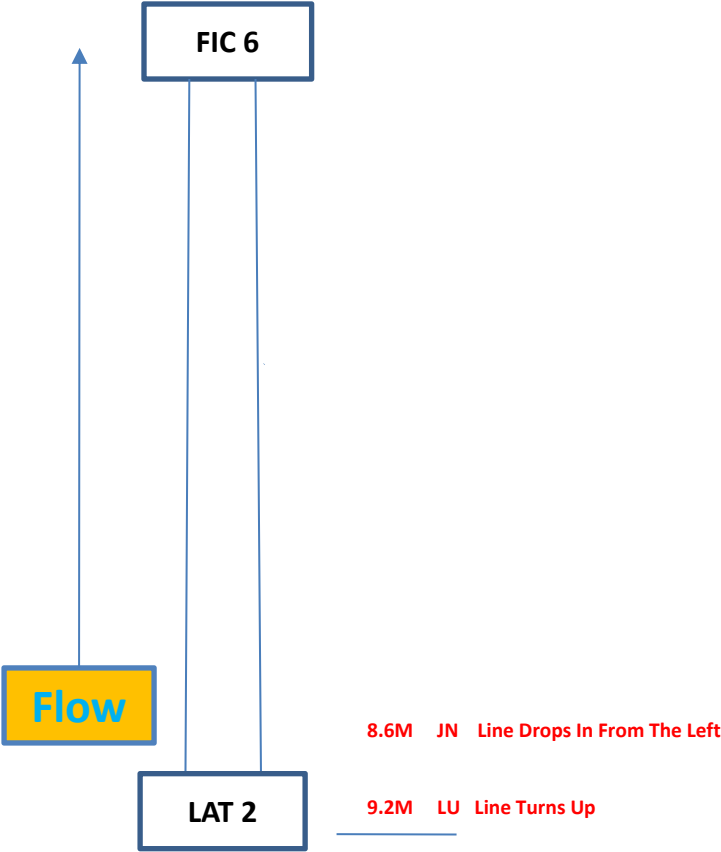
0.0M ST Start Of Survey  
0.0M WL Water Level 0 %

REM ; THERE ARE NO MAJOR PROBLEMS WITH THIS SECTION OF PIPE

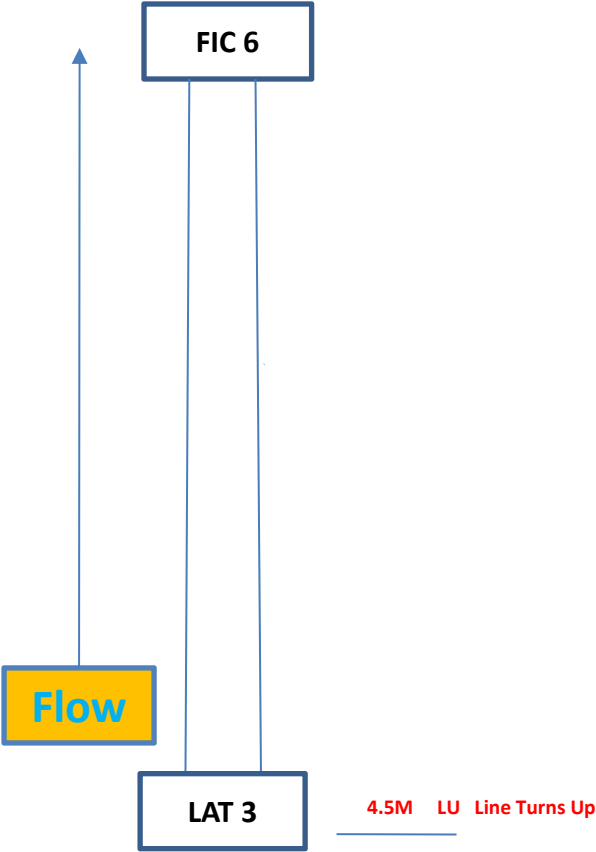
0.0M ST Start Of Survey  
0.0M WL Water Level 0 %

REM ; THERE ARE NO MAJOR PROBLEMS WITH THIS SECTION OF PIPE

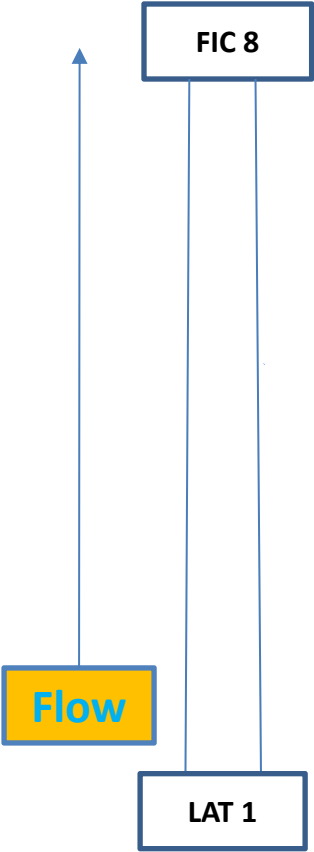
0.0M ST Start Of Survey  
0.0M WL Water Level 0 %

4.4M JN Line Drops In From The Left

8.6M JN Line Drops In From The Right

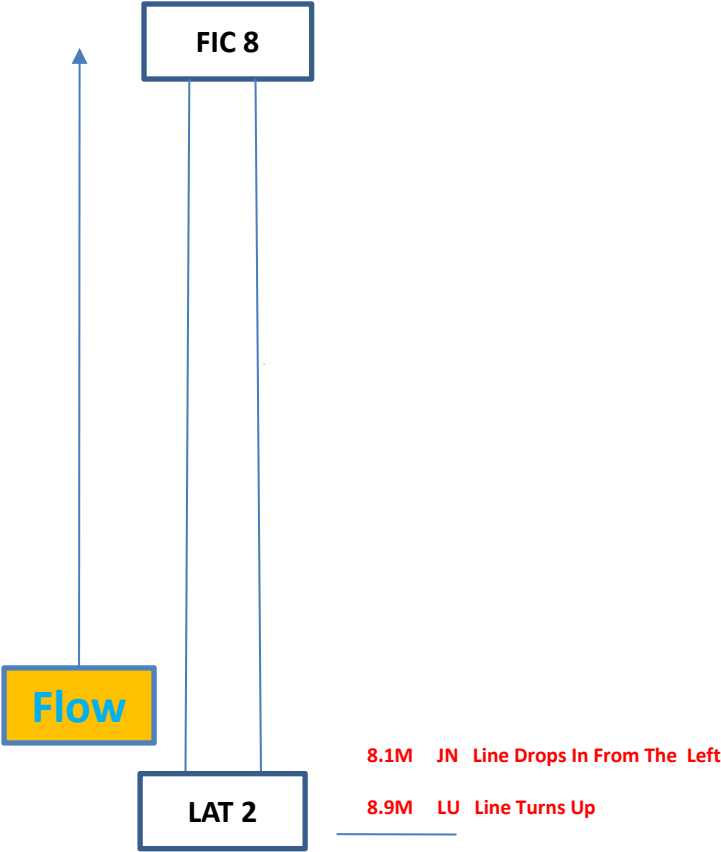
0.0M ST Start Of Survey  
0.0M WL Water Level 0 %

REM ; THERE ARE NO MAJOR PROBLEMS WITH THIS SECTION OF PIPE

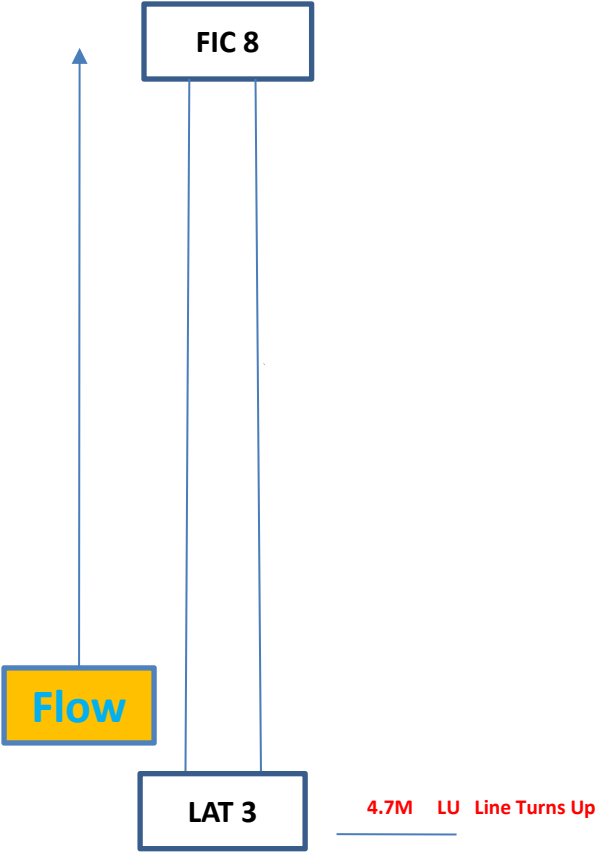
0.0M ST Start Of Survey  
0.0M WL Water Level 0 %

REM ; THERE ARE NO MAJOR PROBLEMS WITH THIS SECTION OF PIPE

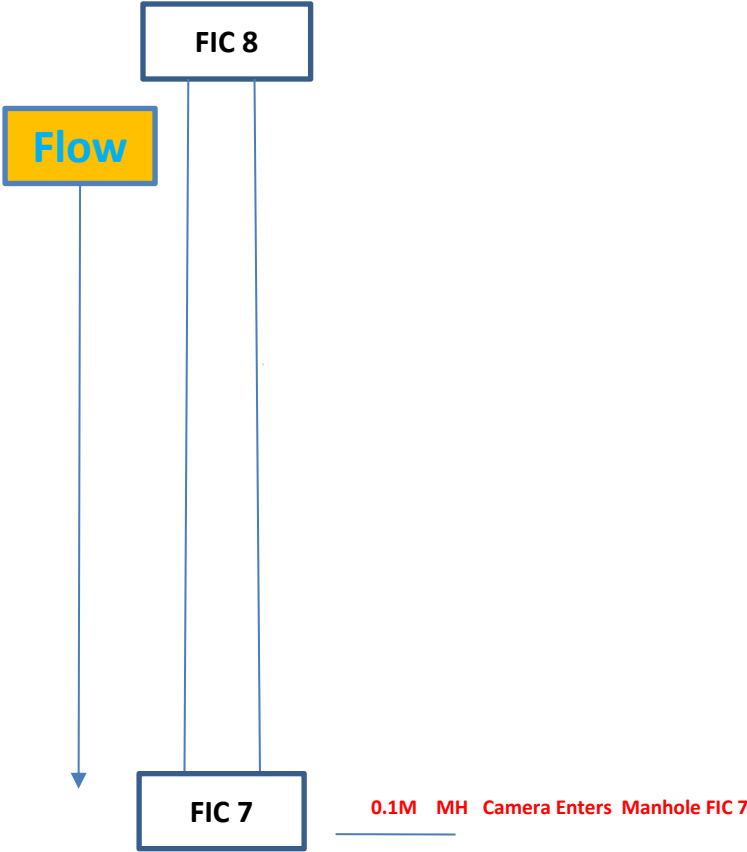
0.0M ST Start Of Survey  
0.0M WL Water Level 0 %

REM ; THERE ARE NO MAJOR PROBLEMS WITH THIS SECTION OF PIPE

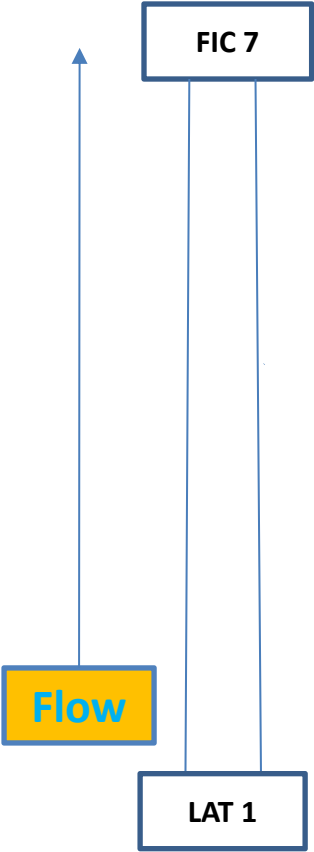
0.0M ST Start Of Survey  
0.0M WL Water Level 0 %

REM ; THERE ARE NO MAJOR PROBLEMS WITH THIS SECTION OF PIPE

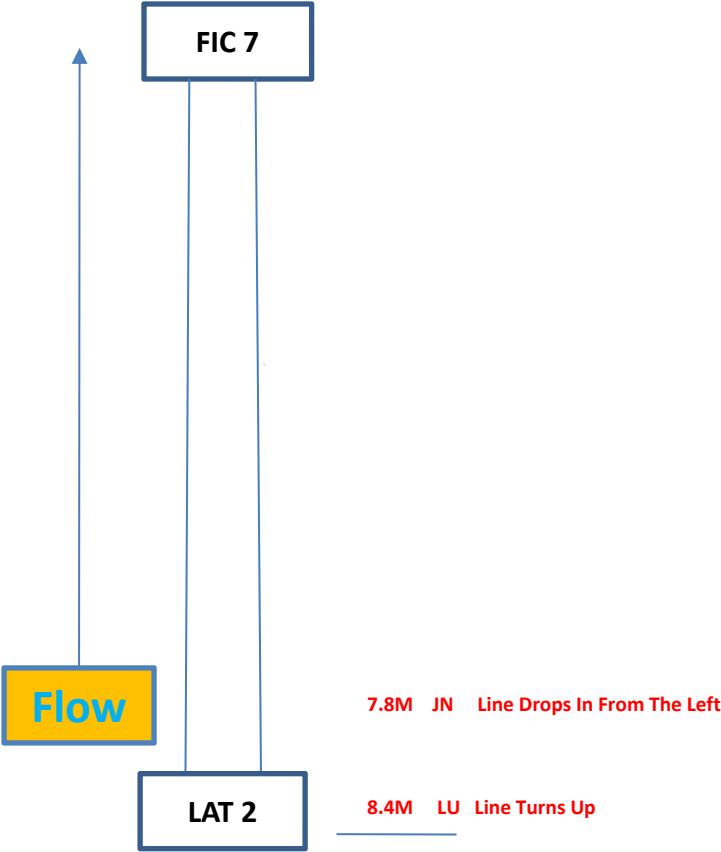
0.0M ST Start Of Survey  
0.0M WL Water Level 0 %

REM ; THERE ARE NO MAJOR PROBLEMS WITH THIS SECTION OF PIPE

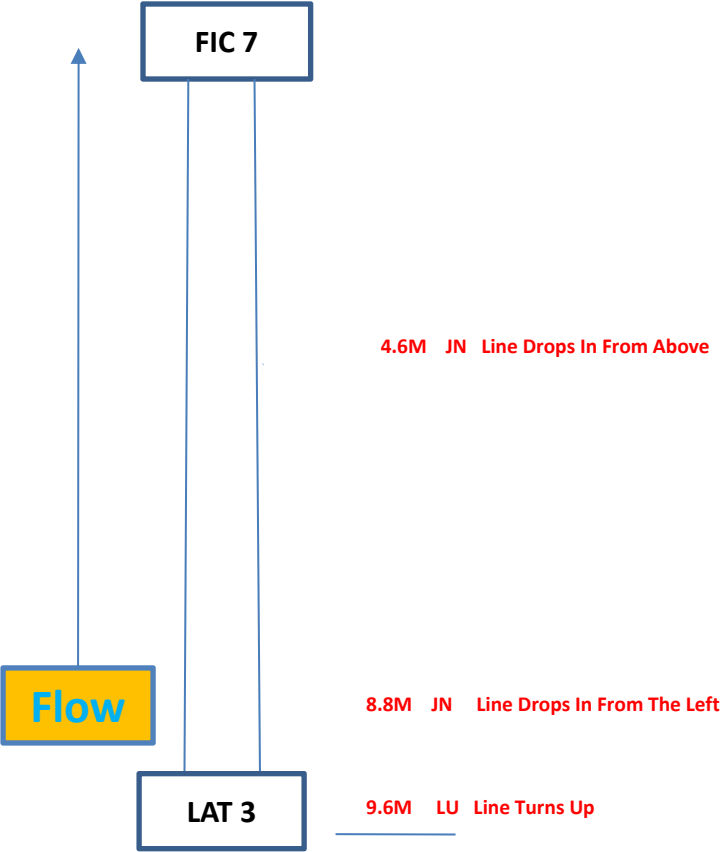
0.0M ST Start Of Survey  
0.0M WL Water Level 0 %

REM ; THERE ARE NO MAJOR PROBLEMS WITH THIS SECTION OF PIPE

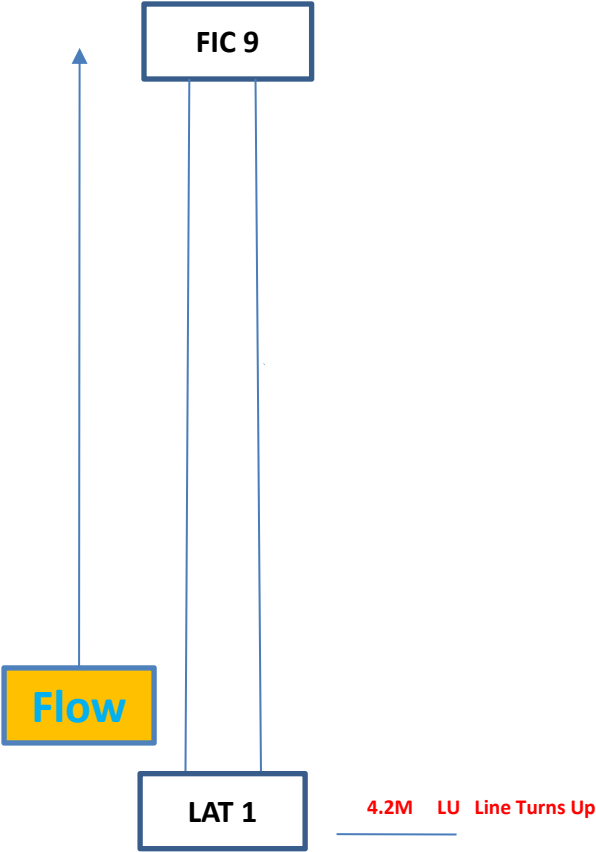
0.0M ST Start Of Survey  
0.0M WL Water Level 0 %

REM ; THERE ARE NO MAJOR PROBLEMS WITH THIS SECTION OF PIPE

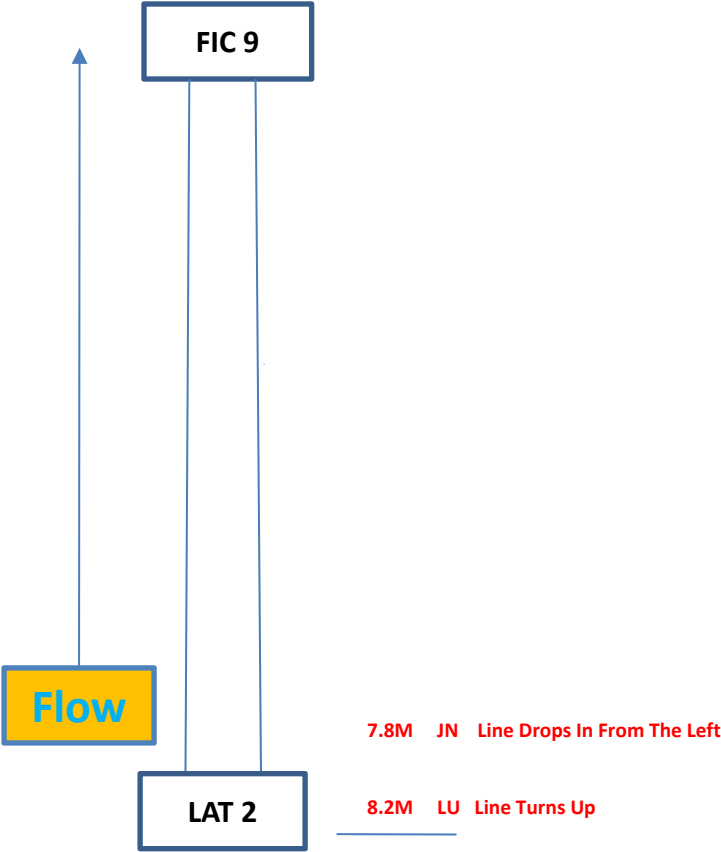
0.0M ST Start Of Survey  
0.0M WL Water Level 0 %

REM ; THERE ARE NO MAJOR PROBLEMS WITH THIS SECTION OF PIPE

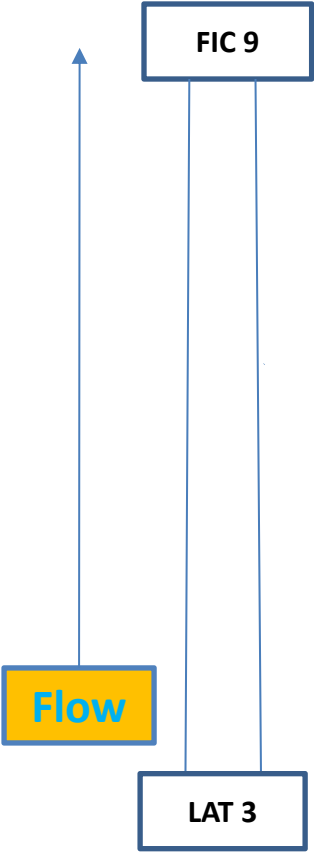
0.0M ST Start Of Survey  
0.0M WL Water Level 0 %

4.2M JN Line Drops In From Above

8.7M JN Line Drops In From The Left

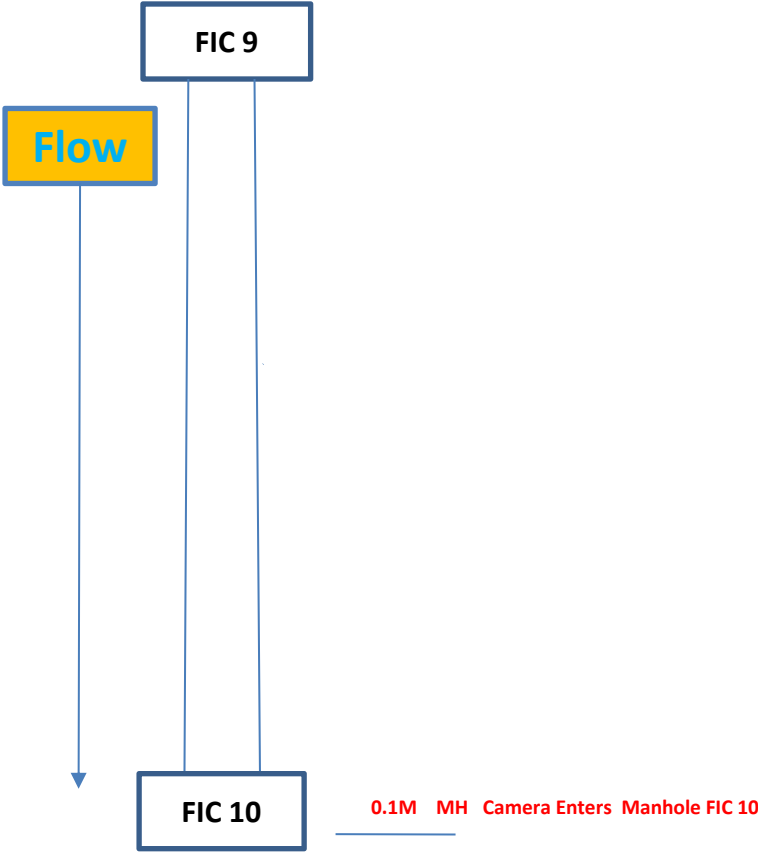
0.0M ST Start Of Survey  
0.0M WL Water Level 0 %

REM ; THERE ARE NO MAJOR PROBLEMS WITH THIS SECTION OF PIPE

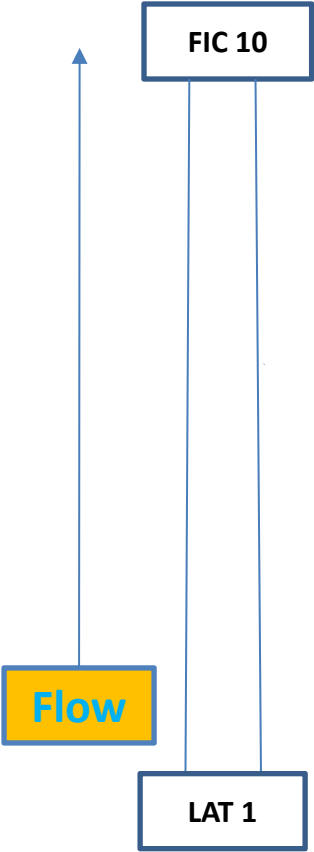
0.0M ST Start Of Survey  
0.0M WL Water Level 0 %

4.5M JN Line Drops In From Above

8.7M JN Line Drops In From The Right

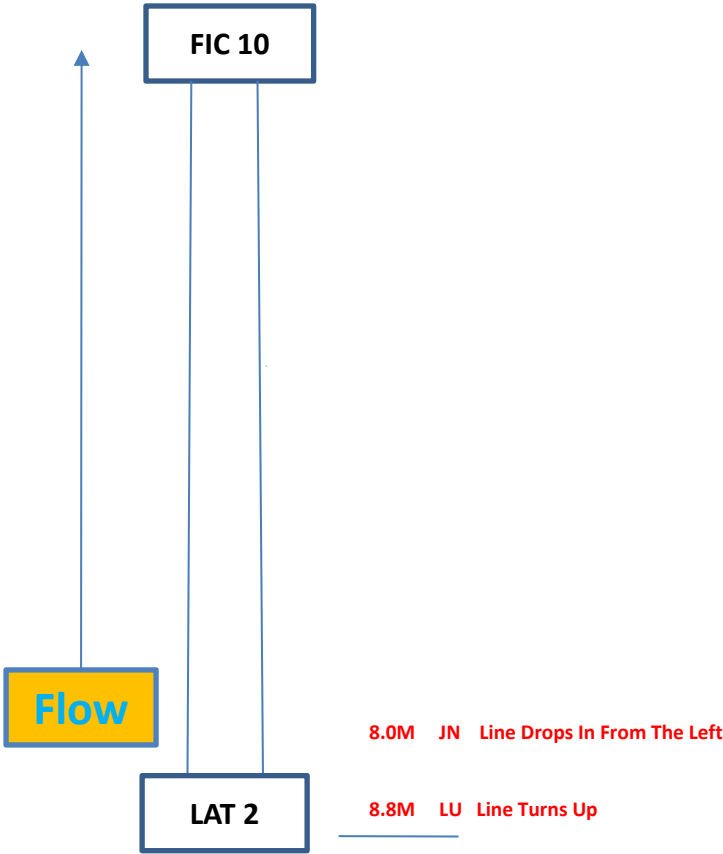
0.0M ST Start Of Survey  
0.0M WL Water Level 0 %

REM ; THERE ARE NO MAJOR PROBLEMS WITH THIS SECTION OF PIPE

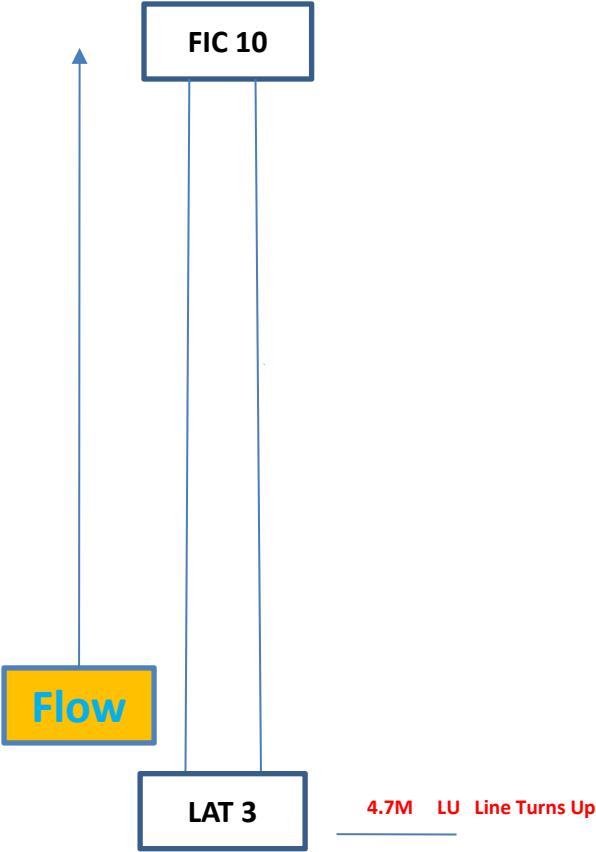
0.0M ST Start Of Survey  
0.0M WL Water Level 0 %

REM ; THERE ARE NO MAJOR PROBLEMS WITH THIS SECTION OF PIPE

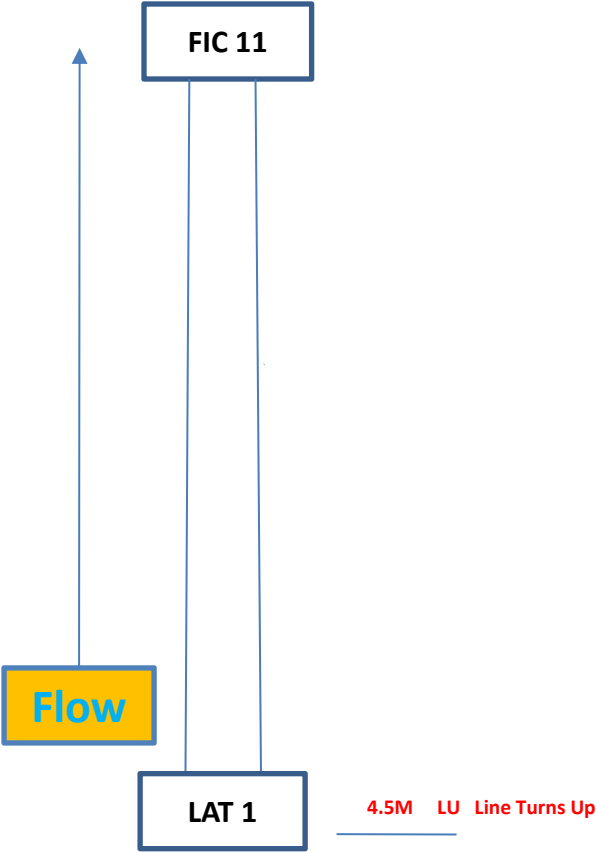
0.0M ST Start Of Survey  
0.0M WL Water Level 0 %

REM ; THERE ARE NO MAJOR PROBLEMS WITH THIS SECTION OF PIPE

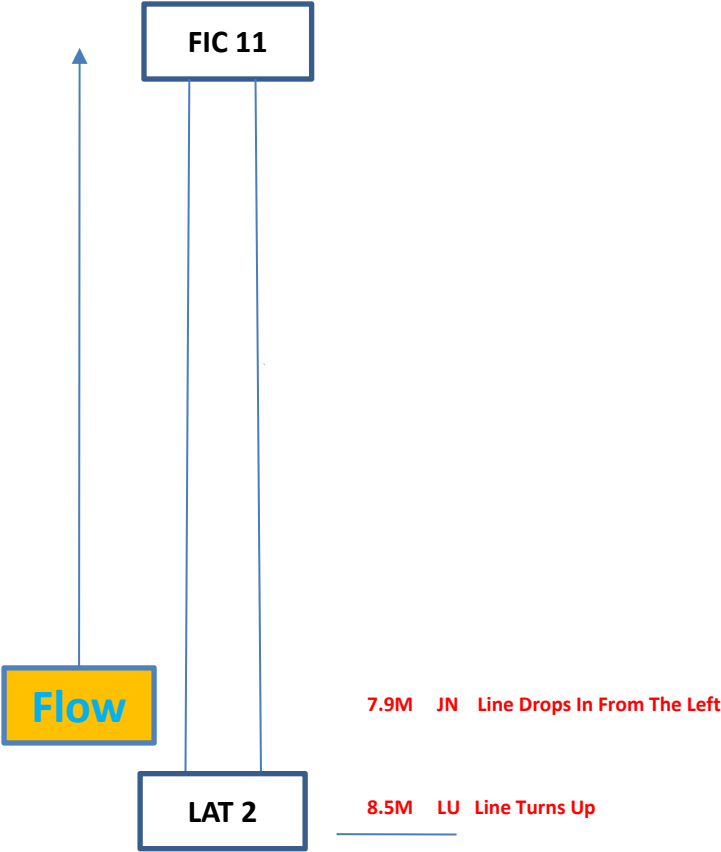
0.0M ST Start Of Survey  
0.0M WL Water Level 0 %

REM ; THERE ARE NO MAJOR PROBLEMS WITH THIS SECTION OF PIPE

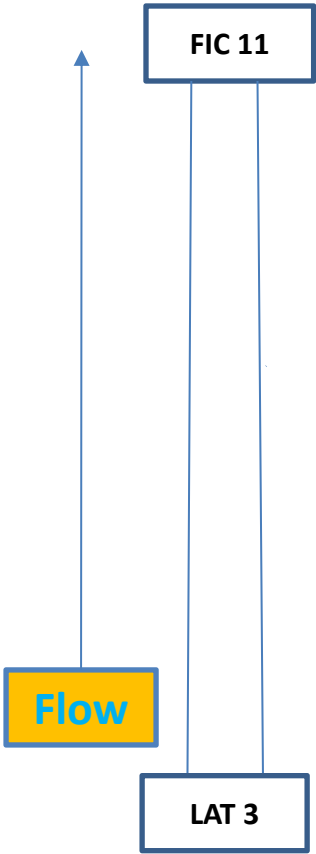
0.0M ST Start Of Survey  
0.0M WL Water Level 0 %

4.5M JN Line Drops In From The Right

8.8M JN Line Drops In From The Left

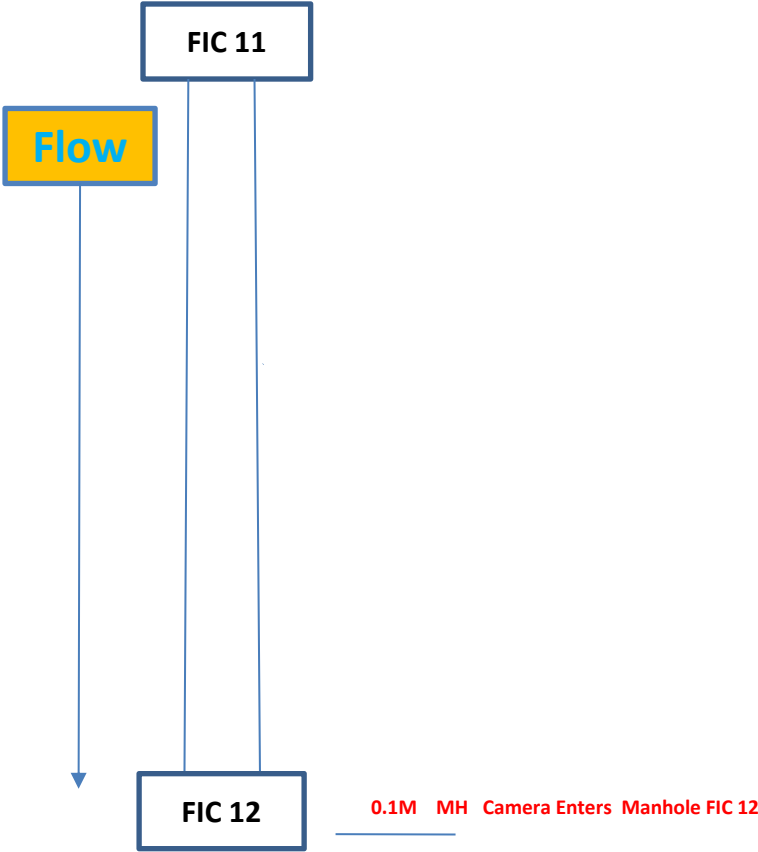
0.0M ST Start Of Survey  
0.0M WL Water Level 0 %

REM ; THERE ARE NO MAJOR PROBLEMS WITH THIS SECTION OF PIPE

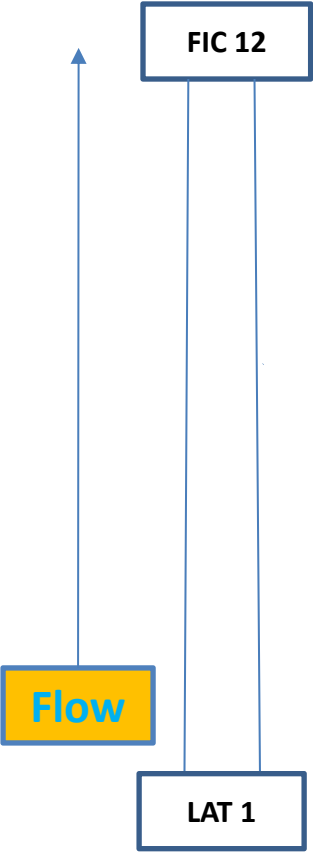
0.0M ST Start Of Survey  
0.0M WL Water Level 0 %

4.7M JN Line Drops In From The Right

8.6M JN Line Drops In From The Right

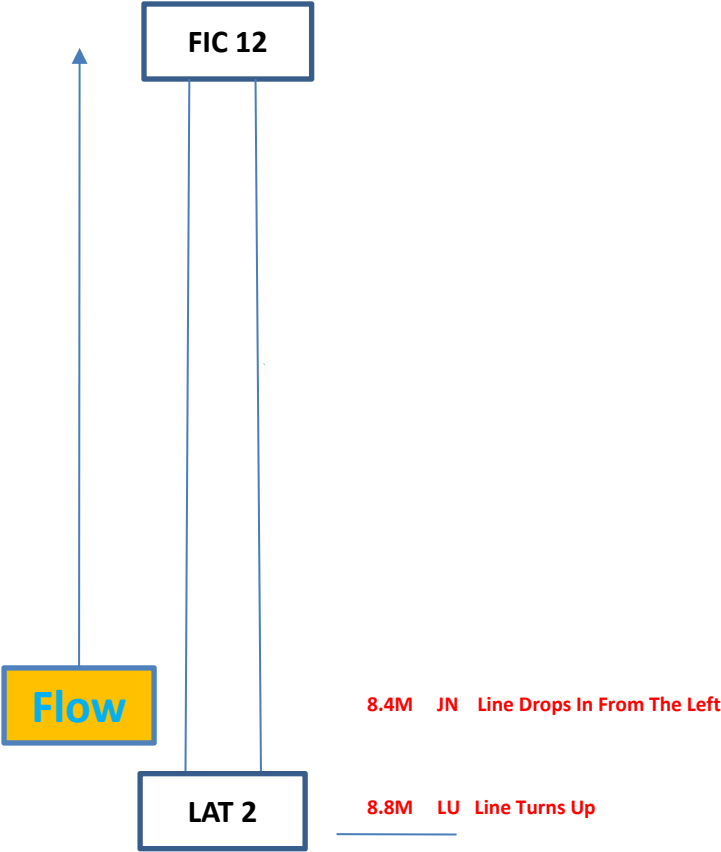
0.0M ST Start Of Survey  
0.0M WL Water Level 0 %

REM ; THERE ARE NO MAJOR PROBLEMS WITH THIS SECTION OF PIPE

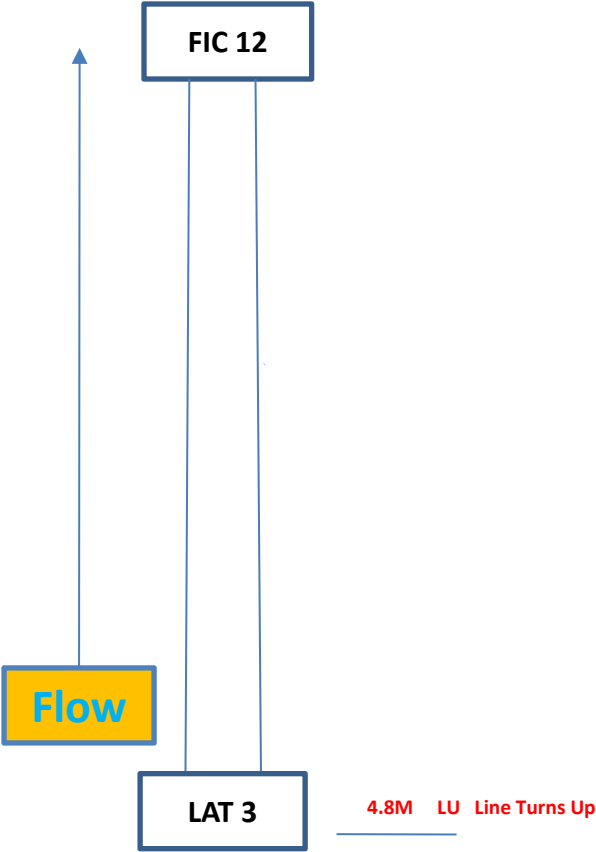
0.0M ST Start Of Survey  
0.0M WL Water Level 0 %

REM ; THERE ARE NO MAJOR PROBLEMS WITH THIS SECTION OF PIPE

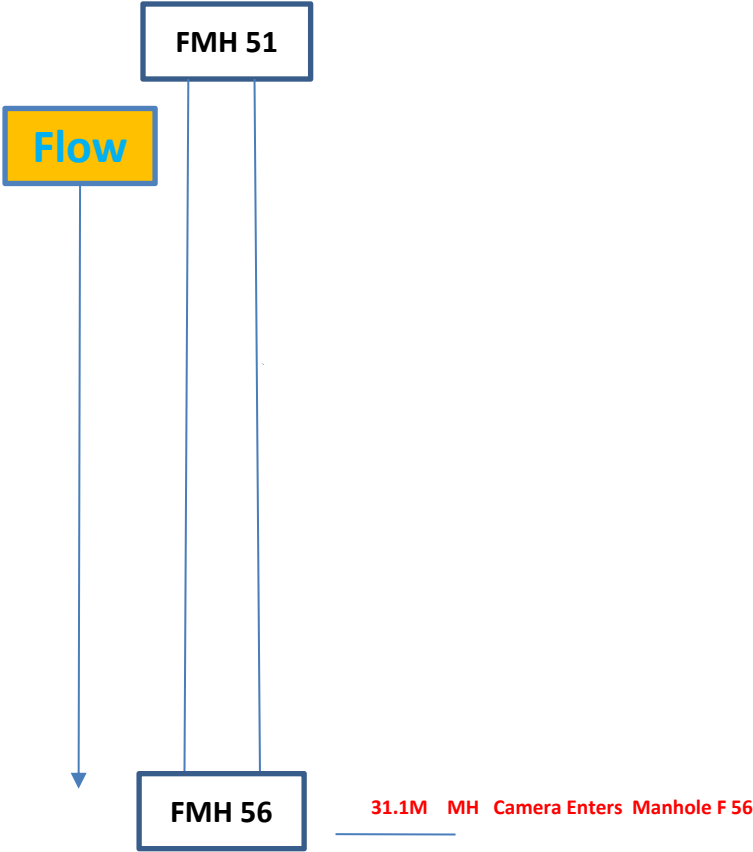
REM ; THERE ARE NO MAJOR PROBLEMS WITH THIS SECTION OF PIPE

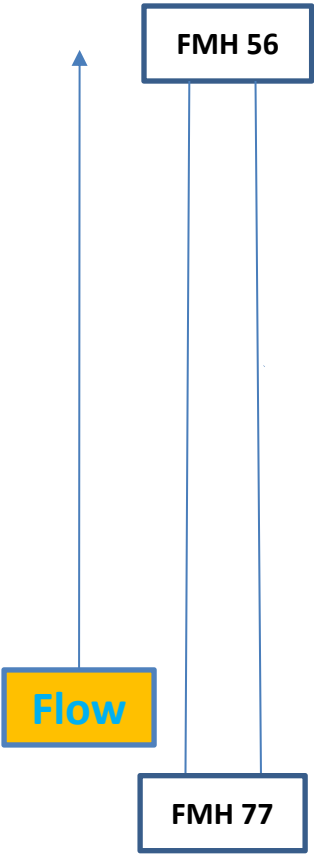
0.0M ST Start Of Survey  
0.0M WL Water Level 0 %  
0.3M JN Line Drops In From The Left

2.1M JN Line Drops In From The Right

REM ; THERE ARE NO MAJOR PROBLEMS WITH THIS SECTION OF PIPE

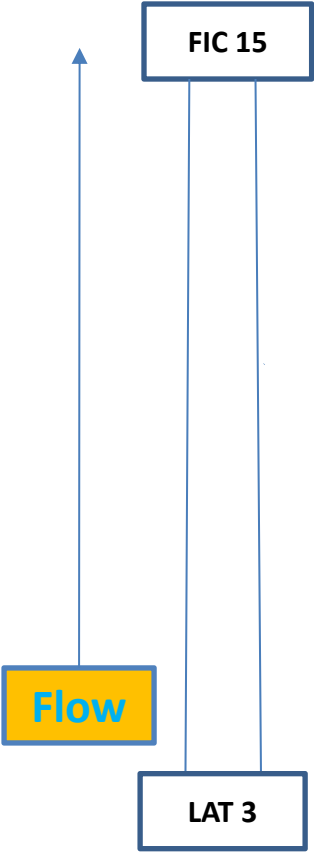
4.2M JN Line Drops In From The Right

9.0M JN Line Drops In From The Left

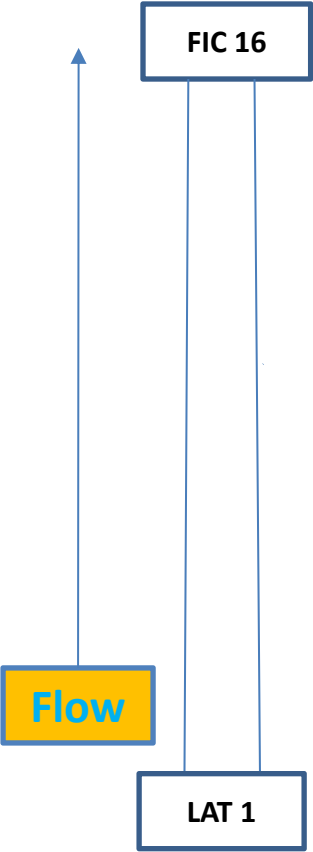
4.3M JN Line Drops In From The Left

8.0M JN Line Drops In From The Right
